Expertise

Protocol number: 44785717  
Order No. / Reference: 26192187  
Inspection date: 1 Apr 2026

Manufacturer: Ford

Model: Transit 310 L2H2 Lkw VA Trend

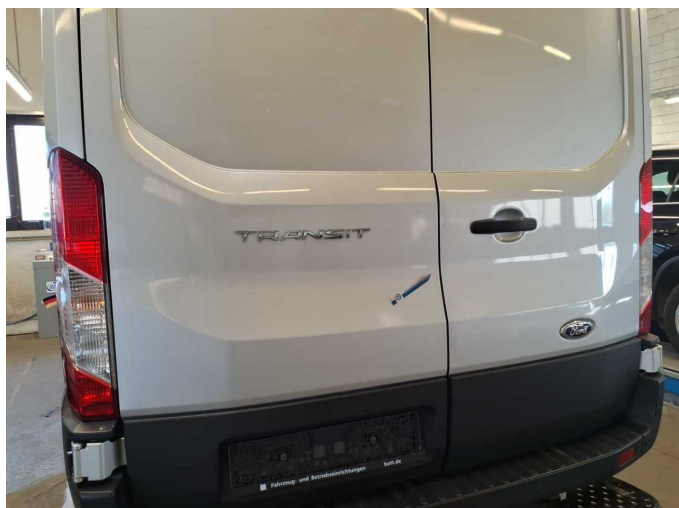
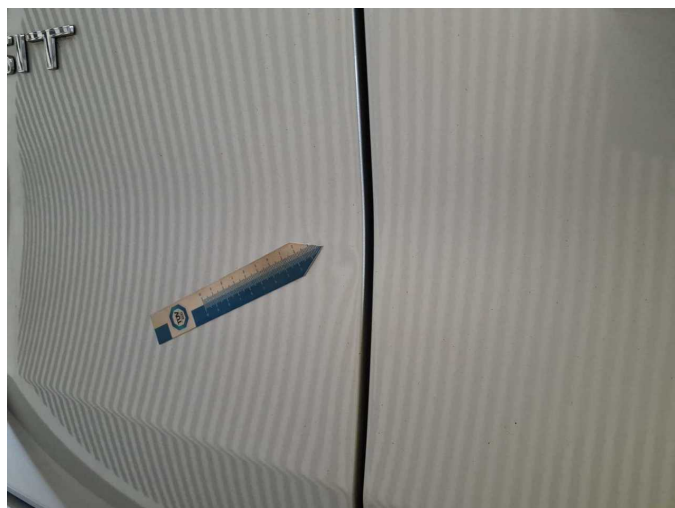
| No. | Component group | Description |
|---|---|---|
| 2 | Boot lid / rear door | Rear door - left side - dent(s) - Smooth repair work |

**Damage 2:** Boot lid / rear door: Rear door - left side - dent(s) - Smooth repair work

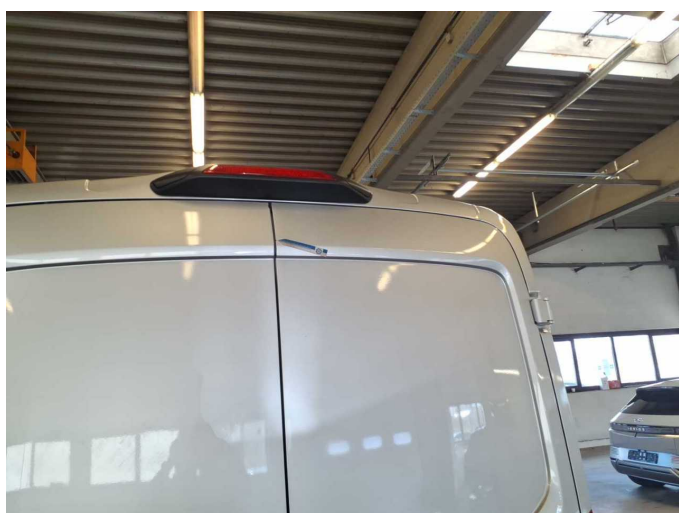
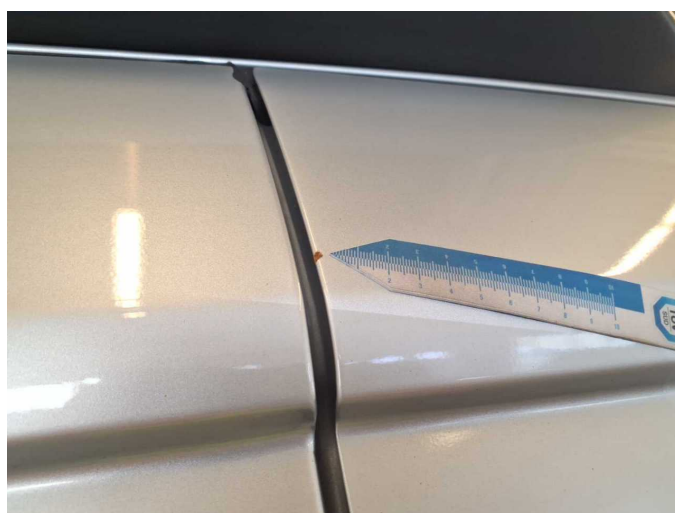
| No. | Component group | Description |
|---|---|---|
| 3 | Boot lid / rear door | Rear door - right side - Scratch(es) - Smart repair |

**Damage 3:** Boot lid / rear door: Rear door - right side - Scratch(es) - Smart repair

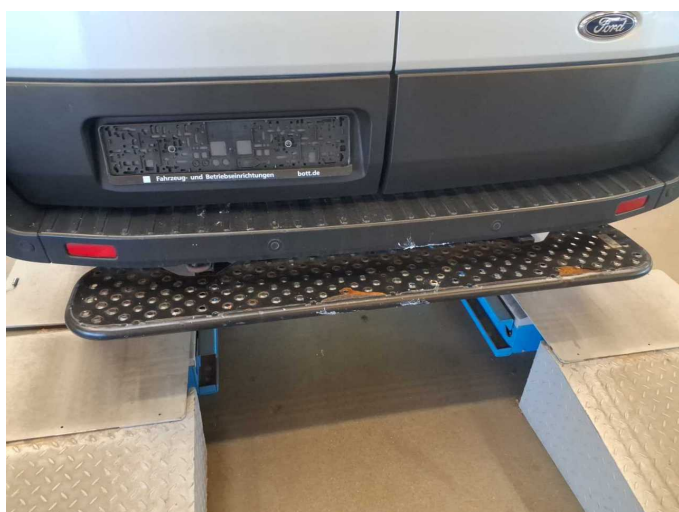
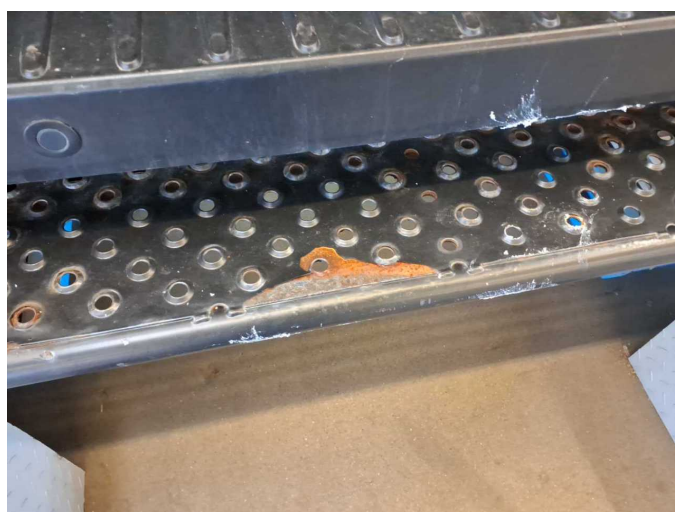
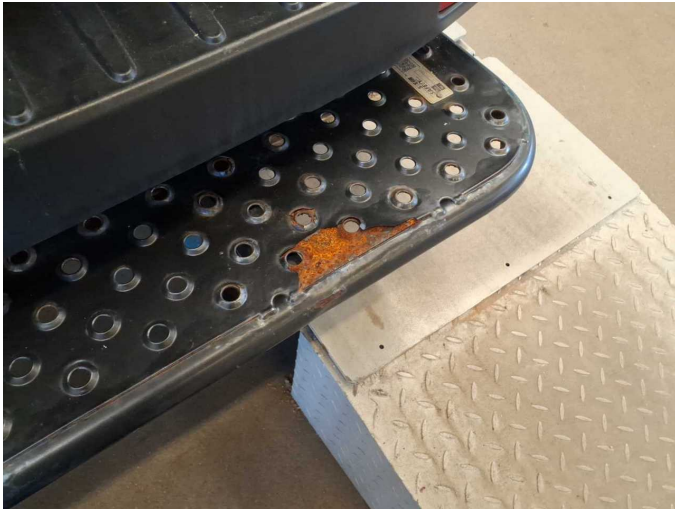
| No. | Component group | Description |
|---|---|---|
| 4 | Rear of vehicle | Foot plate - Paint defect - Loss in value |

**Damage 4:** Rear of vehicle: Foot plate - Paint defect - Loss in value

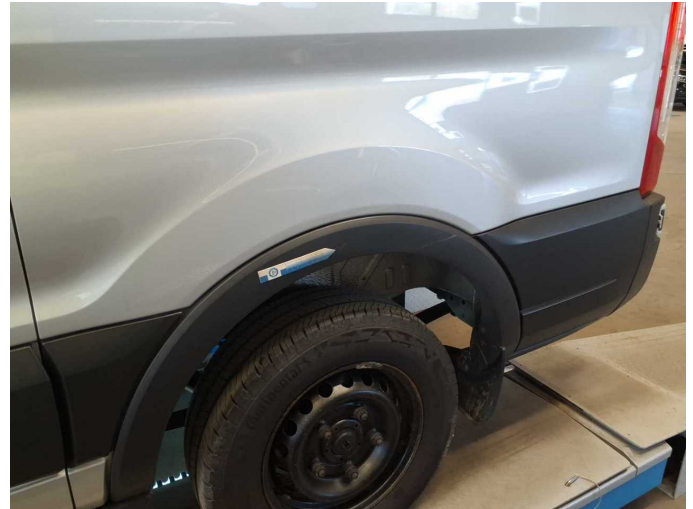
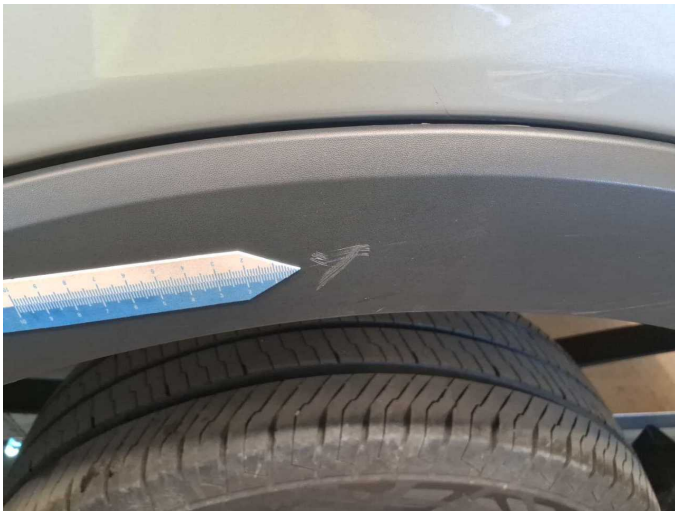
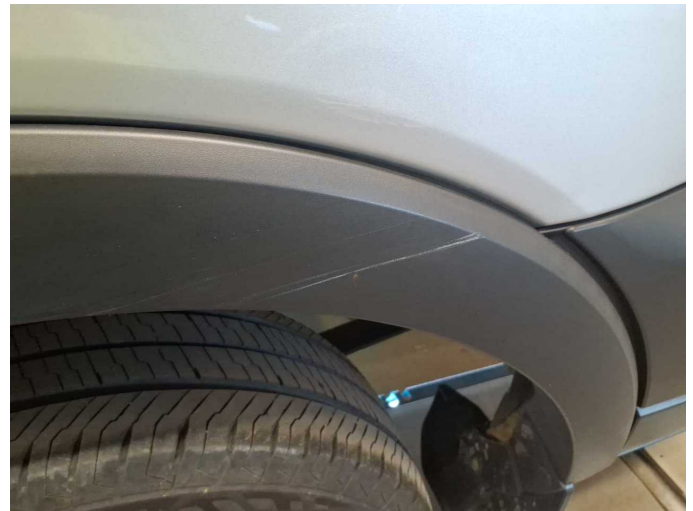
| No. | Component group | Description |
|---|---|---|
| 5 | Side panel - rear left side | Wheel well extension - Scratch(es) - Loss in value |

**Damage 5:** Side panel - rear left side: Wheel well extension - Scratch(es) - Loss in value

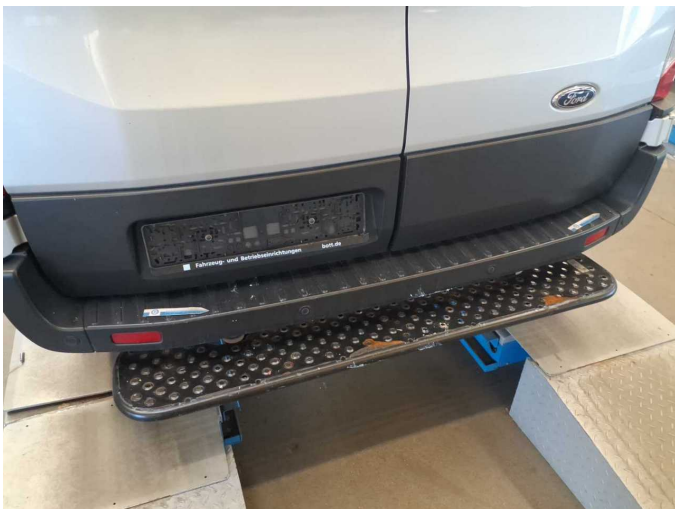
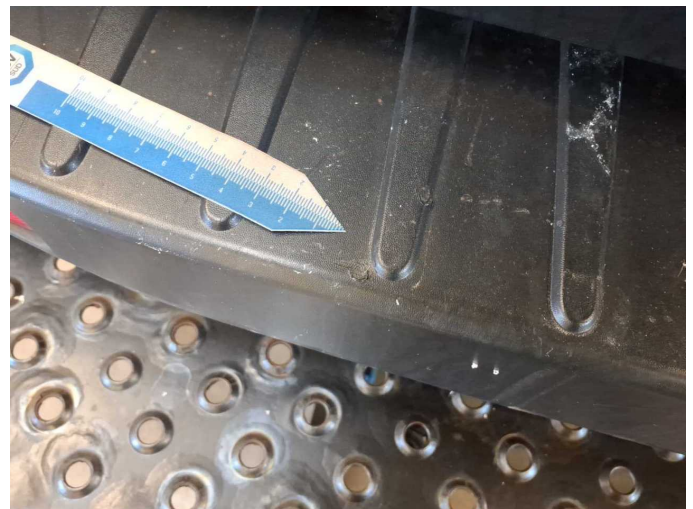
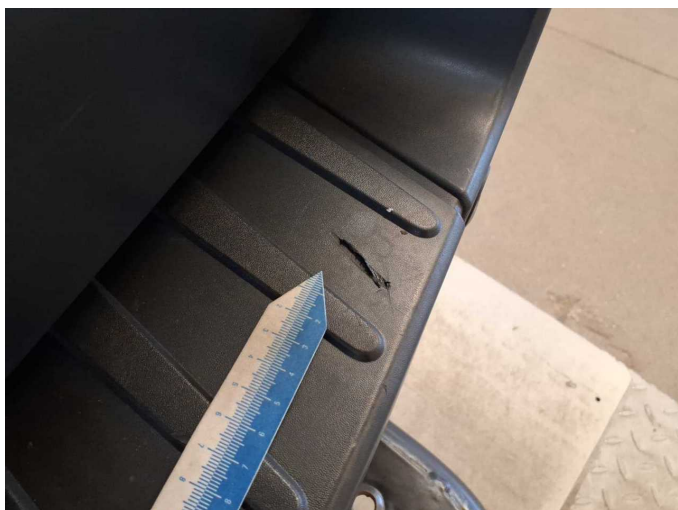
| No. | Component group | Description |
|---|---|---|
| 6 | Rear bumper | Rear bumper (unpainted) - Scratch(es) - Loss in value |

**Damage 6:** Rear bumper: Rear bumper (unpainted) - Scratch(es) - Loss in value

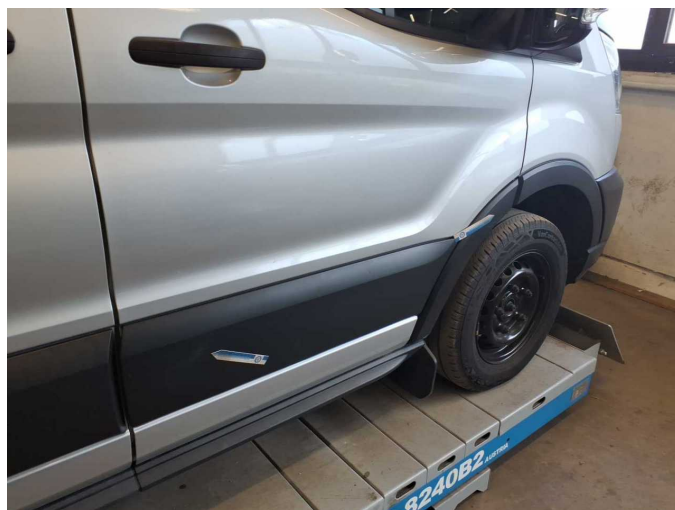
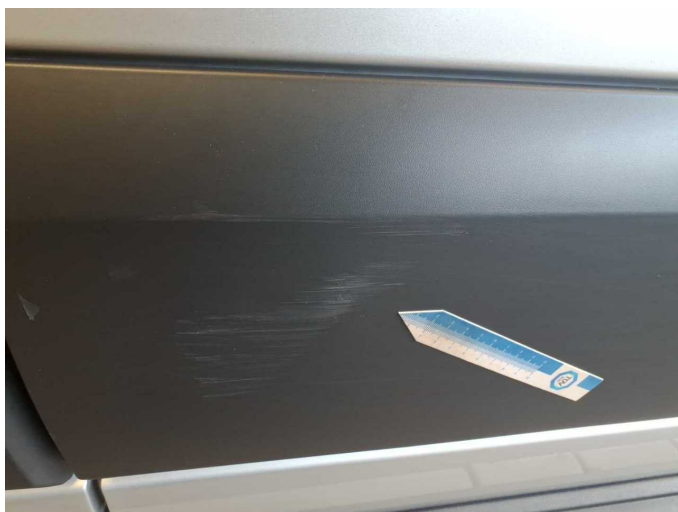
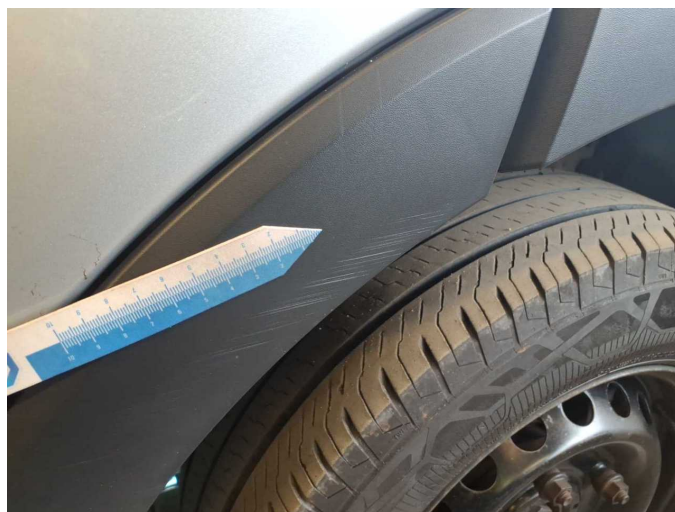
| No. | Component group | Description |
|---|---|---|
| 7 | Door - front right side | Door (Verkleidung außen) - Scratch(es) - Loss in value |

**Damage 7:** Door - front right side: Door (Verkleidung außen) - Scratch(es) - Loss in value

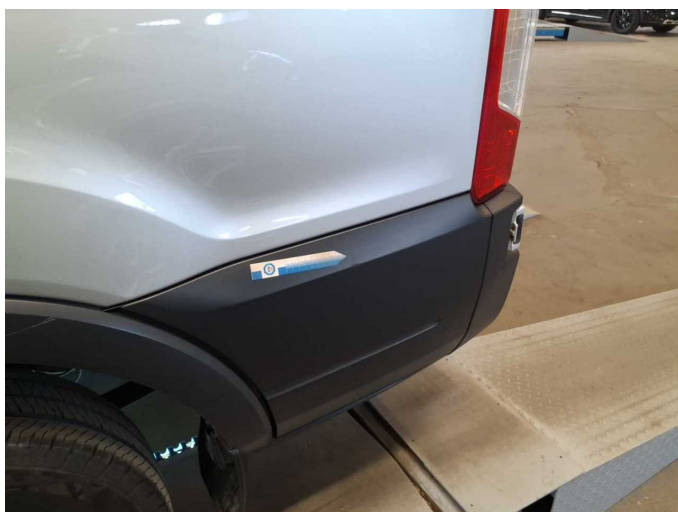
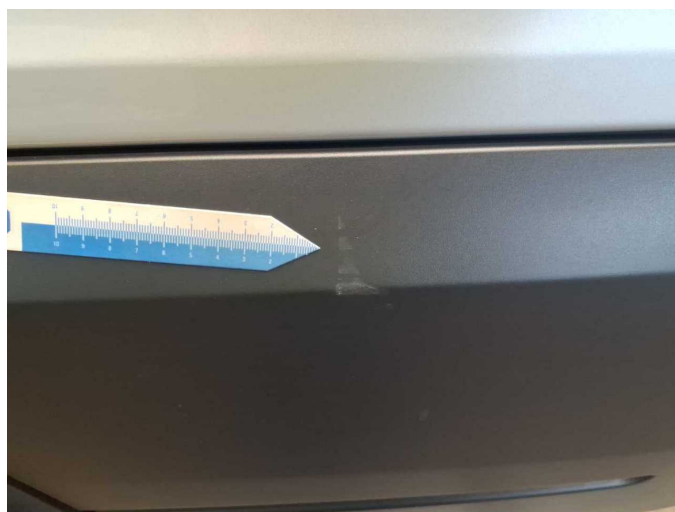
| No. | Component group | Description |
|---|---|---|
| 8 | Trim / covers | Trim / covers (Seitenwand links) - Scratch(es) - Loss in value |

**Damage 8:** Trim / covers: Trim / covers (Seitenwand links) - Scratch(es) - Loss in value

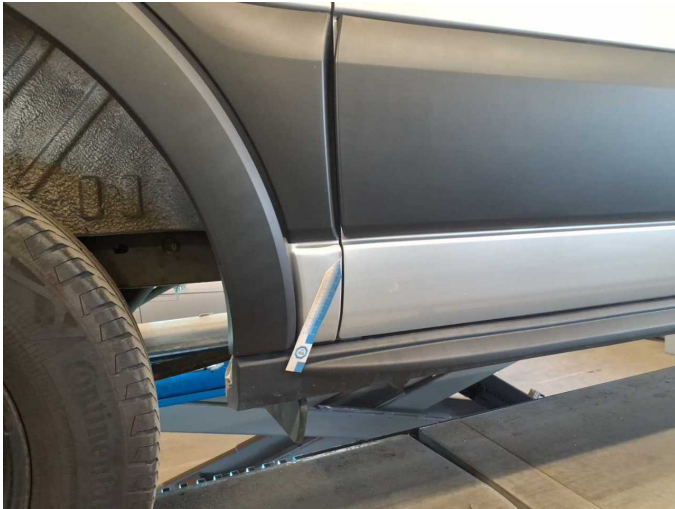
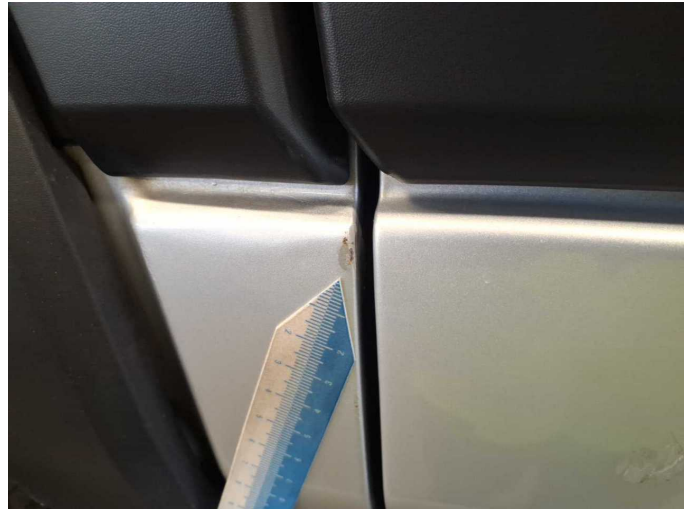
| No. | Component group | Description |
|---|---|---|
| 9 | Side panel - rear right side | Side panel - Scratch(es) - Smart repair |

**Damage 9:** Side panel - rear right side: Side panel - Scratch(es) - Smart repair

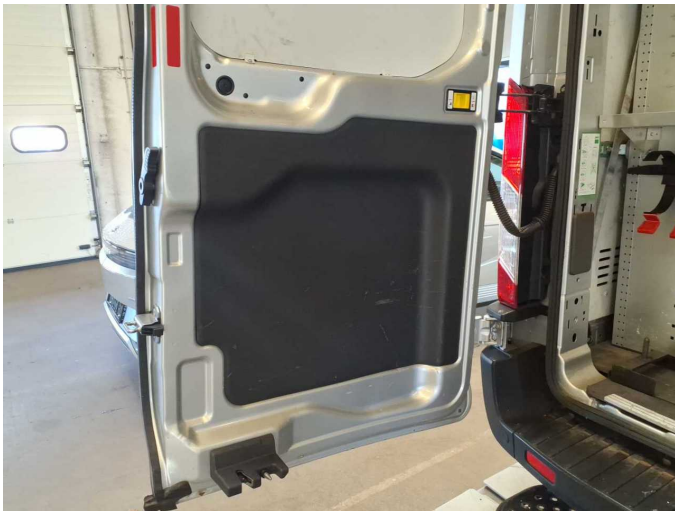
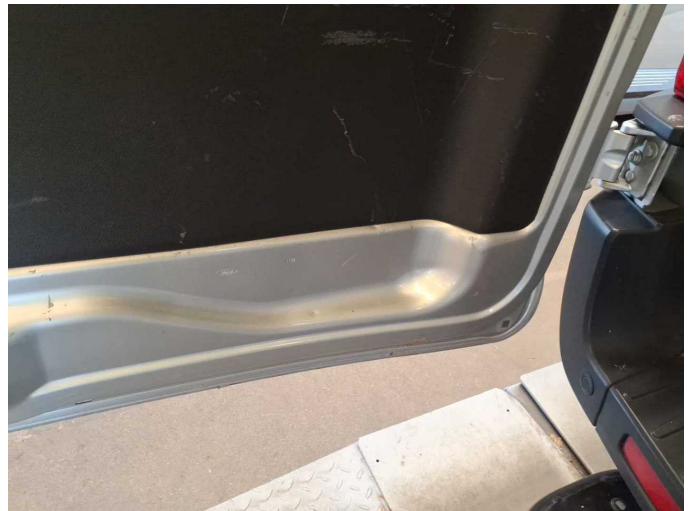
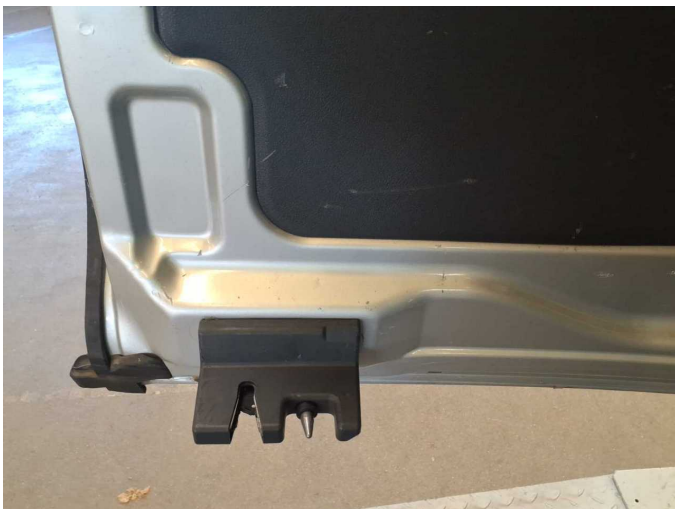
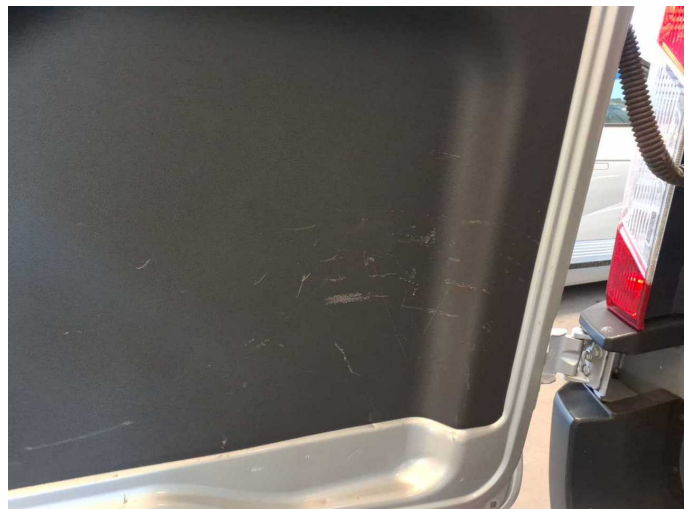
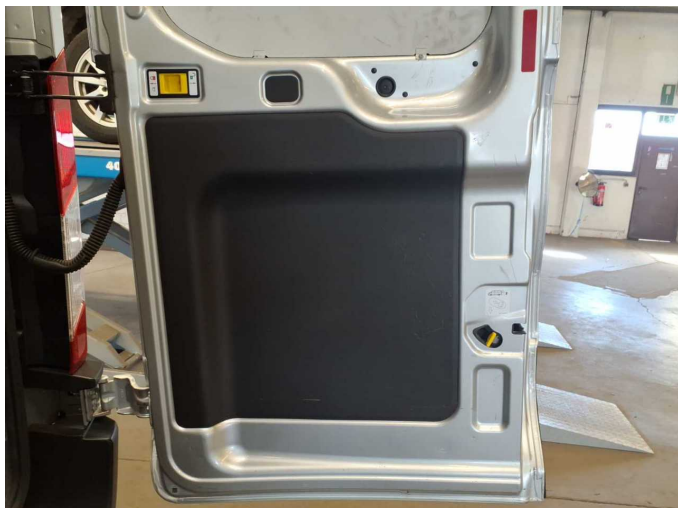
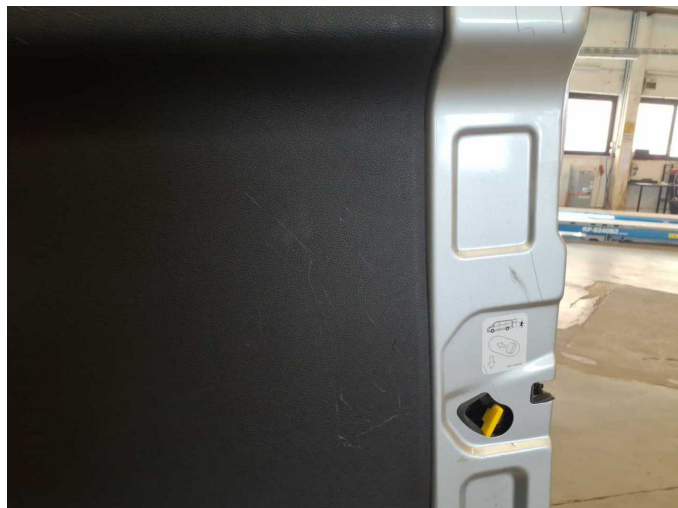
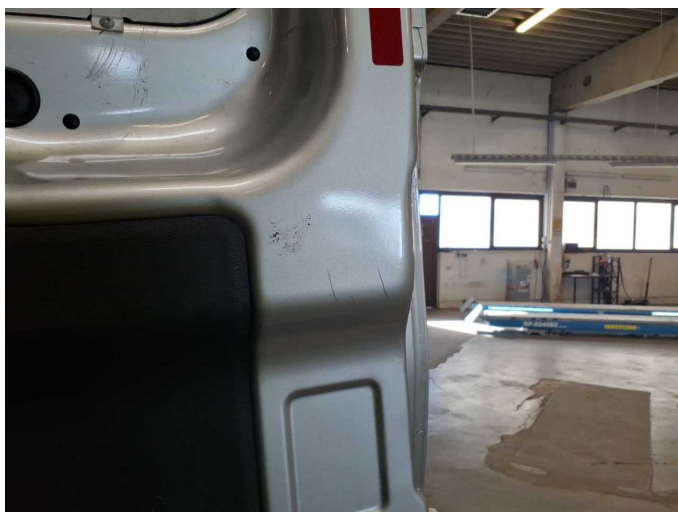
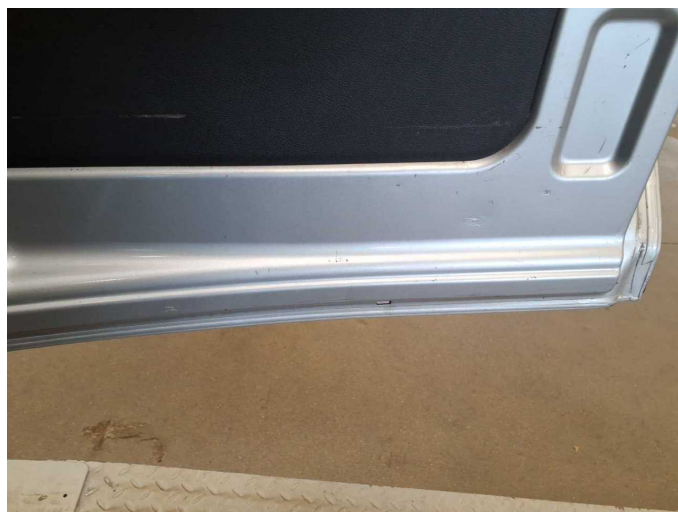
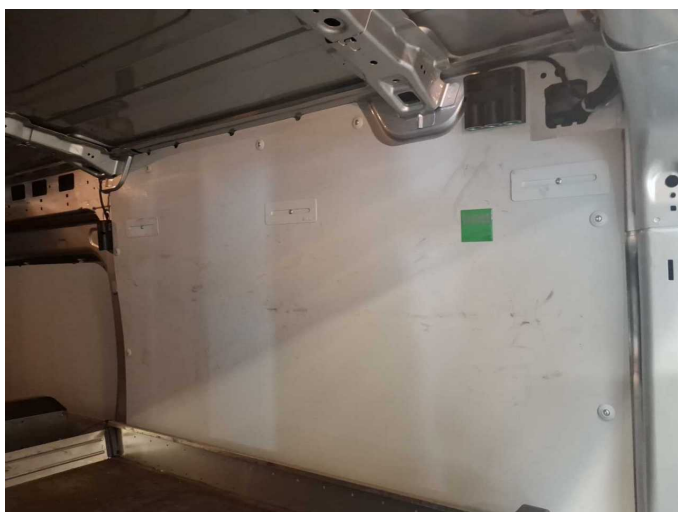
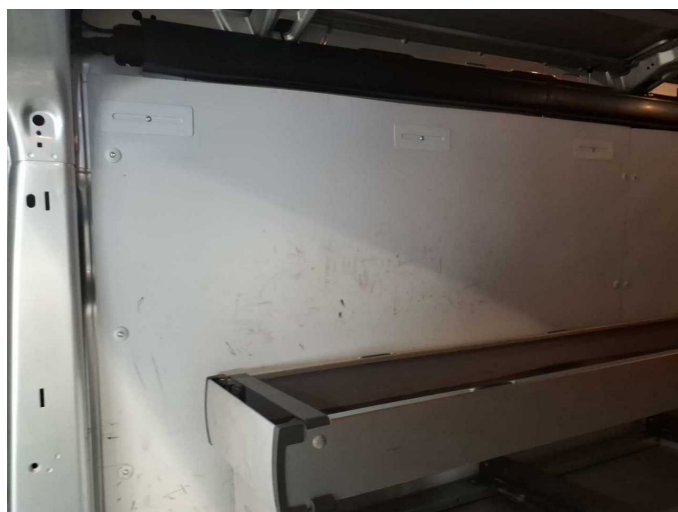
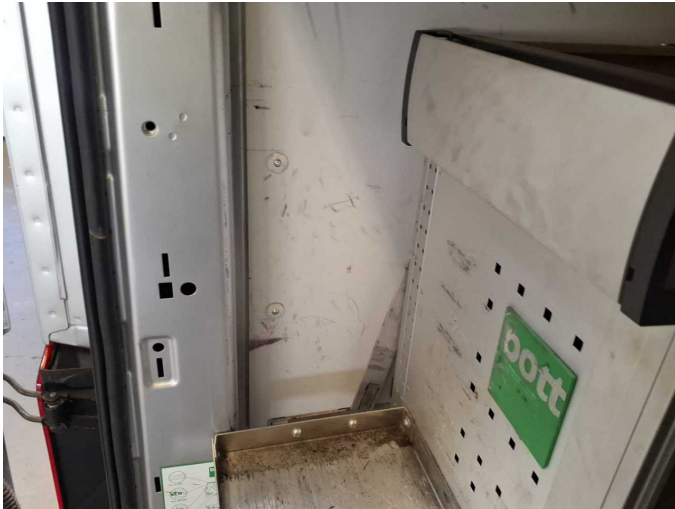
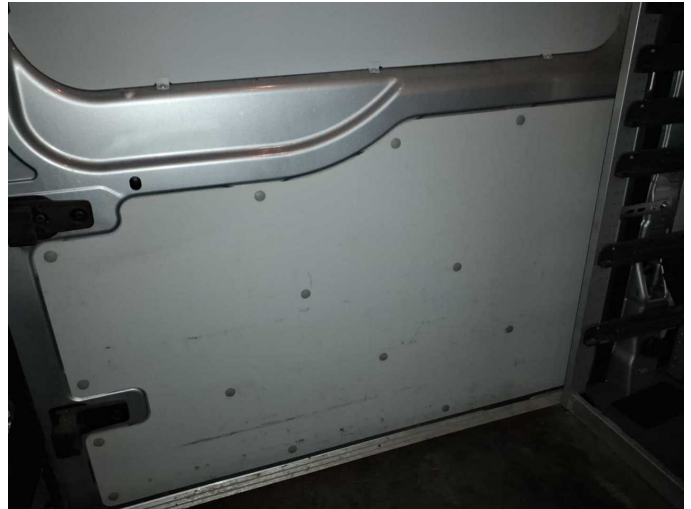
| No. | Component group | Description |
|---|---|---|
| 10 | Interior | Cargo space partition - Scratched - Loss in value |

**Damage 10:** Interior: Cargo space partition - Scratched - Loss in value

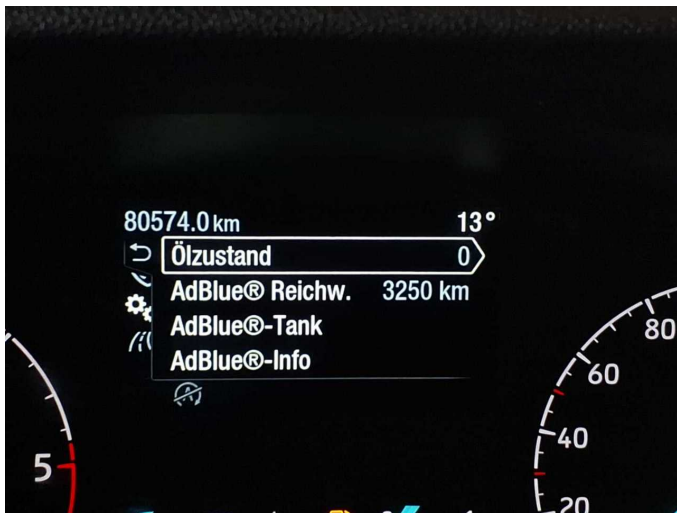
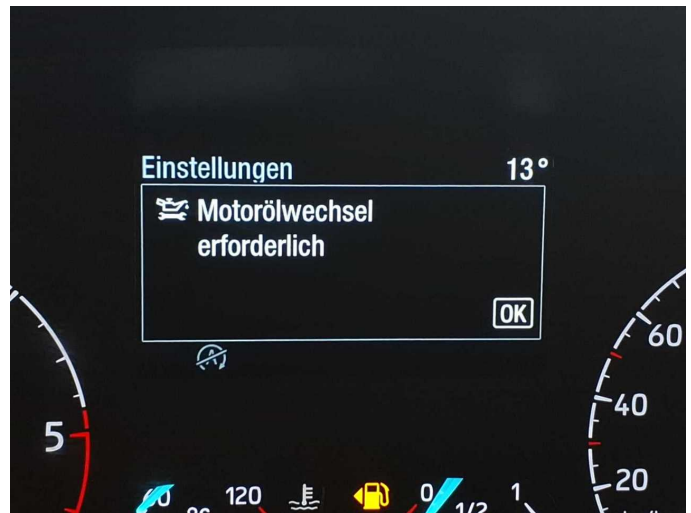
| No. | Component group | Description |
|---|---|---|
| 11 | Misc. | Inspection / maintenance - Due - Perform |

**Damage 11:** Misc.: Inspection / maintenance - Due - Perform

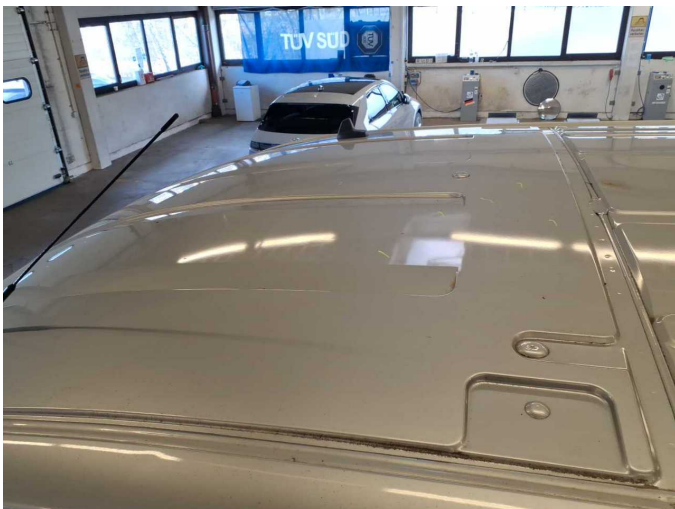
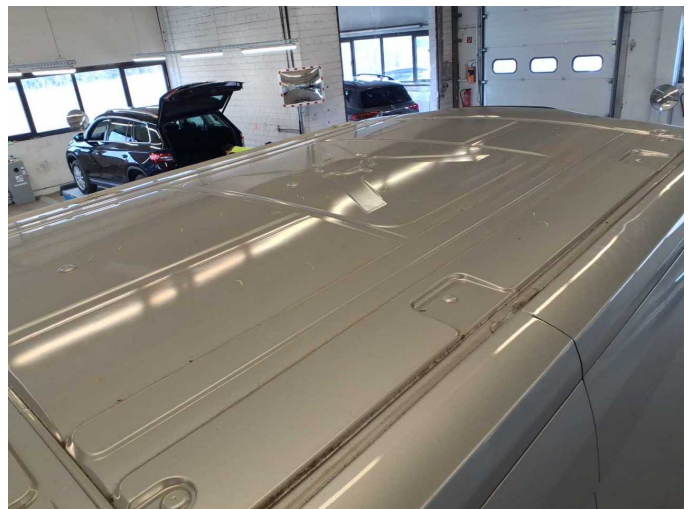
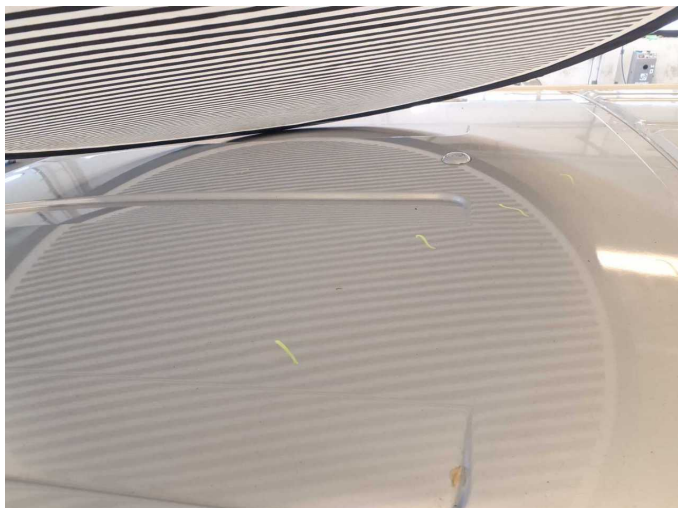
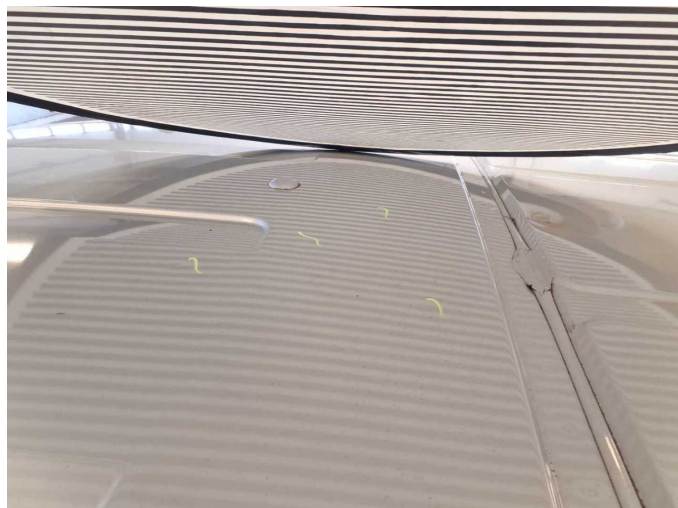
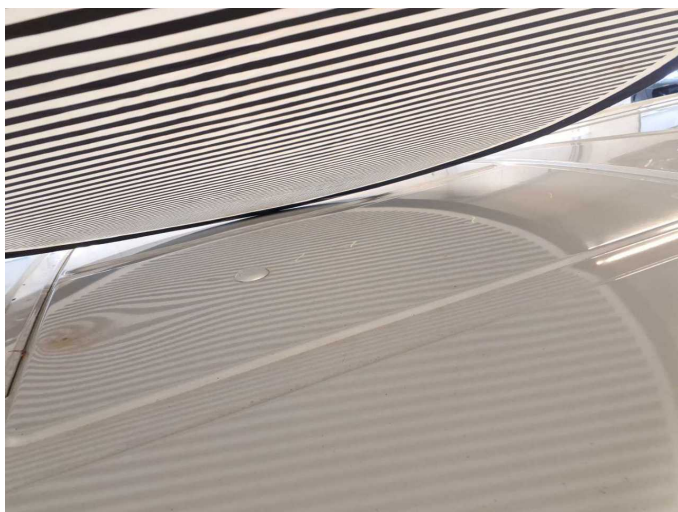
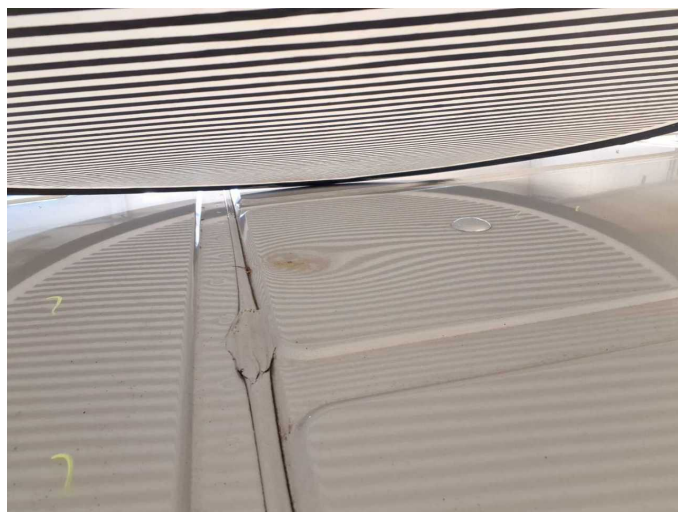
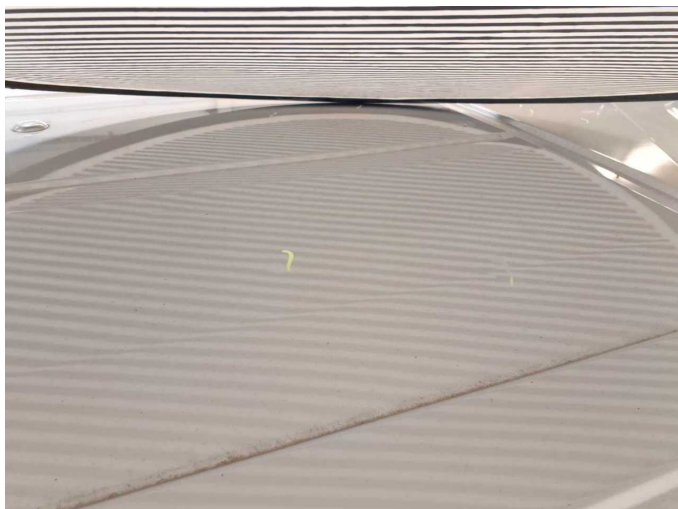
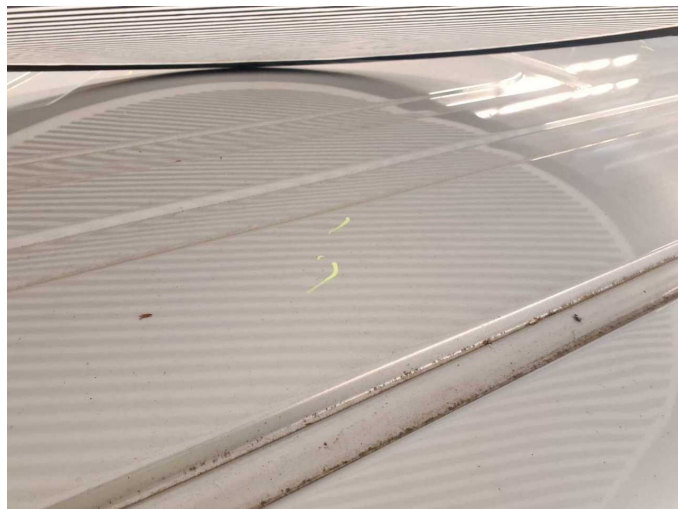
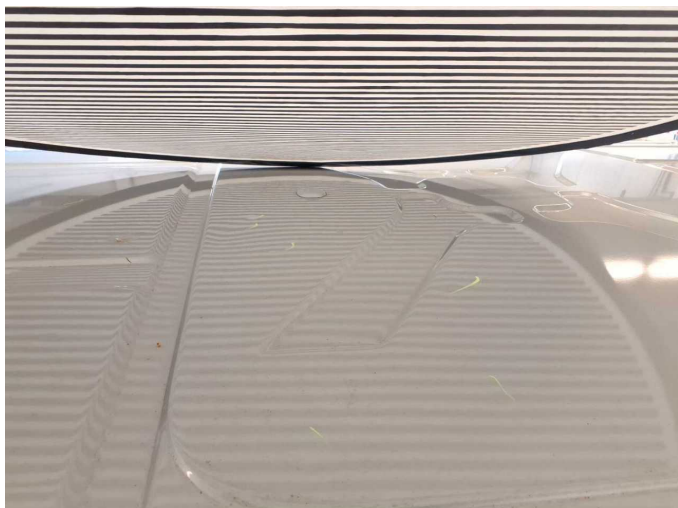
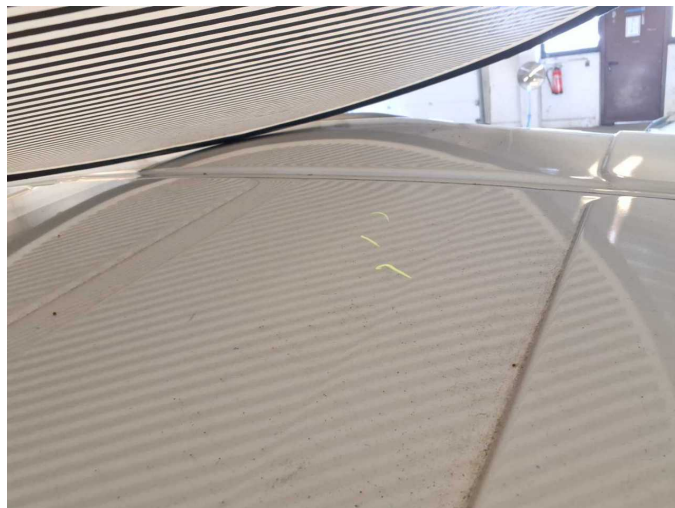
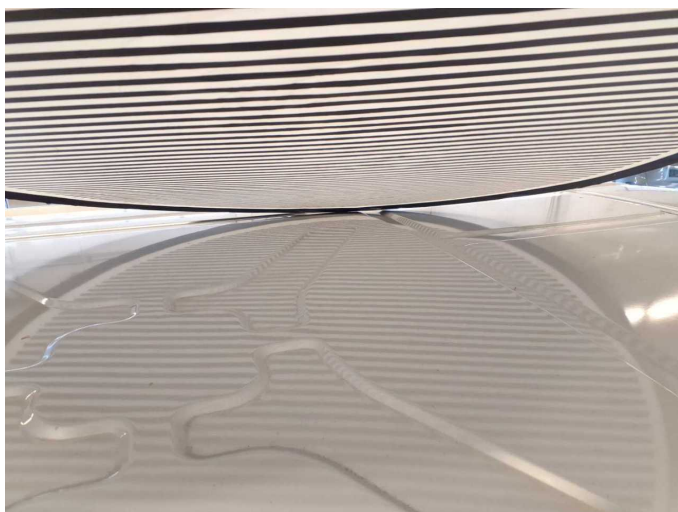
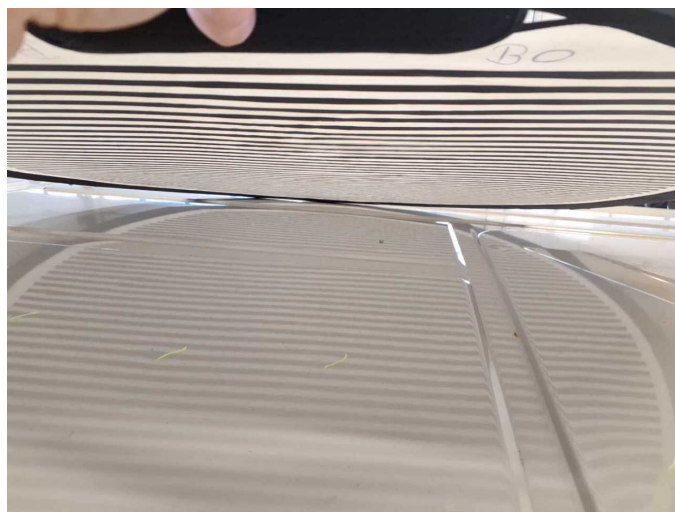
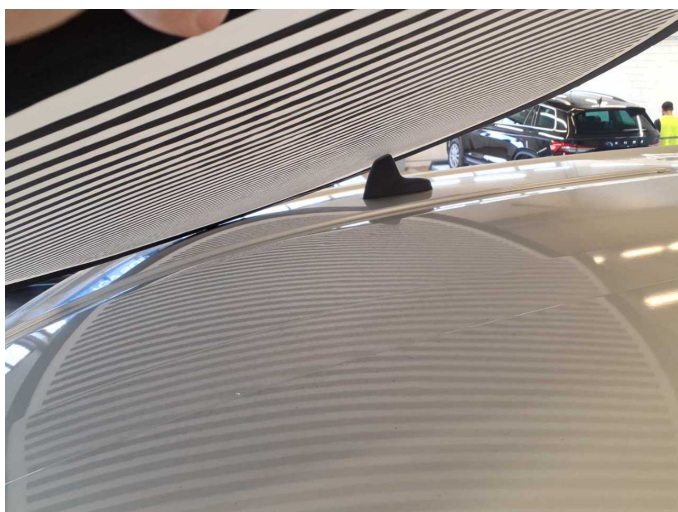
| No. | Component group | Description |
|---|---|---|
| 12 | Roof | Roof (Dellen+ Verformung) - Deformed - repair according to calculation |

**Damage 12:** Roof: Roof (Dellen+ Verformung) - Deformed - repair according to calculation

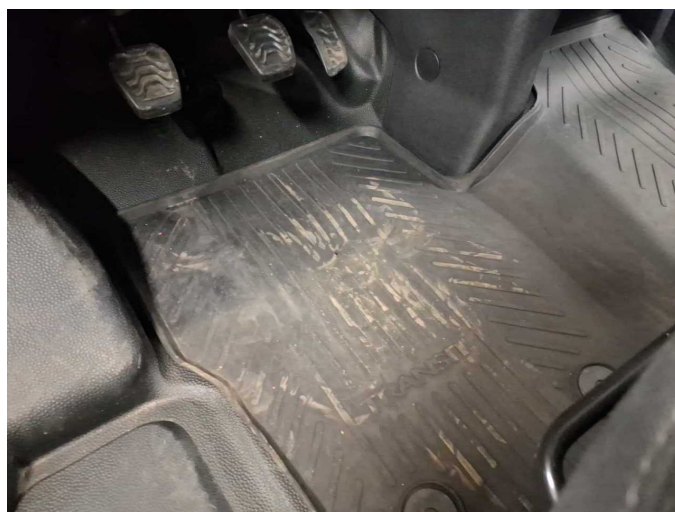
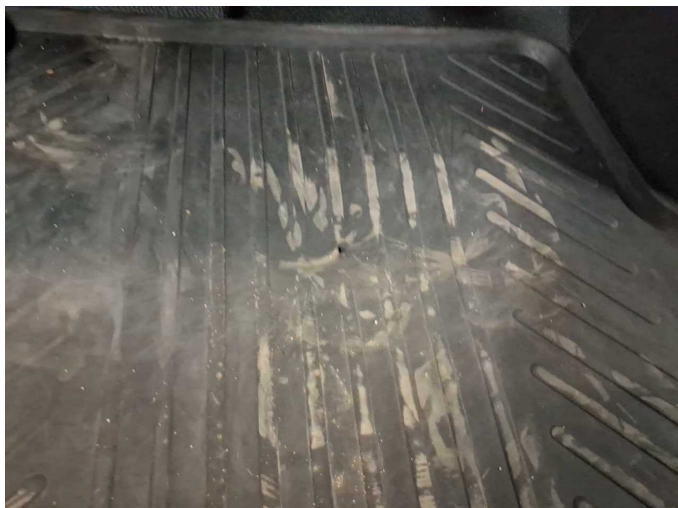
| No. | Component group | Description |
|---|---|---|
| 7 | Trim / covers | Floor mats - Holes - No deduction |

**Wear and tear 7:** Trim / covers: Floor mats - Holes - No deduction
