Expertise

Protocol number: 46471719  
Order No. / Reference: 26493697  
Inspection date: 7 Jul 2026

Manufacturer: Mercedes-Benz  
VIN: W1V3KBFZXT862042

Model: 317 CDI Sprinter Standard HA -PRO

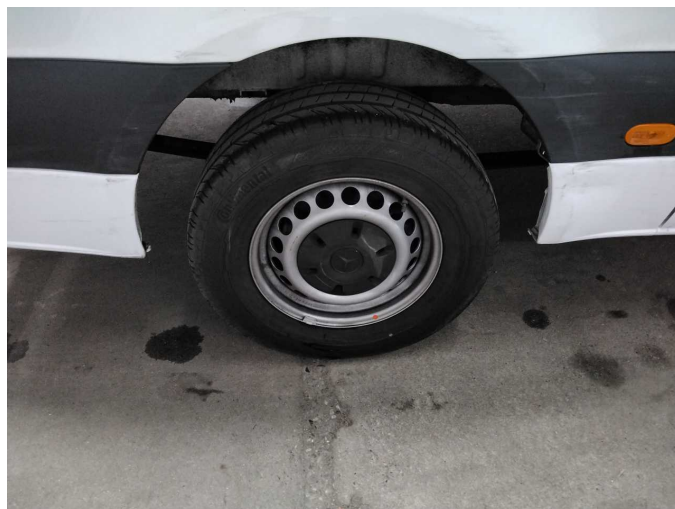
| No. | Component group | Description |
|---|---|---|
| 1 | Wheel / tyres | Wheel cover - rear right side - Scratch(es) - Replace |

**Damage 1:** Wheel / tyres: Wheel cover - rear right side - Scratch(es) - Replace

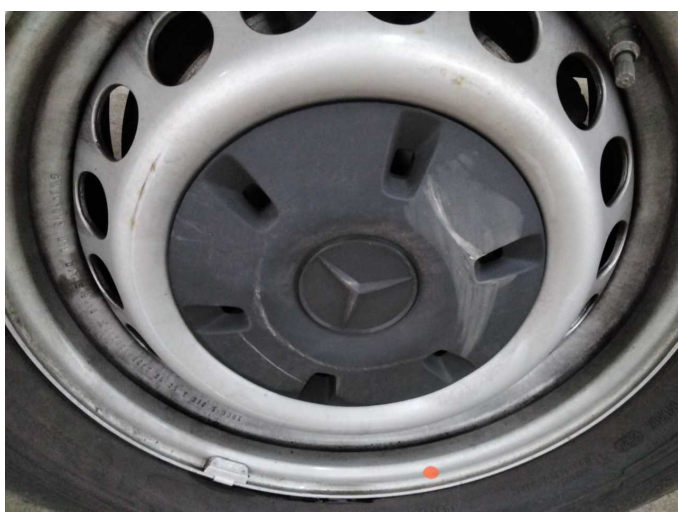
**Damage 1:** Wheel / tyres: Wheel cover - rear right side - Scratch(es) - Replace

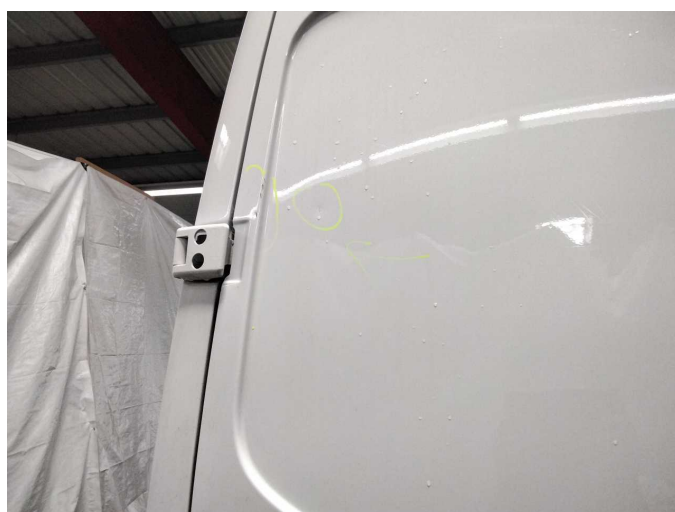
| No. | Component group | Description |
|---|---|---|
| 2 | Boot lid / rear door | Rear door - left side - Dent / paintcoat damage - Smart repair |

**Damage 2:** Boot lid / rear door: Rear door - left side - Dent / paintcoat damage - Smart repair

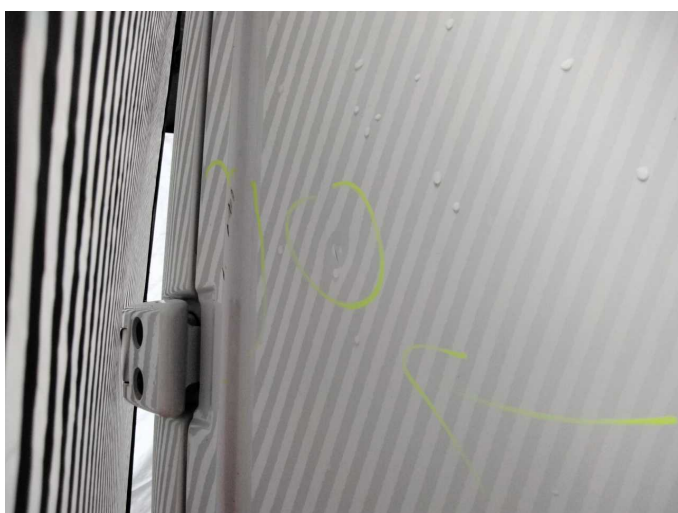
**Damage 2:** Boot lid / rear door: Rear door - left side - Dent / paintcoat damage - Smart repair

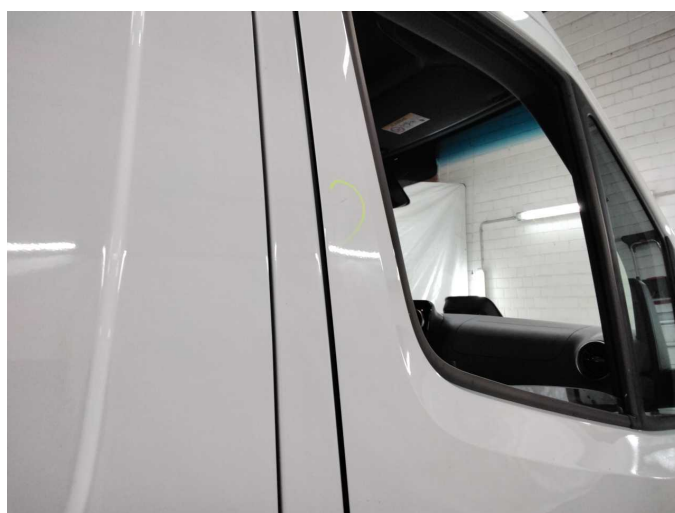
| No. | Component group | Description |
|---|---|---|
| 3 | Door - front right side | Door - Dent / paintcoat damage - Smart repair |

**Damage 3:** Door - front right side: Door - Dent / paintcoat damage - Smart repair

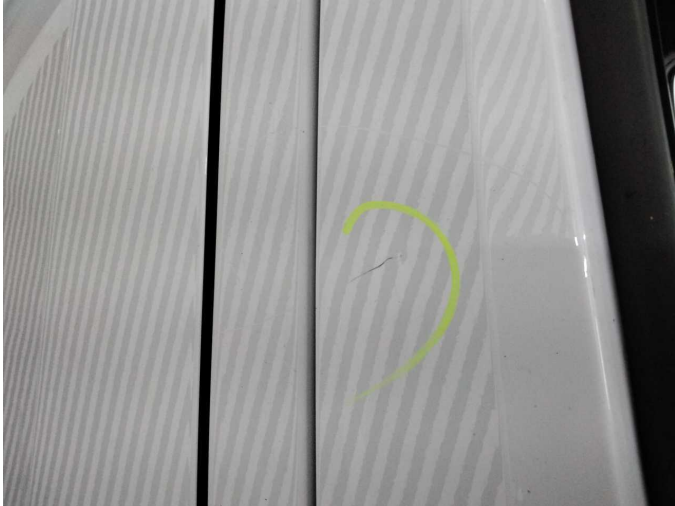
**Damage 3:** Door - front right side: Door - Dent / paintcoat damage - Smart repair

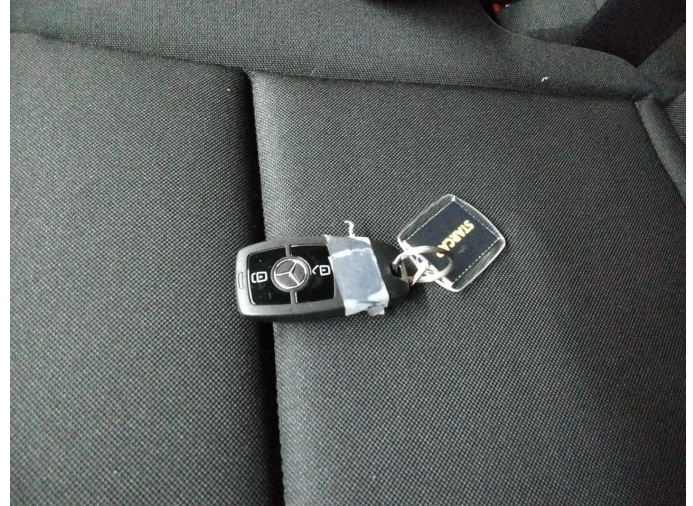
Equipment - Vehicle key

**Missing part 1:** Equipment: Vehicle key - Missing - Replace

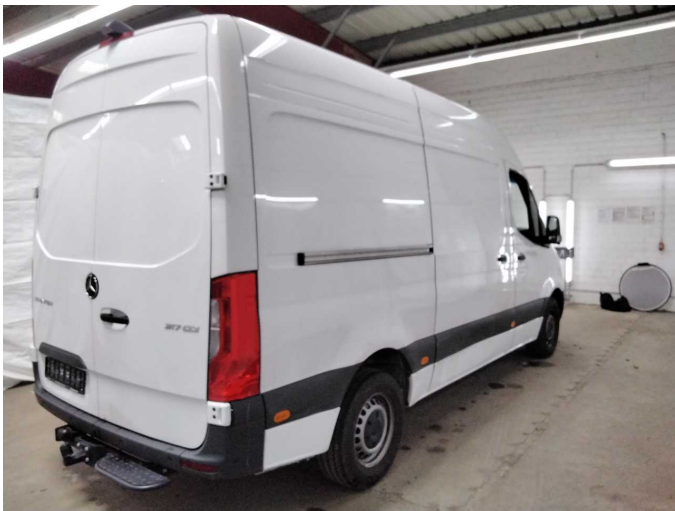
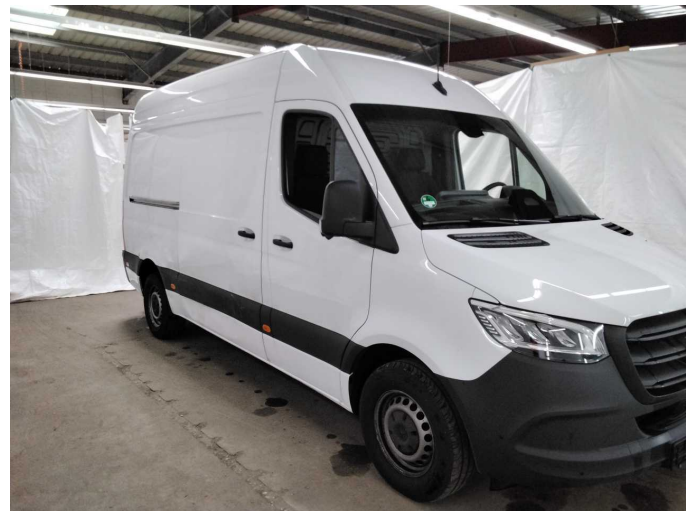
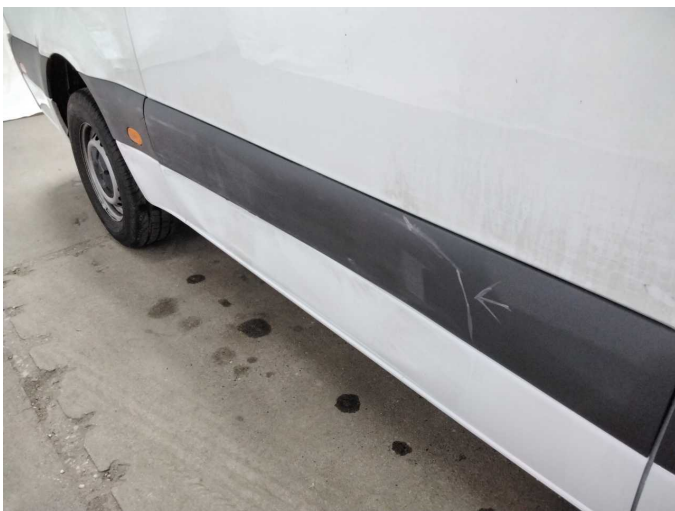
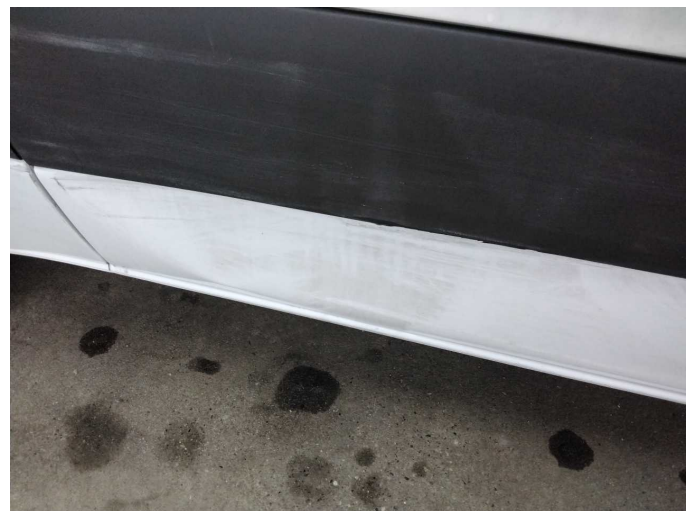
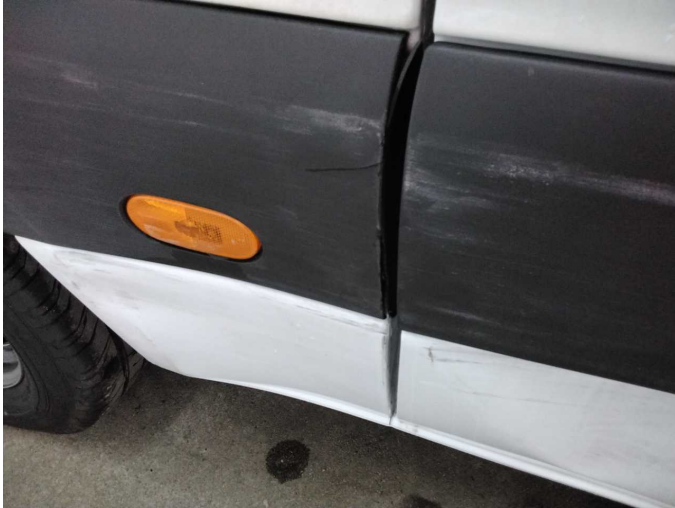
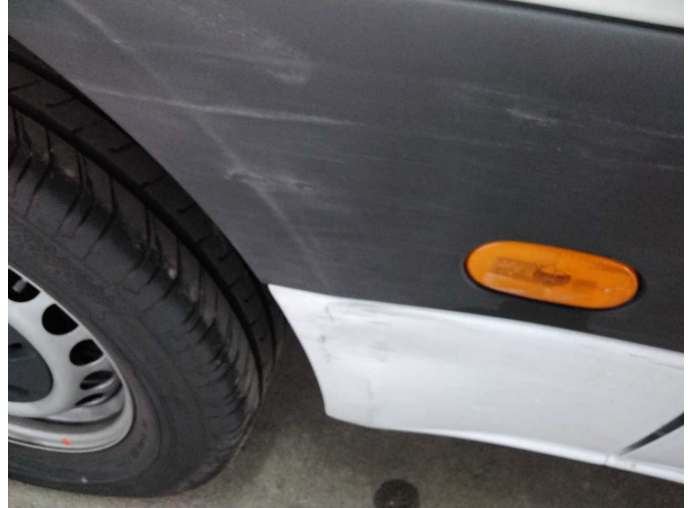
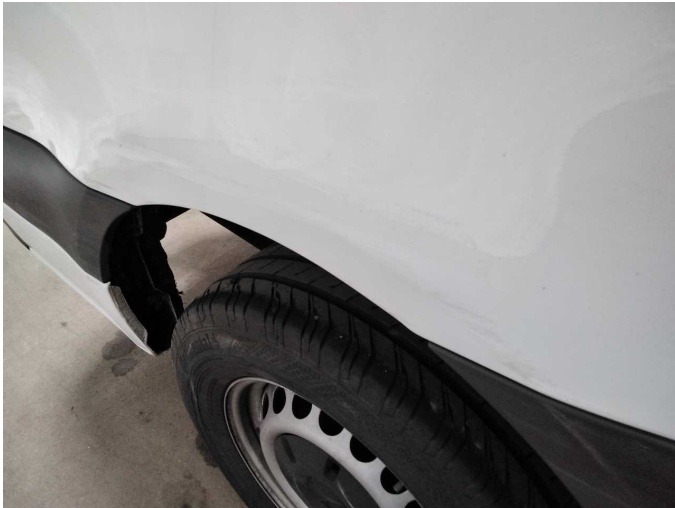
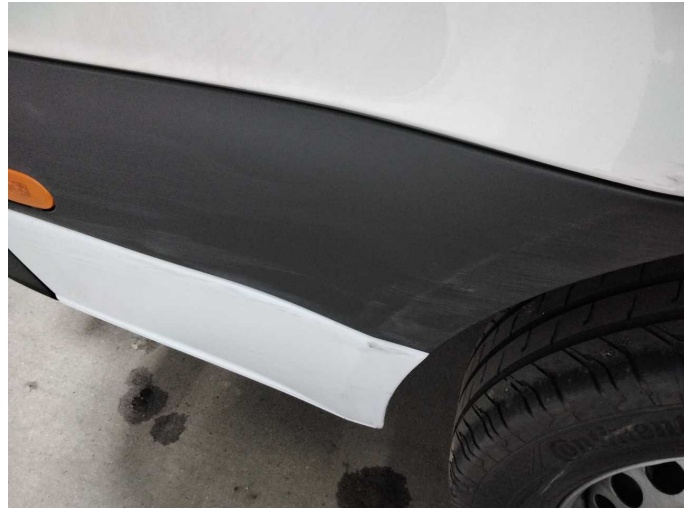
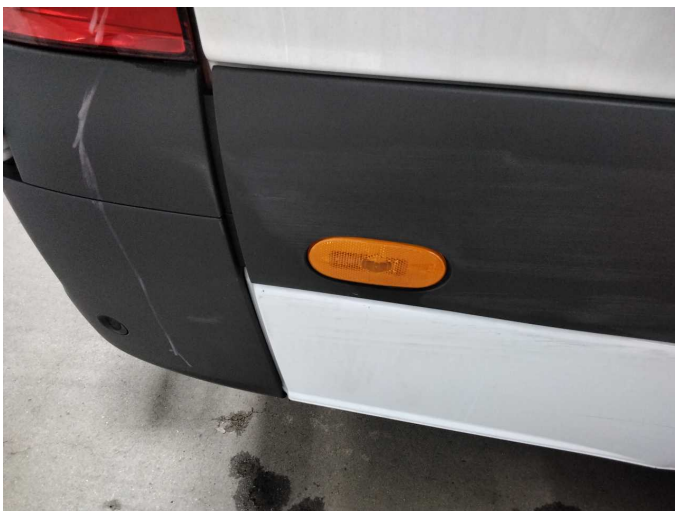
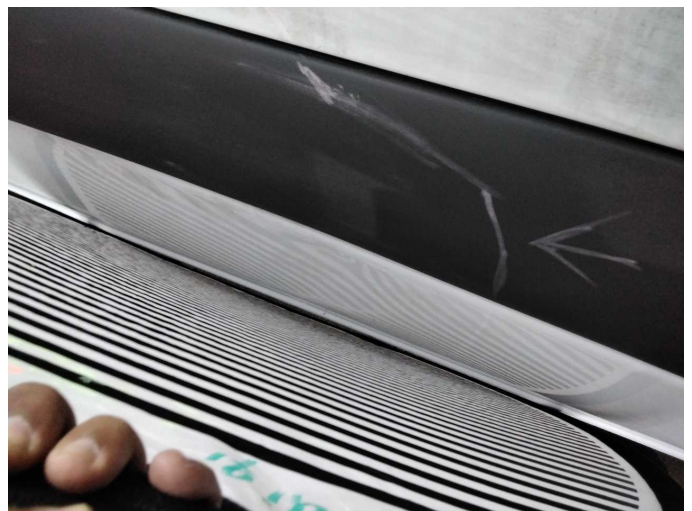
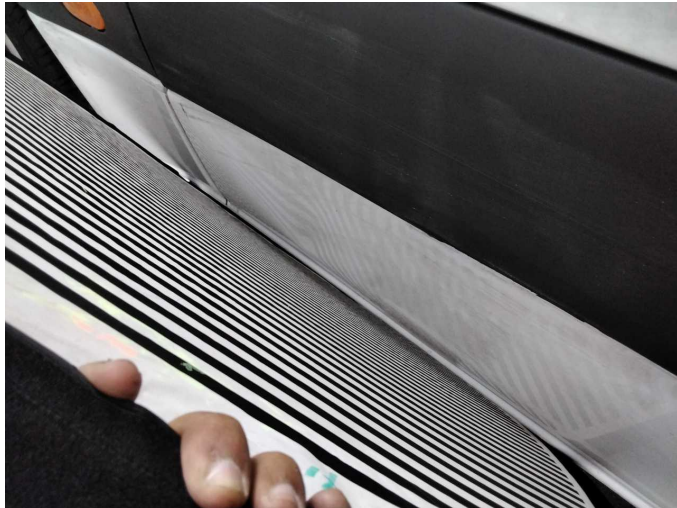
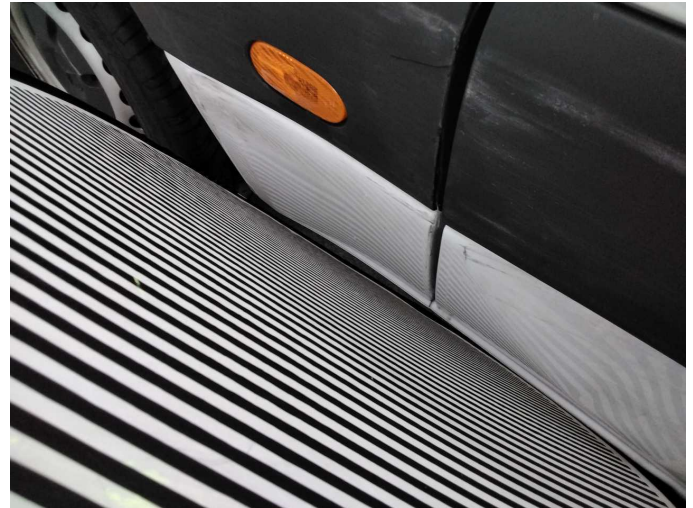
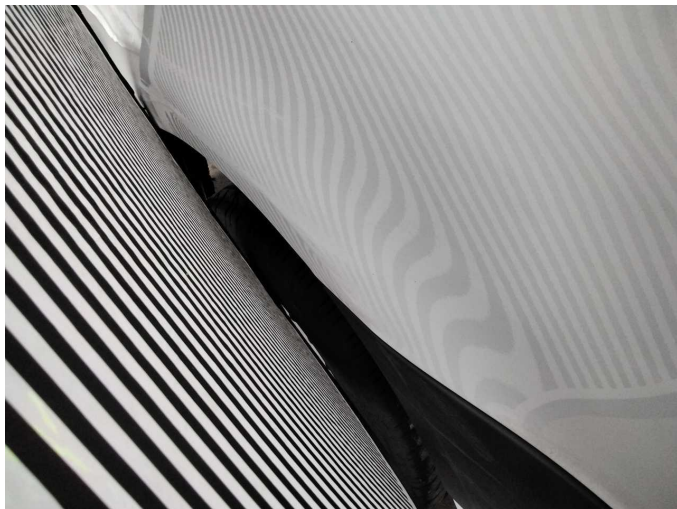
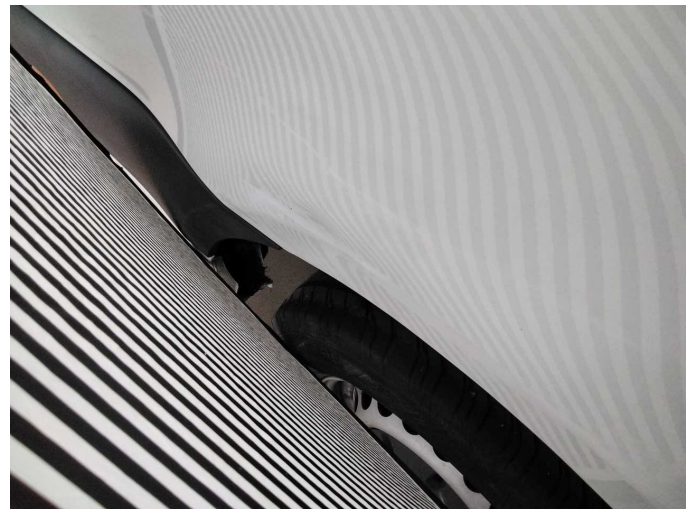
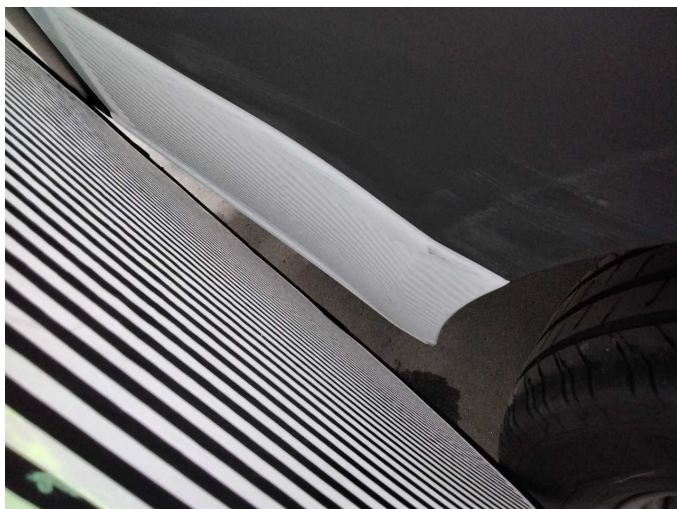
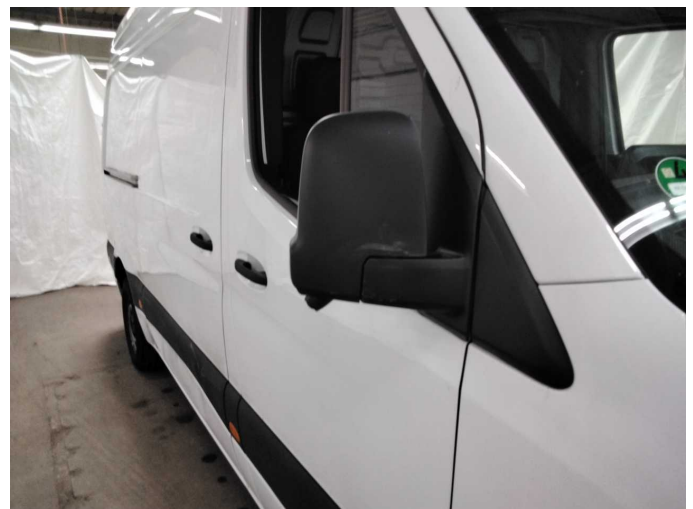
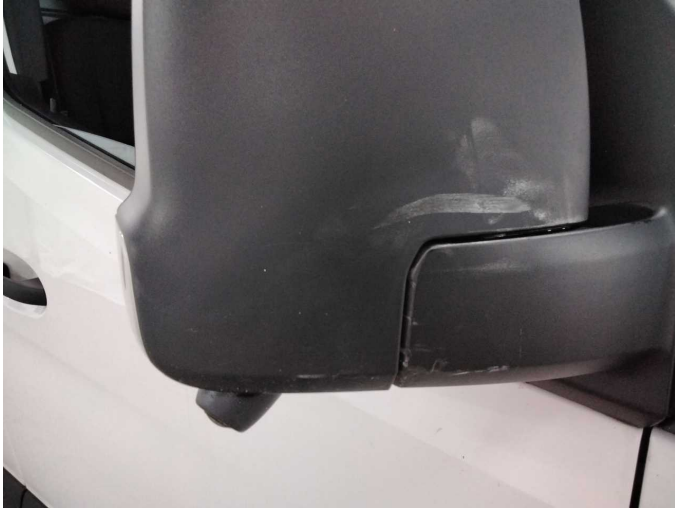
1 Side right

Non-repaired previous damages were found at the vehicle. The necessary repair costs are listed in the expert report or if necessary, are listed in detail in a separately enclosed repair cost calculation.

**Accident 1:** Side right
