## Expertise

Protocol number: 46170579  
Order No. / Reference: 26535447  
Inspection date: 22 Jun 2026

Model: 208 BlueHDi 100 GT

VIN: VR3UBYHTKP5146839

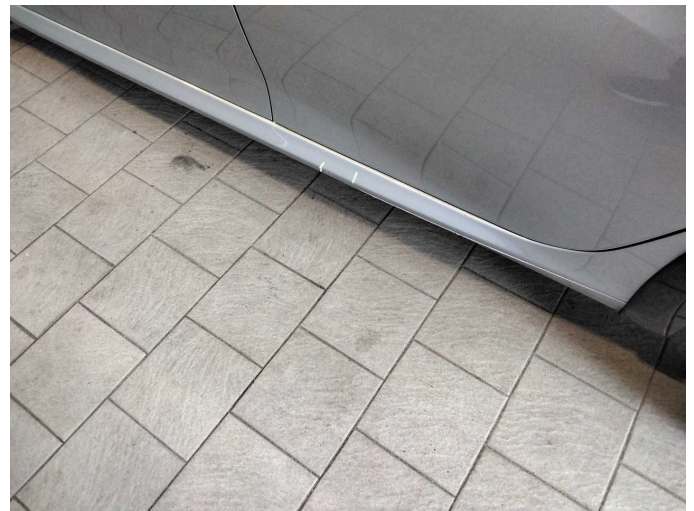
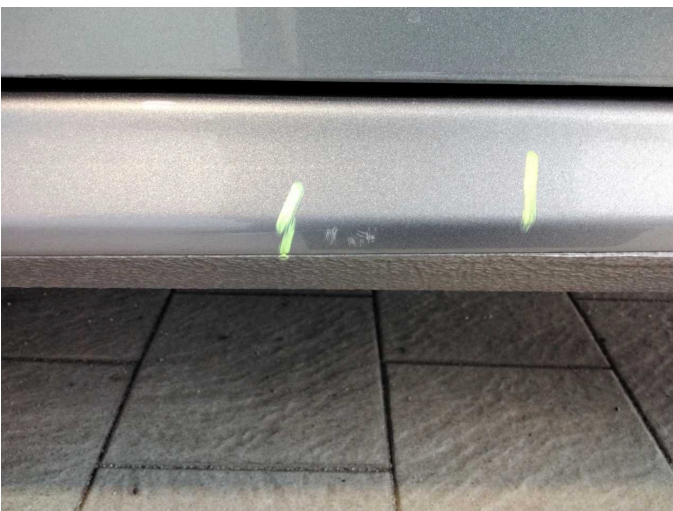
Damage 2: Sill - left side: Sill - Scratch(es) - Smart repair

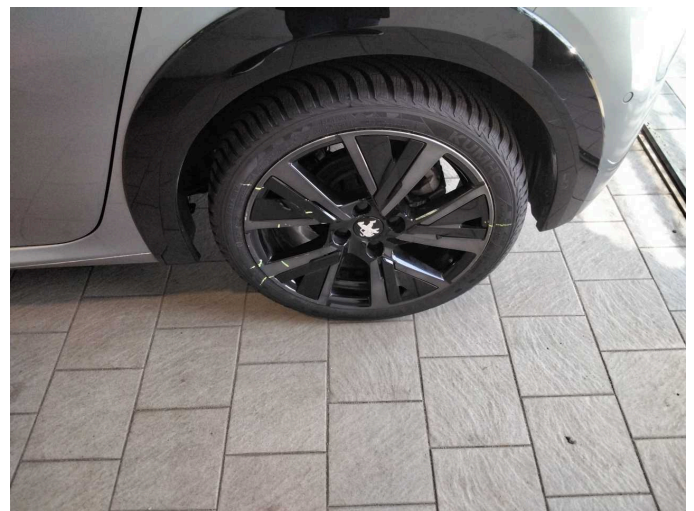
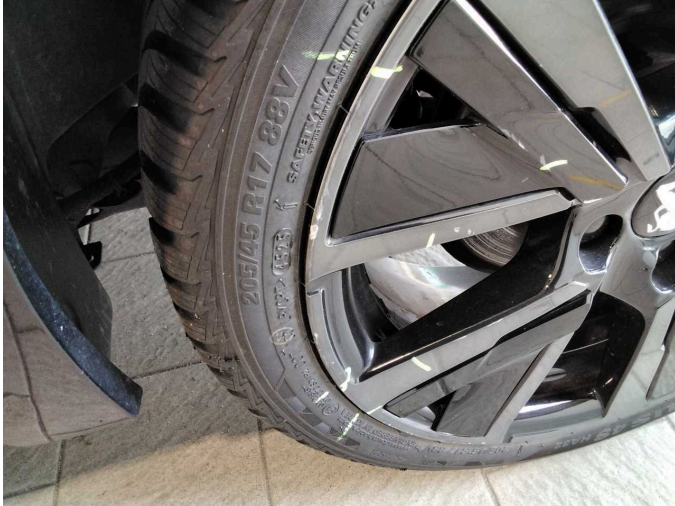
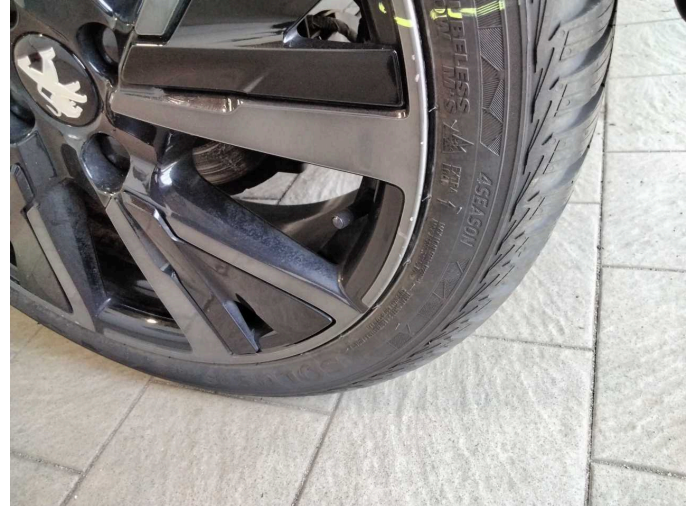
Damage 3: Wheel / tyres: Alloy rim - rear left side - Scratch(es) - Loss in value

**Damage 3:** Wheel / tyres: Alloy rim - rear left side - Scratch(es) - Loss in value

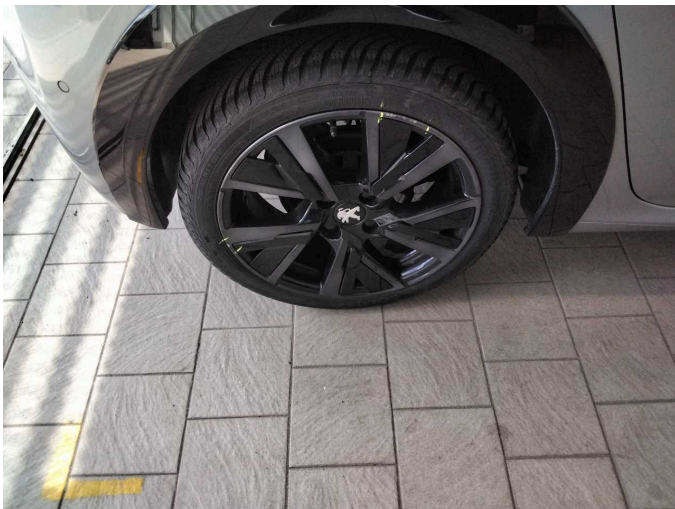
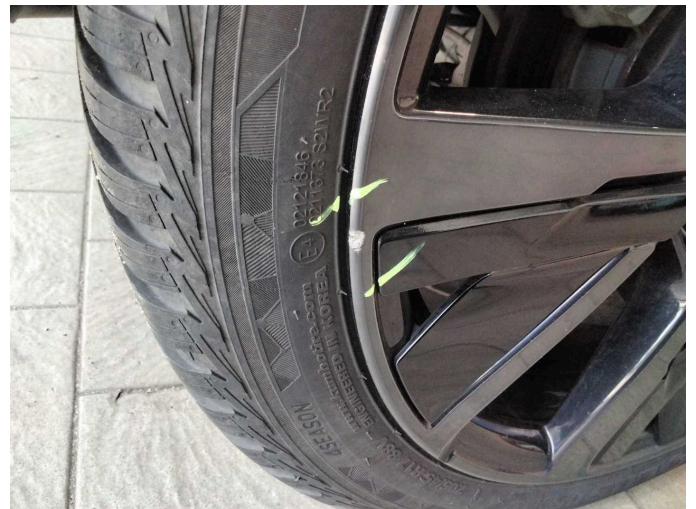
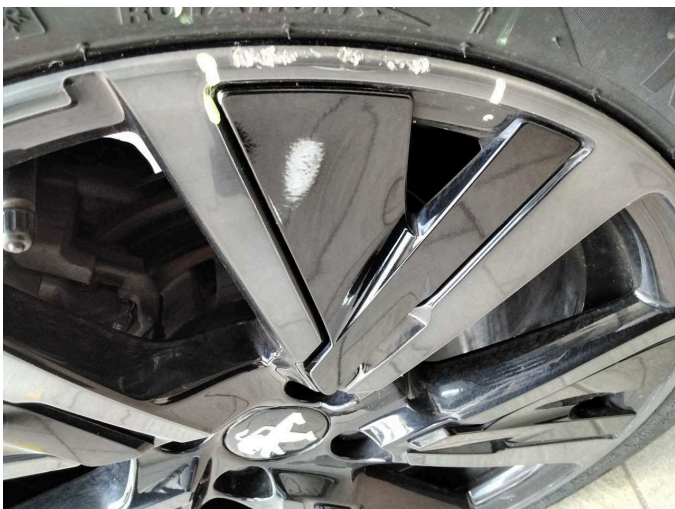
**Damage 4:** Wheel / tyres: Alloy rim - rear right side - Scratch(es) - Loss in value

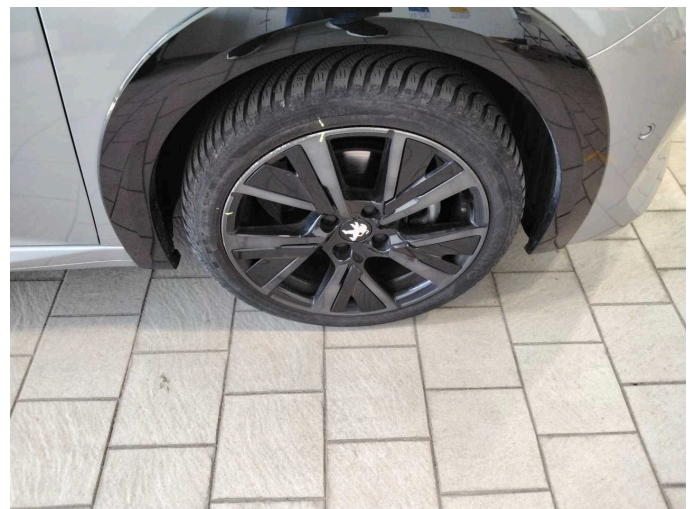
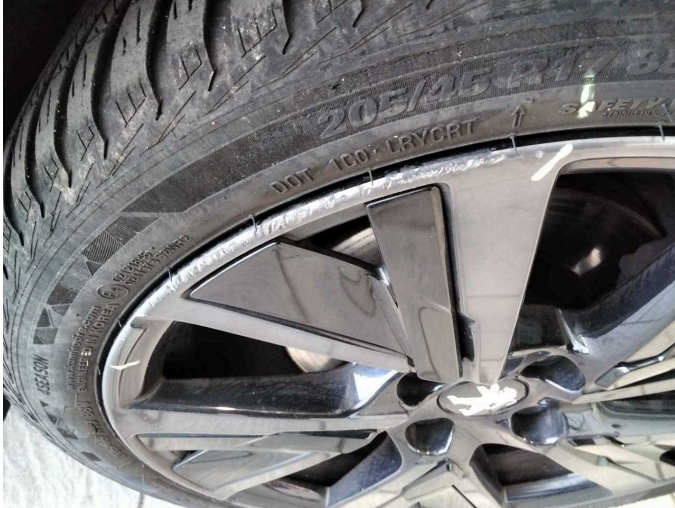
**Damage 5:** Wheel / tyres: Alloy rim - front right side - Scratch(es) - Loss in value

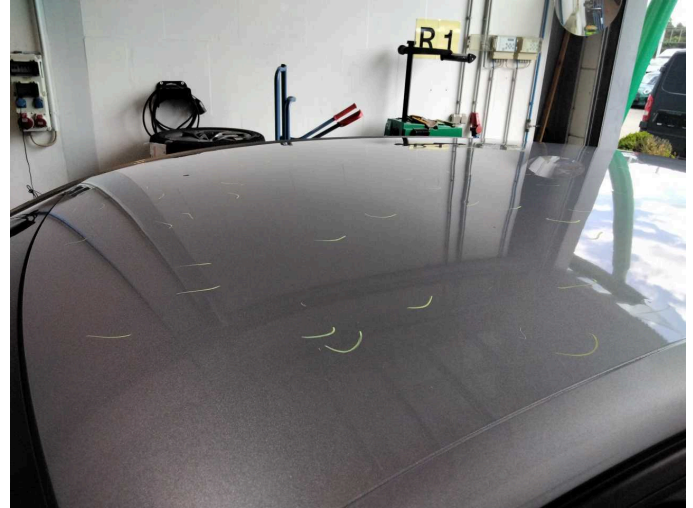
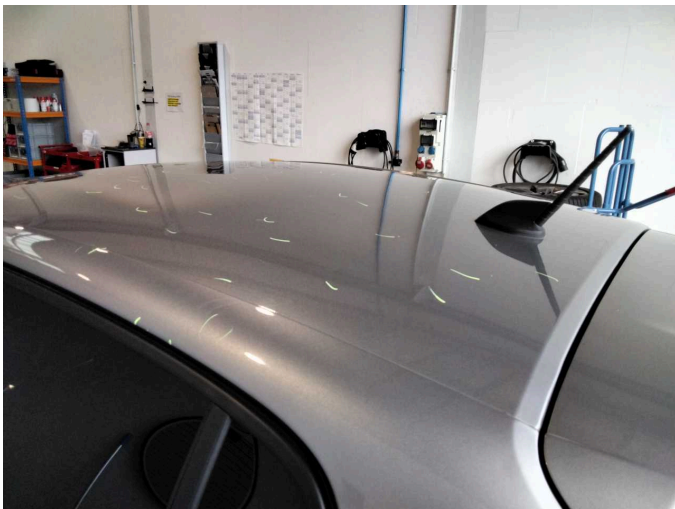
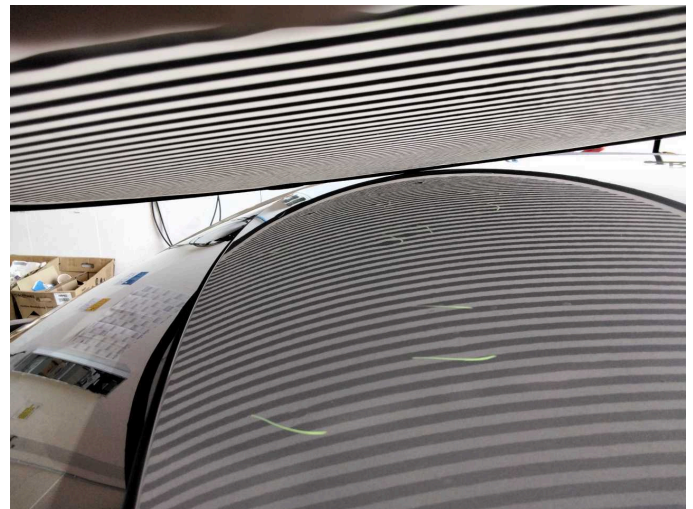
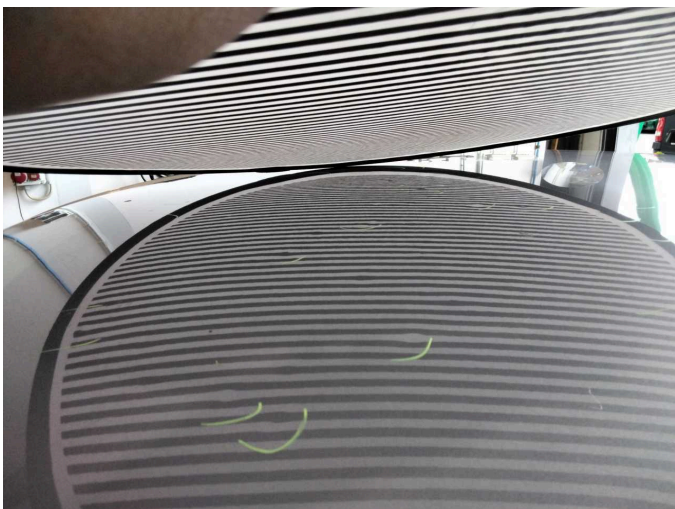
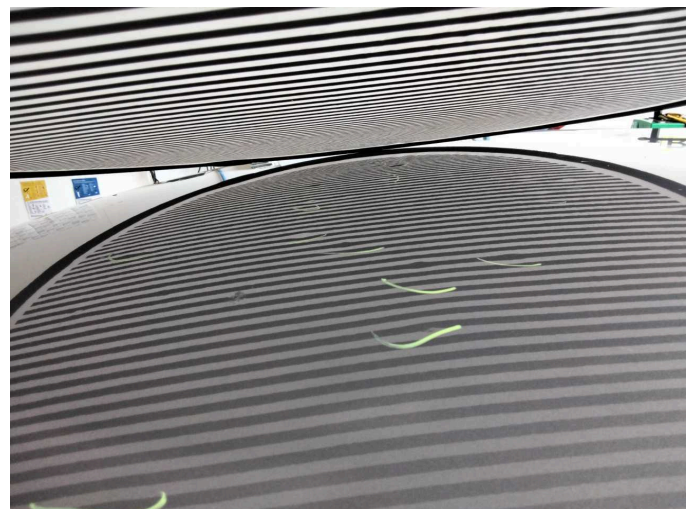
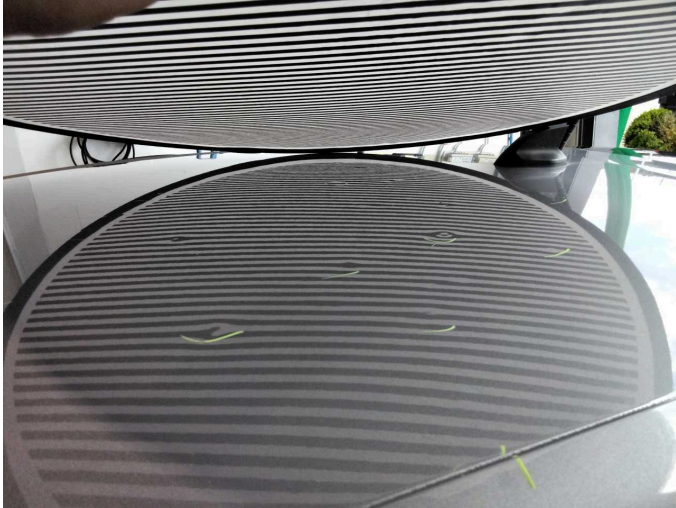
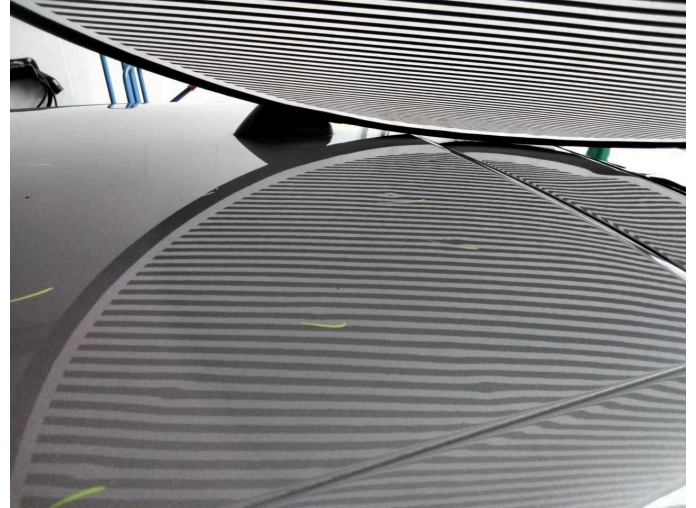
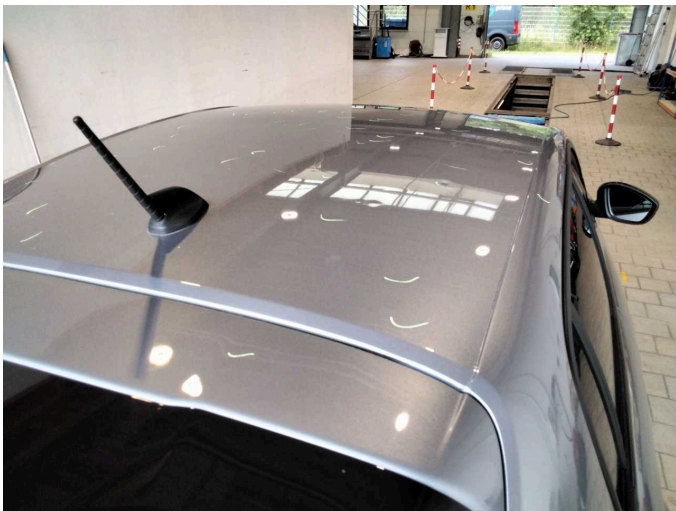
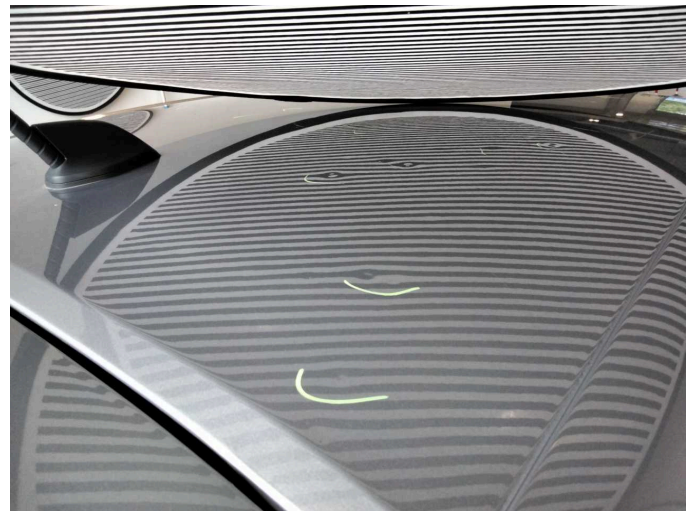
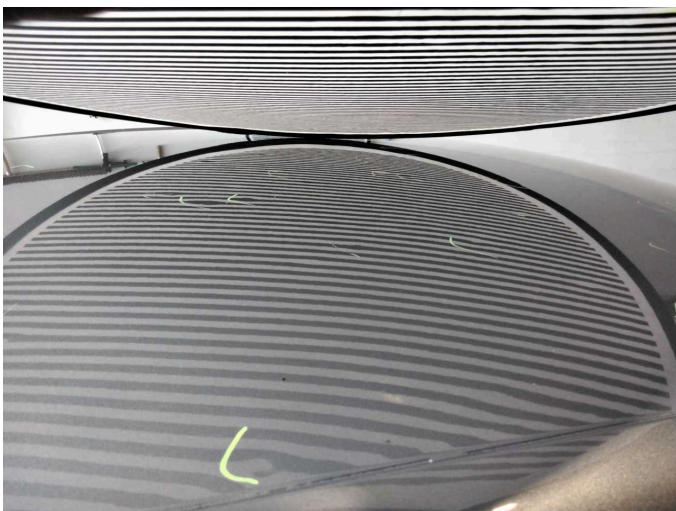
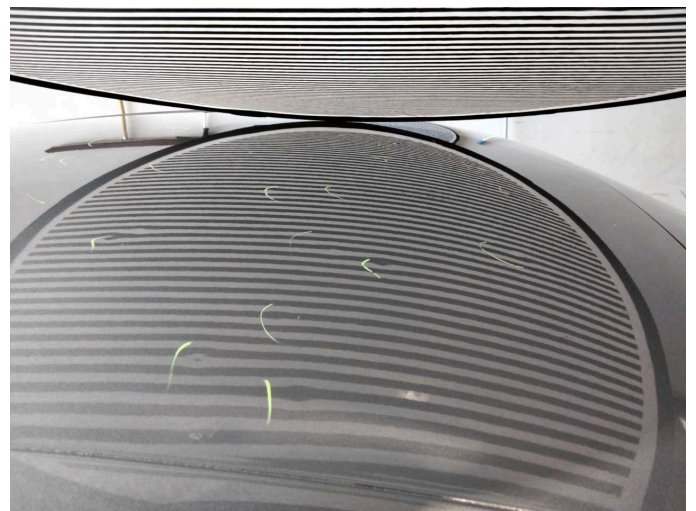
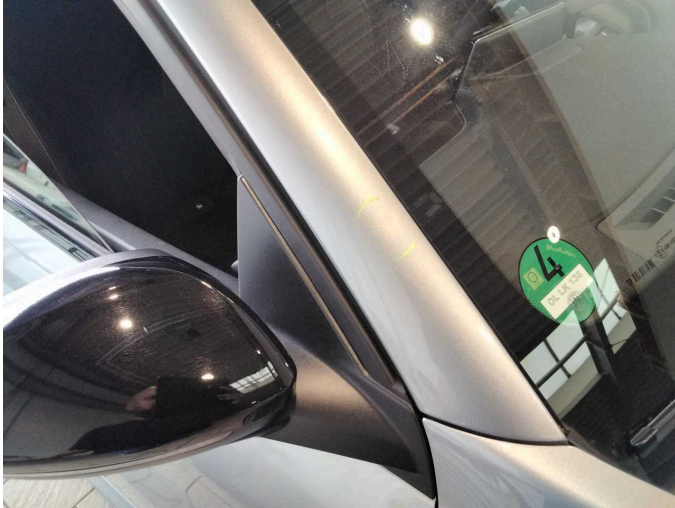
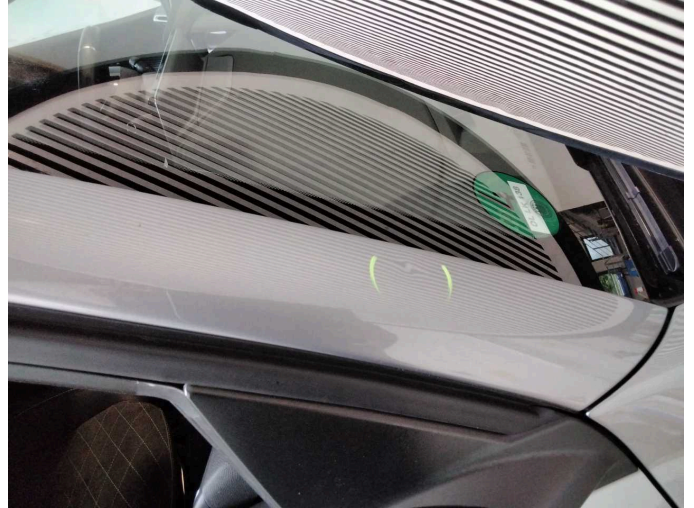
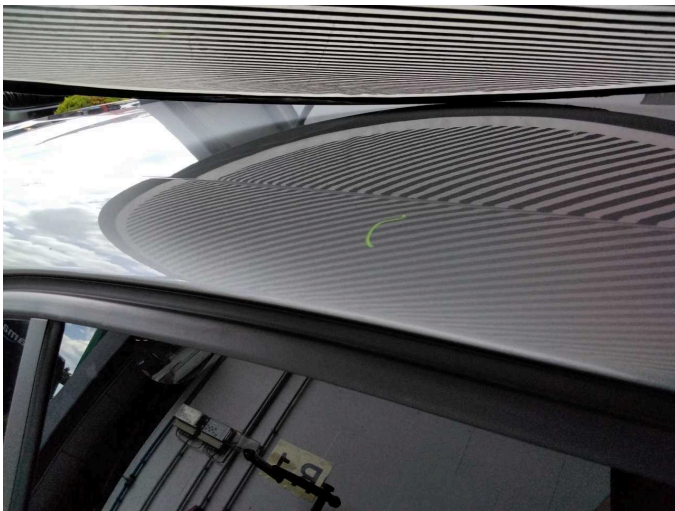
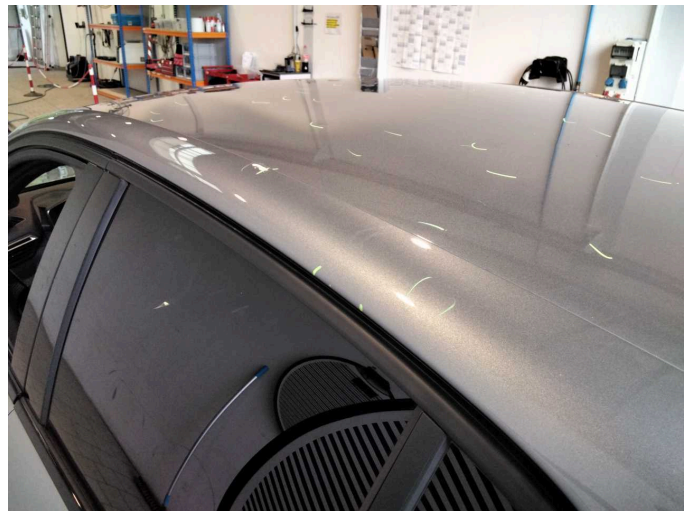
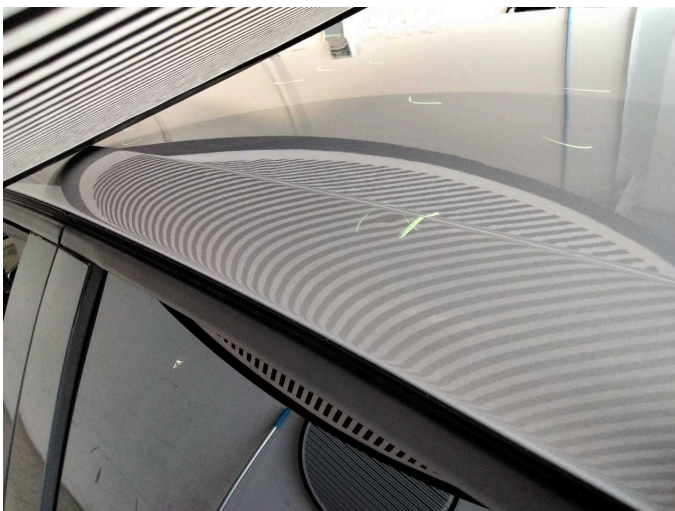
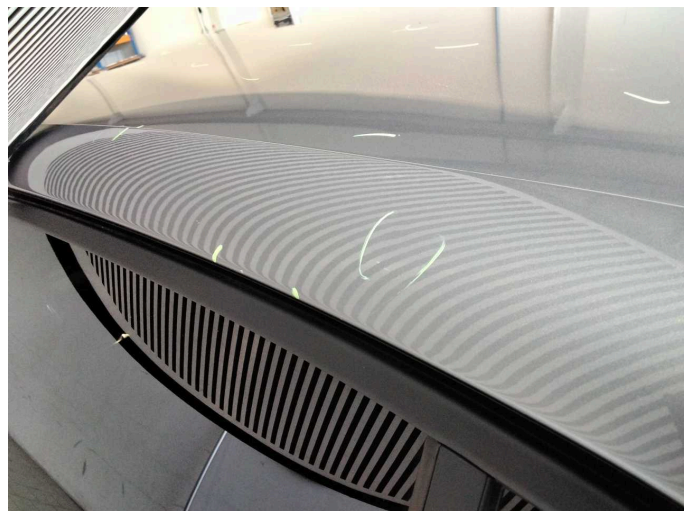
Die beigefügte Reparaturkostenkalkulation wurde nach bestem Wissen und Gewissen im demontagefreien Zustand erstellt. Es können Mehrkosten und somit Abweichung der für den Hagelschaden ausgewiesener Reparaturkosten nicht ausgeschlossen werden.

**Damage 6:** Body: Body - Damage by hail - repair according to calculation

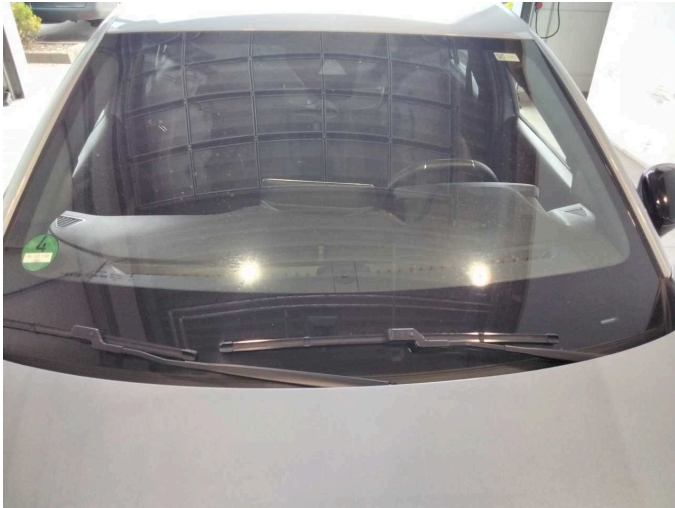
**Wear and tear 1:** Vehicle glazing: Windscreen - Stone chips - No deduction

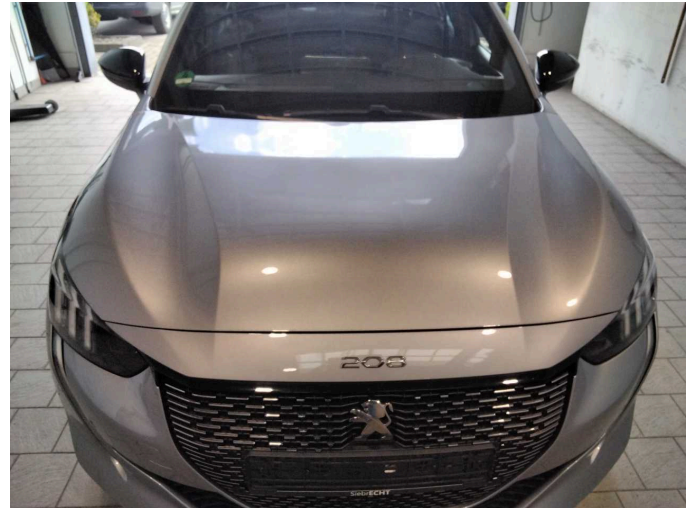
**Wear and tear 2:** Bonnet: Bonnet - Stone chips - No deduction

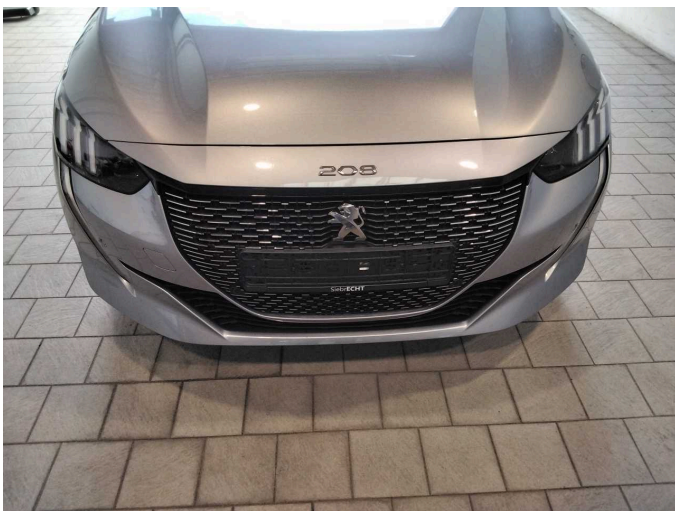
**Wear and tear 3:** Front bumper: Front bumper - Stone chips - No deduction

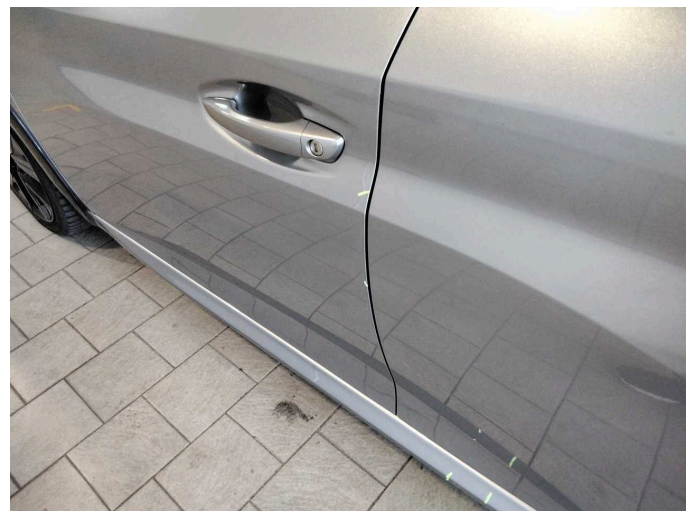
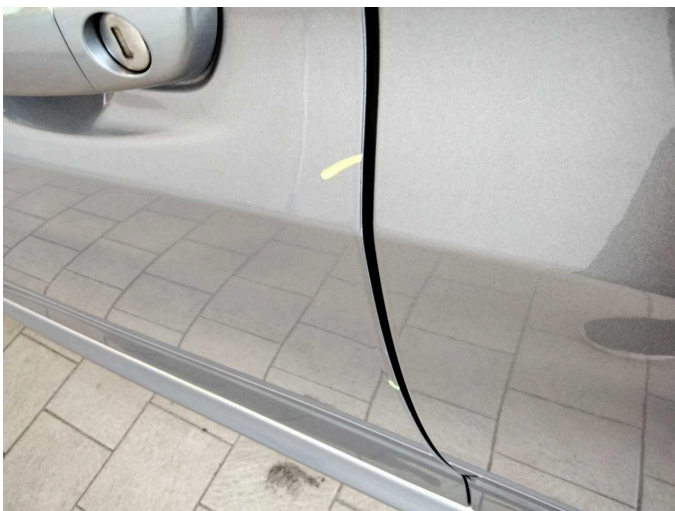
**Wear and tear 4:** Door - front left side: Door edge - Scratch(es) - Smart repair

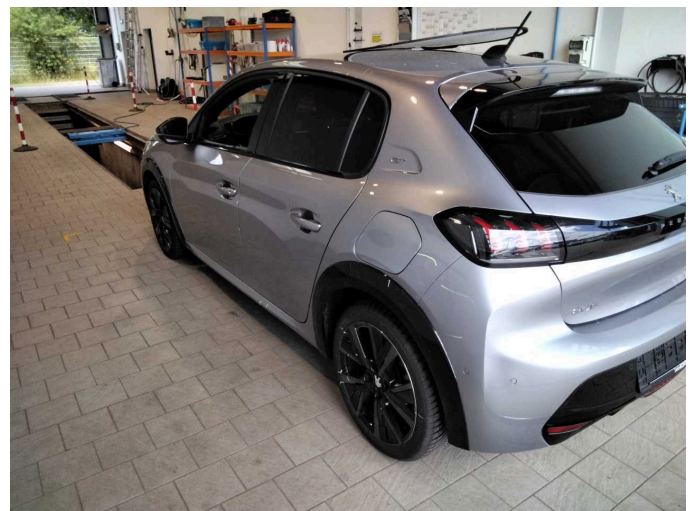
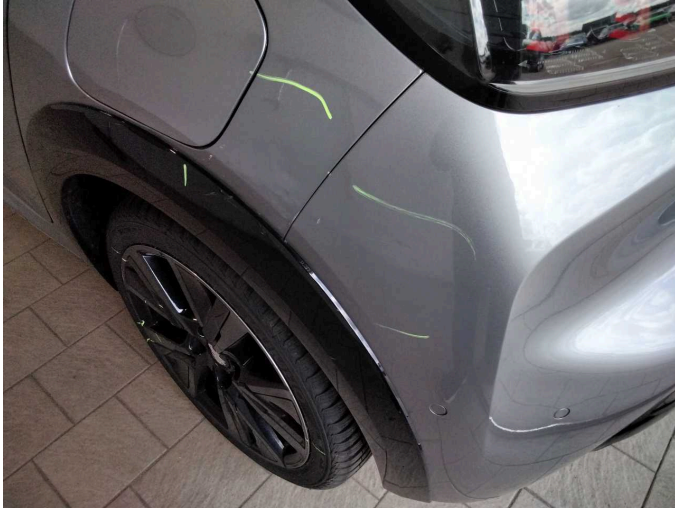
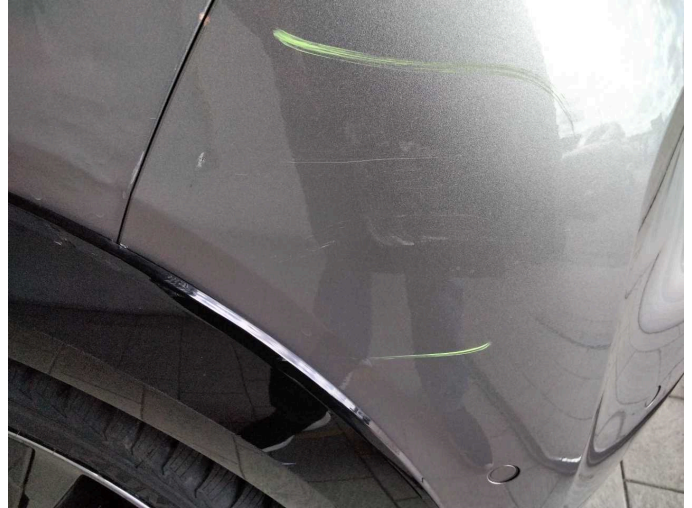
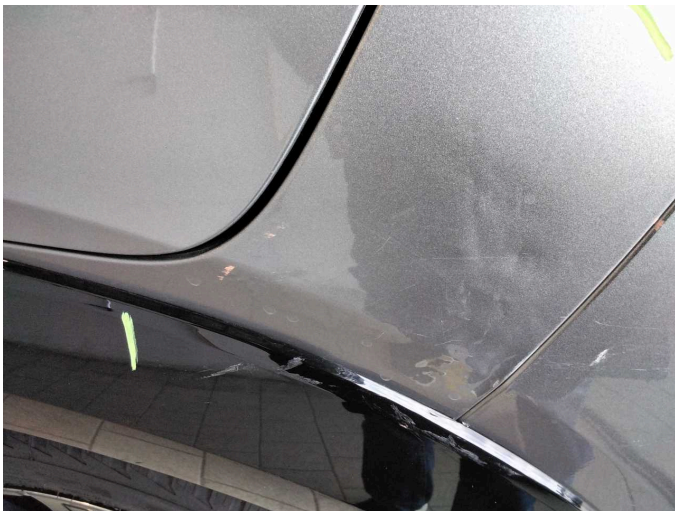
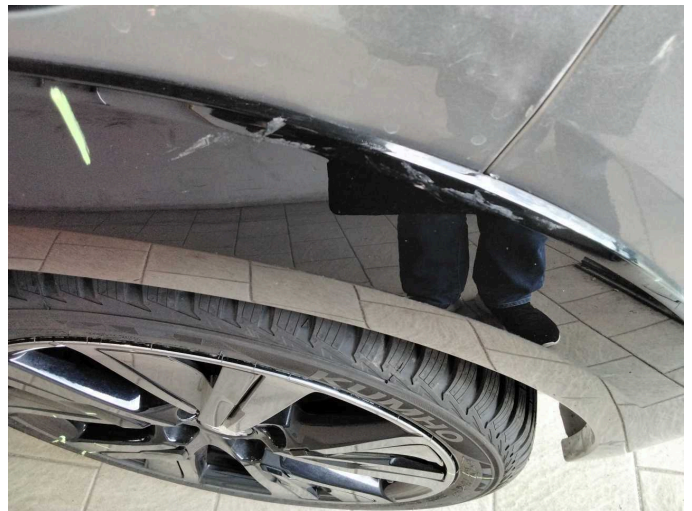
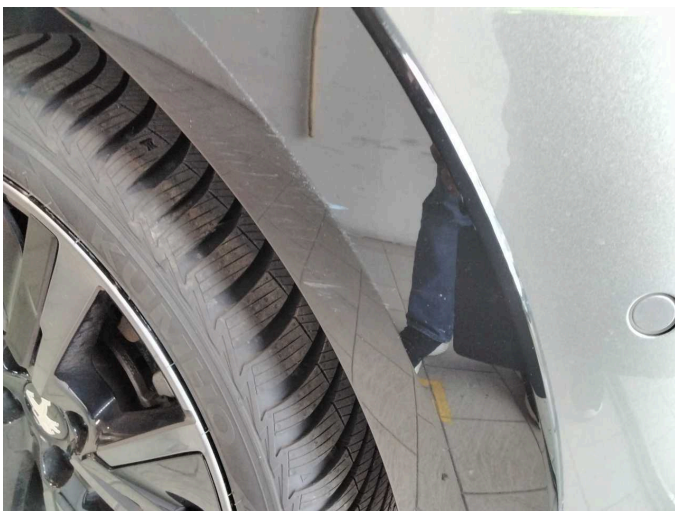
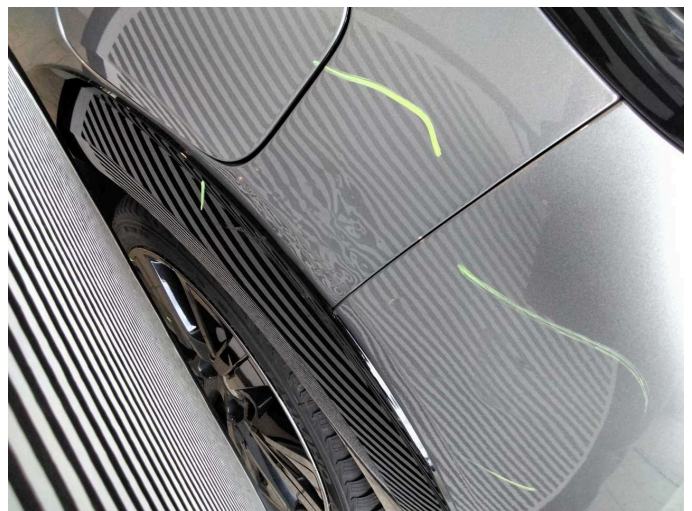
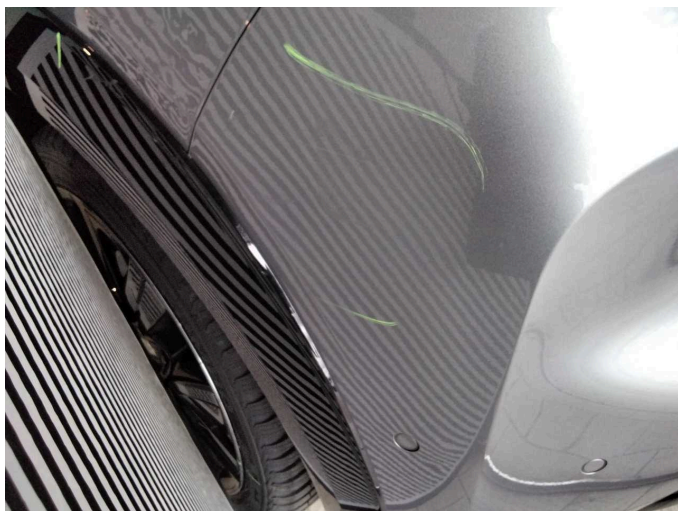
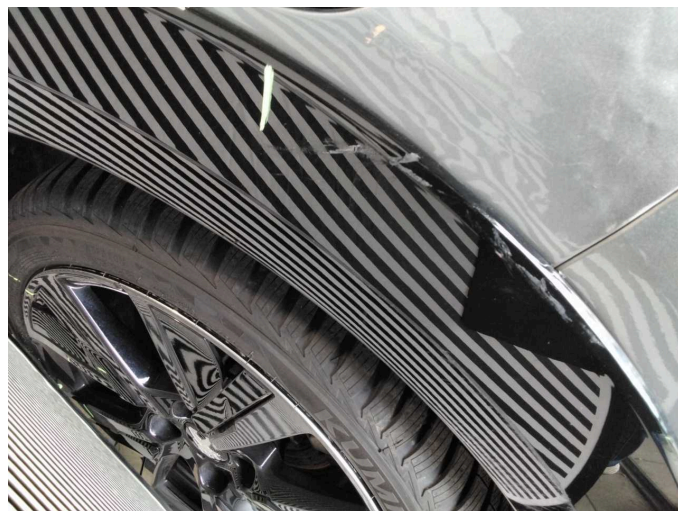
Die beigefügte Reparaturkostenkalkulation wurde nach bestem Wissen und Gewissen unter eingeschränkten Besichtigungsbedingung im demontagefreien Zustand erstellt. Es können aufgrund verdeckter Beschädigung erhebliche Mehrkosten und somit Abweichung der für den Unfall ausgewiesenen Reparaturkosten nicht ausgeschlossen werden.

**Accident 1:** Side - left

Accident 1: Side - left
