Expertise

Protocol number: 46773816  
Order No. / Reference: 26755321  
Inspection date: 29 Jul 2026

Manufacturer: Ford

Model: Transit 310 L2H2 Lkw VA Trend

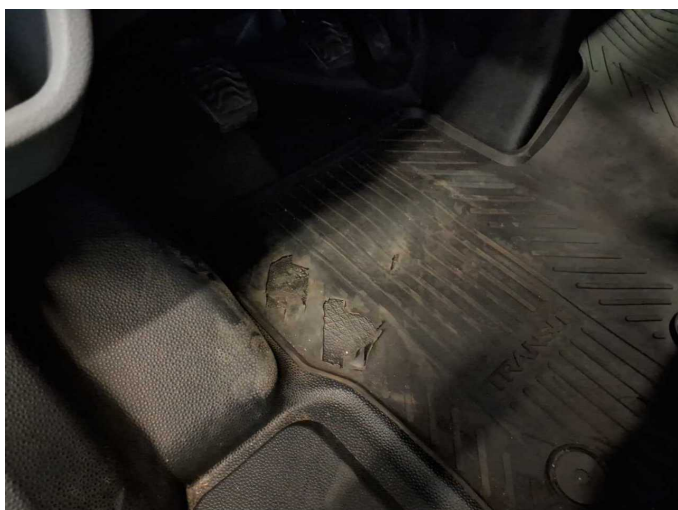
| No. | Component group | Description |
|---|---|---|
| 1 | Trim / covers | Floor mats (VL) - Holes - Replace |

Damage 1: Trim / covers: Floor mats (VL) - Holes - Replace

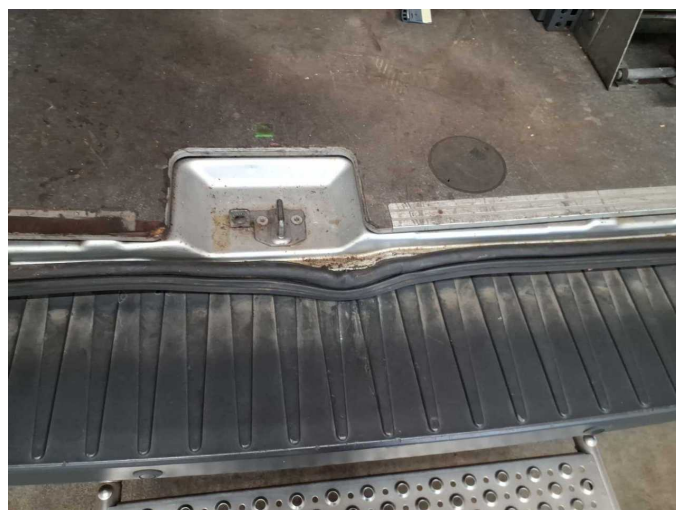
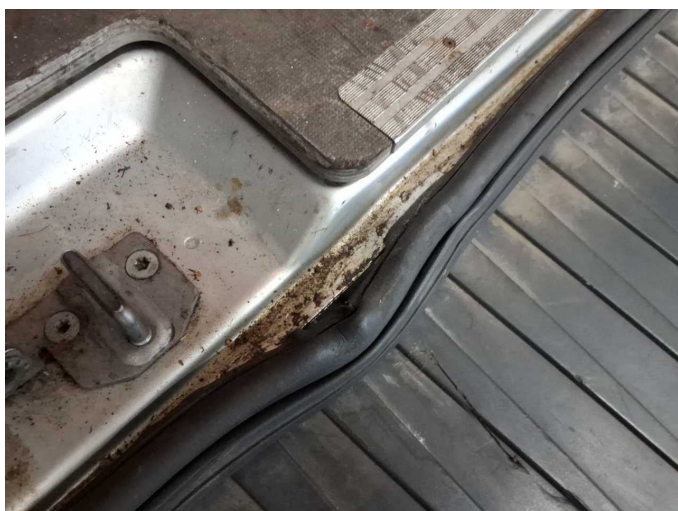
| No. | Component group | Description |
|---|---|---|
| 2 | Boot lid / rear door | Seal - Malposition - Repair |

Damage 2: Boot lid / rear door: Seal - Malposition - Repair

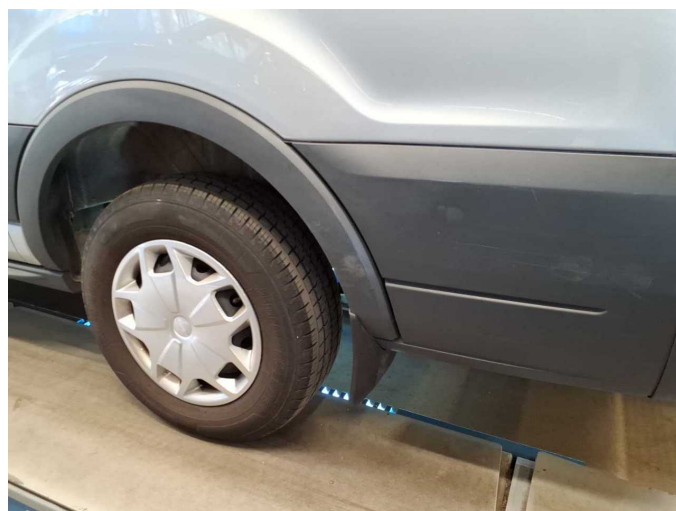
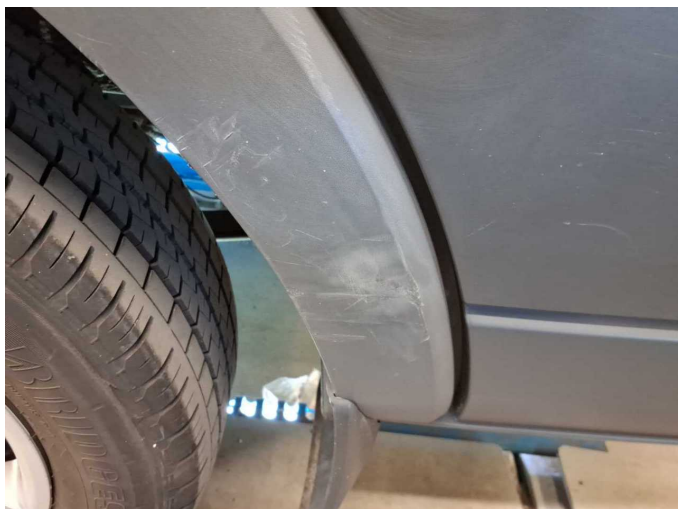
| No. | Component group | Description |
|---|---|---|
| 3 | Side panel - rear left side | Wheel arch - Scratch(es) - Loss in value |

Damage 3: Side panel - rear left side: Wheel arch - Scratch(es) - Loss in value

**Damage 3:** Side panel - rear left side: Wheel arch - Scratch(es) - Loss in value

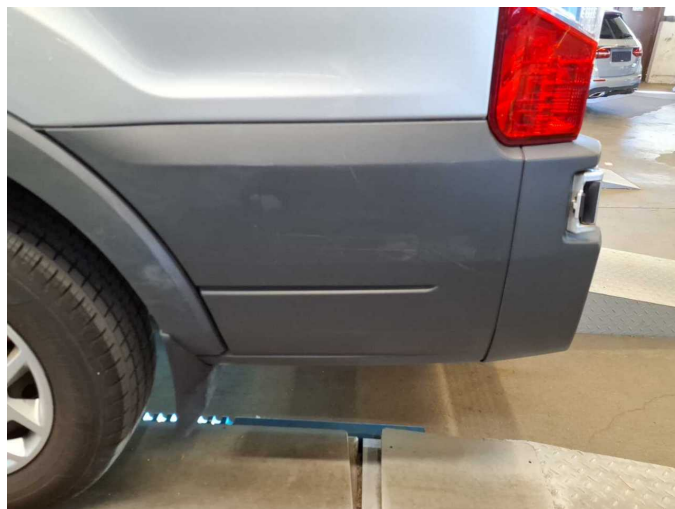
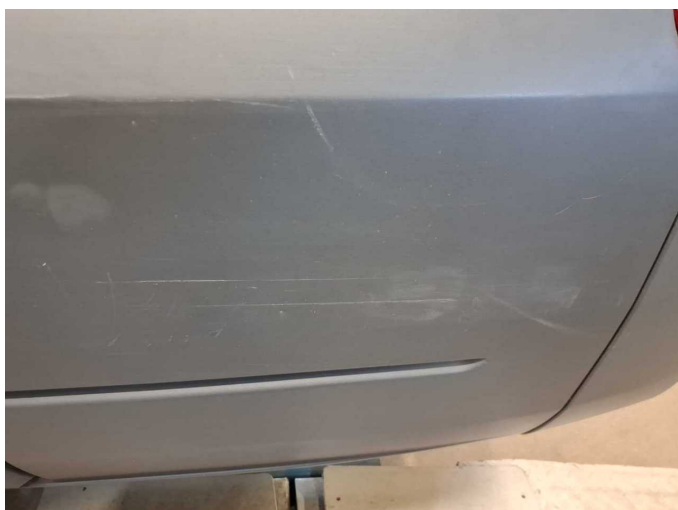
| No. | Component group | Description |
|---|---|---|
| 4 | Side panel - rear left side | Side panel (Zierleiste) - Scratch(es) - Loss in value |

**Damage 4:** Side panel - rear left side: Side panel (Zierleiste) - Scratch(es) - Loss in value

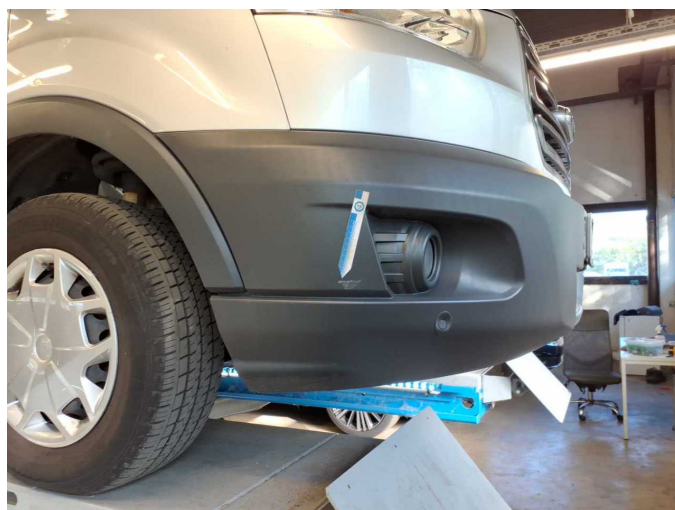
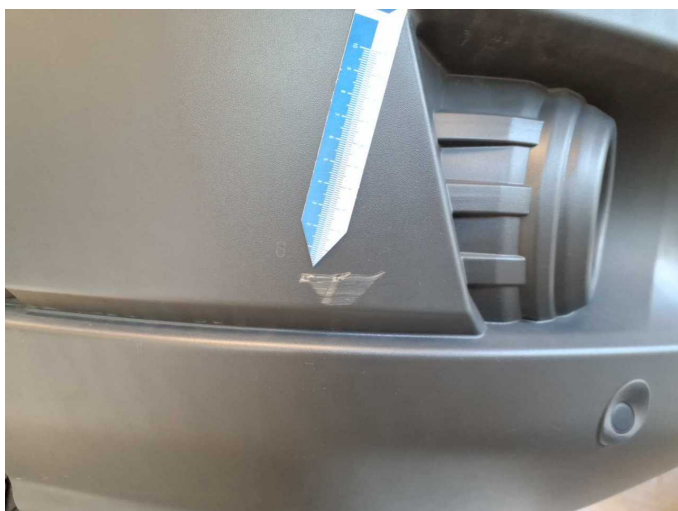
| No. | Component group | Description |
|---|---|---|
| 5 | Front bumper | Front bumper (unpainted) - Scratch(es) - Smart repair |

**Damage 5:** Front bumper: Front bumper (unpainted) - Scratch(es) - Smart repair

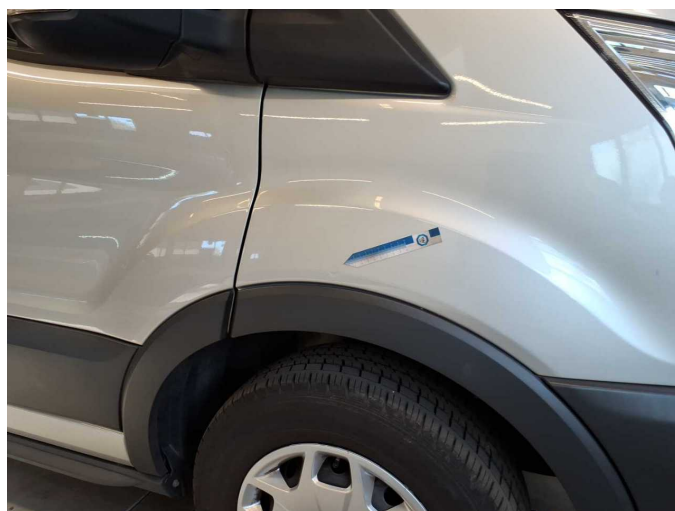
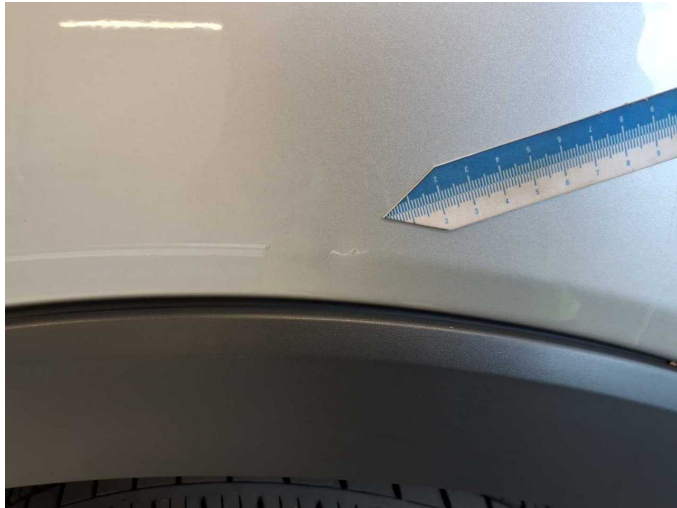
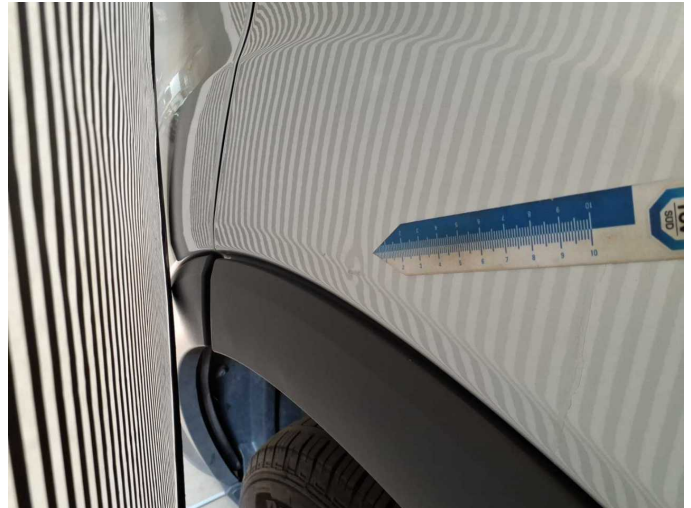
| No. | Component group | Description |
|---|---|---|
| 6 | Mudguard - right side | Mudguard - right side - Dent / paintcoat damage - Smart repair |

**Damage 6:** Mudguard - right side: Mudguard - right side - Dent / paintcoat damage - Smart repair

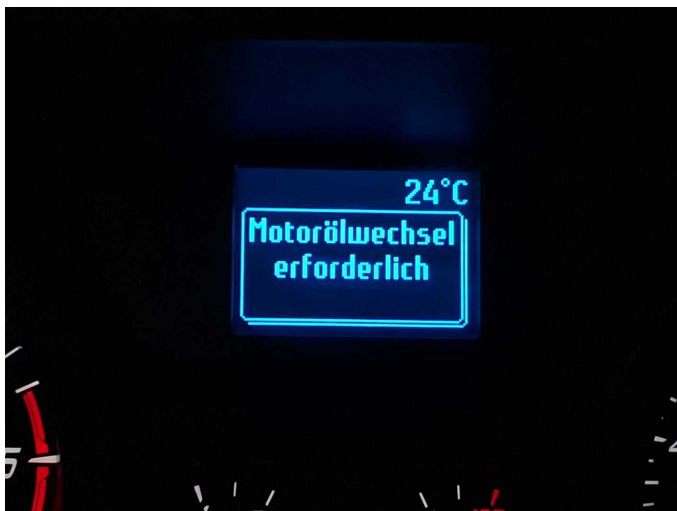
| No. | Component group | Description |
|---|---|---|
| 7 | Misc. | Inspection / maintenance - Due - Perform |

**Damage 7:** Misc.: Inspection / maintenance - Due - Perform

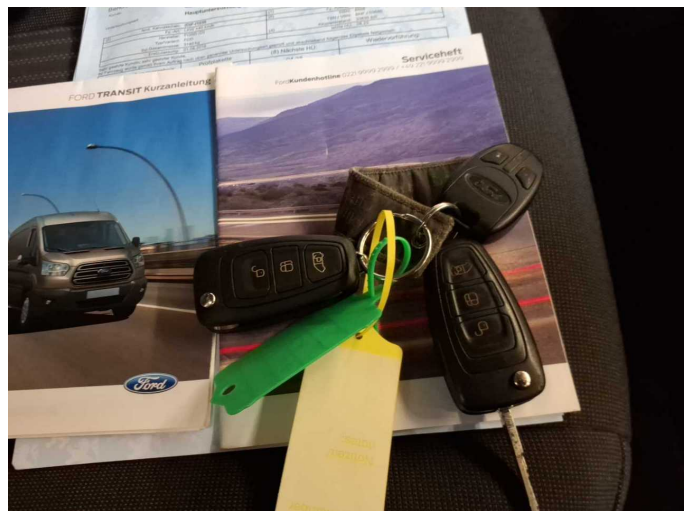
Equipment - Vehicle key (3 und 4)

**Missing part 1:** Equipment: Vehicle key (3 und 4) - Missing - Replace

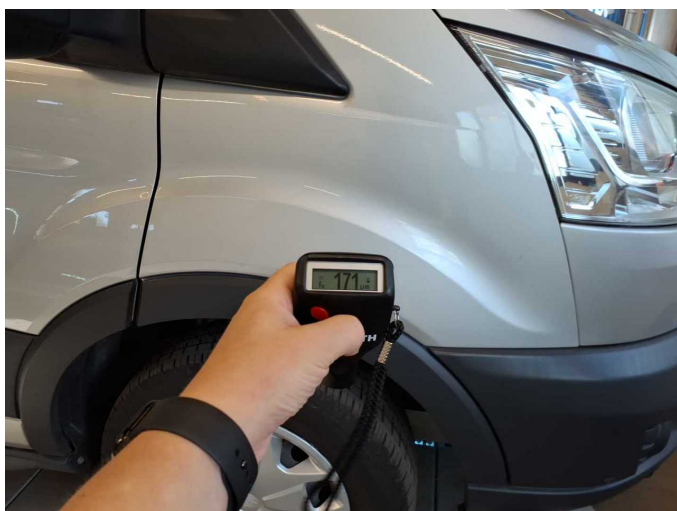
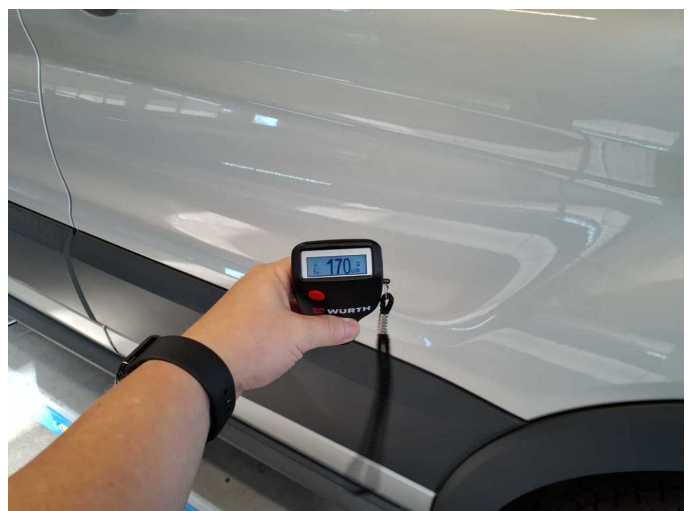
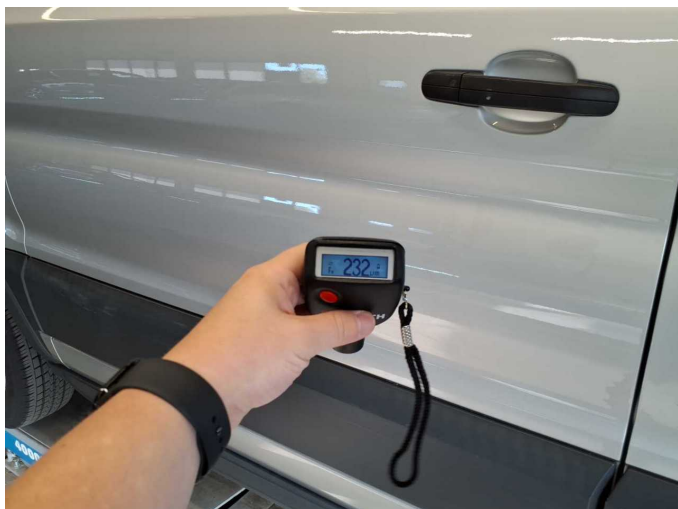
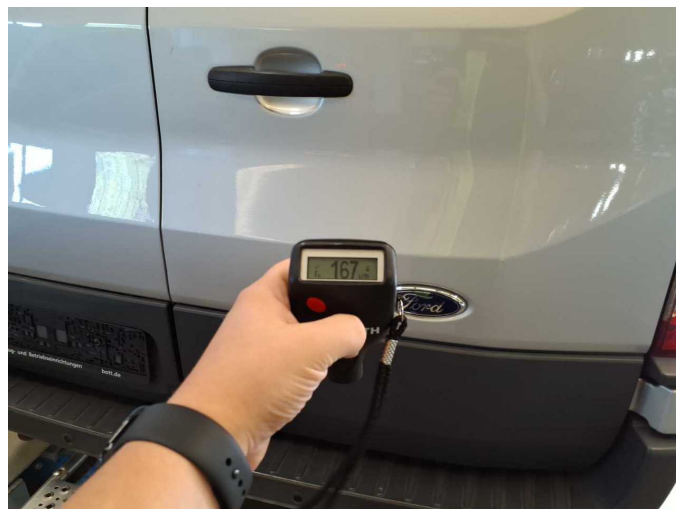
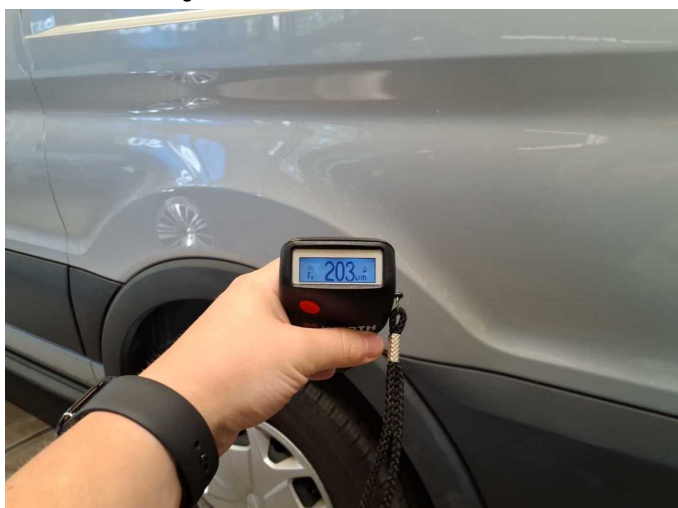
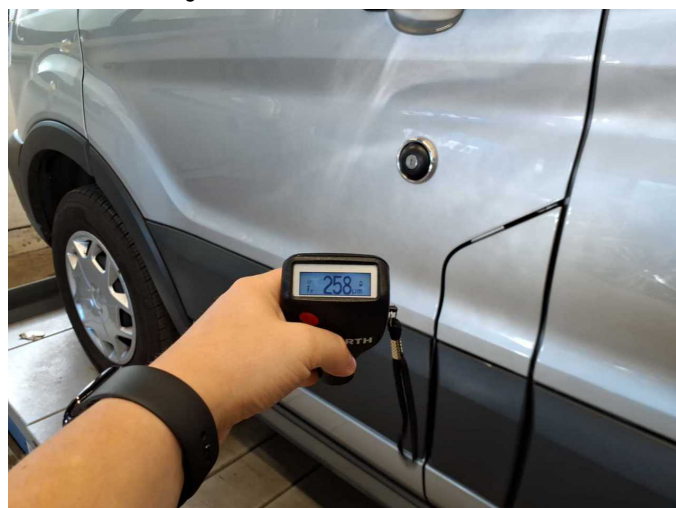
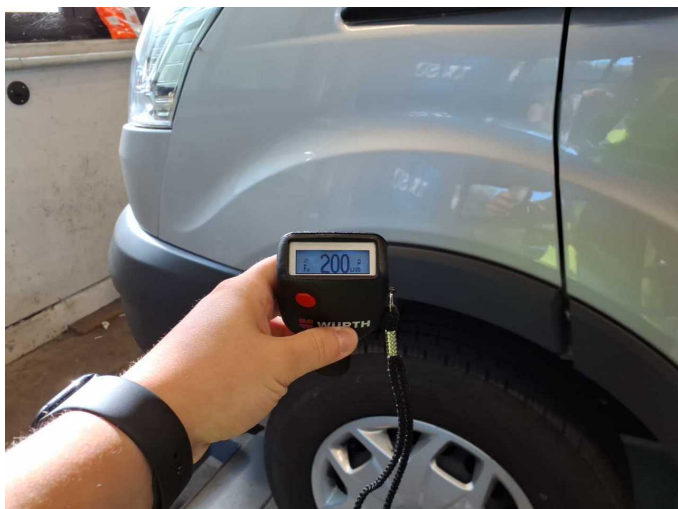
| No. | Repainting |
|---|---|
| 1 | Boot lid / rear door, Mudguard - left side, Mudguard - right side, Side panel - rear left side, Door - rear right side, Door - front left side, Door - front right side, Professionally carried out, Invoice of repair done |

| Boot lid / rear door | 167 µm | Mudguard - left side | 200 µm |
| Mudguard - right side | 171 µm | Side panel - rear left side | 203 µm |
| Door - rear right side | 232 µm | Door - front left side | 258 µm |
| Door - front right side | 170 µm | | |

**Repainting 1:** Boot lid / rear door, Mudguard - left side, Mudguard - right side, Side panel - rear left side, Door - rear right side, Door - front left side, Door - front right side
