## Expertise

Protocol number: 45743690  
Order No. / Reference: 26264146  
Inspection date: 29 May 2026

Manufacturer: Opel

Model: Astra Sports Tourer 1.5 D Automatik GS Line

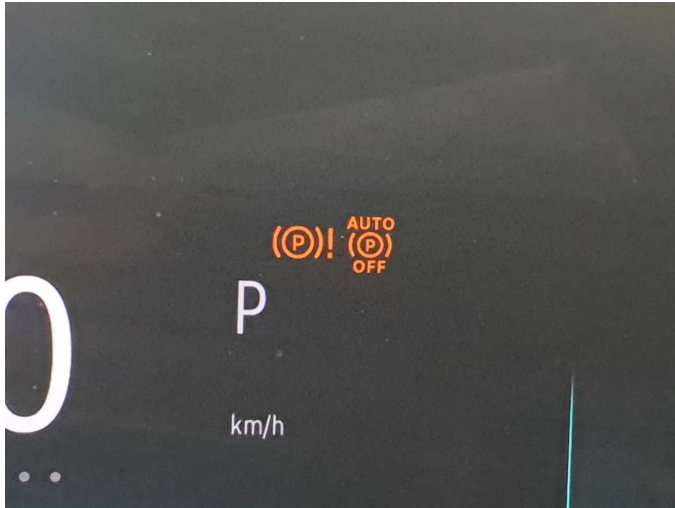
**Damage 1:** Electrical system: Battery (Tiefenentladen, zusätzlich Kontrollleuchten leuchten) - Functional / admissibility - Perform diagnosis

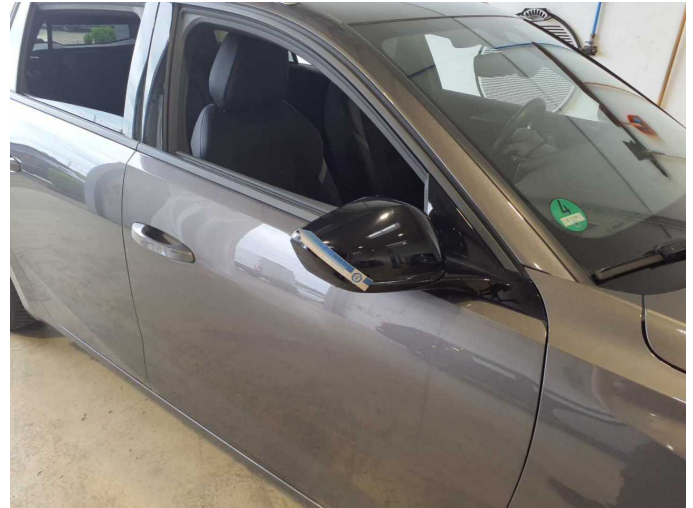
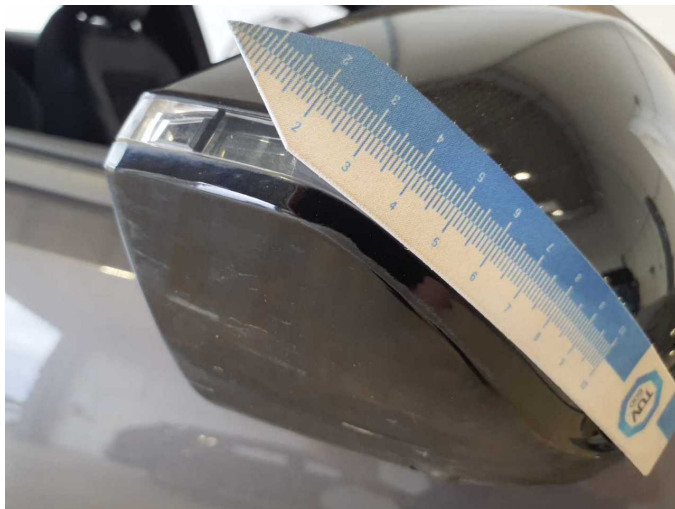
**Damage 2:** Wing mirror - right side: Cap - Scratch(es) - Paint

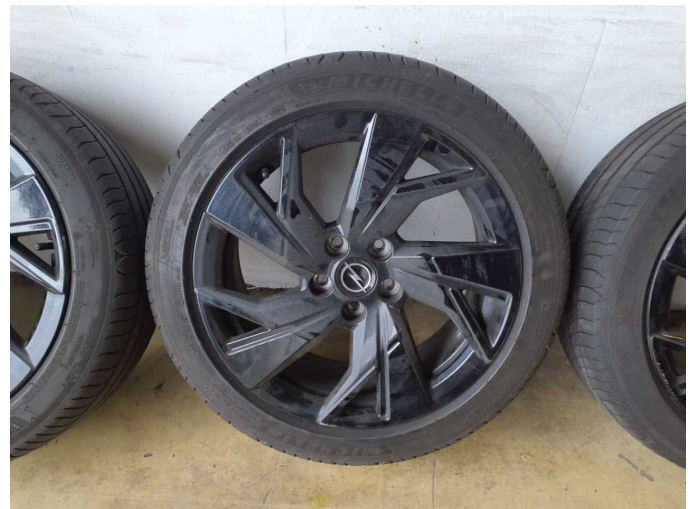
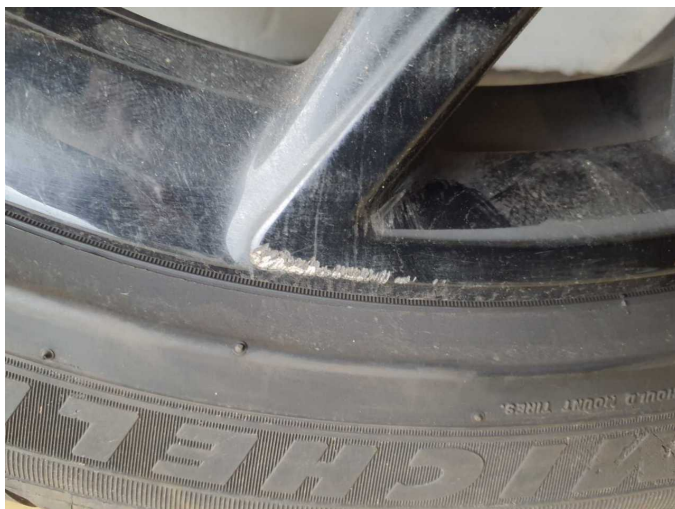
**Damage 3:** 2nd wheel set: 1 alloy rim - Scratch(es) - Smart repair

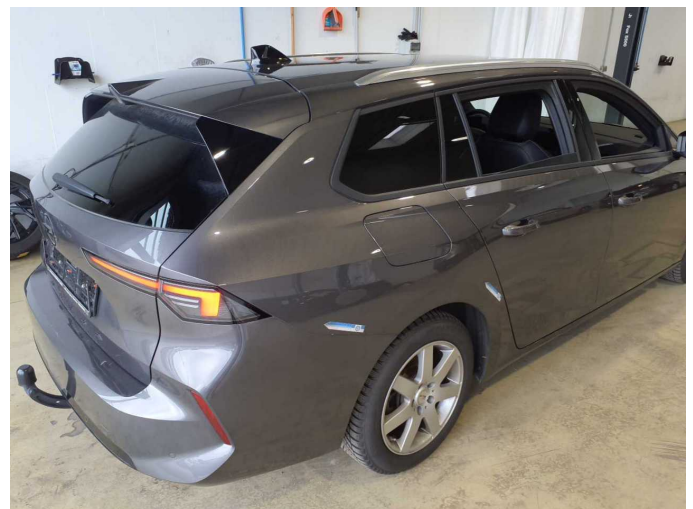
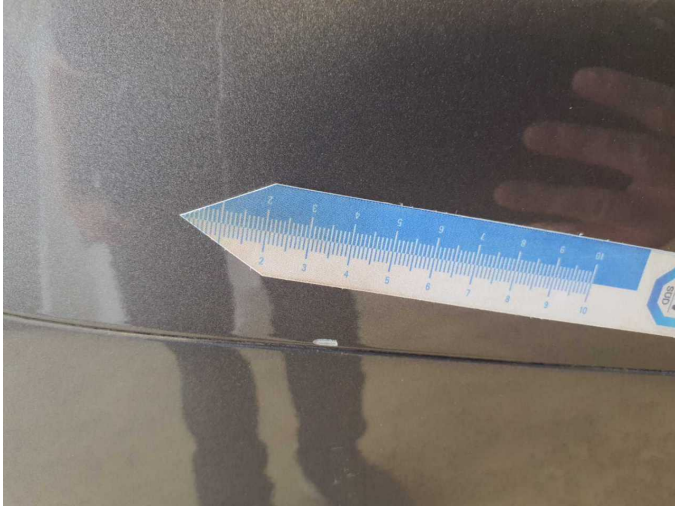
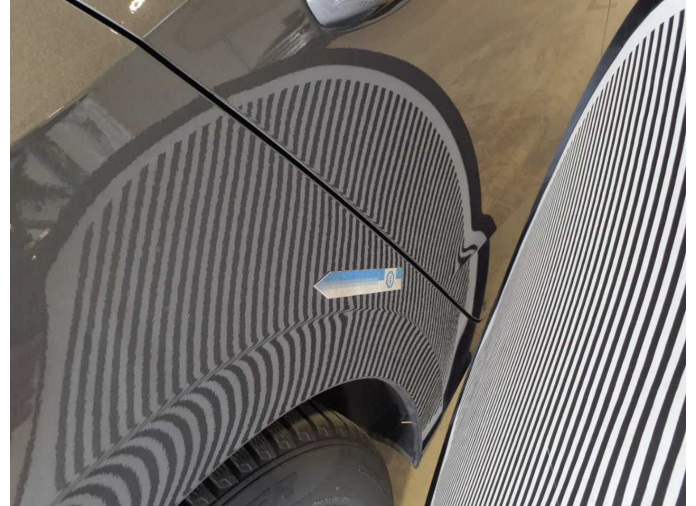
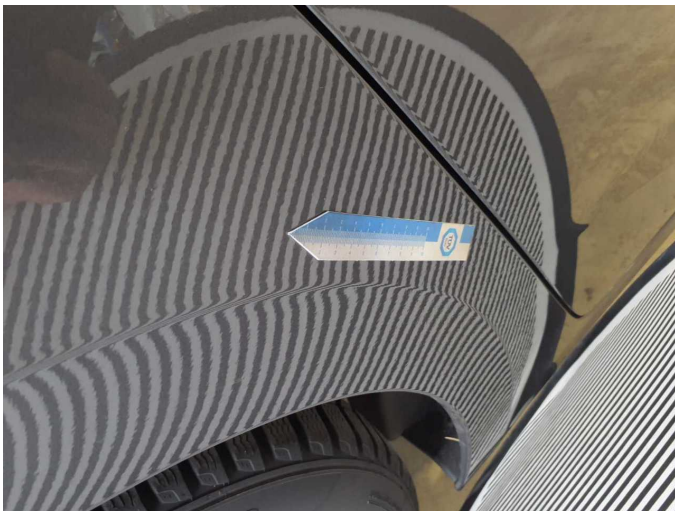
**Damage 4:** Side panel - rear right side: Side panel - Dent / paintcoat damage - Smart repair

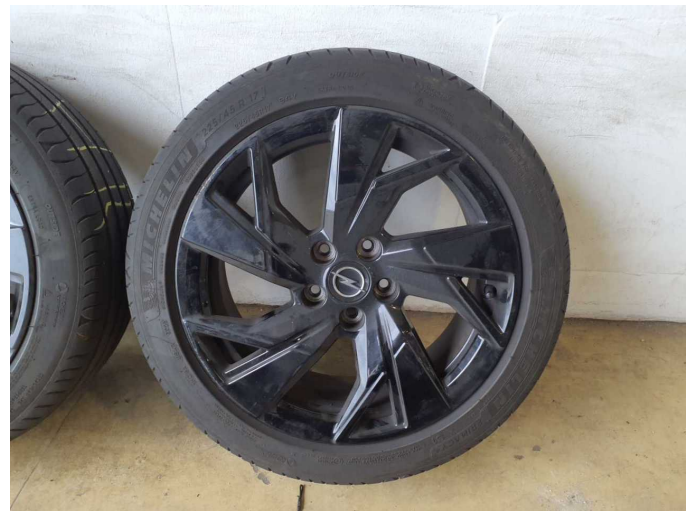
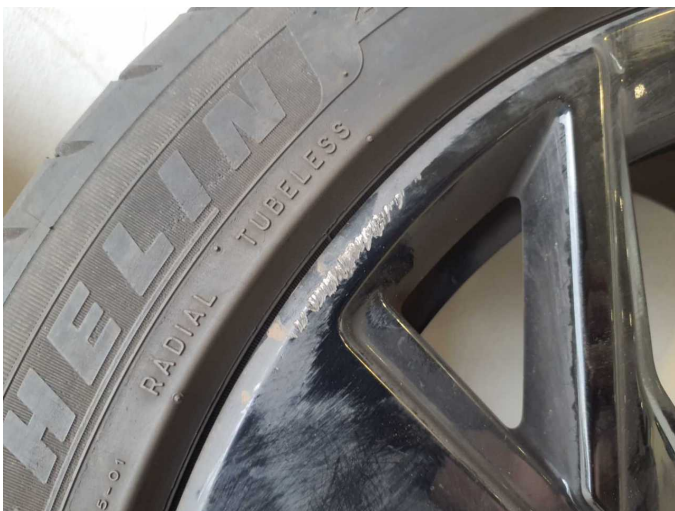
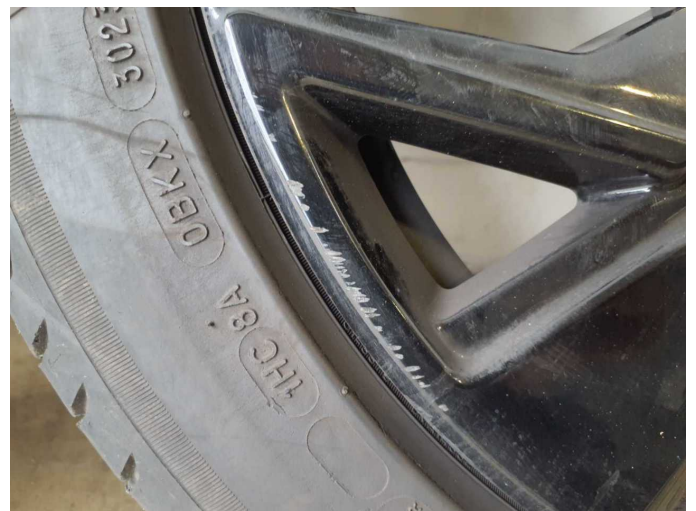
**Damage 6:** 2nd wheel set: 1 alloy rim - Scratch(es) - Replace

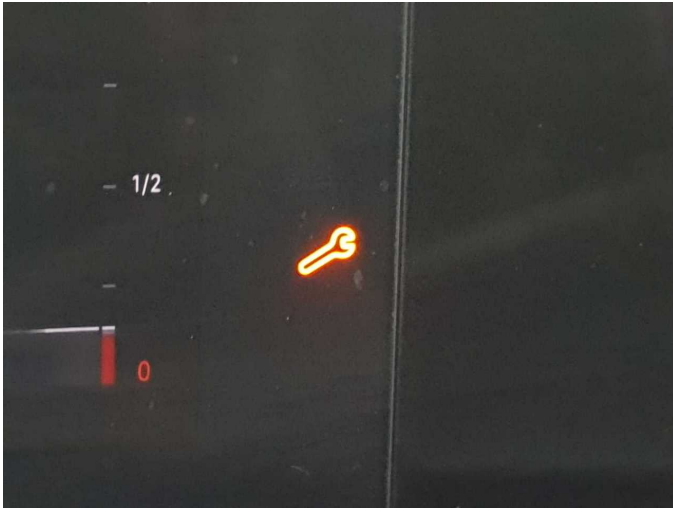
**Damage 7:** Misc.: Inspection / maintenance - Due - Perform

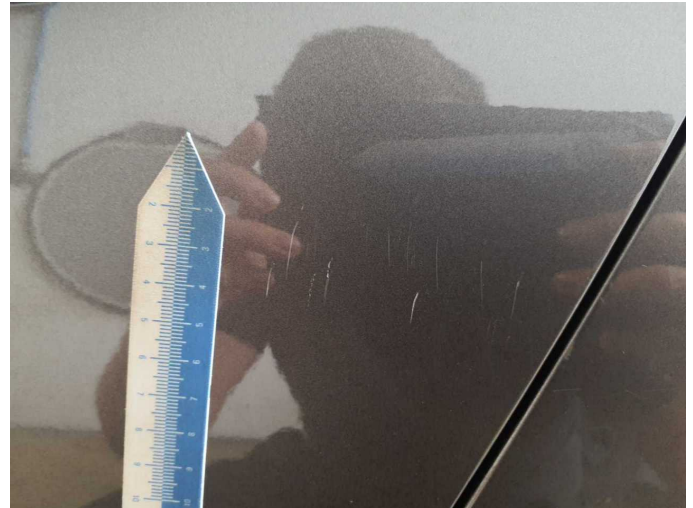
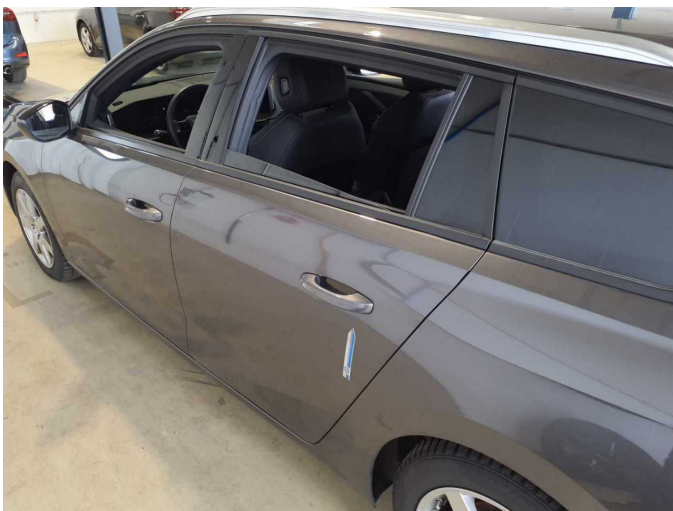
**Damage 8:** Door - rear left side: Door - Scratch(es) - Paint

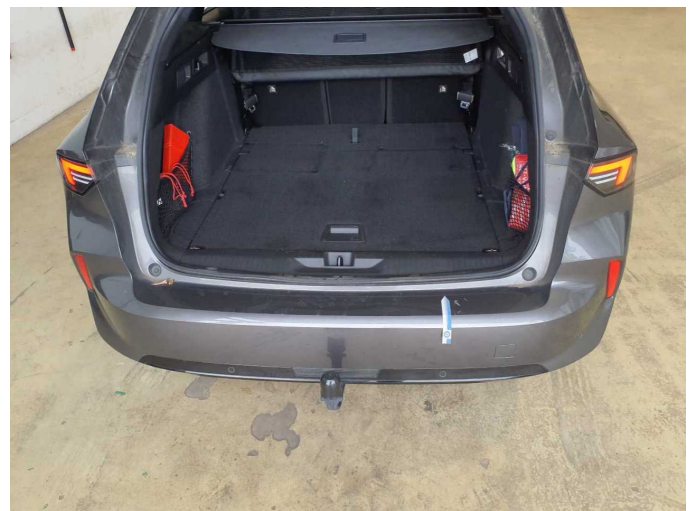
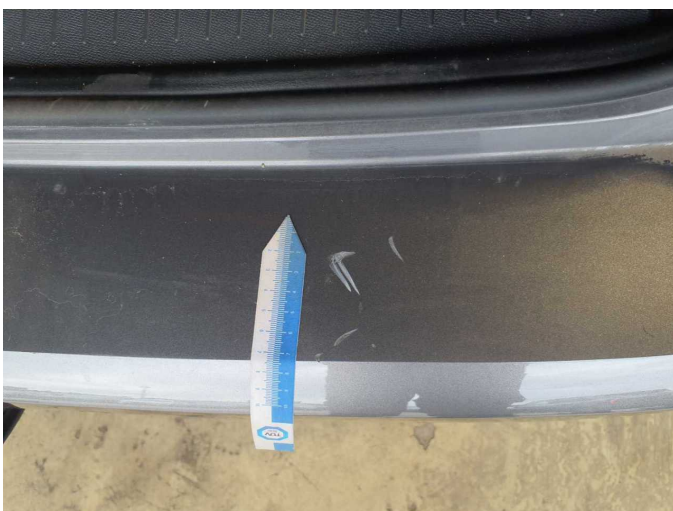
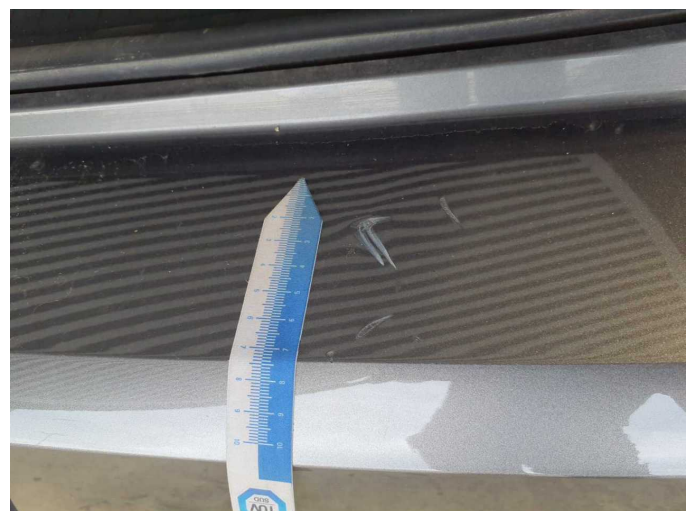
**Damage 9:** Rear bumper: Rear bumper - Dent / paintcoat damage - Repair and paint

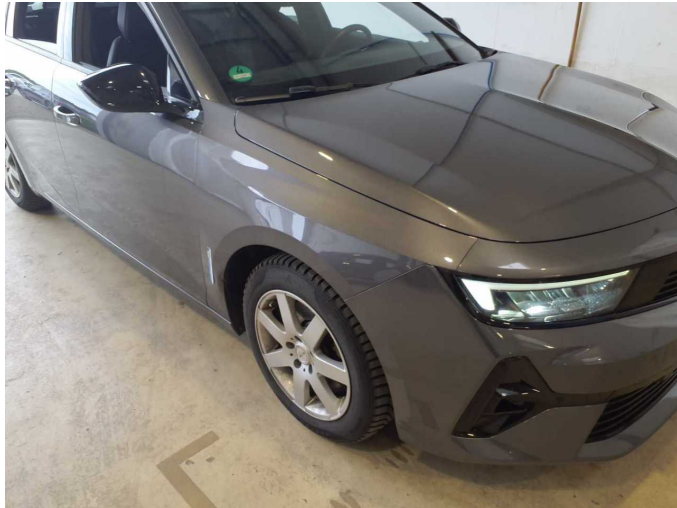
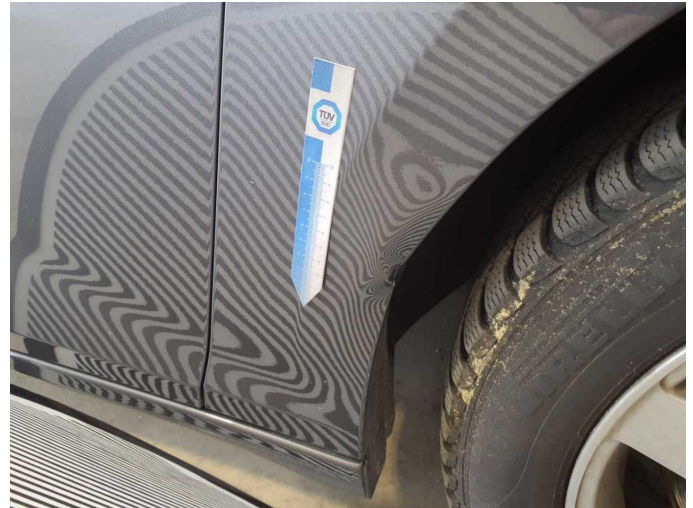
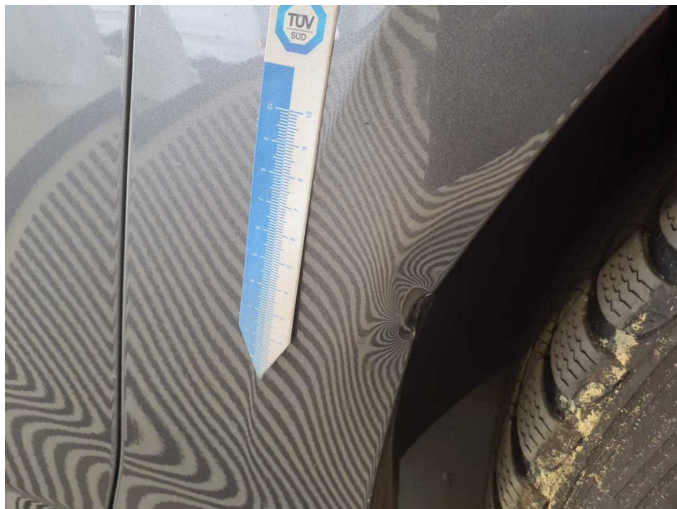
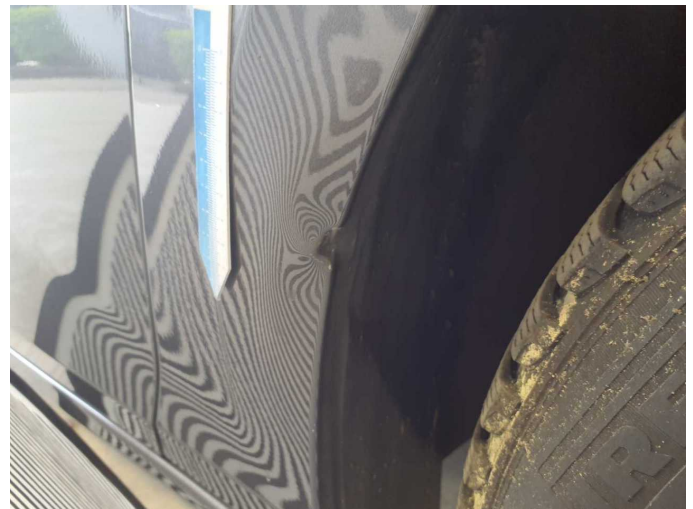
**Damage 10:** Mudguard - right side: Mudguard - right side - Deformed - Replace
