Expertise

Protocol number: 46557591  
Order No. / Reference: 26544840  
Inspection date: 16 Jul 2026

Manufacturer: Ford

Model: Focus Turnier 1.5 EcoBlue Start-Stopp-System Aut.  
COOL&CONNECT

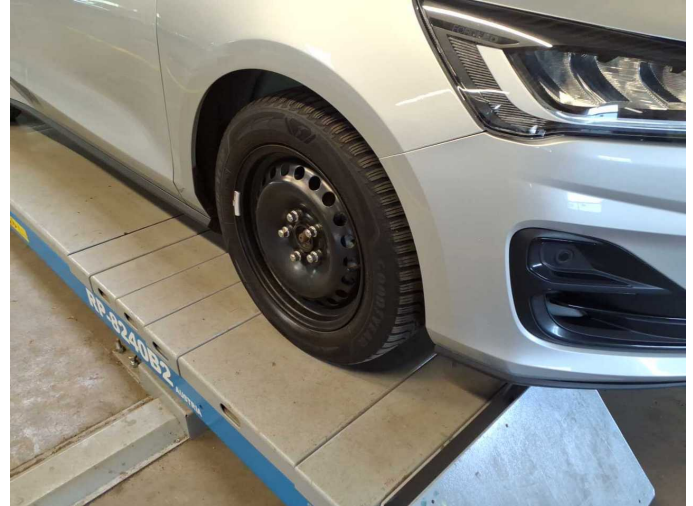
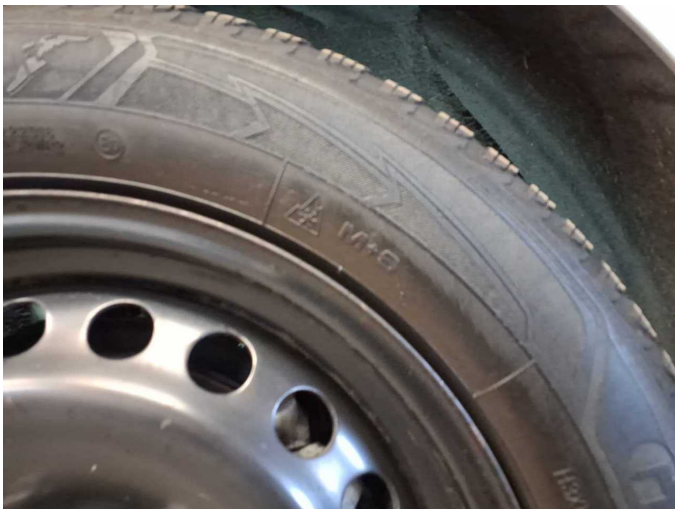
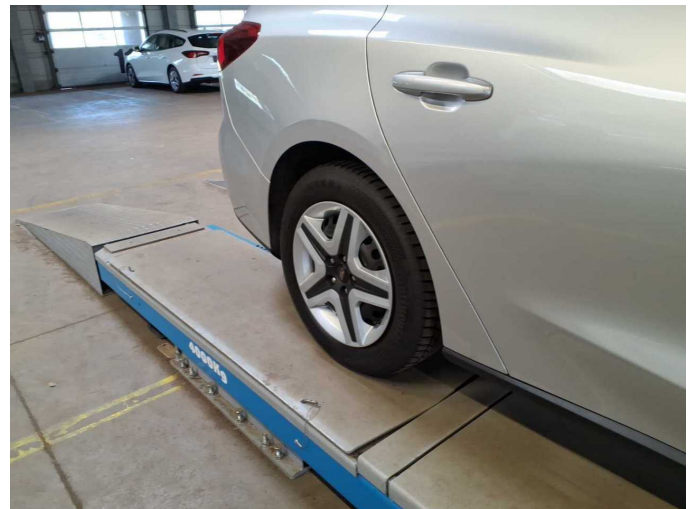
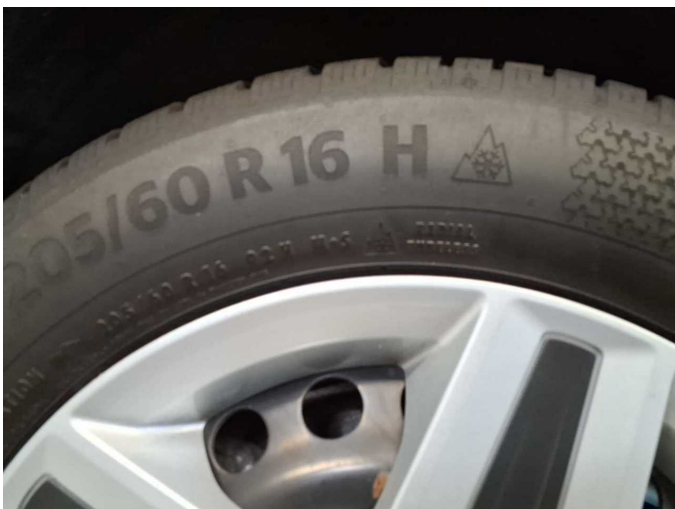
| No. | Component group | Description |
|---|---|---|
| 1 | Wheel / tyres | Tyres - complete set - Differs from the original configuration - No deduction |

**Damage 1:** Wheel / tyres: Tyres - complete set - Differs from the original configuration - No deduction

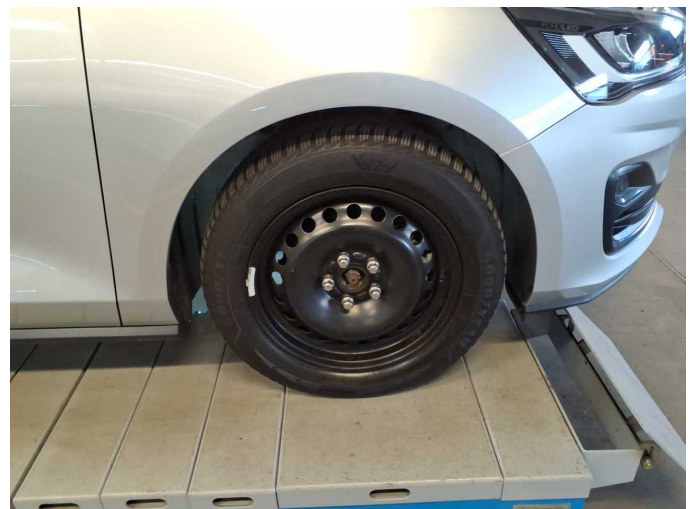
| No. | Component group | Description |
|---|---|---|
| 3 | Wheel / tyres | Wheel cover - front right side - Missing - Replace |

**Damage 3:** Wheel / tyres: Wheel cover - front right side - Missing - Replace

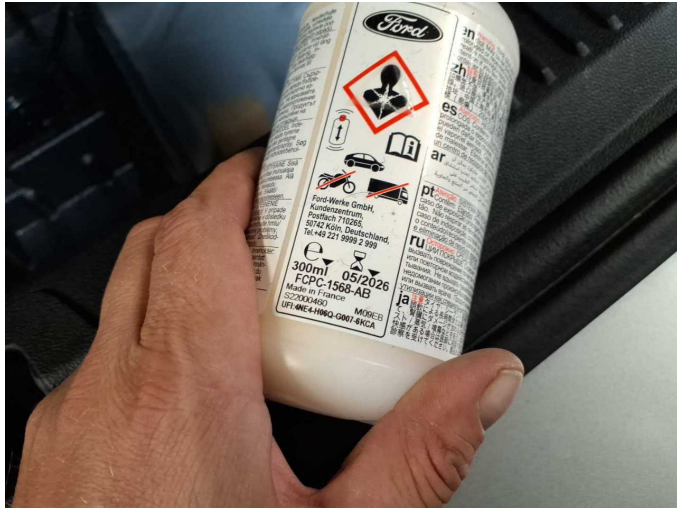
| No. | Component group | Description |
|---|---|---|
| 4 | Equipment | Tirefit filler - Expired - Replace |

**Damage 4:** Equipment: Tirefit filler - Expired - Replace

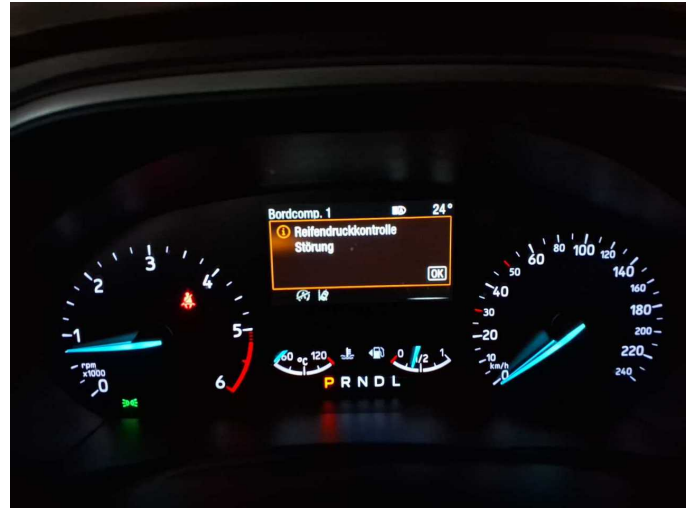
| No. | Component group | Description |
|---|---|---|
| 5 | Electronic systems | Electronic systems - Functional / admissibility - Perform diagnosis |

**Damage 5:** Electronic systems: Electronic systems - Functional / admissibility - Perform diagnosis

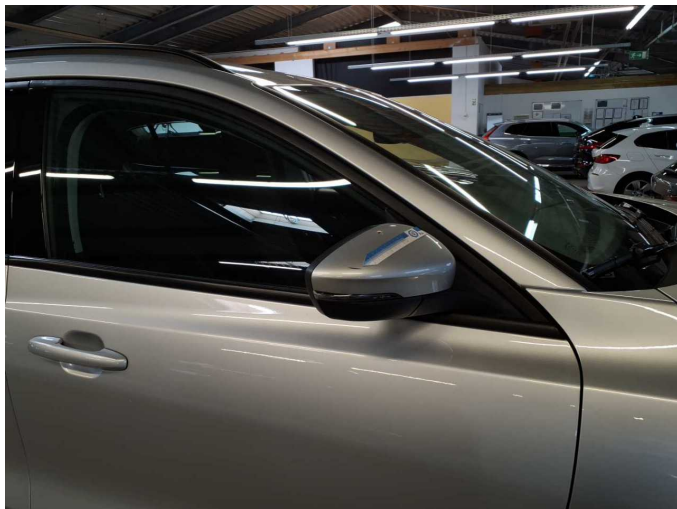
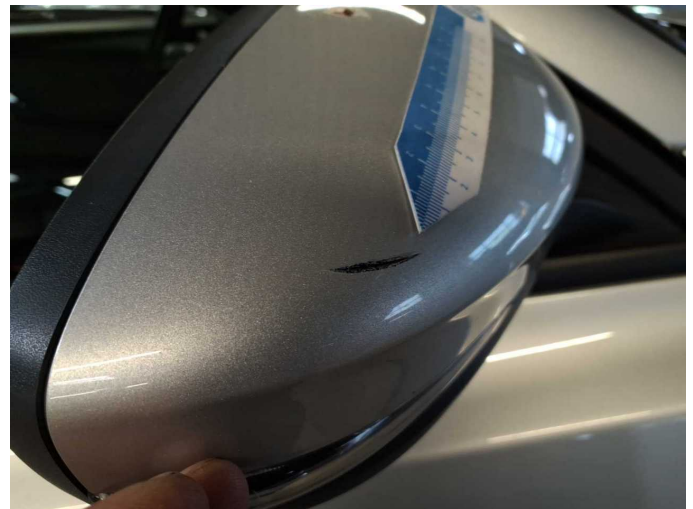
| No. | Component group | Description |
|---|---|---|
| 6 | Wing mirror - right side | Cap - Scratch(es) - Smart repair |

**Damage 6:** Wing mirror - right side: Cap - Scratch(es) - Smart repair

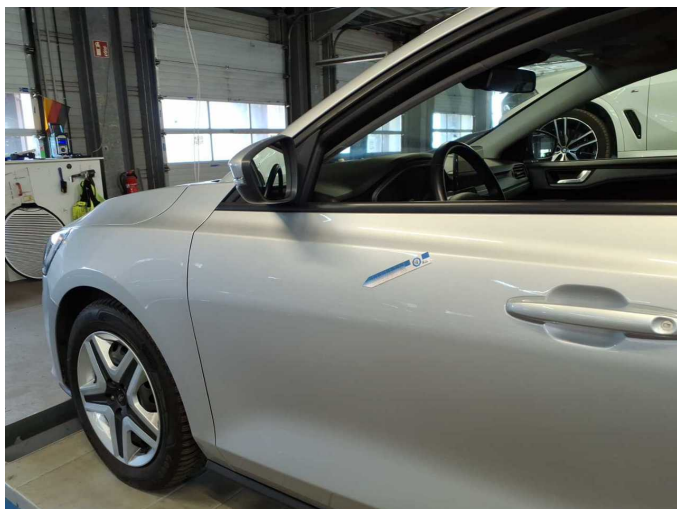
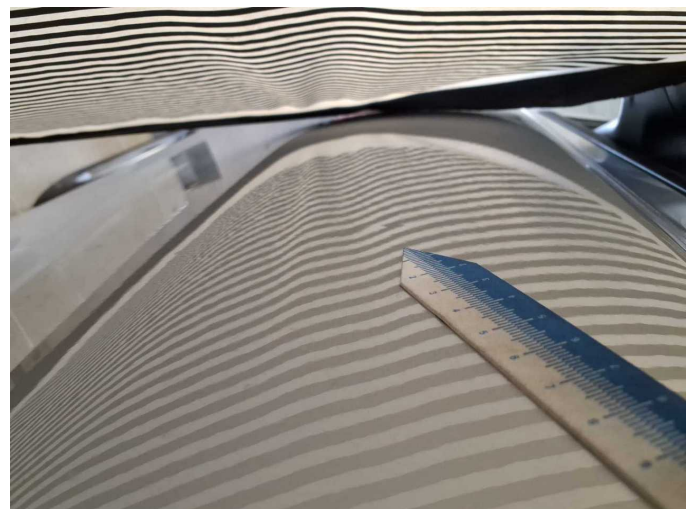
| No. | Component group | Description |
|---|---|---|
| 7 | Door - front left side | Door - dent(s) - Smooth repair work |

**Damage 7:** Door - front left side: Door - dent(s) - Smooth repair work

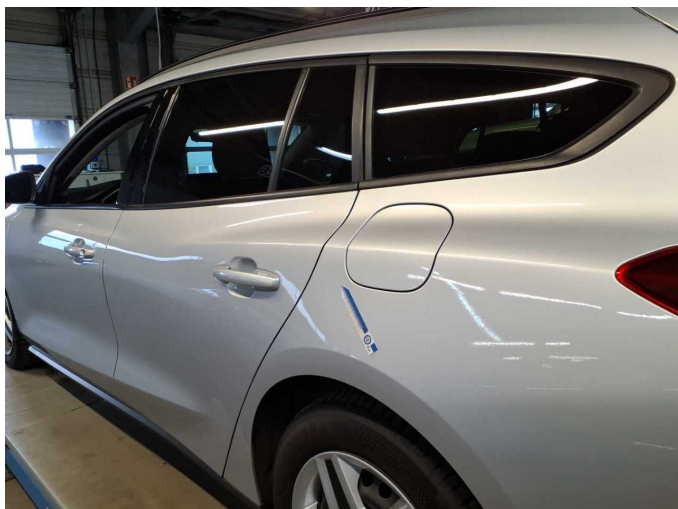
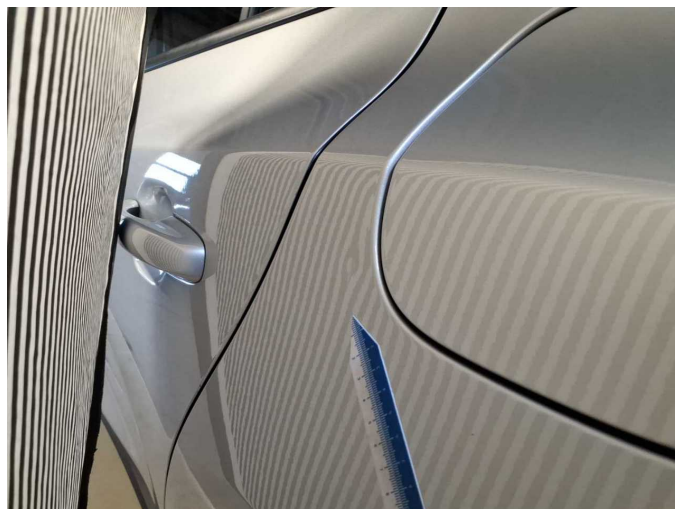
| No. | Component group | Description |
|---|---|---|
| 8 | Side panel - rear left side | Side panel - dent(s) - Smooth repair work |

**Damage 8:** Side panel - rear left side: Side panel - dent(s) - Smooth repair work

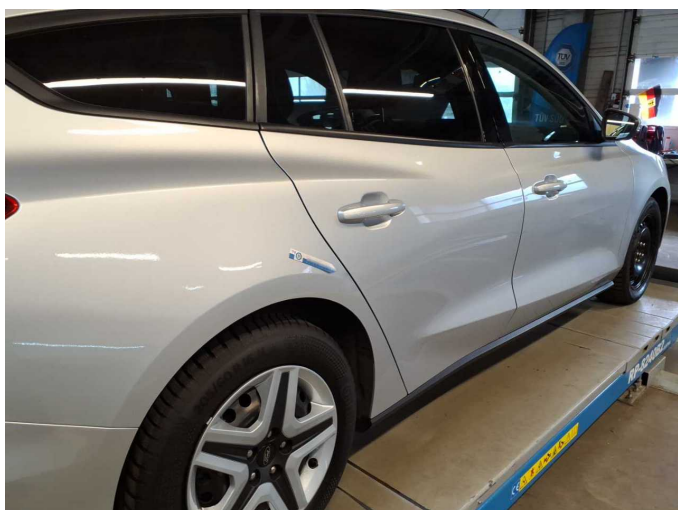
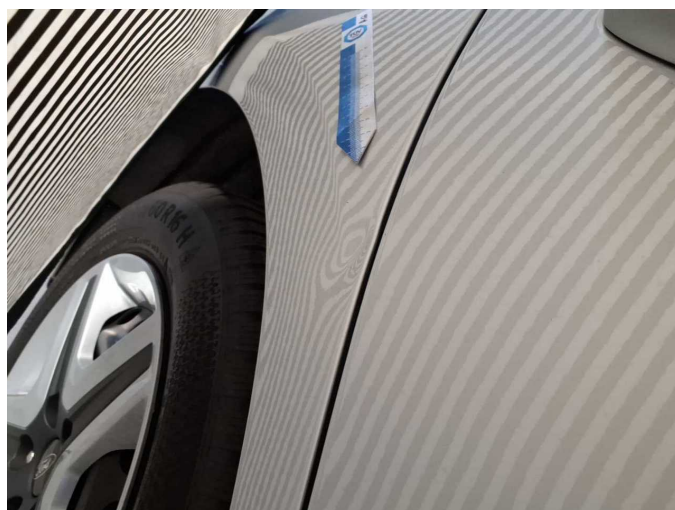
| No. | Component group | Description |
|---|---|---|
| 9 | Side panel - rear right side | Side panel - dent(s) - Smooth repair work |

**Damage 9:** Side panel - rear right side: Side panel - dent(s) - Smooth repair work

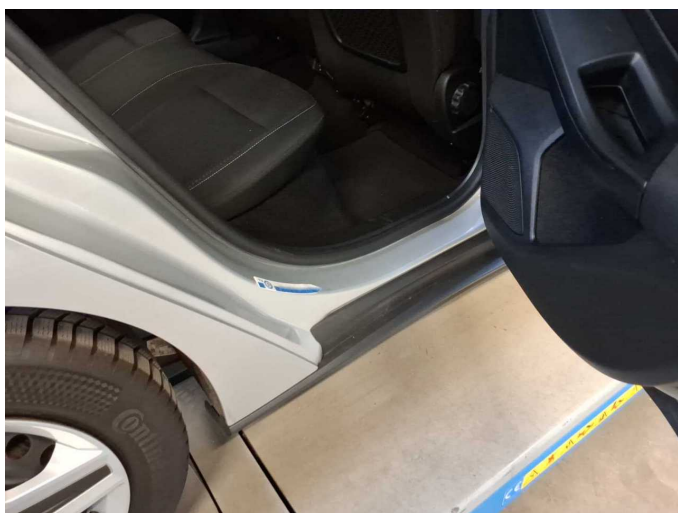
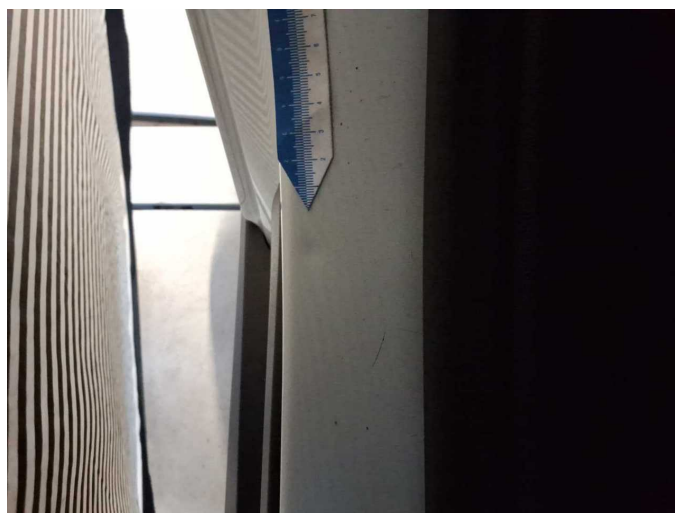
| No. | Component group | Description |
|---|---|---|
| 10 | Side panel - rear right side | Sill - dent(s) - Smooth repair work |

**Damage 10:** Side panel - rear right side: Sill - dent(s) - Smooth repair work

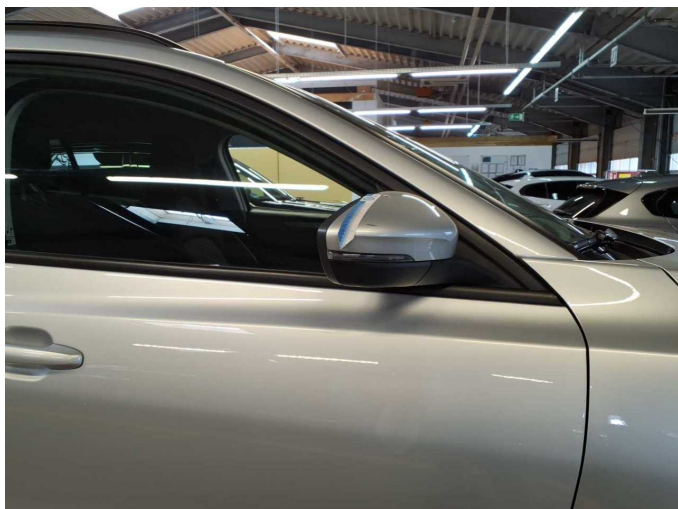
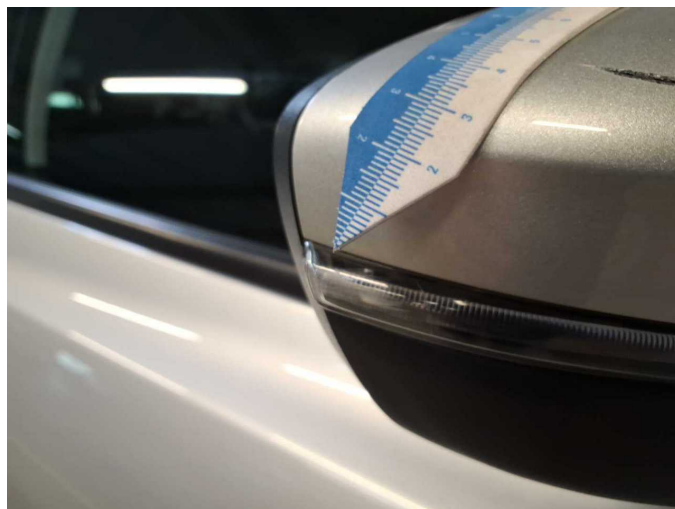
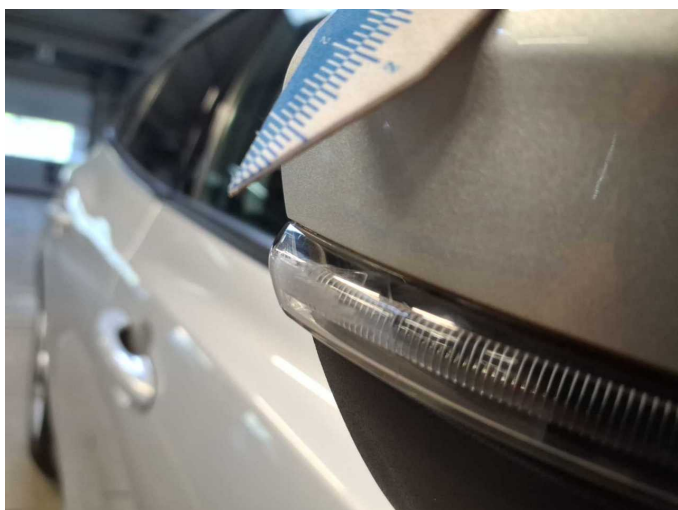
| No. | Component group | Description |
|---|---|---|
| 11 | Indicator - front | Mirror - right side (Materialabtrag) - Scratched - Replace |

**Damage 11:** Indicator - front: Mirror - right side (Materialabtrag) - Scratched - Replace

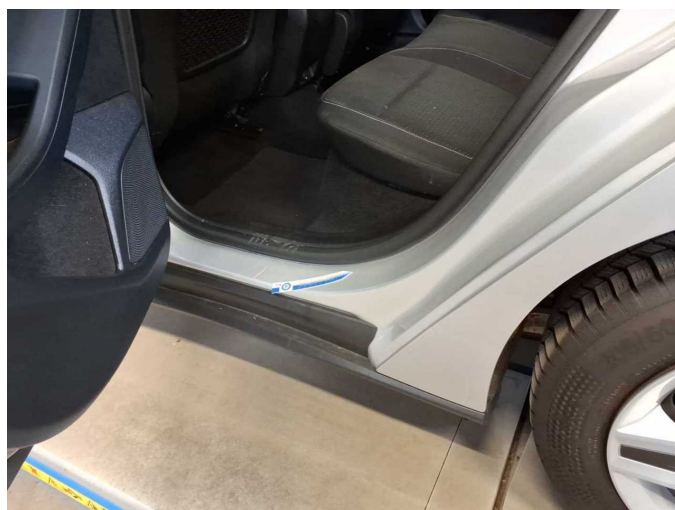
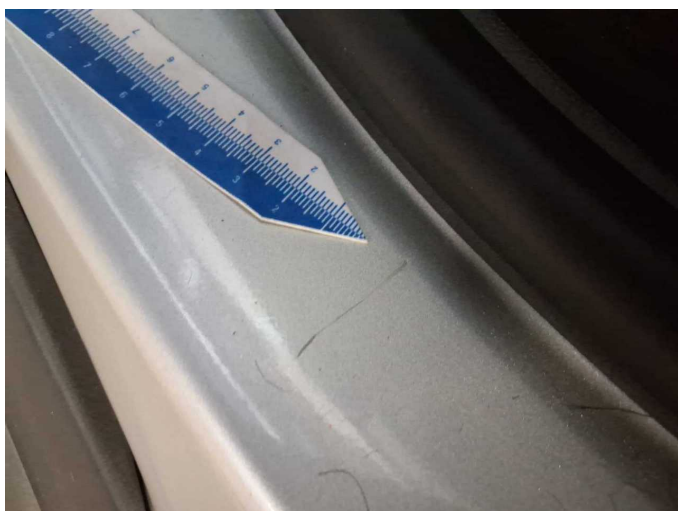
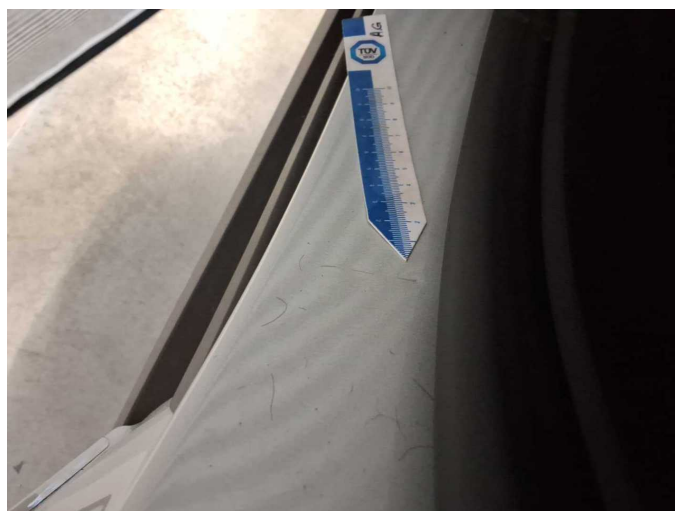
| No. | Component group | Description |
|---|---|---|
| 12 | Side panel - rear left side | Sill - Dent / paintcoat damage - Smart repair |

**Damage 12:** Side panel - rear left side: Sill - Dent / paintcoat damage - Smart repair

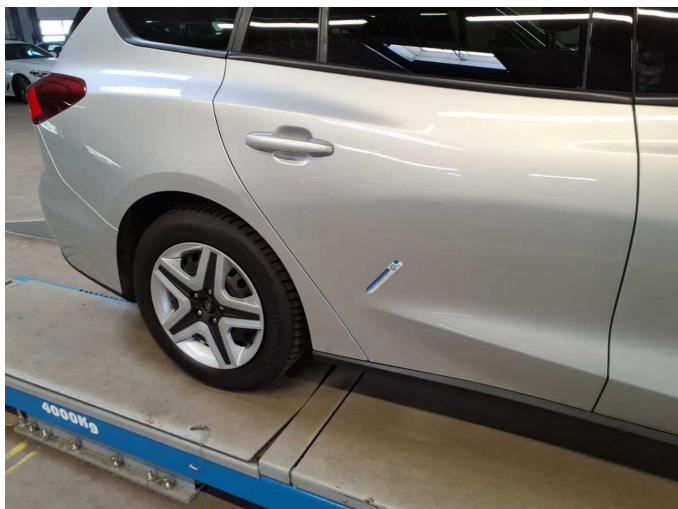
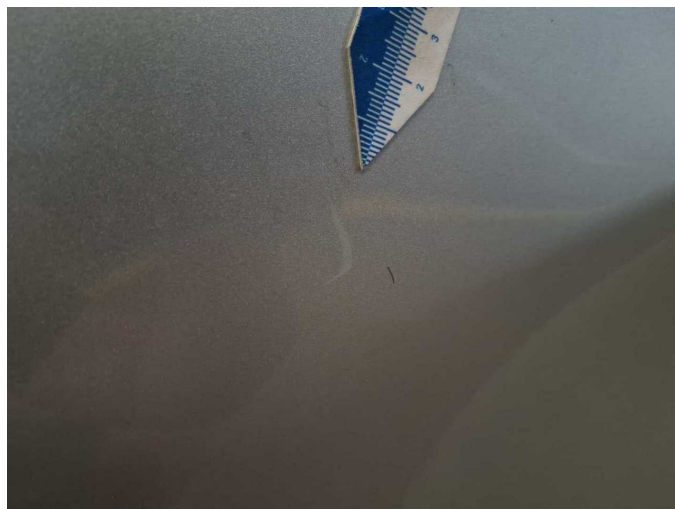
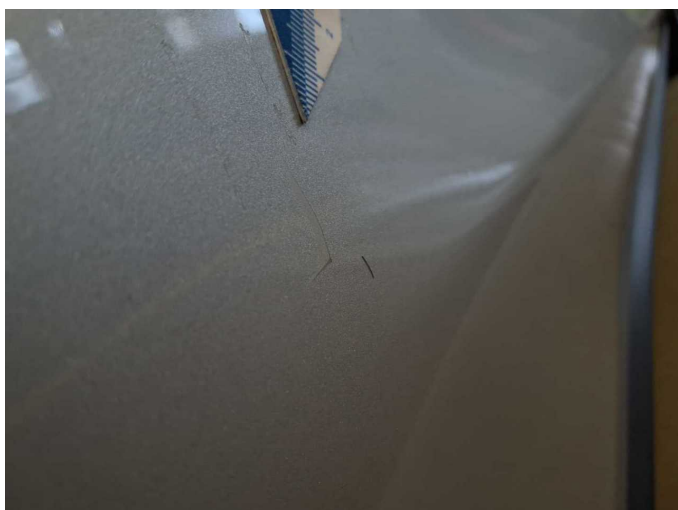
| No. | Component group | Description |
|---|---|---|
| 13 | Door - rear right side | Door - Scratch(es) - Smart repair |

**Damage 13:** Door - rear right side: Door - Scratch(es) - Smart repair

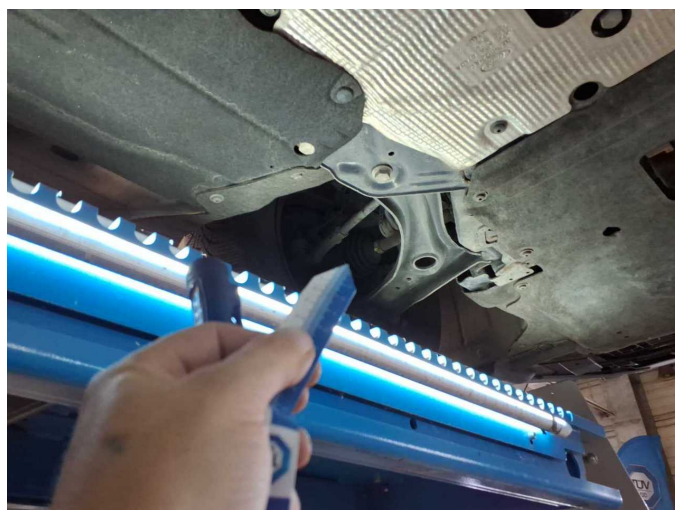
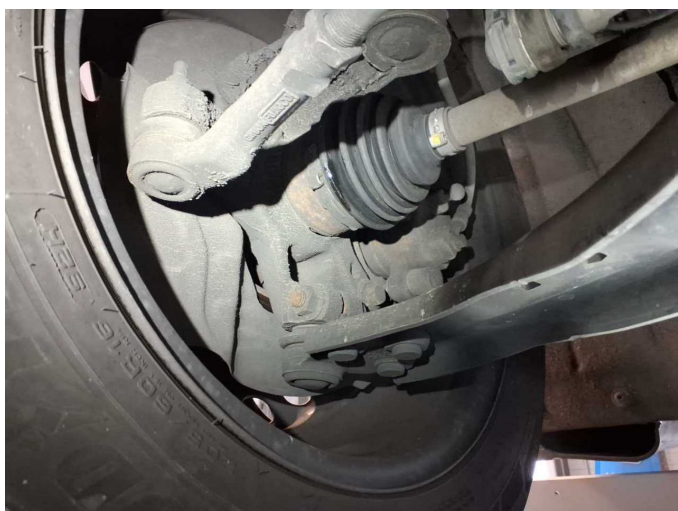
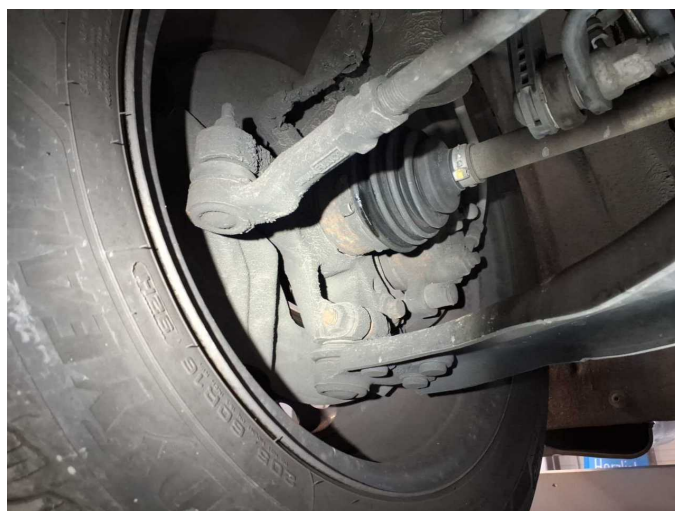
| No. | Component group | Description |
|---|---|---|
| 14 | Drive train | Sleeve prop shaft - front left side (knarrt beim einlenken) - Broken / torn - Perform diagnosis |

**Damage 14:** Drive train: Sleeve prop shaft - front left side (knarrt beim einlenken) - Broken / torn - Perform diagnosis

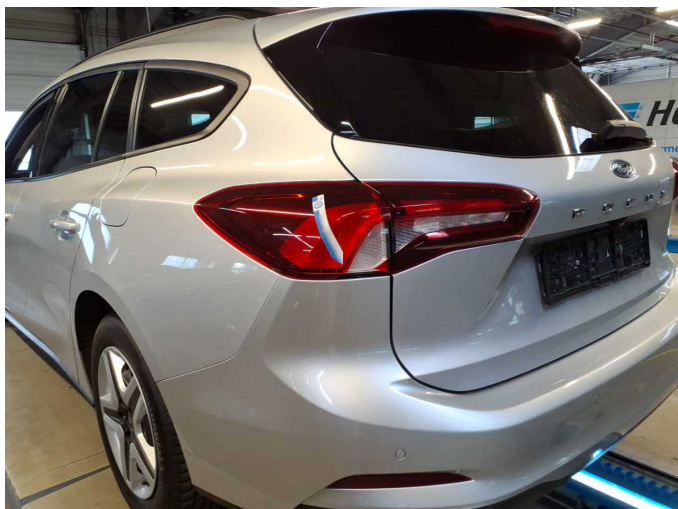
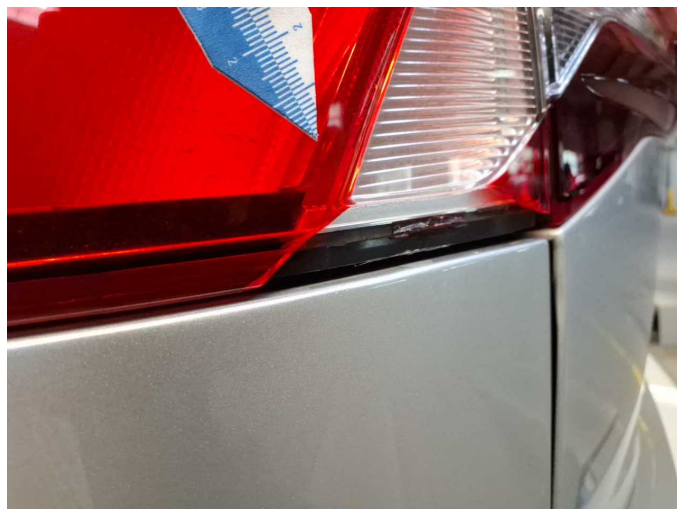
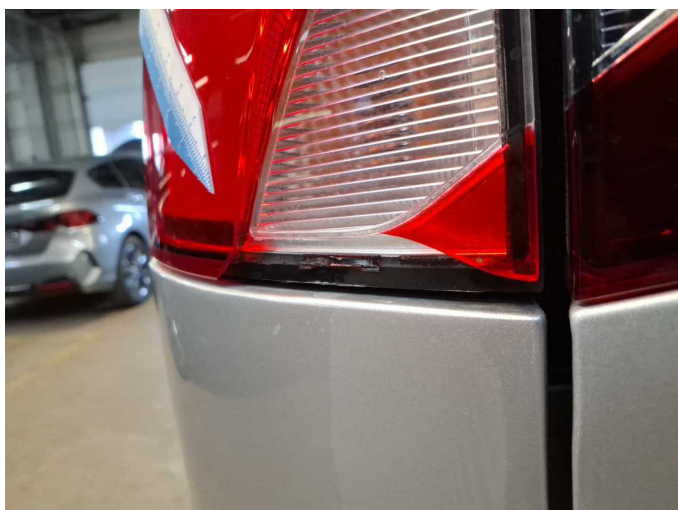
| No. | Component group | Description |
|---|---|---|
| 15 | Tail light | Tail lamp - left side - Broken / torn - Replace |

**Damage 15:** Tail light: Tail lamp - left side - Broken / torn - Replace

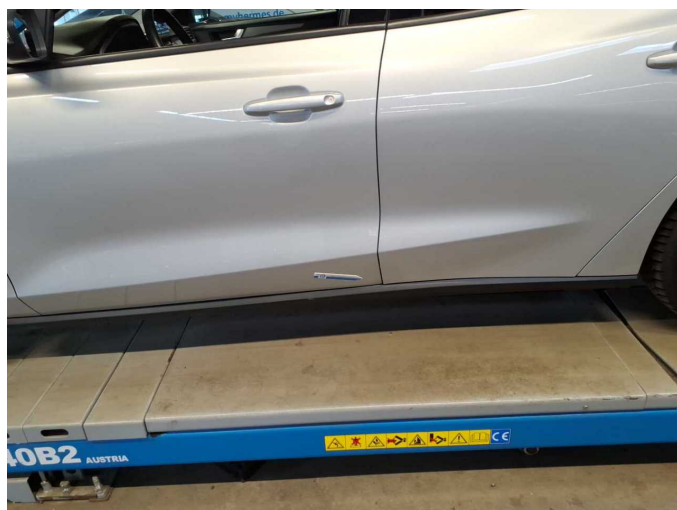
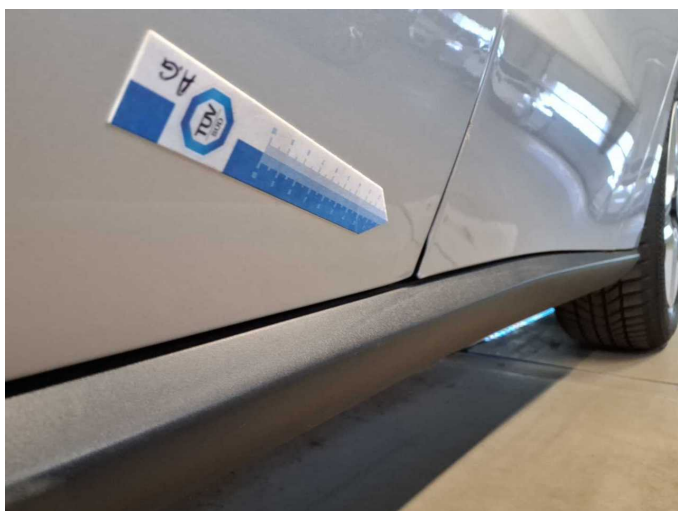
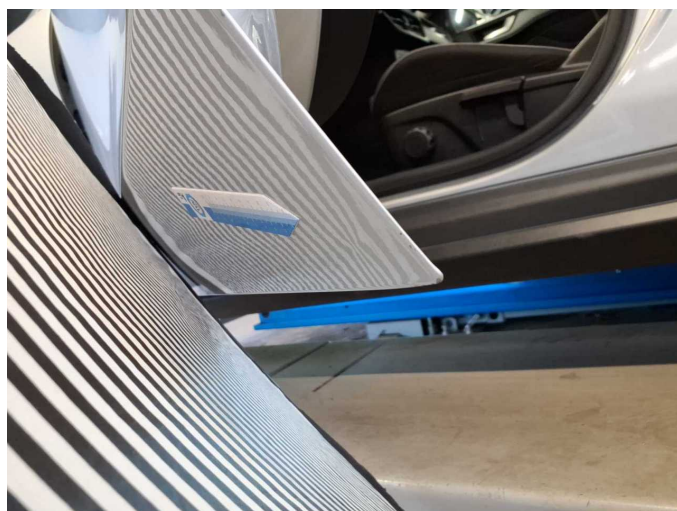
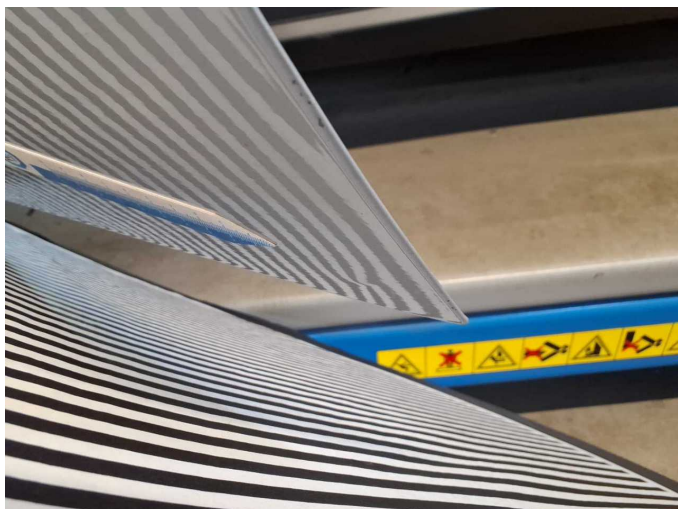
| No. | Component group | Description |
|---|---|---|
| 16 | Door - front left side | Door - Deformed - Repair and paint |

**Damage 16:** Door - front left side: Door - Deformed - Repair and paint

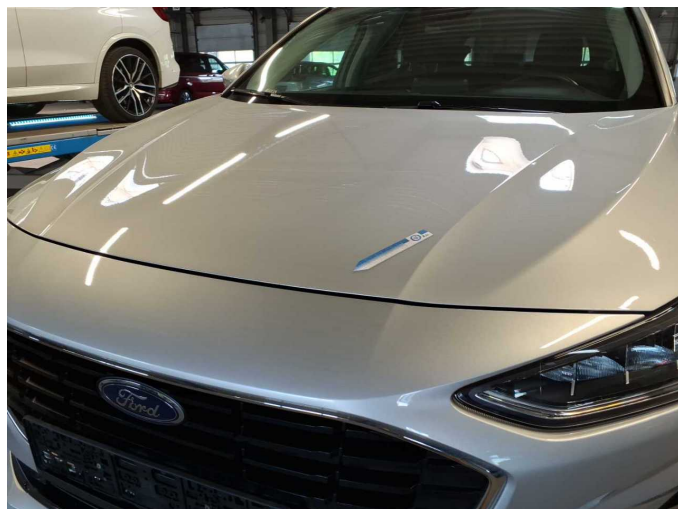
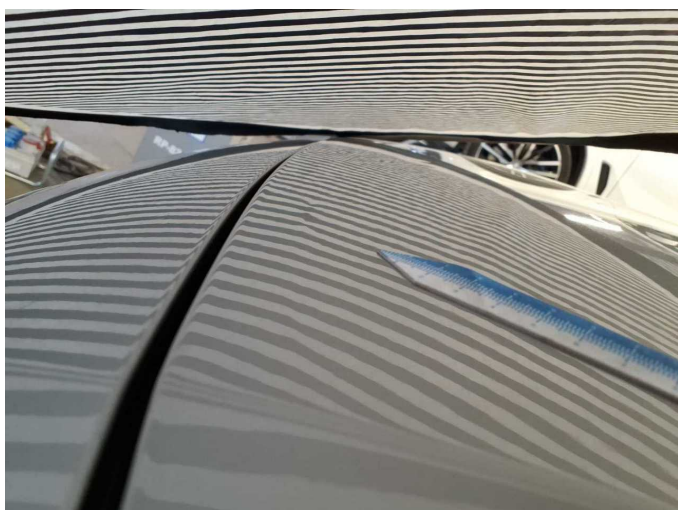
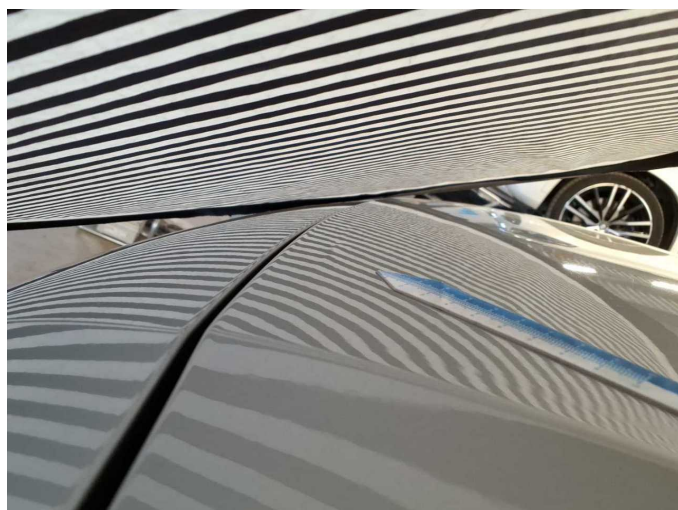
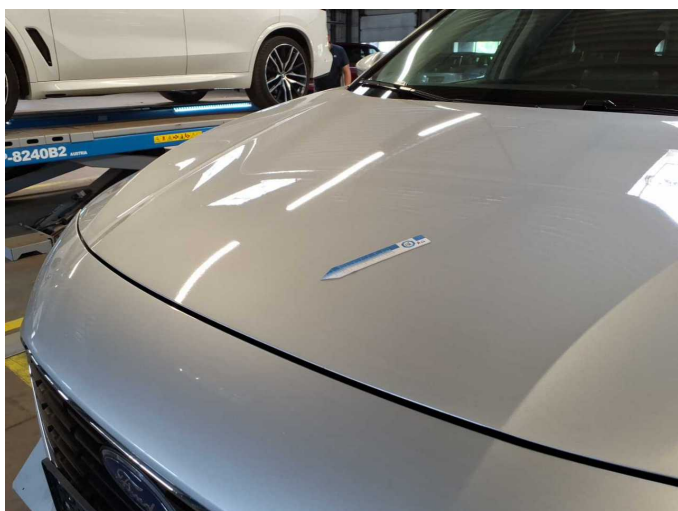
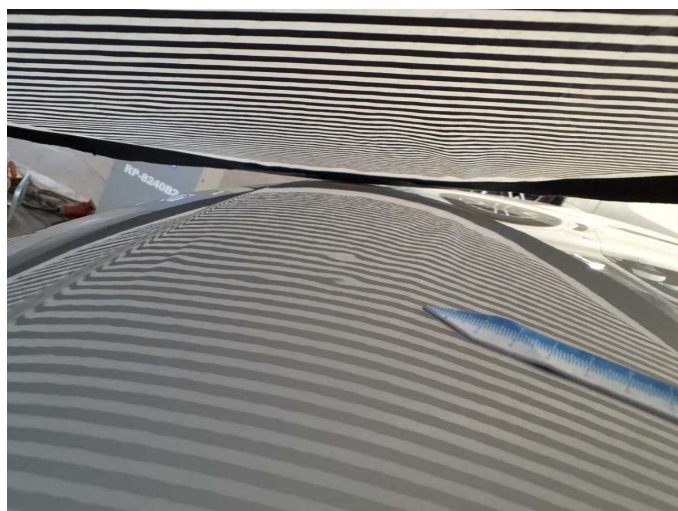
| No. | Component group | Description |
|---|---|---|
| 17 | Bonnet | Bonnet - Deformed - Repair and paint |

**Damage 17:** Bonnet: Bonnet - Deformed - Repair and paint

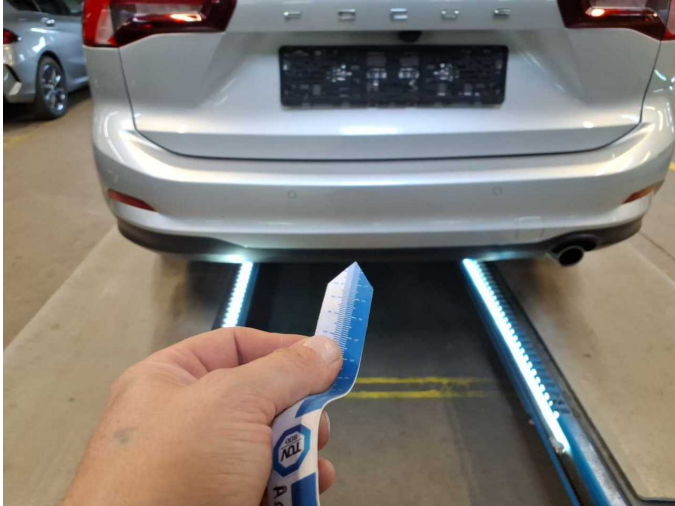
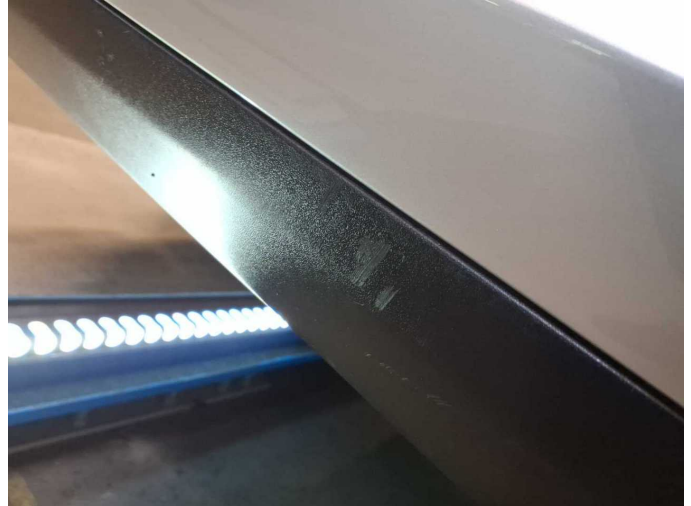
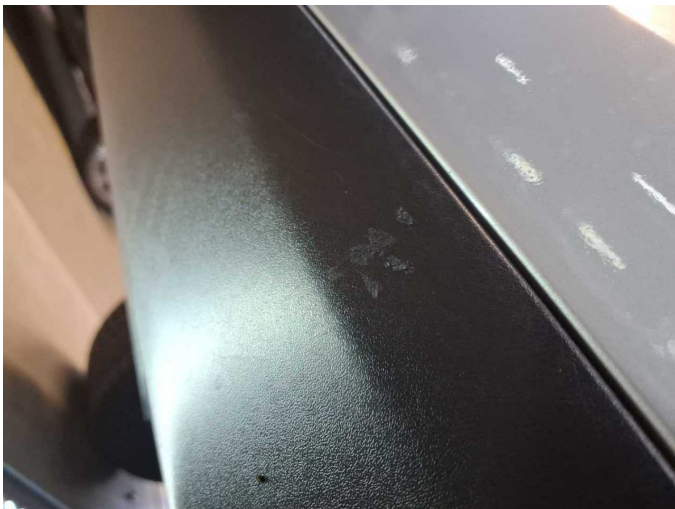
| No. | Component group | Description |
|---|---|---|
| 2 | Rear bumper | Spoiler - Scratch(es) - Smart repair |

**Wear and tear 2:** Rear bumper: Spoiler - Scratch(es) - Smart repair

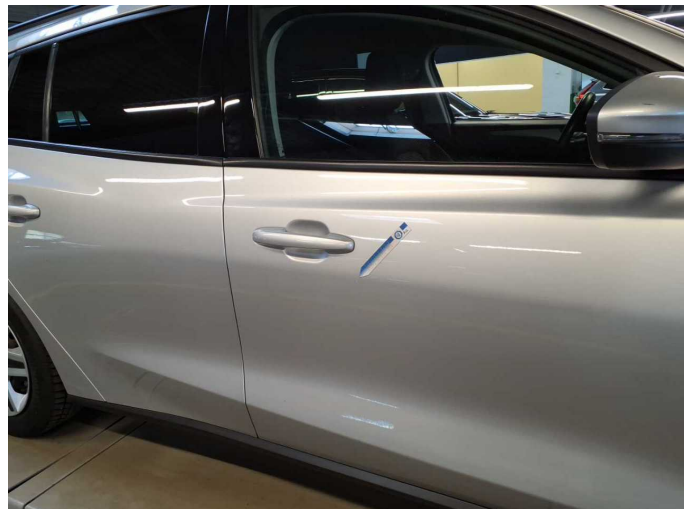
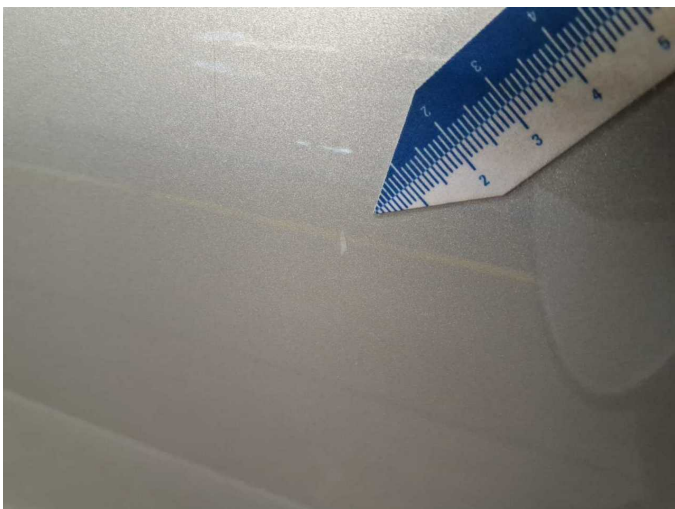
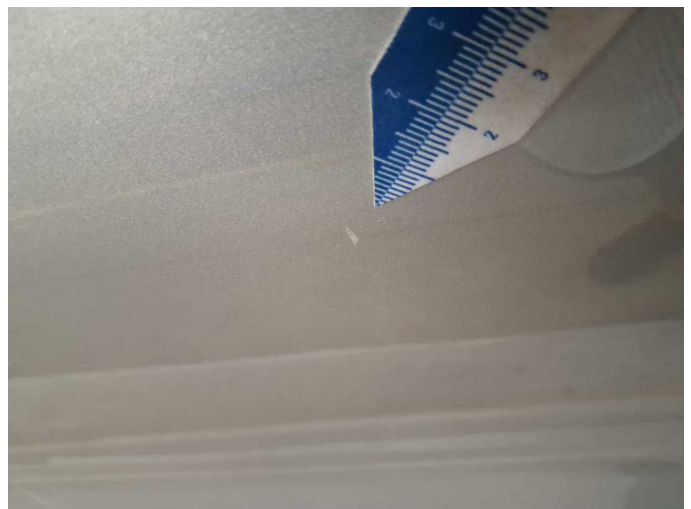
| No. | Component group | Description |
|---|---|---|
| 3 | Door - front right side | Door - Scratch(es) - Smart repair |

**Wear and tear 3:** Door - front right side: Door - Scratch(es) - Smart repair

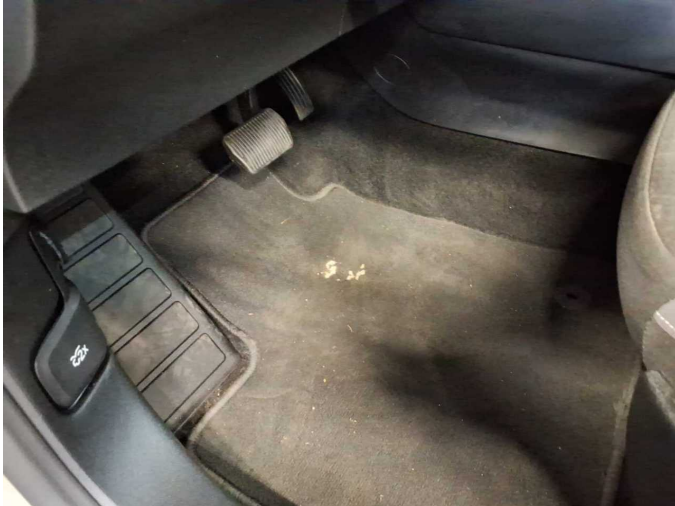
| No. | Component group | Description |
|---|---|---|
| 4 | Trim / covers | Floor mats - Broken / torn - No deduction |

**Wear and tear 4:** Trim / covers: Floor mats - Broken / torn - No deduction

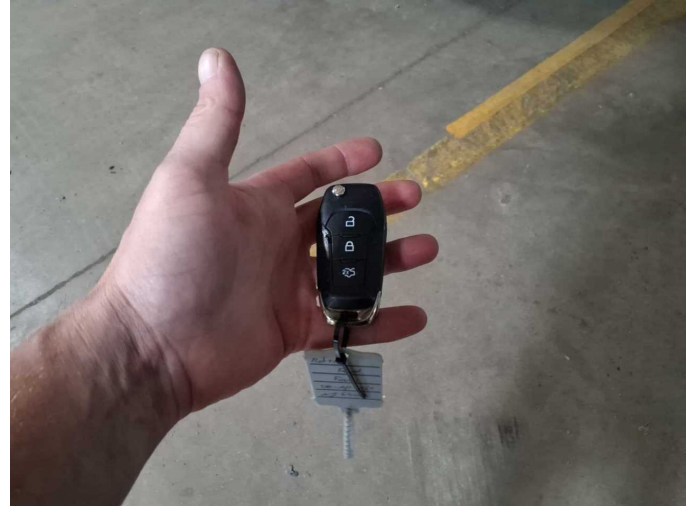
Equipment - Vehicle key with remote control

**Missing part 3:** Equipment: Vehicle key with remote control - Missing - Replace

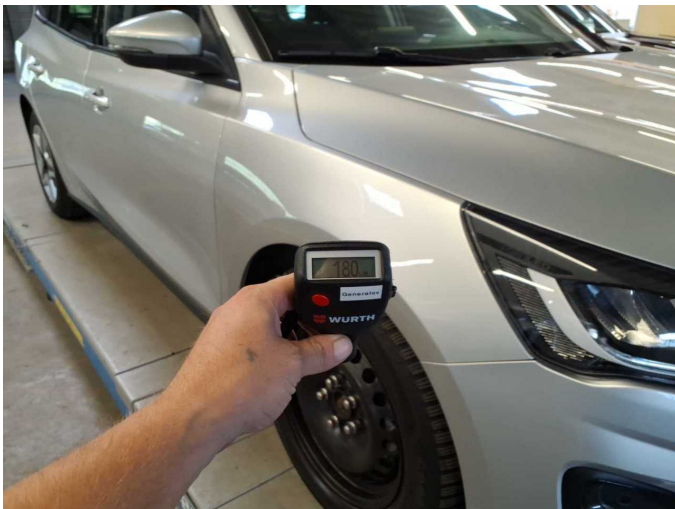
**Repainting 1:** Mudguard - right side

- Mudguard - right side, Professionally carried out, Invoice of repair done Non-existent
- Door - front right side, Professionally carried out, Invoice of repair done Non-existent

| Mudguard - right side | 180 µm | Door - front right side | 169 µm |
