Expertise

Protocol number: 45976911
Order No. / Reference: 26463134
Inspection date: 15 Jun 2026

Manufacturer: Opel

Model: Corsa-e Elegance

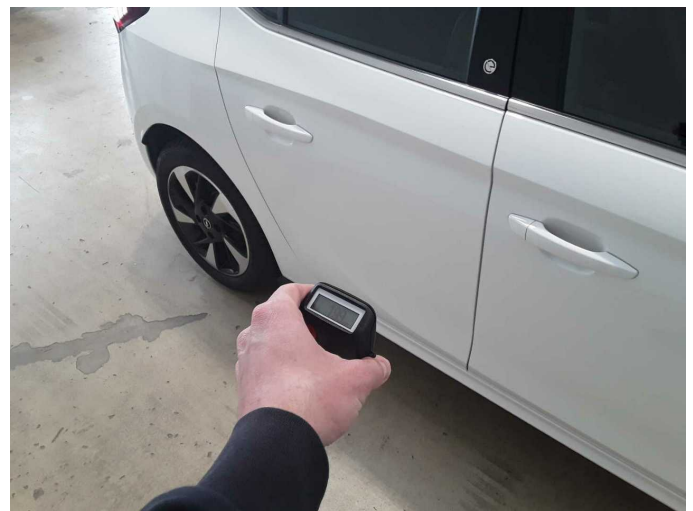
No.	Repainting
1	Door - rear right side, Professionally carried out, Invoice of repair done
2	Door - front right side, Professionally carried out, Invoice of repair done

Door - rear right side	199 µm	Door - front right side	1,030 µm
------------------------	--------	-------------------------	----------

Repainting 1: Door - rear right side

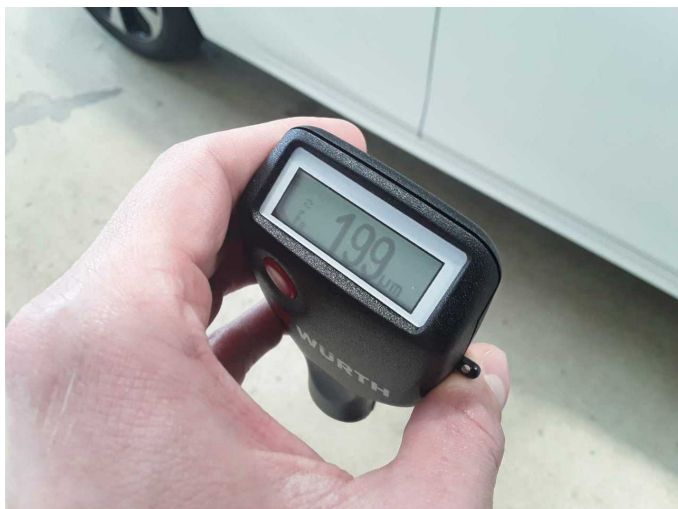
Repainting 1: Door - rear right side

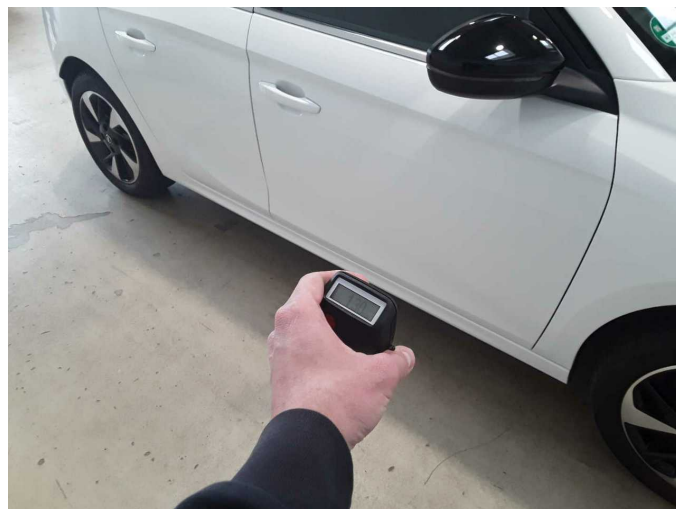
Repainting 2: Door - front right side

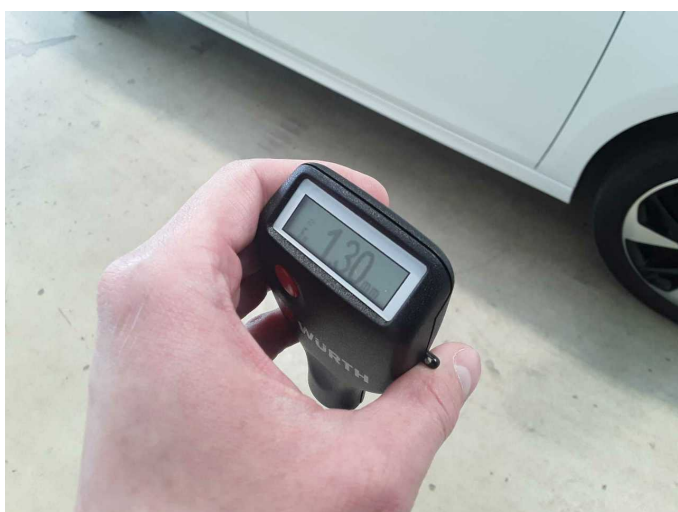
Repainting 2: Door - front right side
