Expertise

Protocol number: 46714293  
Order No. / Reference: 26733811  
Inspection date: 25 Jul 2026

Manufacturer: Ford

Model: Kuga 2.5 Duratec PHEV VIGNALE

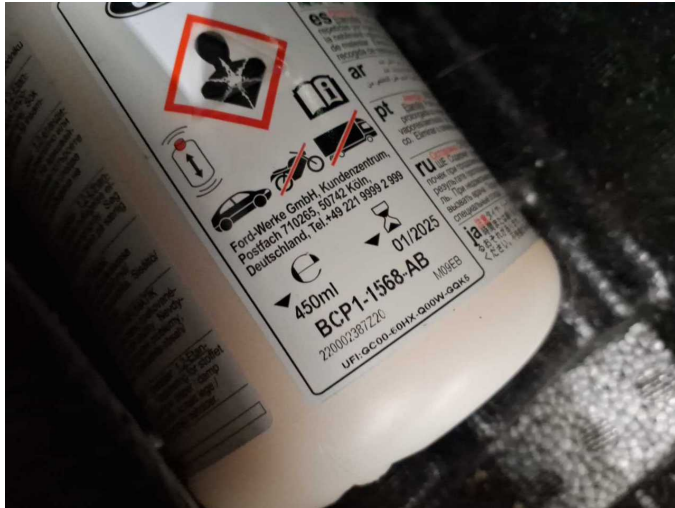
| No. | Component group | Description |
|---|---|---|
| 1 | Equipment | Tirefit filler - Expired - Replace |

**Damage 1:** Equipment: Tirefit filler - Expired - Replace

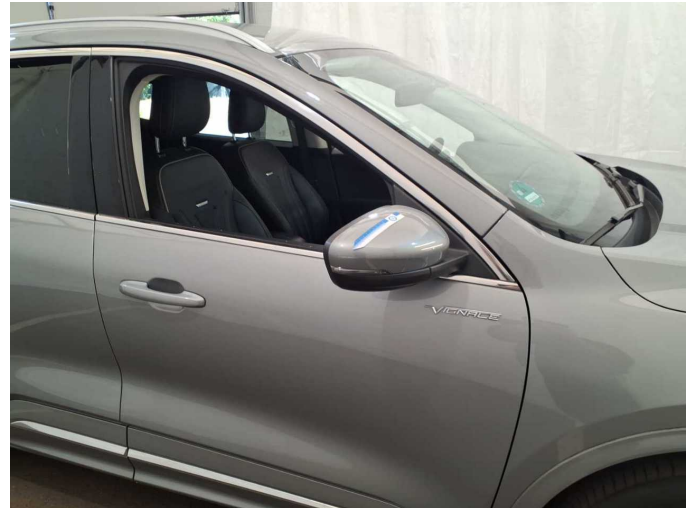
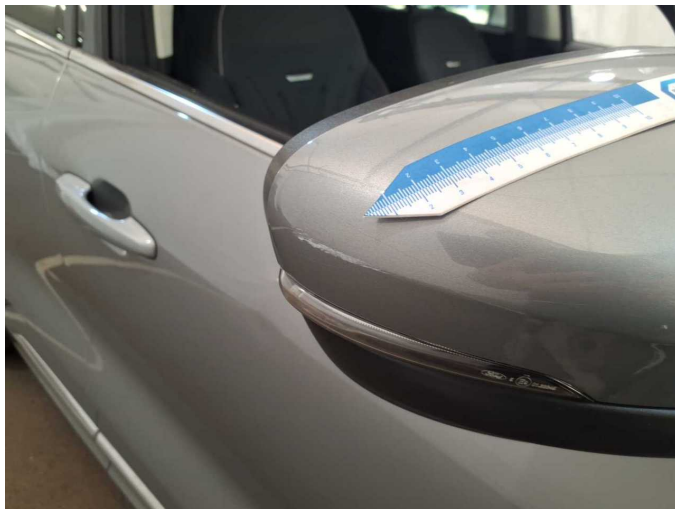
| No. | Component group | Description |
|---|---|---|
| 2 | Wing mirror - right side | Cap - Scratch(es) - Smart repair |

**Damage 2:** Wing mirror - right side: Cap - Scratch(es) - Smart repair

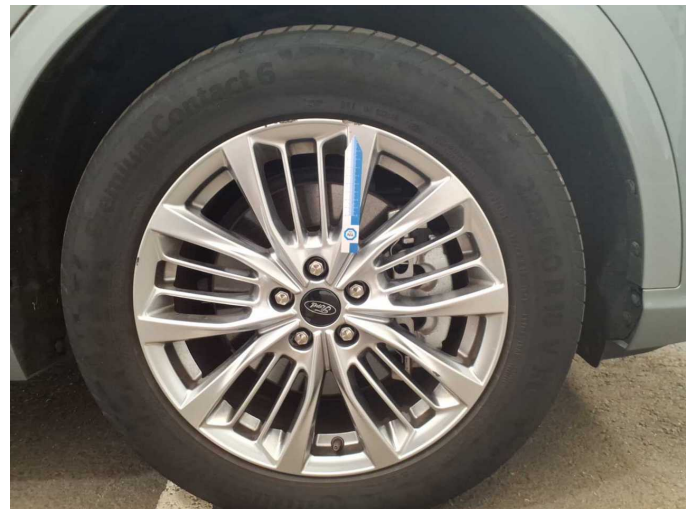
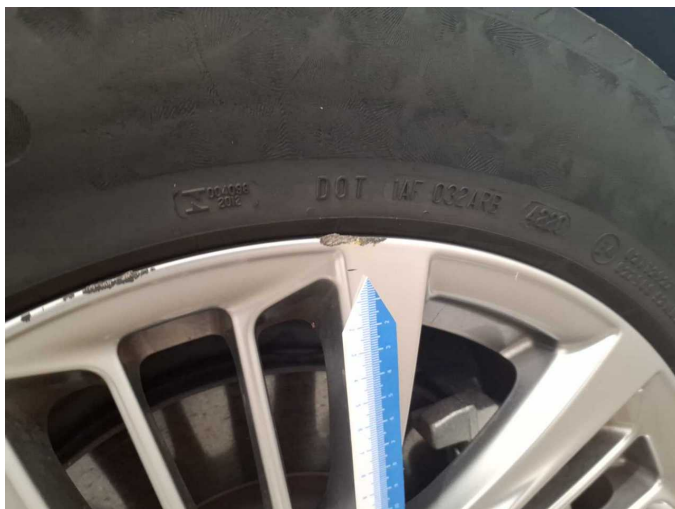
| No. | Component group | Description |
|---|---|---|
| 3 | Wheel / tyres | Alloy rim - front right side - Scratch(es) - Loss in value |

**Damage 3:** Wheel / tyres: Alloy rim - front right side - Scratch(es) - Loss in value

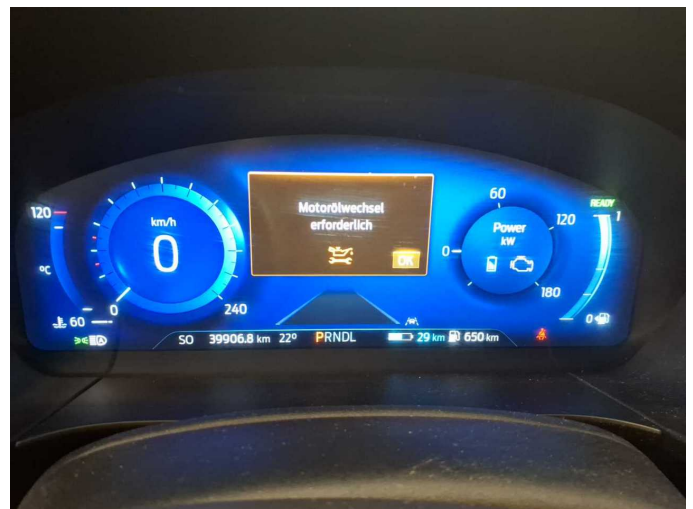
| No. | Component group | Description |
|---|---|---|
| 4 | Misc. | Inspection / maintenance - Due - Perform |

**Damage 4:** Misc.: Inspection / maintenance - Due - Perform
