Expertise

Protocol number: 46052026  
Order No. / Reference: 26601148  
Inspection date: 19 Jun 2026

Manufacturer: Skoda  
VIN: TMBJJ9NS5L8521334

Model: Kodiaq 2.0 TDI DSG Style

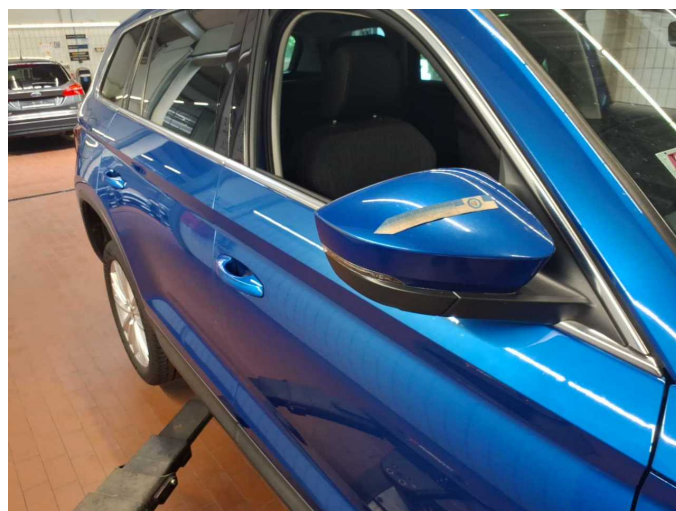
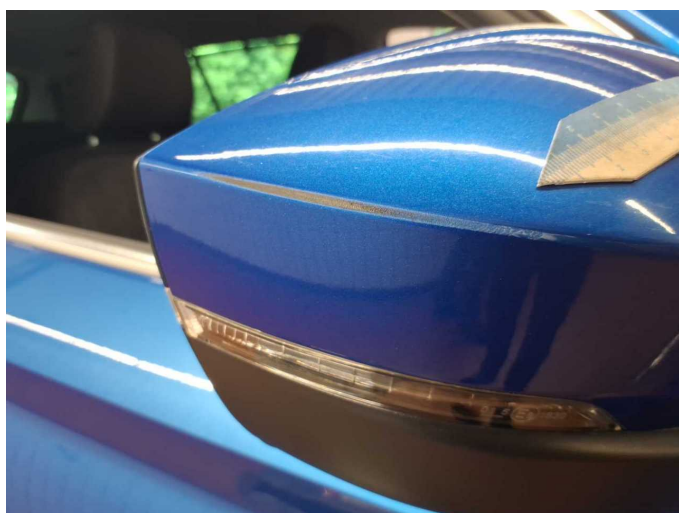
| No. | Component group | Description |
|---|---|---|
| 3 | Wing mirror - right side | Cap - Scratch(es) - Smart repair |

**Damage 3:** Wing mirror - right side: Cap - Scratch(es) - Smart repair

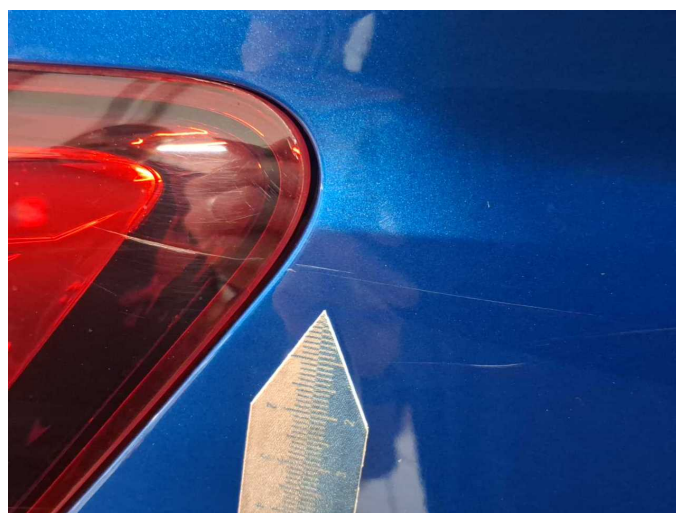
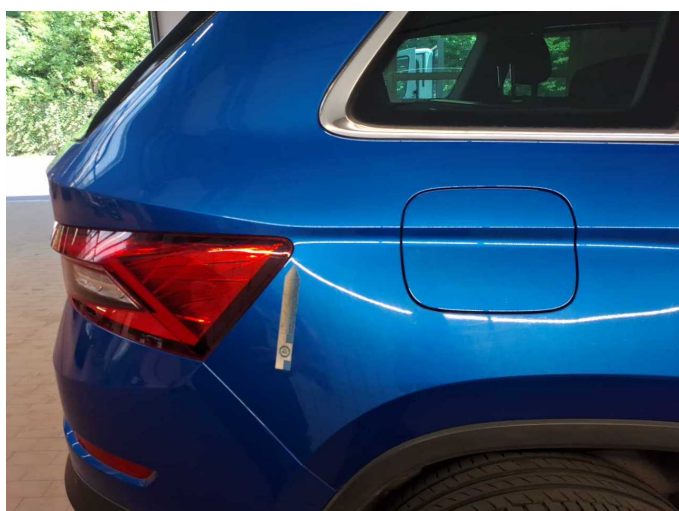
| No. | Component group | Description |
|---|---|---|
| 4 | Side panel - rear right side | Side panel - Scratch(es) - Smart repair |

**Damage 4:** Side panel - rear right side: Side panel - Scratch(es) - Smart repair

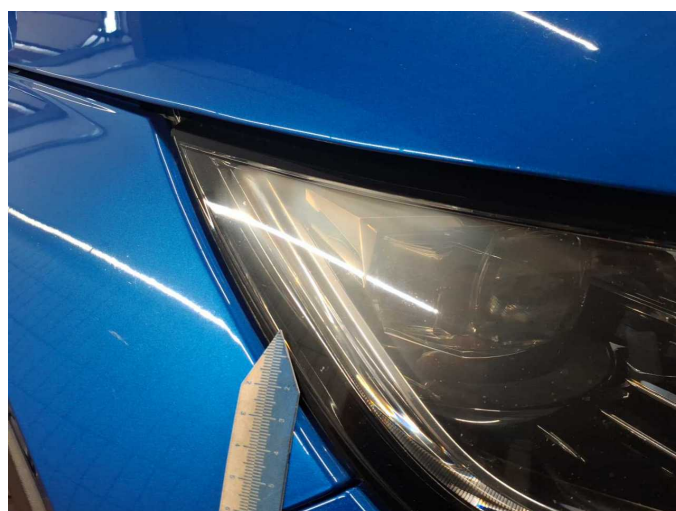
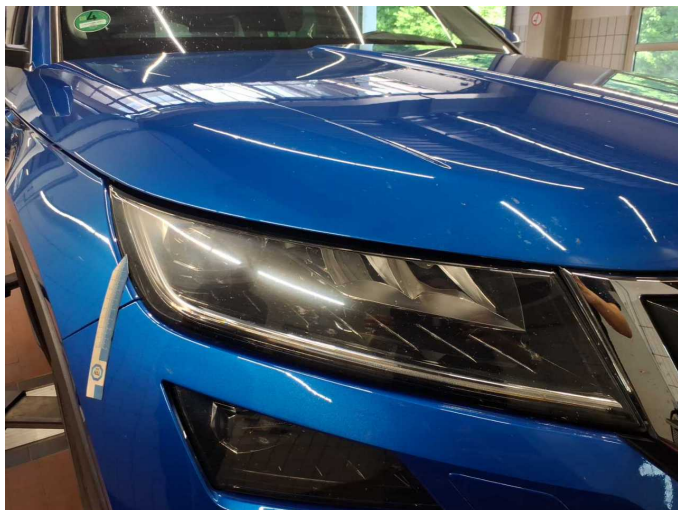
| No. | Component group | Description |
|---|---|---|
| 5 | Headlight | Headlight - right side (- Mehrkosten möglich) - Leaking - Perform diagnosis |

**Damage 5:** Headlight: Headlight - right side (- Mehrkosten möglich) - Leaking - Perform diagnosis

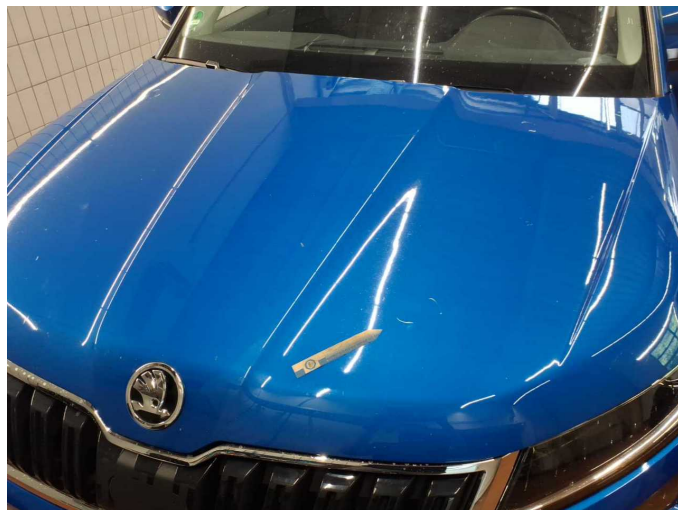
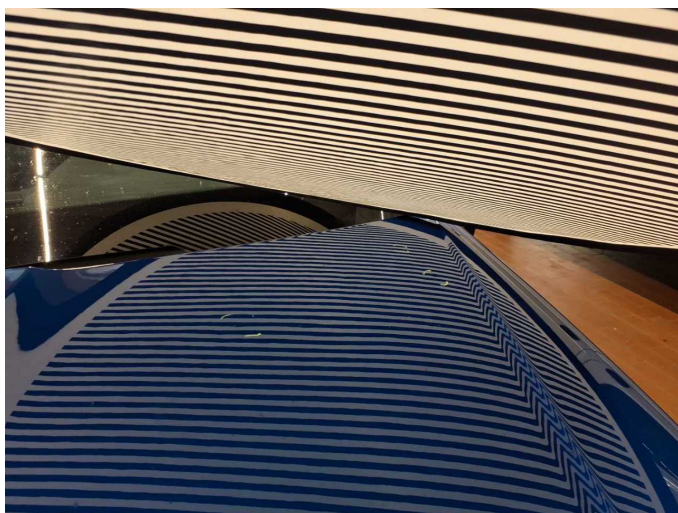
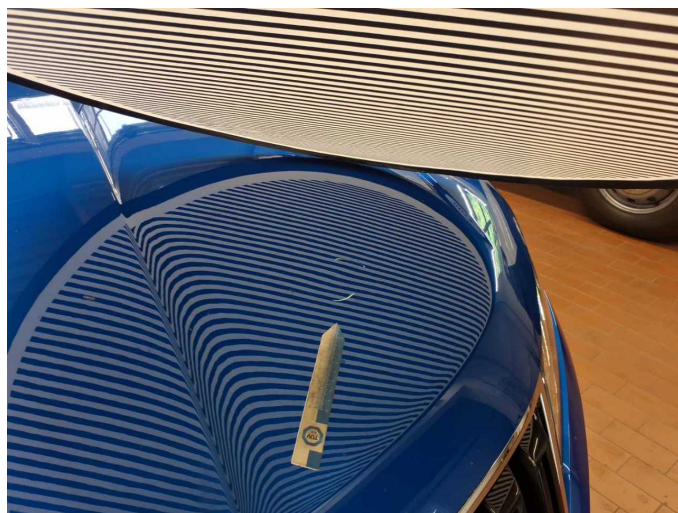
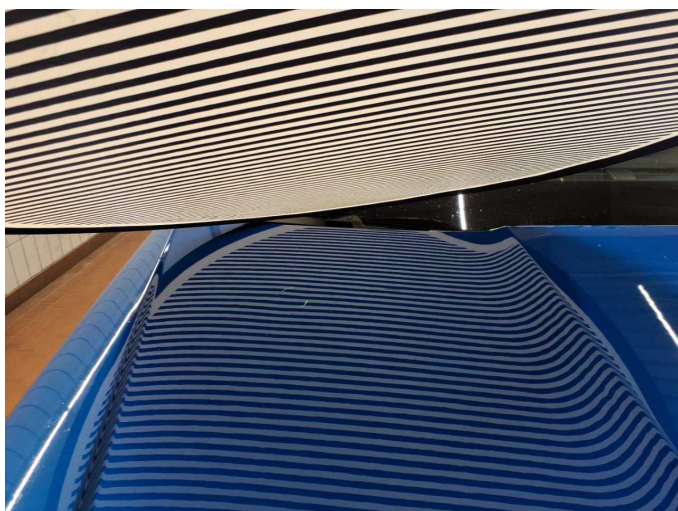
| No. | Component group | Description |
|---|---|---|
| 6 | Bonnet | Bonnet - dent(s) - Smart repair |

**Damage 6:** Bonnet: Bonnet - dent(s) - Smart repair

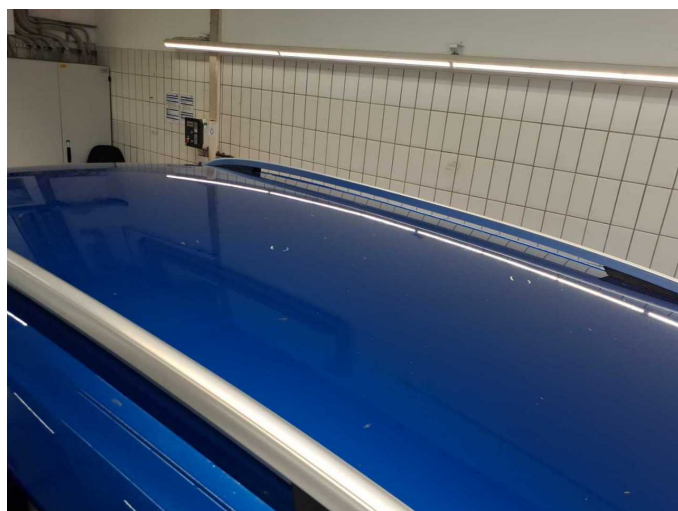
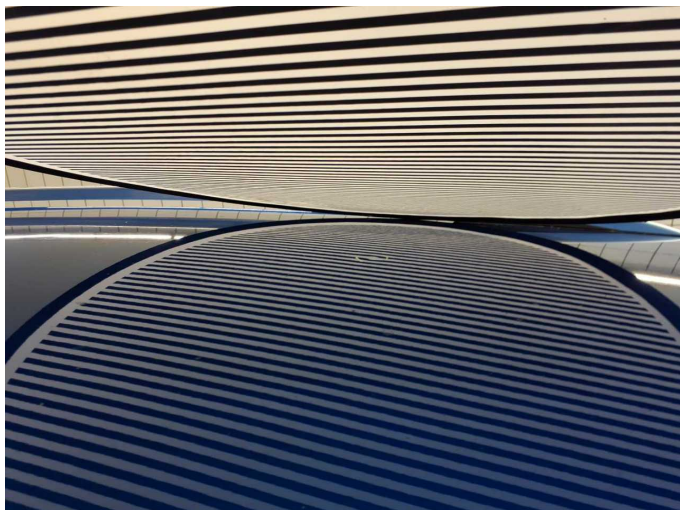
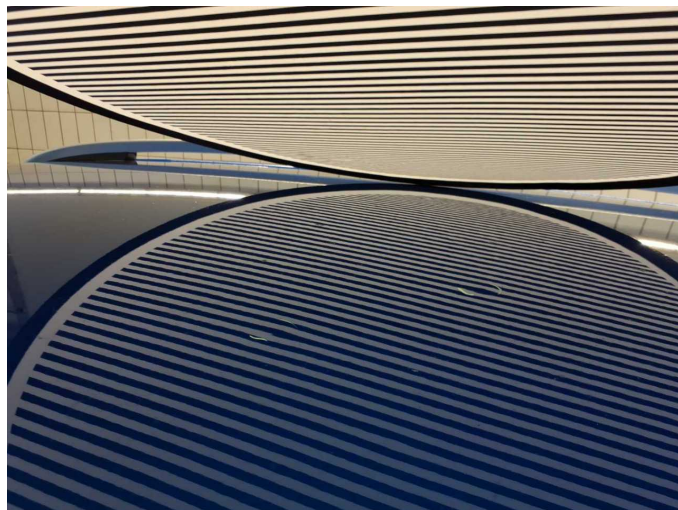
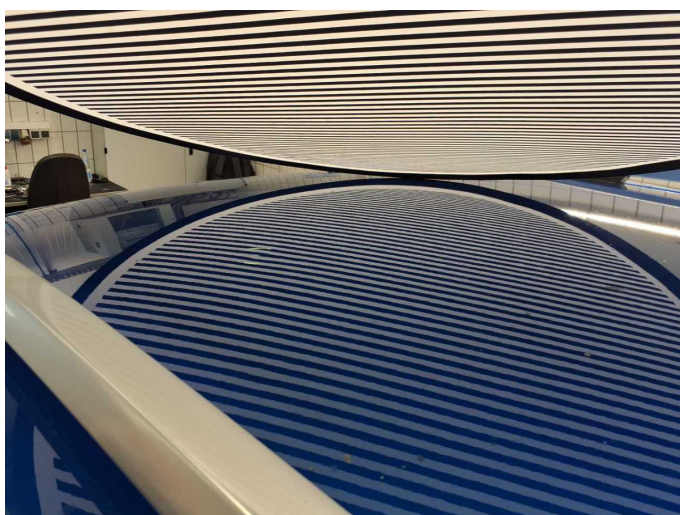
| No. | Component group | Description |
|---|---|---|
| 7 | Roof | Roof - dent(s) - Smooth repair work |

**Damage 7:** Roof: Roof - dent(s) - Smooth repair work

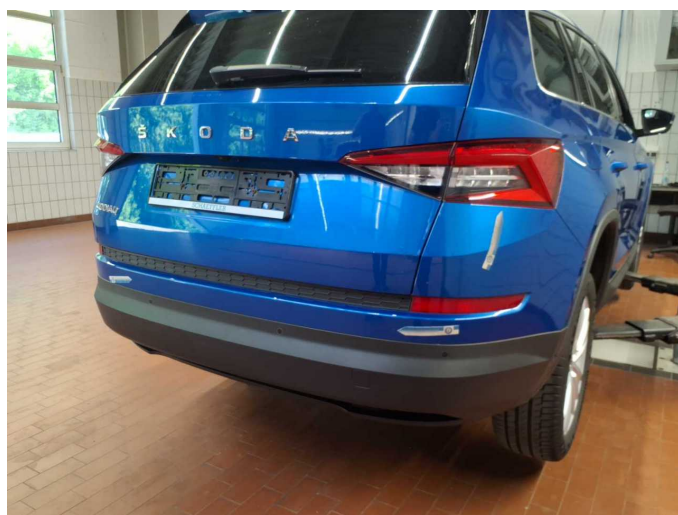
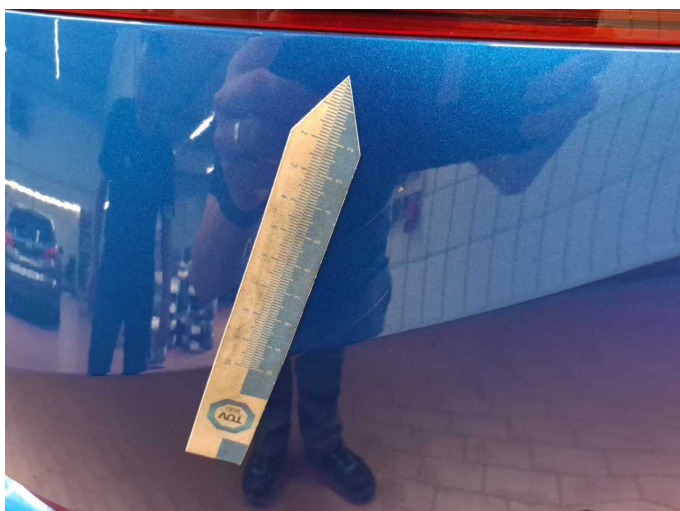
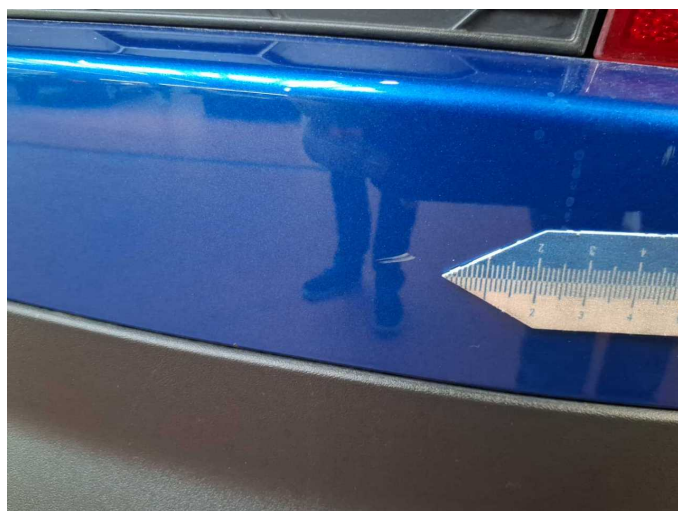
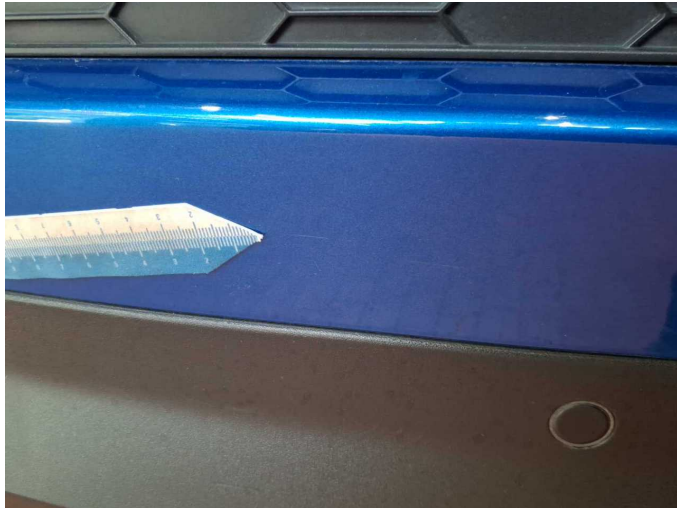
| No. | Component group | Description |
|---|---|---|
| 8 | Rear bumper | Rear bumper - Scratch(es) - Paint |

**Damage 8:** Rear bumper: Rear bumper - Scratch(es) - Paint

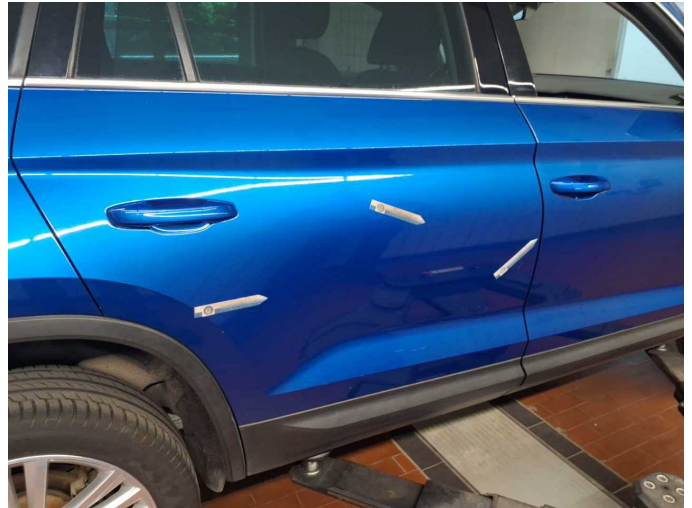
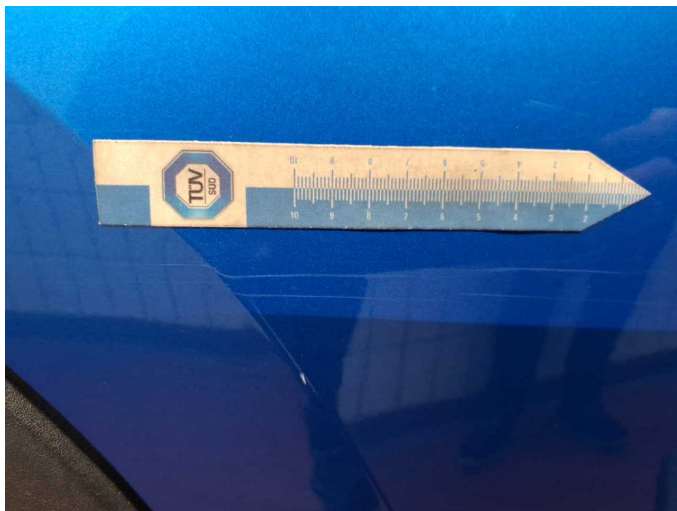
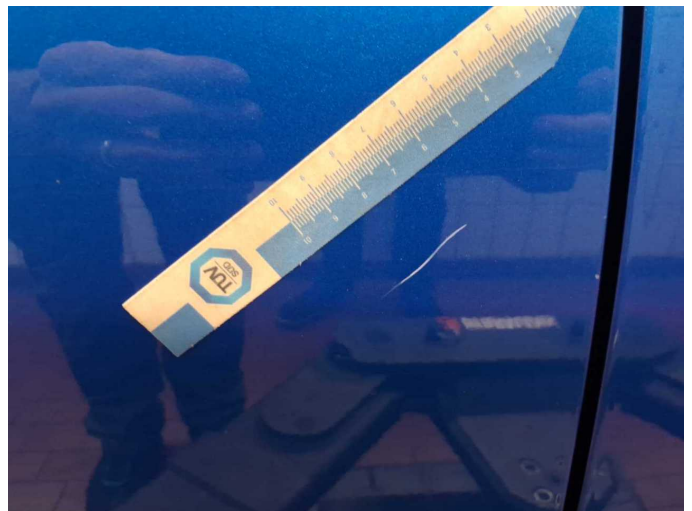
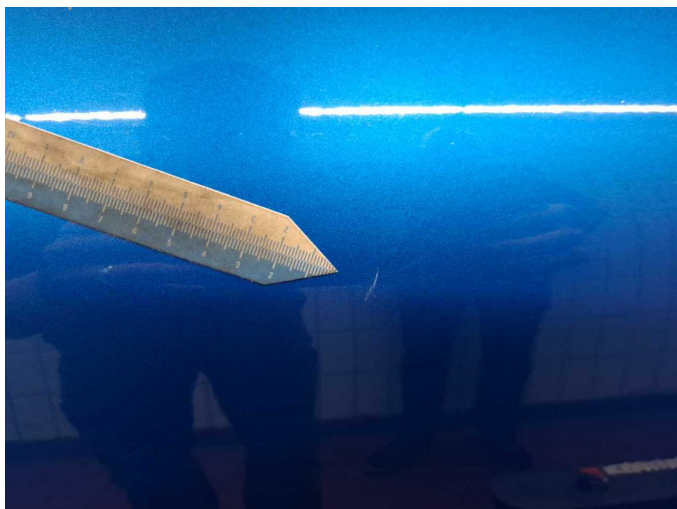
| No. | Component group | Description |
|---|---|---|
| 9 | Door - rear right side | Door - Scratch(es) - Paint |

**Damage 9:** Door - rear right side: Door - Scratch(es) - Paint

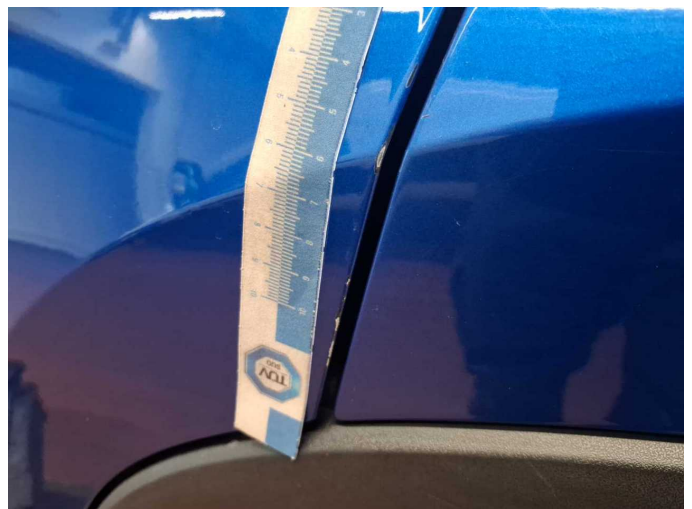
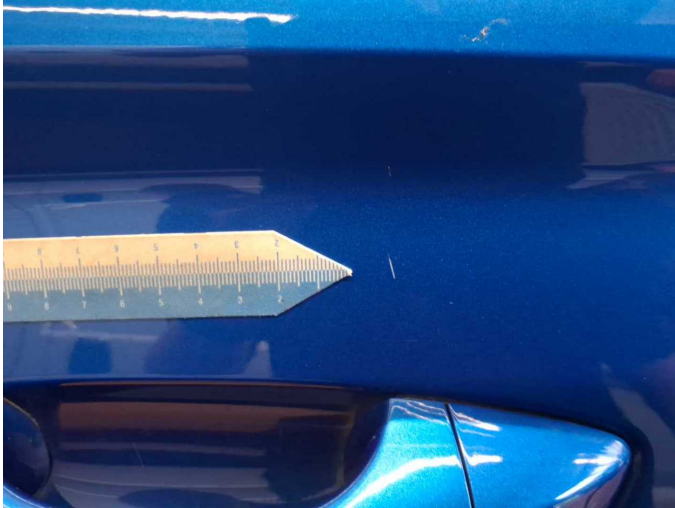
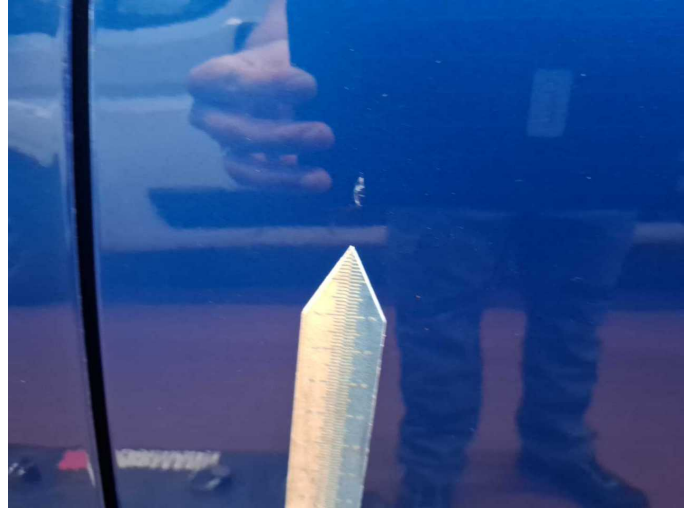
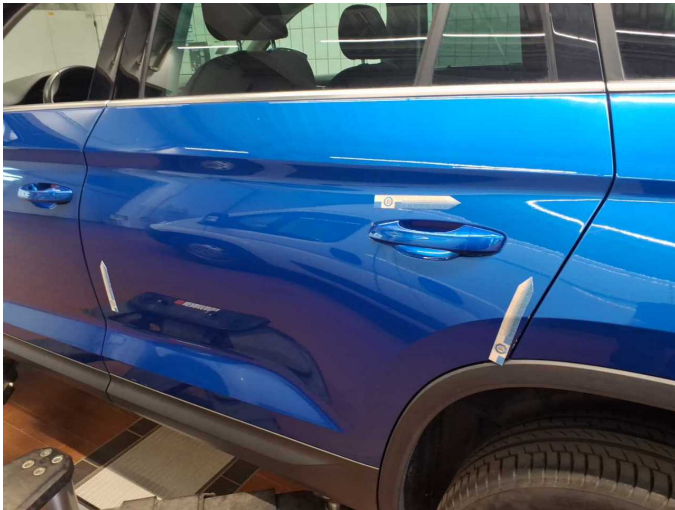
| No. | Component group | Description |
|---|---|---|
| 10 | Door - rear left side | Door - Scratch(es) - Paint |

**Damage 10:** Door - rear left side: Door - Scratch(es) - Paint

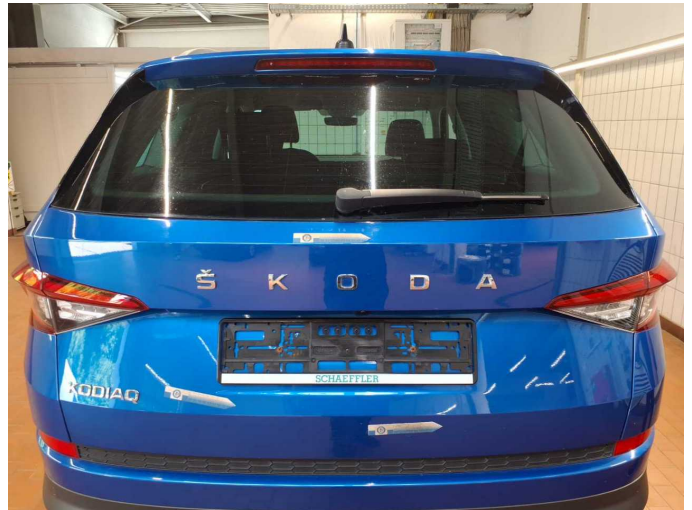
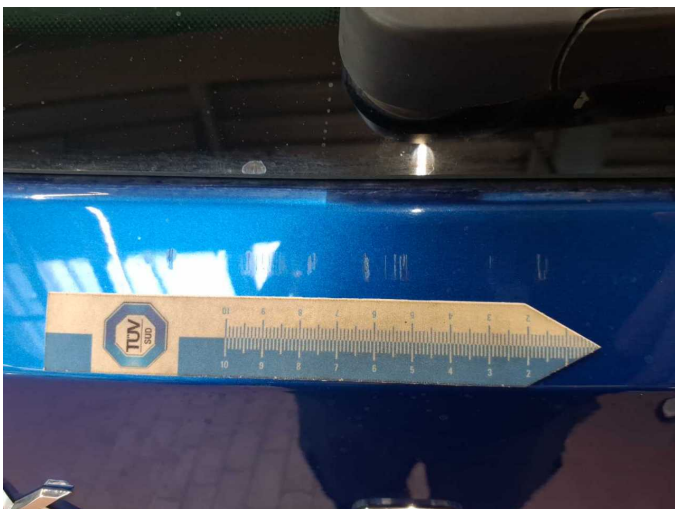
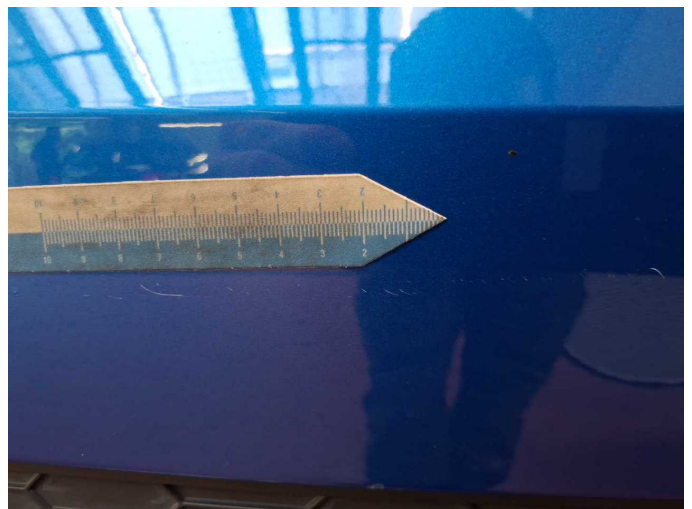
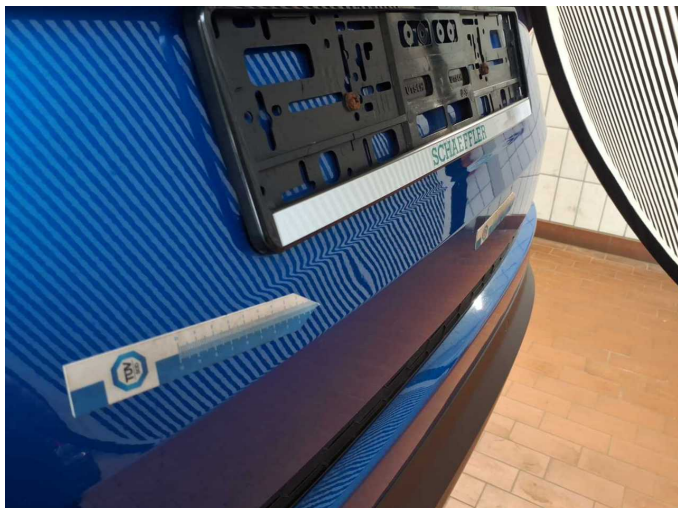
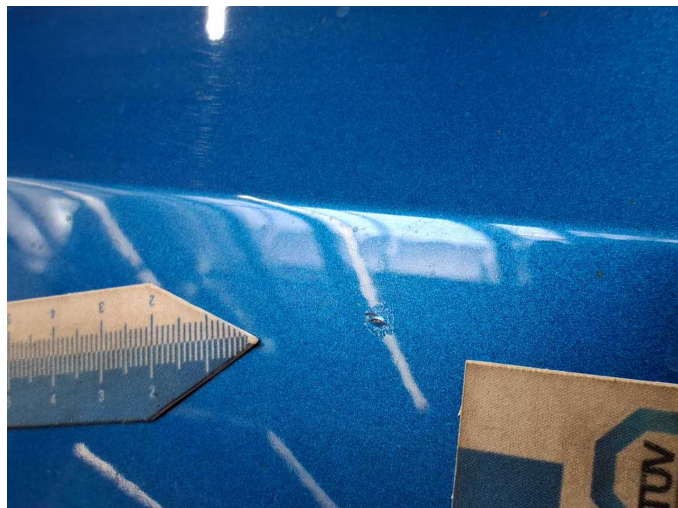
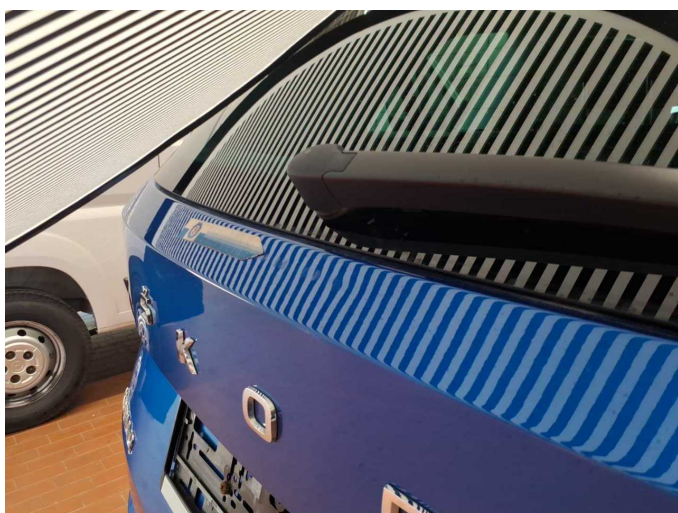
| No. | Component group | Description |
|---|---|---|
| 11 | Boot lid / rear door | Boot lid - Dent / paintcoat damage - Repair and paint |

**Damage 11:** Boot lid / rear door: Boot lid - Dent / paintcoat damage - Repair and paint

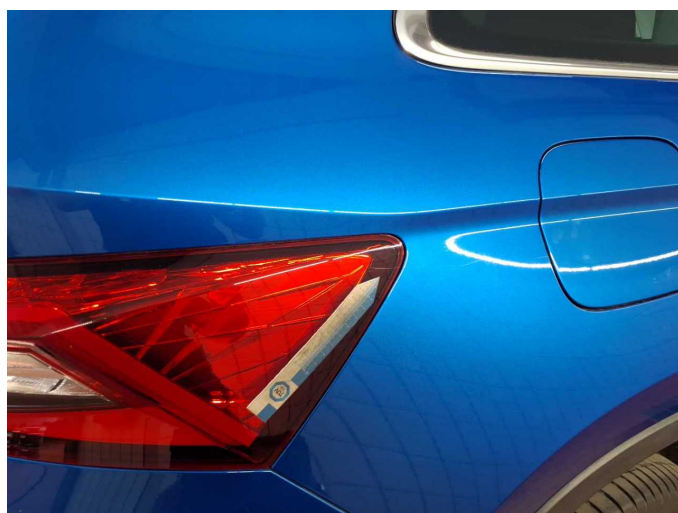
| No. | Component group | Description |
|---|---|---|
| 3 | Tail light | Tail lamp - right side - Scratch(es) - No deduction |

**Wear and tear 3:** Tail light: Tail lamp - right side - Scratch(es) - No deduction

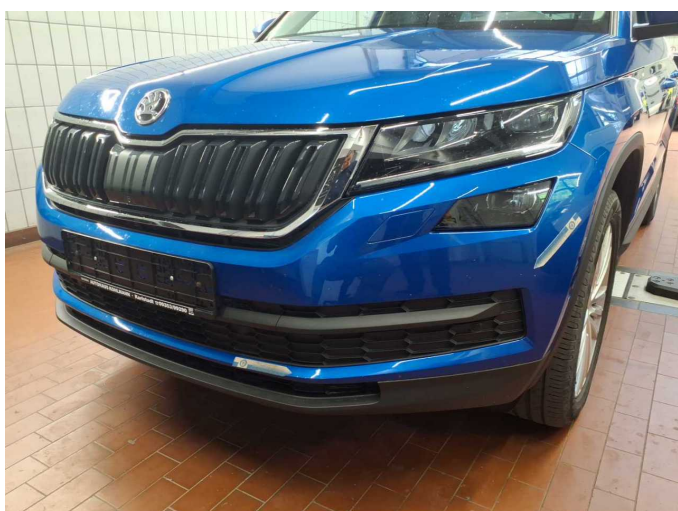
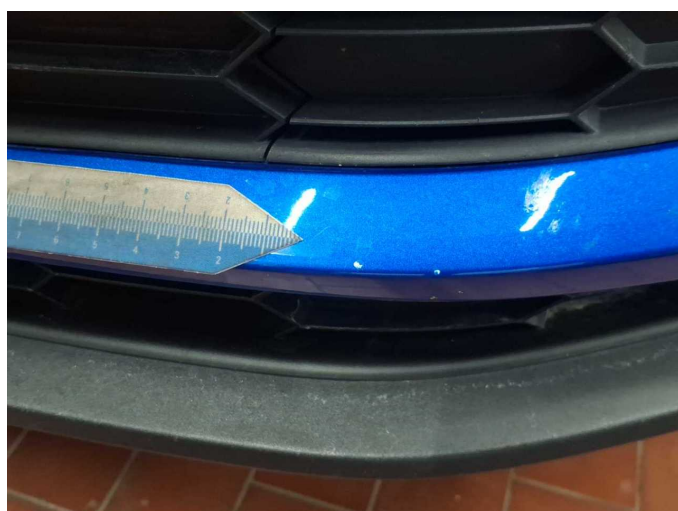
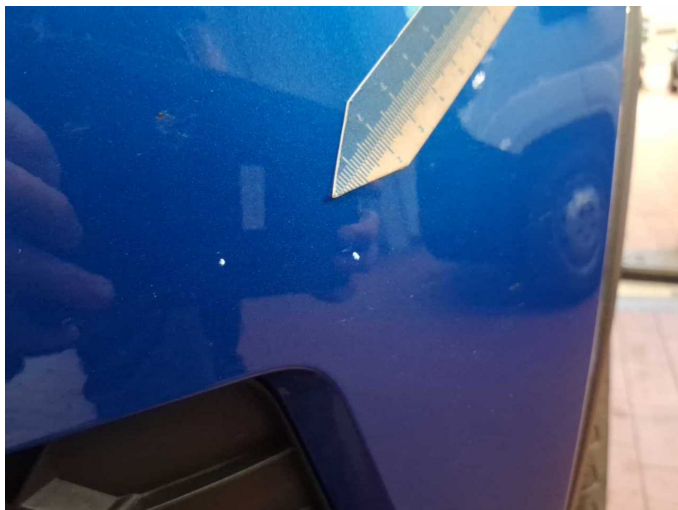
| No. | Component group | Description |
|---|---|---|
| 5 | Front bumper | Front bumper - Stone chips - No deduction |

**Wear and tear 5:** Front bumper: Front bumper - Stone chips - No deduction

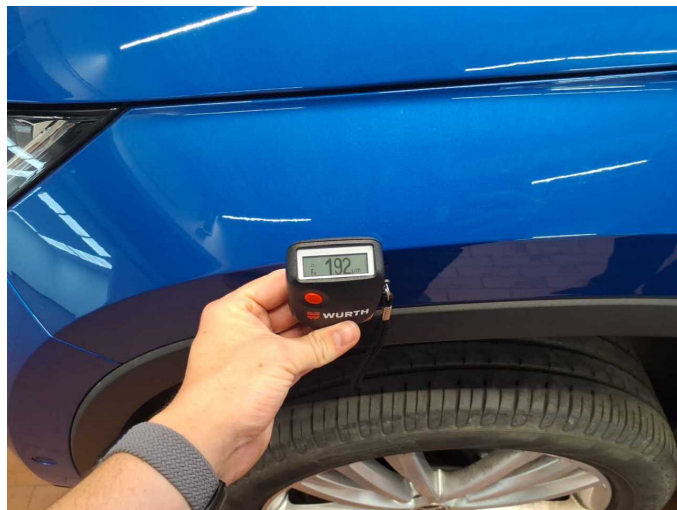
| Mudguard - left side | 192 µm | Mudguard - right side | 176 µm |

**Repainting 1:** Mudguard - left side

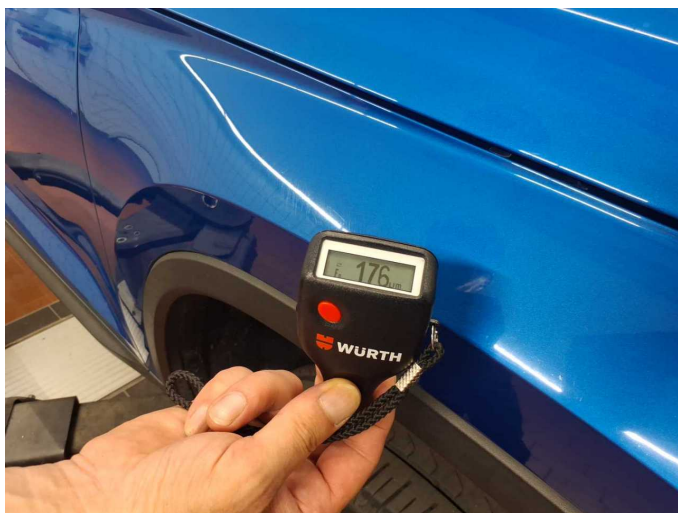
**Repainting 2:** Mudguard - right side

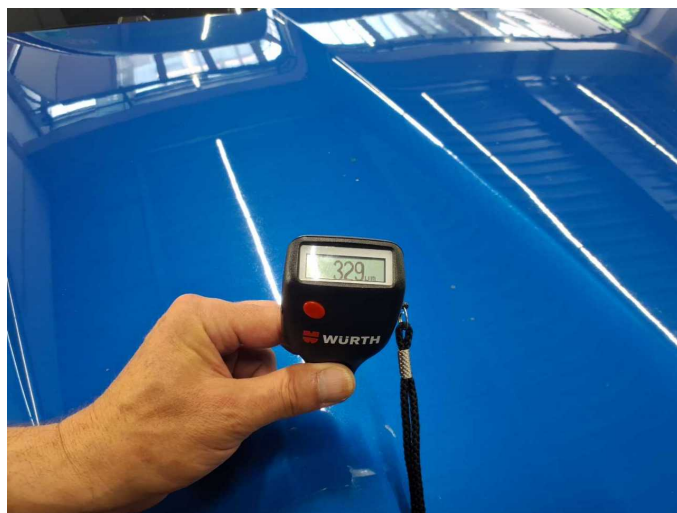
| Bonnet | 329 µm | Door - front left side | 227 µm |

**Repainting 3:** Bonnet

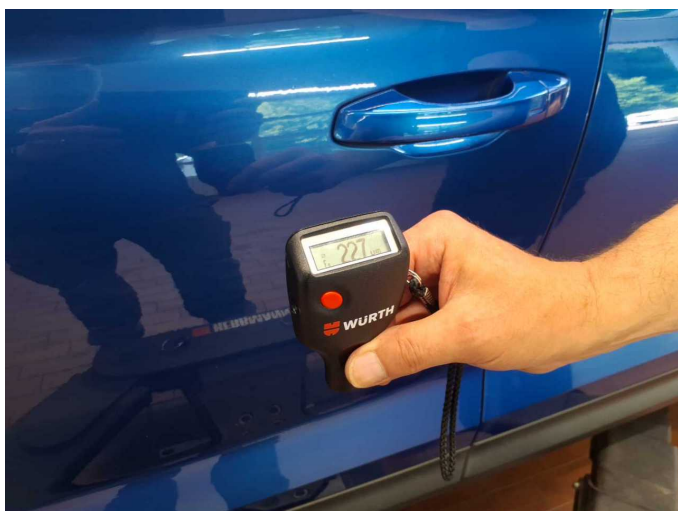
**Repainting 4:** Door - front left side

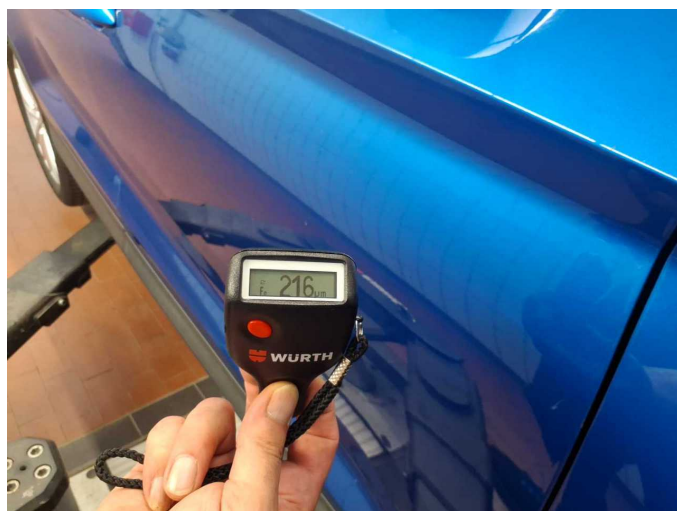
| Door - front right side | 216 µm | | |

**Repainting 5:** Door - front right side
