Expertise

Protocol number: 46538023  
Order No. / Reference: 26769141  
Inspection date: 13 Jul 2026

Manufacturer: Mercedes-Benz  
VIN: W1VVLCEZ4T4563628

Model: Vito Kawa 116 CDI Extralang HA Aut. PRO

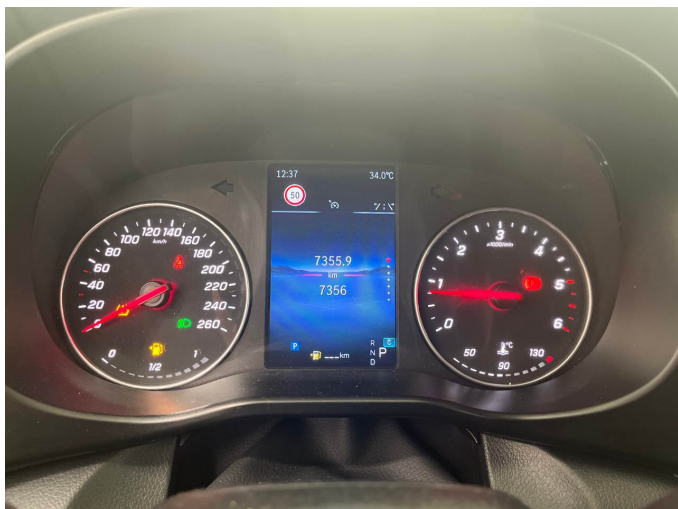
| No. | Component group | Description |
|---|---|---|
| 1 | Instrument panel | Indicator light (Reifendruckkontrolle) - on - Perform diagnosis |

**Damage 1:** Instrument panel: Indicator light (Reifendruckkontrolle) - on - Perform diagnosis

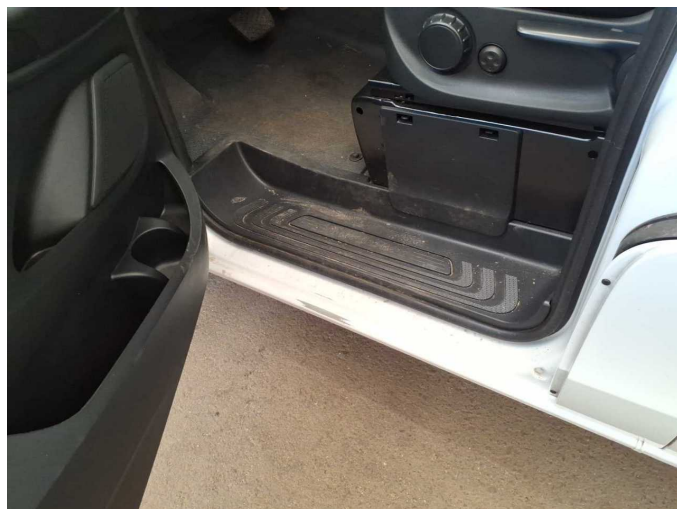
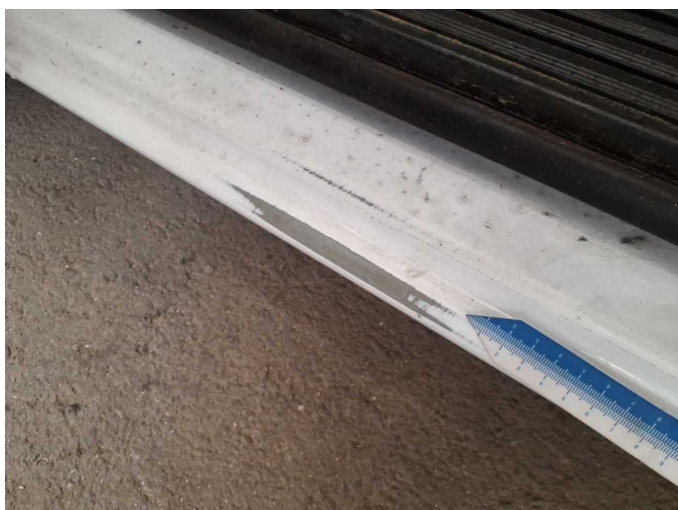
| No. | Component group | Description |
|---|---|---|
| 2 | Sill - left side | Sill - Scratched - Smart repair |

**Damage 2:** Sill - left side: Sill - Scratched - Smart repair

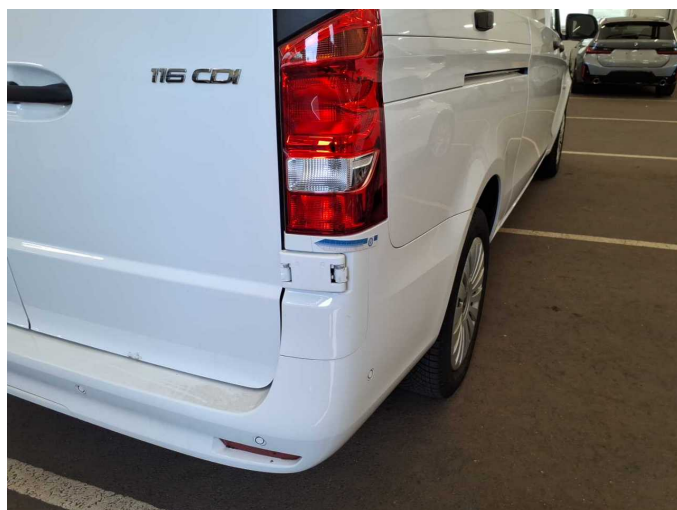
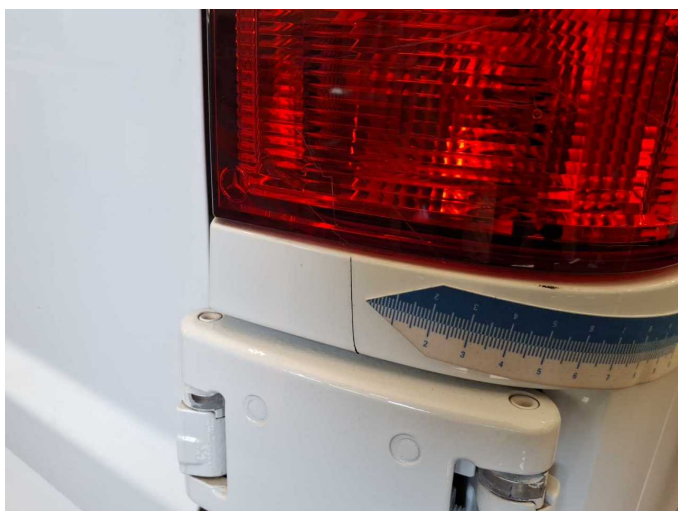
| No. | Component group | Description |
|---|---|---|
| 3 | Rear bumper | Cover - bumper - rear - Scratch(es) - Smart repair |

**Damage 3:** Rear bumper: Cover - bumper - rear - Scratch(es) - Smart repair

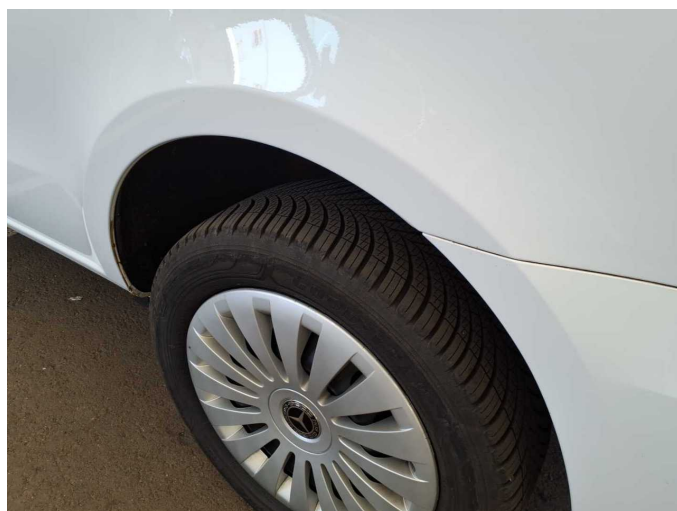
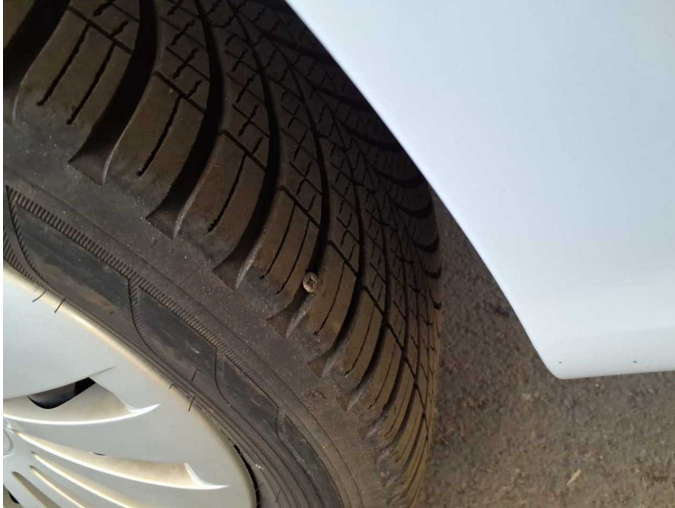
| No. | Component group | Description |
|---|---|---|
| 4 | Wheel / tyres | Tyre - rear left side (Fremdkörper in Lauffläche) - Defective - Replace |

**Damage 4:** Wheel / tyres: Tyre - rear left side (Fremdkörper in Lauffläche) - Defective - Replace

**Damage 4:** Wheel / tyres: Tyre - rear left side (Fremdkörper in Lauffläche)  
- Defective - Replace

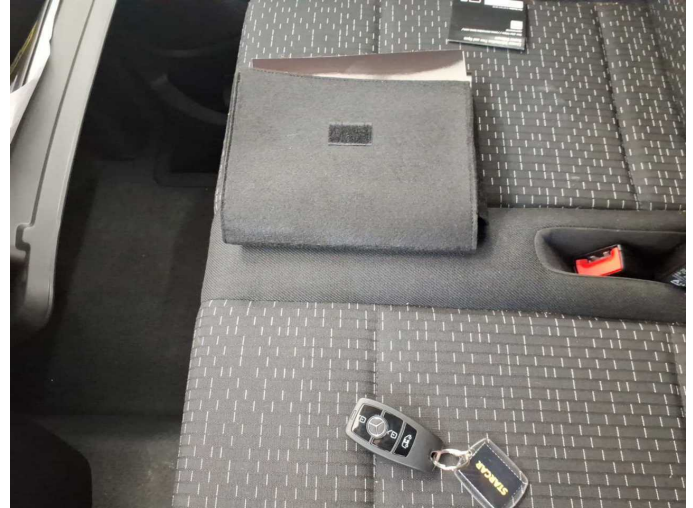
Equipment - Vehicle key

**Missing part 1:** Equipment: Vehicle key - Missing - Replace
