Expertise

Protocol number: 46303294
Order No. / Reference: 26512979
Inspection date: 24 Jun 2026

Manufacturer: Mercedes-Benz

Model: Vito 114 CDI Lang HA PRO

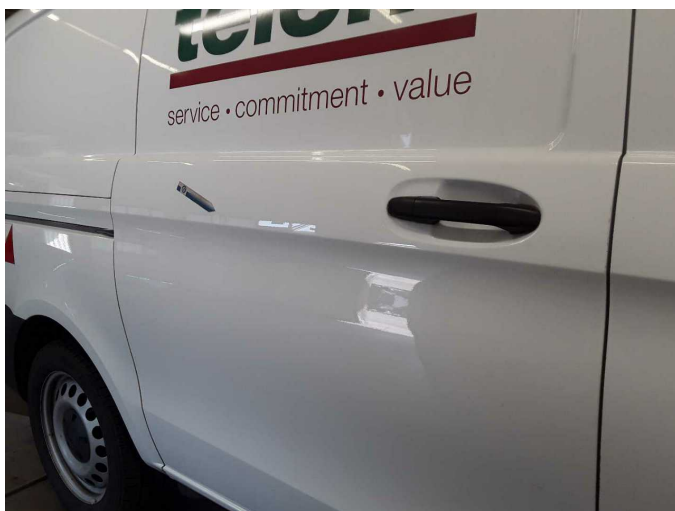
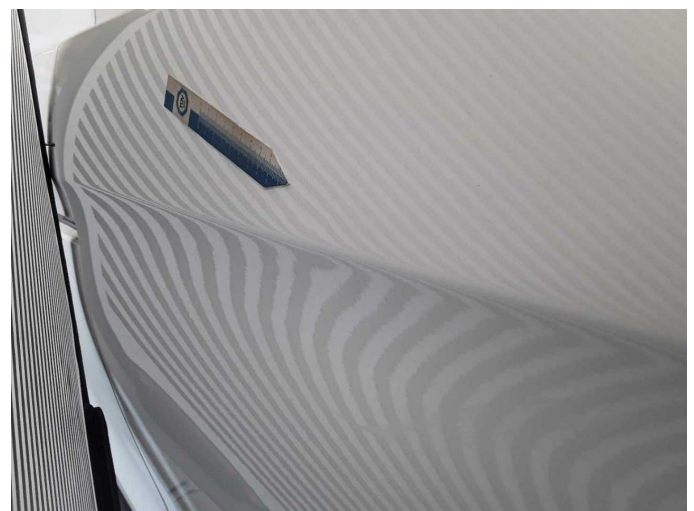
Damage 1: Door - rear right side: Door - dent(s) - Smooth repair work

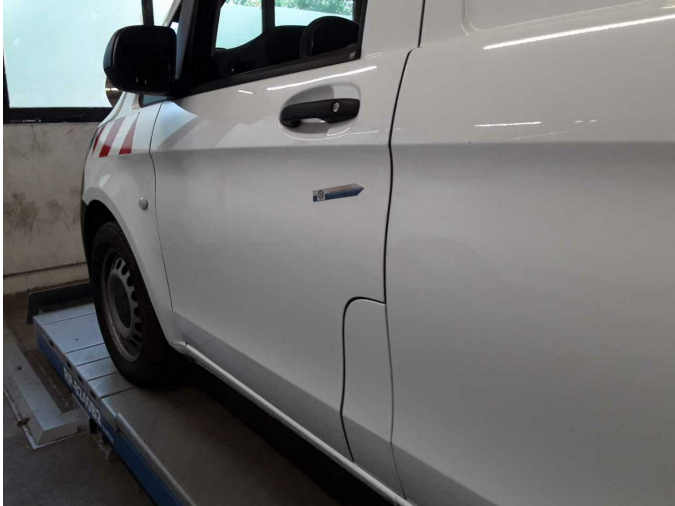
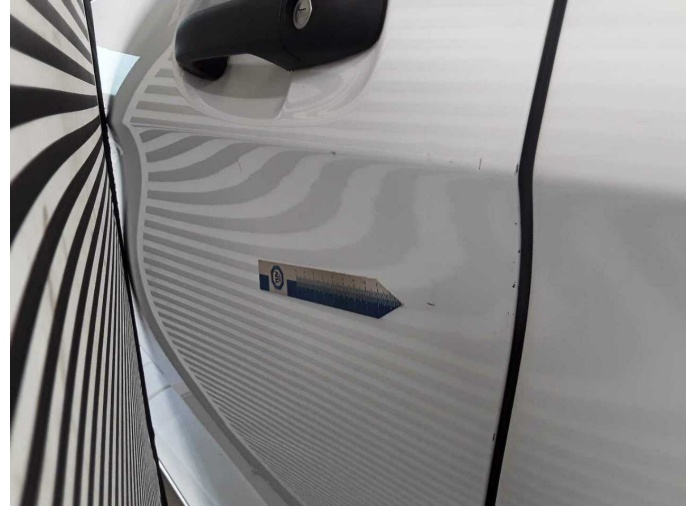
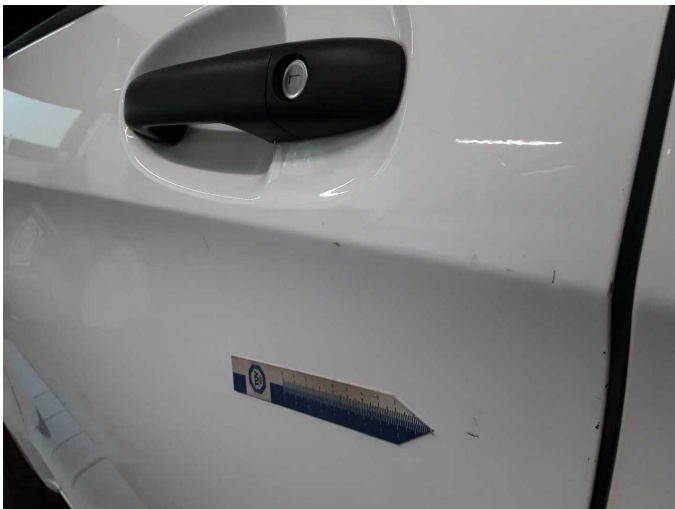
Damage 2: Door - front left side: Door - Dent / paintcoat damage - Smart repair

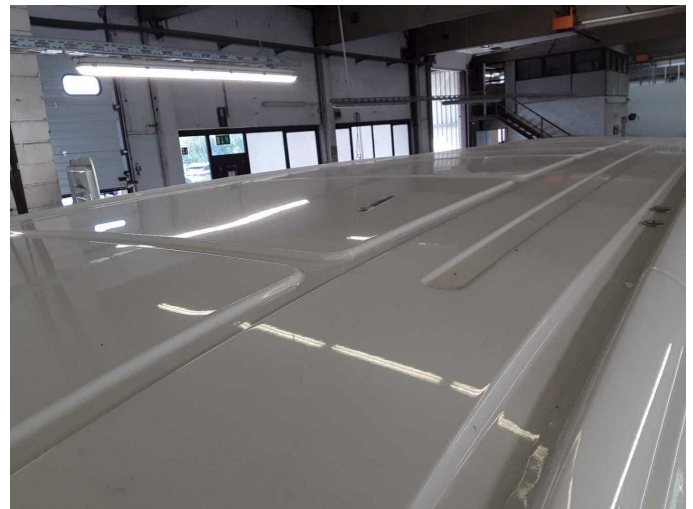
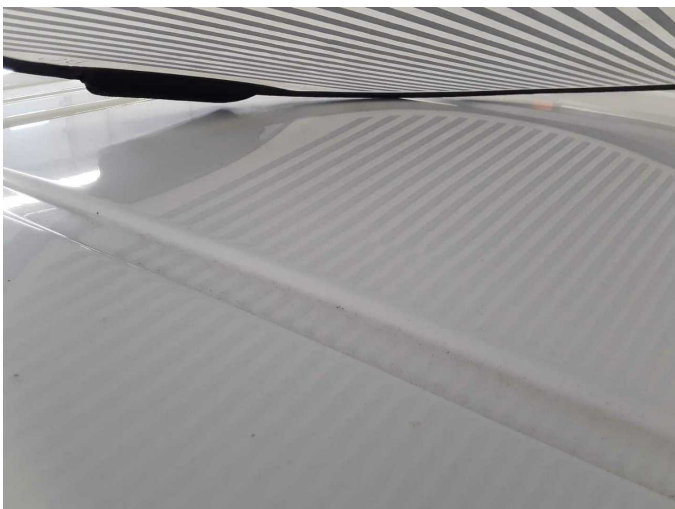
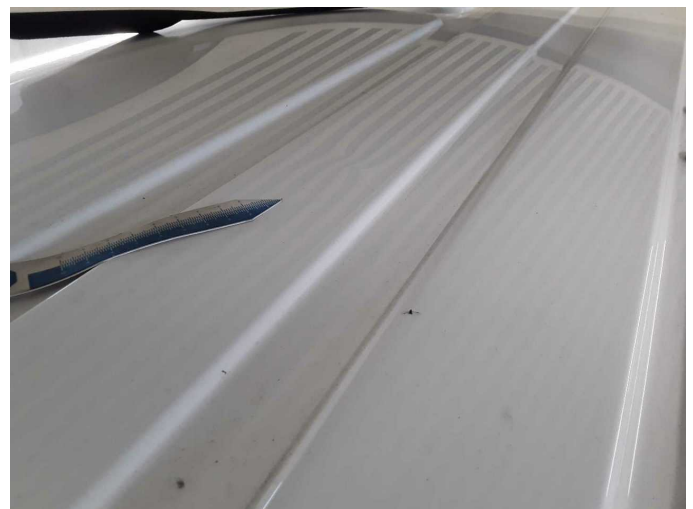
Damage 3: Roof: Roof - dent(s) - Smooth repair work

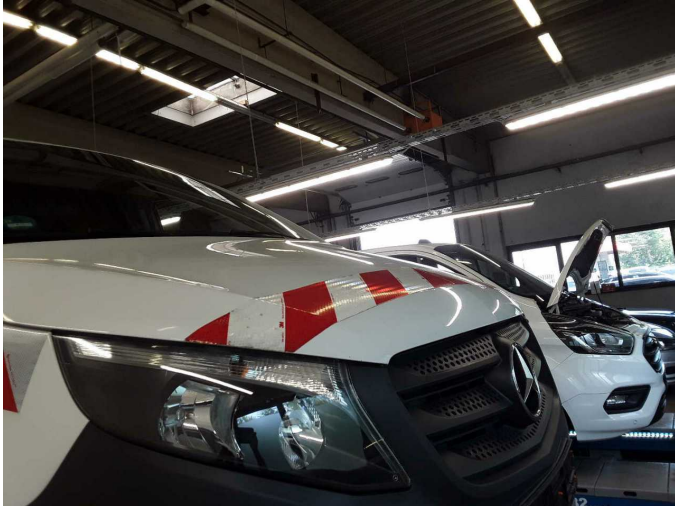
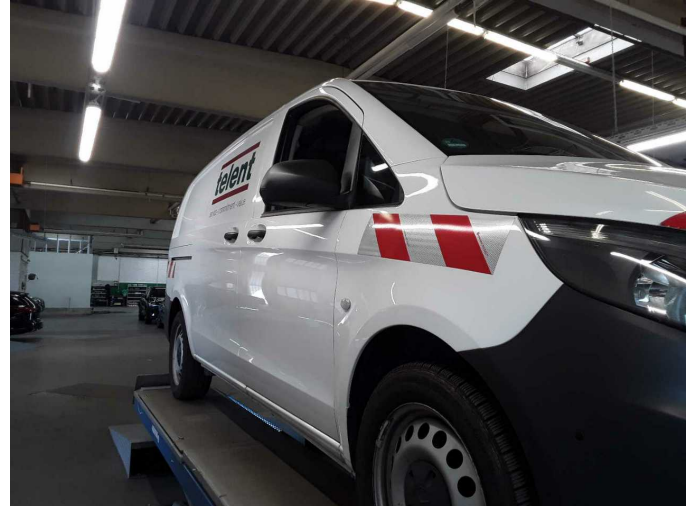
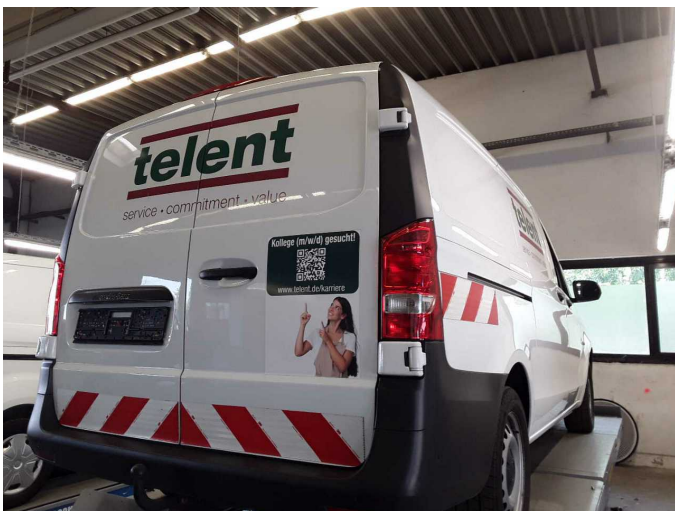
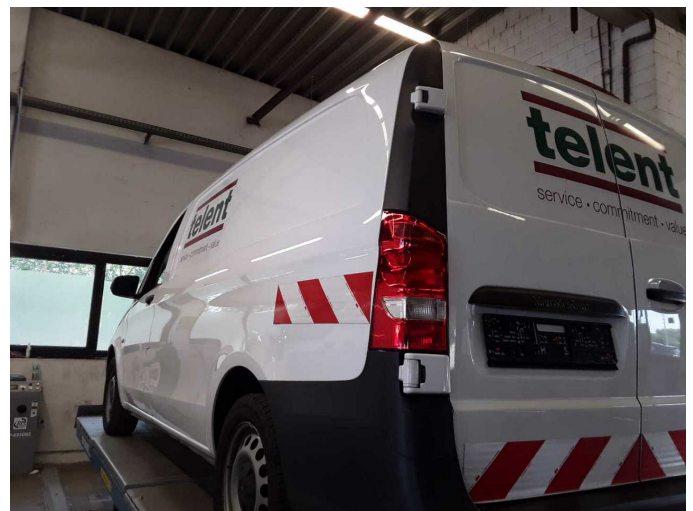
Damage 4: Body: Body - Glued / labelled - De-glue / neutralise

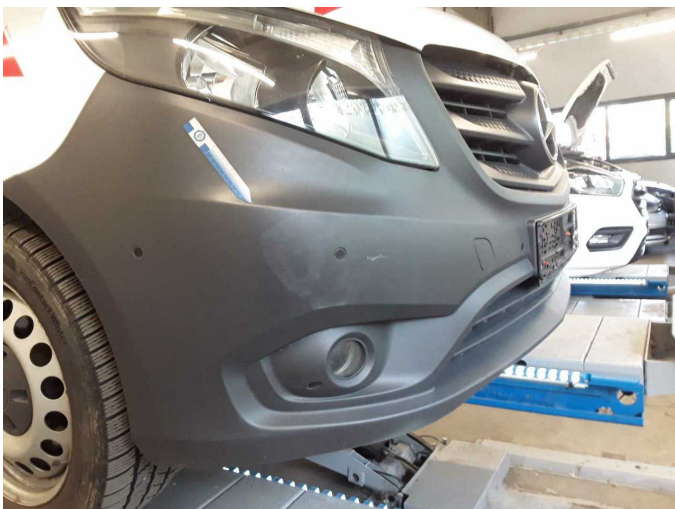
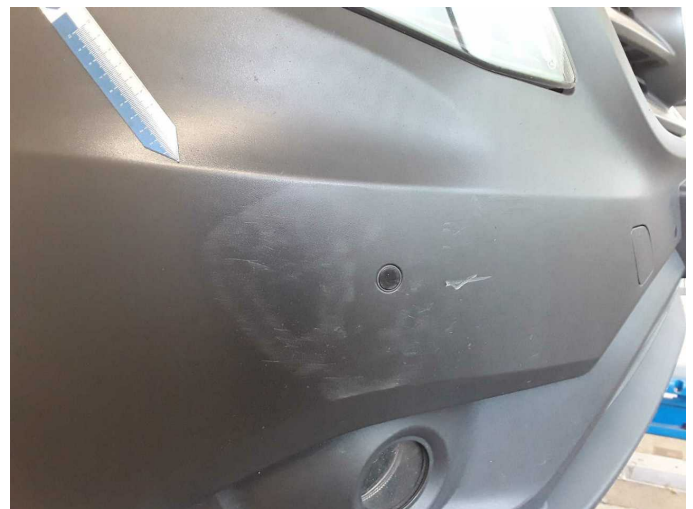
Wear and tear 1: Front bumper: Front bumper (unpainted) - Scratched - No deduction

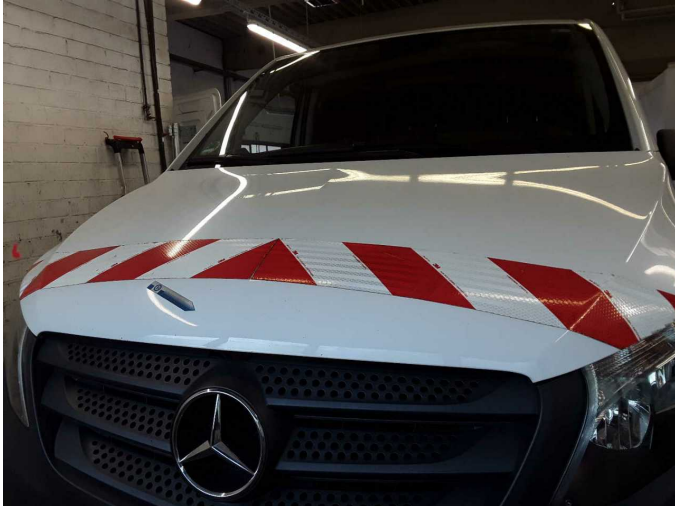
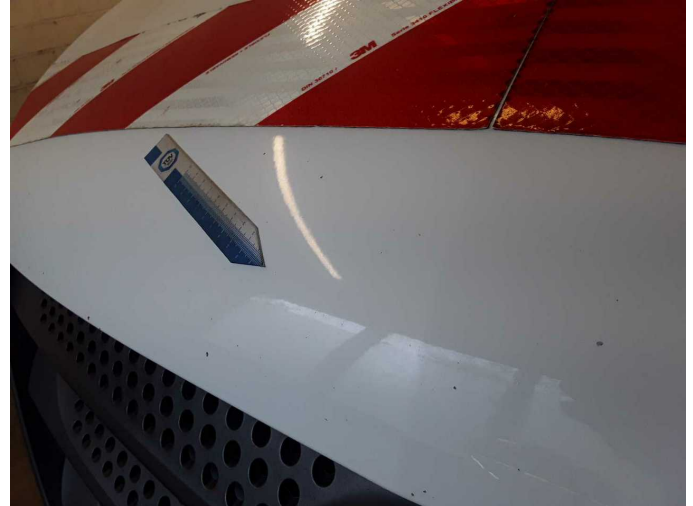
Wear and tear 2: Bonnet: Bonnet - Stone chips - No deduction

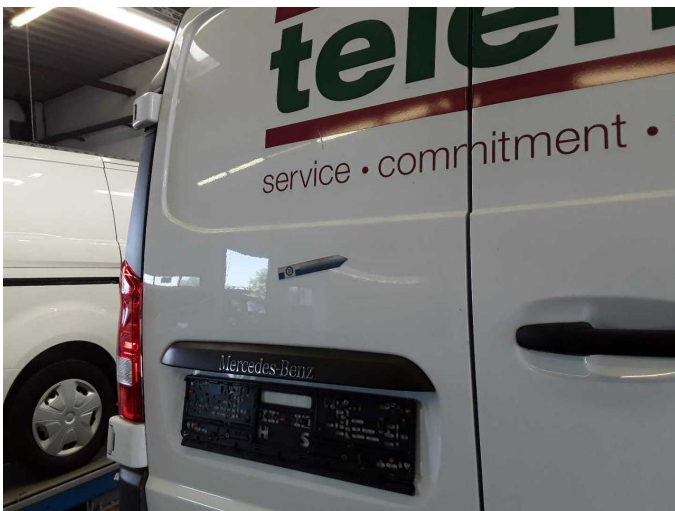
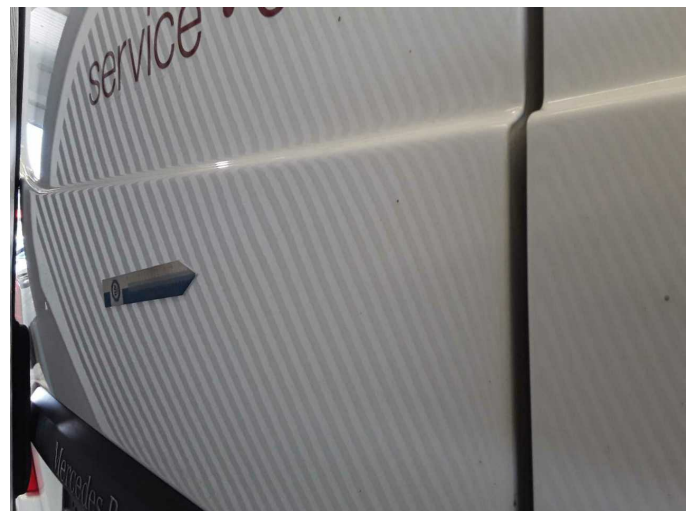
Wear and tear 3: Boot lid / rear door: Rear door - left side - dent(s) - Smooth repair work

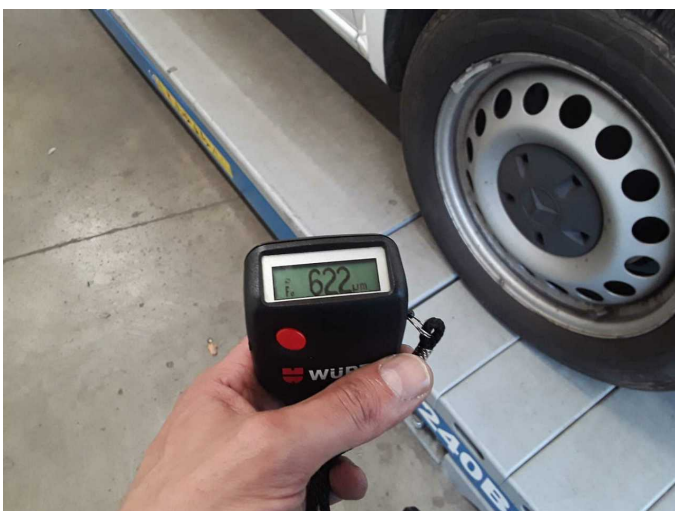
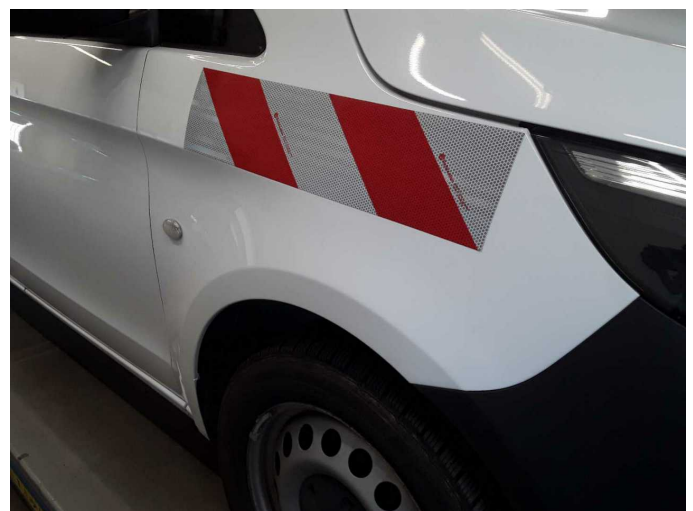
Repainting 1: Mudguard - right side
