**VSSZZZKLZNR041293**

## Zustandsbericht

Besichtigungsdatum: 12.06.2026  
**Protokollnummer: 46415330**  
Erstellt durch: Paula Kube  
Besichtigt durch: Nattias Mirle

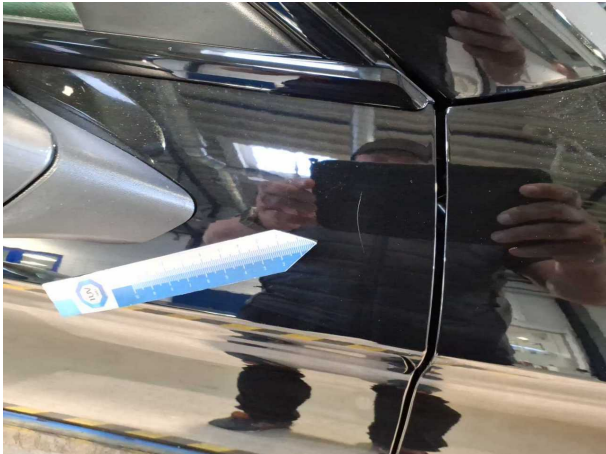
| Nr. | Bauteilgruppe | Beschreibung | Kosten (netto) | Minderwert |
|---|---|---|---|---|
| 1 | Tür vorn rechts | Tür - verkratzt / verschürft - lackieren | 555,00 € | 310,00 € |

**Beschädigung #1:** Tür vorn rechts: Tür - verkratzt / verschürft - lackieren

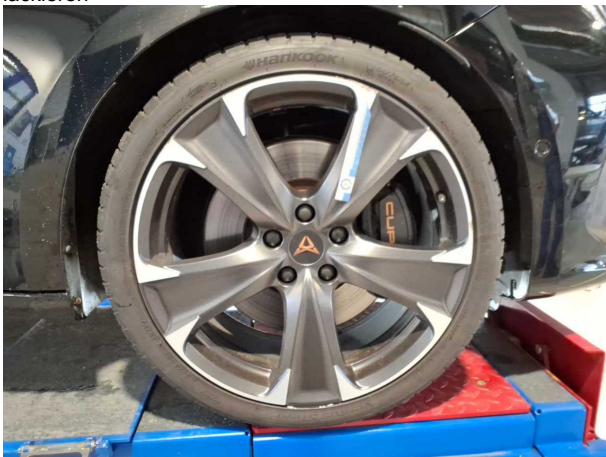
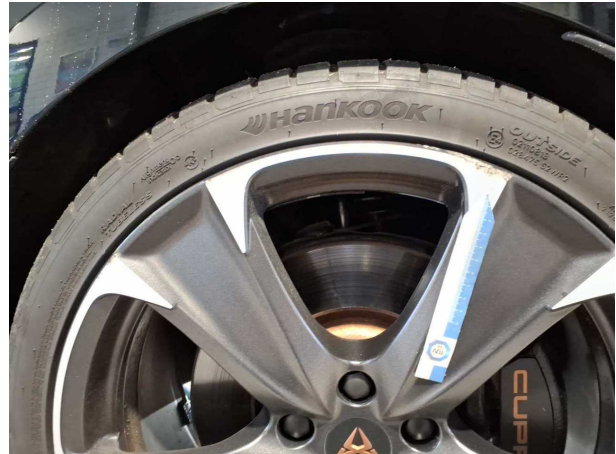
| Nr. | Bauteilgruppe | Beschreibung | Kosten (netto) | Minderwert |
|---|---|---|---|---|
| 2 | Rad/Reifen | Leichtmetallfelge vorn rechts (Materialabrieb) - verkratzt / verschürft - erneuern | 925,00 € | 510,00 € |

**Beschädigung #2:** Rad/Reifen: Leichtmetallfelge vorn rechts (Materialabrieb) - verkratzt / verschürft - erneuern
