INSPECTION REPORT

End of contract

File	305527
License plate	1YRL815
Vehicle identification number	W0VVS3601LB215037
Dossier	2019290173
Make	Opel Mov.CDTI 150 L2H1 3.5T DC
Mileage	53255
First registration	01/01/2021
client availability date	11/02/2026
inspectionDate	05/03/2026

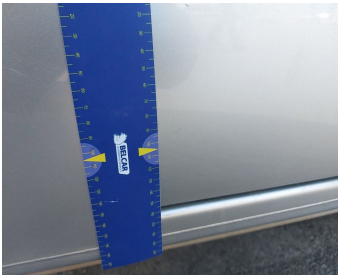
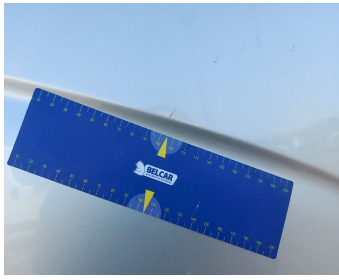
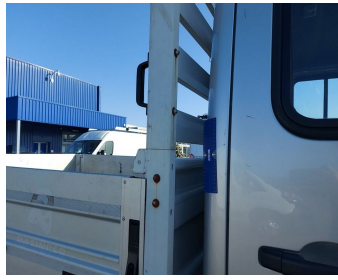
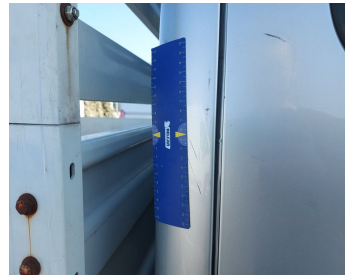
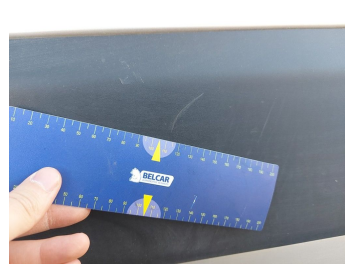
Damage within Renta-norm-hole

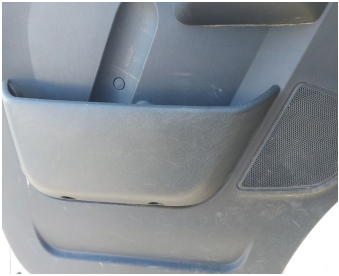
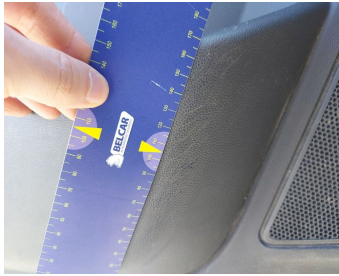
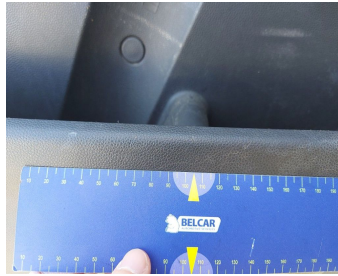
Front Left Door Interior Coating // Replace Completely-scratch

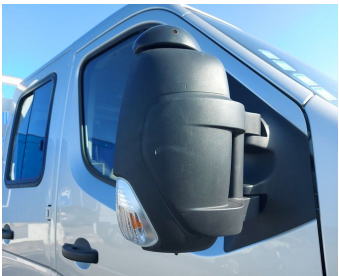
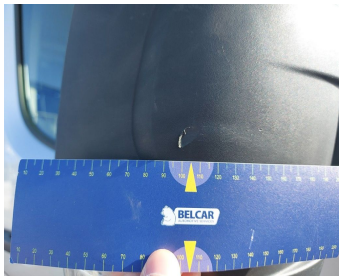
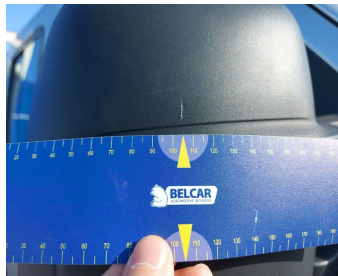
Side View Mirror Right / Shell / Replace Not Painted-scratch

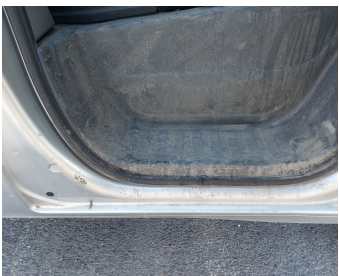
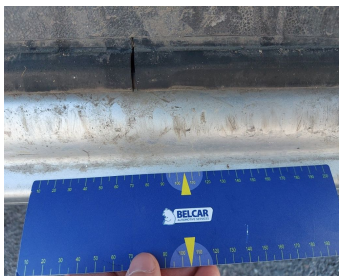
Rocker Panel Right // Polish-scratch

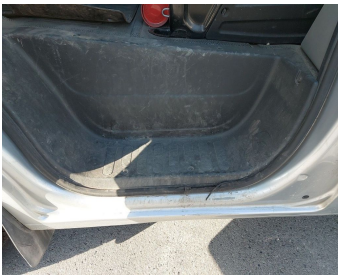
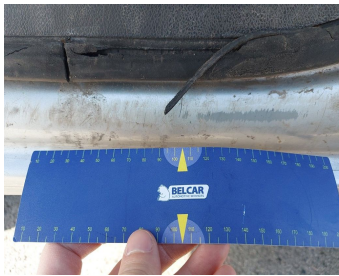
Rocker Panel Left // Smart Repair Medium-scratch

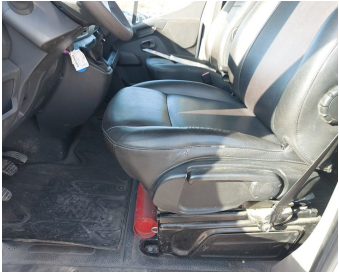
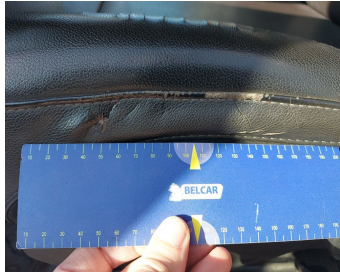
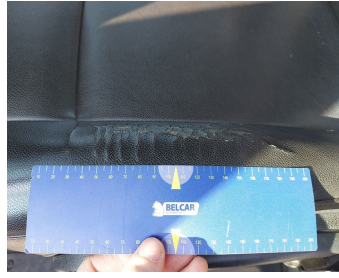
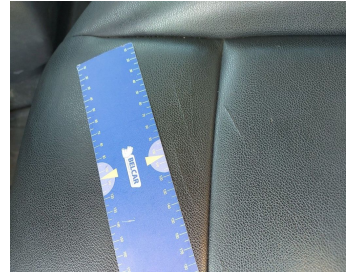
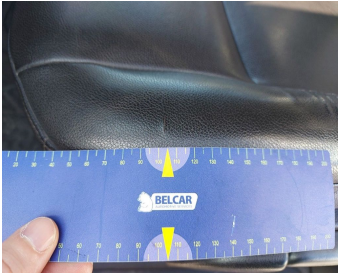
Seat Front Left / Bottom Coating / Replace-scratch

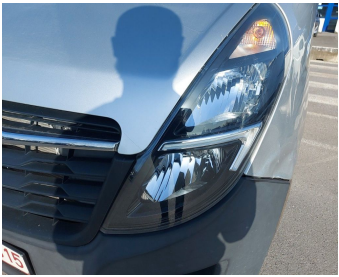
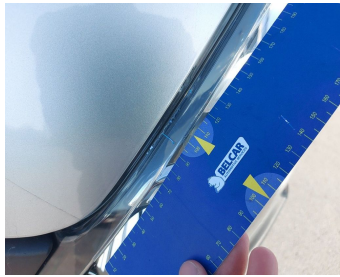
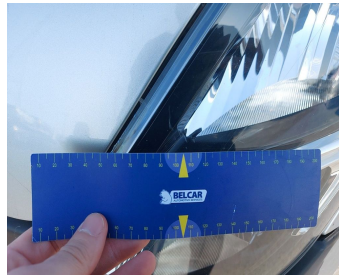
Headlight / Front left / Replace-scratch

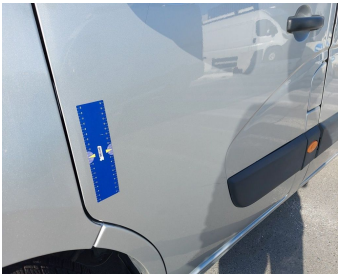
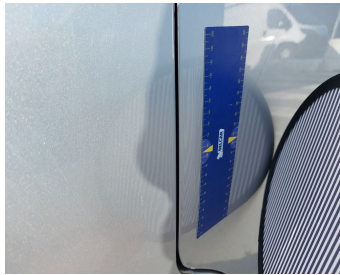
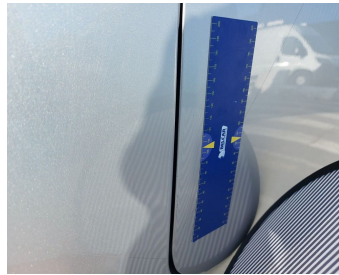
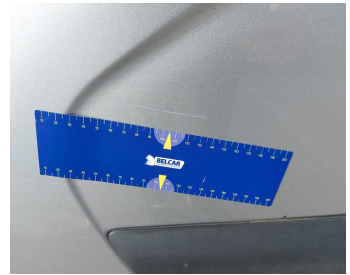
Door Front Left // Smart Repair Medium-dent

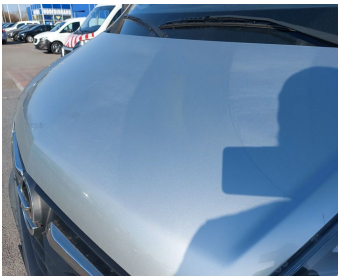
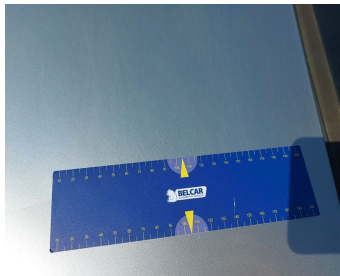
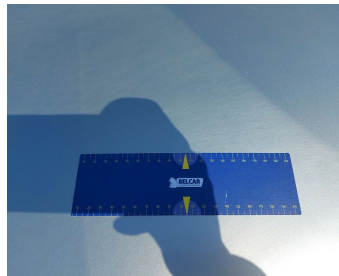
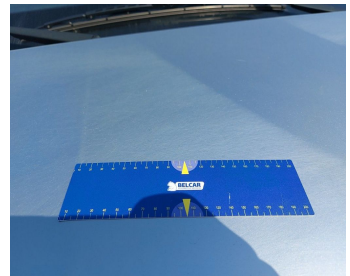
Front Bonnet // Polish-scratch

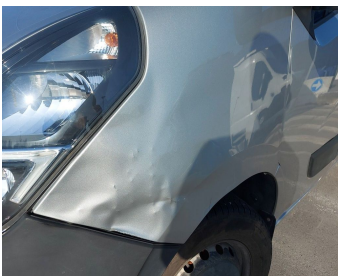
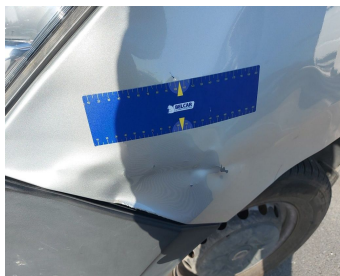
Wing Front Left // Replace & Painting-scratch + dent

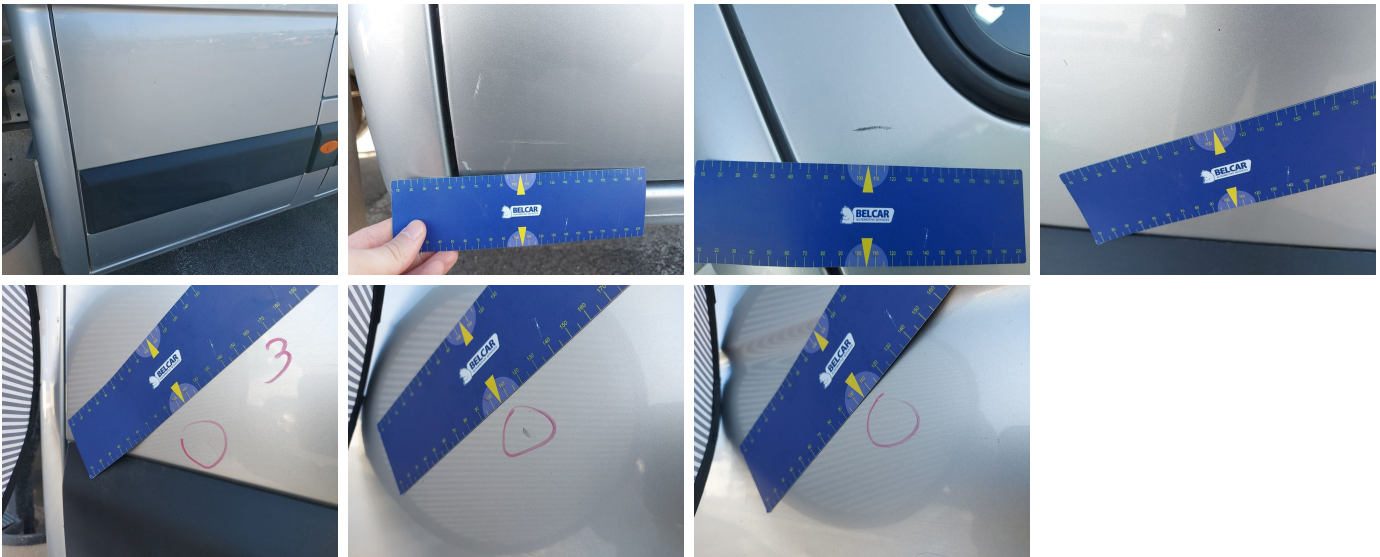
Door Rear Right // Painting-scratch + dent

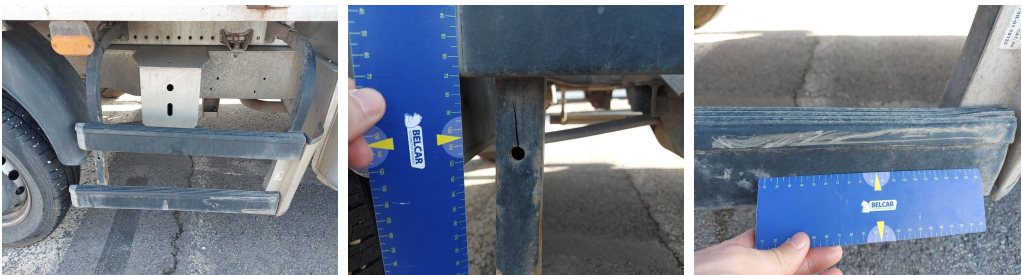
Rocker Panel Right / Cover Not Painted / Replace-Chipped paint

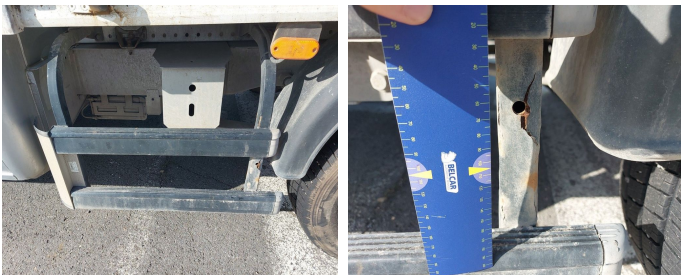
Rocker Panel Left / Cover Not Painted / Replace-Chipped paint

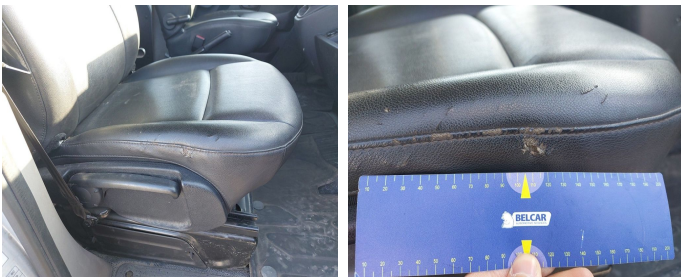
Seat Front Right / Bottom Coating / Replace-hole

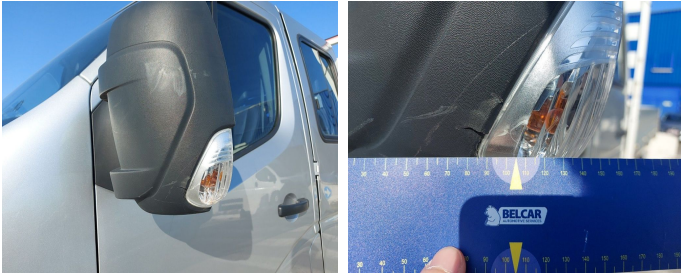
Side View Mirror Left / Direction Indicator / Replace-scratch

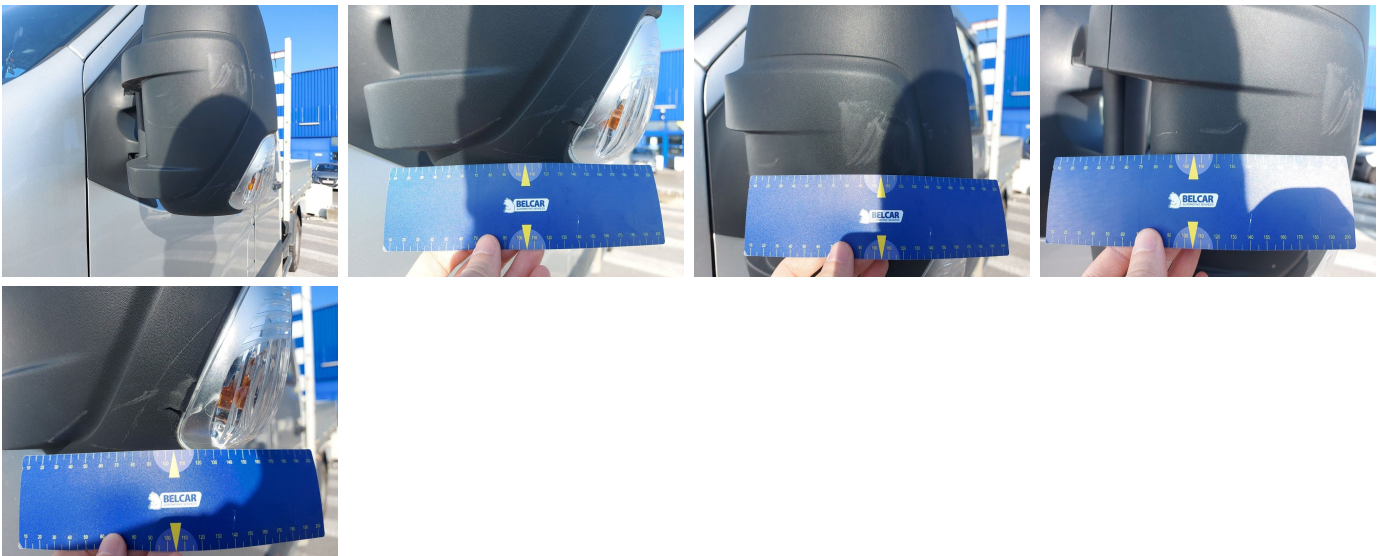
Side View Mirror Left / Shell / Replace Not Painted-cracked

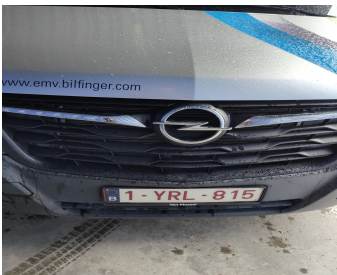
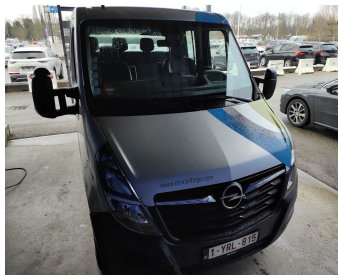
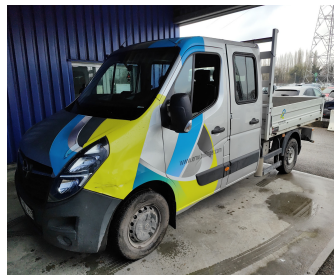
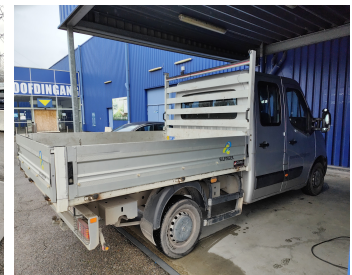
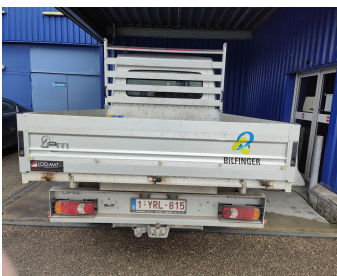
Lettering Removal 15min-

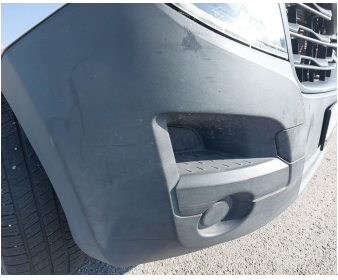
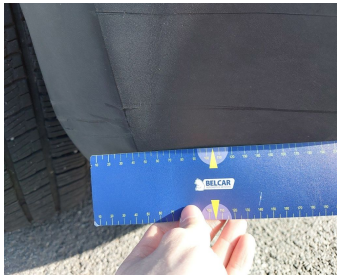
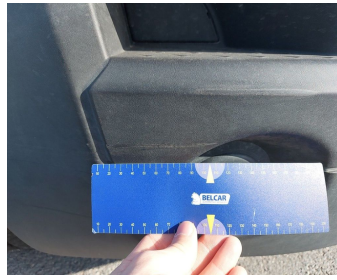
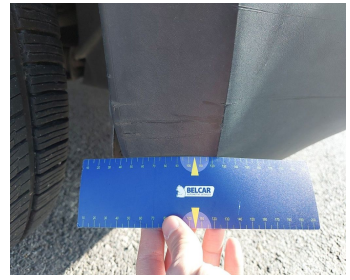
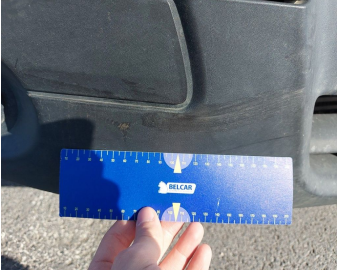
Bumper Front // Smart Repair Large-scratch

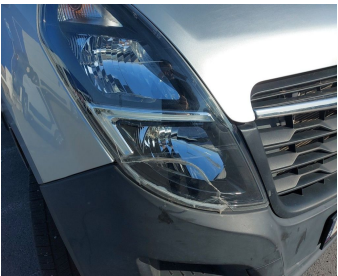
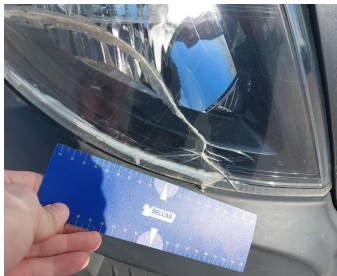
Light / Front Right / Replace-cracked

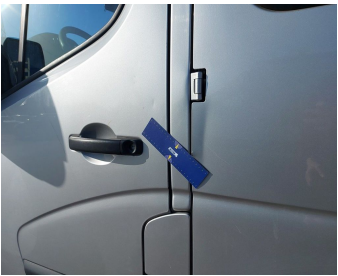
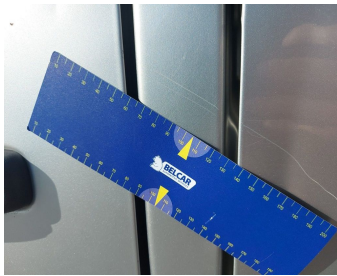
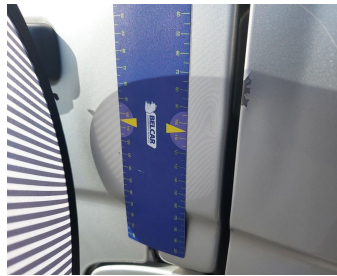
Door Front Left // Smart Repair Medium-dent

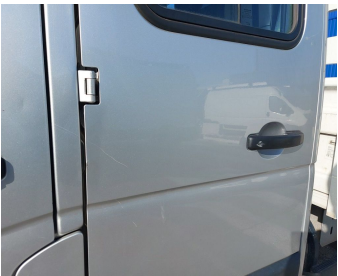
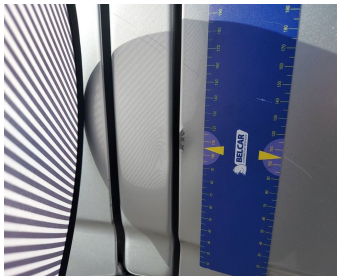
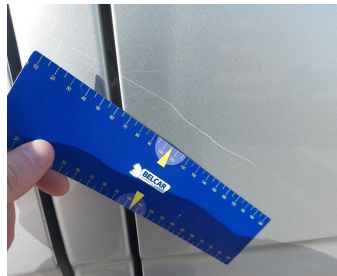
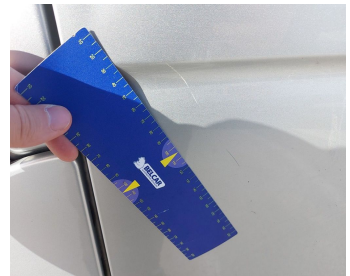
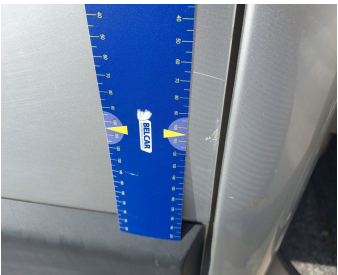
Door Rear Left // Repair & Painting-scratch + dent
