Expertise

Protocol number: 46232076
Order No. / Reference: 26153526
Inspection date: 15 Jun 2026

Model: 317 CDI Sprinter Standard HA 9G-TRONIC PRO

VIN: W1V3KBFZ7TP862483

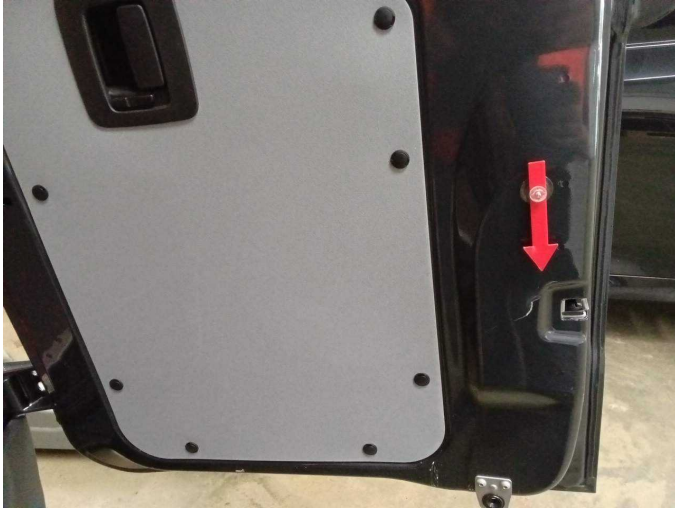
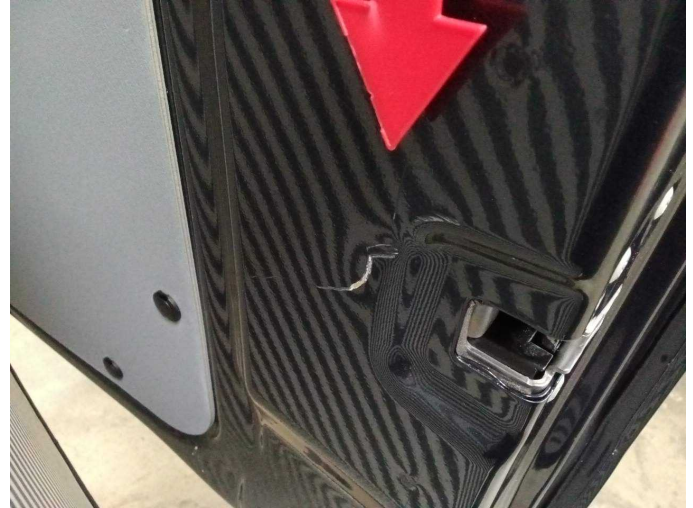
Damage 1: Boot lid / rear door: Boot lid - Dent / paintcoat damage - Smart repair

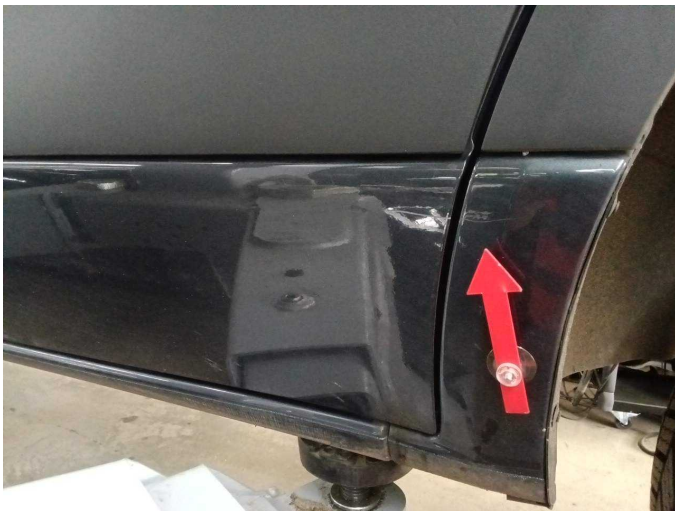
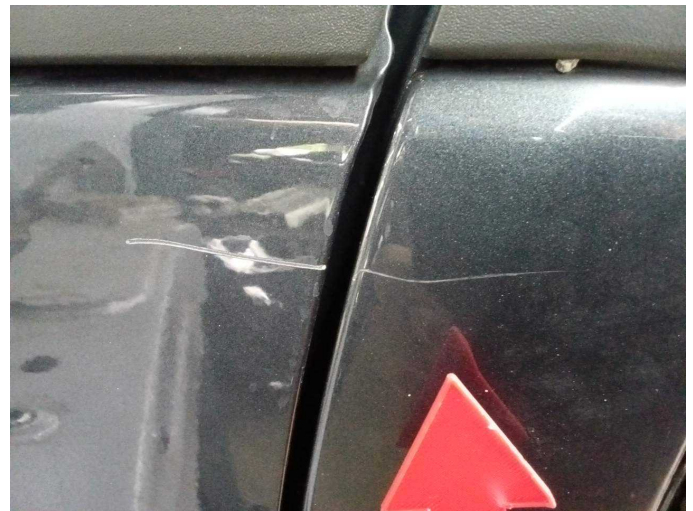
Damage 2: Sill - right side: Trim - Scratch(es) - Smart repair

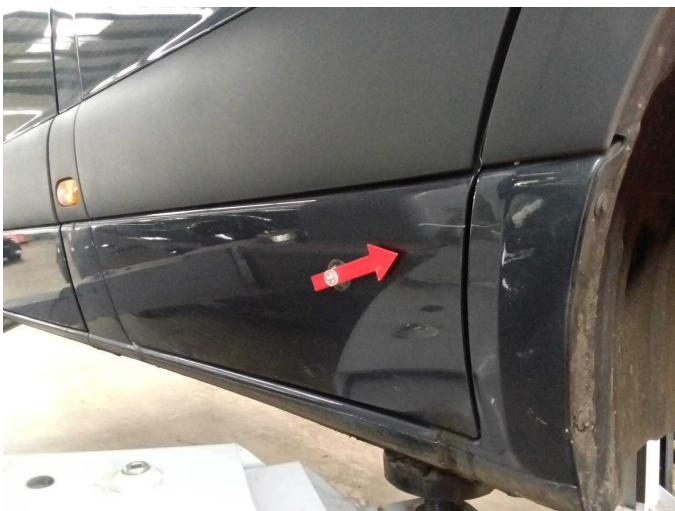
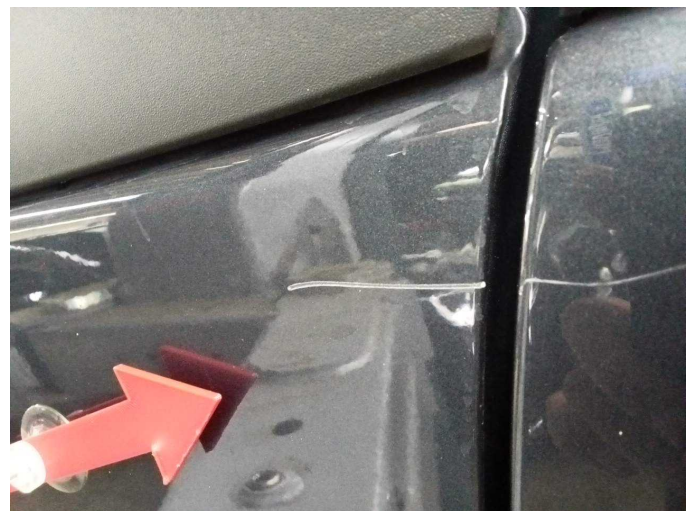
Damage 3: Door - front right side: Door - Scratch(es) - Paint

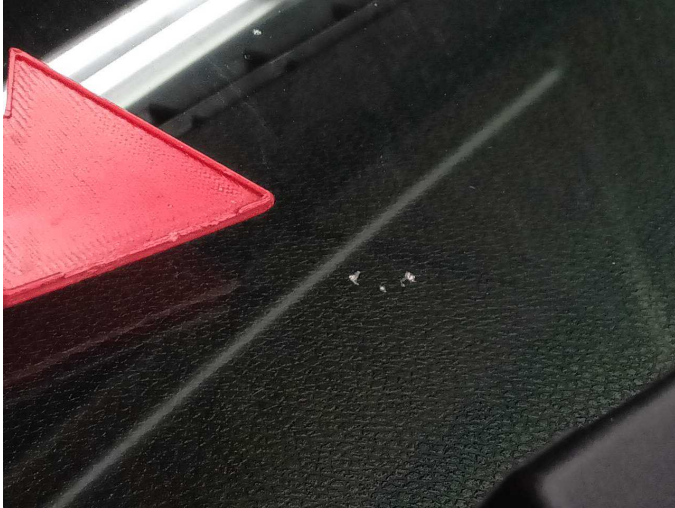
Wear and tear 5: Vehicle glazing: Windscreen - Stone chips - No deduction

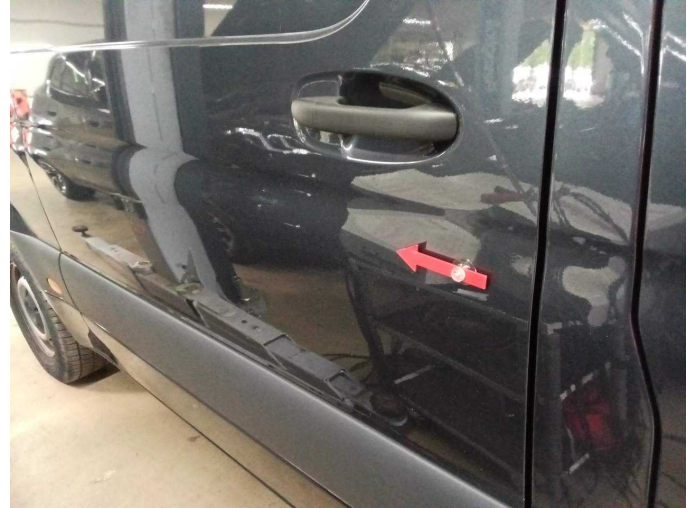
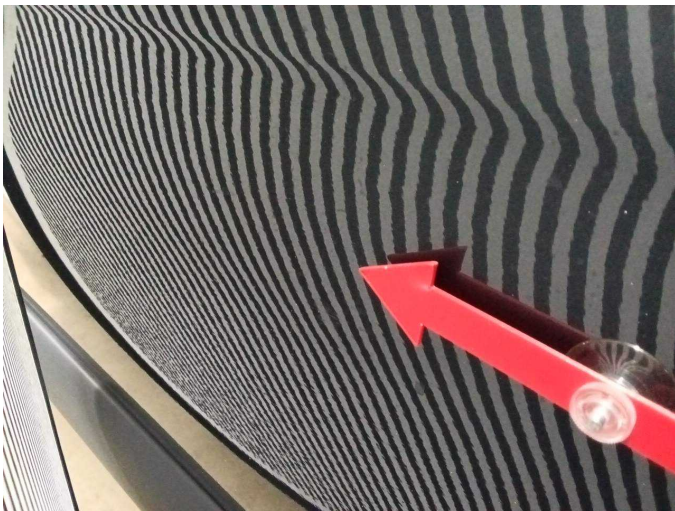
Wear and tear 6: Sliding door, right: Sliding door - dent(s) - No deduction

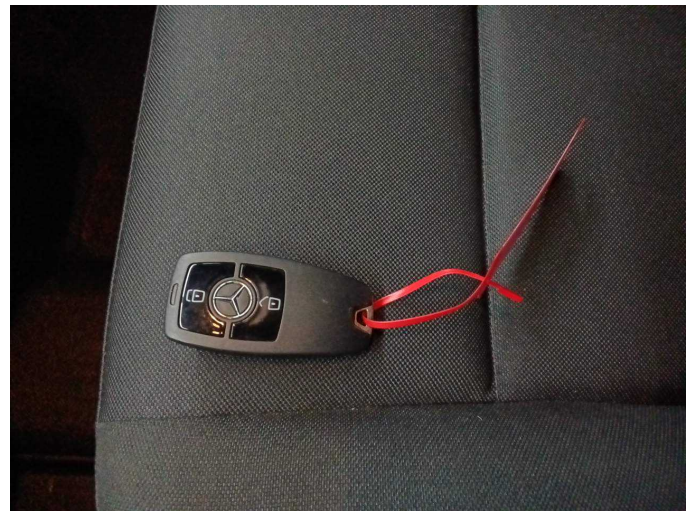
Missing part 1: Equipment: Vehicle key - Missing - Perform
