Expertise

Protocol number: 46104613  
Order No. / Reference: 26470120  
Inspection date: 23 Jun 2026

Manufacturer: Skoda  
VIN: TMBJF7NU3PC217624

Model: Karoq 2.0 TDI SCR DSG Ambition

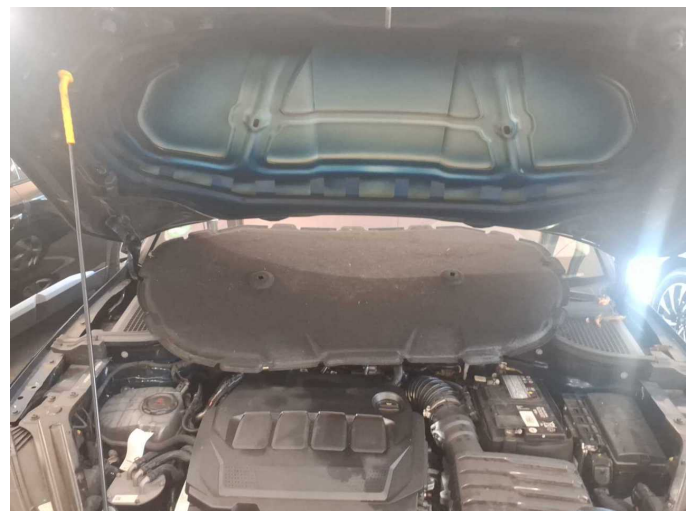
| No. | Component group | Description |
|---|---|---|
| 1 | Bonnet | Insulation lining - Malposition - Un- / install |

**Damage 1:** Bonnet: Insulation lining - Malposition - Un- / install

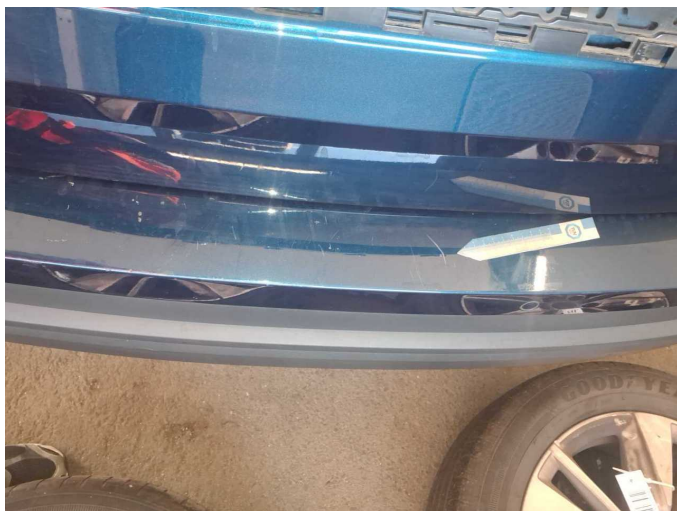
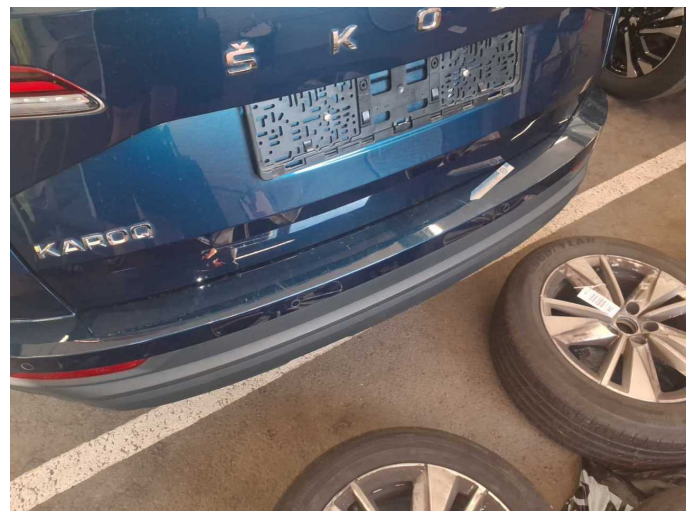
| No. | Component group | Description |
|---|---|---|
| 2 | Rear bumper | Rear bumper - Scratch(es) - Paint |

**Damage 2:** Rear bumper: Rear bumper - Scratch(es) - Paint

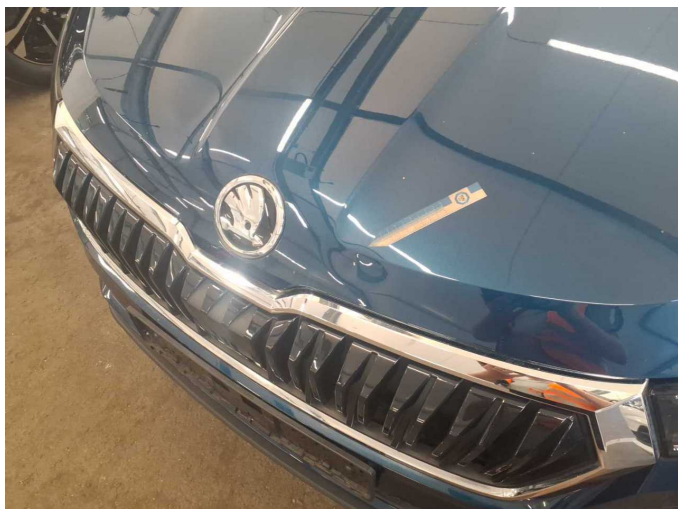
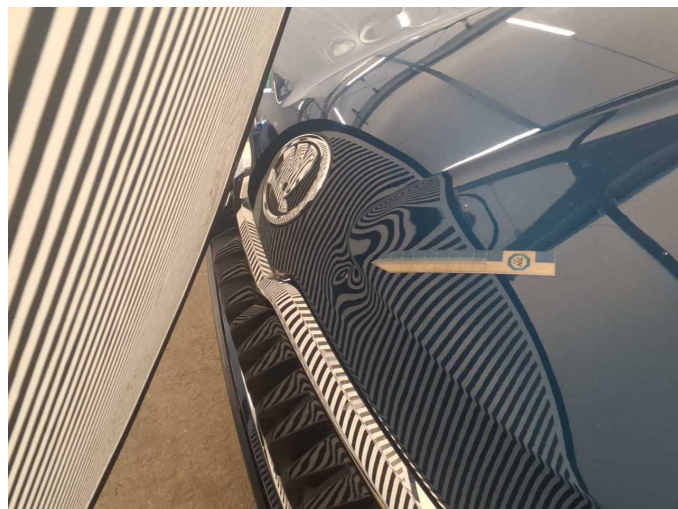
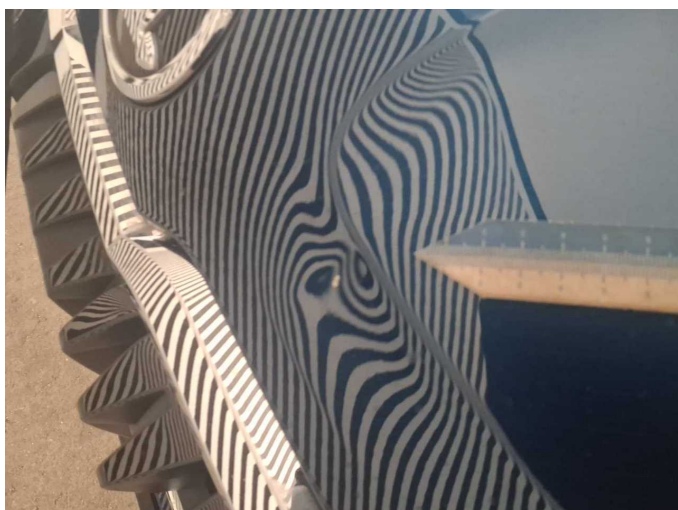
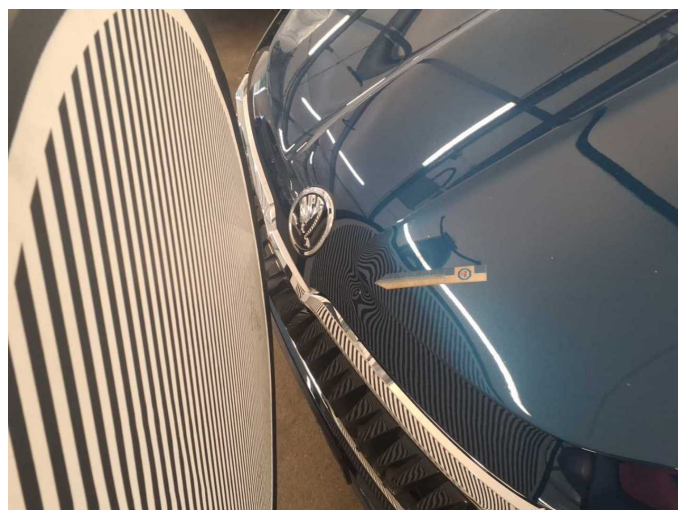
| No. | Component group | Description |
|---|---|---|
| 3 | Bonnet | Bonnet - Dent / paintcoat damage - Repair and paint |

**Damage 3:** Bonnet: Bonnet - Dent / paintcoat damage - Repair and paint

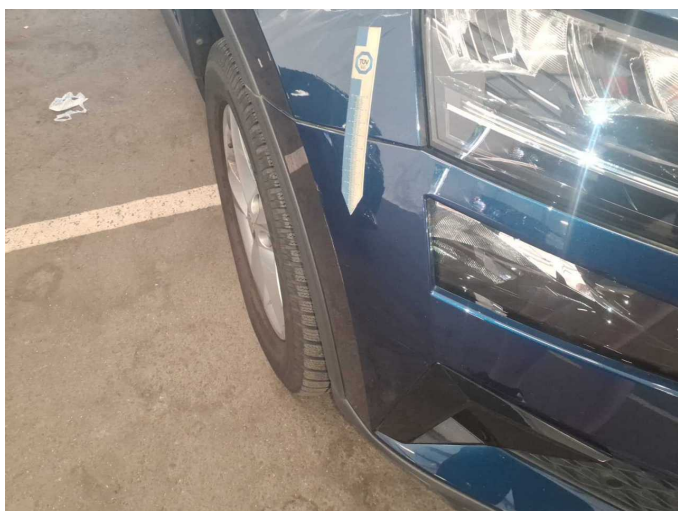
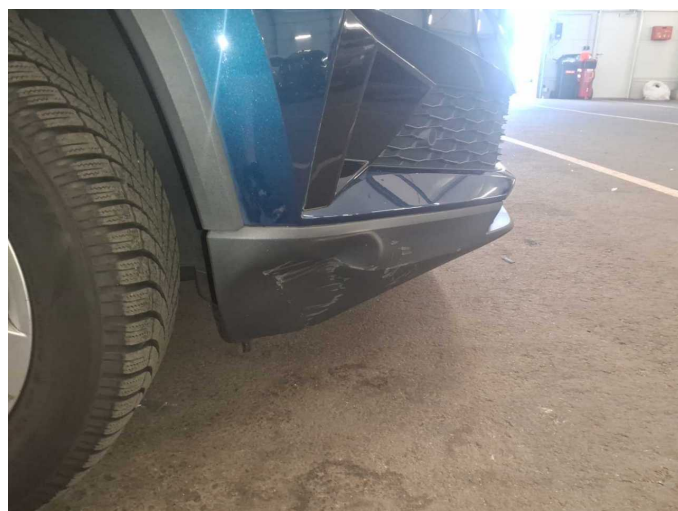
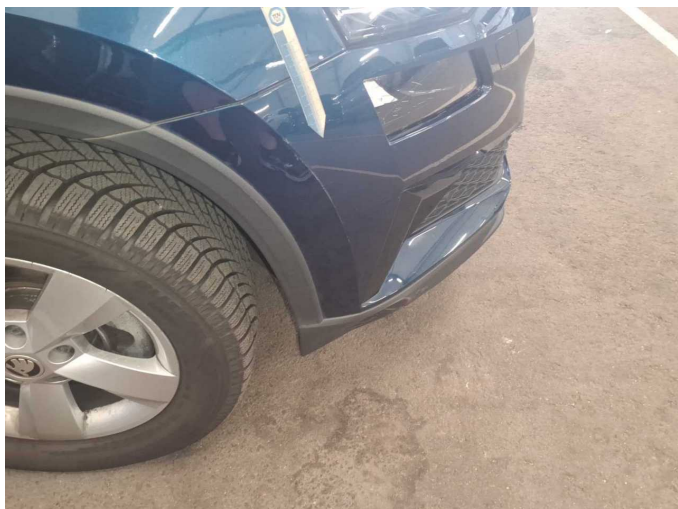
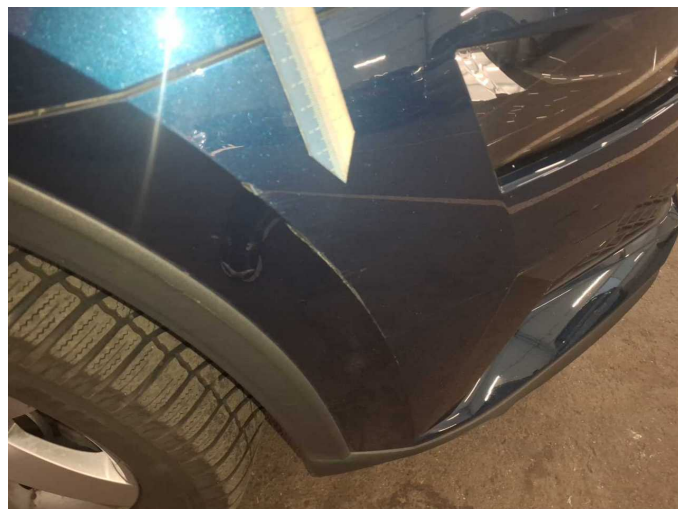
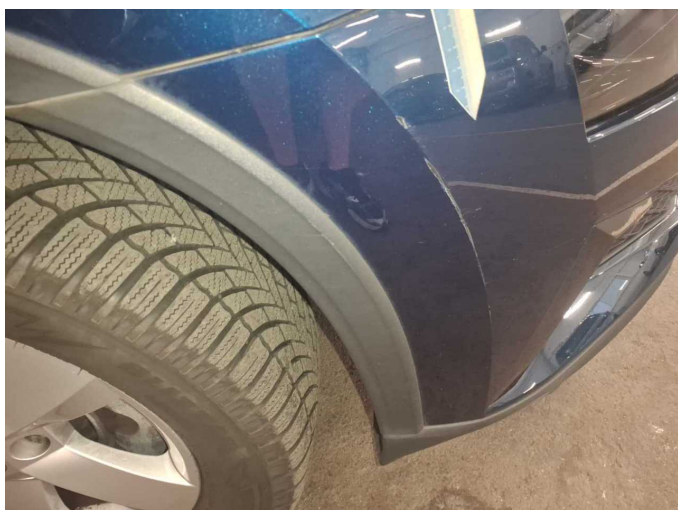
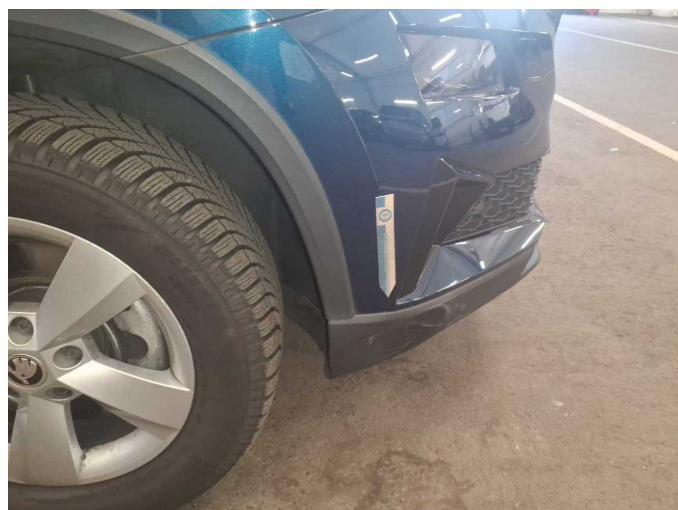
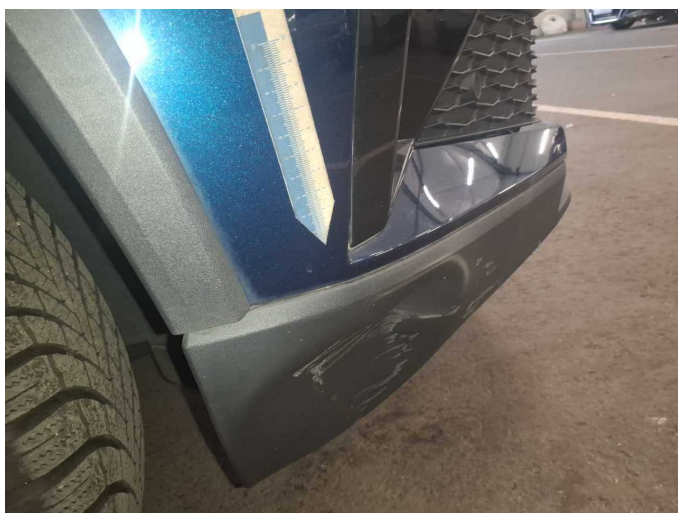
| No. | Component group | Description |
|---|---|---|
| 4 | Front bumper | Front bumper (+Radlauf, + Spoiler) - Damaged - repair according to calculation |

**Damage 4:** Front bumper: Front bumper (+Radlauf, + Spoiler) - Damaged - repair according to calculation

**Damage 4:** Front bumper: Front bumper (+Radlauf, + Spoiler) - Damaged  
- repair according to calculation

Die beigefügte Reparaturkostenkalkulation wurde nach bestem Wissen und Gewissen unter eingeschränkten Besichtigungsbedingung im demontagefreien Zustand erstellt. Es können aufgrund verdeckter Beschädigung, Mehrkosten und somit Abweichung der für die Stoßstange ausgewiesenen Reparaturkosten nicht ausgeschlossen werden.

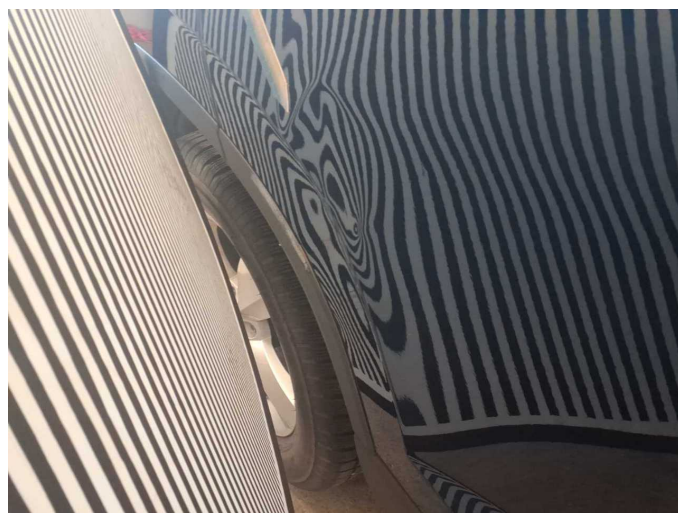
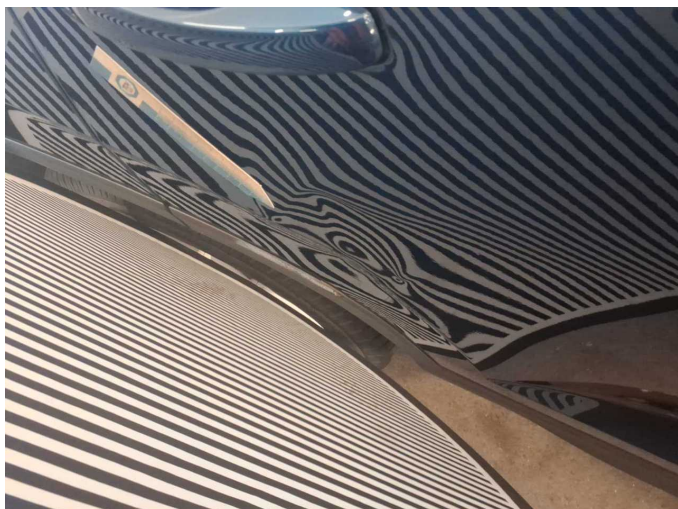
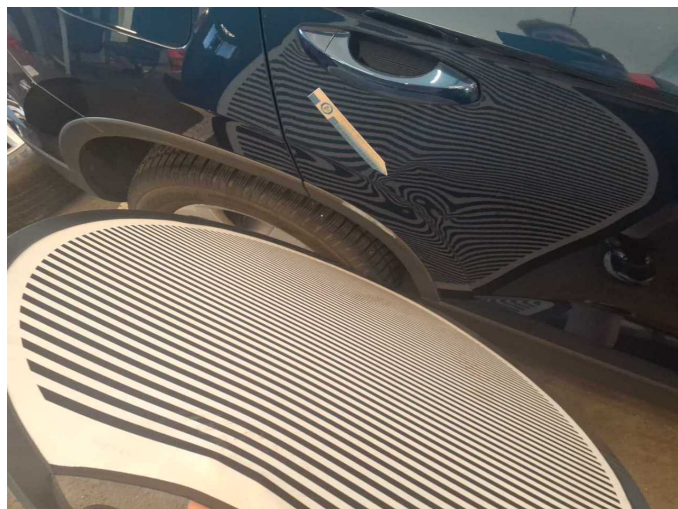
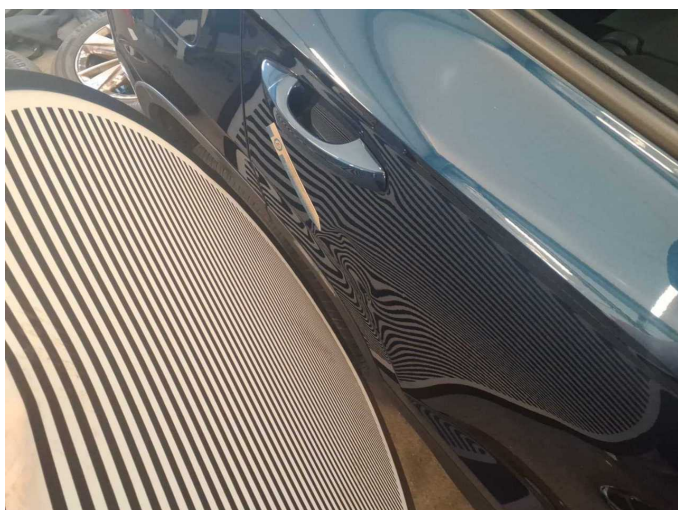
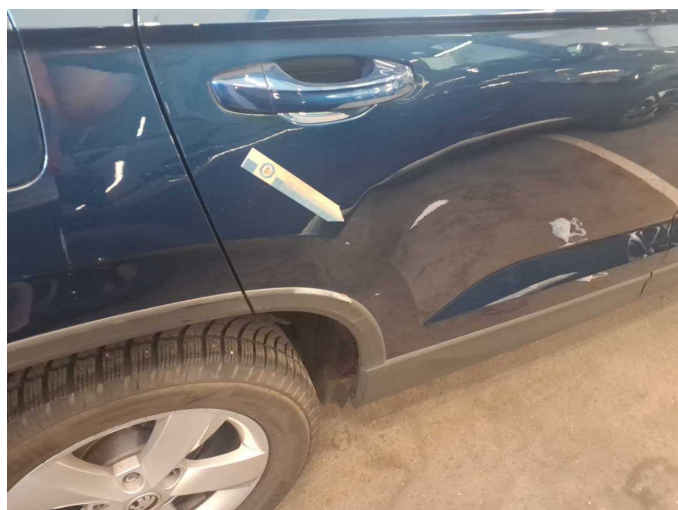
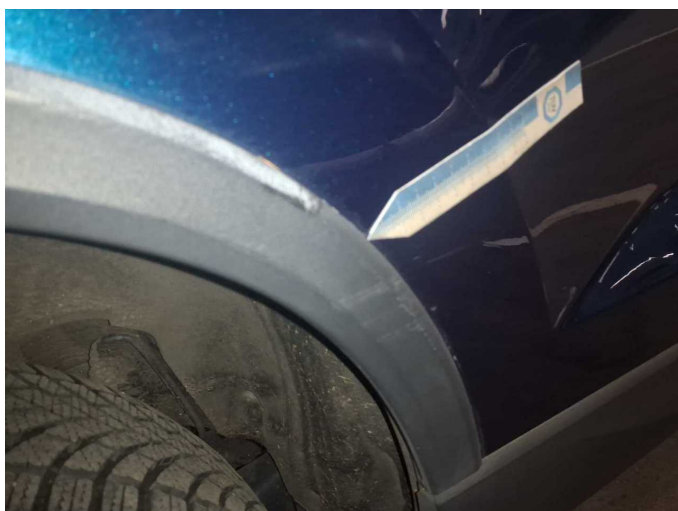
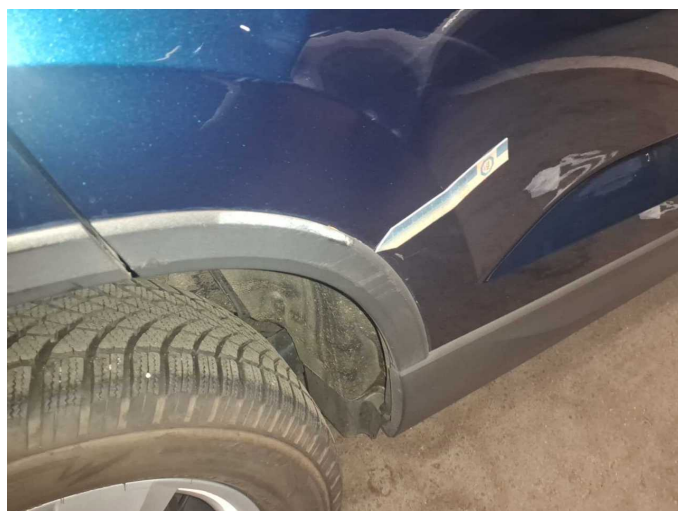
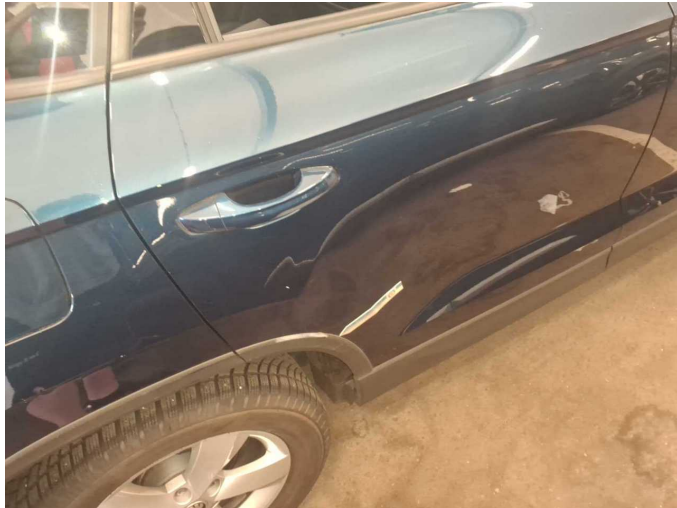
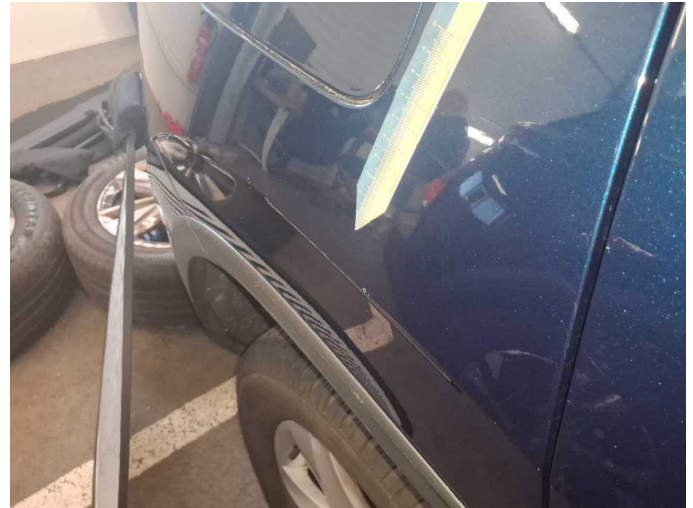
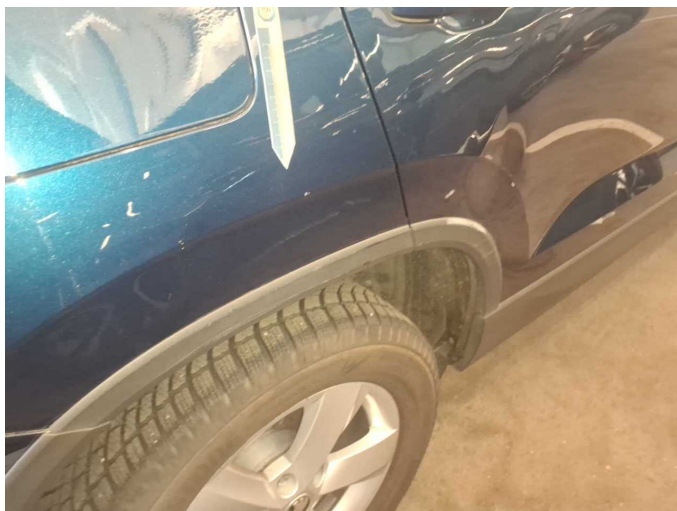
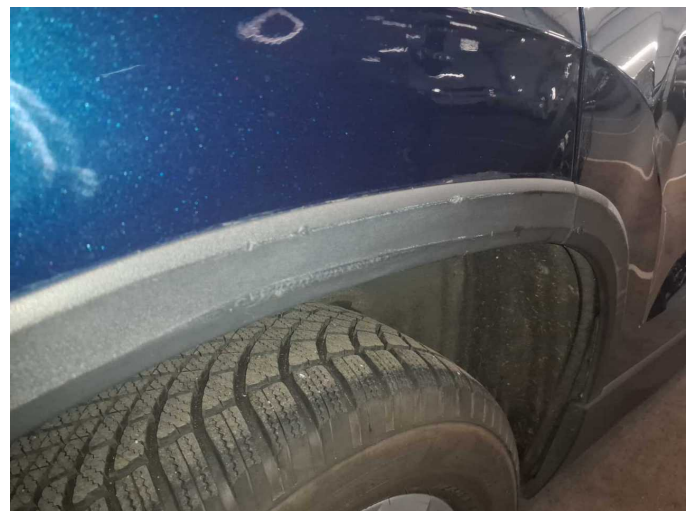
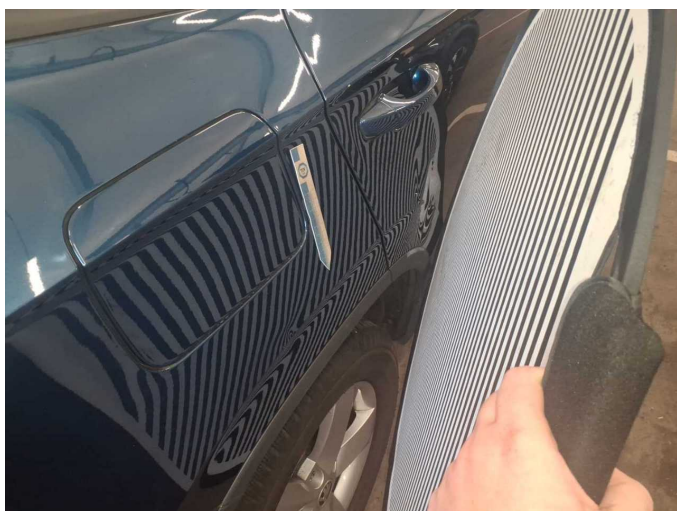
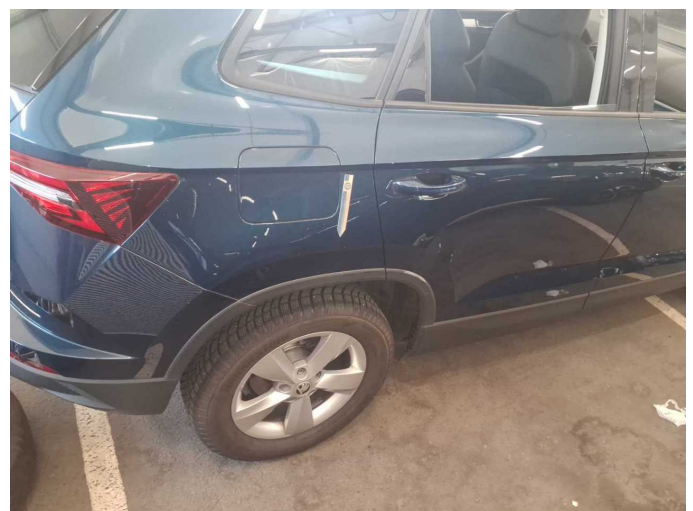
| No. | Accident |
|---|---|
| 1 | Side right |

**Accident 1:** Side right

Die beigefügte Reparaturkostenkalkulation wurde nach bestem Wissen und Gewissen unter eingeschränkten Besichtigungsbedingung im demontagefreien Zustand erstellt. Es können aufgrund verdeckter Beschädigung erhebliche Mehrkosten und somit Abweichung der für den Unfall ausgewiesenen Reparaturkosten nicht ausgeschlossen werden.
