## Expertise

Protocol number: 45918440  
Order No. / Reference: 26496937  
Inspection date: 12 Jun 2026

Model: Focus Turnier 1.5 EcoBlue Start-Stopp-System Aut. TITANIUM

VIN: WF0PXXGCHPNS41691

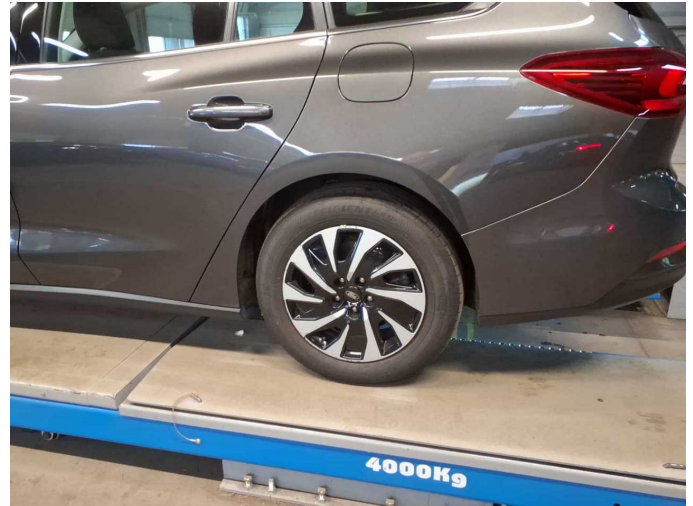
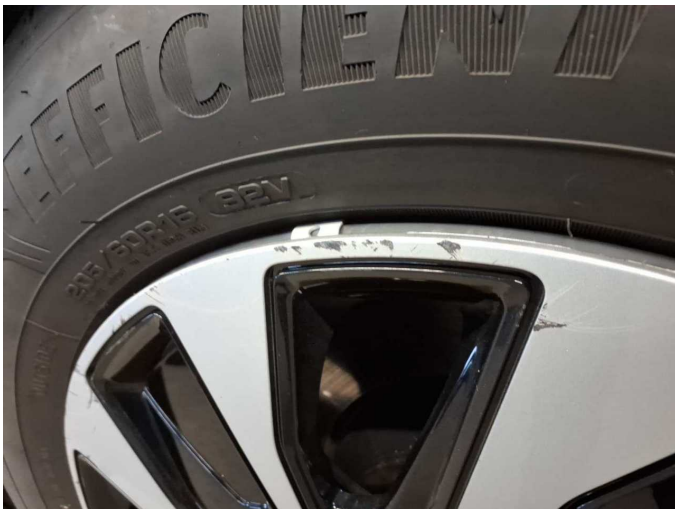
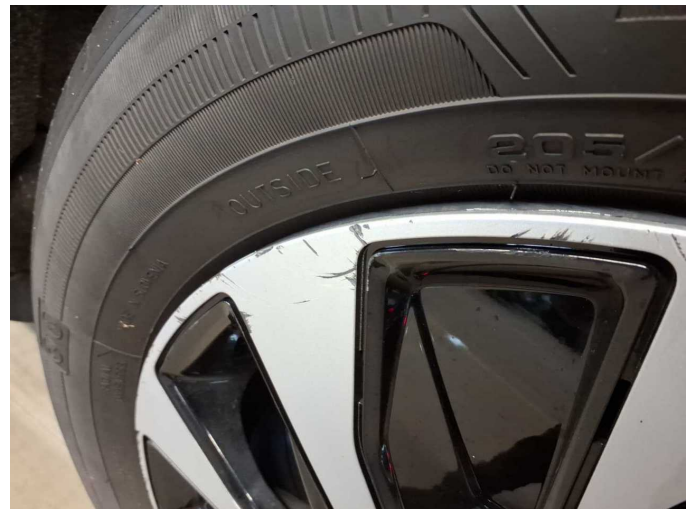
Damage 1: Wheel / tyres: Wheel cover - rear left side - Scratch(es) - Loss in value

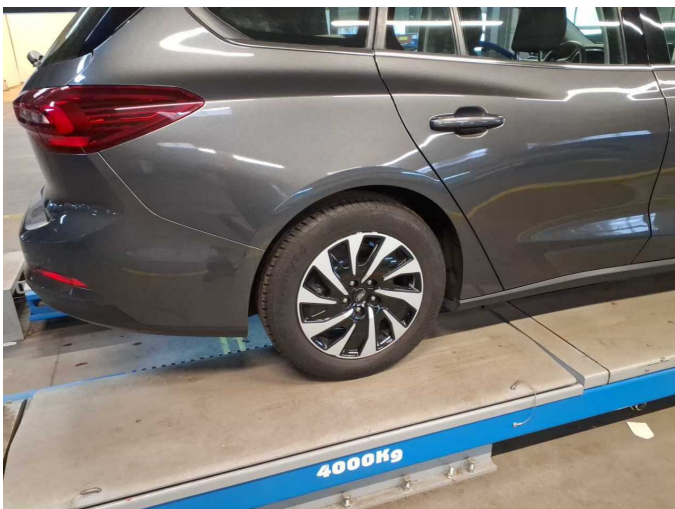
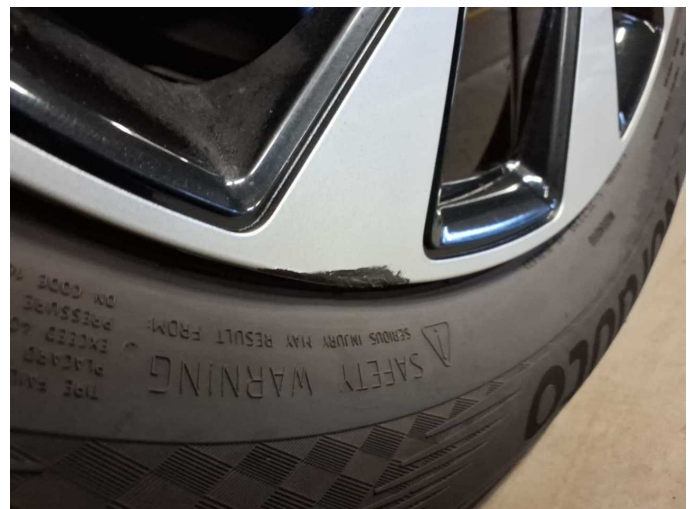
Damage 2: Wheel / tyres: Wheel cover - rear right side - Scratch(es) - Loss in value

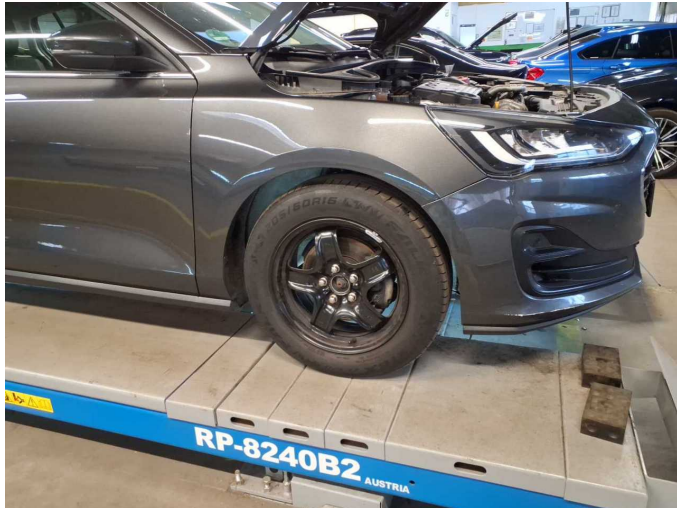
**Damage 3:** Wheel / tyres: Wheel cover - front right side - Missing - Replace

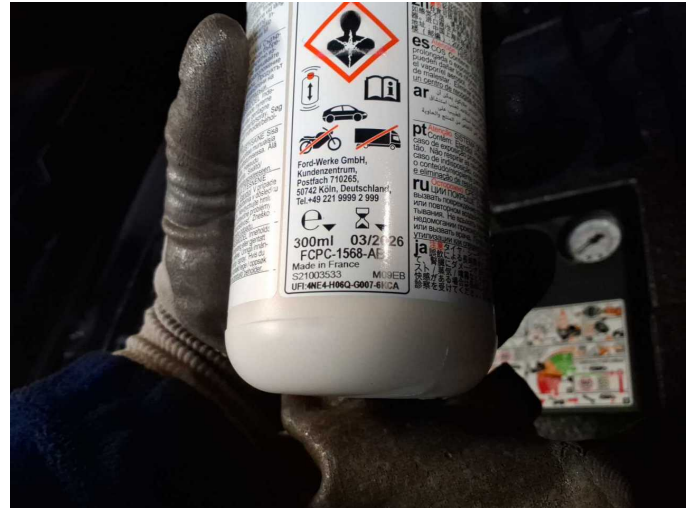
**Damage 4:** Equipment: Tirefit filler - Expired - Replace

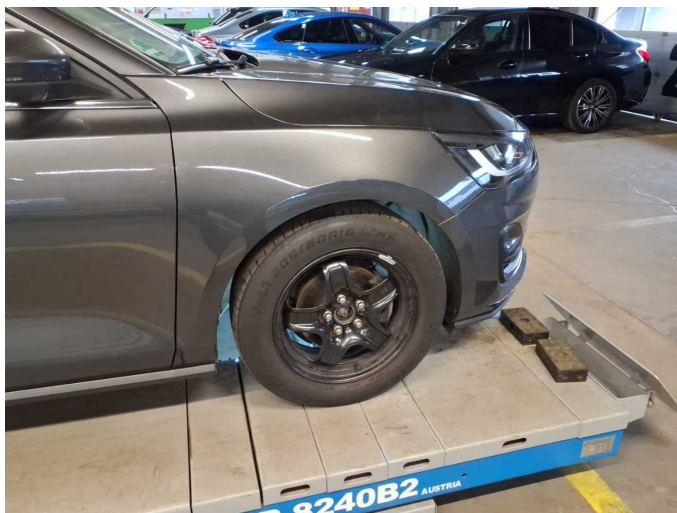
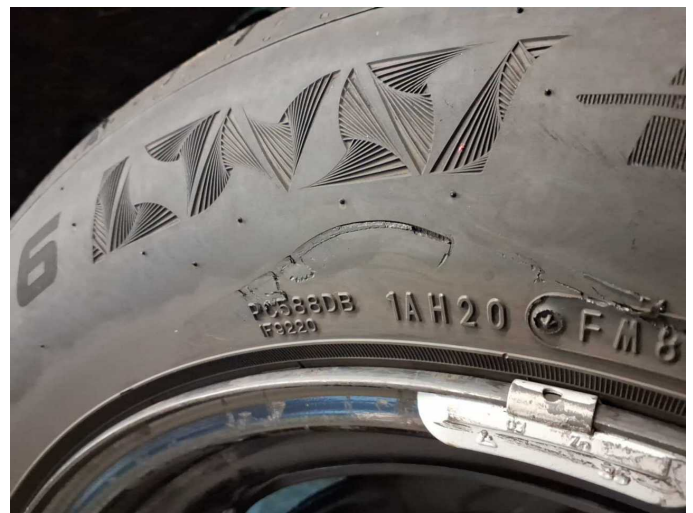
**Damage 5:** Wheel / tyres: Tyre - front right side (Flanke, nicht fahrbereit) - Damaged - Replace

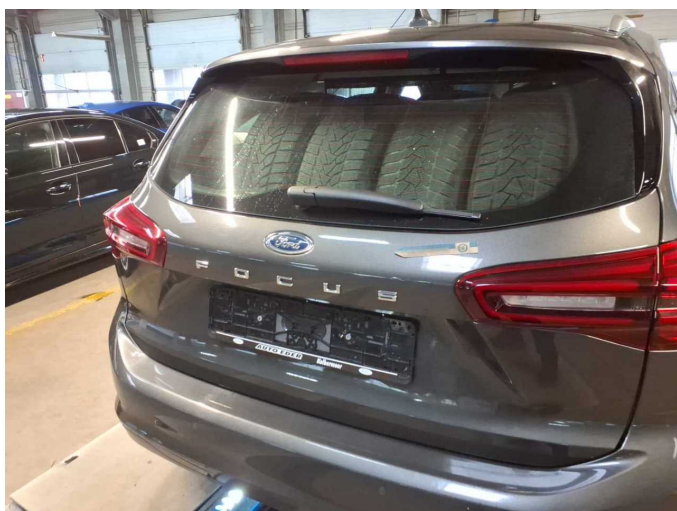
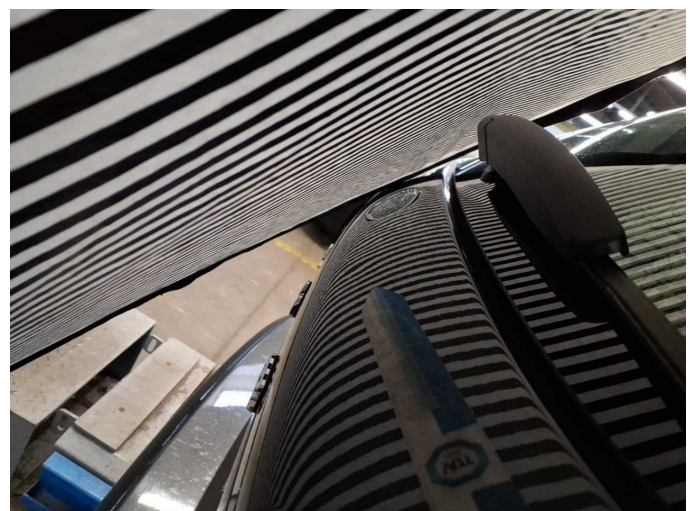
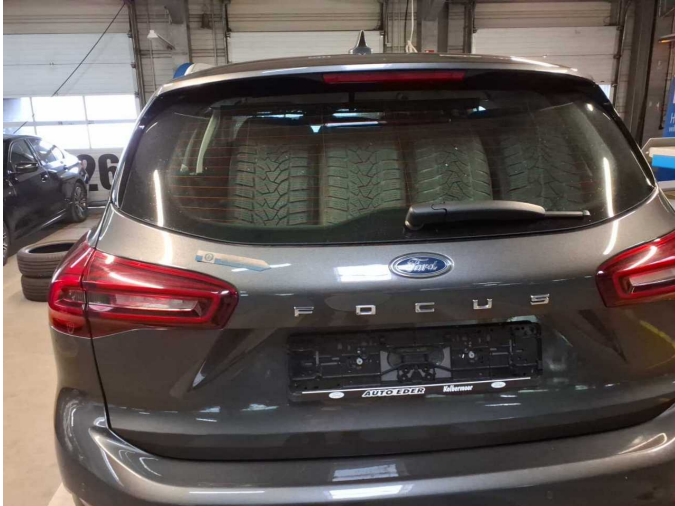
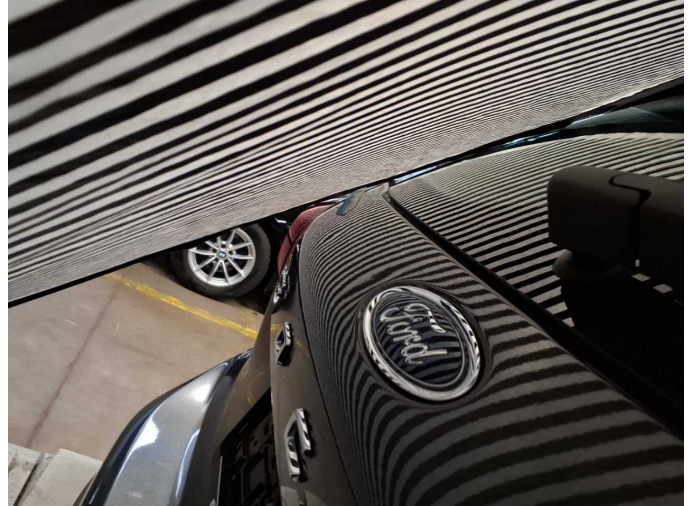
**Damage 6:** Boot lid / rear door: Boot lid - dent(s) - Smooth repair work

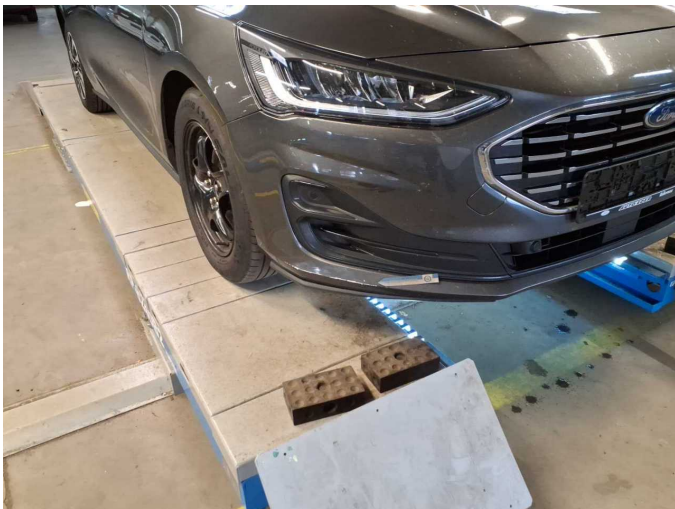
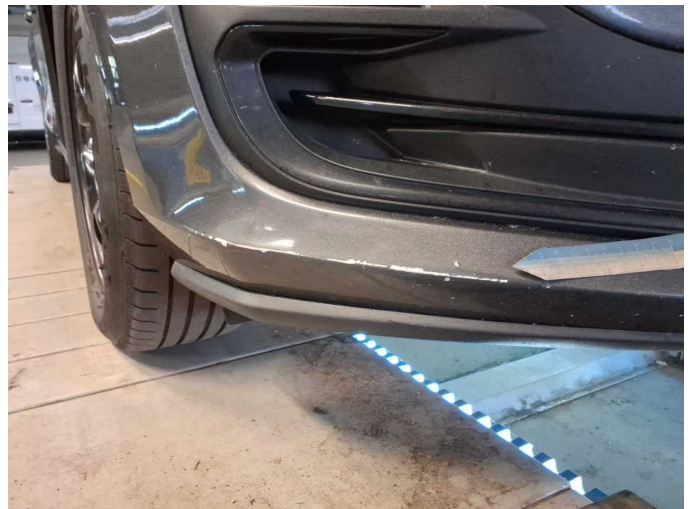
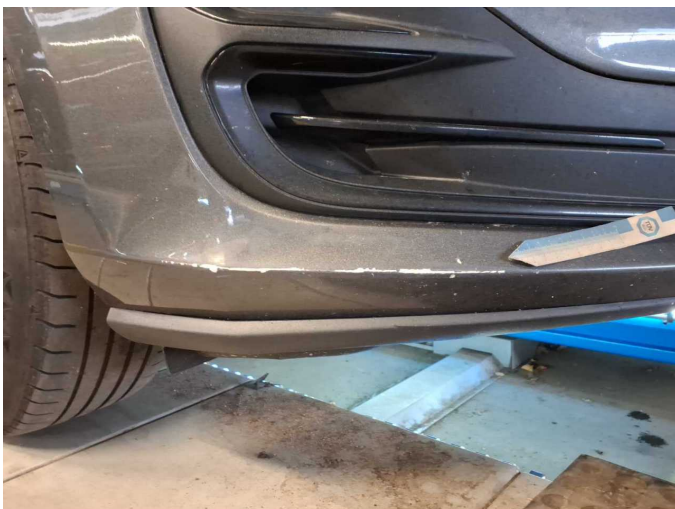
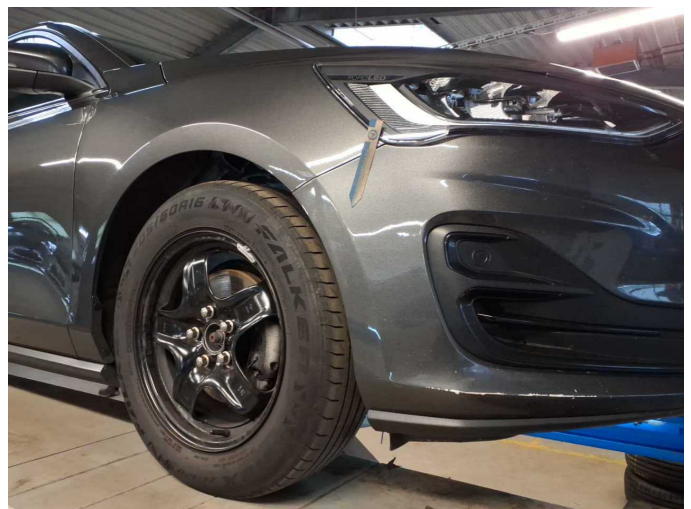
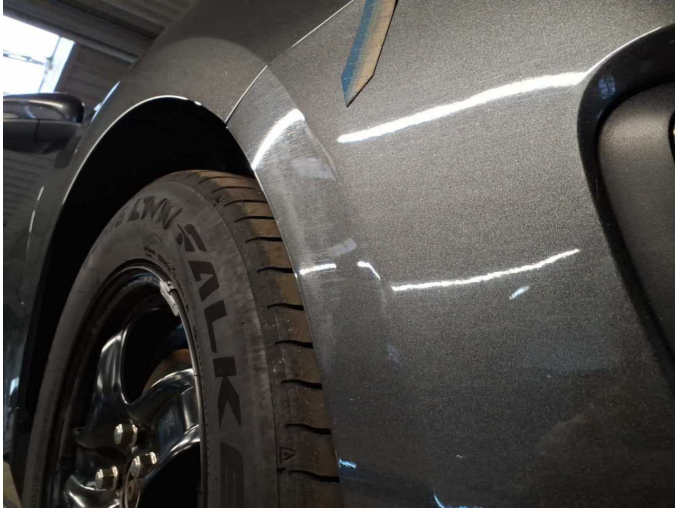
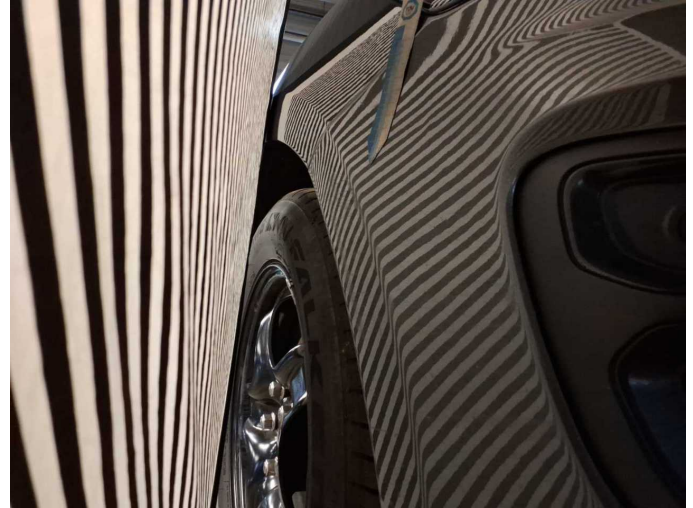
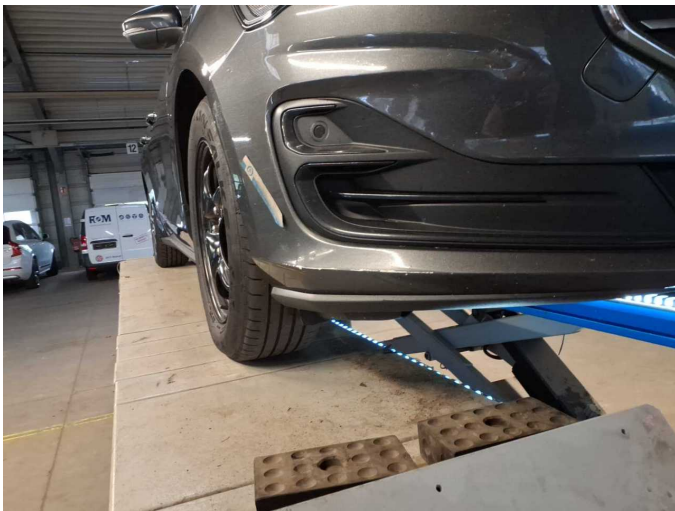
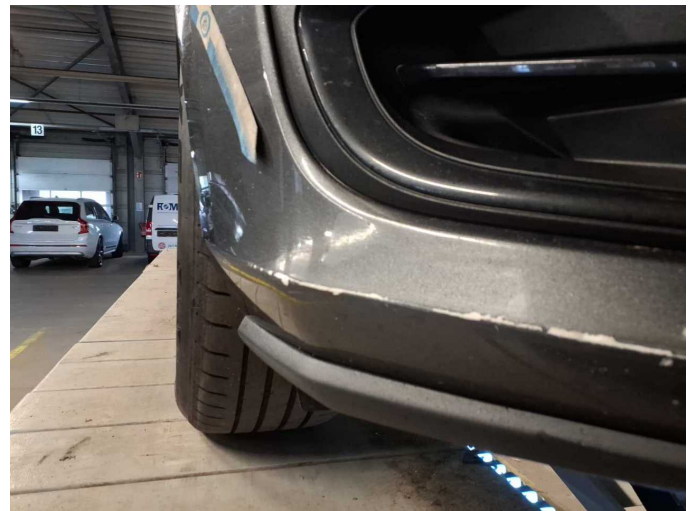
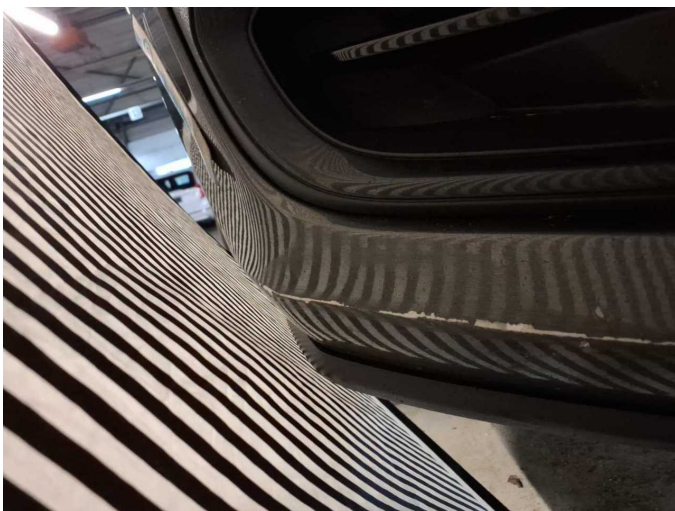
**Damage 7:** Front bumper: Front bumper - Deformed - Repair and paint

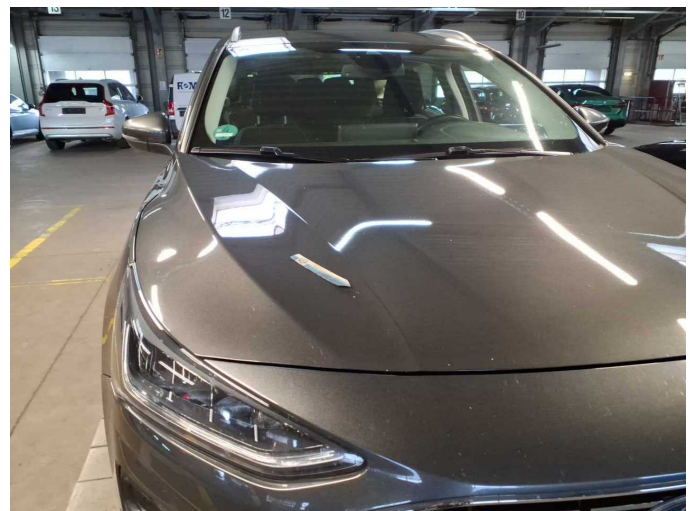
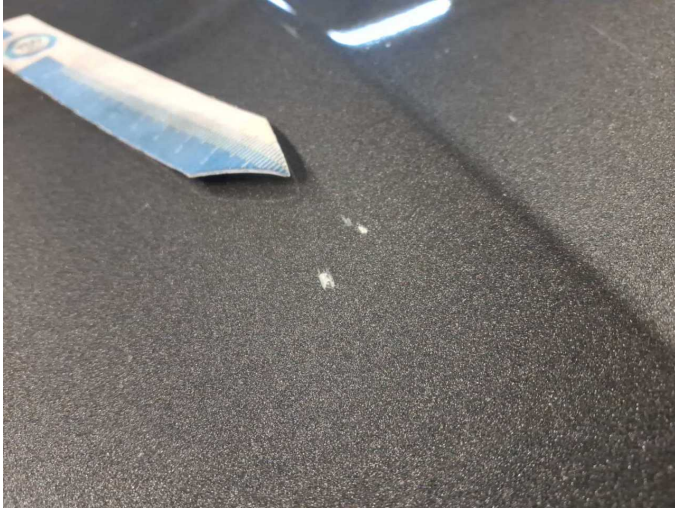
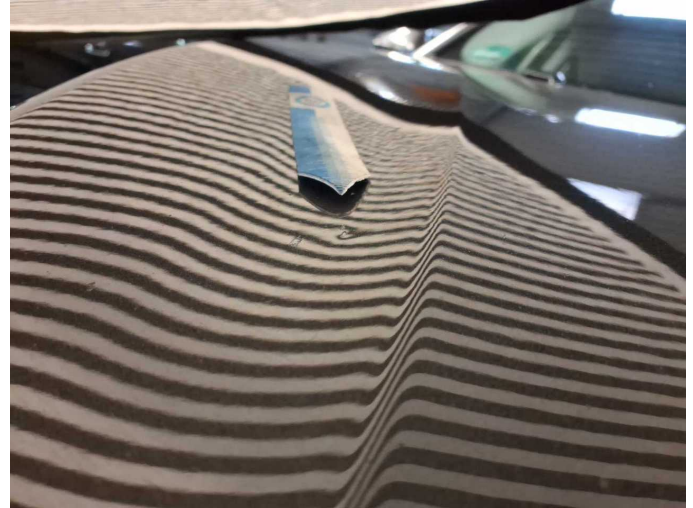
**Damage 8:** Bonnet: Bonnet - Dent / paintcoat damage - Paint
