Expertise

Protocol number: 46130131
 Order No. / Reference: 26616728
 Inspection date: 23 Jun 2026

Manufacturer: Ford

Model: Galaxy 2.0 EcoBlue S&S Aut. VIGNALE

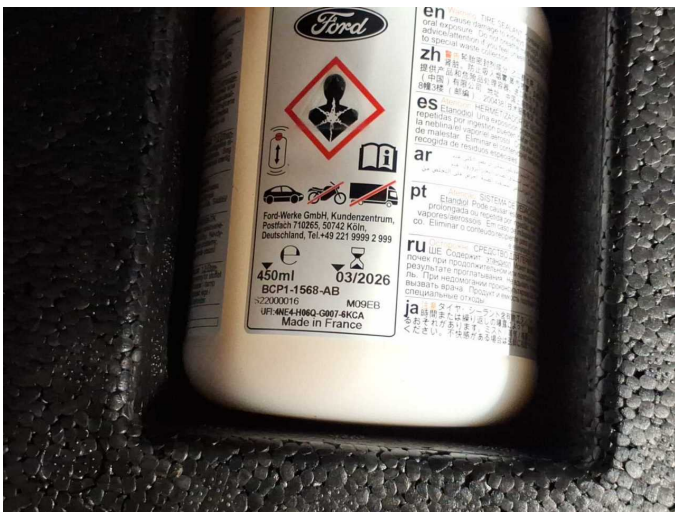
Damage 1: Equipment: Tirefit filler - Expired - Replace

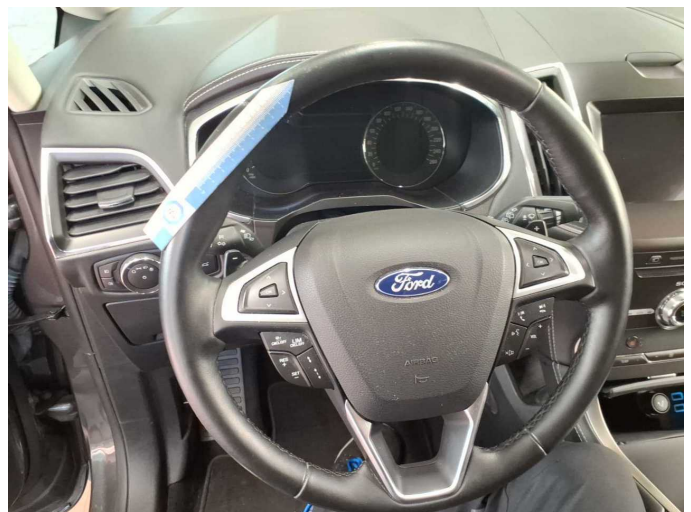
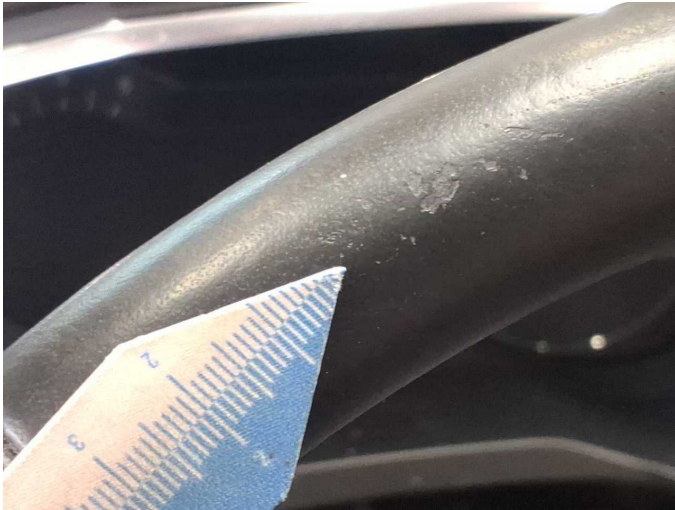
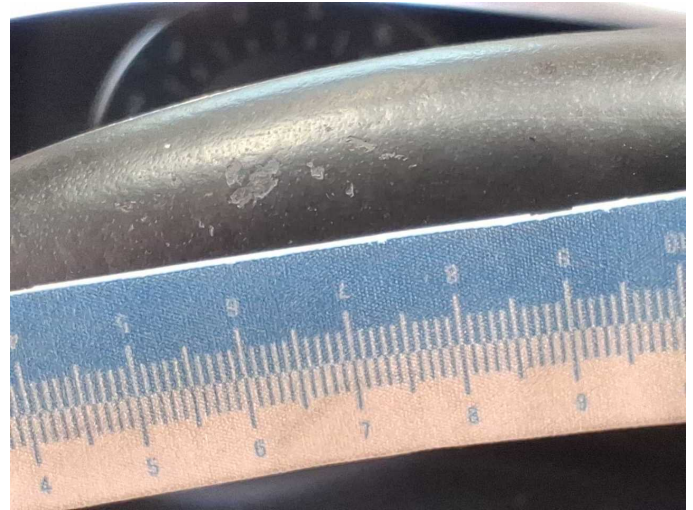
Damage 2: Steering system: Steering wheel - Scratch(es) - Smart repair

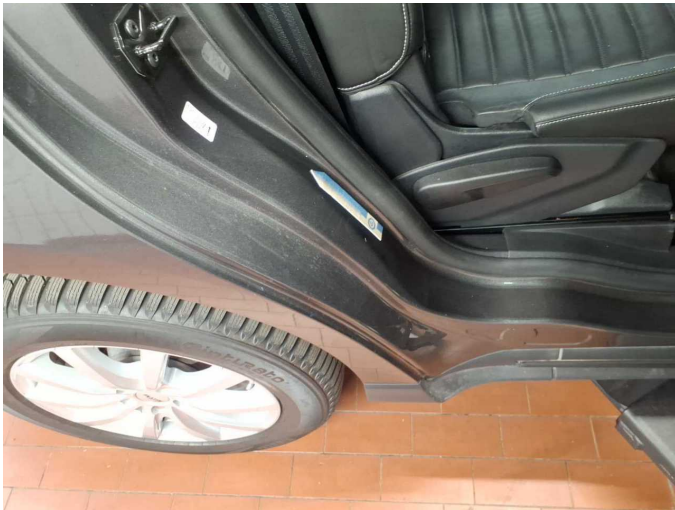
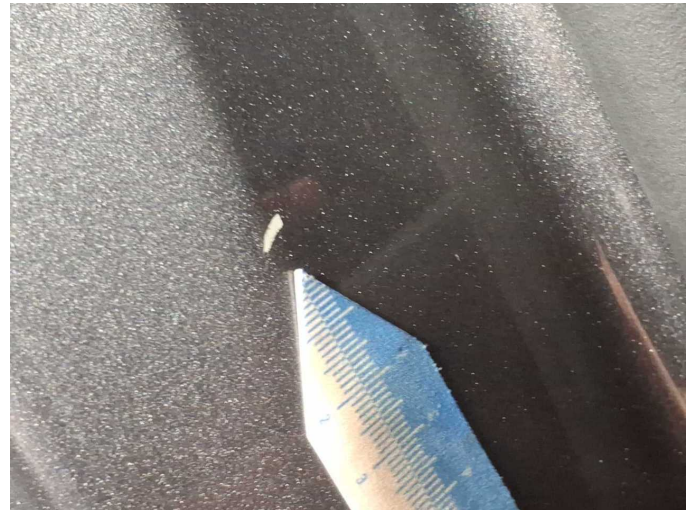
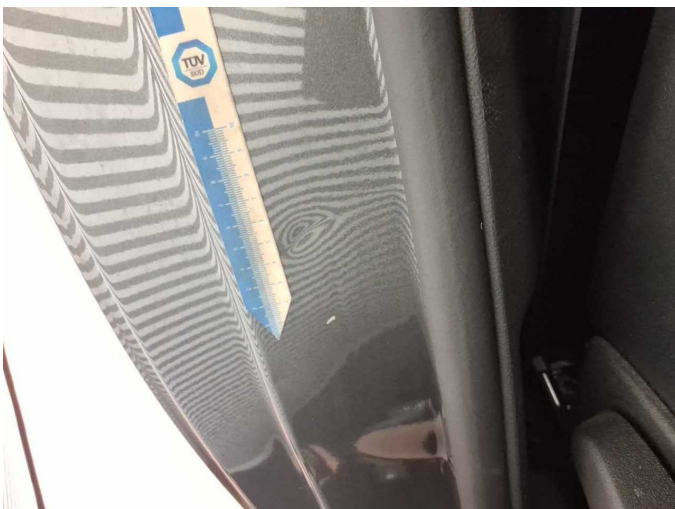
Damage 3: Side panel - rear right side: Sill - Dent / paintcoat damage - Smart repair

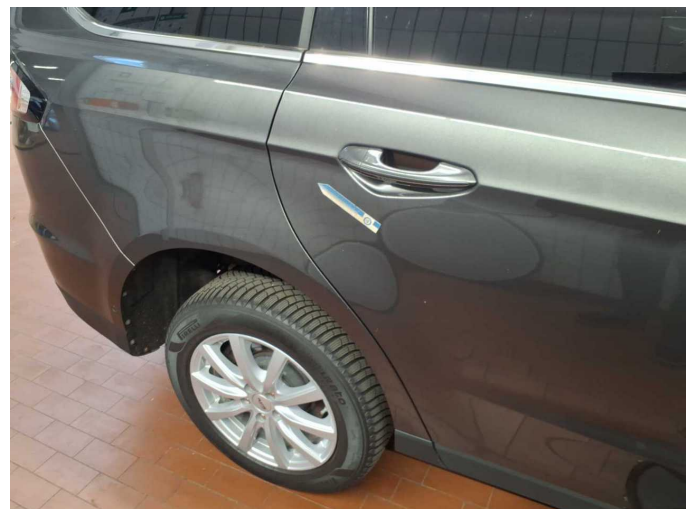
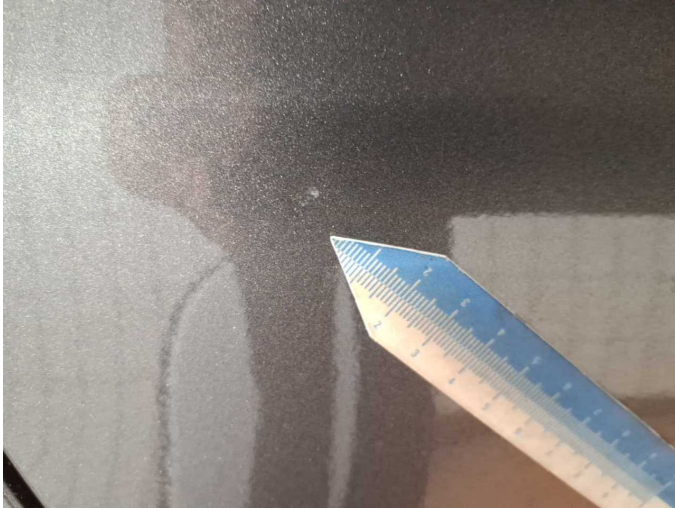
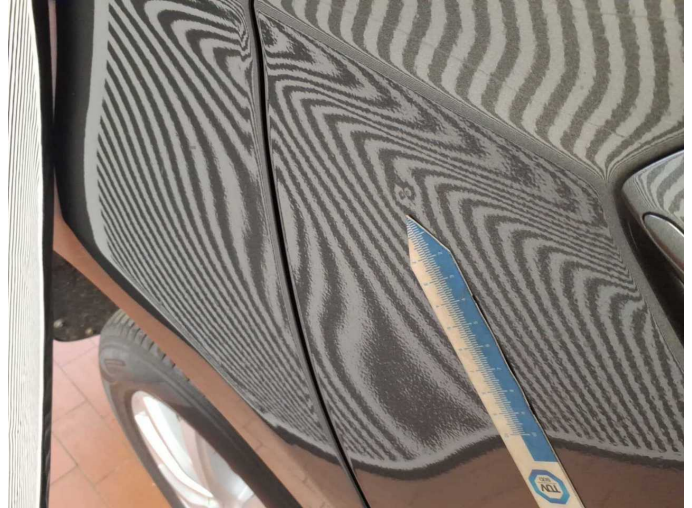
Damage 4: Door - rear right side: Door (Drücken und Auslegen/Polieren) - Dent / paintcoat damage - Smart repair

Damage 4: Door - rear right side: Door (Drücken und Auslegen/Polieren)
- Dent / paintcoat damage - Smart repair

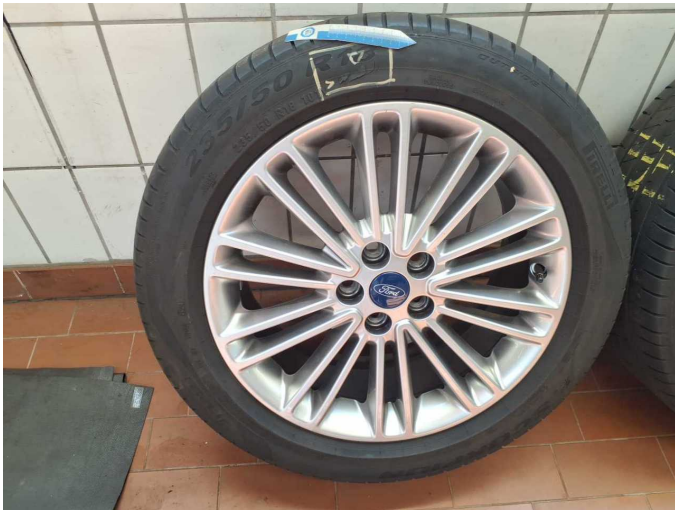
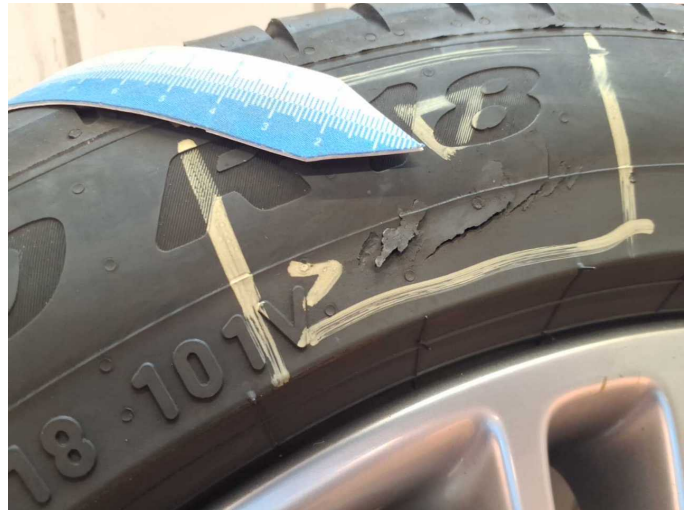
Damage 5: 2nd wheel set: 1 tyre (Sommerreifen) - Broken / torn -
Replace

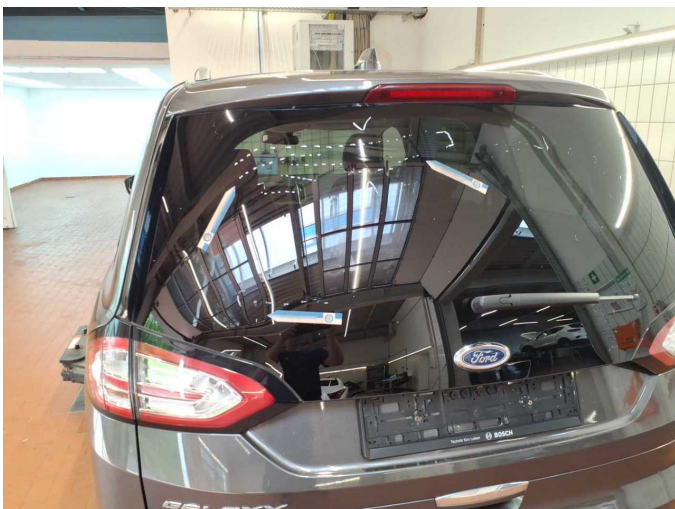
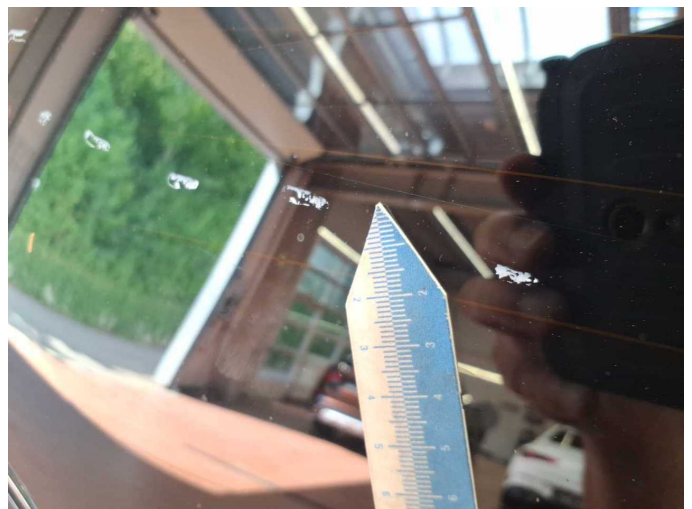
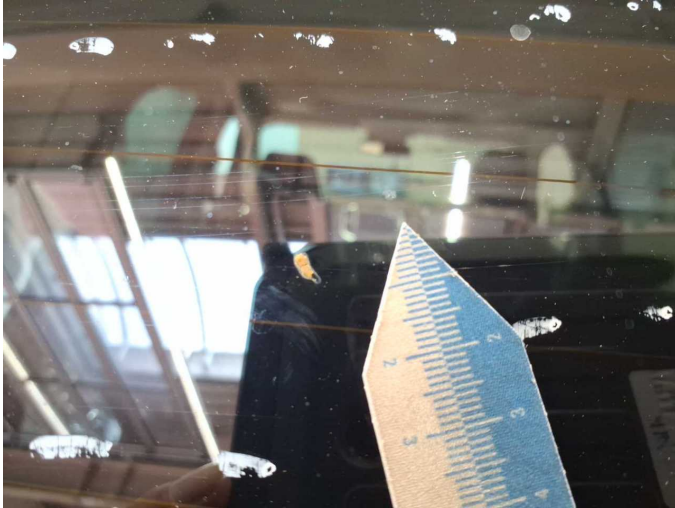
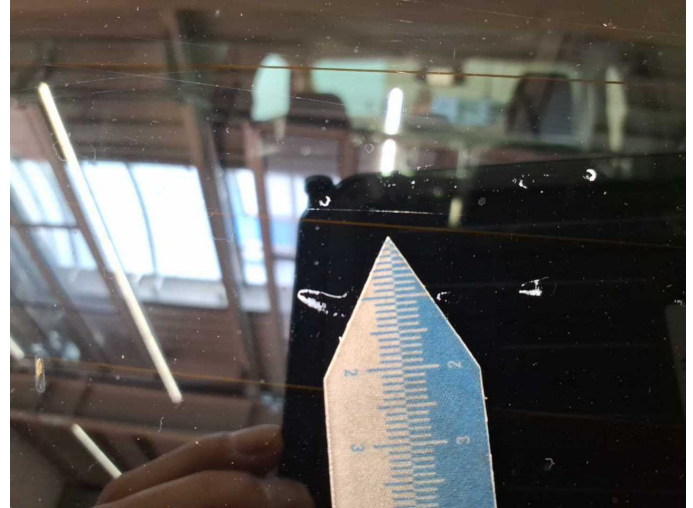
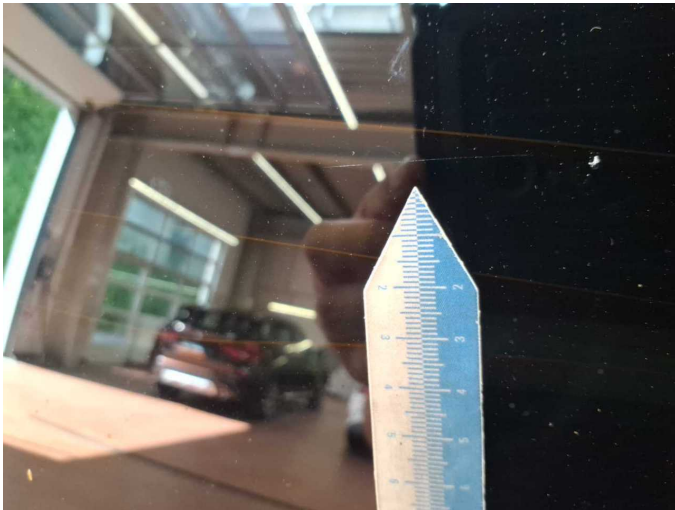
Damage 6: Vehicle glazing: Rear window black glass (Optischer Mangel)
- Scratch(es) - Loss in value

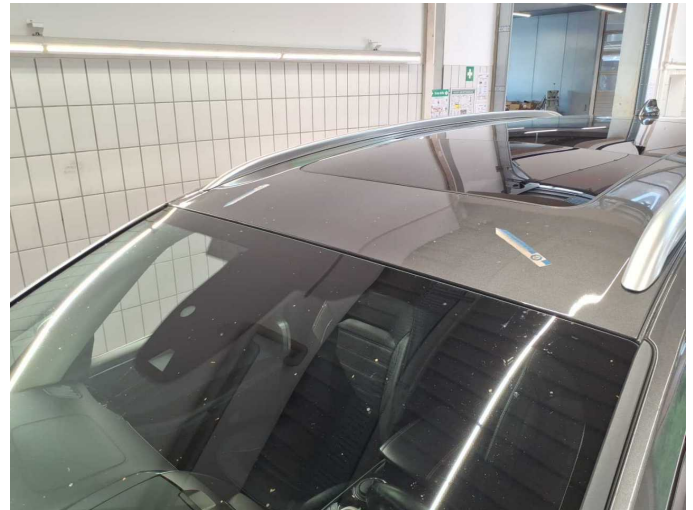
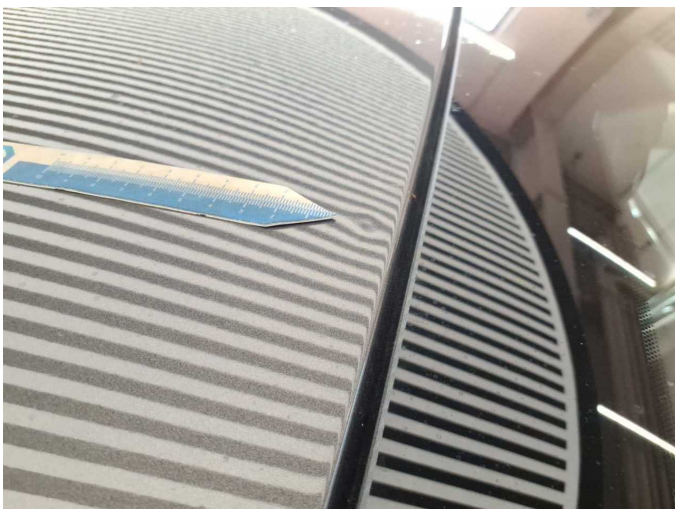
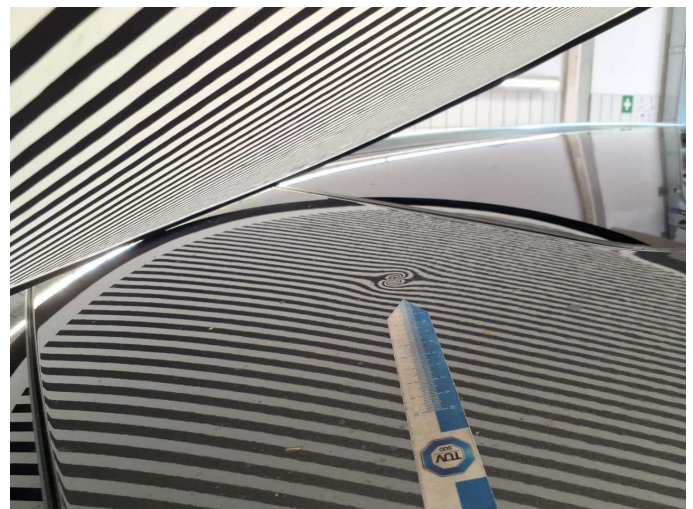
Lackierpreis Dach teilweise berechnet.

Damage 7: Roof: Roof - dent(s) - Paint

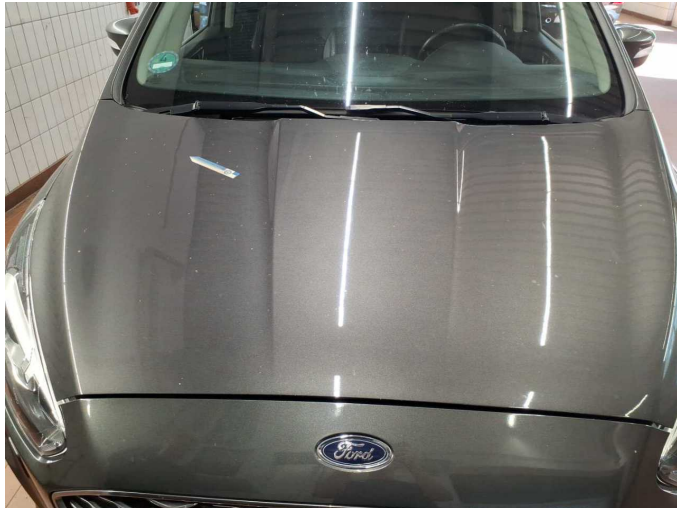
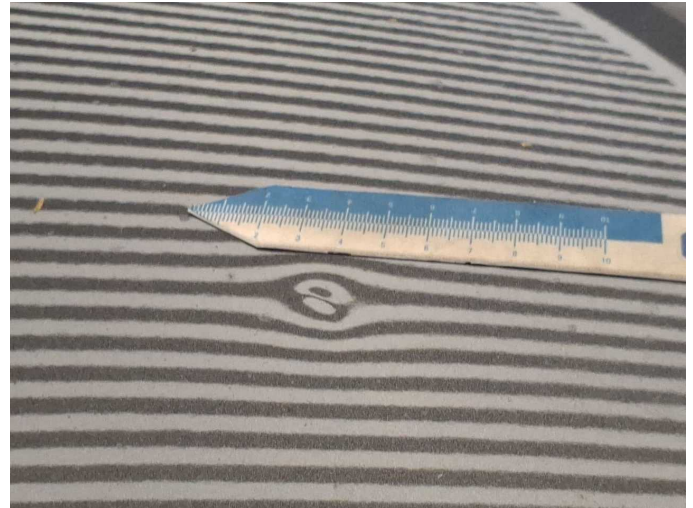
Damage 8: Bonnet: Bonnet - Dent / paintcoat damage - Paint

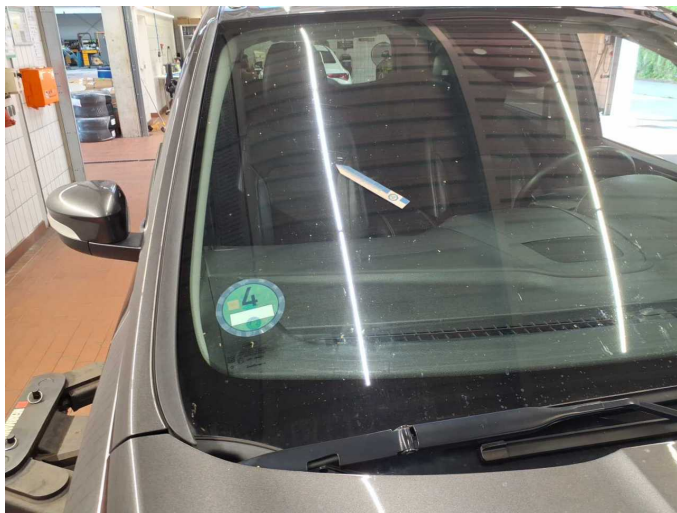
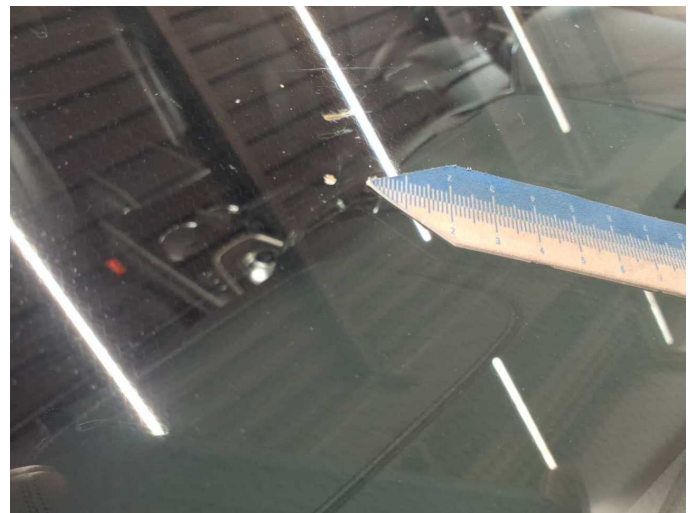
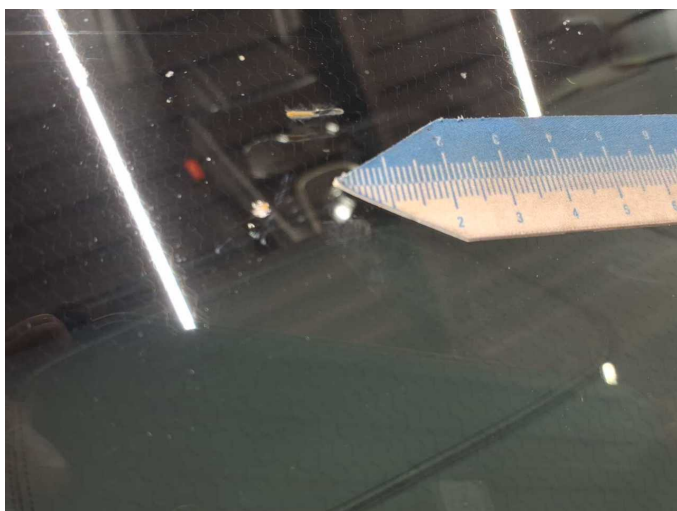
Wear and tear 1: Vehicle glazing: Windscreen (Abplutzer) - Stone chips - No deduction

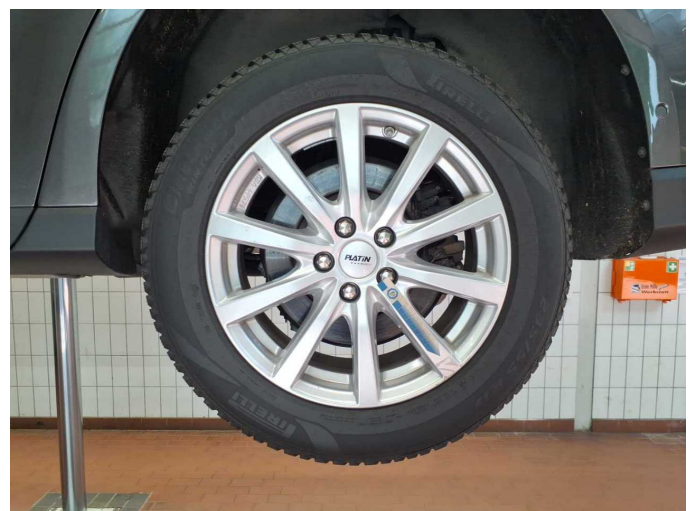
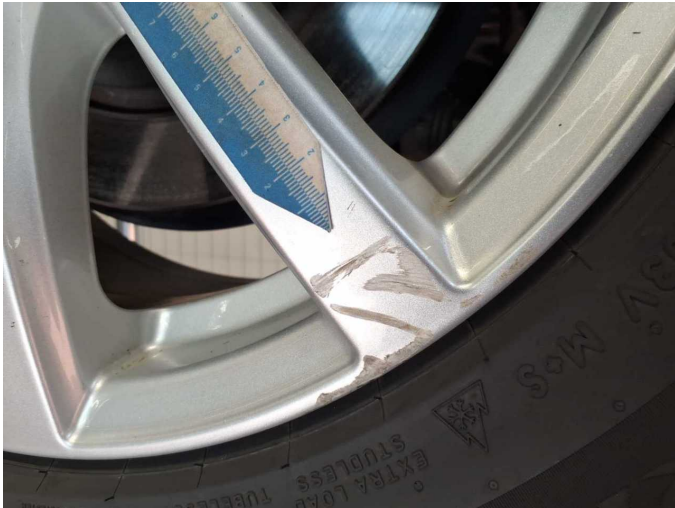
Wear and tear 2: Wheel / tyres: Alloy rim - rear left side (Optischer Mangel -Kein Teil der Ausstattung) - Scratched - No deduction

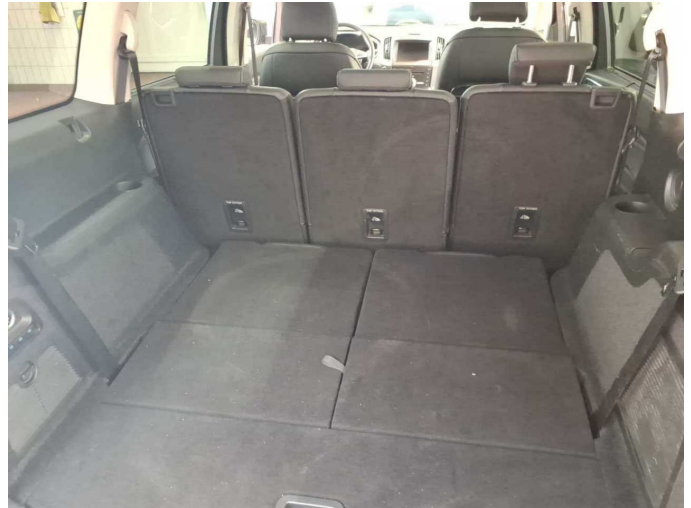
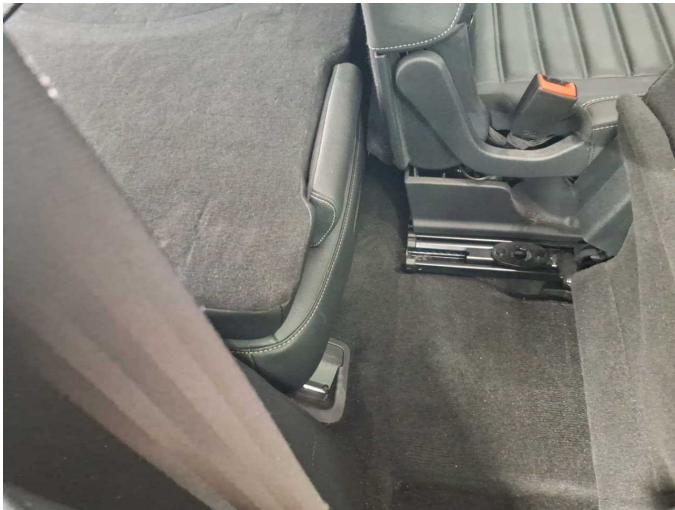
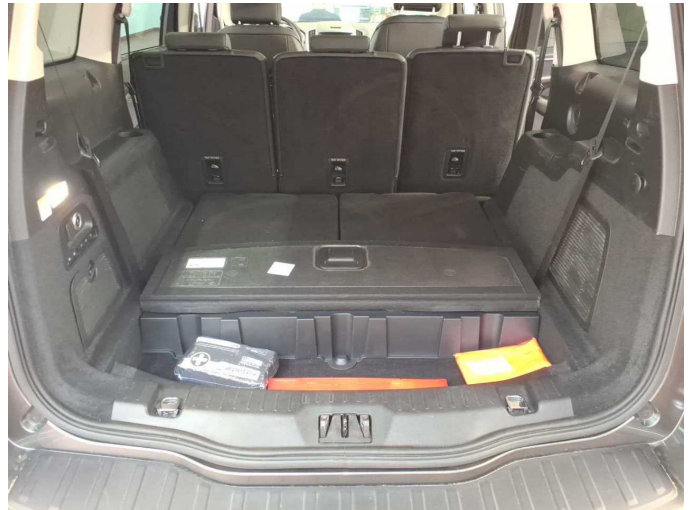
Missing part 1: Interior: Boot cover / roller cover - Missing - Replace

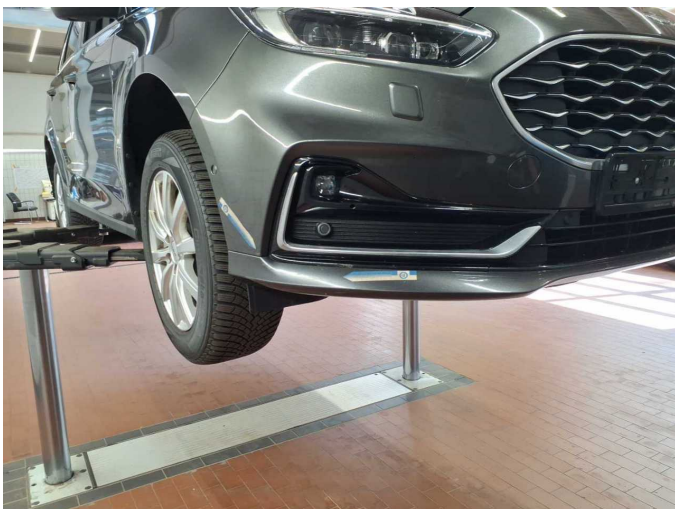
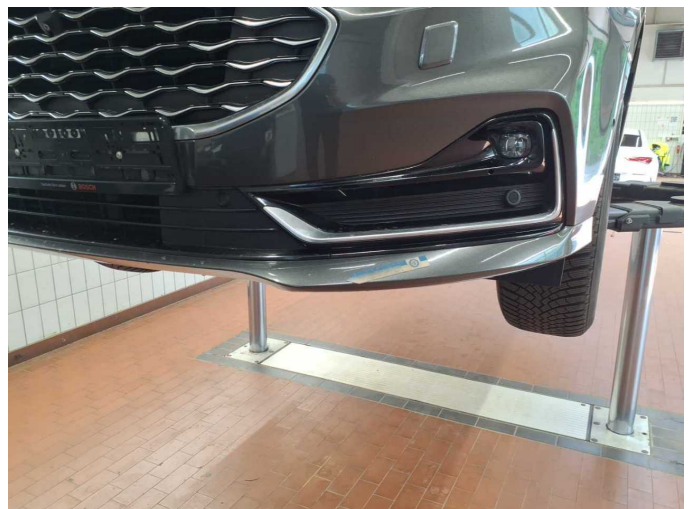
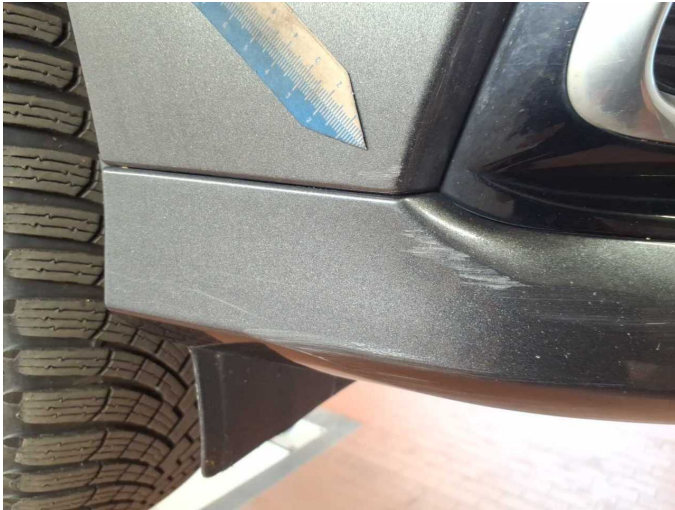
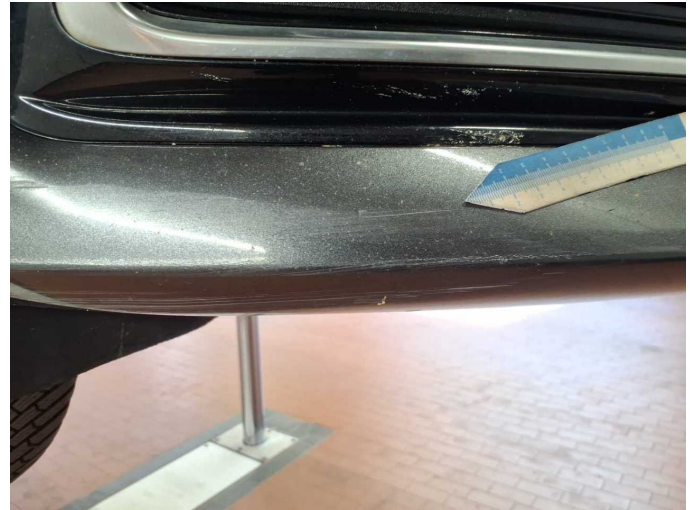
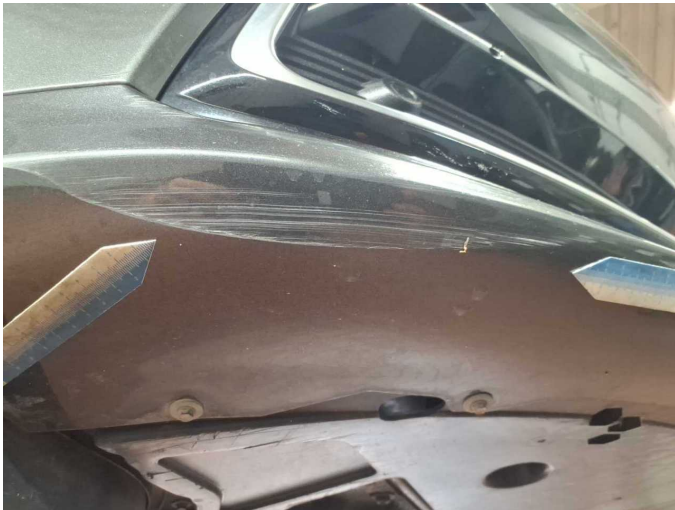
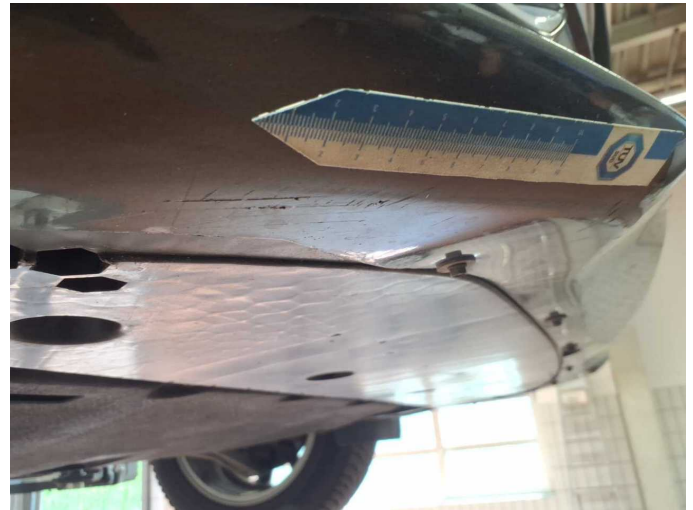
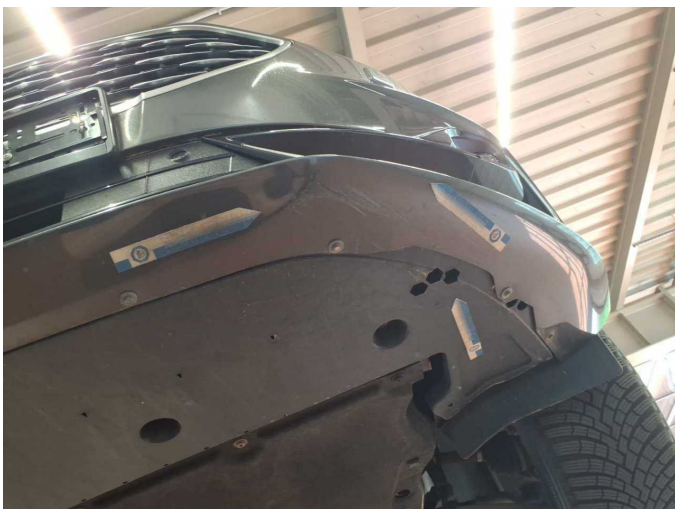
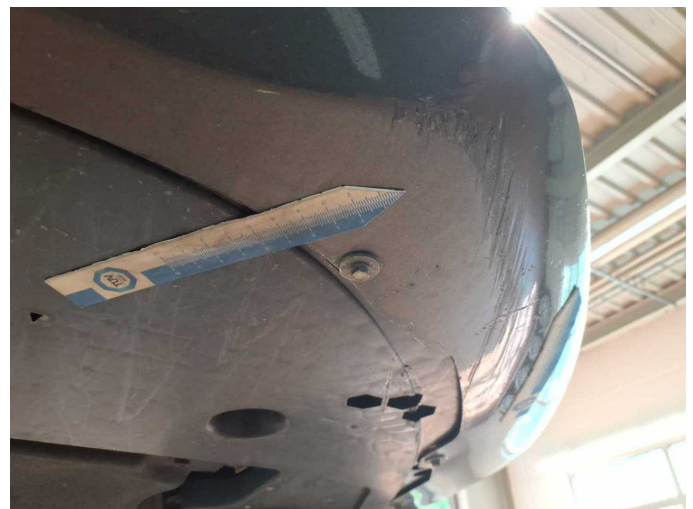
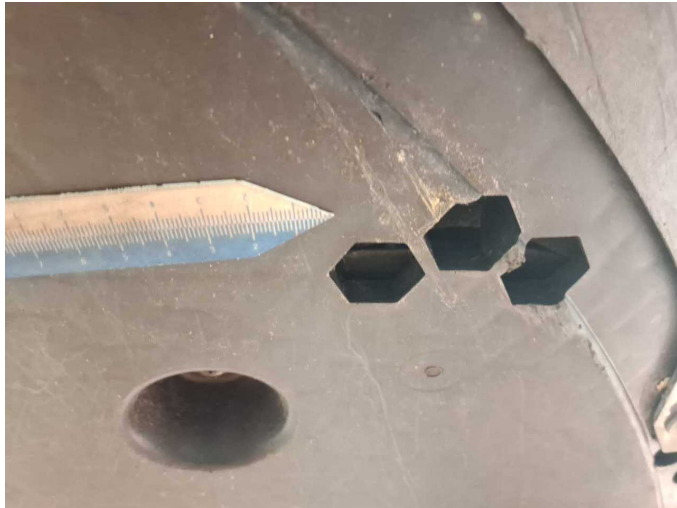
Accident 1: Front

Non-repaired previous damages were found at the vehicle. The necessary repair costs are listed in the expert report or if necessary, are listed in detail in a separately enclosed repair cost calculation.
