Expertise

Protocol number: 46576807  
Order No. / Reference: 26688242  
Inspection date: 17 Jul 2026

Manufacturer: Ford

Model: Transit Connect 250 L2 Trend

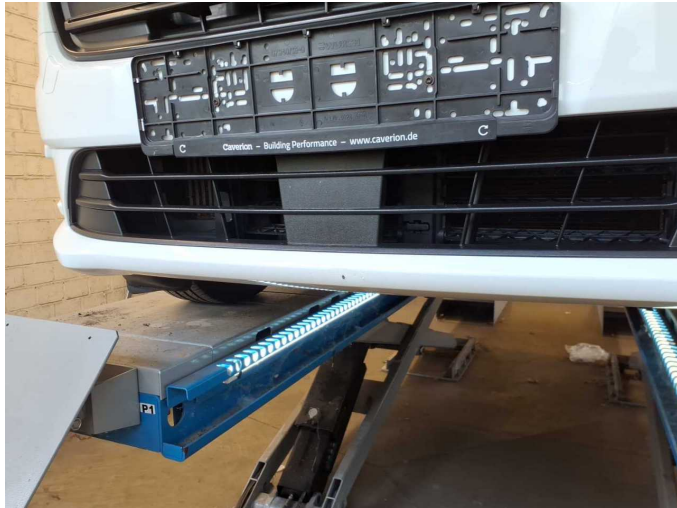
| No. | Component group | Description |
|---|---|---|
| 4 | Front bumper | Front bumper - Scratch(es) - Smart repair |

**Damage 4:** Front bumper: Front bumper - Scratch(es) - Smart repair

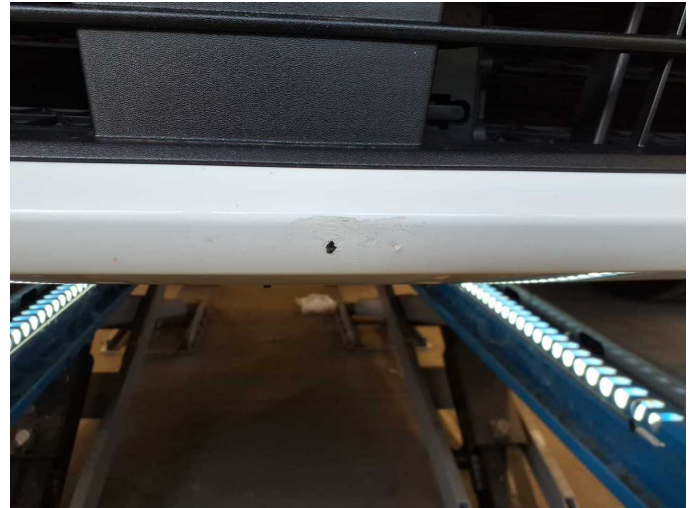
**Damage 4:** Front bumper: Front bumper - Scratch(es) - Smart repair

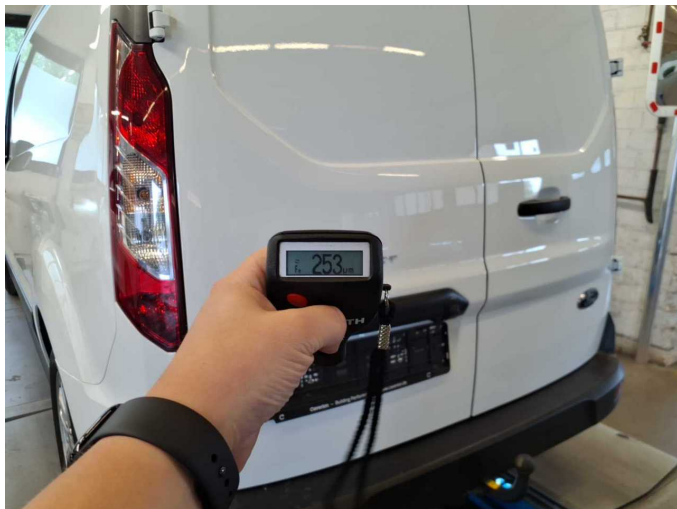
| No. | Repainting |
|---|---|
| 1 | Boot lid / rear door, Professionally carried out, Invoice of repair done Non-existent |

| Boot lid / rear door | 253 µm | Mudguard - left side | 161 µm |

**Repainting 1:** Boot lid / rear door

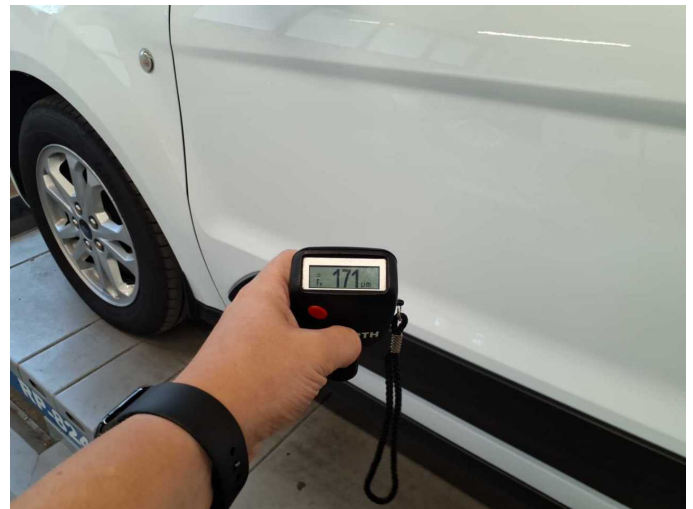
| No. | Repainting |
|---|---|
| 2 | Door - front left side, Professionally carried out, Invoice of repair done Non-existent |

| Door - front left side | 171 µm | | |

**Repainting 2:** Door - front left side
