Expertise

Protocol number: 46043044  
Order No. / Reference: 26307803-1  
Inspection date: 17 Jun 2026

Manufacturer: Opel

Model: Astra Sports Tourer 1.2 Turbo Automatik GS

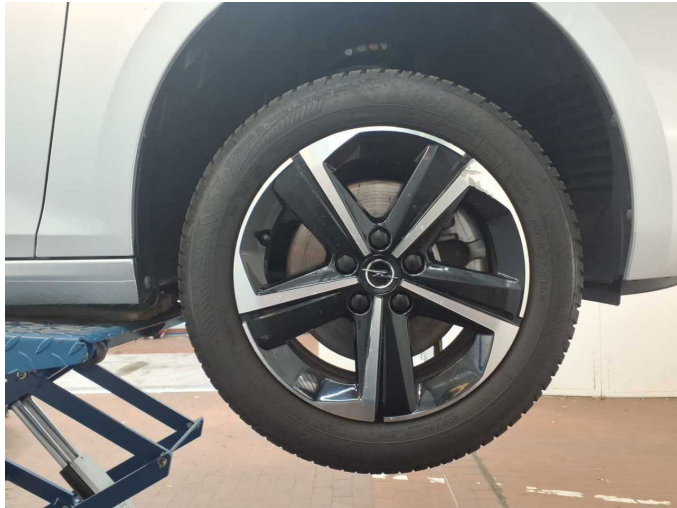
| No. | Component group | Description |
|---|---|---|
| 1 | Wheel / tyres | Alloy rim - front right side - Scratched - Replace |

**Damage 1:** Wheel / tyres: Alloy rim - front right side - Scratched - Replace

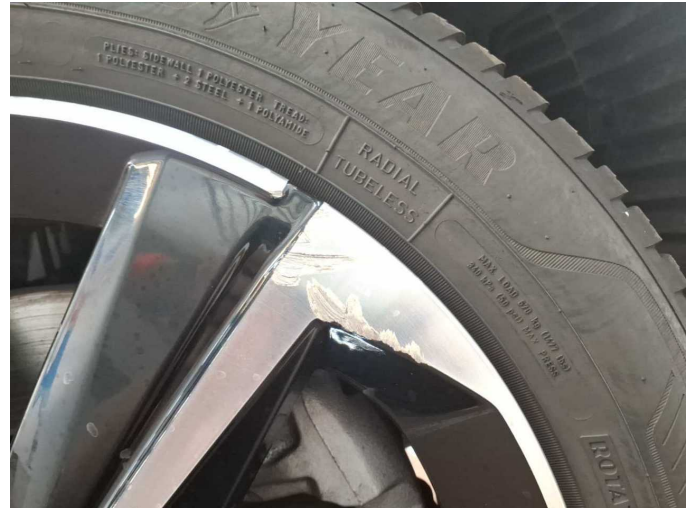
**Damage 1:** Wheel / tyres: Alloy rim - front right side - Scratched - Replace

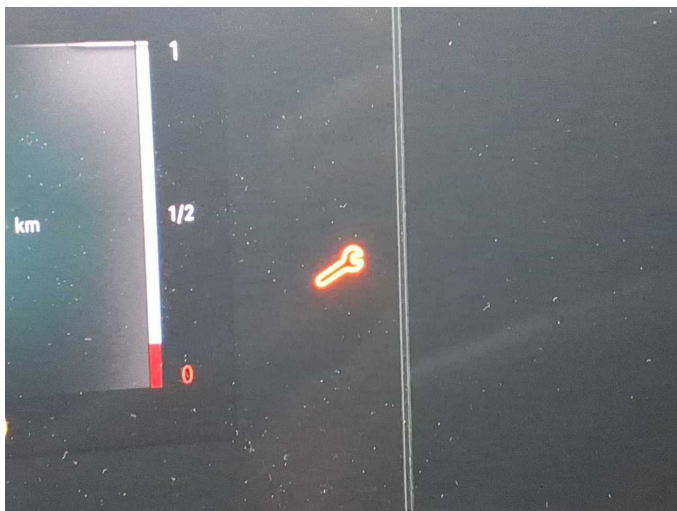
| No. | Component group | Description |
|---|---|---|
| 2 | Misc. | Inspection / maintenance - Due - Perform diagnosis |

**Damage 2:** Misc.: Inspection / maintenance - Due - Perform diagnosis

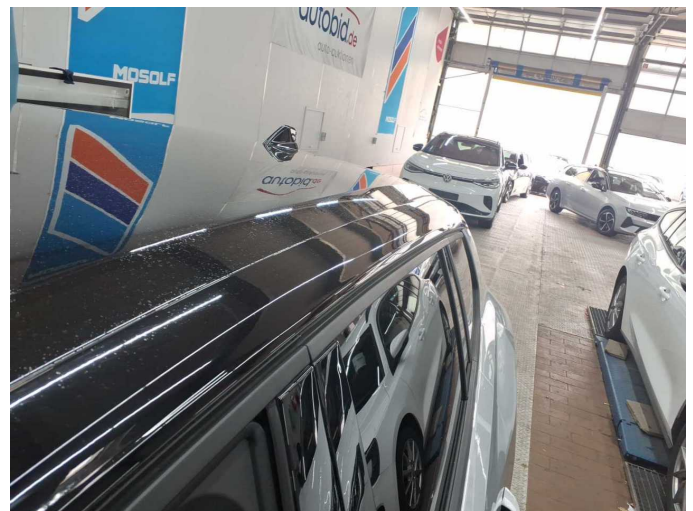
| No. | Component group | Description |
|---|---|---|
| 3 | Roof | Roof rail - left side (Verätzungen) - Paint defect - Paint |

**Damage 3:** Roof: Roof rail - left side (Verätzungen) - Paint defect - Paint

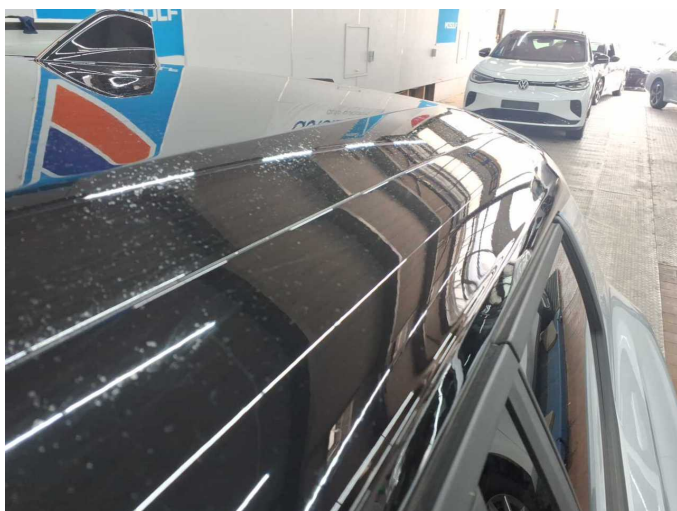
**Damage 3:** Roof: Roof rail - left side (Verätzungen) - Paint defect - Paint

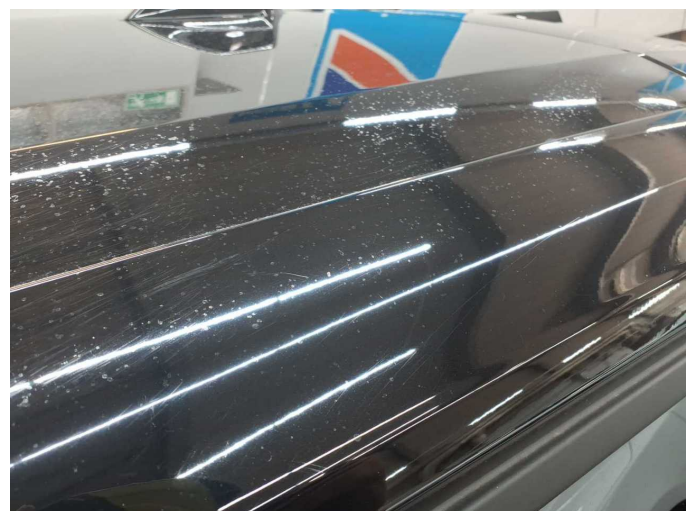
**Damage 3:** Roof: Roof rail - left side (Verätzungen) - Paint defect - Paint

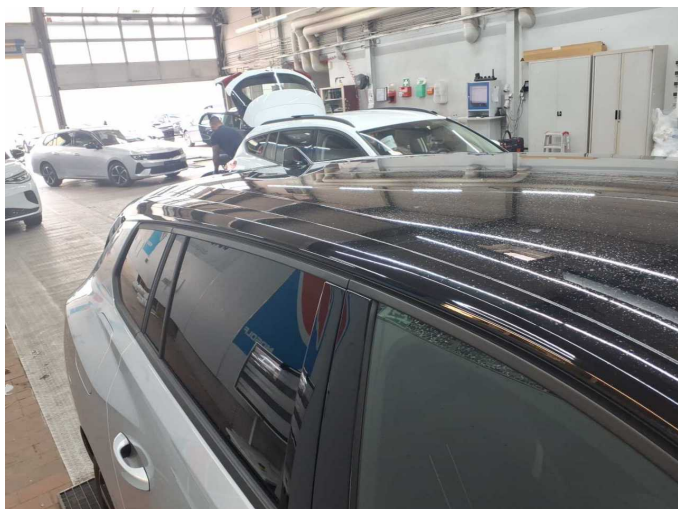
| No. | Component group | Description |
|---|---|---|
| 4 | Roof | Roof rail - right side (Verätzungen) - Paint defect - Paint |

**Damage 4:** Roof: Roof rail - right side (Verätzungen) - Paint defect - Paint

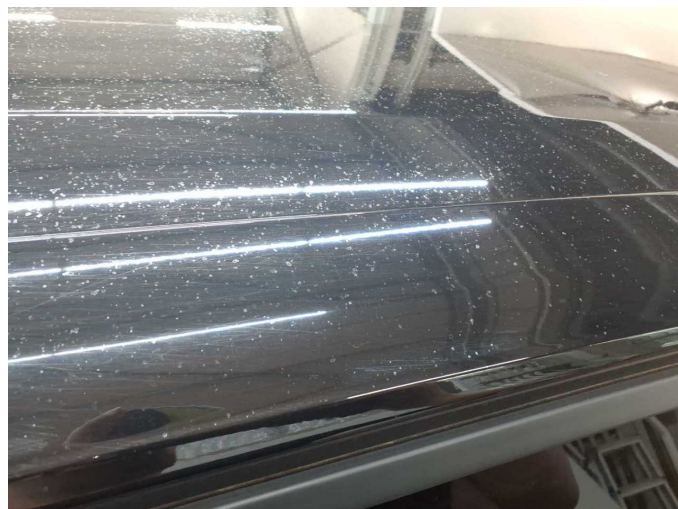
**Damage 4:** Roof: Roof rail - right side (Verätzungen) - Paint defect - Paint

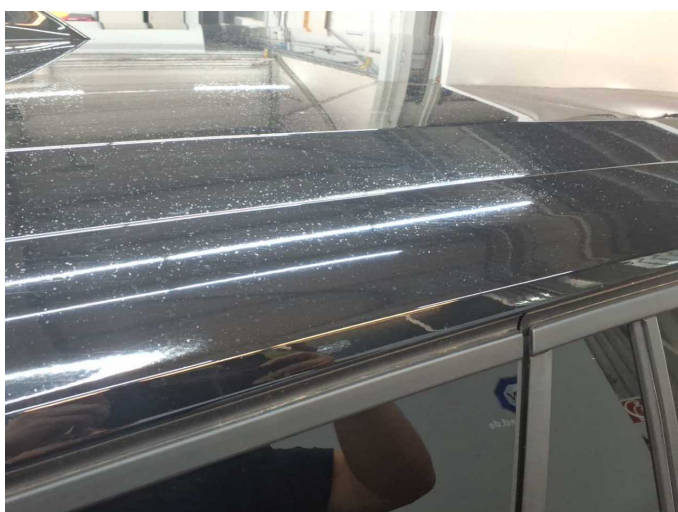
**Damage 4:** Roof: Roof rail - right side (Verätzungen) - Paint defect - Paint

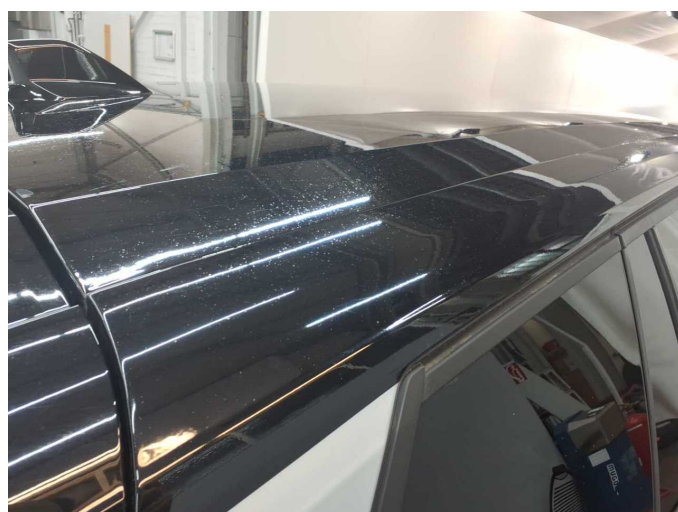
**Damage 4:** Roof: Roof rail - right side (Verätzungen) - Paint defect - Paint

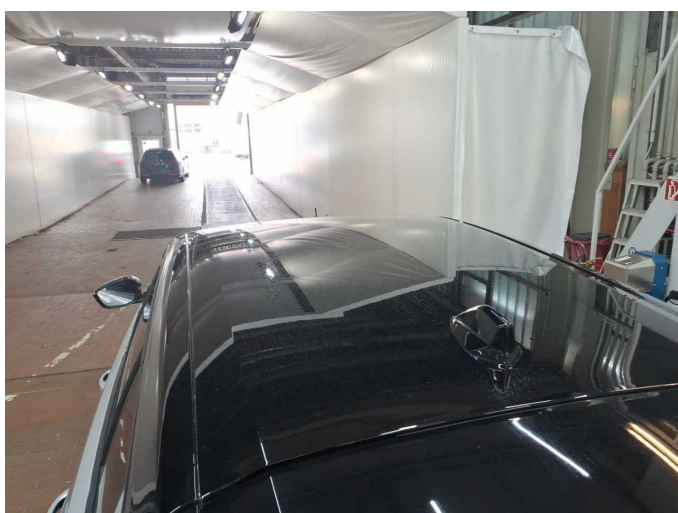
| No. | Component group | Description |
|---|---|---|
| 5 | Roof | Roof (Verätzungen) - Paint defect - Paint |

**Damage 5:** Roof: Roof (Verätzungen) - Paint defect - Paint

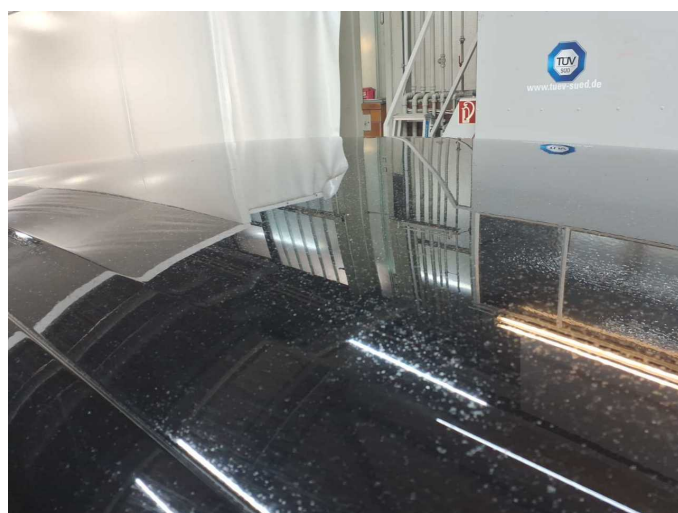
**Damage 5:** Roof: Roof (Verätzungen) - Paint defect - Paint

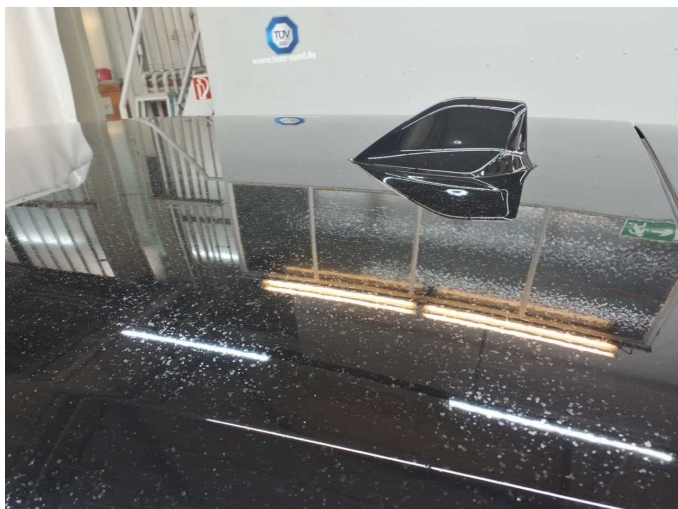
**Damage 5:** Roof: Roof (Verätzungen) - Paint defect - Paint

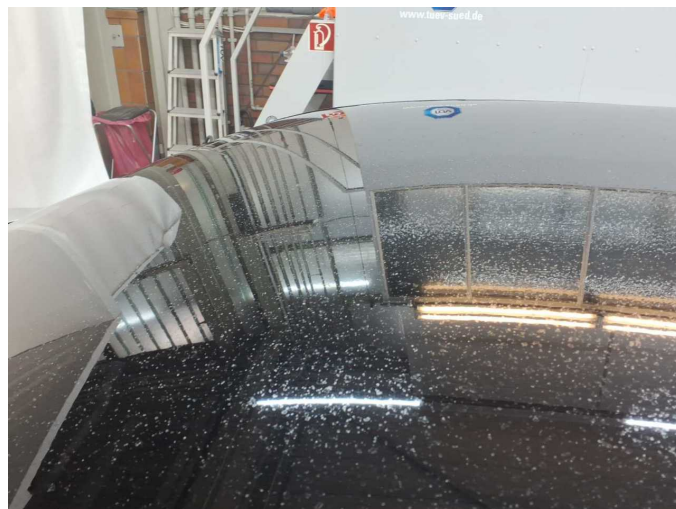
**Damage 5:** Roof: Roof (Verätzungen) - Paint defect - Paint

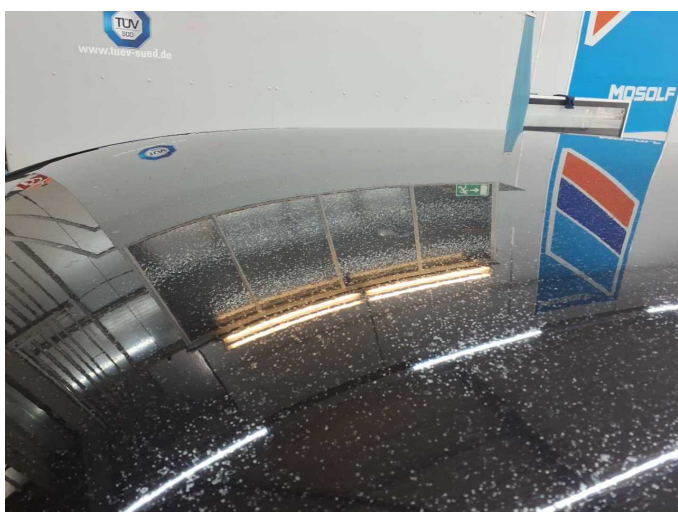
**Damage 5:** Roof: Roof (Verätzungen) - Paint defect - Paint

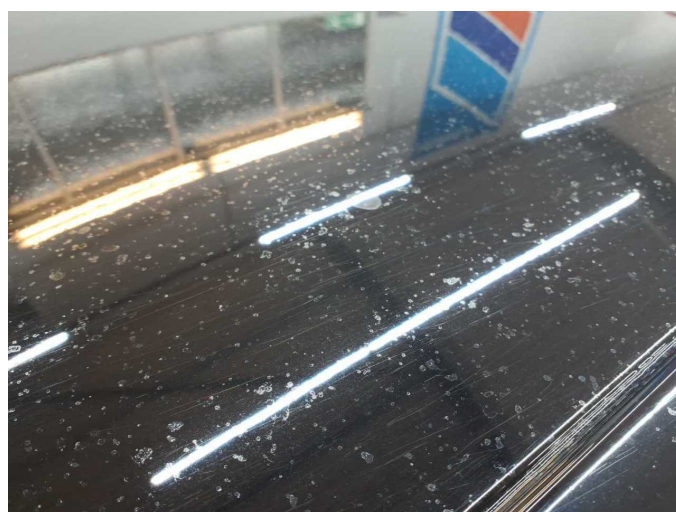
**Damage 5:** Roof: Roof (Verätzungen) - Paint defect - Paint

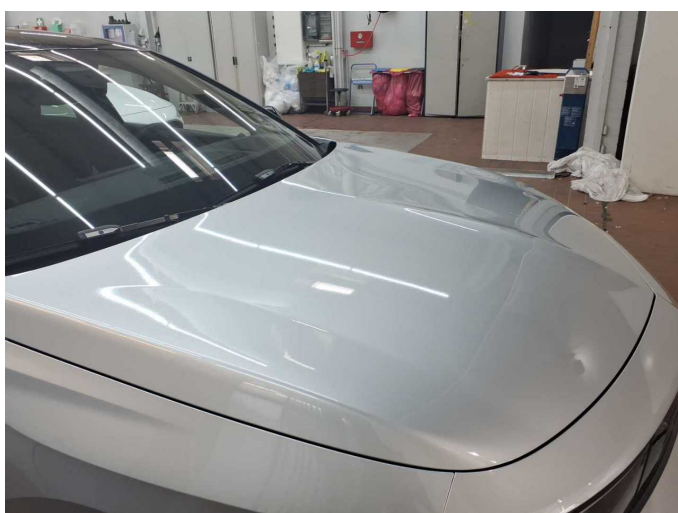
| No. | Component group | Description |
|---|---|---|
| 6 | Bonnet | Bonnet (Verätzungen + verkratzt innen) - Paint defect - Paint |

**Damage 6:** Bonnet: Bonnet (Verätzungen + verkratzt innen) - Paint defect - Paint

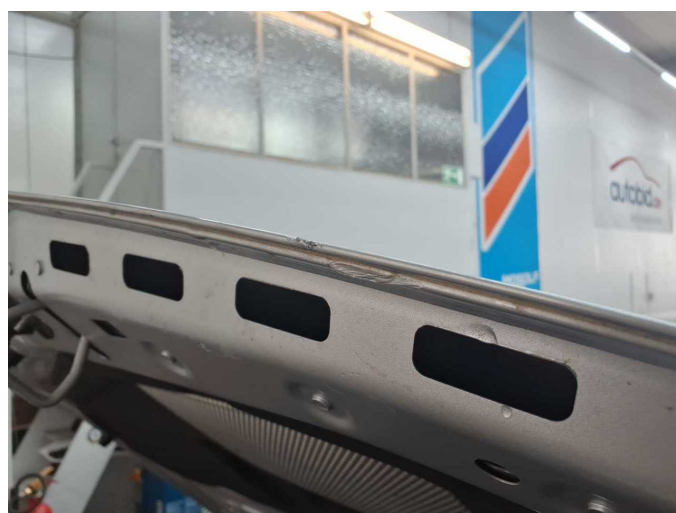
**Damage 6:** Bonnet: Bonnet (Verätzungen + verkratzt innen) - Paint defect - Paint

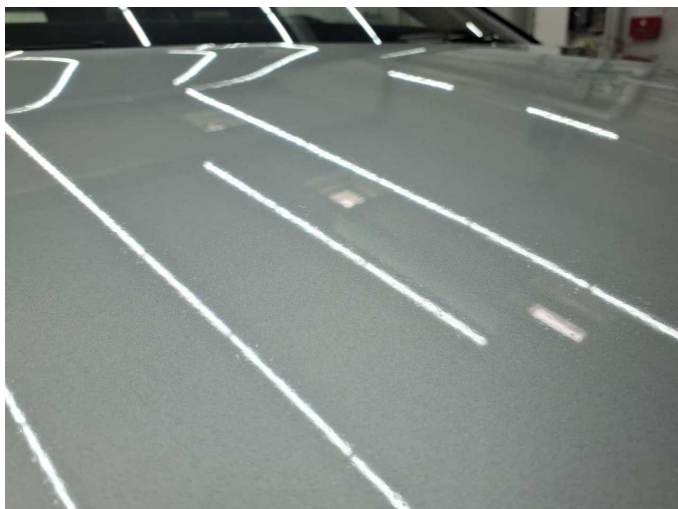
**Damage 6:** Bonnet: Bonnet (Verätzungen + verkratzt innen) - Paint defect  
- Paint

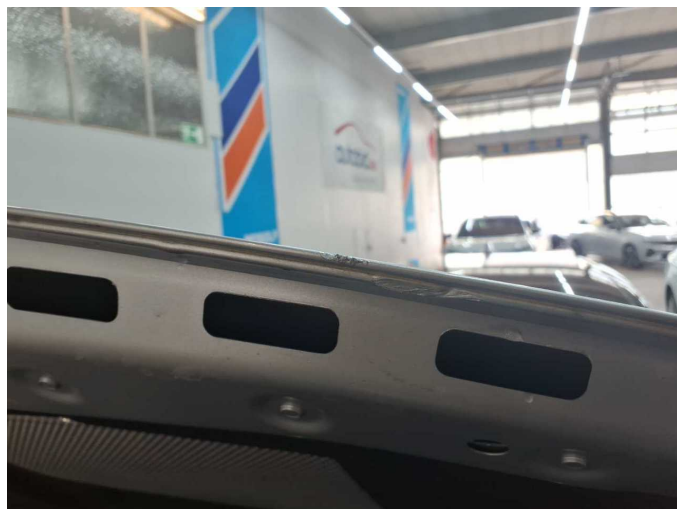
**Damage 6:** Bonnet: Bonnet (Verätzungen + verkratzt innen) - Paint defect  
- Paint

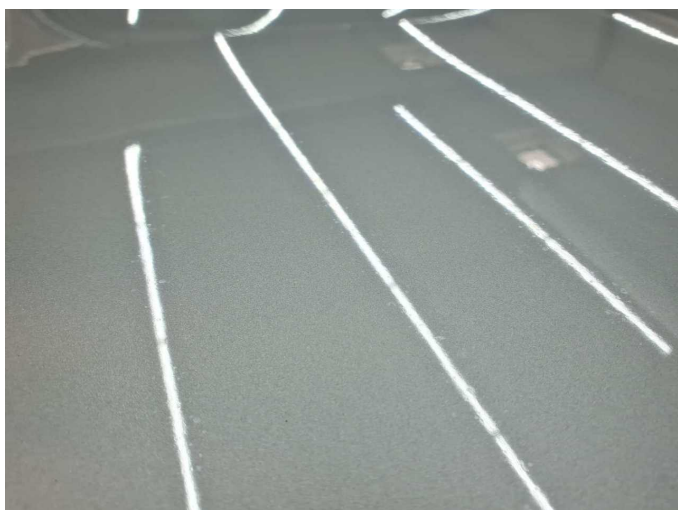
**Damage 6:** Bonnet: Bonnet (Verätzungen + verkratzt innen) - Paint defect  
- Paint

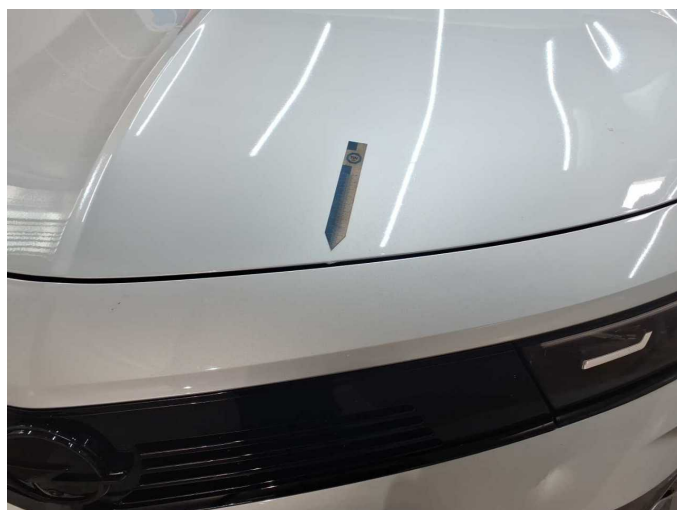
**Damage 6:** Bonnet: Bonnet (Verätzungen + verkratzt innen) - Paint defect  
- Paint

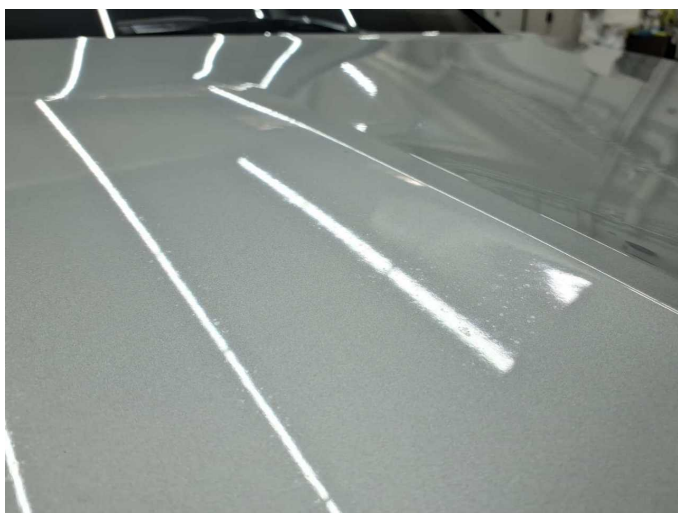
**Damage 6:** Bonnet: Bonnet (Verätzungen + verkratzt innen) - Paint defect  
- Paint

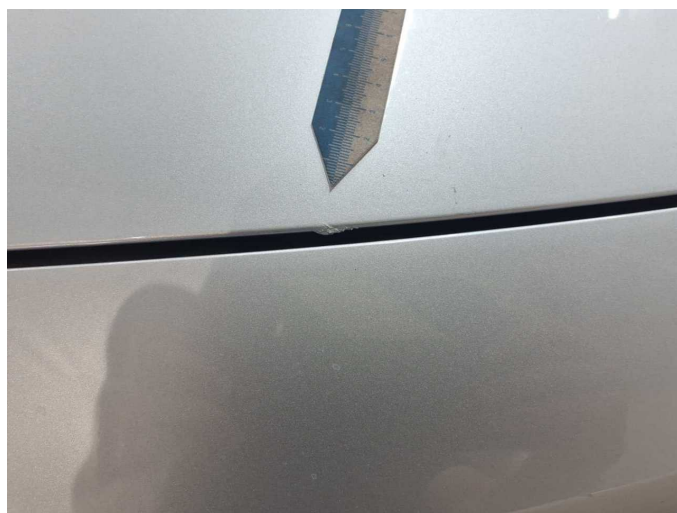
**Damage 6:** Bonnet: Bonnet (Verätzungen + verkratzt innen) - Paint defect  
- Paint

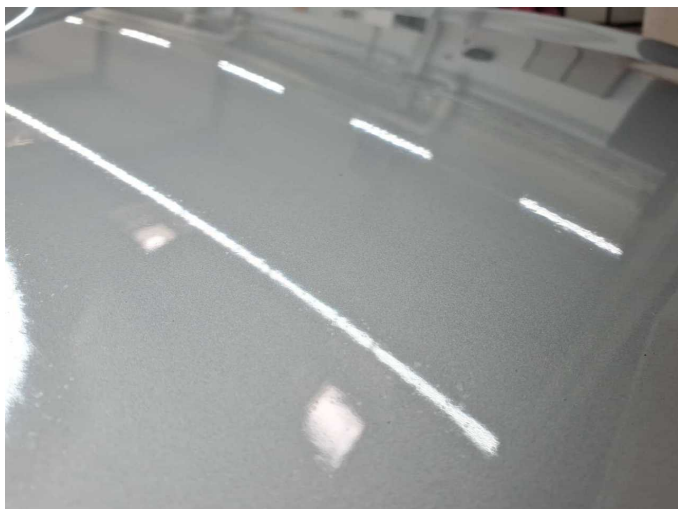
**Damage 6:** Bonnet: Bonnet (Verätzungen + verkratzt innen) - Paint defect  
- Paint

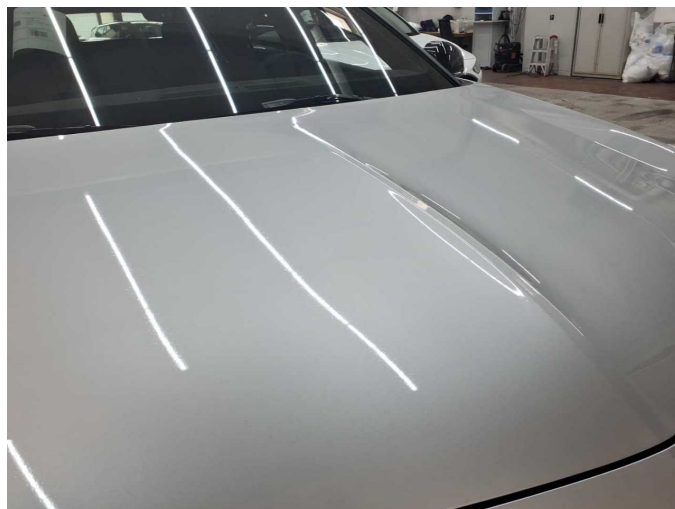
**Damage 6:** Bonnet: Bonnet (Verätzungen + verkratzt innen) - Paint defect  
- Paint
