Expertise

Protocol number: 46079554
Order No. / Reference: 26501269
Inspection date: 18 Jun 2026

Manufacturer: Skoda

Model: Enyaq iV 80x

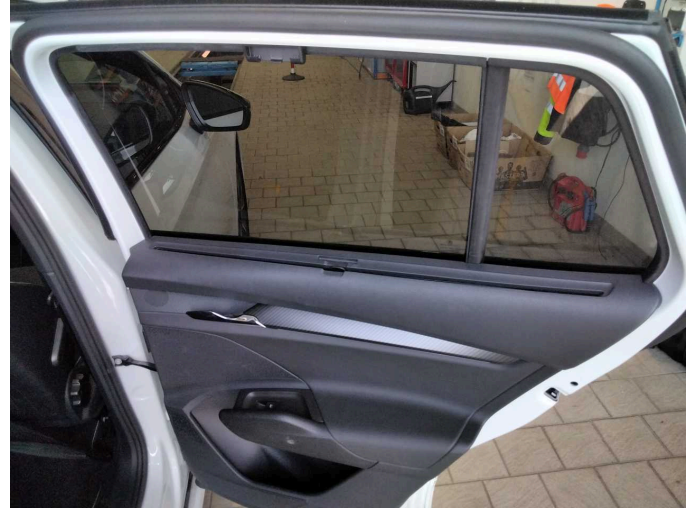
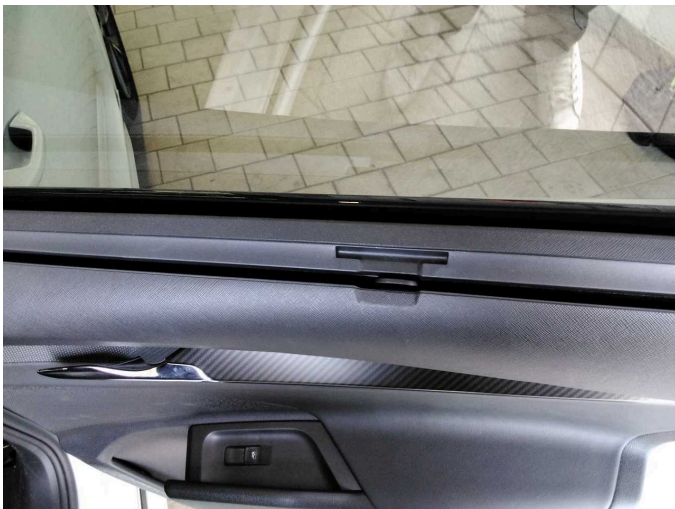
Damage 1: Trim / covers: Door trim - rear right side (Sonnenblenderollo) - Non-operational - Perform diagnosis

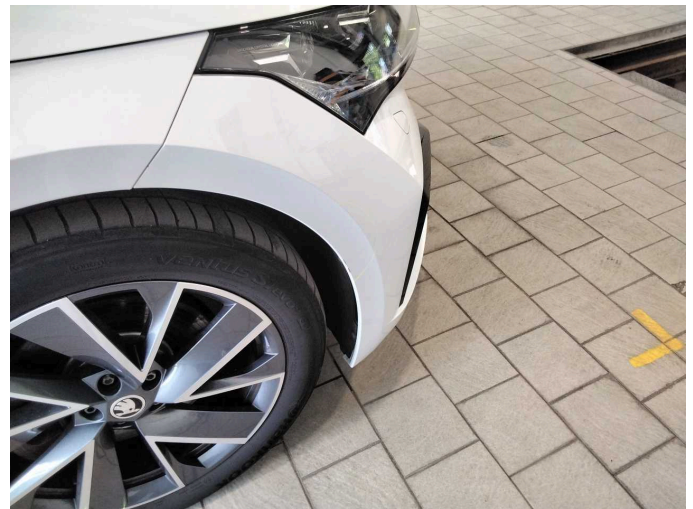
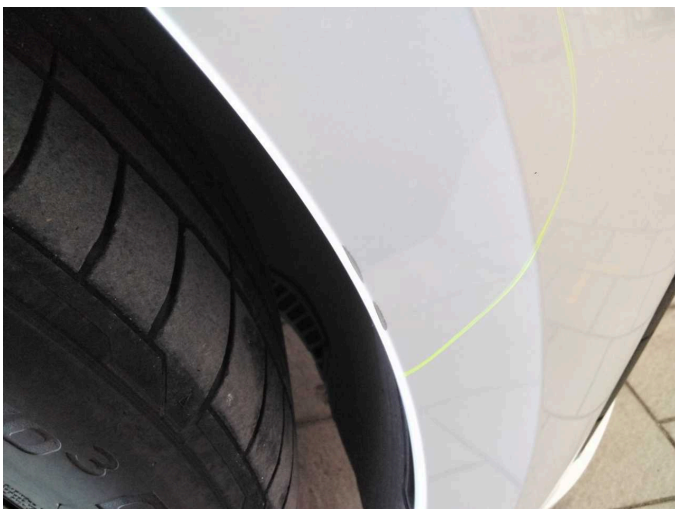
Damage 2: Front bumper: Front bumper - Scratch(es) - Smart repair

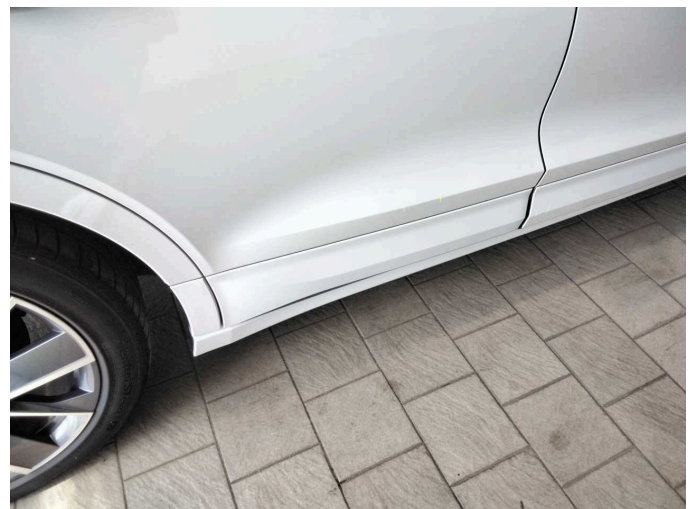
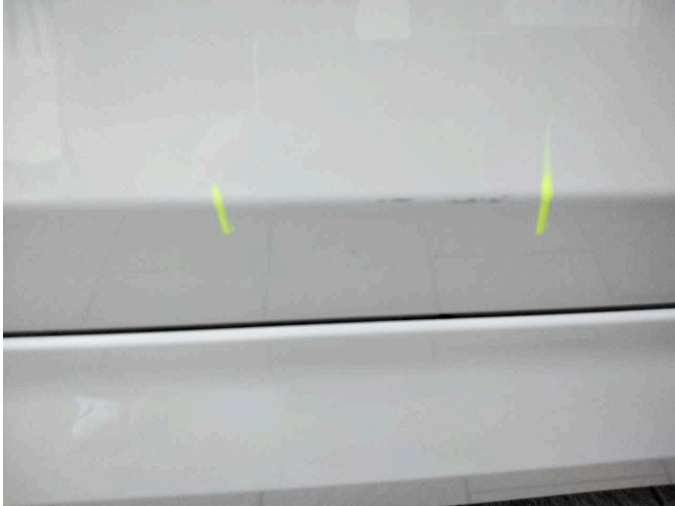
Damage 3: Door - rear right side: Door - Damage caused by marten / rodent - Smart repair

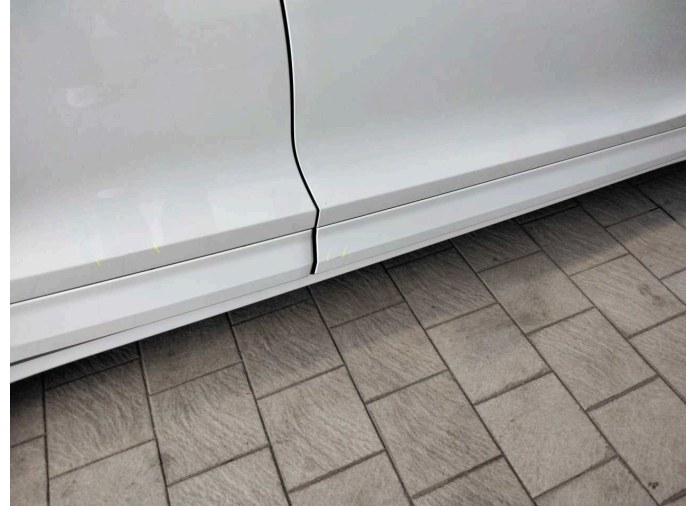
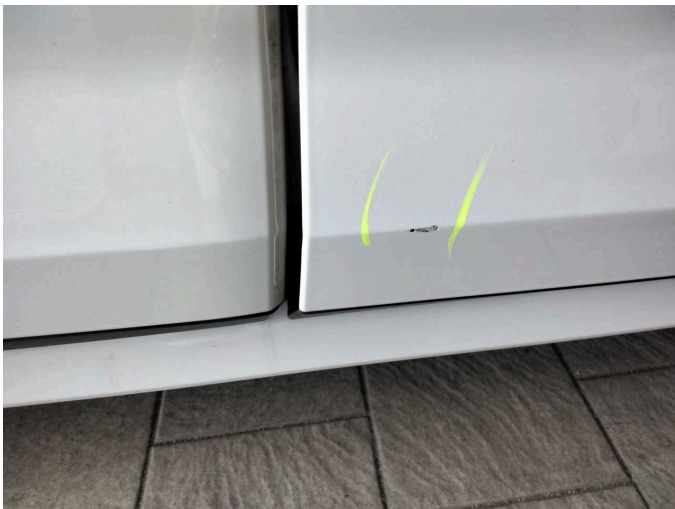
Damage 4: Door - front right side: Brightware - lower - Scratch(es) - Smart repair

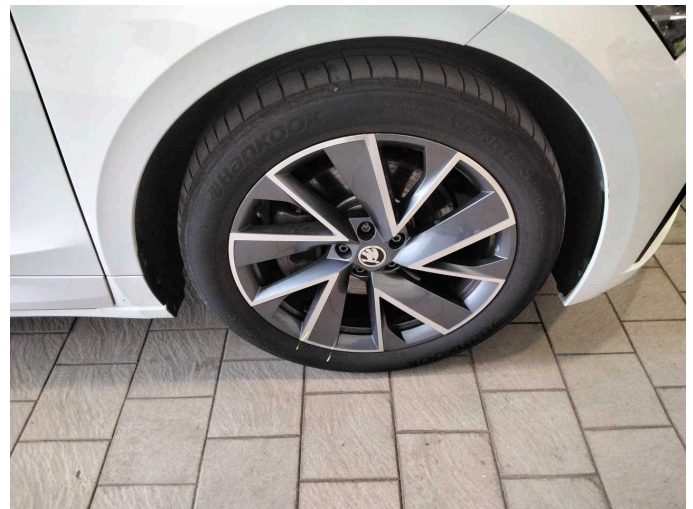
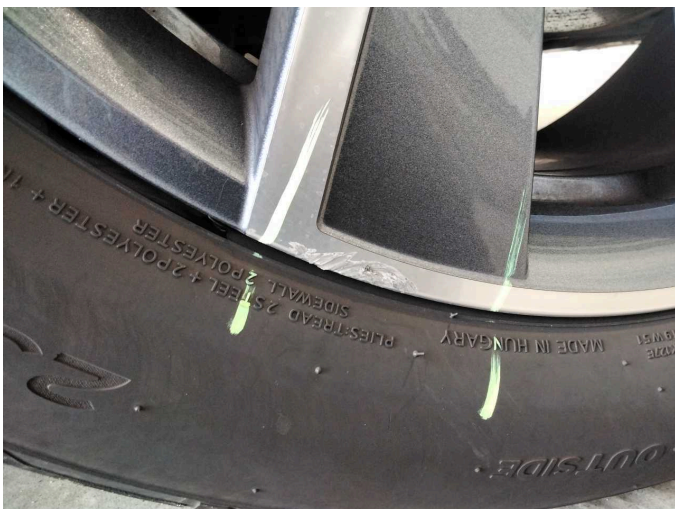
Damage 5: Wheel / tyres: Alloy rim - front right side - Scratch(es) - Loss in value

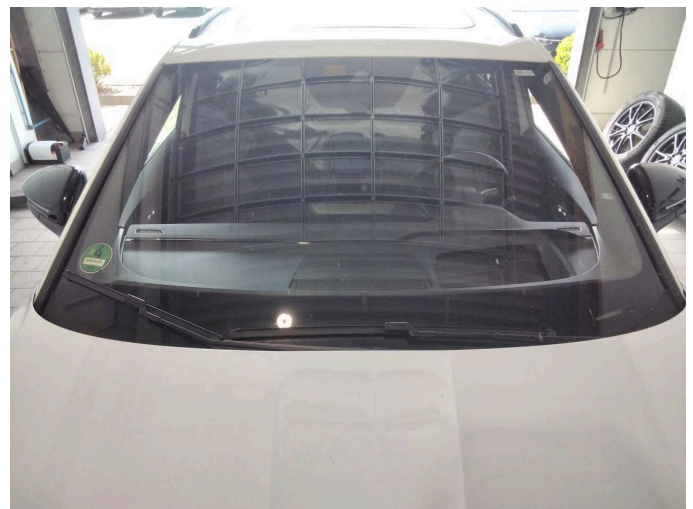
Wear and tear 1: Vehicle glazing: Windscreen - Stone chips - No deduction

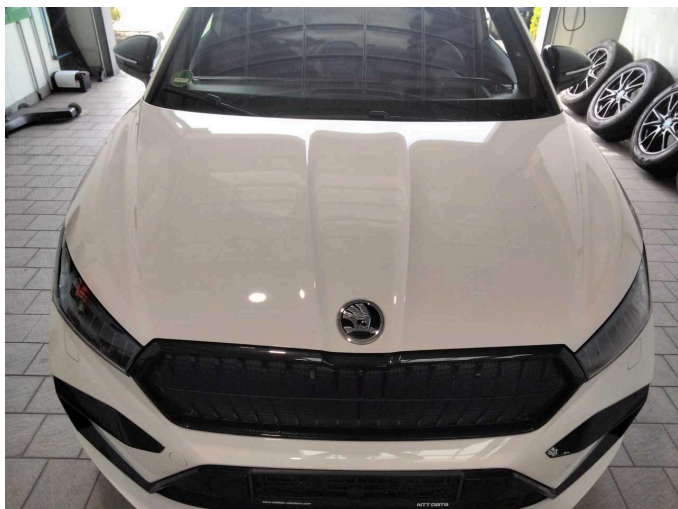
Wear and tear 2: Bonnet: Bonnet - Stone chips - No deduction

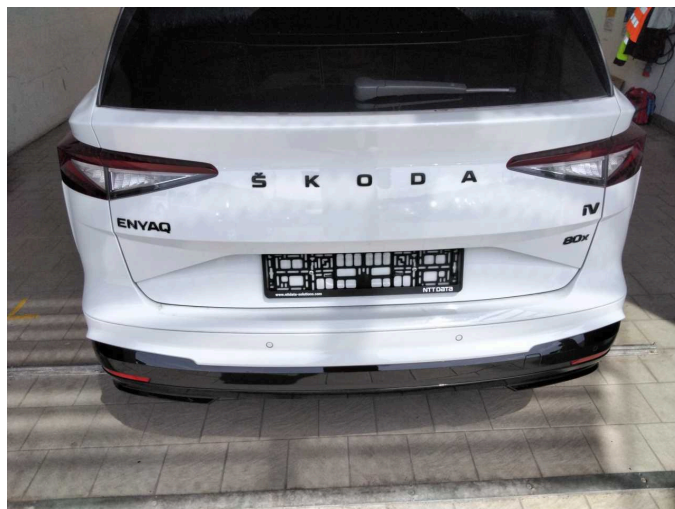
Wear and tear 3: Rear bumper: Rear bumper - Scratch(es) - No deduction
