## Expertise

Protocol number: 46266487  
Order No. / Reference: 26627391  
Inspection date: 30 Jun 2026

Model: S-Max 2.0 EcoBlue Allrad Aut. TITANIUM

VIN: WF0JXXWPCJNS11914

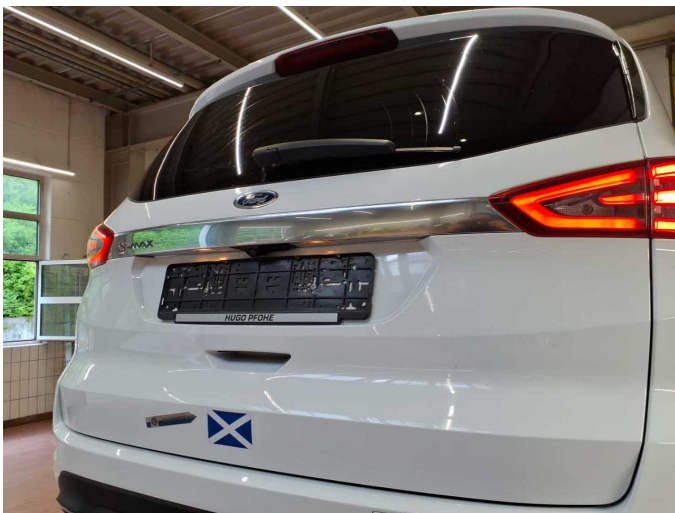
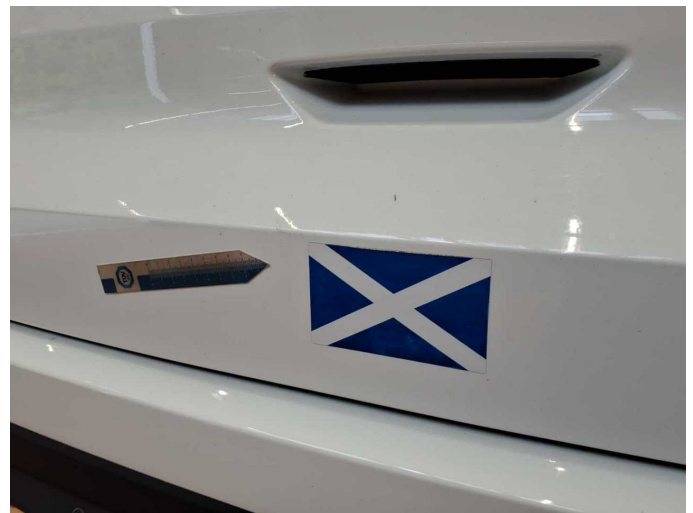
No.	Component group	Description
1	Misc.	Main inspection - No evidence - No deduction
2	Misc.	Inspection / maintenance - No evidence - No deduction
3	Engine	Toothed belt - No evidence - No deduction
4	Boot lid / rear door	Boot lid - Glued / labelled - De-glue / neutralise
5	Interior	Interior (Zigarette) - Odour - Ozone treatment
6	Front bumper	Spoiler - Scratch(es) - Smart repair
7	Bonnet	Bonnet - Stone chips - Paint

Damage 4: Boot lid / rear door: Boot lid - Glued / labelled - De-glue / neutralise

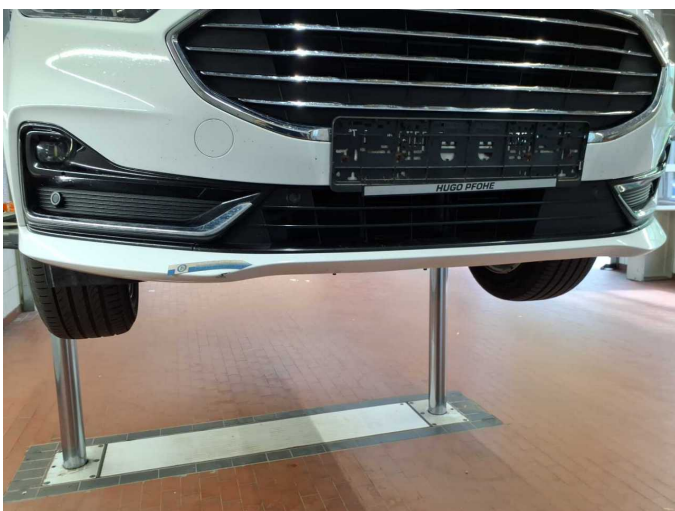
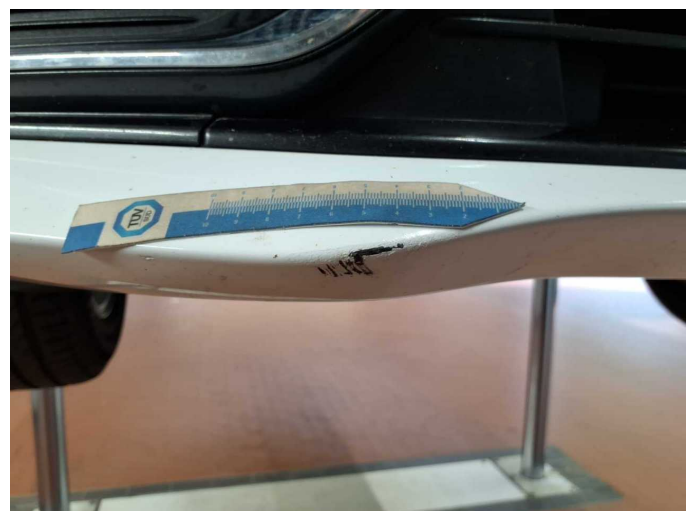
Damage 6: Front bumper: Spoiler - Scratch(es) - Smart repair

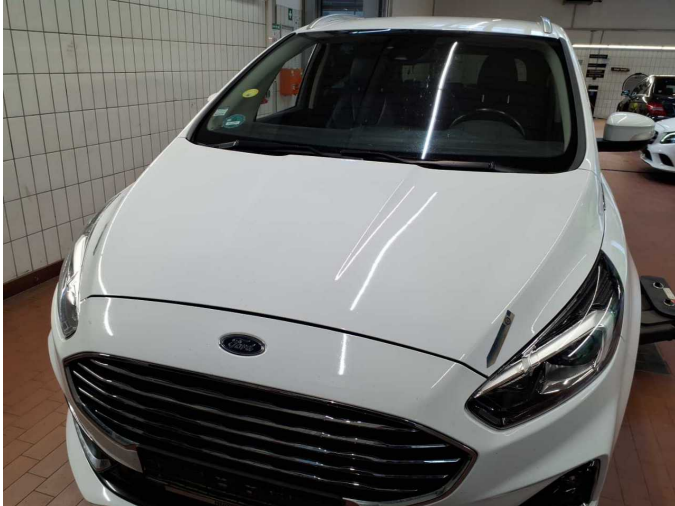
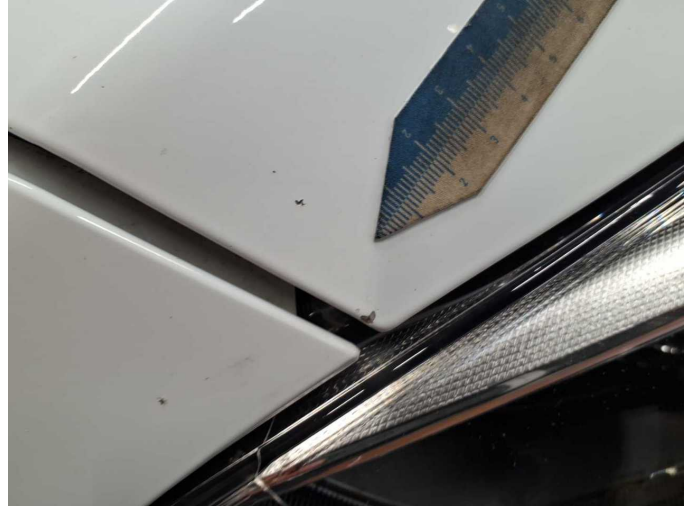
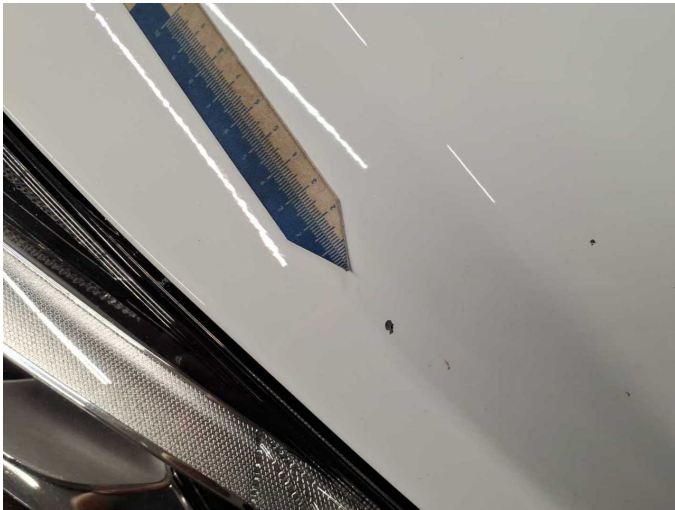
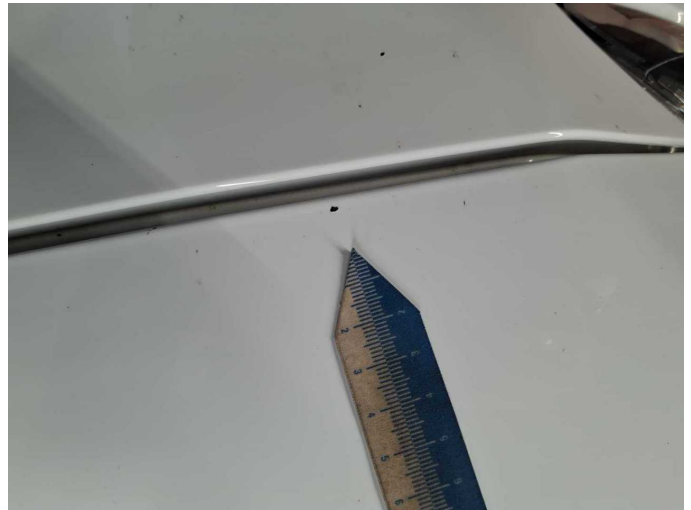
**Damage 7:** Bonnet: Bonnet - Stone chips - Paint

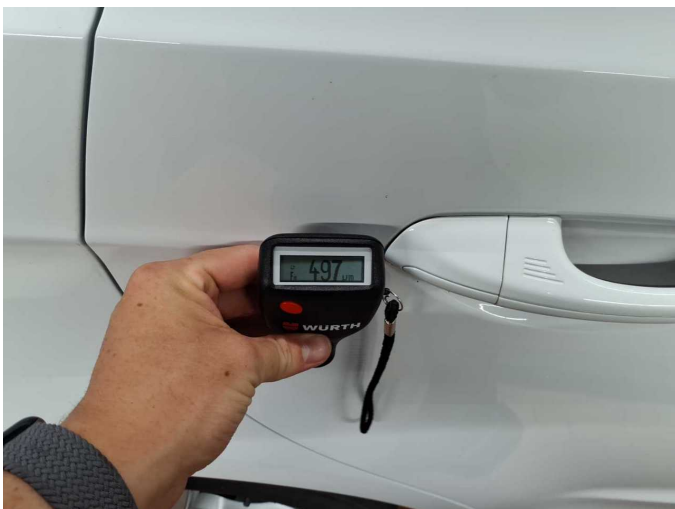
No.	Repainting
1	Door - rear right side, Professionally carried out, Invoice of repair done Non-existent

Door - rear right side	497 µm
------------------------	--------

Das Fahrzeug weist eine erhöhte Lackdicke auf

**Repainting 1:** Door - rear right side
