Expertise

Protocol number: 46190340
Order No. / Reference: 26559554
Inspection date: 29 Jun 2026

Manufacturer: CUPRA

Model: Born 150kW/58kWh

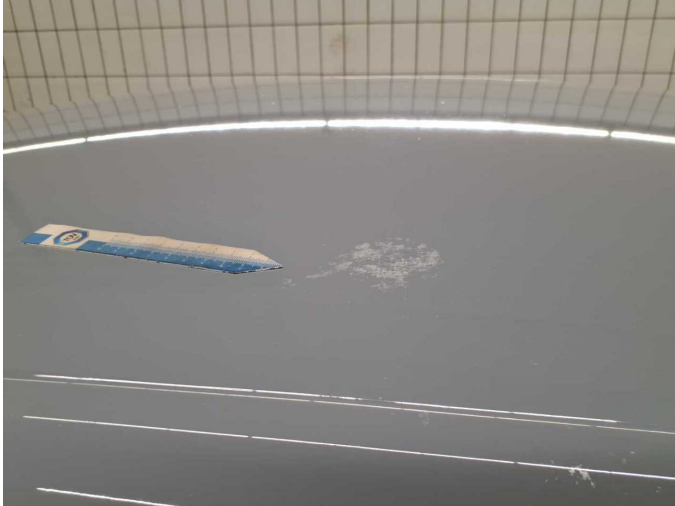
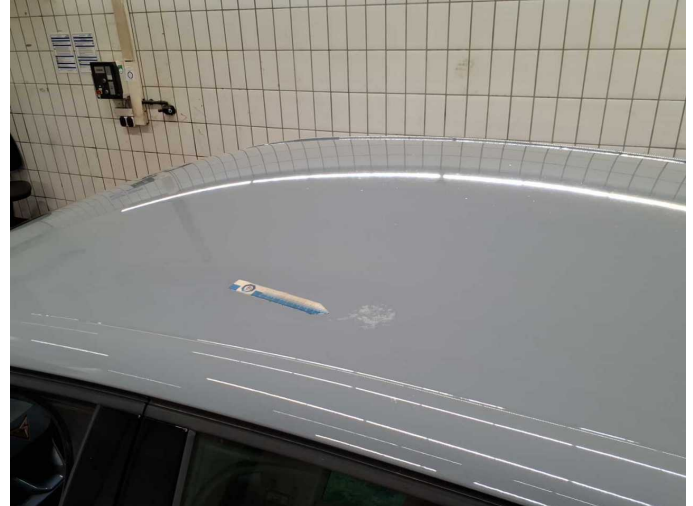
No.	Component group	Description
1	Roof	Roof (Verätzung - Mehrkosten können entstehen) - Soiled - Conditioning
2	Front bumper	Front bumper - Scratch(es) - Paint

Damage 1: Roof: Roof (Verätzung - Mehrkosten können entstehen) - Soiled - Conditioning

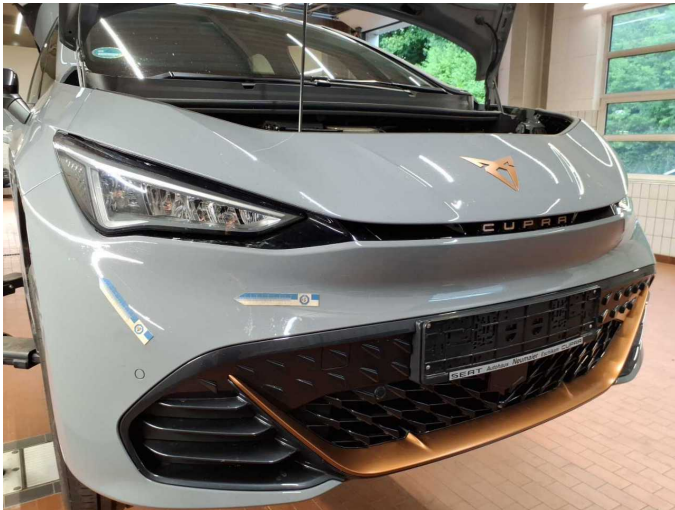
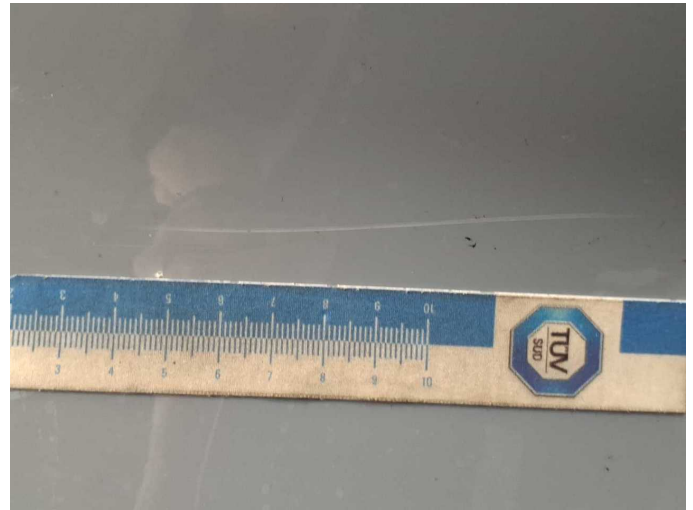
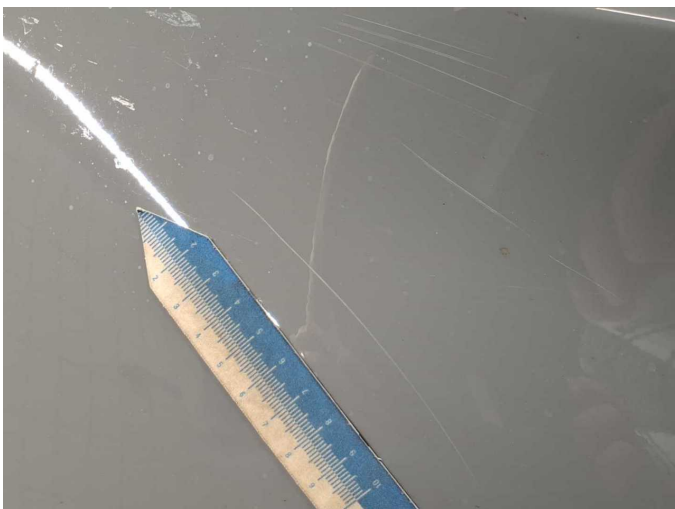
Damage 2: Front bumper: Front bumper - Scratch(es) - Paint

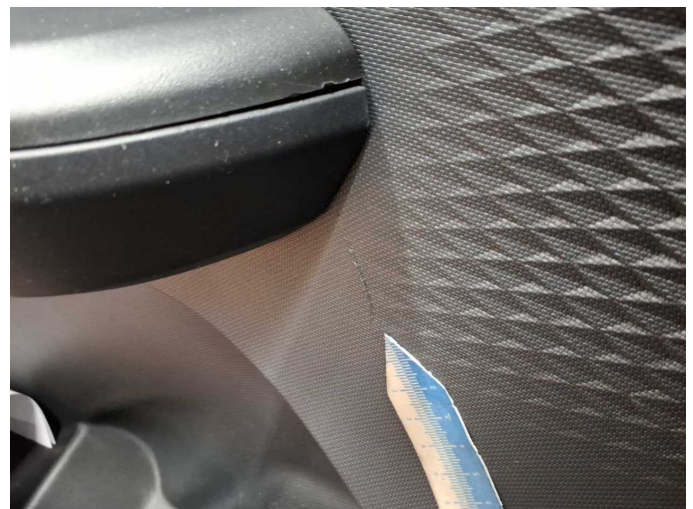
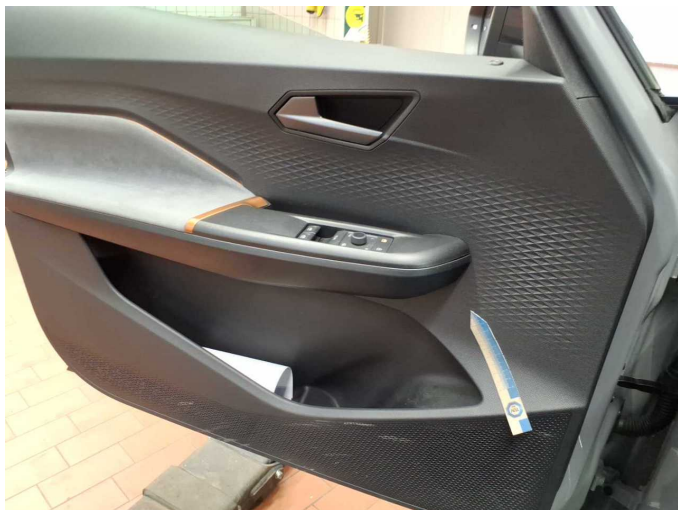
No.	Component group	Description
1	Trim / covers	Door trim - front left side - Scratch(es) - No deduction

Wear and tear 1: Trim / covers: Door trim - front left side - Scratch(es) - No deduction

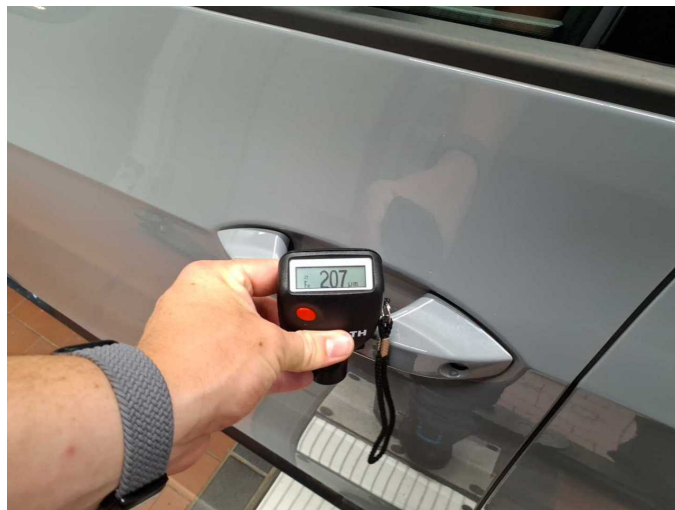
No.	Repainting
1	Door - front left side, Professionally carried out, Invoice of repair done Non-existent
2	Door - front right side, Professionally carried out, Invoice of repair done Non-existent

Door - front left side	207 µm	Door - front right side	210 µm
------------------------	--------	-------------------------	--------

Repainting 1: Door - front left side

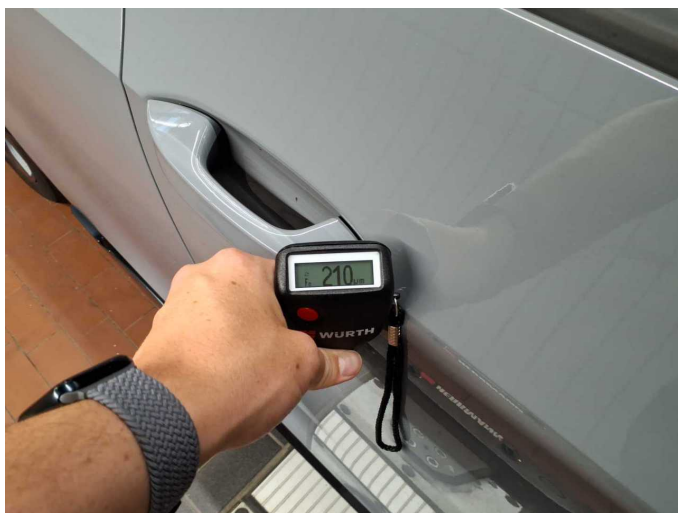
Repainting 2: Door - front right side
