Expertise

Protocol number: 46232497
Order No. / Reference: 26311361
Inspection date: 29 Jun 2026

Manufacturer: Opel

Model: Astra Sports Tourer 1.2 Turbo Automatik GS

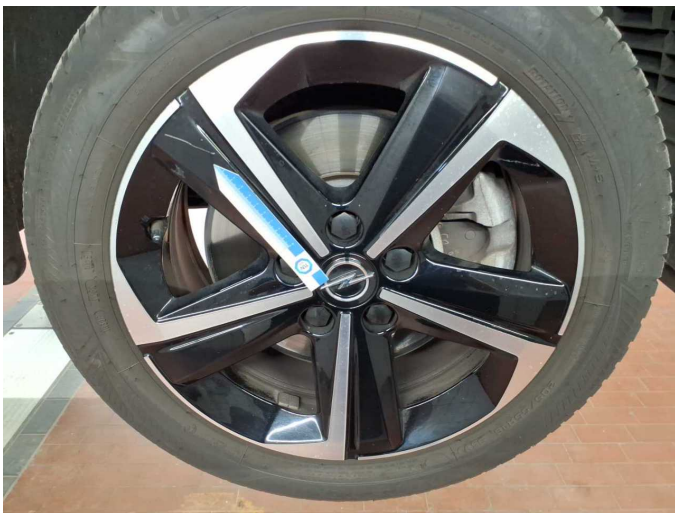
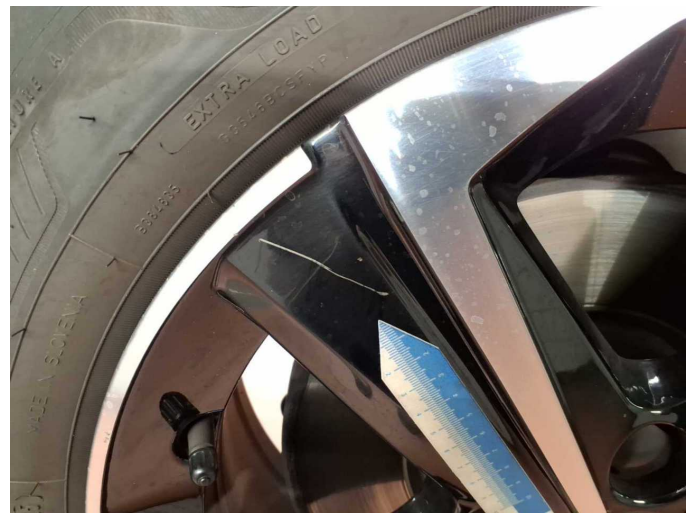
No.	Component group	Description
1	Wheel / tyres	Alloy rim - front right side - Scratch(es) - Loss in value
2	Door - front right side	Door - dent(s) - Smooth repair work

Damage 1: Wheel / tyres: Alloy rim - front right side - Scratch(es) - Loss in value

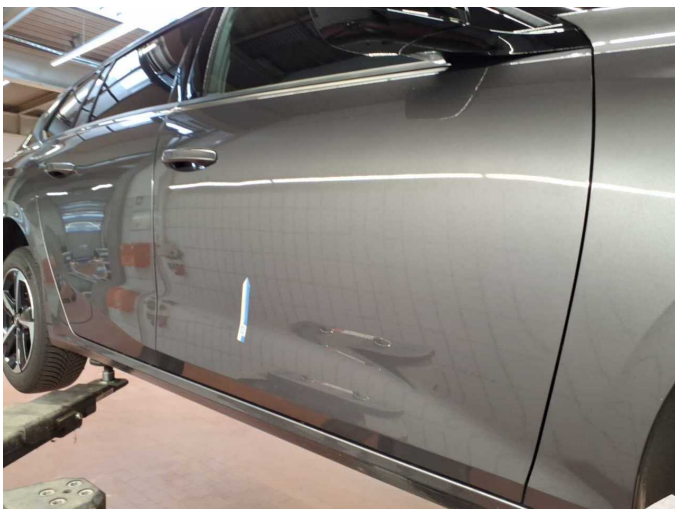
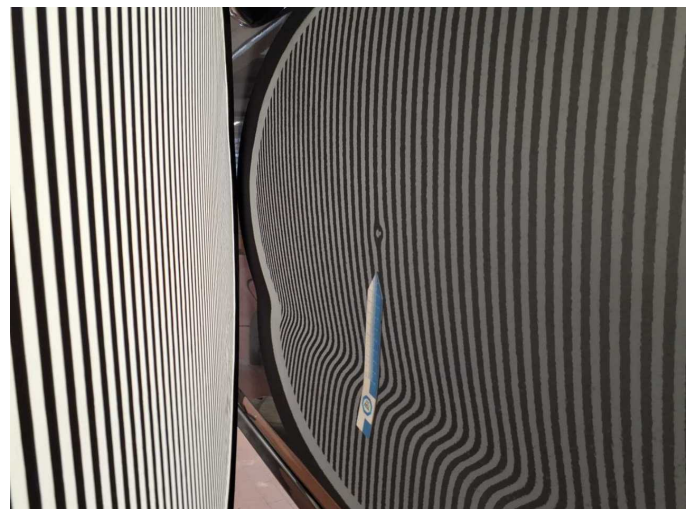
Damage 2: Door - front right side: Door - dent(s) - Smooth repair work

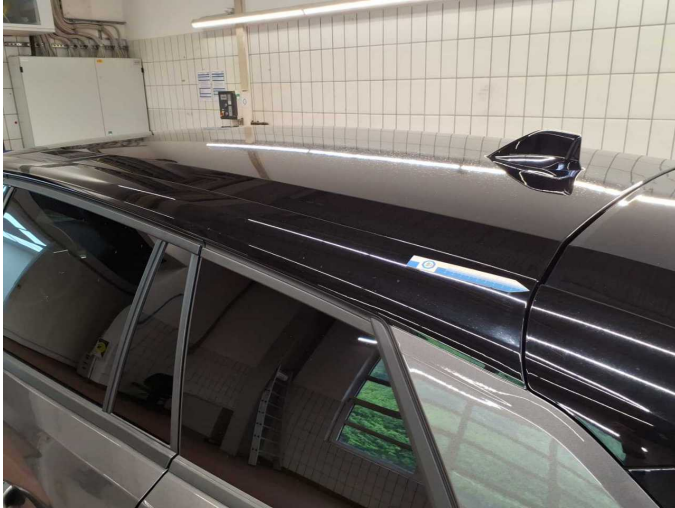
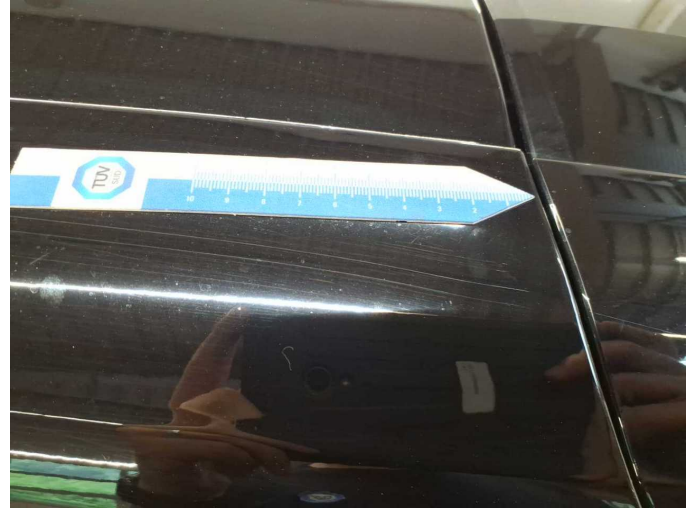
No.	Component group	Description
1	Roof	Roof rail - left side - Scratch(es) - No deduction
2	Rear bumper	Rear bumper - Scratch(es) - No deduction

Wear and tear 1: Roof: Roof rail - left side - Scratch(es) - No deduction

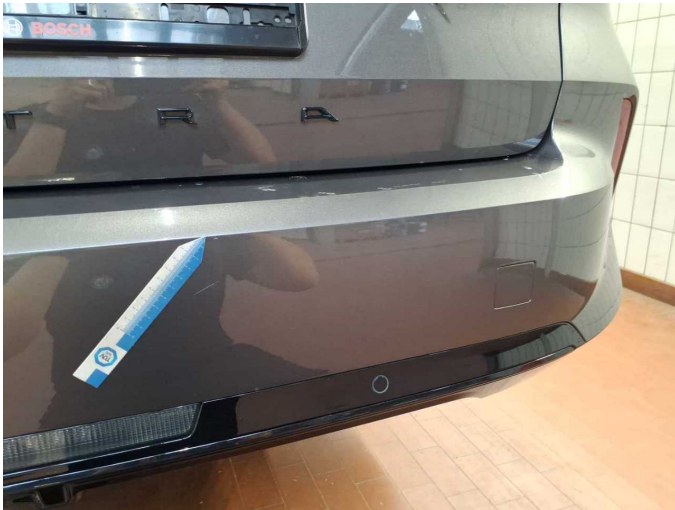
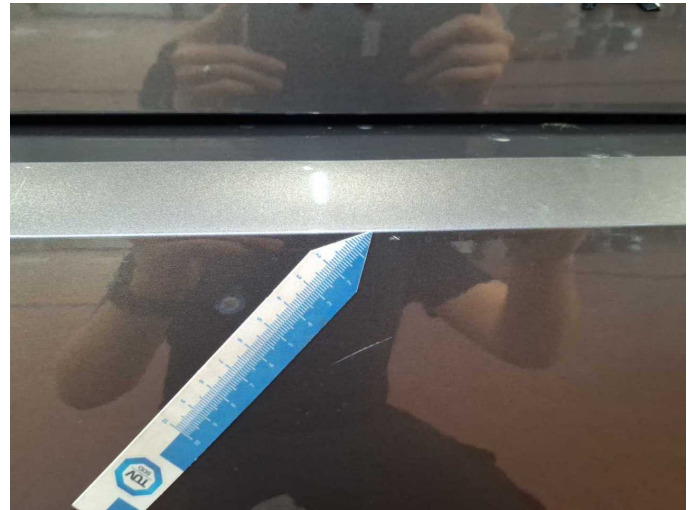
Wear and tear 2: Rear bumper: Rear bumper - Scratch(es) - No deduction
