## Expertise

Protocol number: 46186727  
Order No. / Reference: 26153548  
Inspection date: 16 Jun 2026

Model: 319 CDI Sprinter 4x4 Standard 9G-TRONIC PRO

VIN: W1V3MBTZ1TP849548

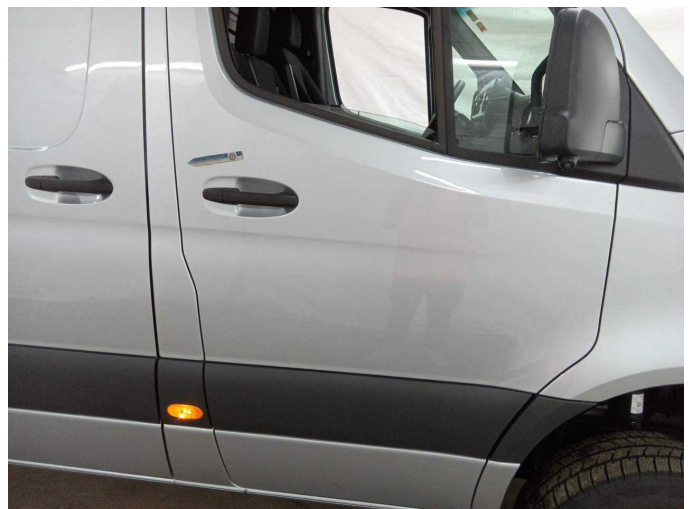
No.	Component group	Description
1	Door - front right side	Door edge - Scratch(es) - Smart repair
2	Instrument panel	Indicator light (Motorkontrolleuchte) - on - Perform diagnosis
3	Rear bumper	Rear bumper - Scratched - Replace

Damage 1: Door - front right side: Door edge - Scratch(es) - Smart repair

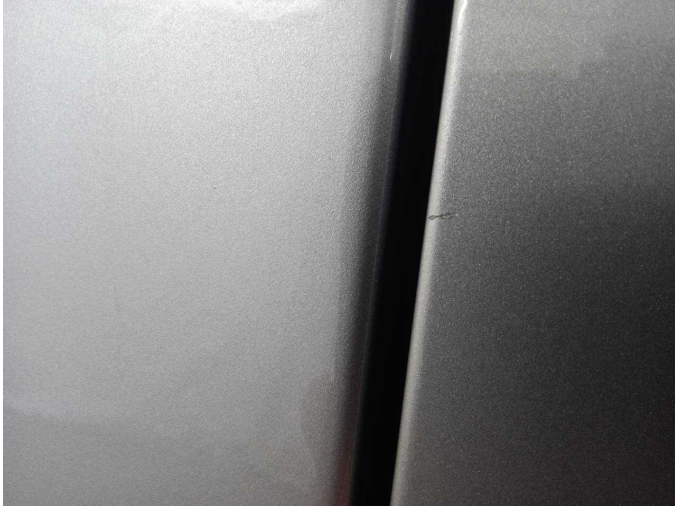
**Damage 1:** Door - front right side: Door edge - Scratch(es) - Smart repair

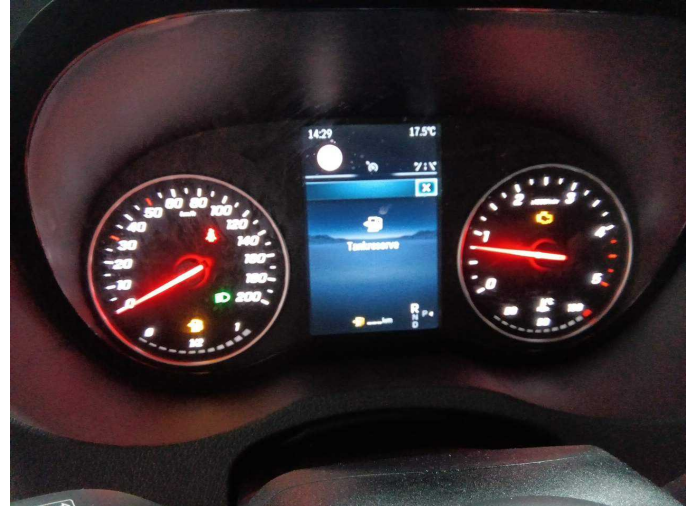
**Damage 2:** Instrument panel: Indicator light (Motorkontrolleuchte) - on - Perform diagnosis

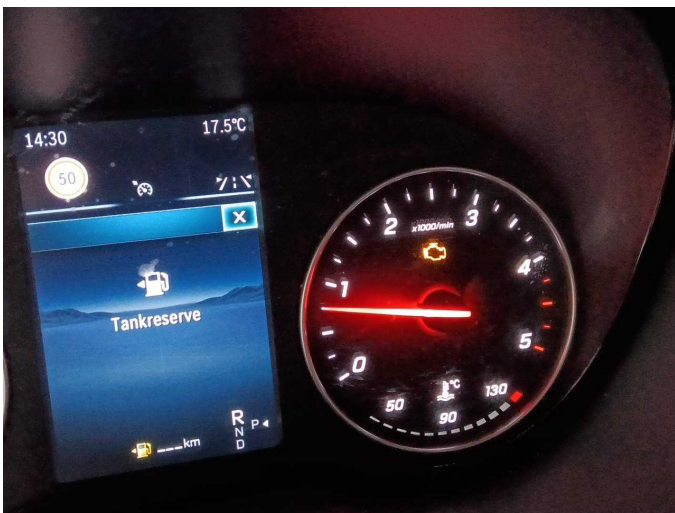
**Damage 2:** Instrument panel: Indicator light (Motorkontrolleuchte) - on - Perform diagnosis

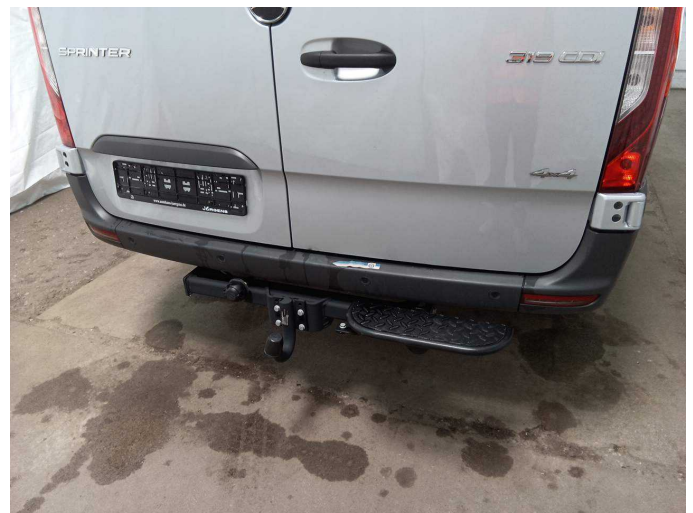
**Damage 3:** Rear bumper: Rear bumper - Scratched - Replace

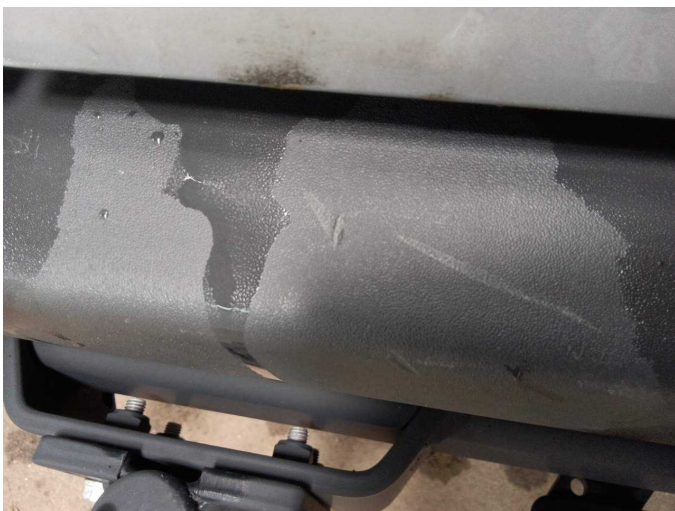
**Damage 3:** Rear bumper: Rear bumper - Scratched - Replace

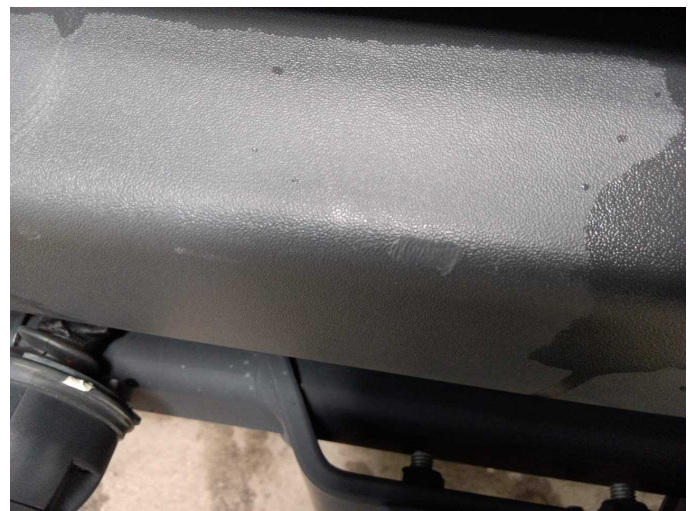
**Damage 3:** Rear bumper: Rear bumper - Scratched - Replace

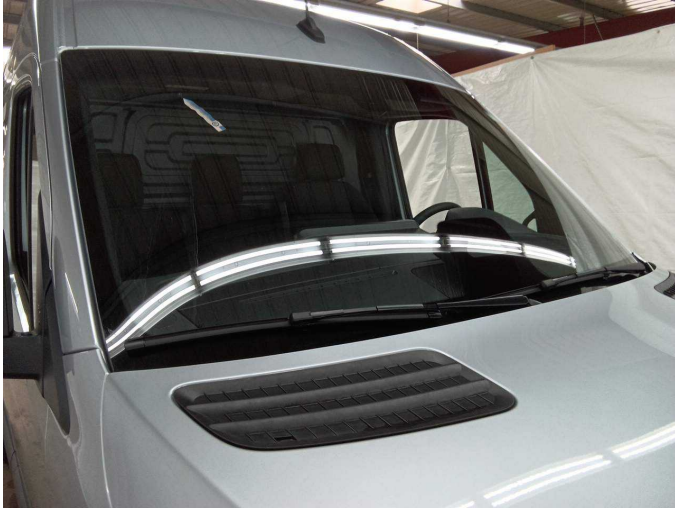
No.	Component group	Description
1	Vehicle glazing	Windscreen - Stone chips - No deduction

**Wear and tear 1:** Vehicle glazing: Windscreen - Stone chips - No deduction
