Expertise

Protocol number: 46605708  
Order No. / Reference: 26699673  
Inspection date: 16 Jul 2026

Manufacturer: Ford

Model: Transit Connect 220 L2 Trend

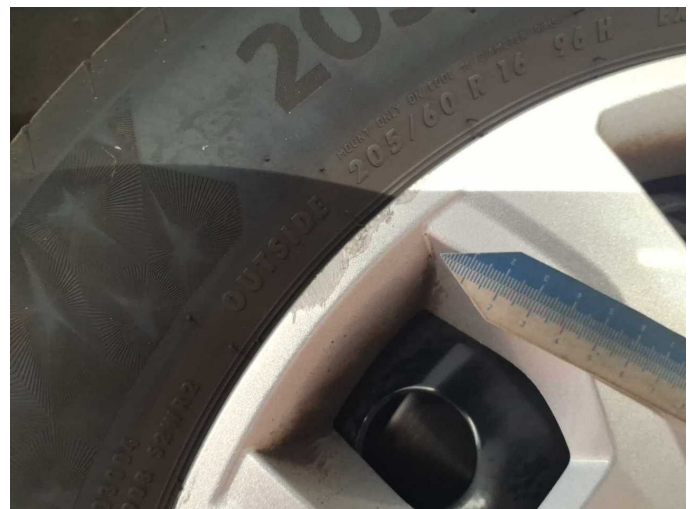
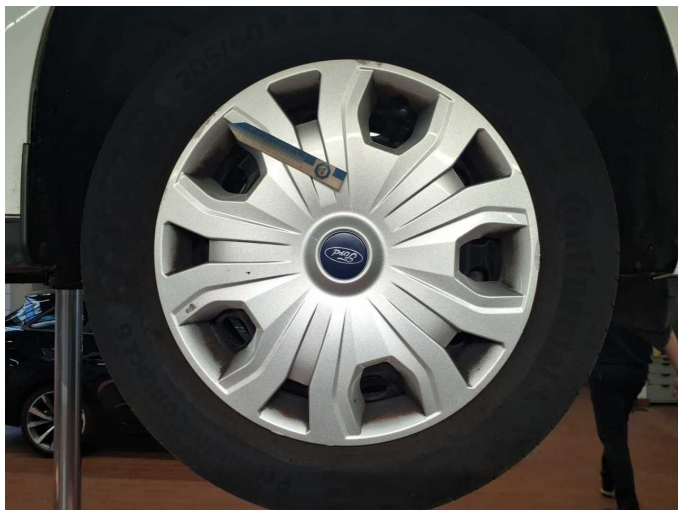
| No. | Component group | Description |
|---|---|---|
| 1 | Wheel / tyres | Wheel cover - front right side - Scratched - Loss in value |

**Damage 1:** Wheel / tyres: Wheel cover - front right side - Scratched - Loss in value

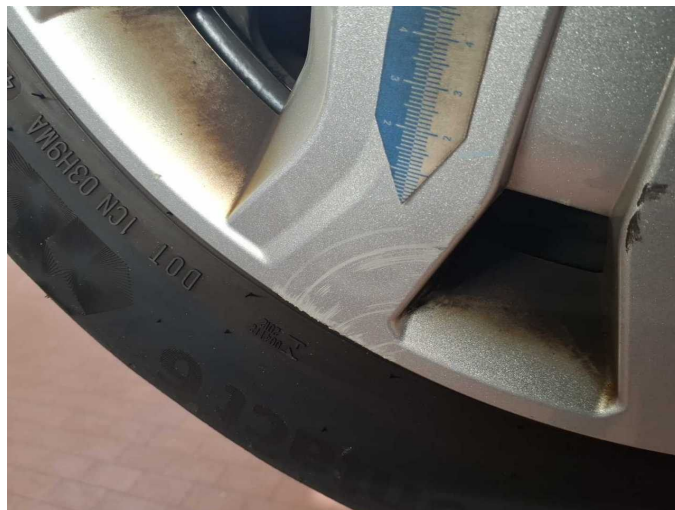
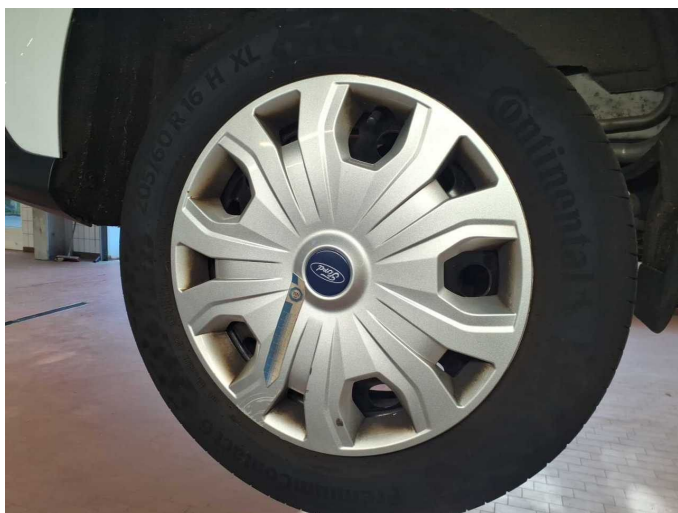
| No. | Component group | Description |
|---|---|---|
| 2 | Wheel / tyres | Wheel cover - rear right side - Scratch(es) - Loss in value |

**Damage 2:** Wheel / tyres: Wheel cover - rear right side - Scratch(es) - Loss in value

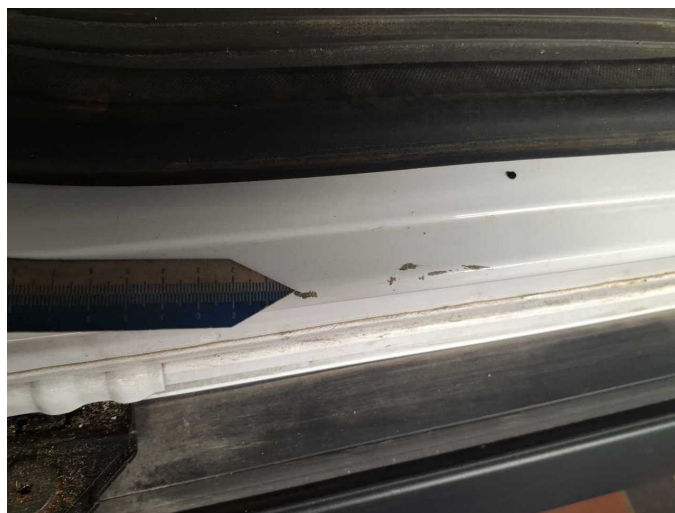
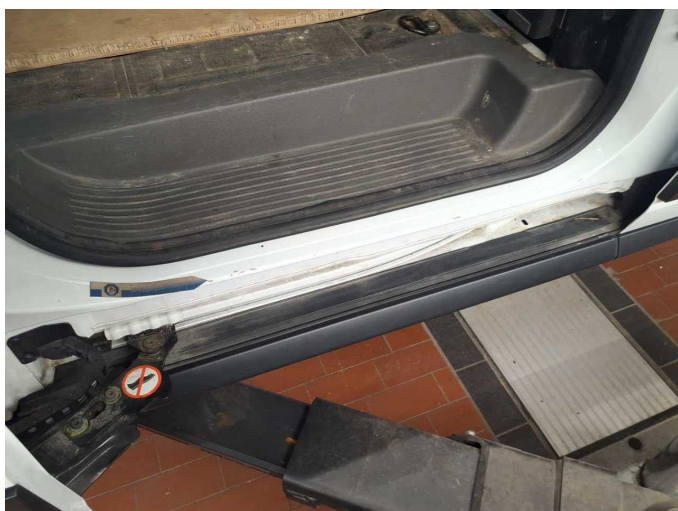
| No. | Component group | Description |
|---|---|---|
| 3 | Side panel - rear right side | Sill - Scratch(es) - Smart repair |

**Damage 3:** Side panel - rear right side: Sill - Scratch(es) - Smart repair

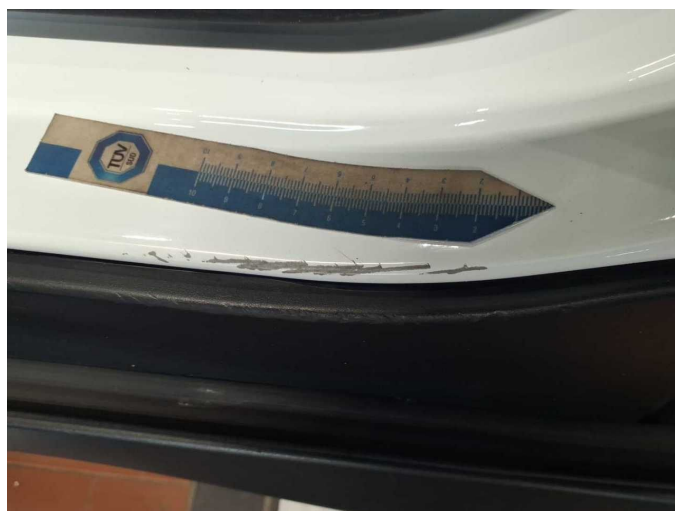
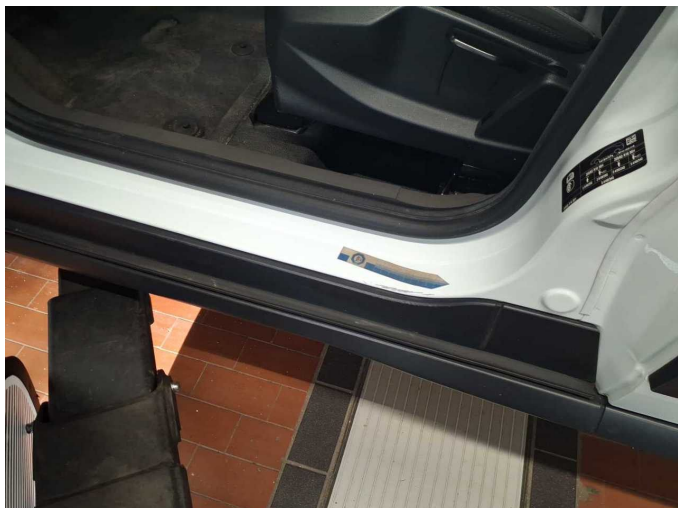
| No. | Component group | Description |
|---|---|---|
| 4 | Sill - left side | Sill - Scratch(es) - Smart repair |

**Damage 4:** Sill - left side: Sill - Scratch(es) - Smart repair

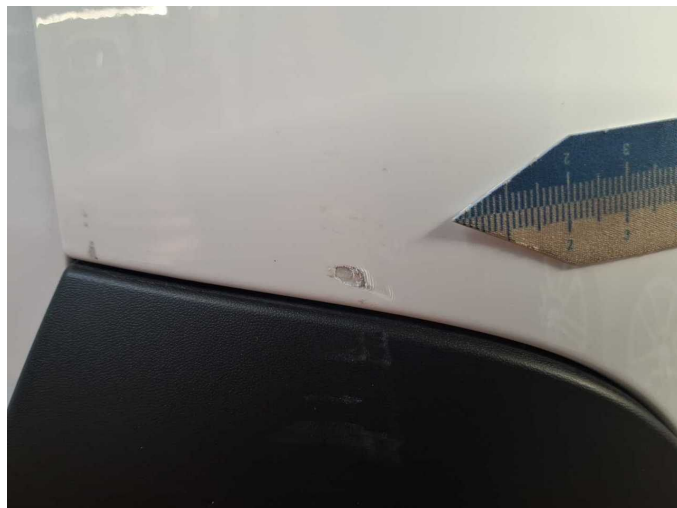
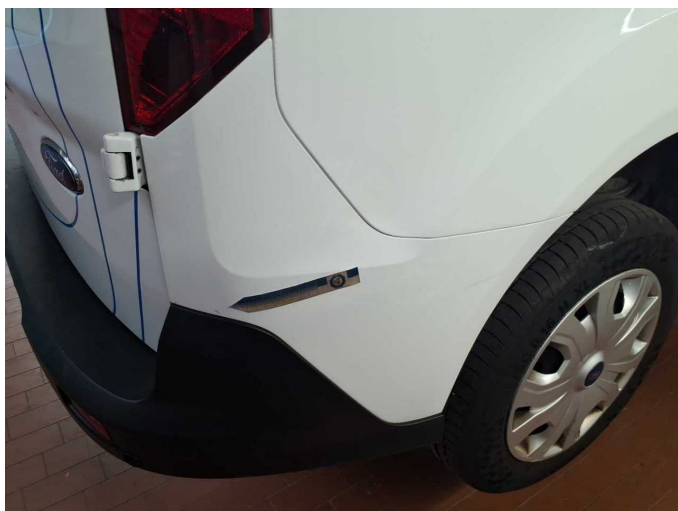
| No. | Component group | Description |
|---|---|---|
| 5 | Rear bumper | Bumper - rear right side - Scratch(es) - Smart repair |

**Damage 5:** Rear bumper: Bumper - rear right side - Scratch(es) - Smart repair

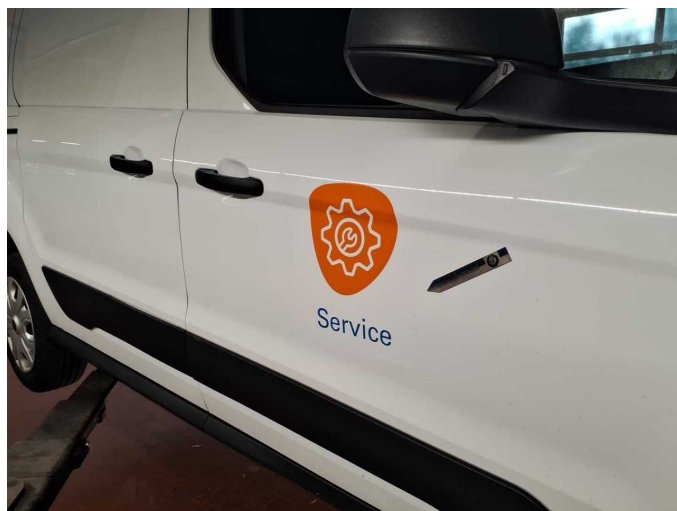
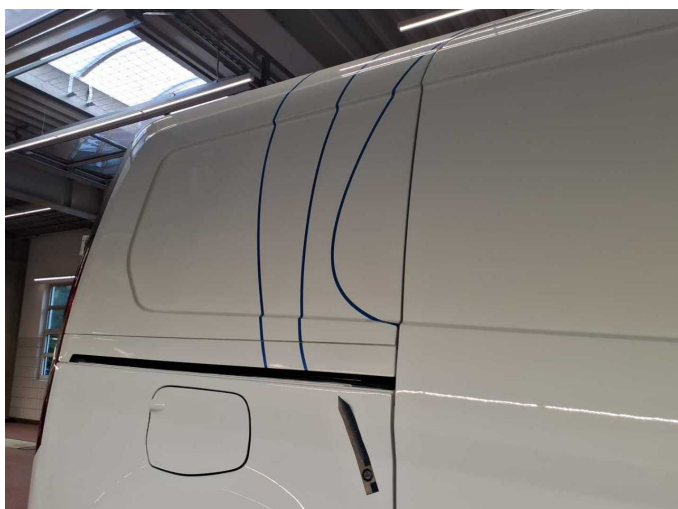
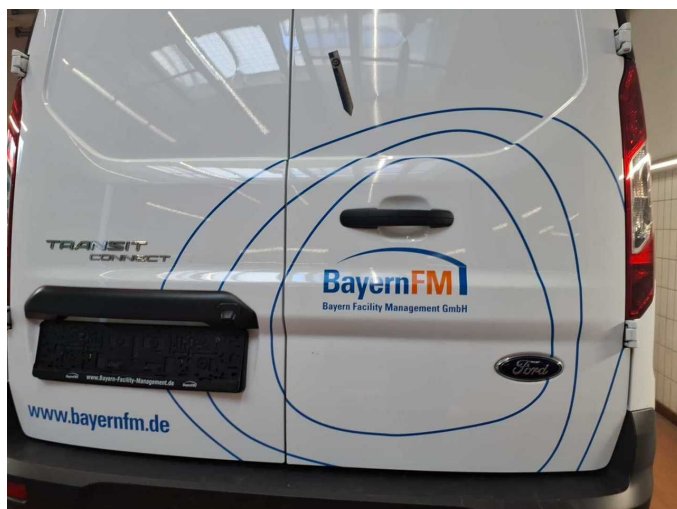
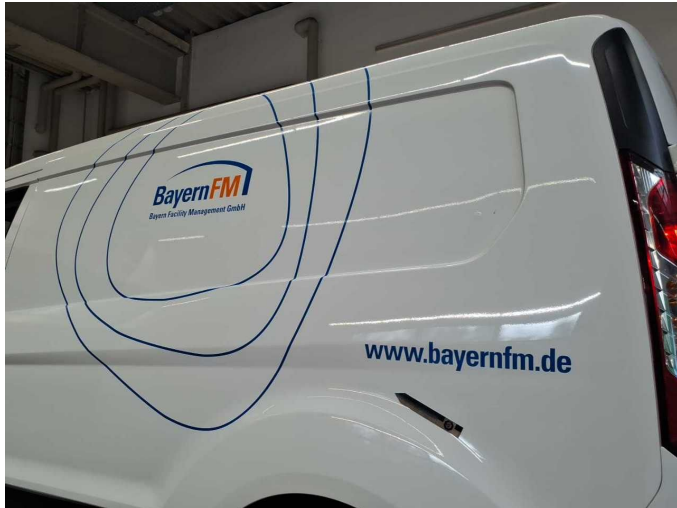
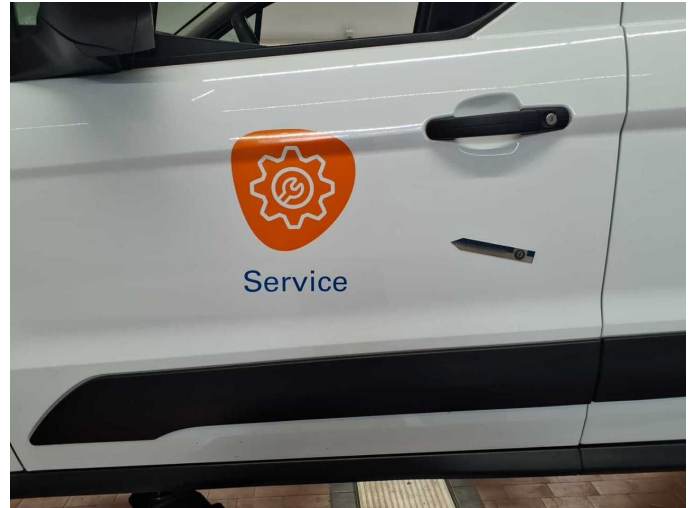
| No. | Component group | Description |
|---|---|---|
| 6 | Body | Body - Glued / labelled - De-glue / neutralise |

Fahrzeug beklebt, verborgene Schäden können nicht ausgeschlossen werden. Schadenausweitung möglich, Zusatzkosten können entstehen.

**Damage 6:** Body: Body - Glued / labelled - De-glue / neutralise

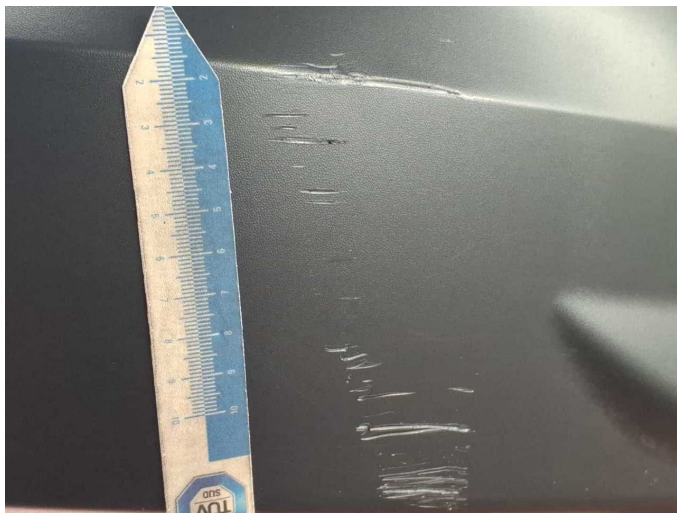
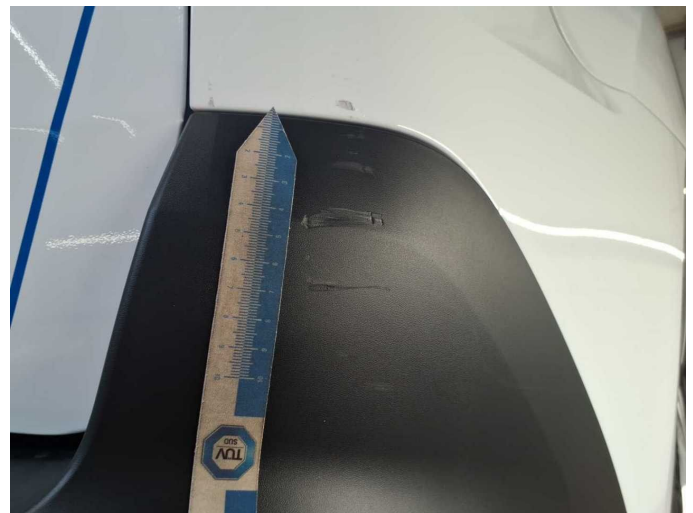
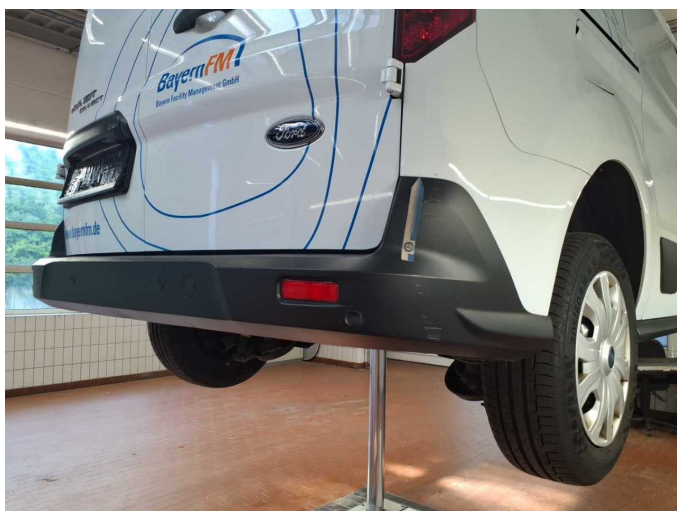
| No. | Component group | Description |
|---|---|---|
| 7 | Rear bumper | Rear bumper - Scratched - Replace |

**Damage 7:** Rear bumper: Rear bumper - Scratched - Replace

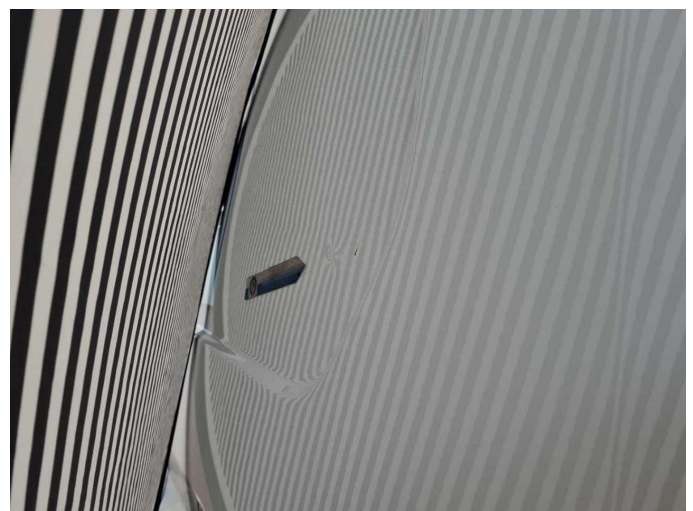
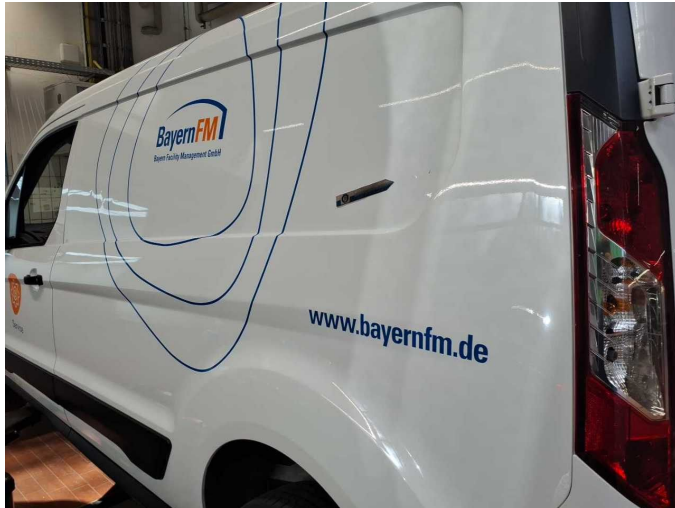
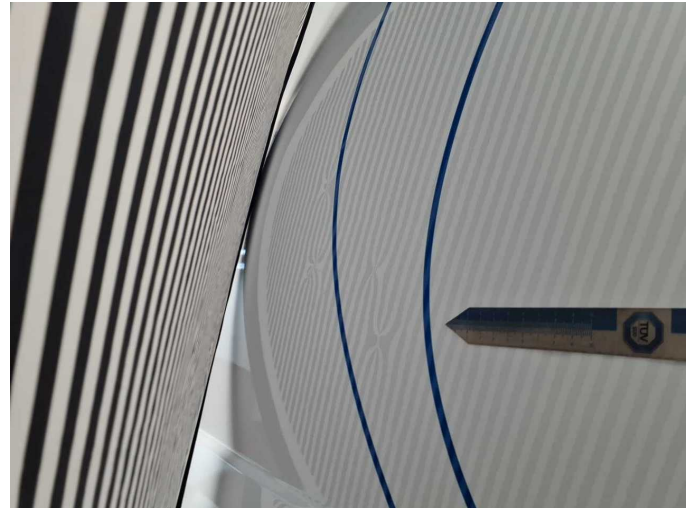
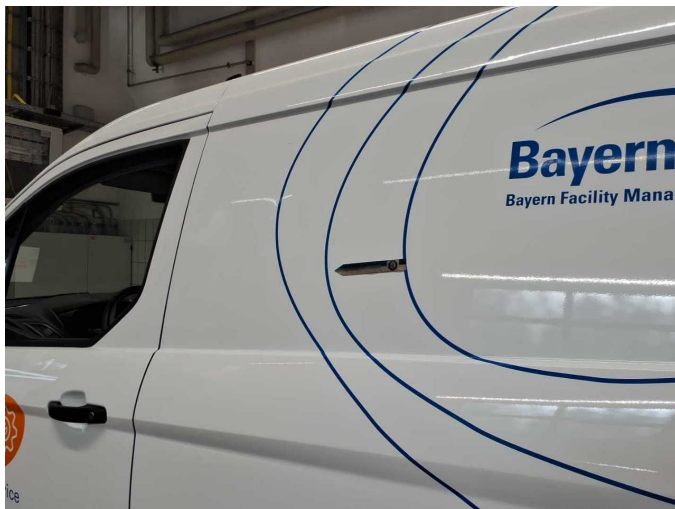
| No. | Component group | Description |
|---|---|---|
| 8 | Side panel - rear left side | Side panel - dent(s) - Repair and paint |

**Damage 8:** Side panel - rear left side: Side panel - dent(s) - Repair and paint

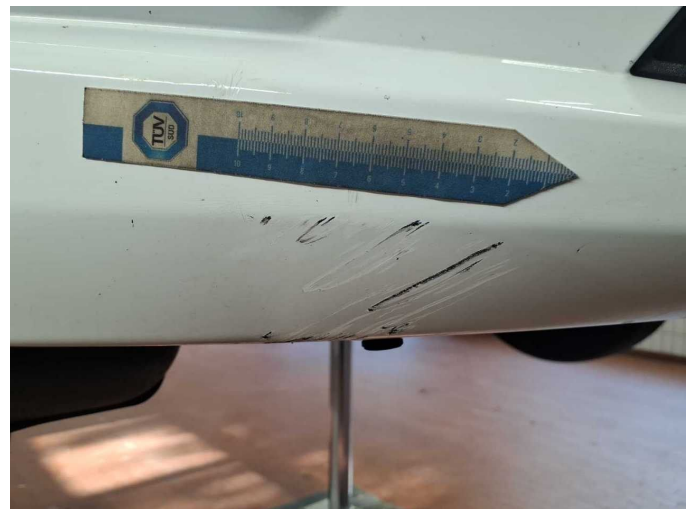
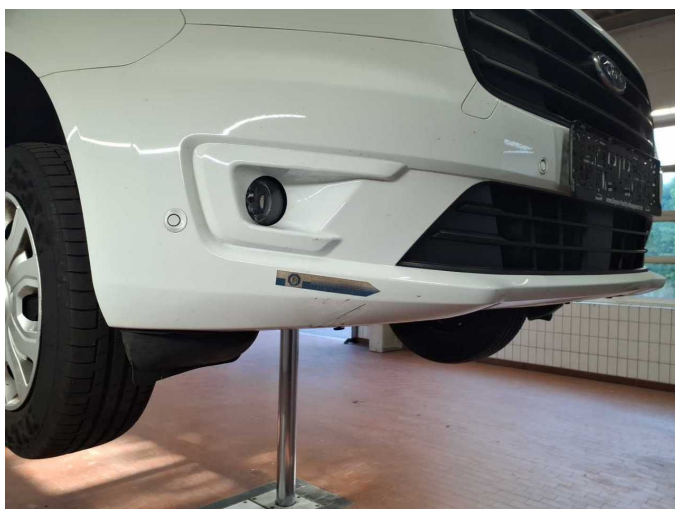
| No. | Component group | Description |
|---|---|---|
| 9 | Front bumper | Front bumper - Scratched - Paint |

**Damage 9:** Front bumper: Front bumper - Scratched - Paint

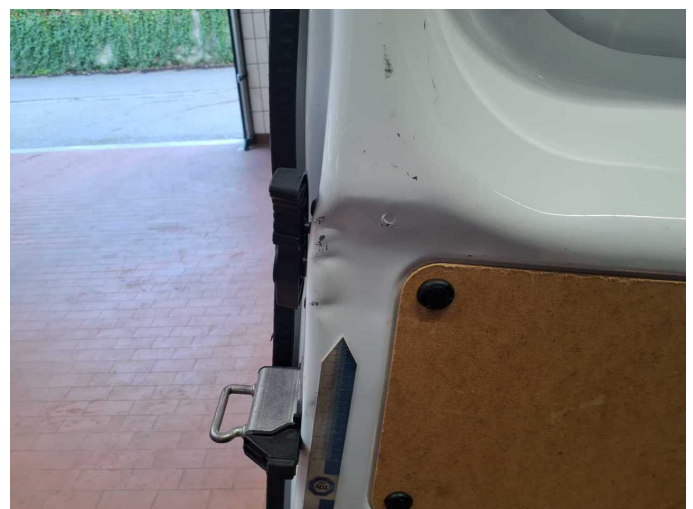
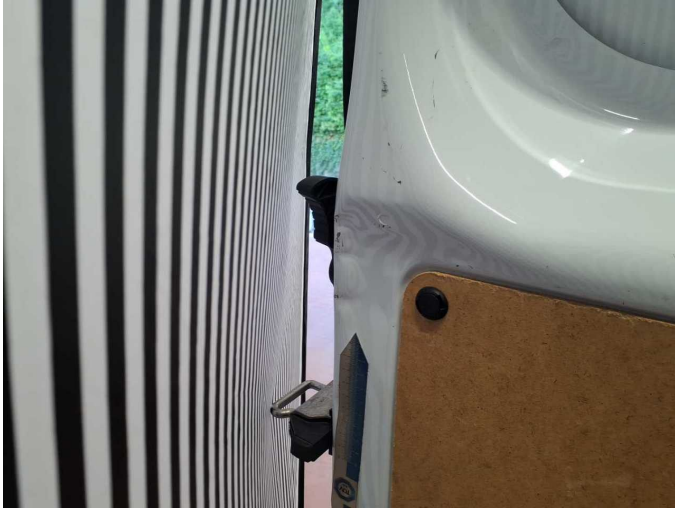
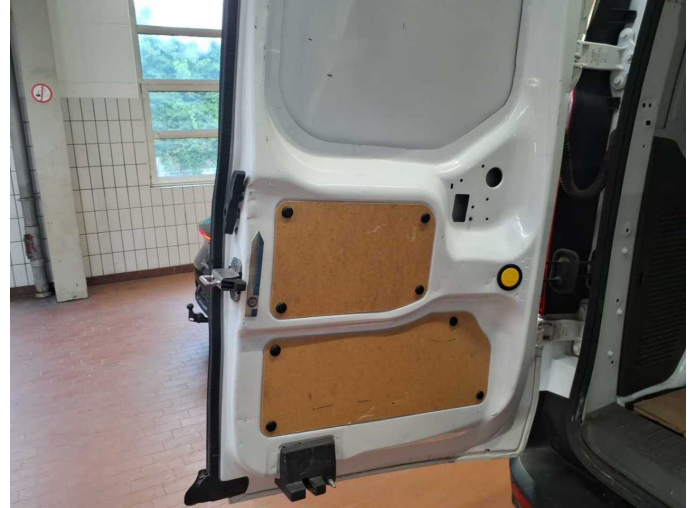
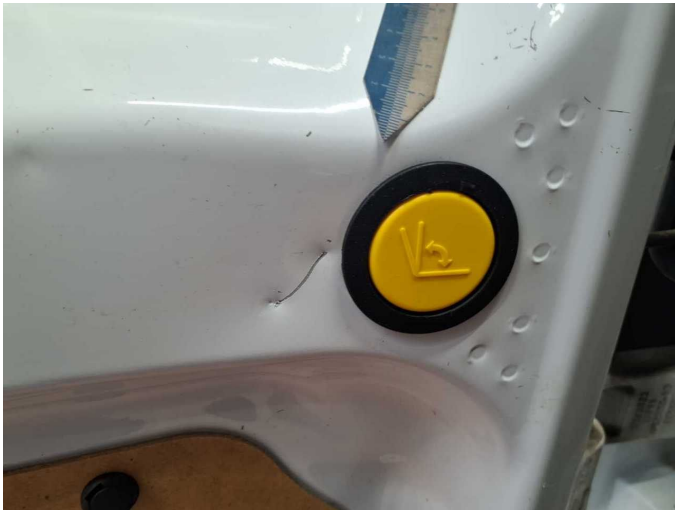
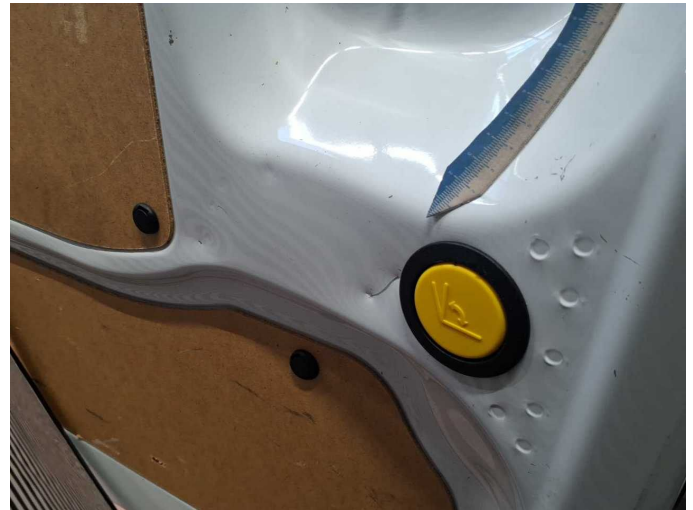
| No. | Component group | Description |
|---|---|---|
| 10 | Boot lid / rear door | Rear door - left side - Dent / paintcoat damage - Repair and paint |

**Damage 10:** Boot lid / rear door: Rear door - left side - Dent / paintcoat damage - Repair and paint

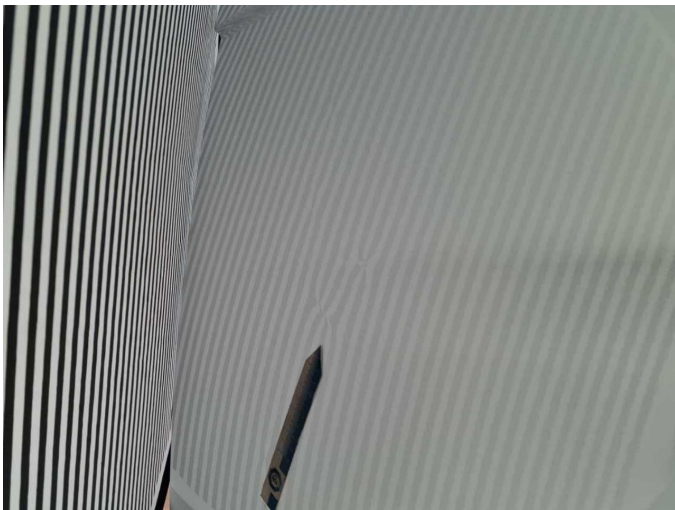
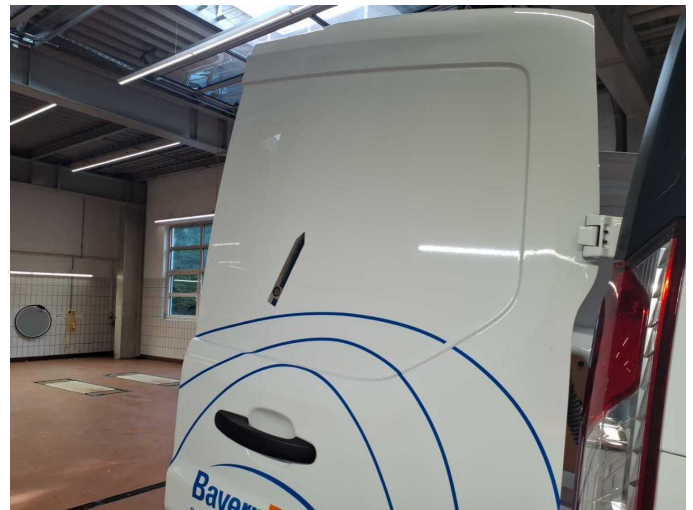
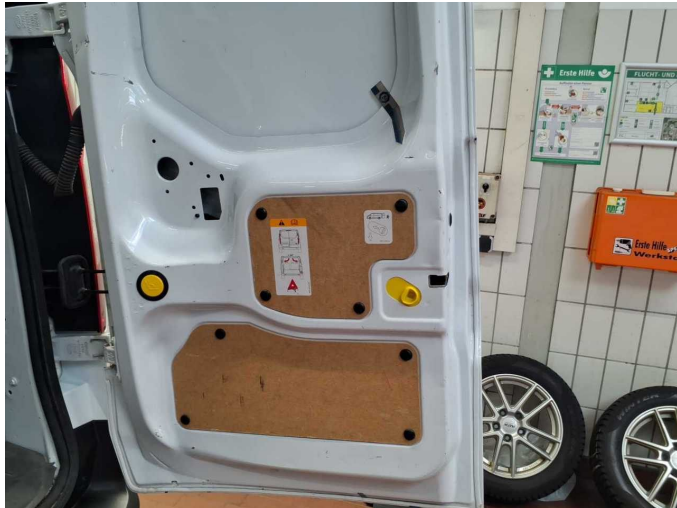
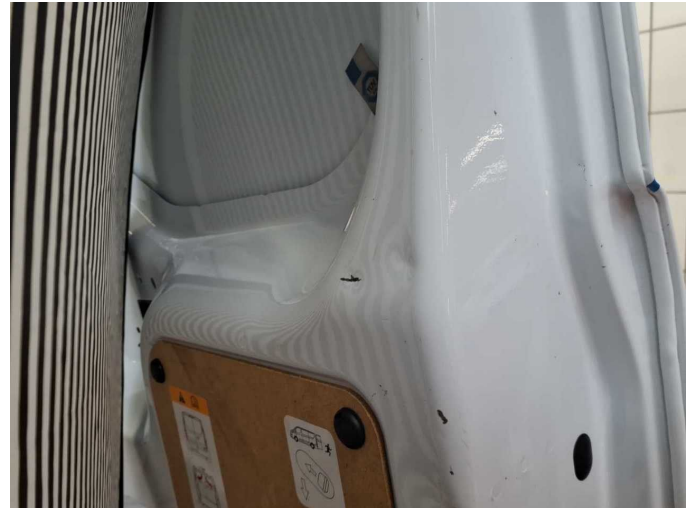
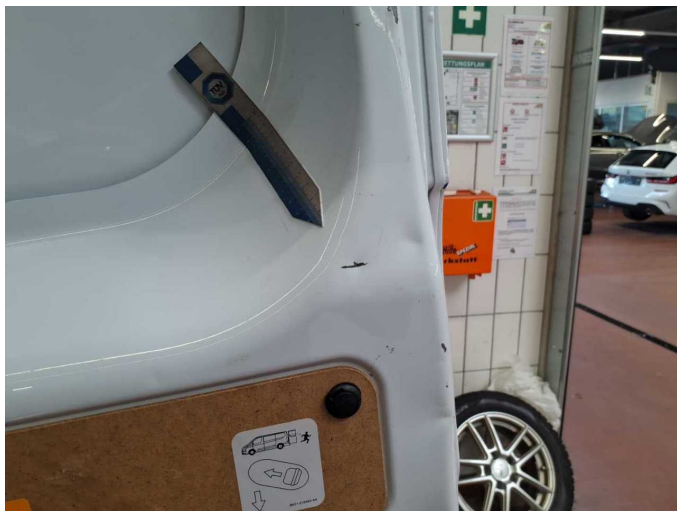
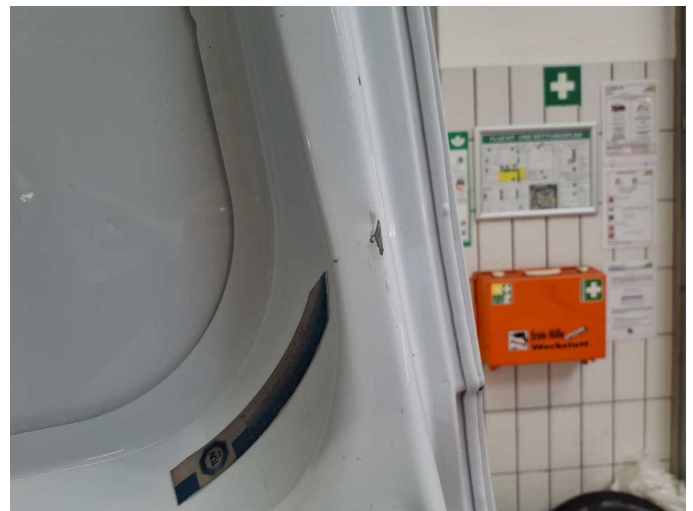
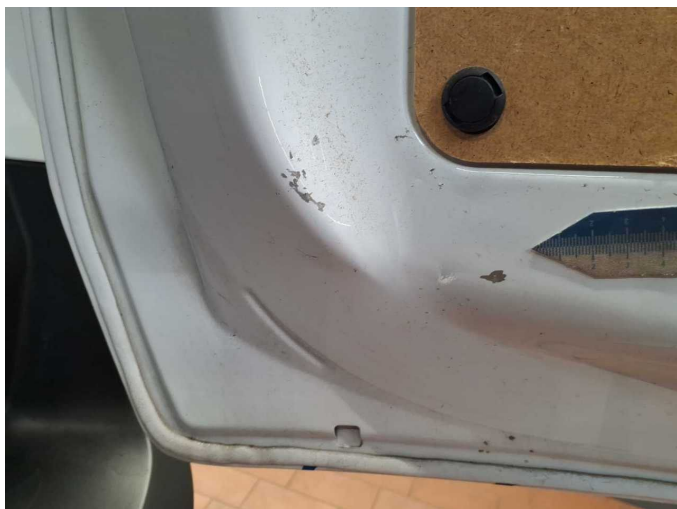
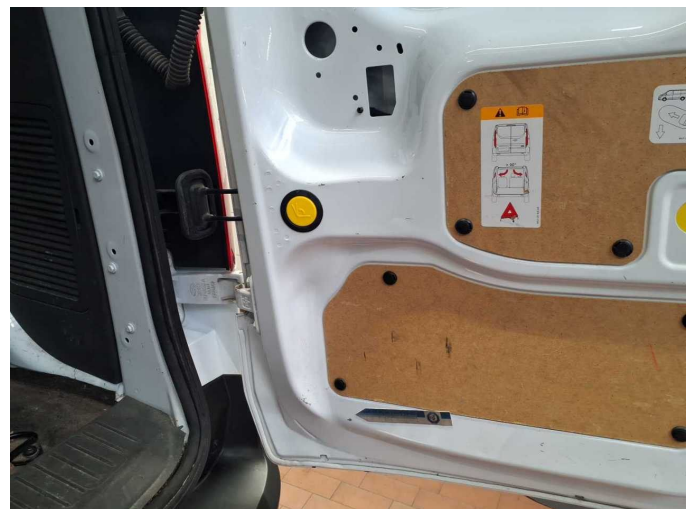
| No. | Component group | Description |
|---|---|---|
| 11 | Boot lid / rear door | Rear door - right side - Dent / paintcoat damage - Repair and paint |

**Damage 11:** Boot lid / rear door: Rear door - right side - Dent / paintcoat damage - Repair and paint

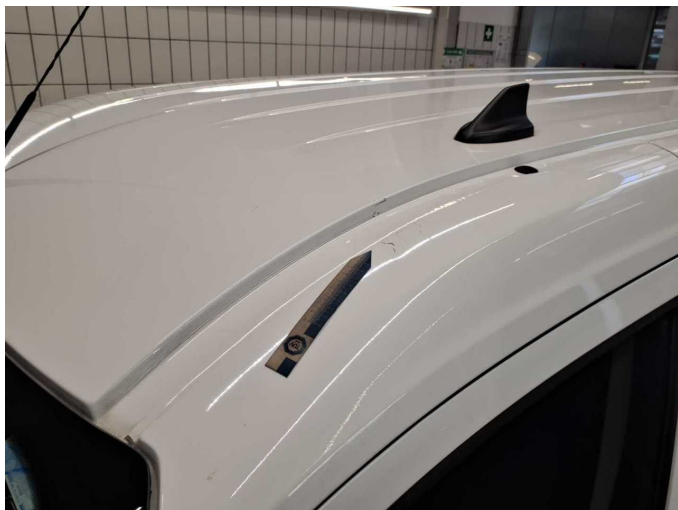
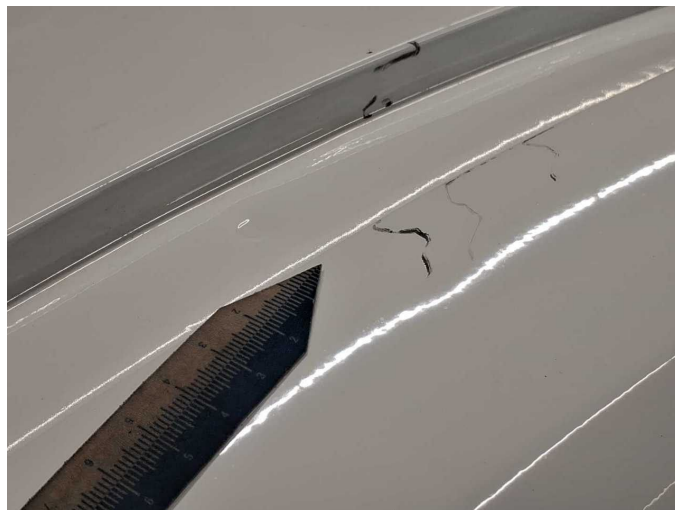
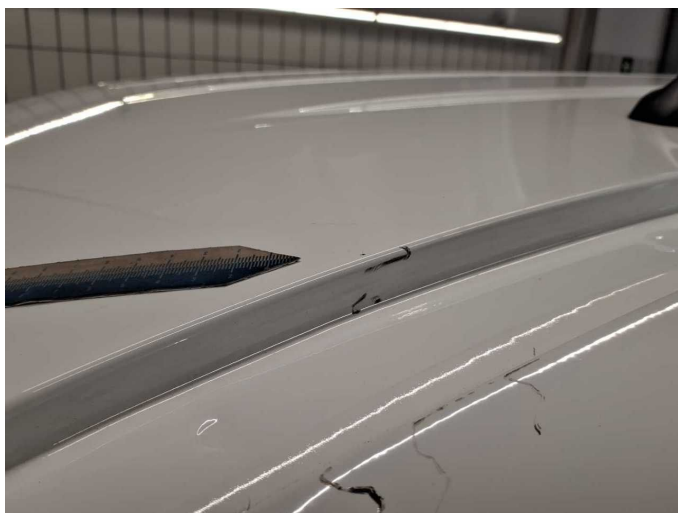
| No. | Component group | Description |
|---|---|---|
| 12 | Roof | Roof - Scratch(es) - Paint |

**Damage 12:** Roof: Roof - Scratch(es) - Paint

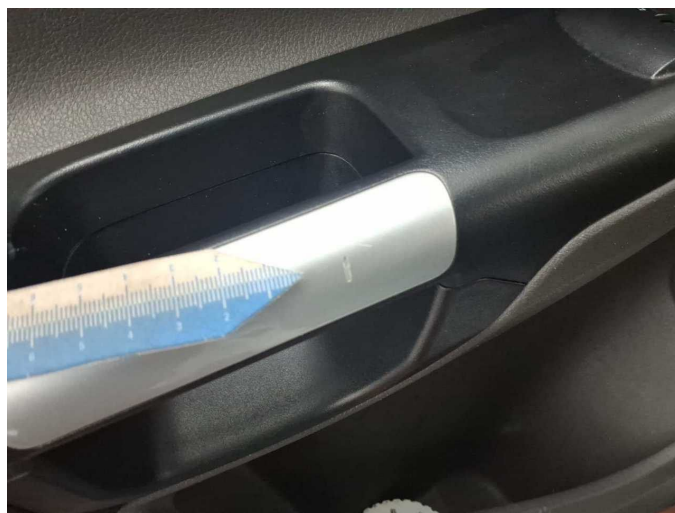
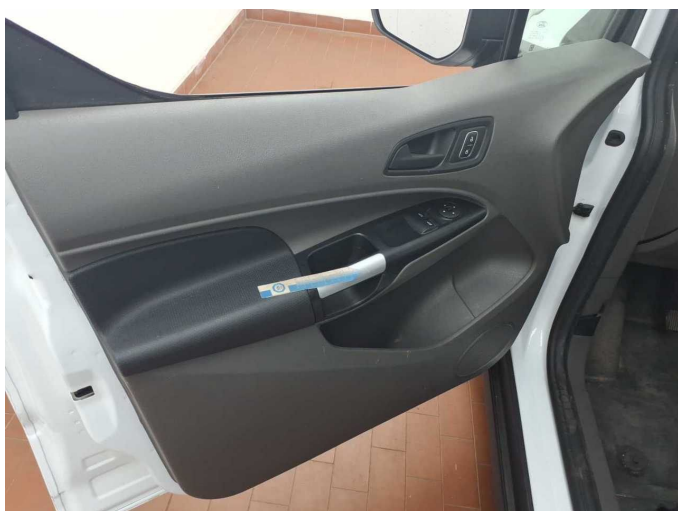
| No. | Component group | Description |
|---|---|---|
| 2 | Trim / covers | Door trim - front left side - Scratch(es) - No deduction |

**Wear and tear 2:** Trim / covers: Door trim - front left side - Scratch(es) - No deduction

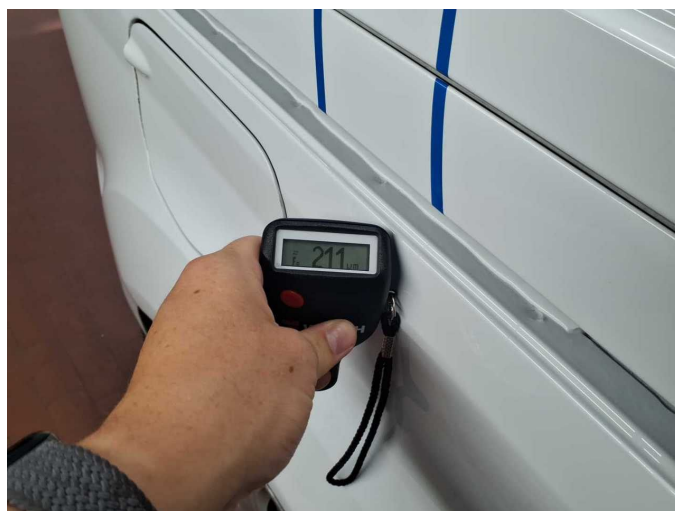
| No. | Repainting |
|---|---|
| 1 | Side panel - rear right side, Professionally carried out, Invoice of repair done Non-existent |

Side panel - rear right side

211 µm

**Repainting 1:** Side panel - rear right side

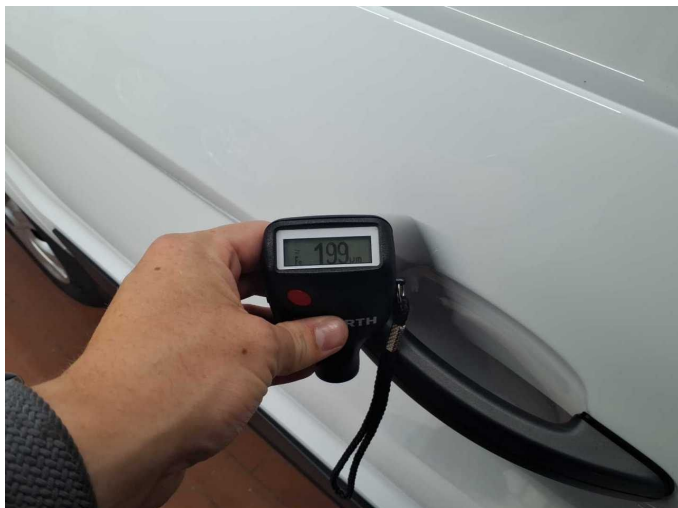
| No. | Repainting |
|---|---|
| 2 | Door - rear right side, Professionally carried out, Invoice of repair done Non-existent |

Door - rear right side

199 µm

**Repainting 2:** Door - rear right side
