Expertise

Protocol number: 46031233
Order No. / Reference: 26482468
Inspection date: 17 Jun 2026

Model: Movano 2.2 BlueHDi 140 L2H2 VA

VIN: VXEYCF6F5SG027388

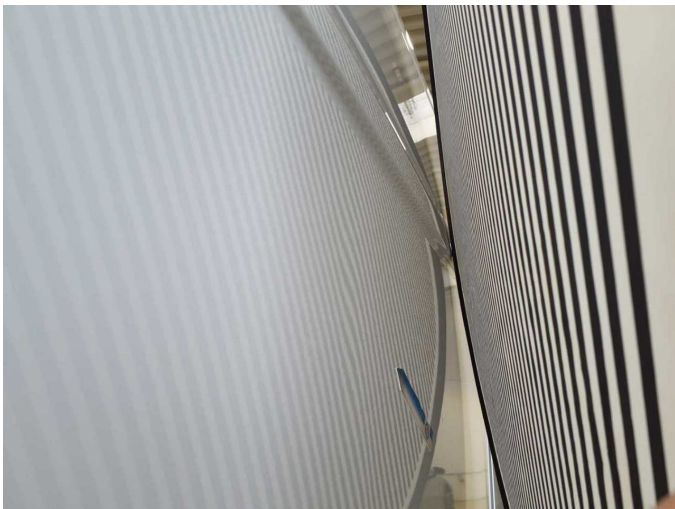
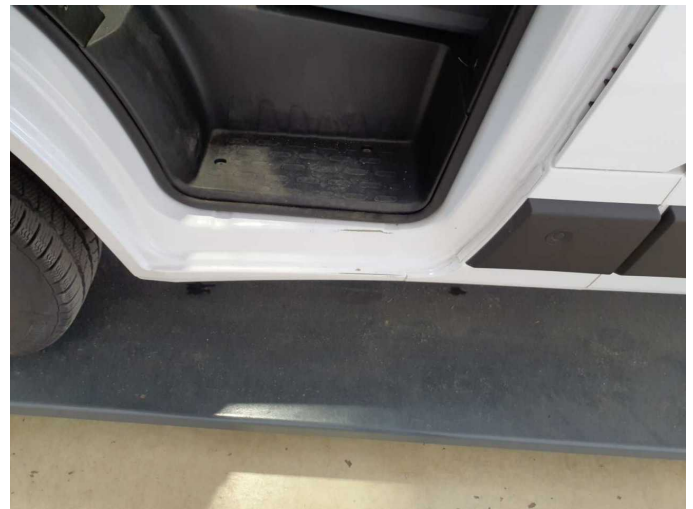
Damage 1: Side panel - rear right side: Side panel - dent(s) - Smooth repair work

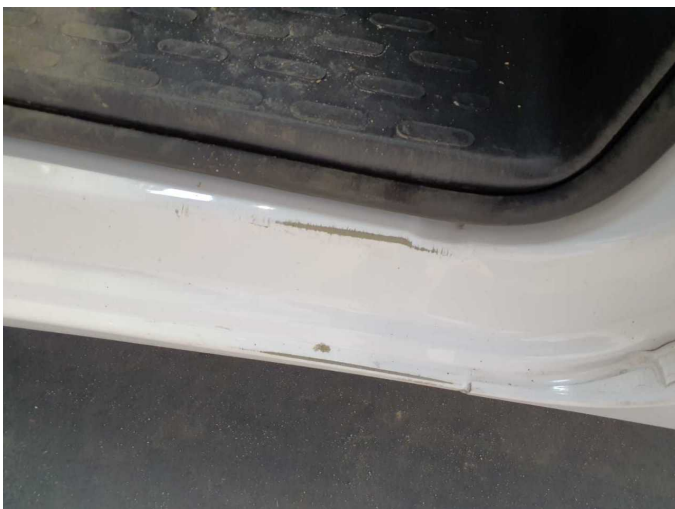
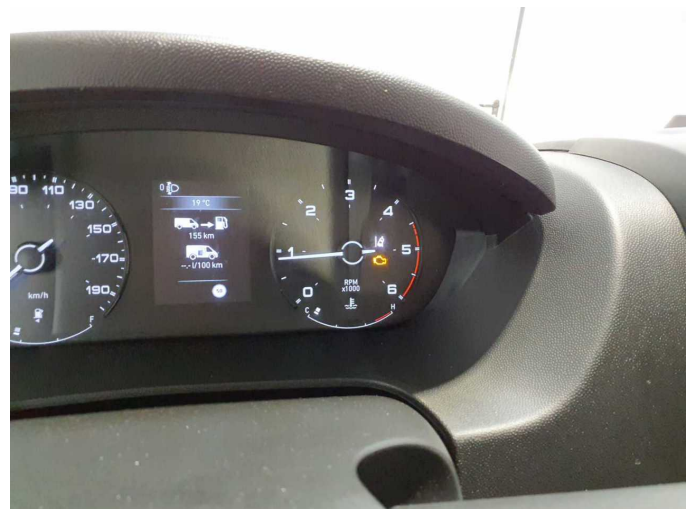
Damage 2: Sill - left side: Sill - Scratch(es) - Smart repair

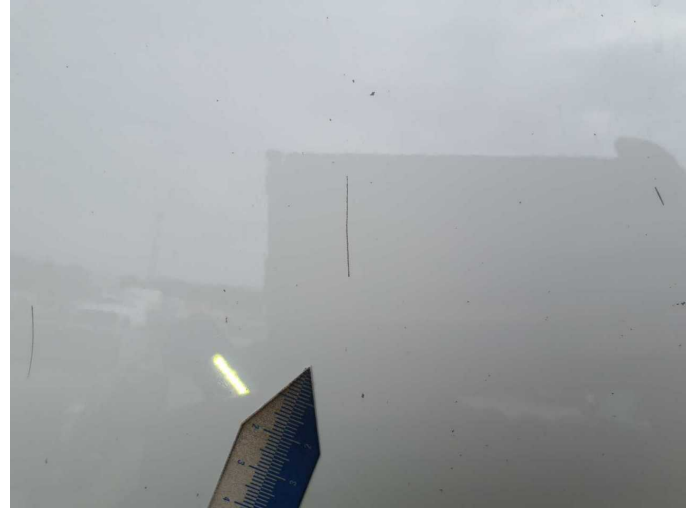
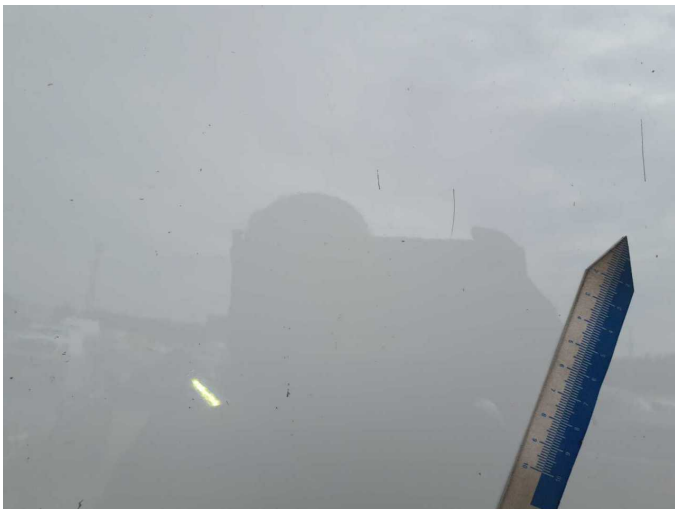
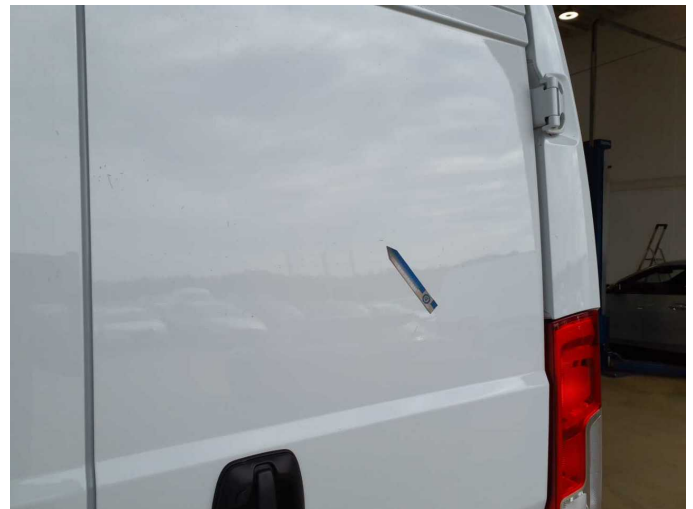
Damage 4: Boot lid / rear door: Rear door - left side - Scratch(es) - Paint

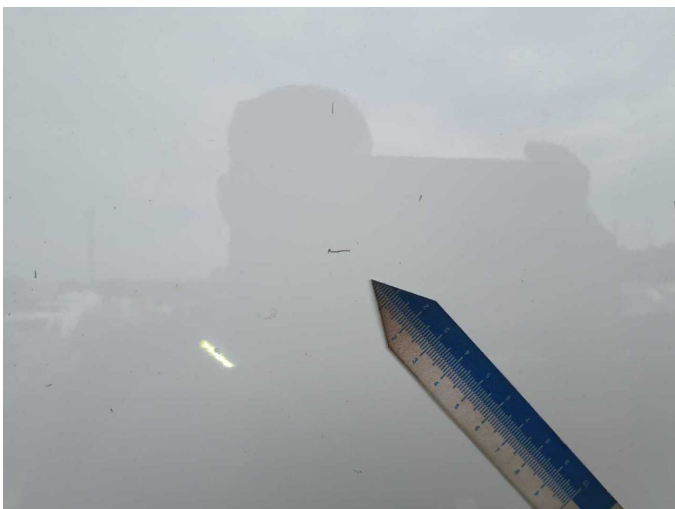
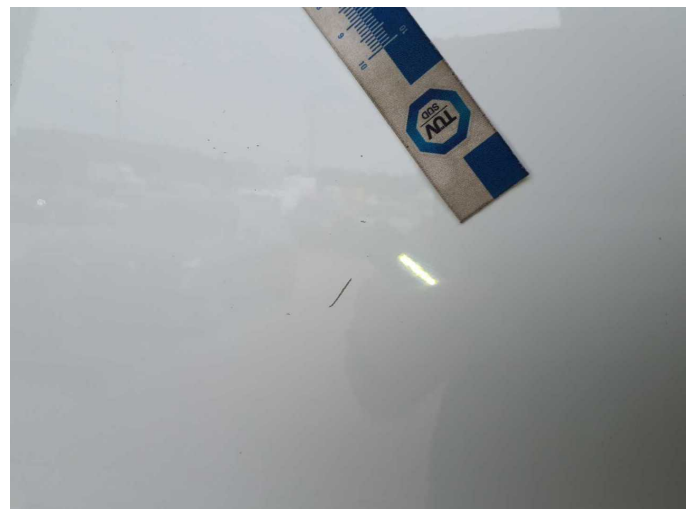
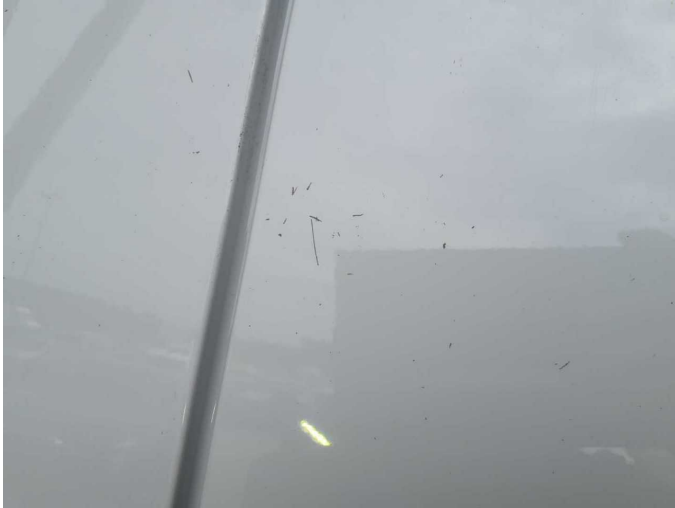
Damage 5: Boot lid / rear door: Rear door - right side - Scratch(es) - Paint
