Expertise

Protocol number: 46898058  
Order No. / Reference: 26737203  
Inspection date: 5 Aug 2026

Manufacturer: Ford

Model: S-Max 2.5 Duratec FHEV TREND

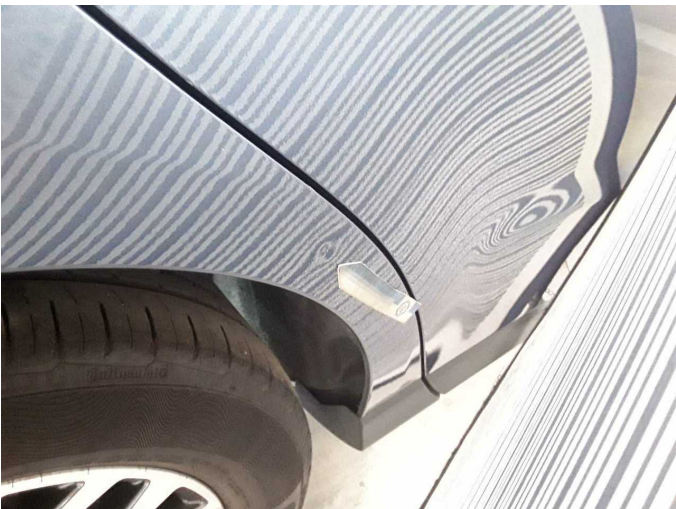
| No. | Component group | Description |
|---|---|---|
| 2 | Side panel - rear right side | Side panel - dent(s) - Smooth repair work |

Damage 2: Side panel - rear right side: Side panel - dent(s) - Smooth repair work

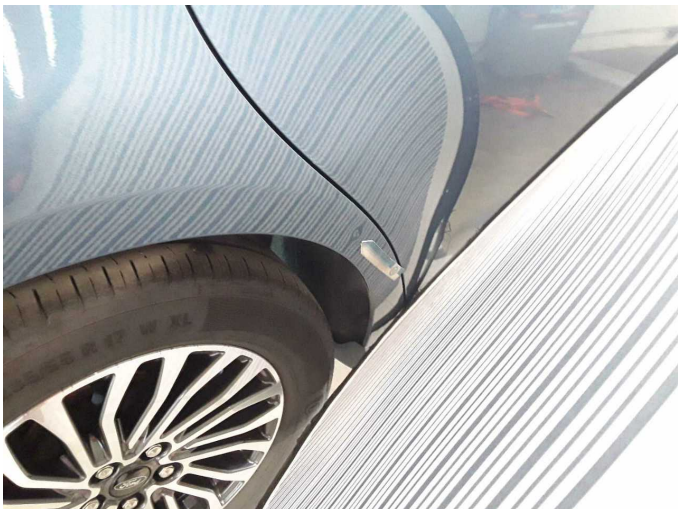
Damage 2: Side panel - rear right side: Side panel - dent(s) - Smooth repair work

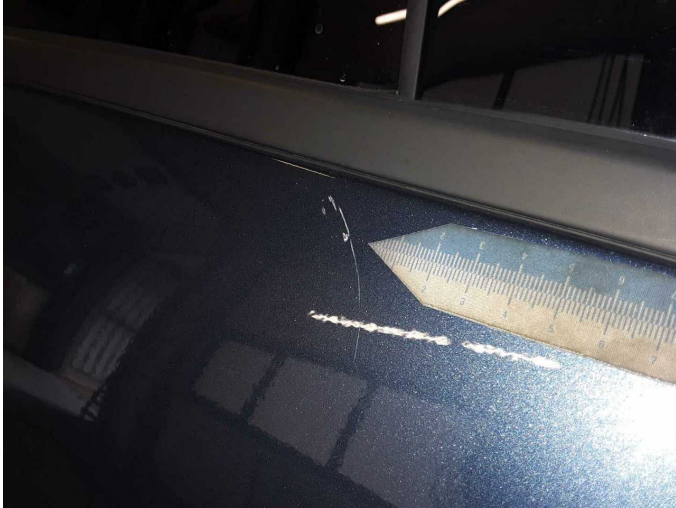
| No. | Component group | Description |
|---|---|---|
| 3 | Door - rear right side | Door - Scratch(es) - Smart repair |

**Damage 3:** Door - rear right side: Door - Scratch(es) - Smart repair

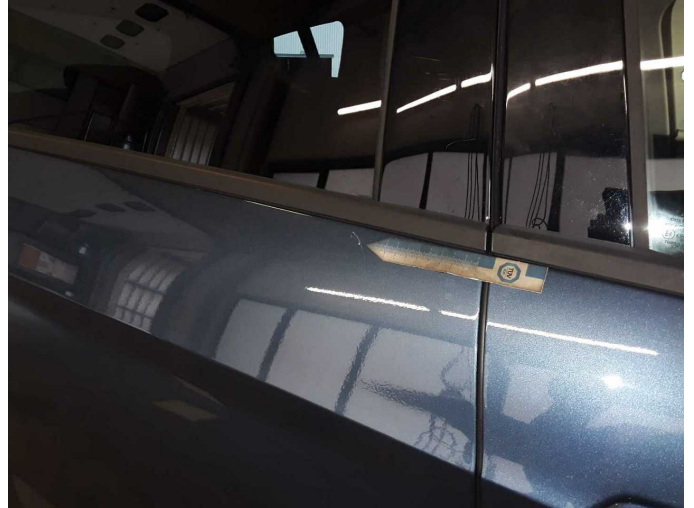
**Damage 3:** Door - rear right side: Door - Scratch(es) - Smart repair

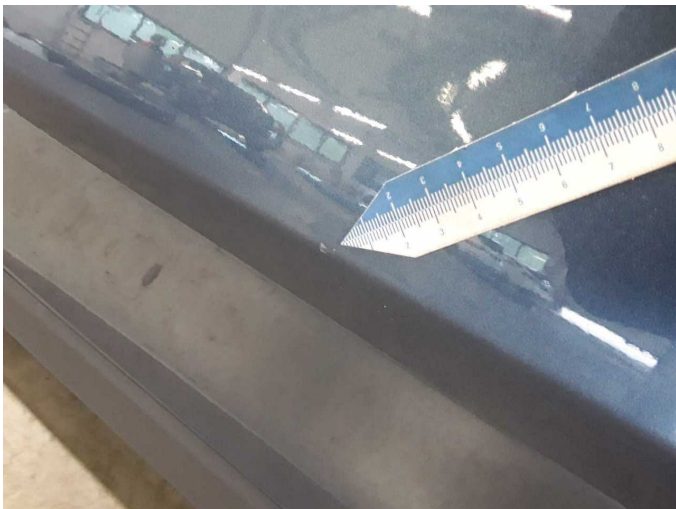
| No. | Component group | Description |
|---|---|---|
| 4 | Door - front left side | Door - Scratch(es) - Smart repair |

**Damage 4:** Door - front left side: Door - Scratch(es) - Smart repair

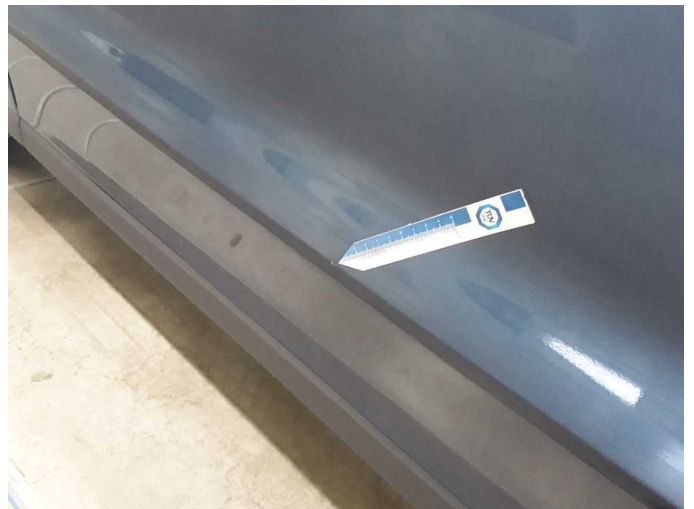
**Damage 4:** Door - front left side: Door - Scratch(es) - Smart repair

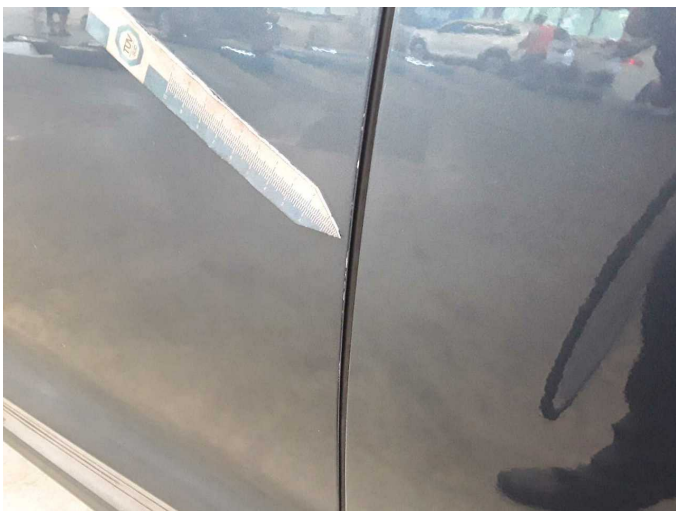
| No. | Component group | Description |
|---|---|---|
| 5 | Door - front left side | Door edge - Scratch(es) - Smart repair |

**Damage 5:** Door - front left side: Door edge - Scratch(es) - Smart repair

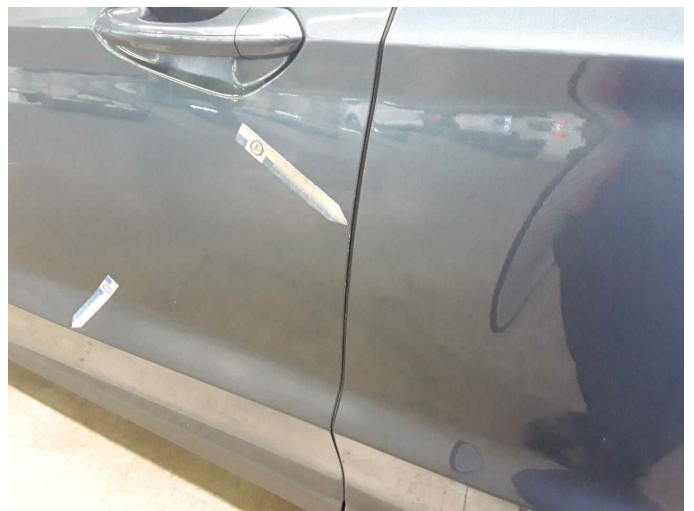
**Damage 5:** Door - front left side: Door edge - Scratch(es) - Smart repair

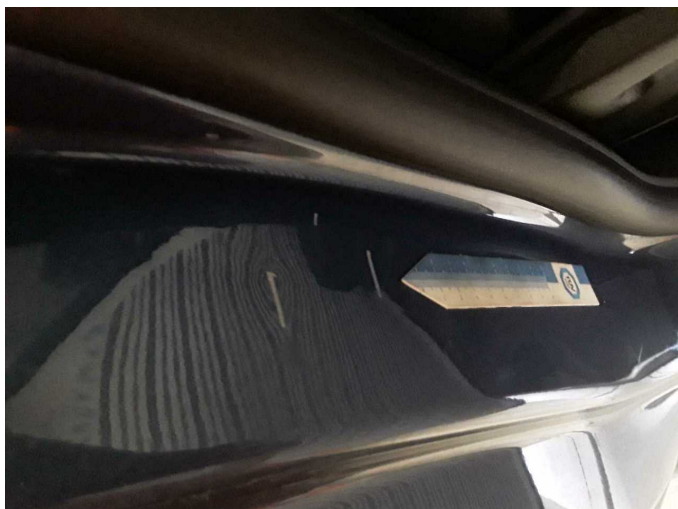
| No. | Component group | Description |
|---|---|---|
| 7 | Side panel - rear right side | Elbow - Dent / paintcoat damage - Smart repair |

**Damage 7:** Side panel - rear right side: Elbow - Dent / paintcoat damage  
- Smart repair

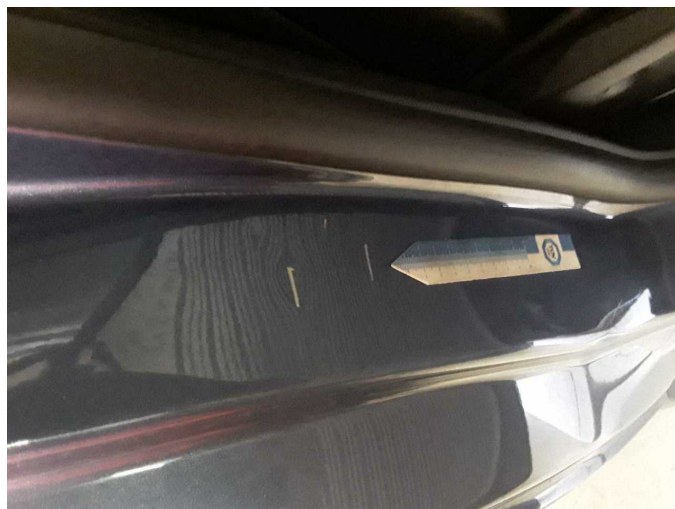
**Damage 7:** Side panel - rear right side: Elbow - Dent / paintcoat damage  
- Smart repair

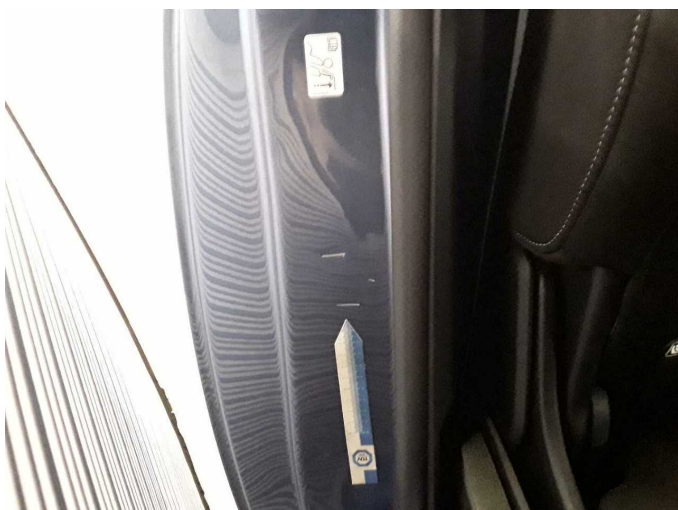
**Damage 7:** Side panel - rear right side: Elbow - Dent / paintcoat damage  
- Smart repair

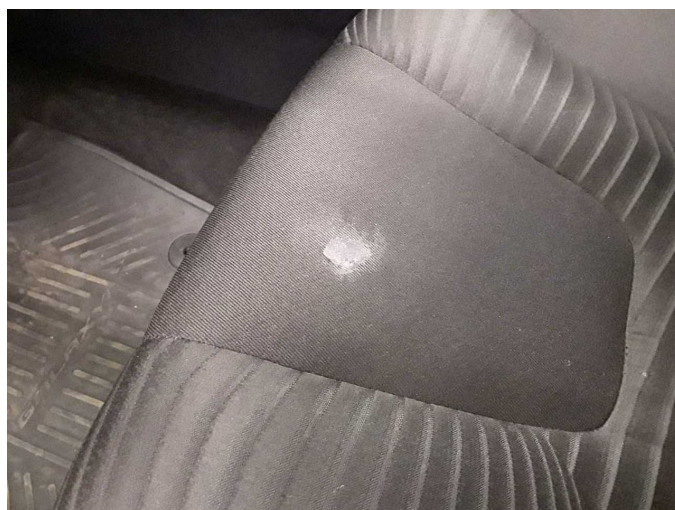
| No. | Component group | Description |
|---|---|---|
| 8 | Seat - front | Seat cover - left side - Damaged - Replace |

**Damage 8:** Seat - front: Seat cover - left side - Damaged - Replace

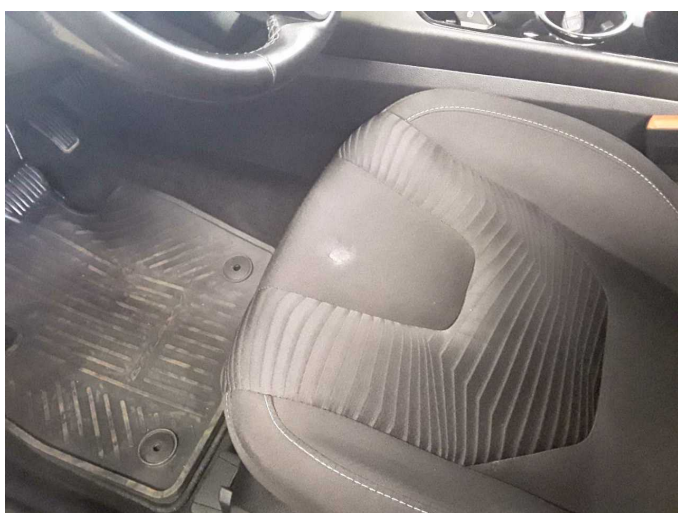
**Damage 8:** Seat - front: Seat cover - left side - Damaged - Replace

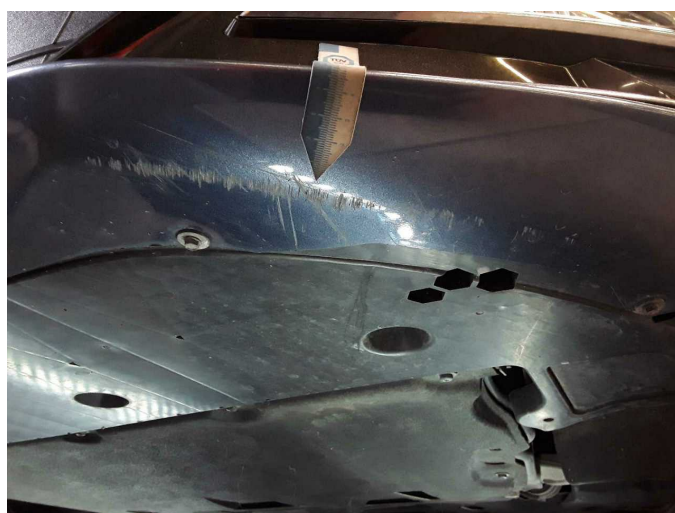
| No. | Component group | Description |
|---|---|---|
| 9 | Front bumper | Spoiler - Scratched - Paint |

**Damage 9:** Front bumper: Spoiler - Scratched - Paint

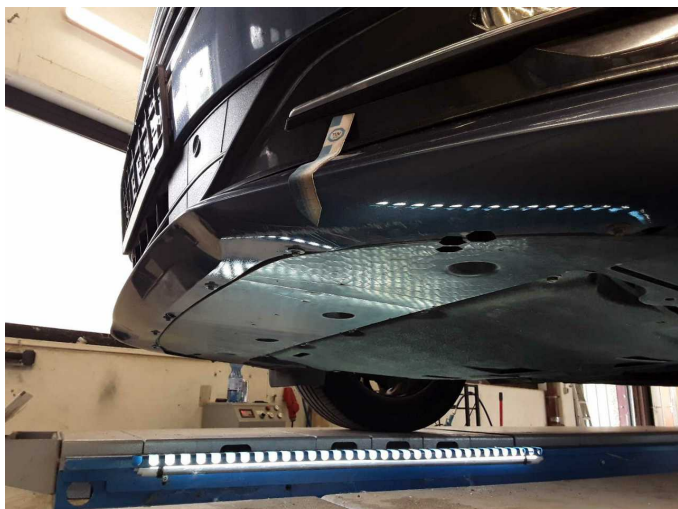
**Damage 9:** Front bumper: Spoiler - Scratched - Paint

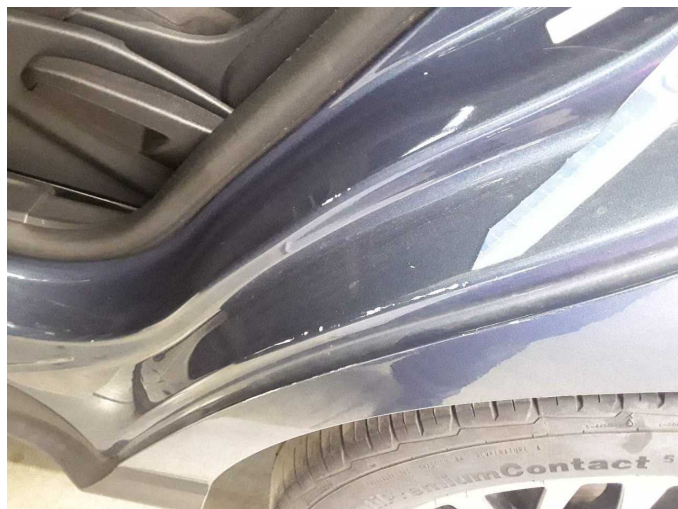
| No. | Component group | Description |
|---|---|---|
| 10 | Side panel - rear left side | Elbow - Scratch(es) - Paint |

**Damage 10:** Side panel - rear left side: Elbow - Scratch(es) - Paint

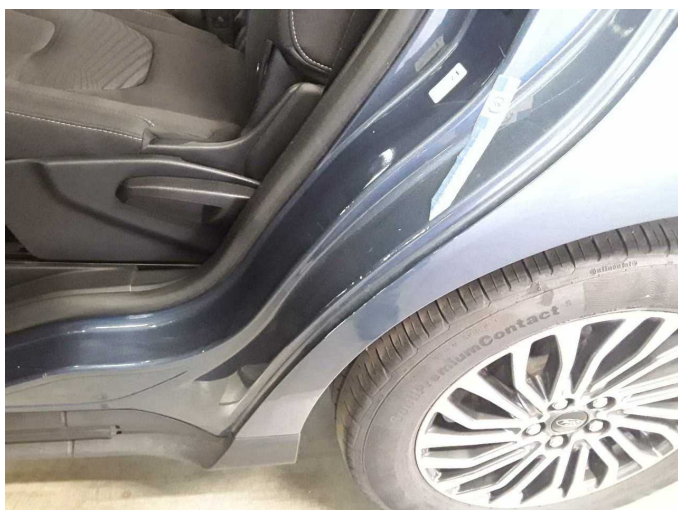
**Damage 10:** Side panel - rear left side: Elbow - Scratch(es) - Paint

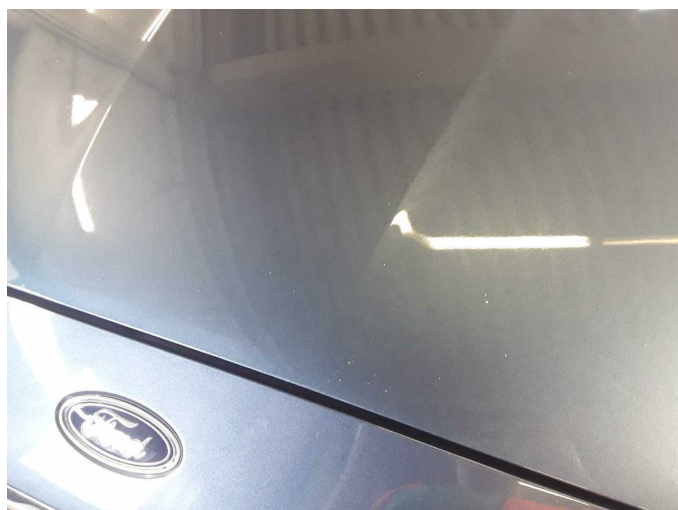
| No. | Component group | Description |
|---|---|---|
| 11 | Bonnet | Bonnet - Stone chips - Paint |

**Damage 11:** Bonnet: Bonnet - Stone chips - Paint

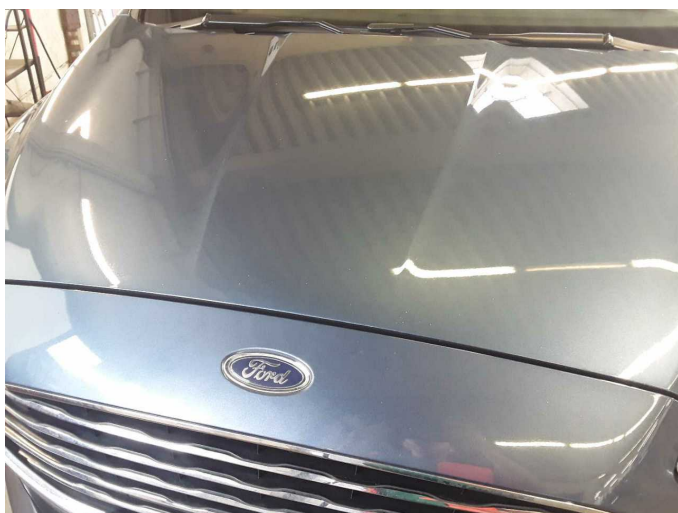
**Damage 11:** Bonnet: Bonnet - Stone chips - Paint

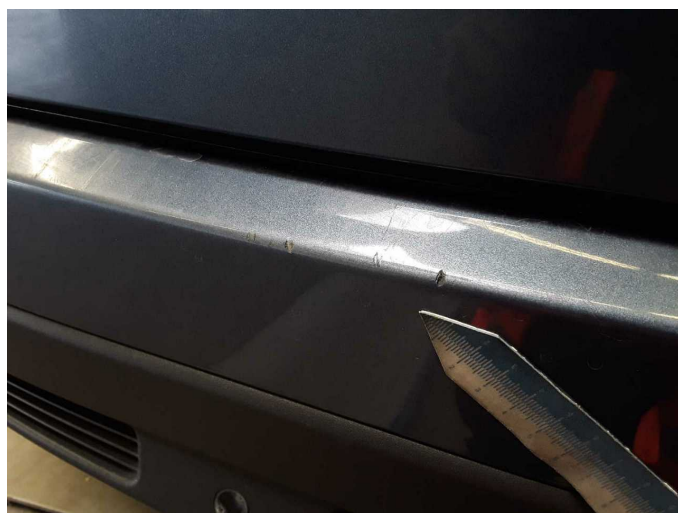
| No. | Component group | Description |
|---|---|---|
| 12 | Rear bumper | Rear bumper - Scratch(es) - Paint |

**Damage 12:** Rear bumper: Rear bumper - Scratch(es) - Paint

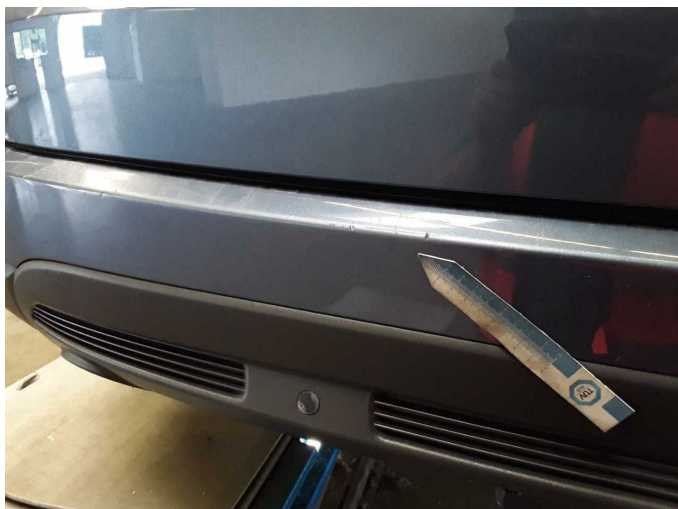
**Damage 12:** Rear bumper: Rear bumper - Scratch(es) - Paint

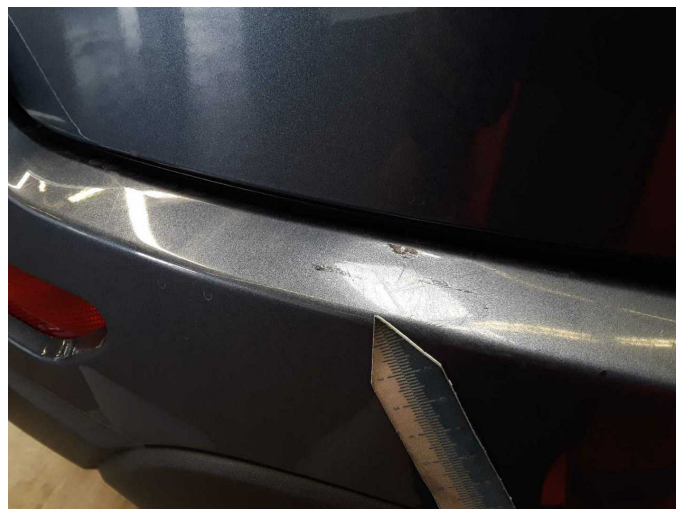
**Damage 12:** Rear bumper: Rear bumper - Scratch(es) - Paint

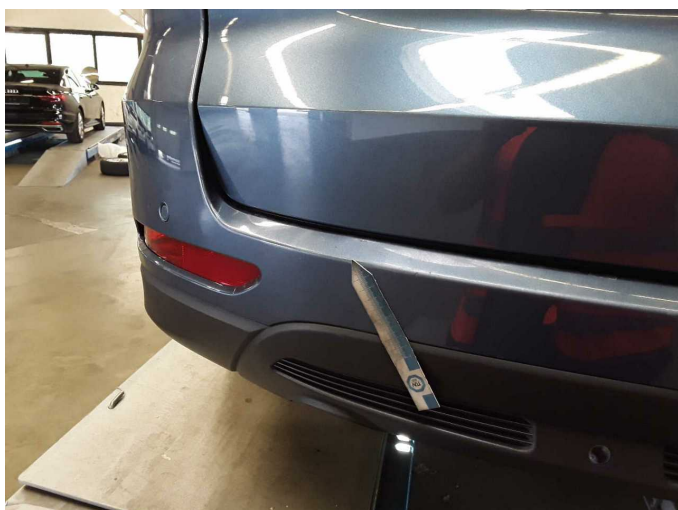
**Damage 12:** Rear bumper: Rear bumper - Scratch(es) - Paint

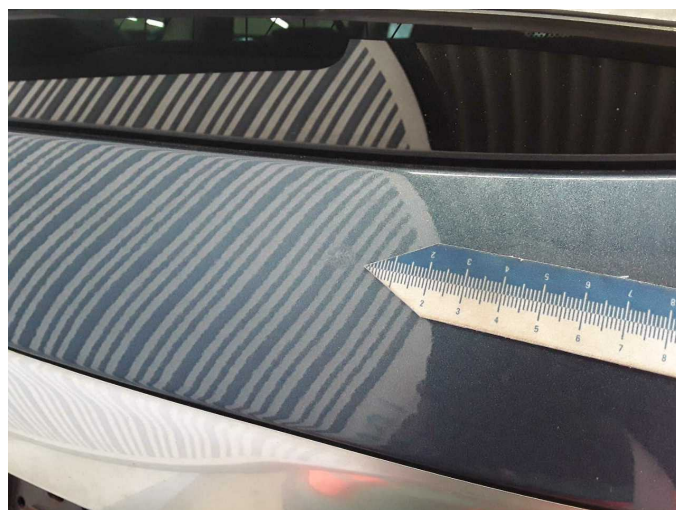
| No. | Component group | Description |
|---|---|---|
| 13 | Boot lid / rear door | Boot lid (Rostansatz) - Corrosion - Paint |

**Damage 13:** Boot lid / rear door: Boot lid (Rostansatz) - Corrosion - Paint

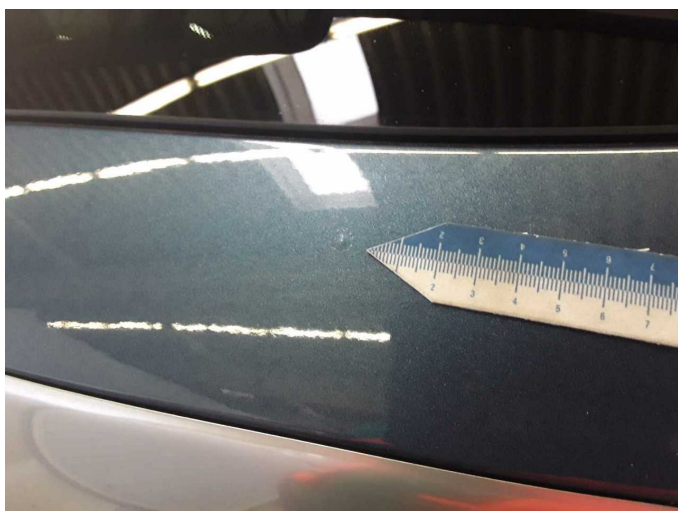
**Damage 13:** Boot lid / rear door: Boot lid (Rostansatz) - Corrosion - Paint

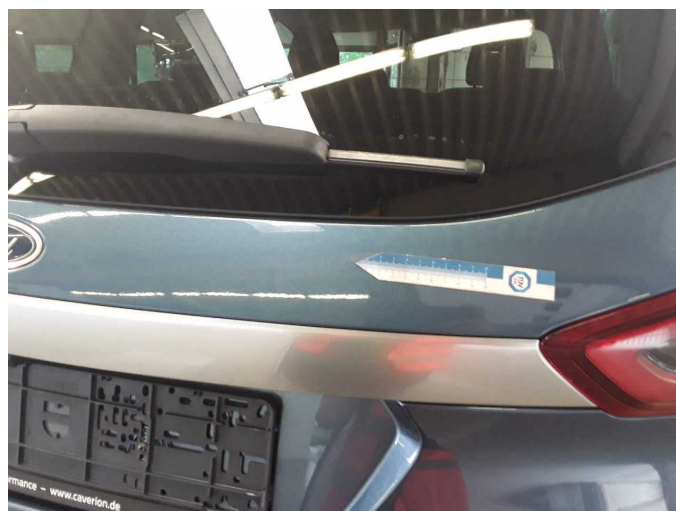
**Damage 13:** Boot lid / rear door: Boot lid (Rostansatz) - Corrosion - Paint
