Expertise

Protocol number: 47029000  
Order No. / Reference: 26652165-1  
Inspection date: 29 Jul 2026

Manufacturer: Iveco  
VIN: ZCFCR35A805543646

Model: 35 S 14NA8 V

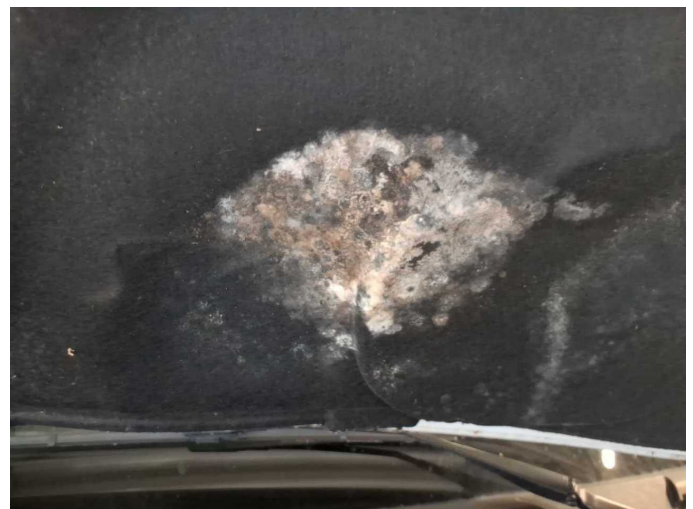
| No. | Component group | Description |
|---|---|---|
| 2 | Bonnet | Insulation lining - Soiled - Replace |

Damage 2: Bonnet: Insulation lining - Soiled - Replace

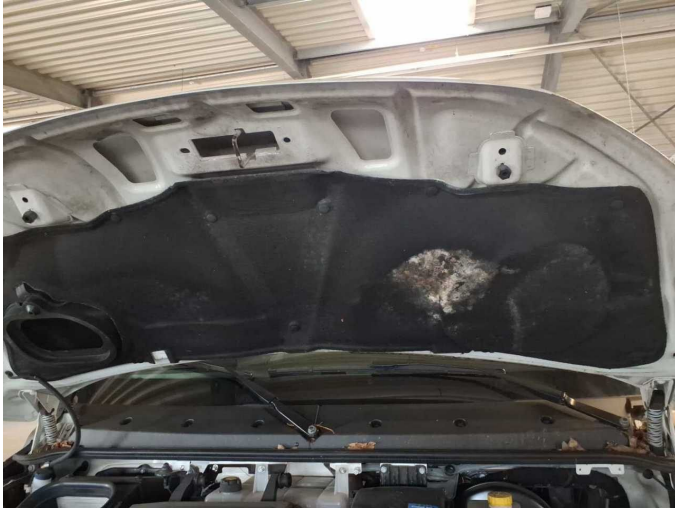
**Damage 2:** Bonnet: Insulation lining - Soiled - Replace

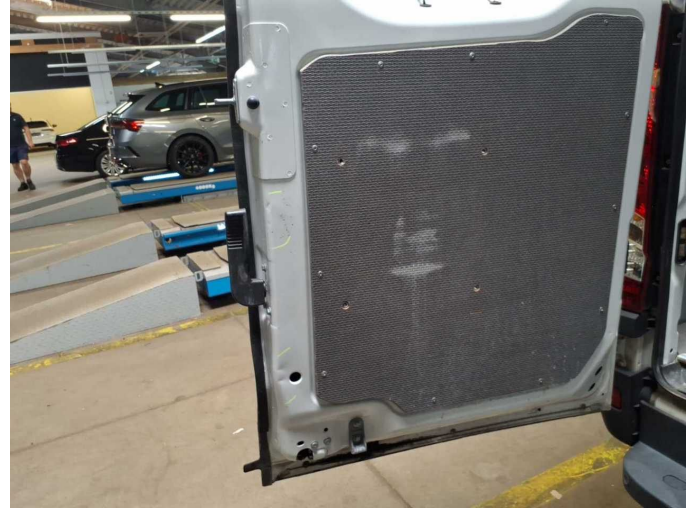
| No. | Component group | Description |
|---|---|---|
| 3 | Boot lid / rear door | Rear door - left side - dent(s) - Smart repair |

**Damage 3:** Boot lid / rear door: Rear door - left side - dent(s) - Smart repair

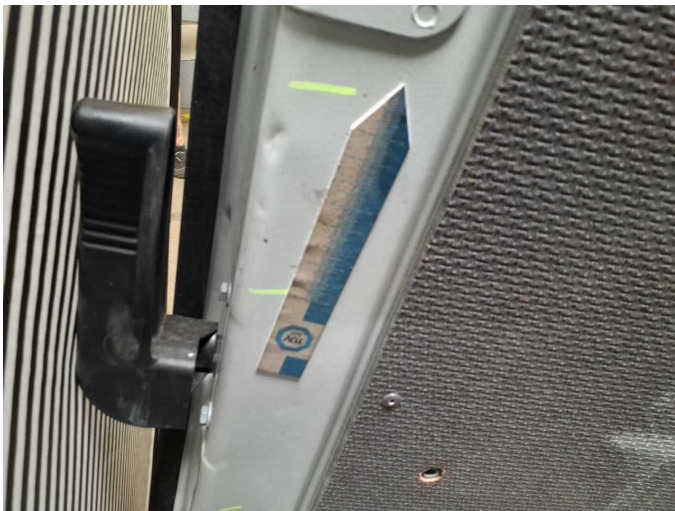
**Damage 3:** Boot lid / rear door: Rear door - left side - dent(s) - Smart repair

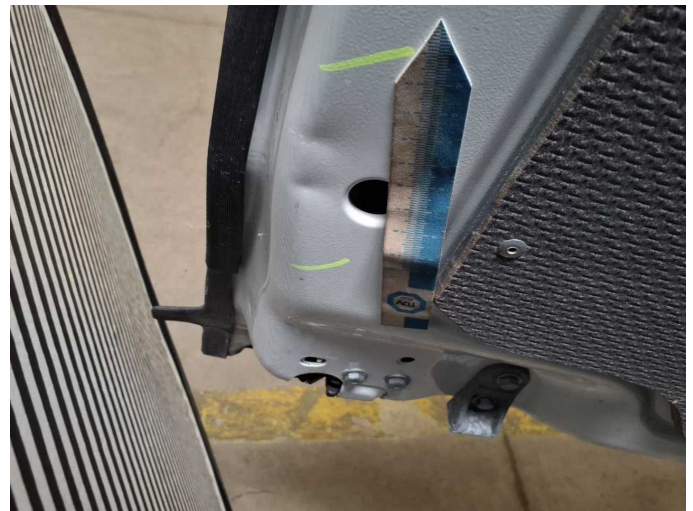
**Damage 3:** Boot lid / rear door: Rear door - left side - dent(s) - Smart repair

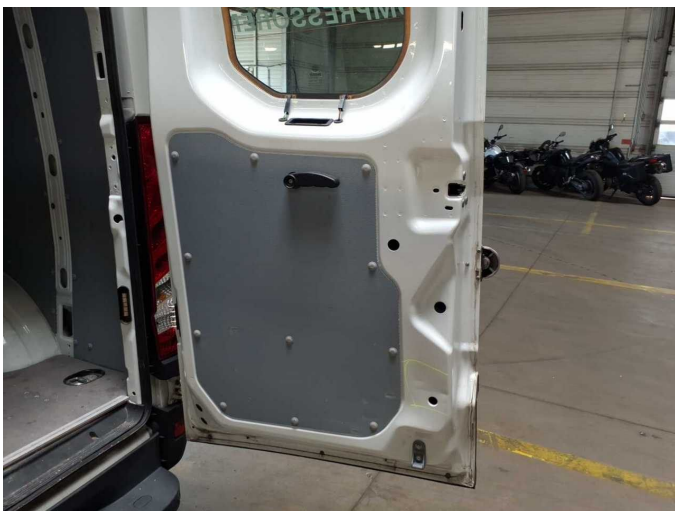
| No. | Component group | Description |
|---|---|---|
| 4 | Boot lid / rear door | Rear door - right side - dent(s) - Smart repair |

**Damage 4:** Boot lid / rear door: Rear door - right side - dent(s) - Smart repair

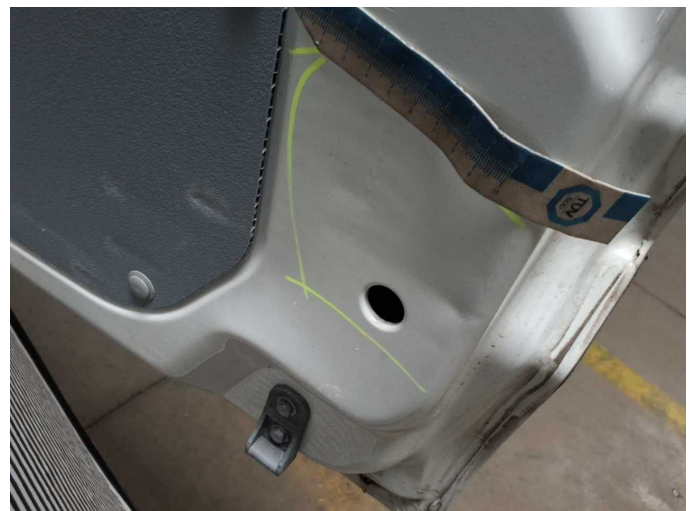
**Damage 4:** Boot lid / rear door: Rear door - right side - dent(s) - Smart repair

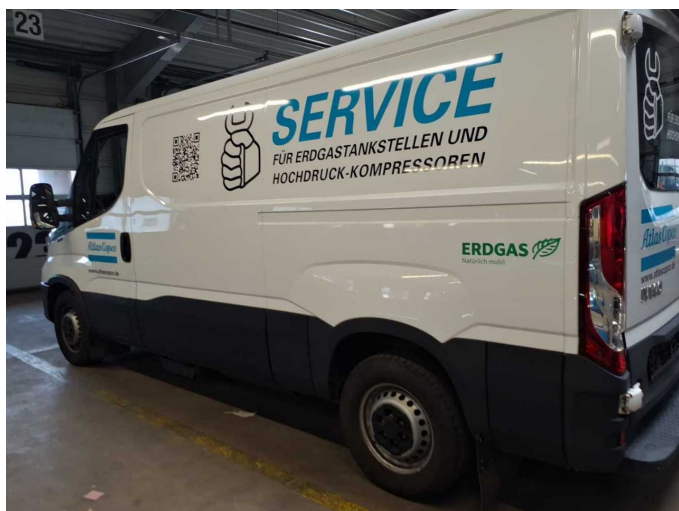
| No. | Component group | Description |
|---|---|---|
| 5 | Misc. | Vehicle - Glued / labelled - De-glue / neutralise |

Damage 5: Misc.: Vehicle - Glued / labelled - De-glue / neutralise

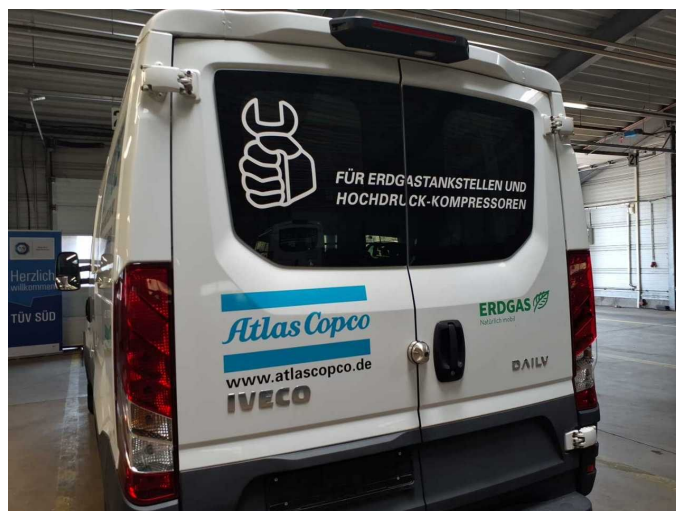
Damage 5: Misc.: Vehicle - Glued / labelled - De-glue / neutralise

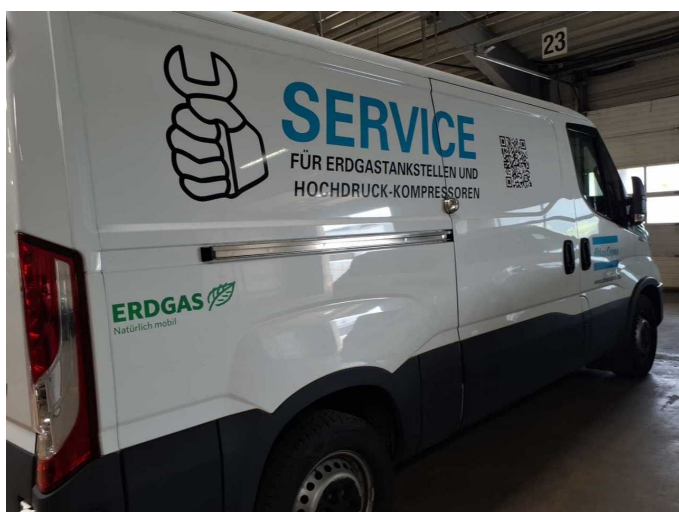
Damage 5: Misc.: Vehicle - Glued / labelled - De-glue / neutralise
