Expertise

Protocol number: 45858927
Order No. / Reference: 26490215
Inspection date: 8 Jun 2026

Manufacturer: Opel

Model: Astra Sports Tourer 1.5 D Business Elegance

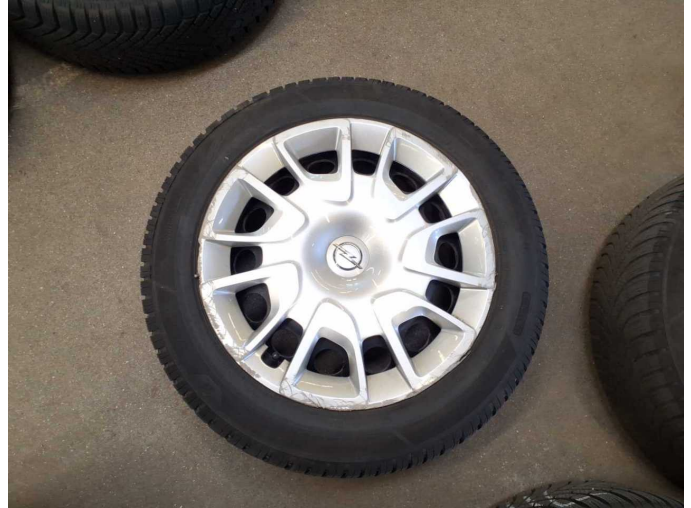
Damage 1: 2nd wheel set: 1 wheel cover - Broken / torn - Replace

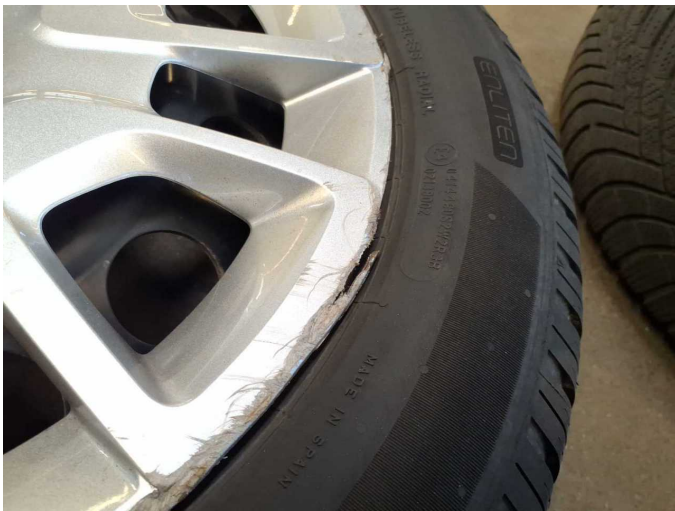
Damage 1: 2nd wheel set: 1 wheel cover - Broken / torn - Replace

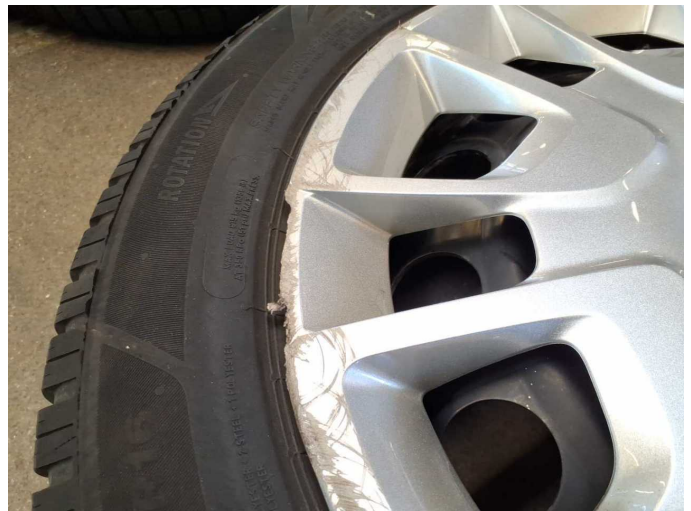
Damage 1: 2nd wheel set: 1 wheel cover - Broken / torn - Replace

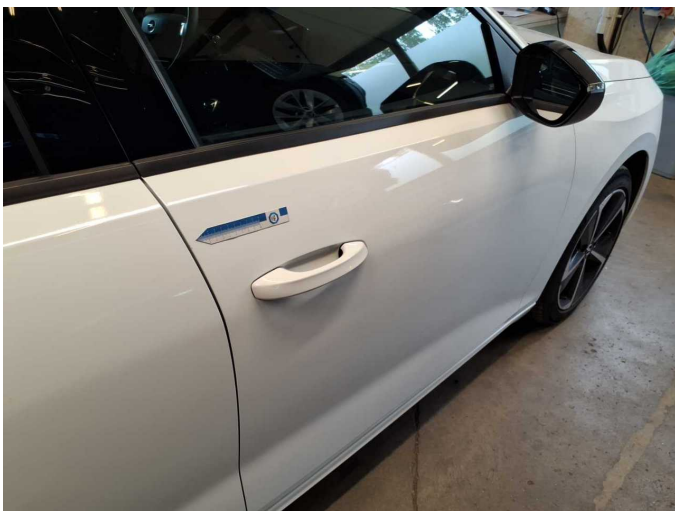
Damage 2: Door - front right side: Door edge - Scratched - Smart repair

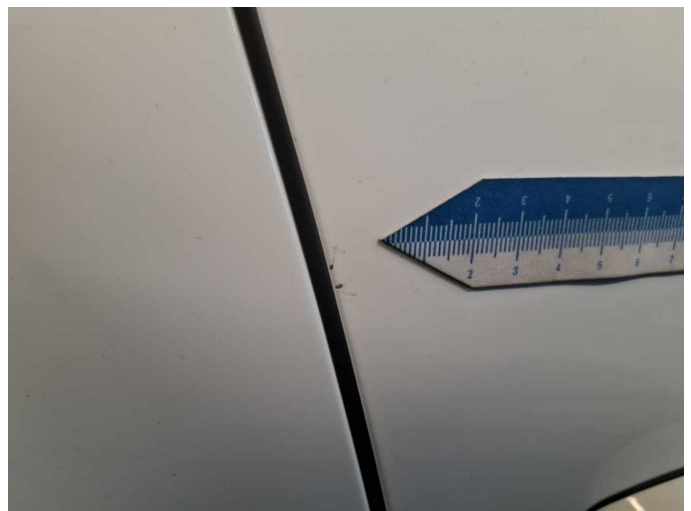
Damage 2: Door - front right side: Door edge - Scratched - Smart repair

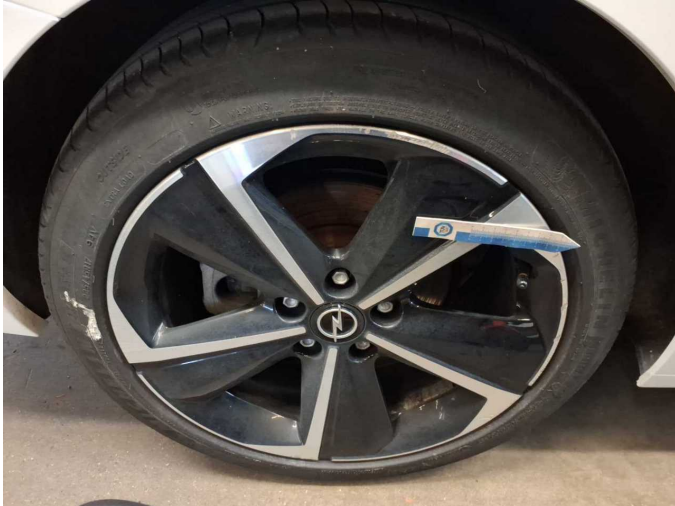
Damage 3: Wheel / tyres: Tyre - rear right side - Broken / torn - Replace

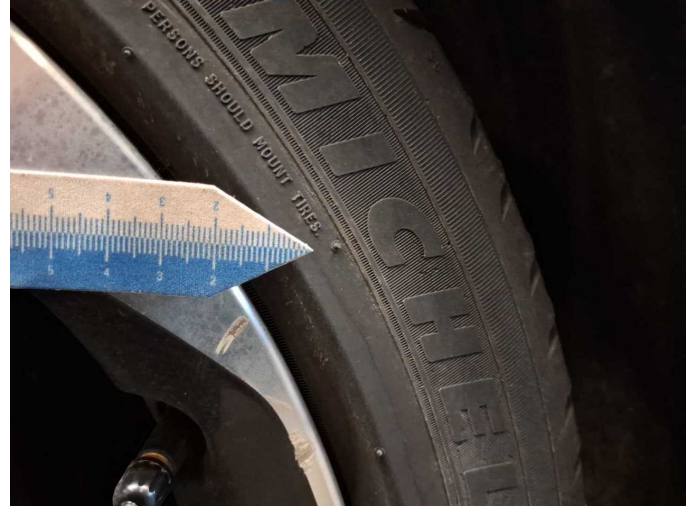
Damage 3: Wheel / tyres: Tyre - rear right side - Broken / torn - Replace

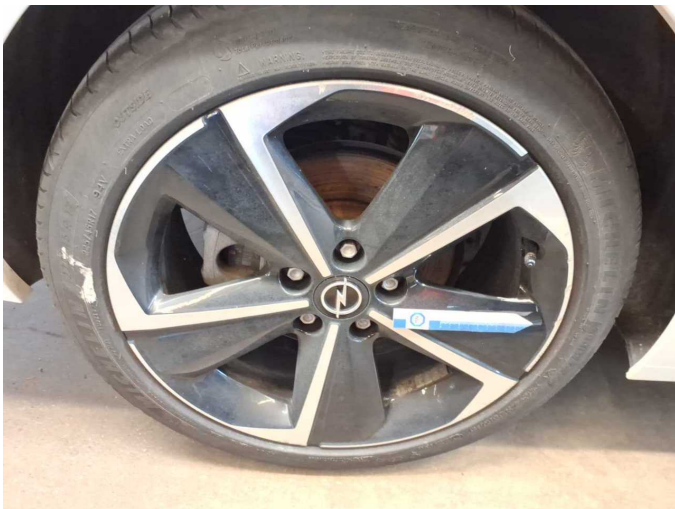
Damage 4: Wheel / tyres: Alloy rim - rear right side (Materialabtrag) - Scratched - Replace

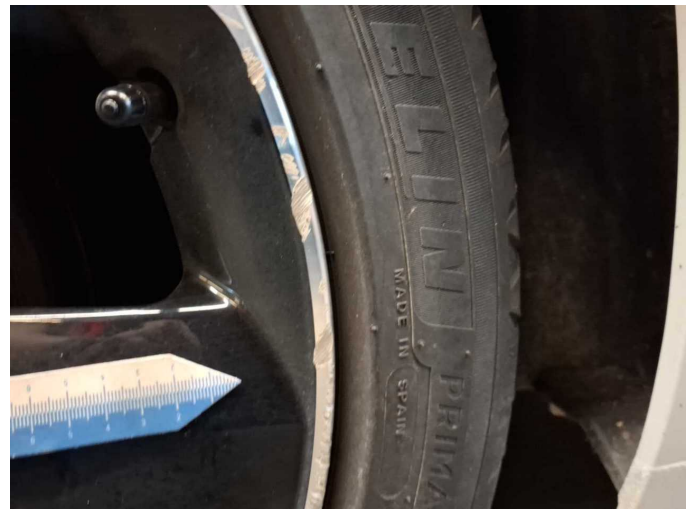
Damage 4: Wheel / tyres: Alloy rim - rear right side (Materialabtrag) - Scratched - Replace

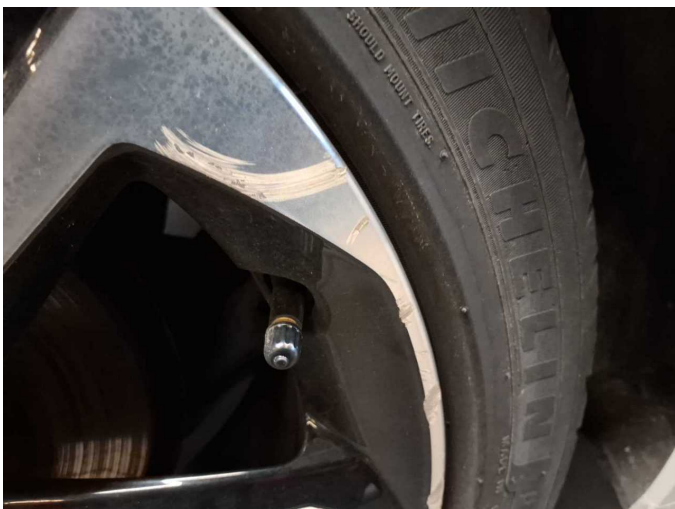
Damage 4: Wheel / tyres: Alloy rim - rear right side (Materialabtrag) - Scratched - Replace

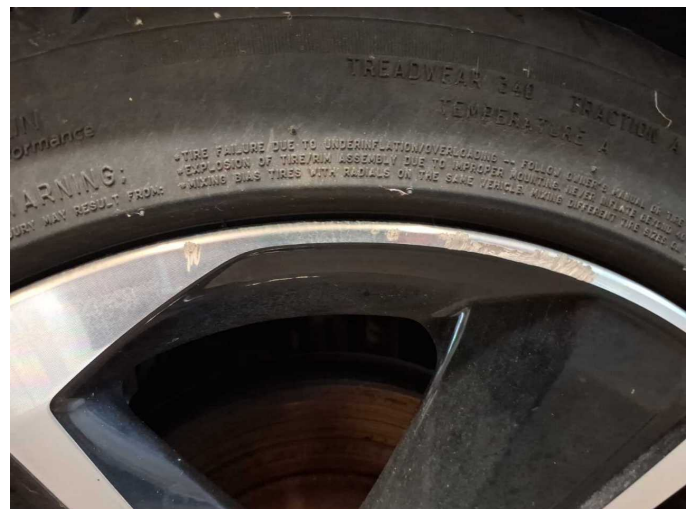
Damage 4: Wheel / tyres: Alloy rim - rear right side (Materialabtrag) - Scratched - Replace

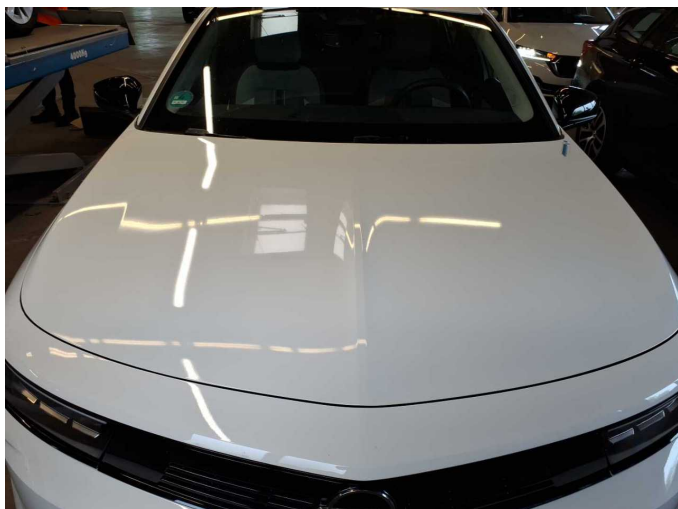
Damage 5: Bonnet: Bonnet - Dent / paintcoat damage - Repair and paint

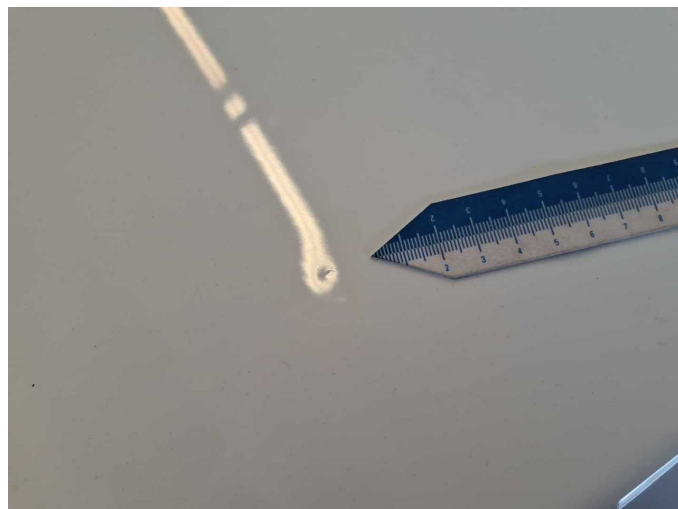
Damage 5: Bonnet: Bonnet - Dent / paintcoat damage - Repair and paint

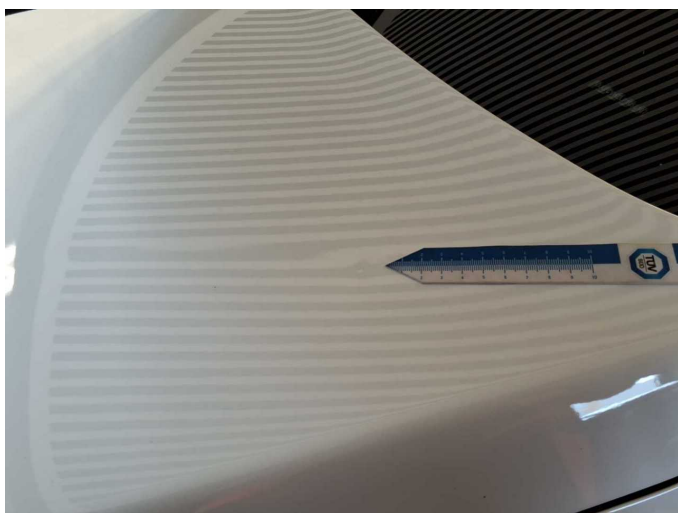
Damage 5: Bonnet: Bonnet - Dent / paintcoat damage - Repair and paint
