## Expertise

Protocol number: 46382848  
Order No. / Reference: 26293391  
Inspection date: 7 Jul 2026

Manufacturer: Mercedes-Benz

Model: Vito 116 CDI Lang HA Aut. PRO

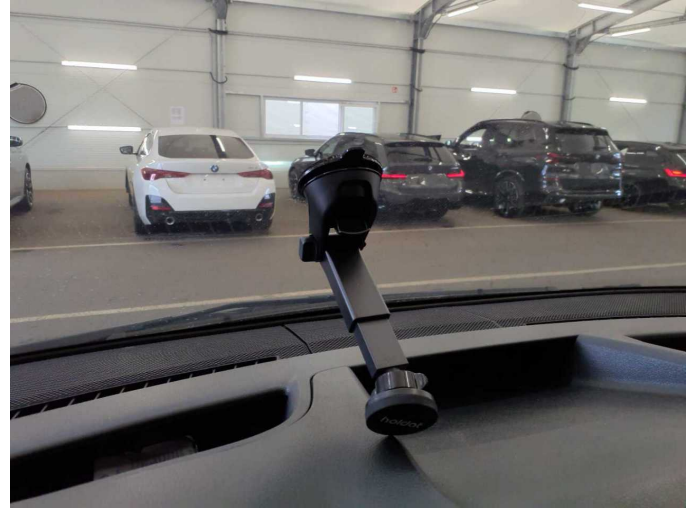
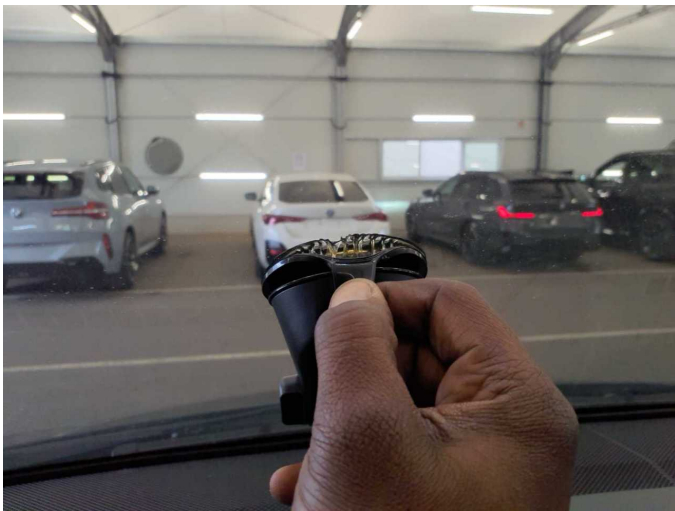
No.	Component group	Description
1	Vehicle glazing	Windscreen - Glued / labelled - De-glue / neutralise
2	Front bumper	Front bumper - Scratch(es) - Paint

**Damage 1:** Vehicle glazing: Windscreen - Glued / labelled - De-glove / neutralise

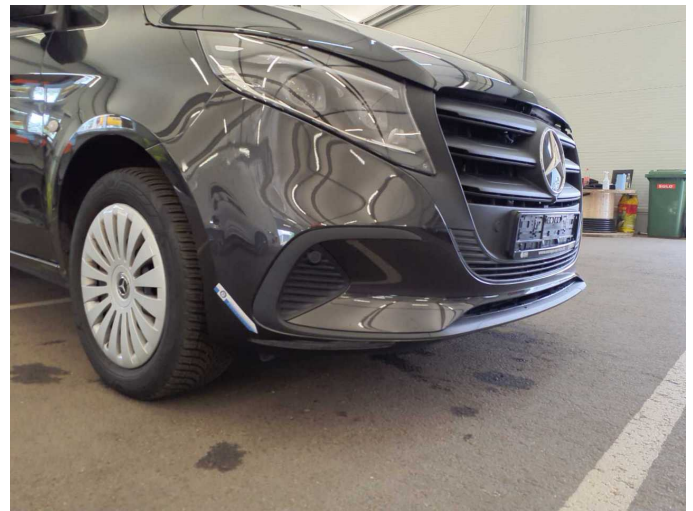
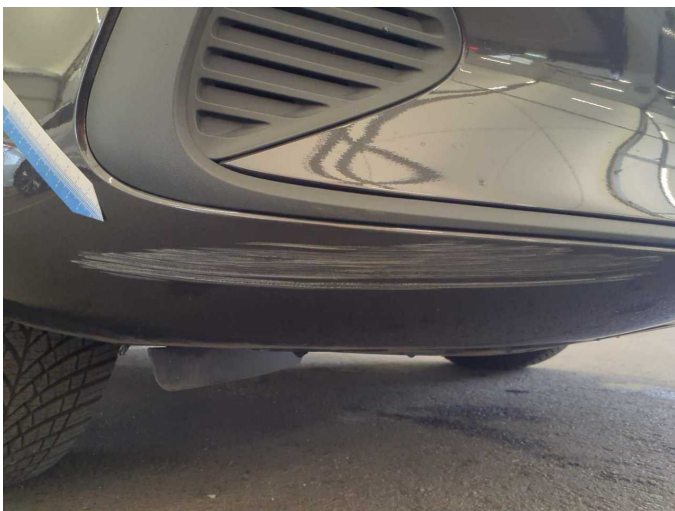
**Damage 2:** Front bumper: Front bumper - Scratch(es) - Paint

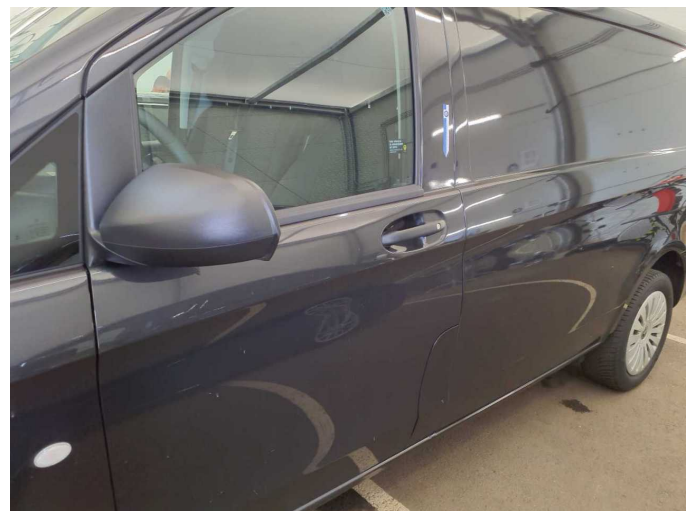
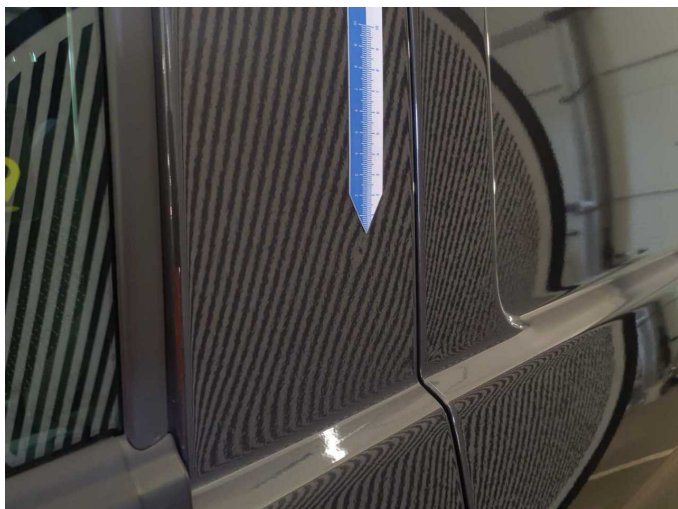
No.	Component group	Description
1	Rear bumper	Rear bumper - Scratch(es) - No deduction
2	Door - front left side	Door - dent(s) - No deduction

**Wear and tear 2:** Door - front left side: Door - dent(s) - No deduction

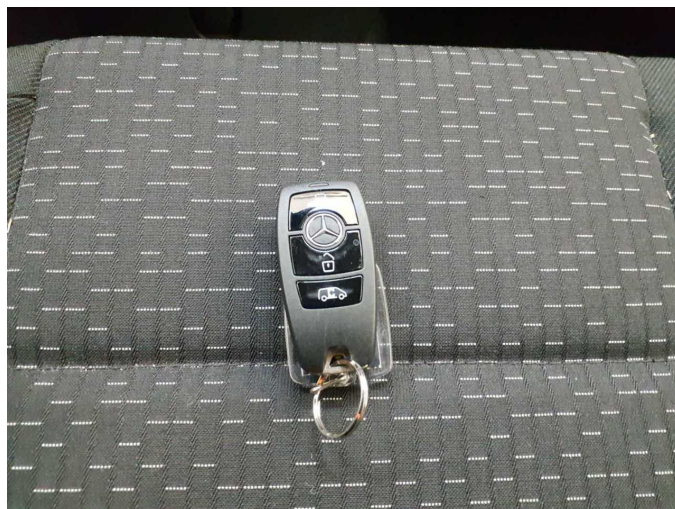
Equipment - Vehicle key

**Missing part 1:** Equipment: Vehicle key - Missing - Replace
