## Expertise

Protocol number: 46001455  
Order No. / Reference: 26503750  
Inspection date: 17 Jun 2026

Manufacturer: Skoda

Model: Superb Combi 2.0 TDI DSG Ambition

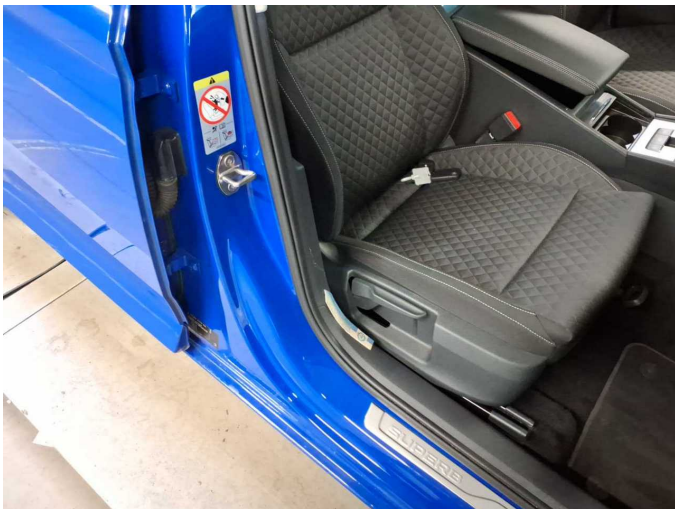
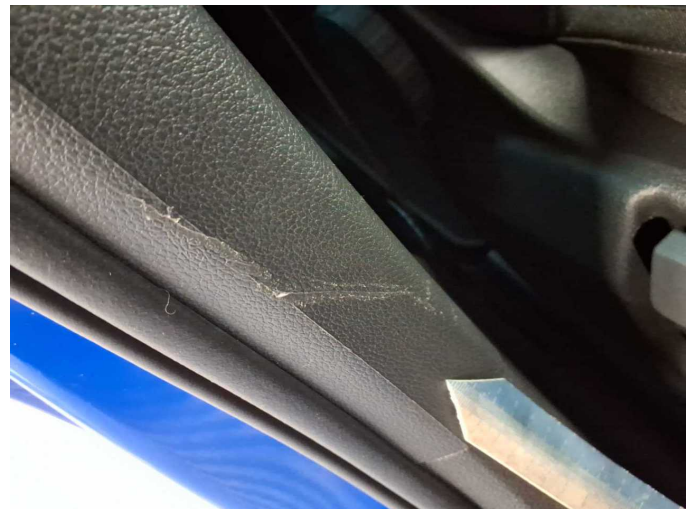
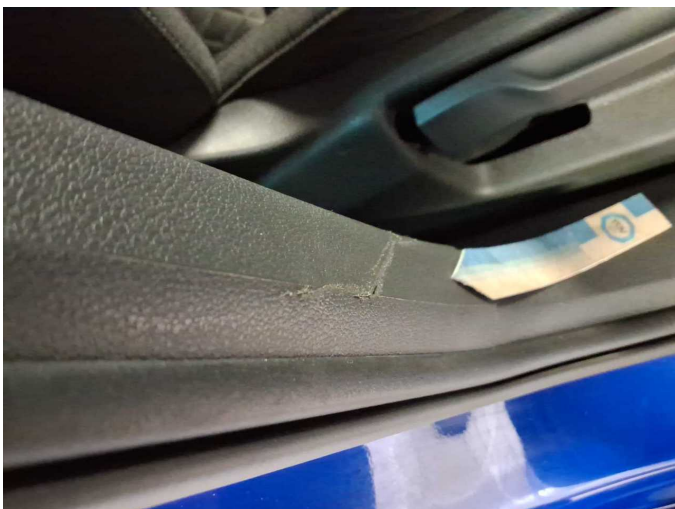
Damage 2: Trim / covers: B-pillar - trim - interior, right side - Scratched - Replace

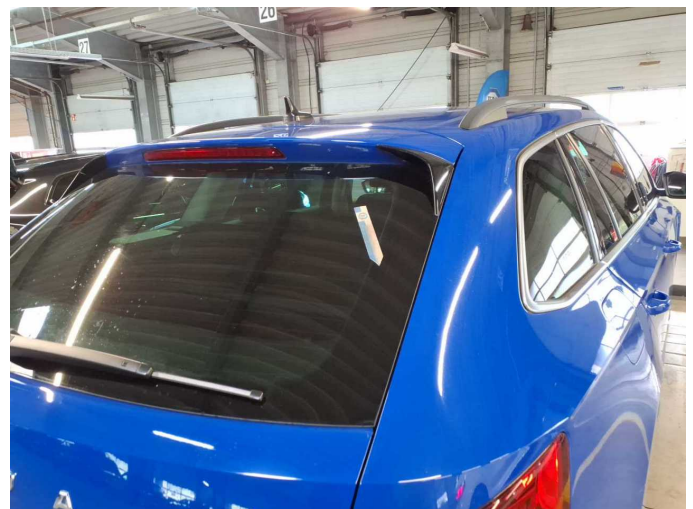
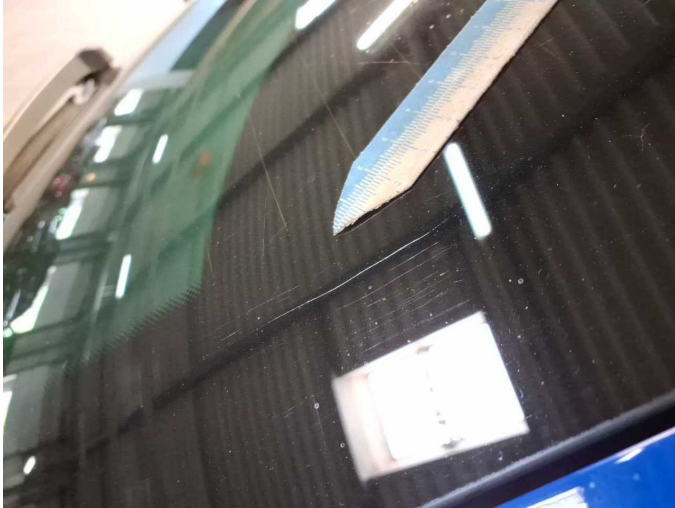
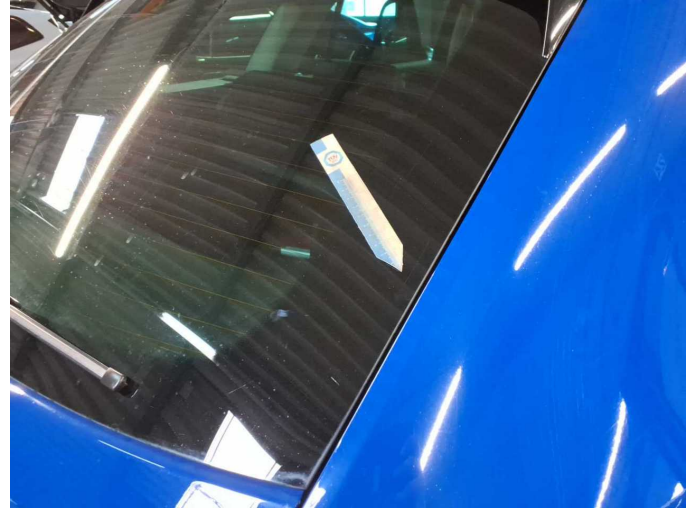
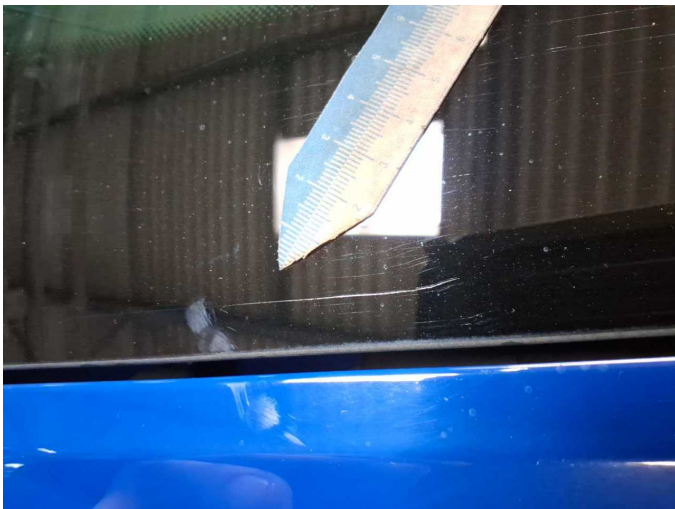
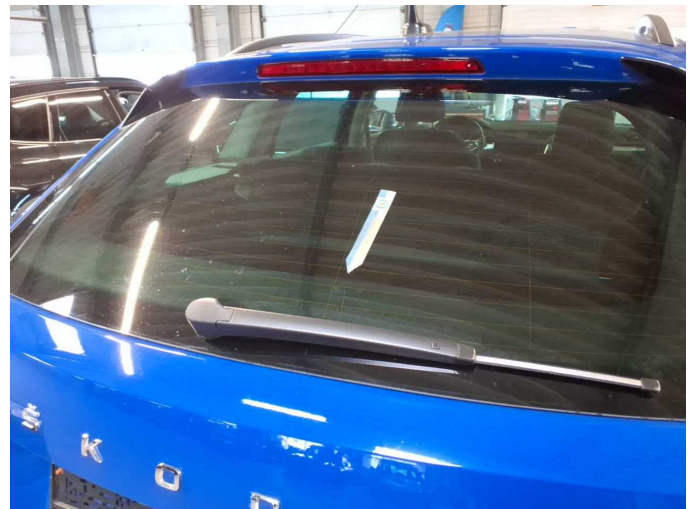
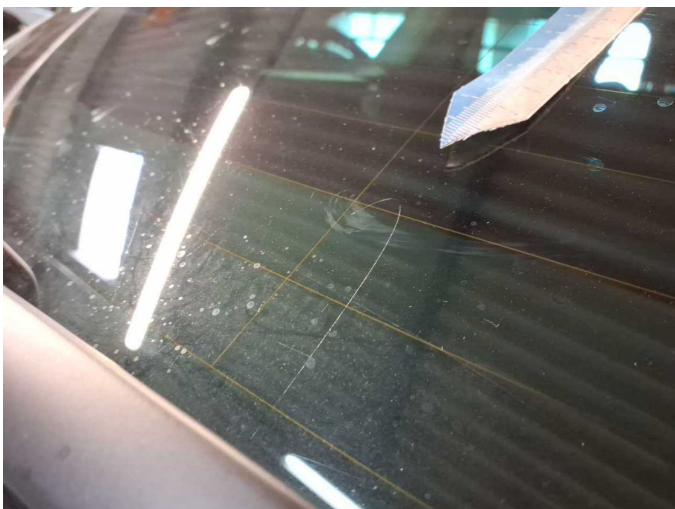
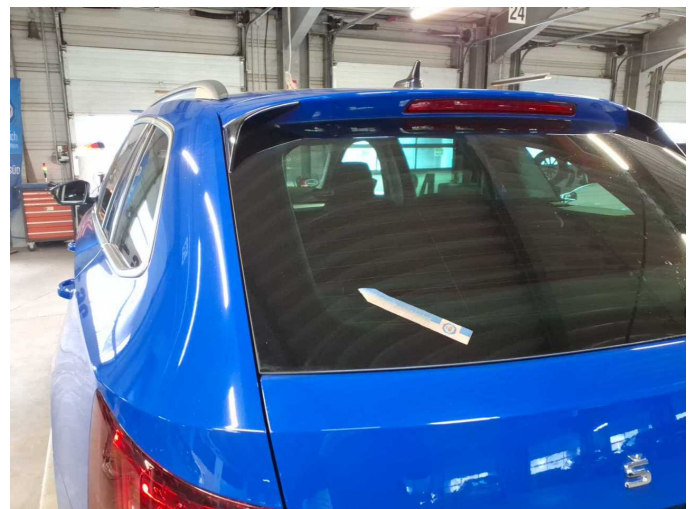
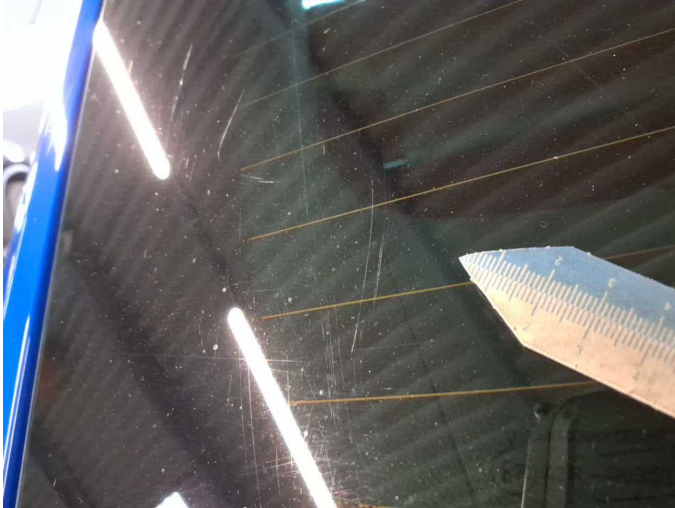
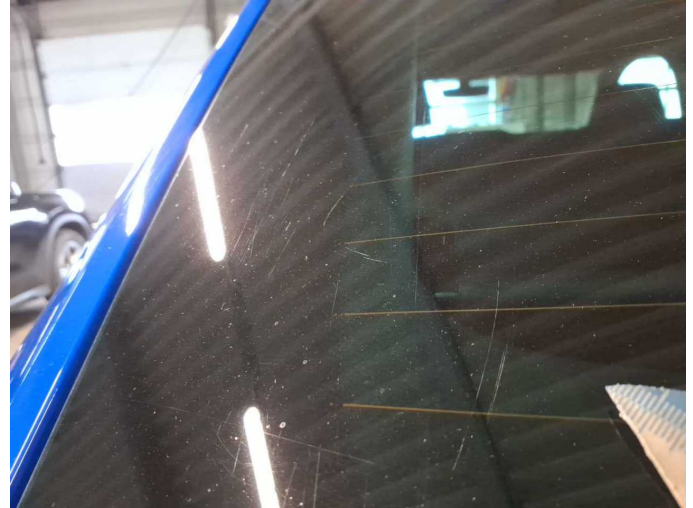
Damage 3: Vehicle glazing: Rear window - Scratched - Loss in value

**Damage 3:** Vehicle glazing: Rear window - Scratched - Loss in value

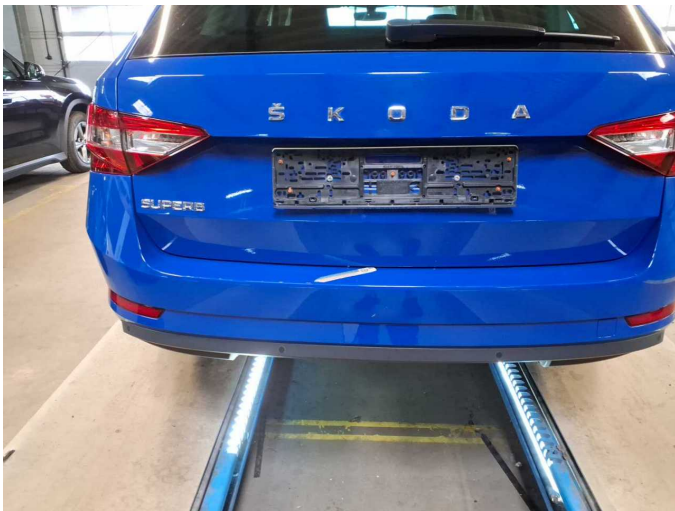
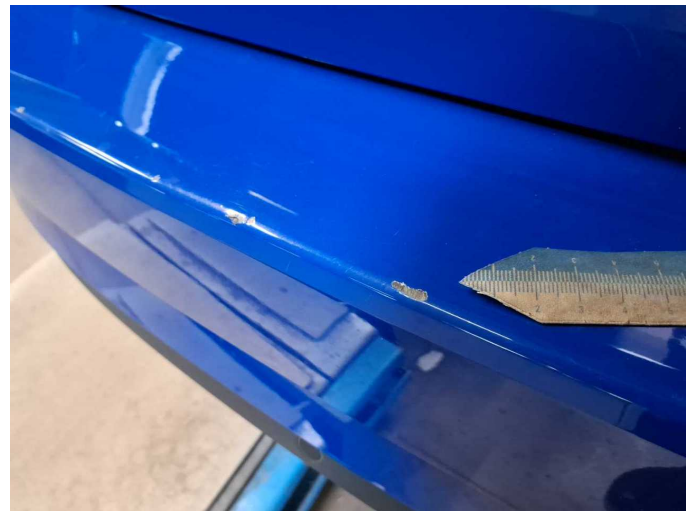
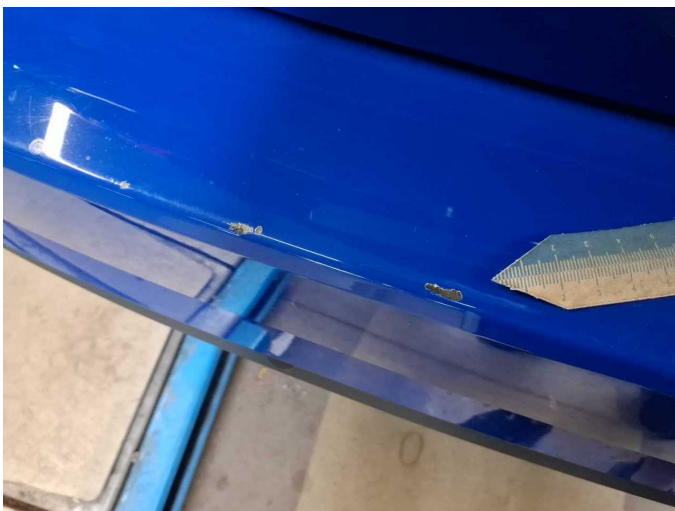
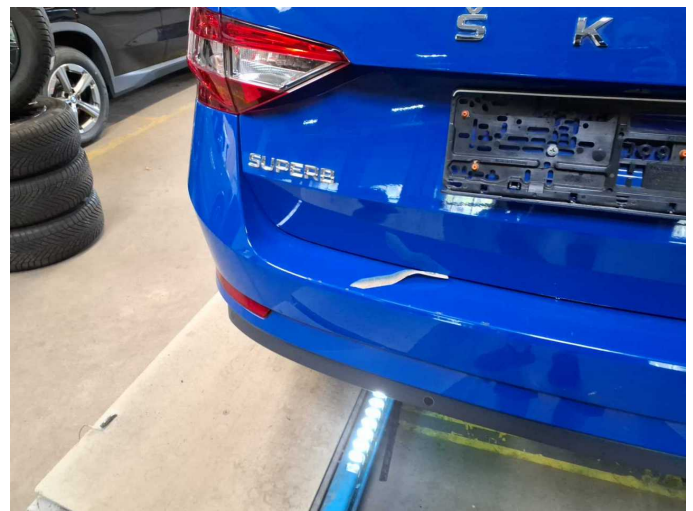
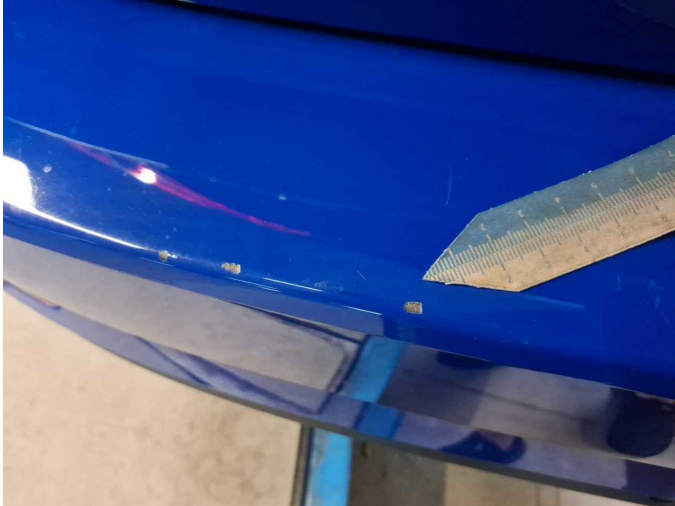
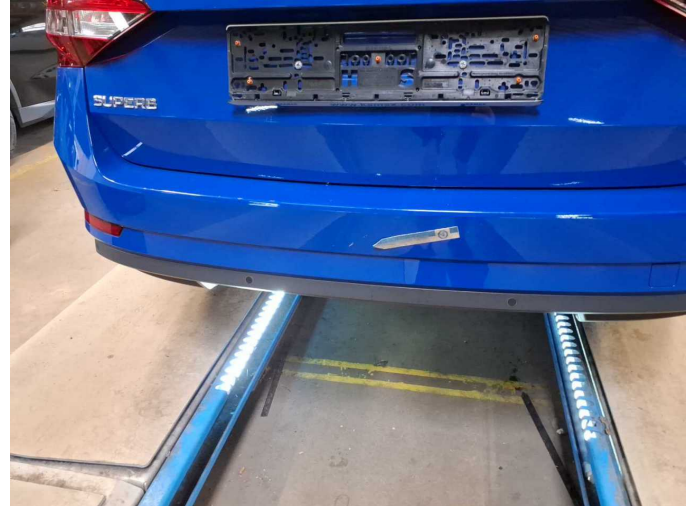
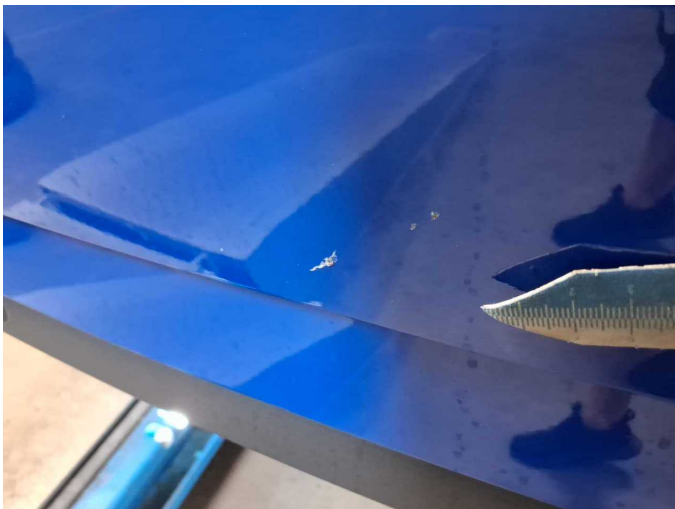
**Damage 4:** Rear bumper: Rear bumper - Scratched - Paint

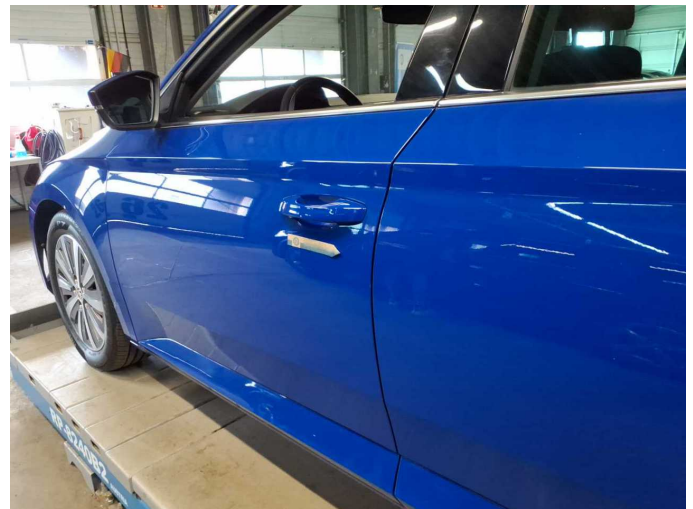
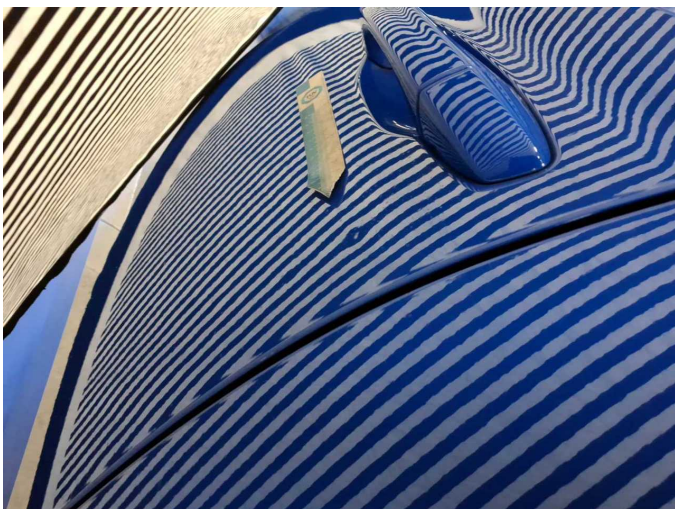
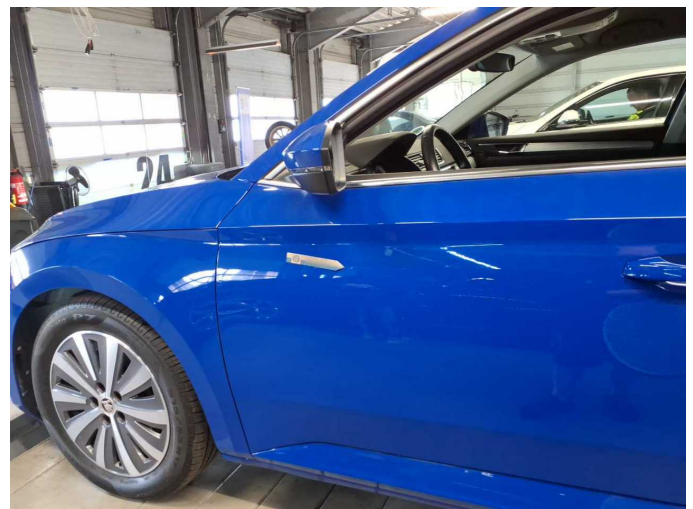
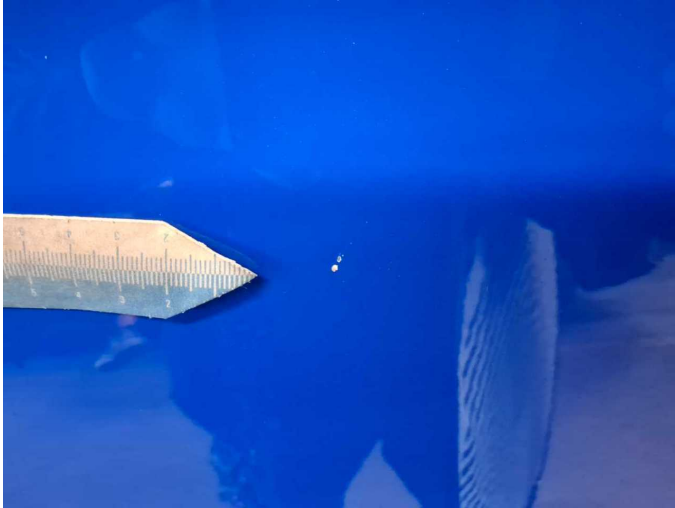
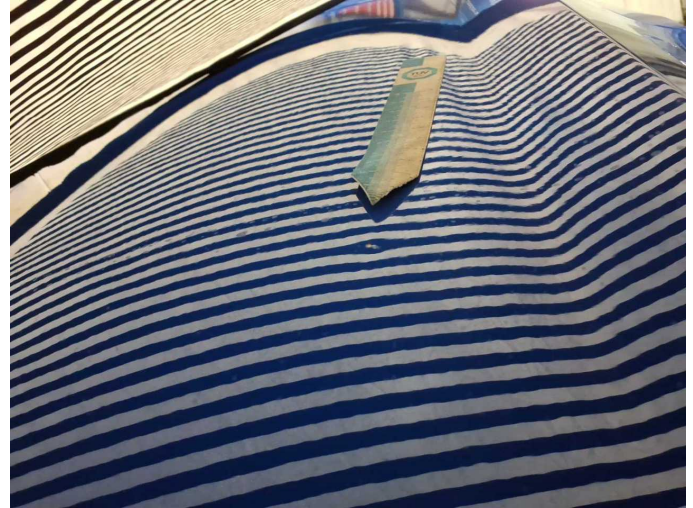
**Damage 5:** Door - front left side: Door - Dent / paintcoat damage - Paint

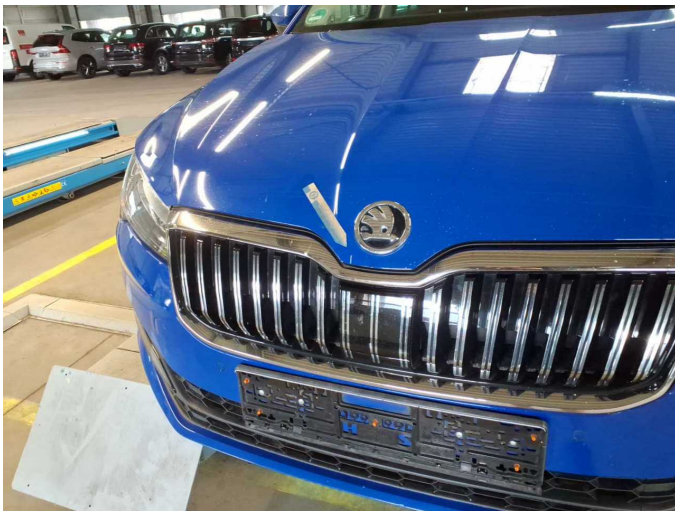
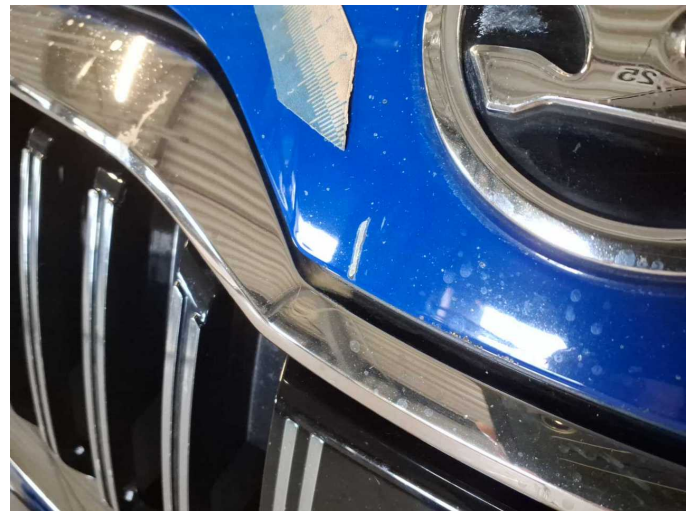
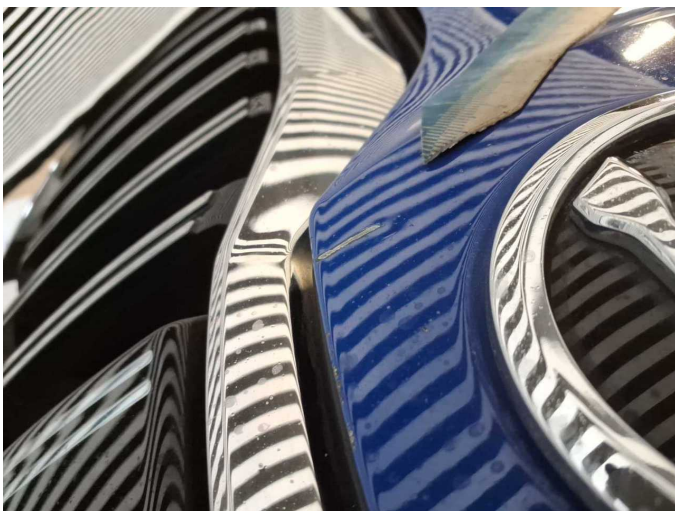
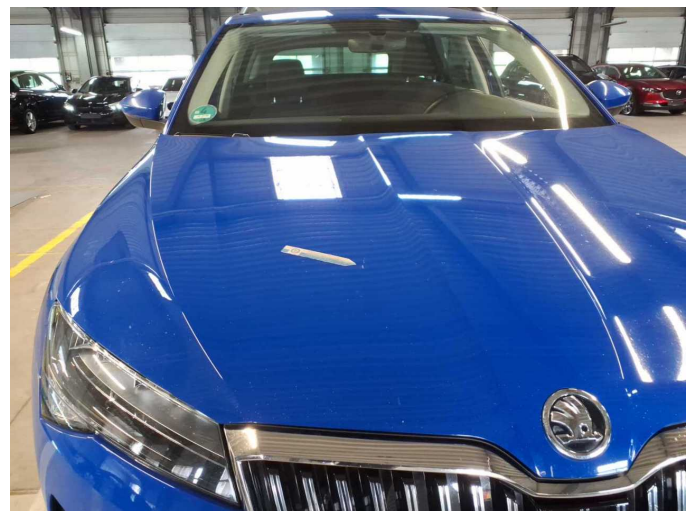
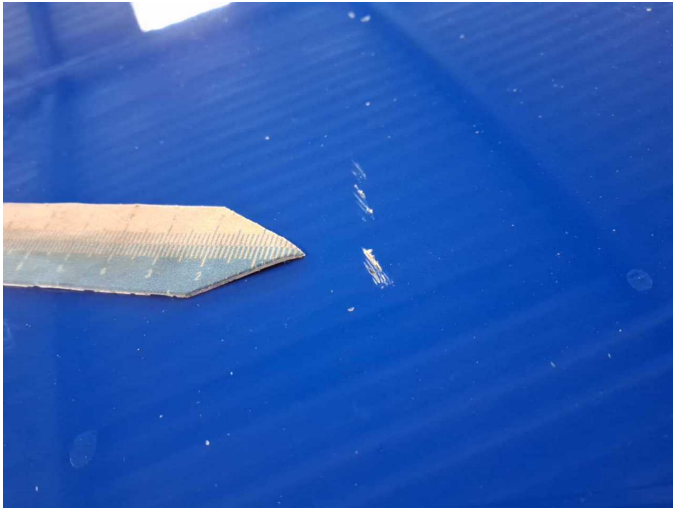
**Damage 6:** Bonnet: Bonnet - Dent / paintcoat damage - Paint

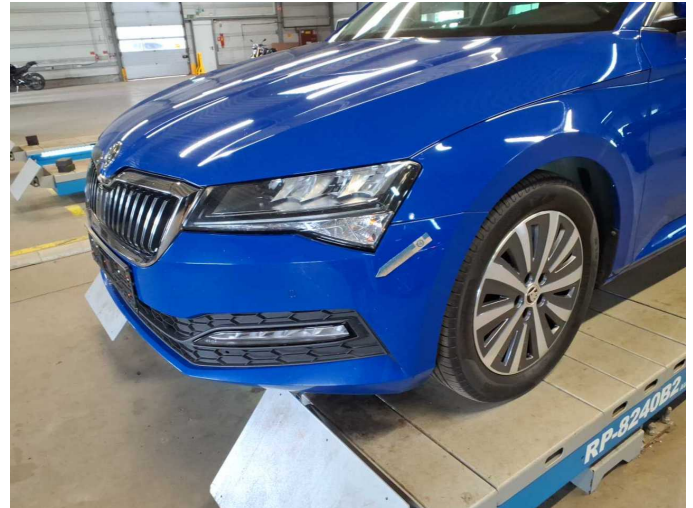
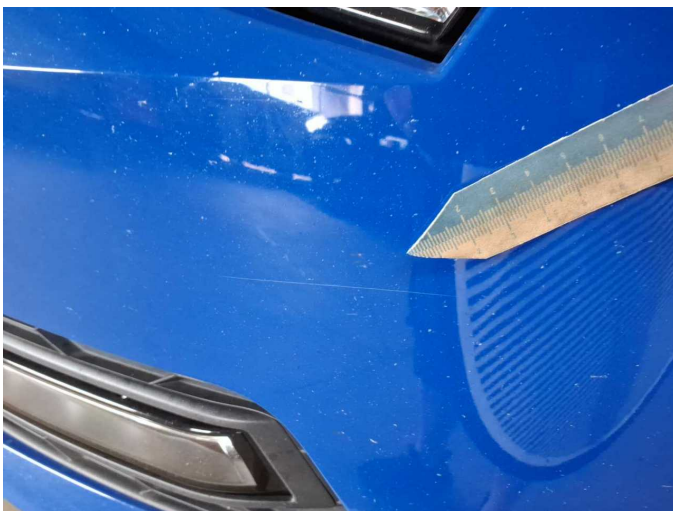
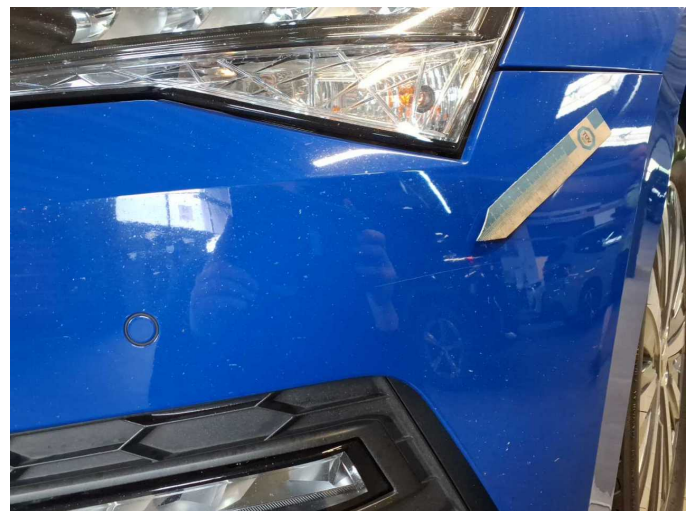
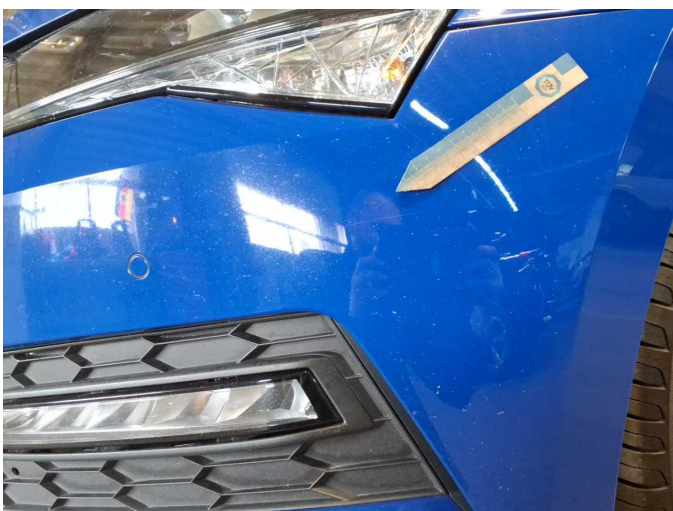
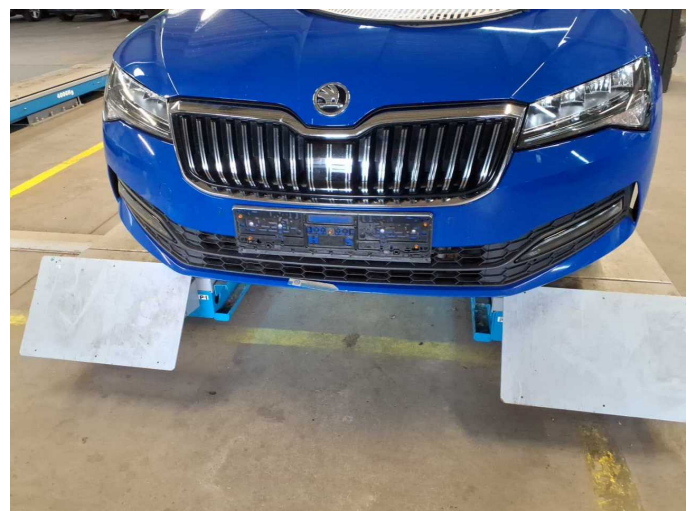
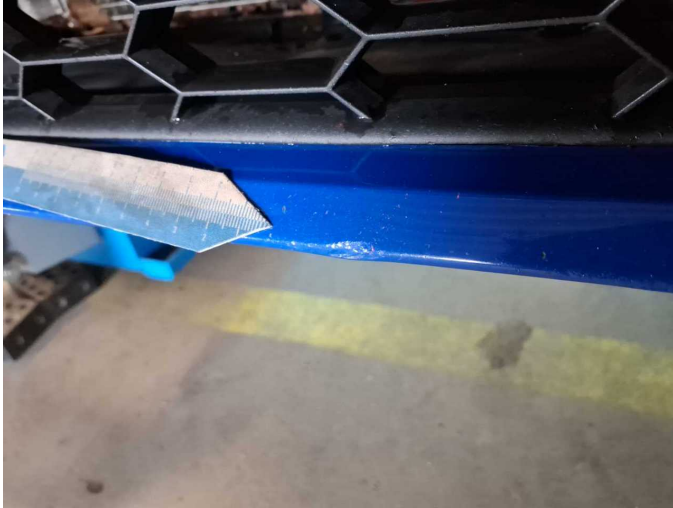
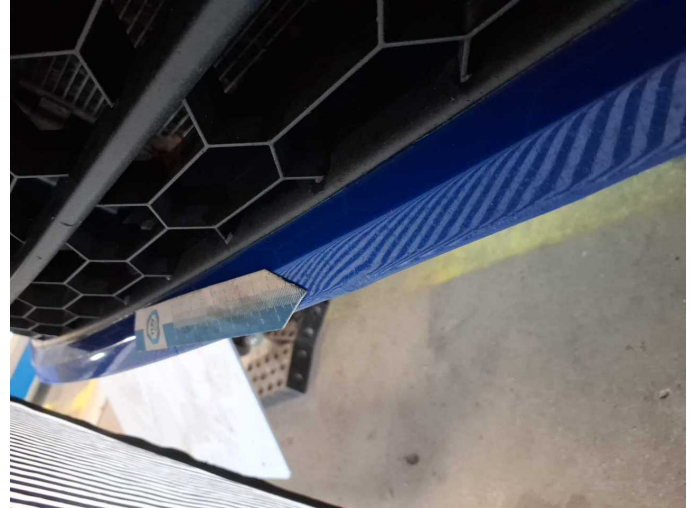
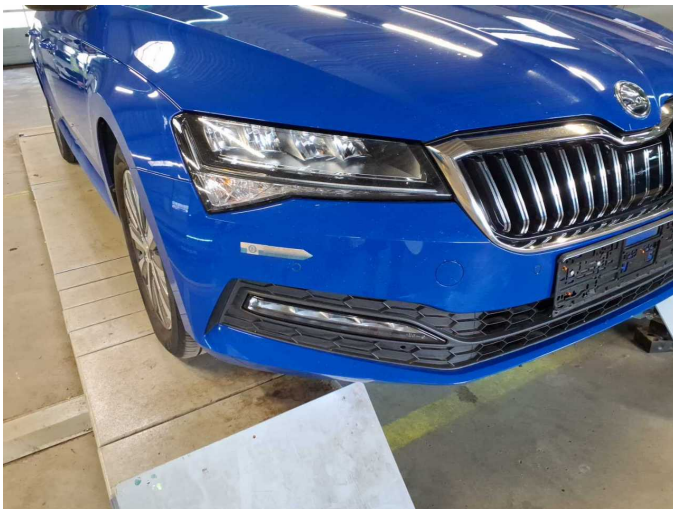
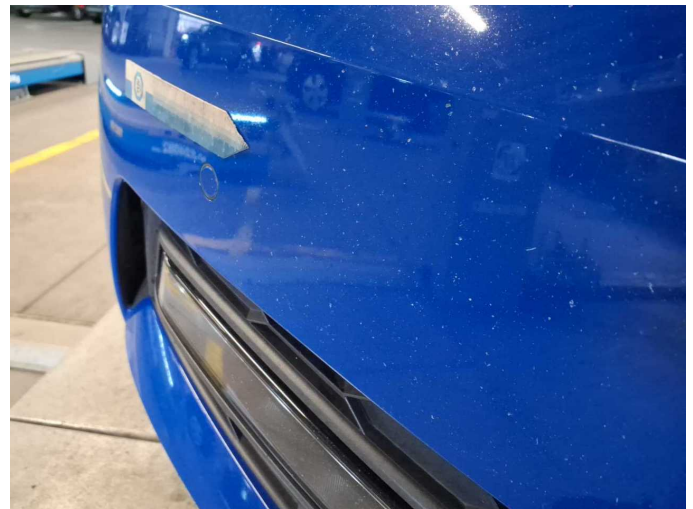
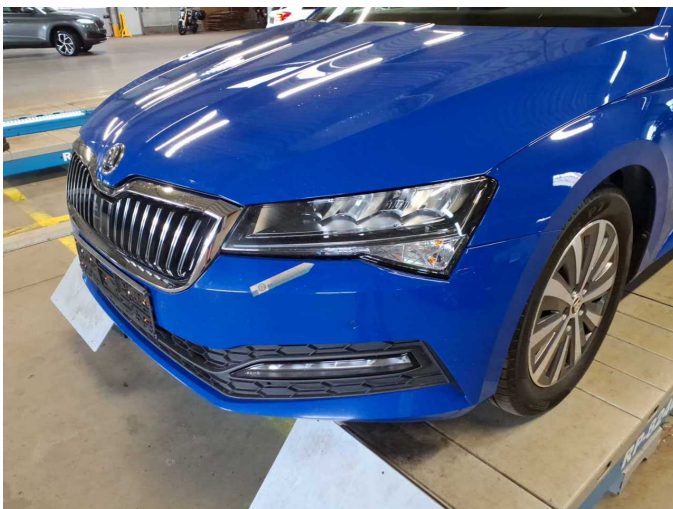
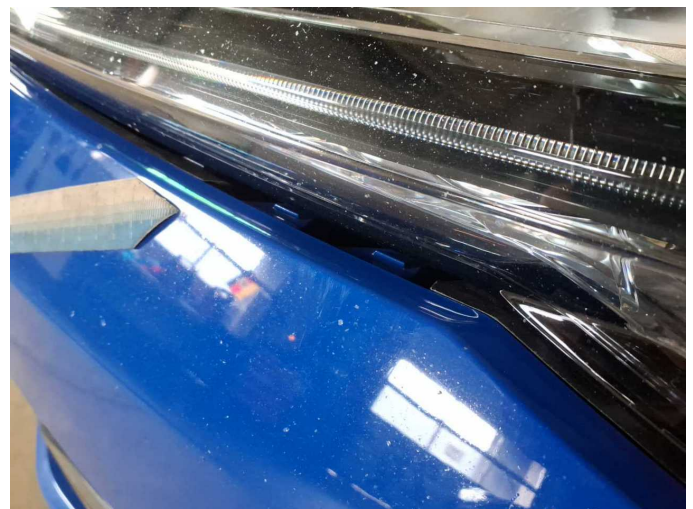
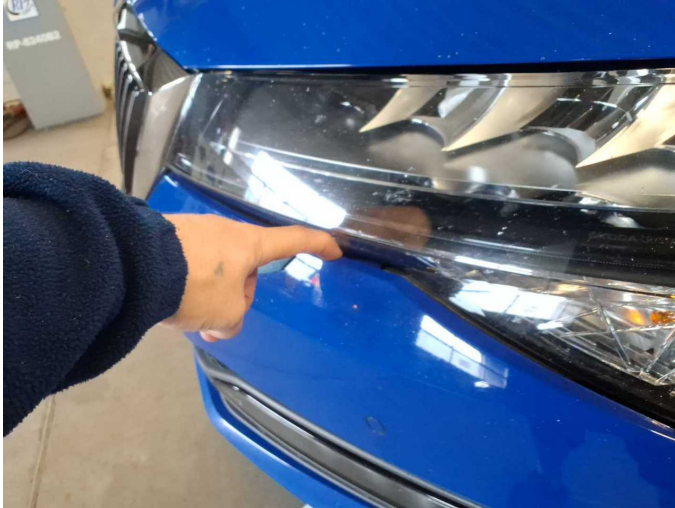
**Damage 7:** Front bumper: Front bumper (Sandstrahleffekt, Kratzer, fehlstellung) - Stone chips - Paint

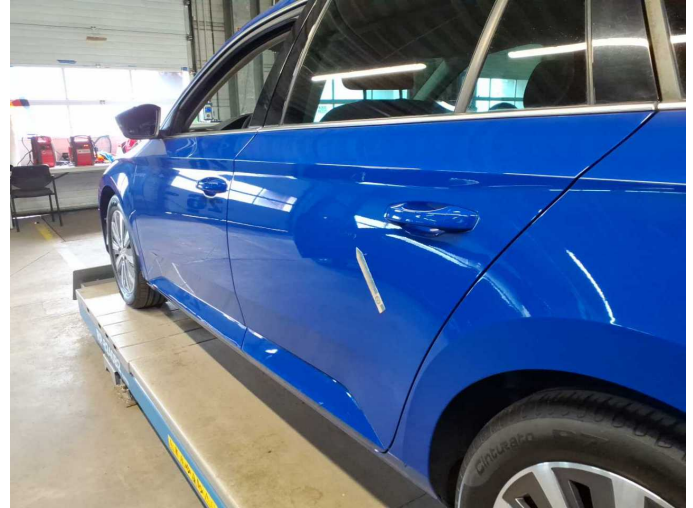
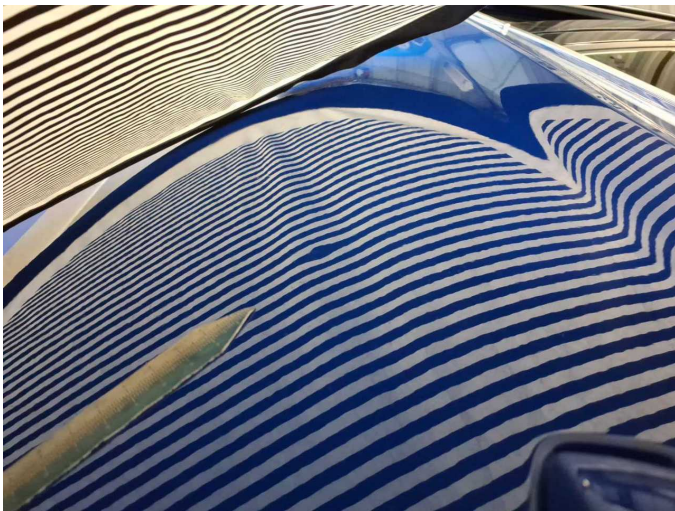
**Wear and tear 4:** Door - rear left side: Door - dent(s) - No deduction
