Expertise

Protocol number: 46776759  
Order No. / Reference: 26841746  
Inspection date: 29 Jul 2026

Model: Grandland 1.5 D Automatik Enjoy

VIN: W0VZCYHZ4R6022566

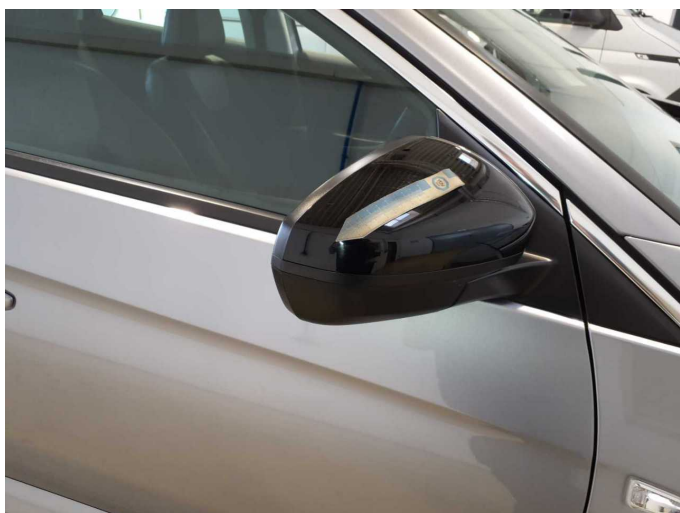
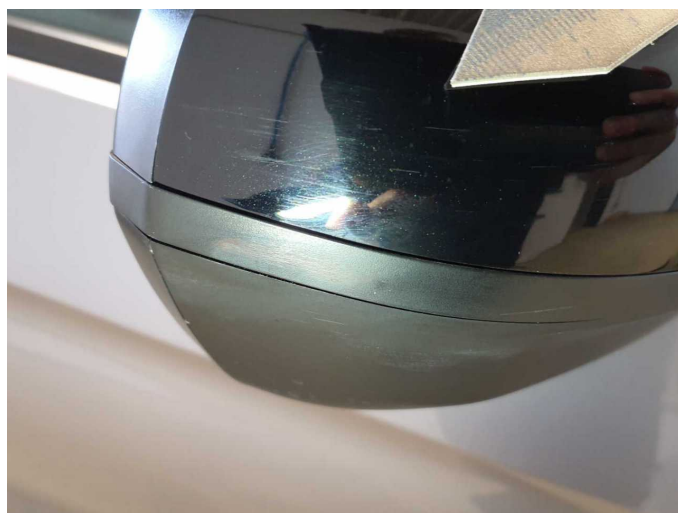
| No. | Component group | Description |
|---|---|---|
| 2 | Wing mirror - right side | Cap - Scratch(es) - Smart repair |

Damage 2: Wing mirror - right side: Cap - Scratch(es) - Smart repair

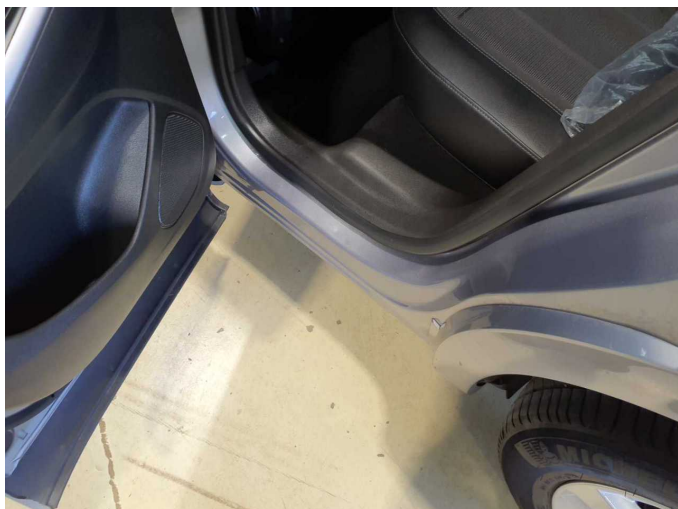
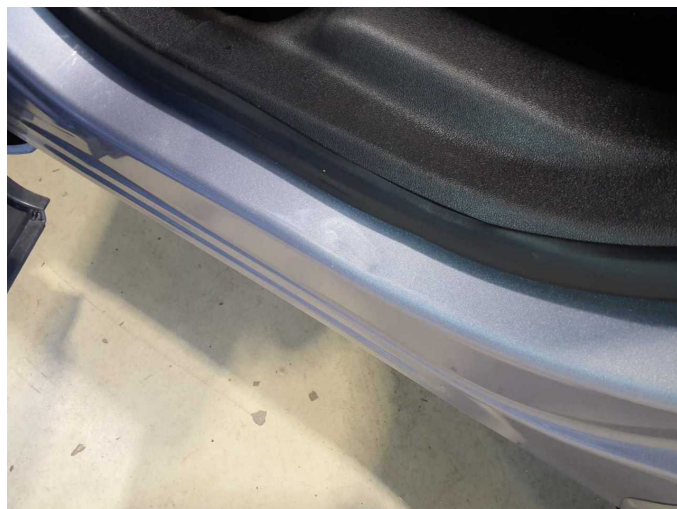
| No. | Component group | Description |
|---|---|---|
| 3 | Side panel - rear left side | Sill - dent(s) - Smooth repair work |

**Damage 3:** Side panel - rear left side: Sill - dent(s) - Smooth repair work

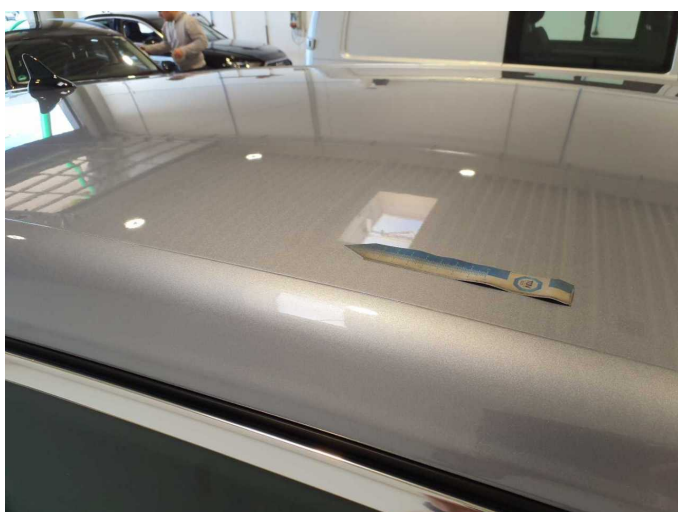
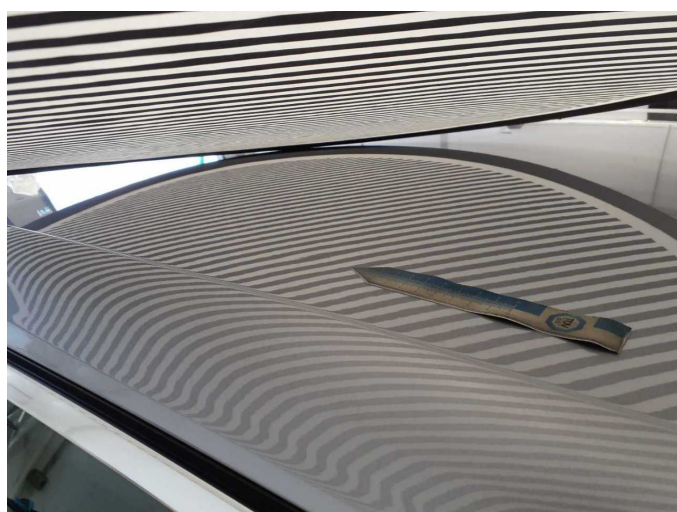
| No. | Component group | Description |
|---|---|---|
| 4 | Roof | Roof - dent(s) - Smooth repair work |

**Damage 4:** Roof: Roof - dent(s) - Smooth repair work

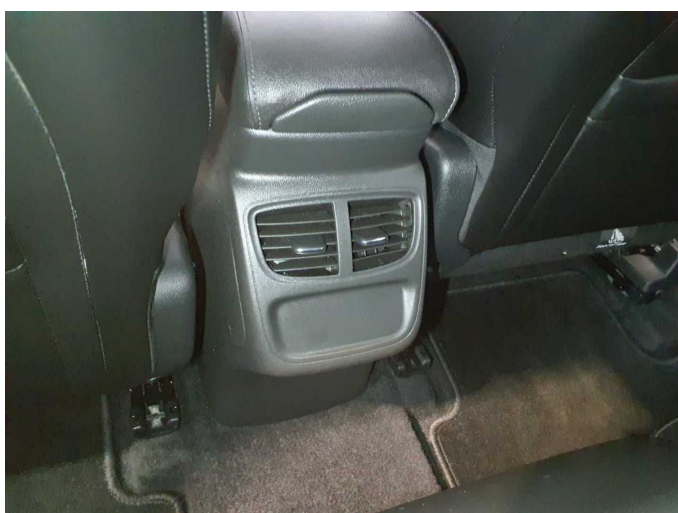
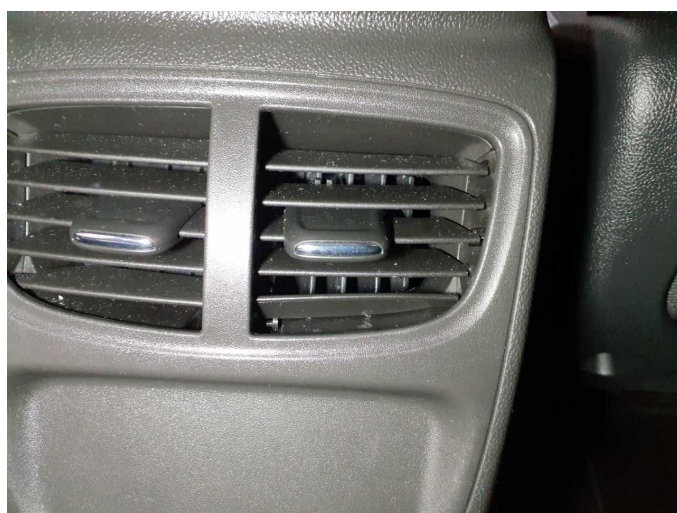
| No. | Component group | Description |
|---|---|---|
| 5 | Instrument panel | Air nozzle - centre (Hinten) - Broken / torn - Replace |

**Damage 5:** Instrument panel: Air nozzle - centre (Hinten) - Broken / torn - Replace

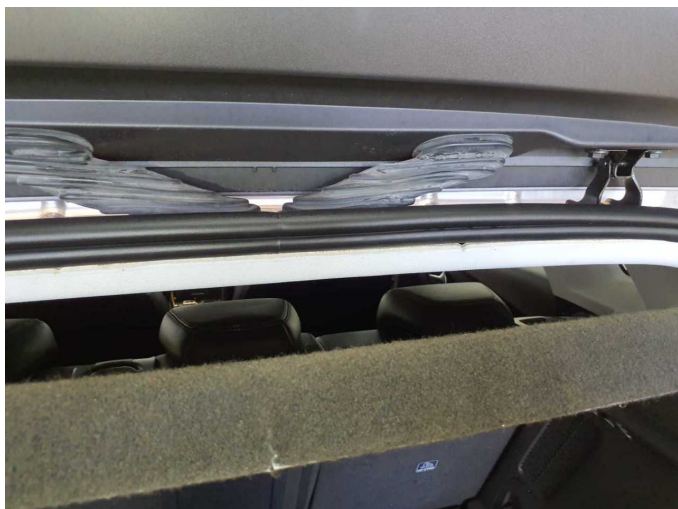
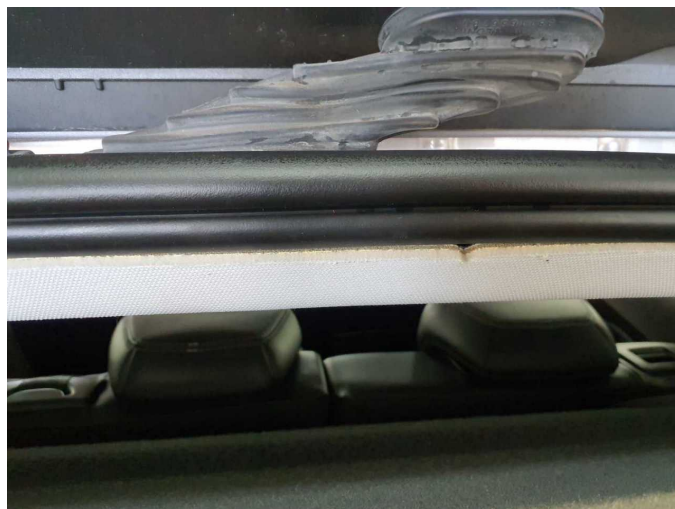
| No. | Component group | Description |
|---|---|---|
| 6 | Trim / covers | Roof lining - Loose - Repair |

**Damage 6:** Trim / covers: Roof lining - Loose - Repair

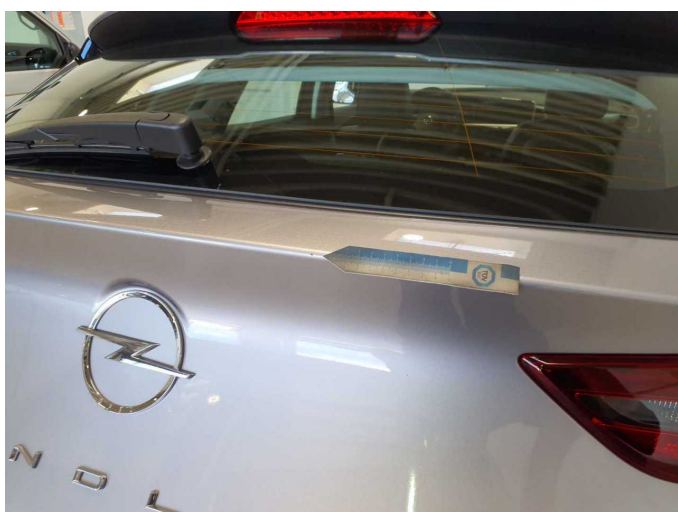
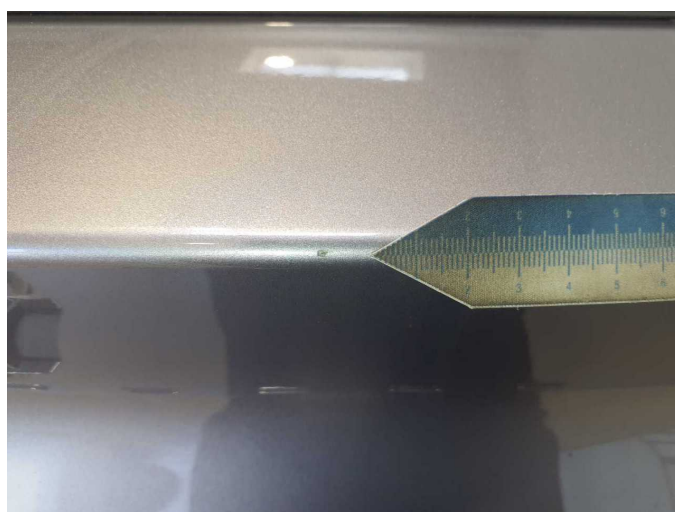
| No. | Component group | Description |
|---|---|---|
| 7 | Boot lid / rear door | Boot lid - Scratch(es) - Smart repair |

**Damage 7:** Boot lid / rear door: Boot lid - Scratch(es) - Smart repair

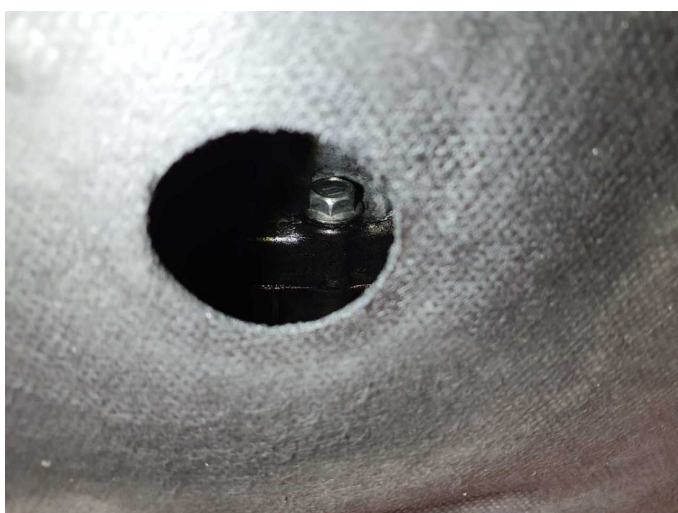
| No. | Component group | Description |
|---|---|---|
| 8 | Engine | Engine - Leaking - Perform diagnosis |

**Damage 8:** Engine: Engine - Leaking - Perform diagnosis

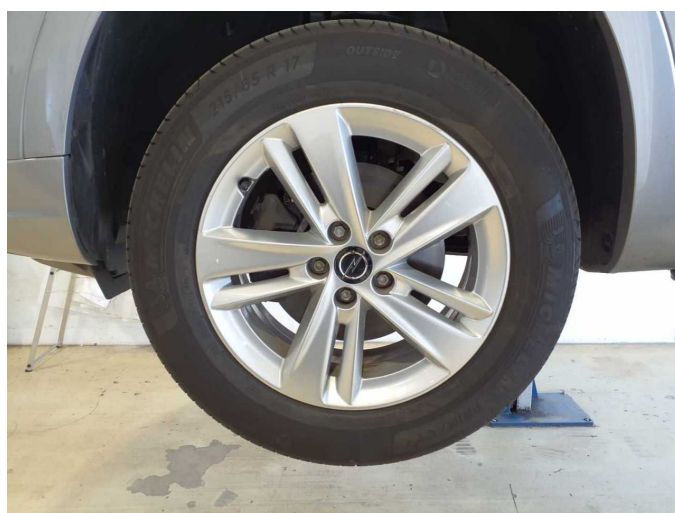
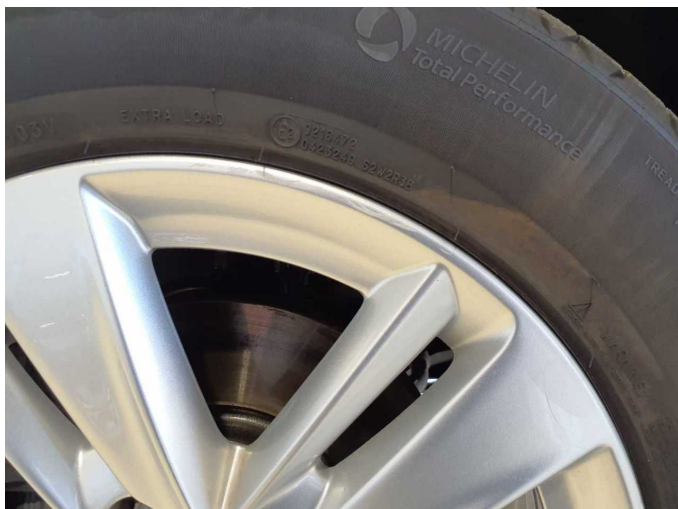
| No. | Component group | Description |
|---|---|---|
| 9 | Wheel / tyres | Alloy rim - front left side - Scratch(es) - Loss in value |

**Damage 9:** Wheel / tyres: Alloy rim - front left side - Scratch(es) - Loss in value

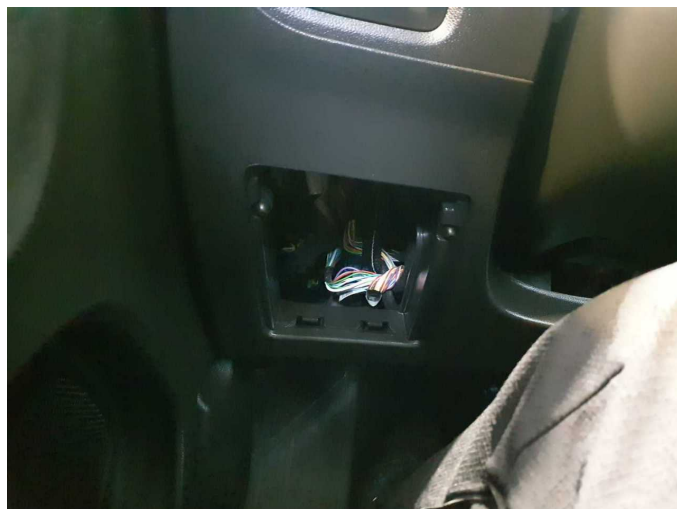
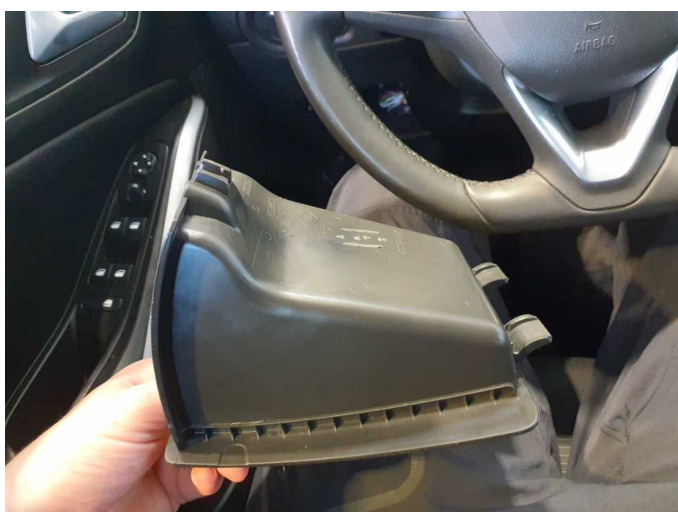
| No. | Component group | Description |
|---|---|---|
| 10 | Trim / covers | Trim / covers (Ablagefach) - Broken / torn - Replace |

**Damage 10:** Trim / covers: Trim / covers (Ablagefach) - Broken / torn - Replace

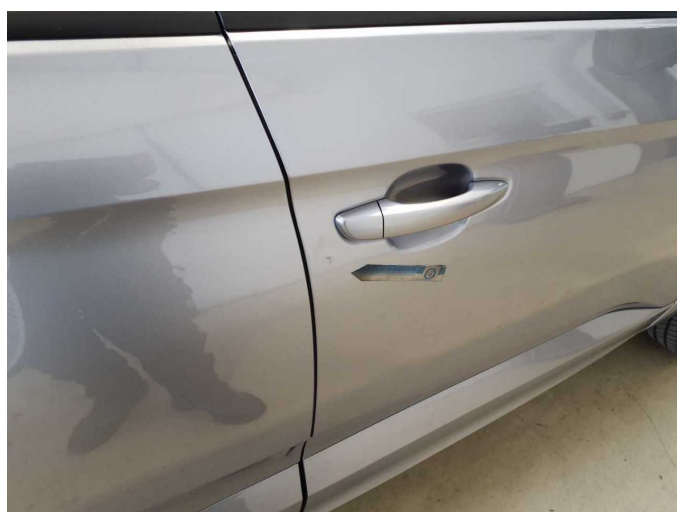
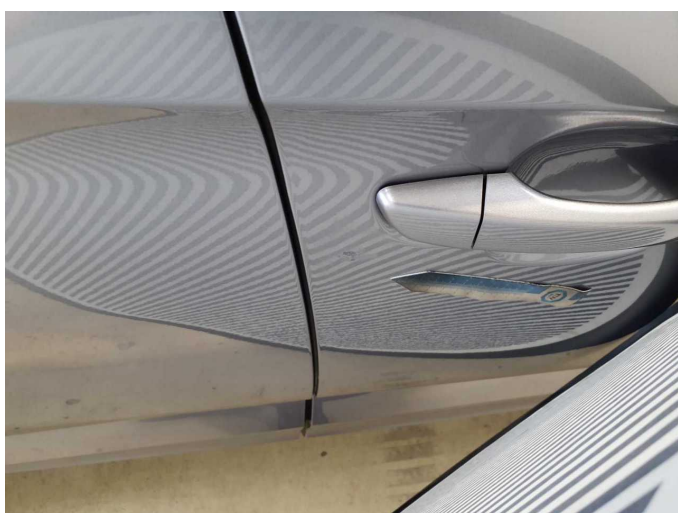
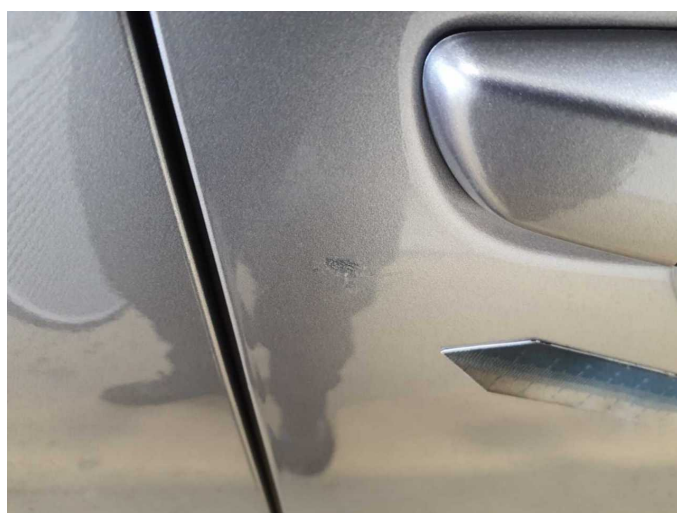
| No. | Component group | Description |
|---|---|---|
| 11 | Door - front right side | Door - Dent / paintcoat damage - Smart repair |

**Damage 11:** Door - front right side: Door - Dent / paintcoat damage - Smart repair

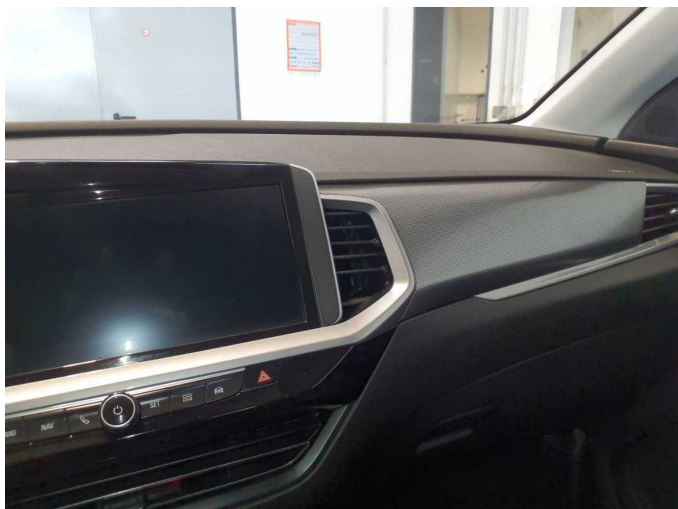
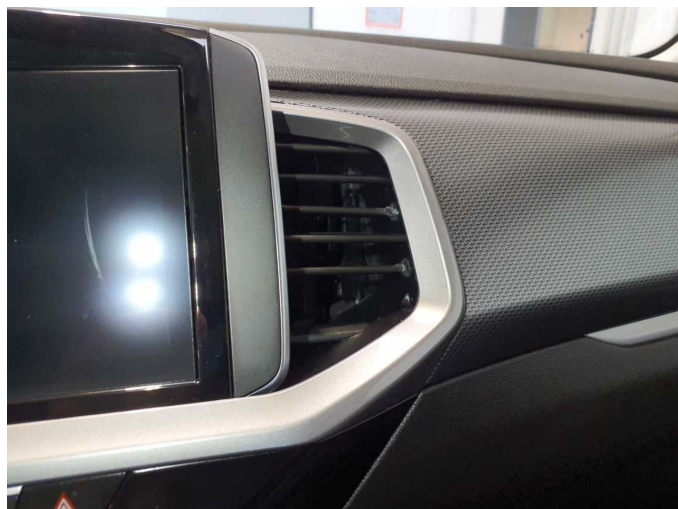
| No. | Component group | Description |
|---|---|---|
| 12 | Instrument panel | Air nozzle - centre - Broken / torn - Replace |

**Damage 12:** Instrument panel: Air nozzle - centre - Broken / torn - Replace

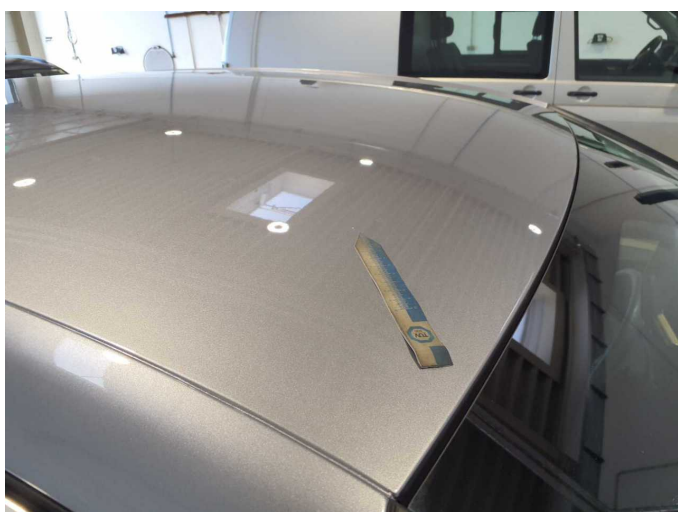
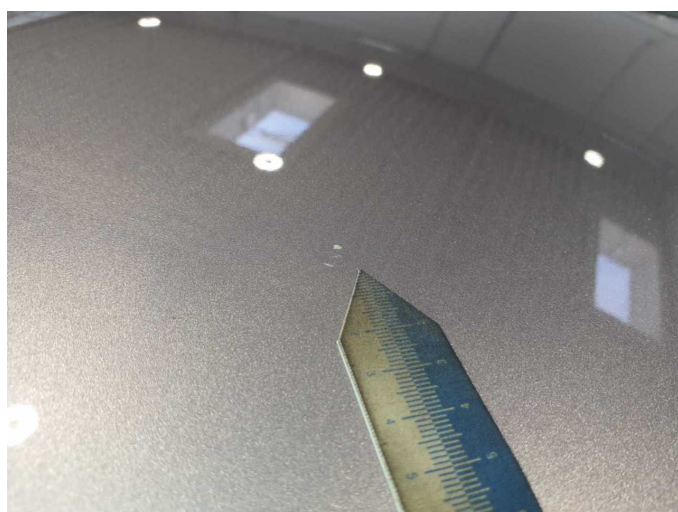
| No. | Component group | Description |
|---|---|---|
| 13 | Roof | Roof - Stone chips - Loss in value |

**Damage 13:** Roof: Roof - Stone chips - Loss in value

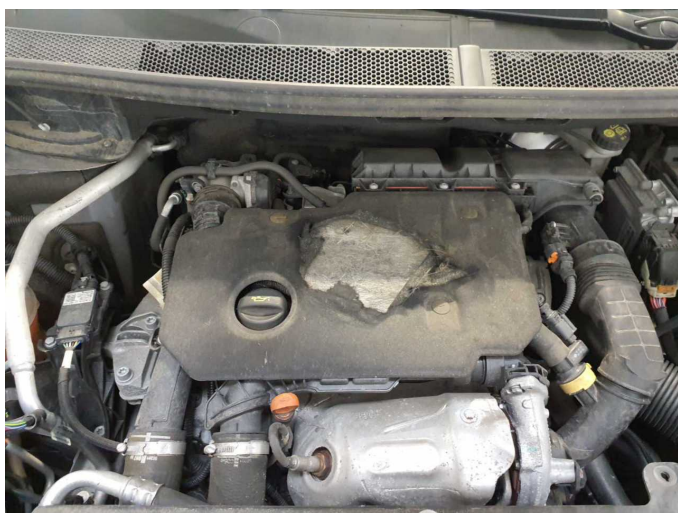
| No. | Component group | Description |
|---|---|---|
| 14 | Engine | Engine cover - Damage caused by marten / rodent - Replace |

**Damage 14:** Engine: Engine cover - Damage caused by marten / rodent - Replace

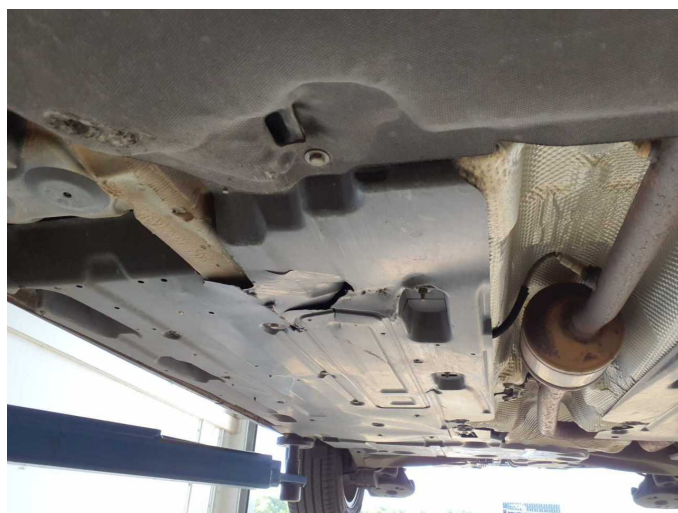
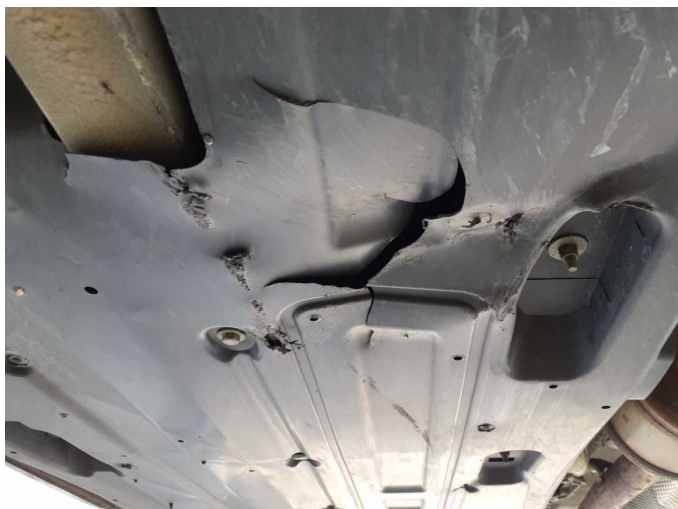
| No. | Component group | Description |
|---|---|---|
| 15 | Body | Underbody panelling - Broken / torn - Replace |

**Damage 15:** Body: Underbody panelling - Broken / torn - Replace

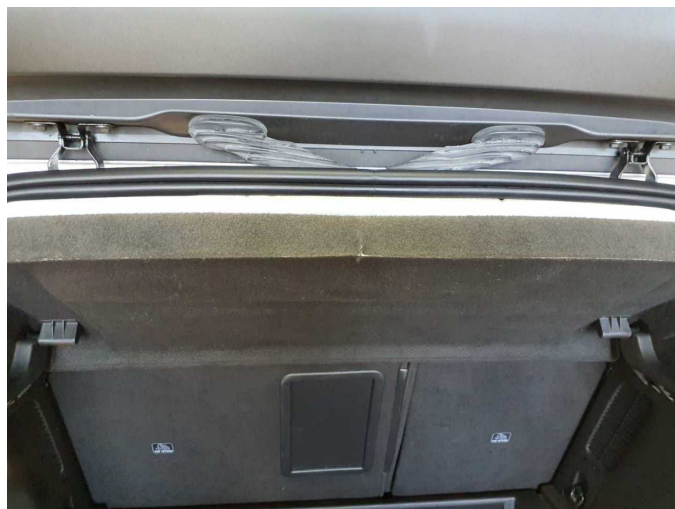
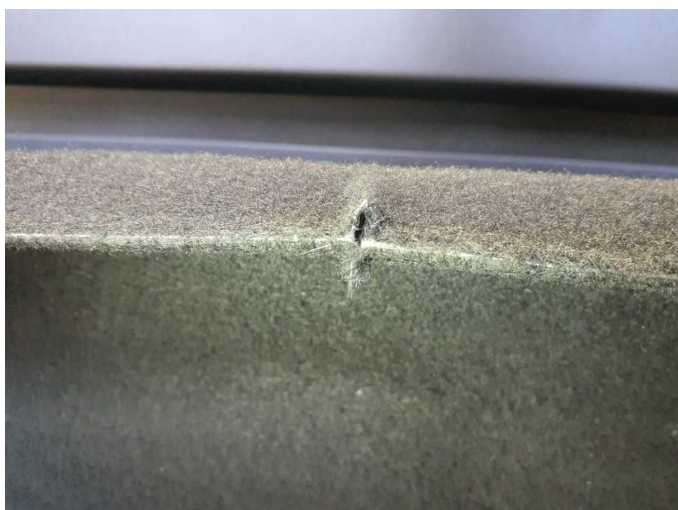
| No. | Component group | Description |
|---|---|---|
| 16 | Interior | Boot cover / roller cover - Broken / torn - Replace |

**Damage 16:** Interior: Boot cover / roller cover - Broken / torn - Replace

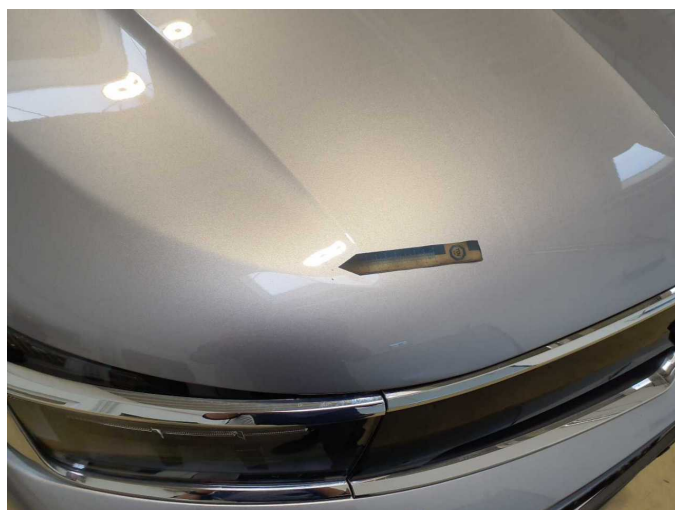
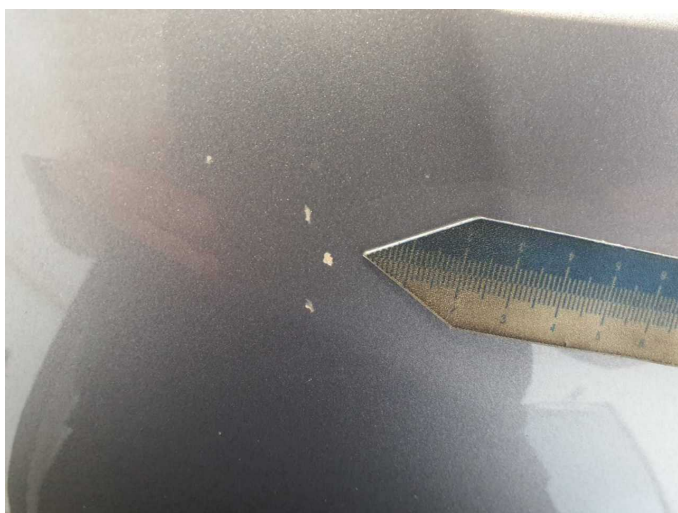
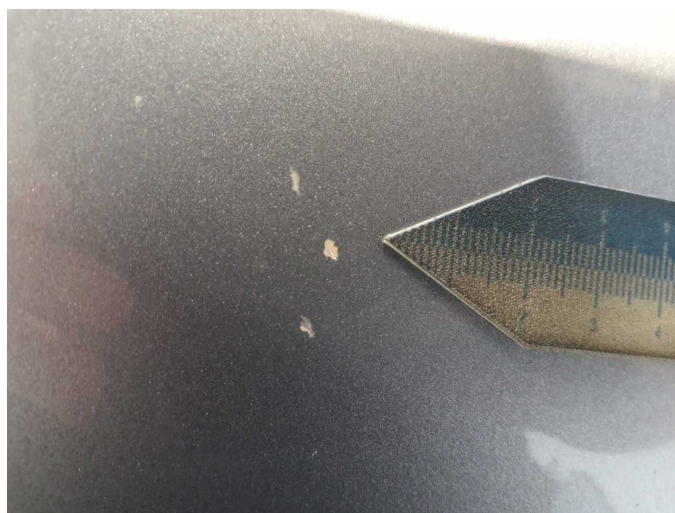
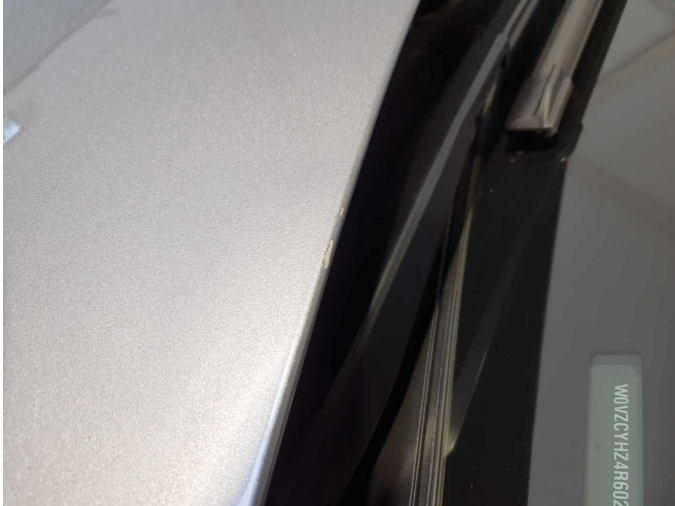
| No. | Component group | Description |
|---|---|---|
| 17 | Bonnet | Bonnet - Corrosion - Paint |

**Damage 17:** Bonnet: Bonnet - Corrosion - Paint

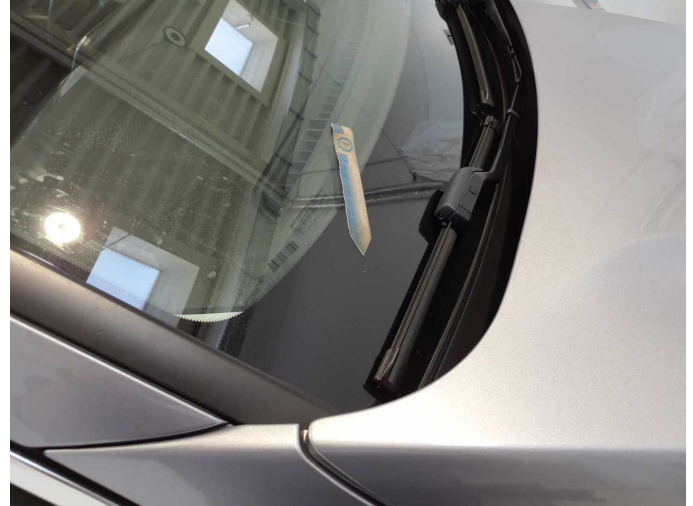
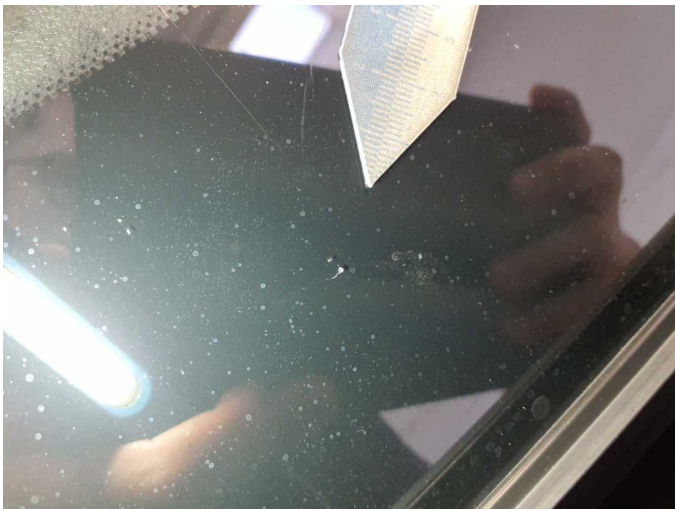
| No. | Component group | Description |
|---|---|---|
| 18 | Vehicle glazing | Windscreen (Randbereich) - Stone chips - Replace |

**Damage 18:** Vehicle glazing: Windscreen (Randbereich) - Stone chips - Replace

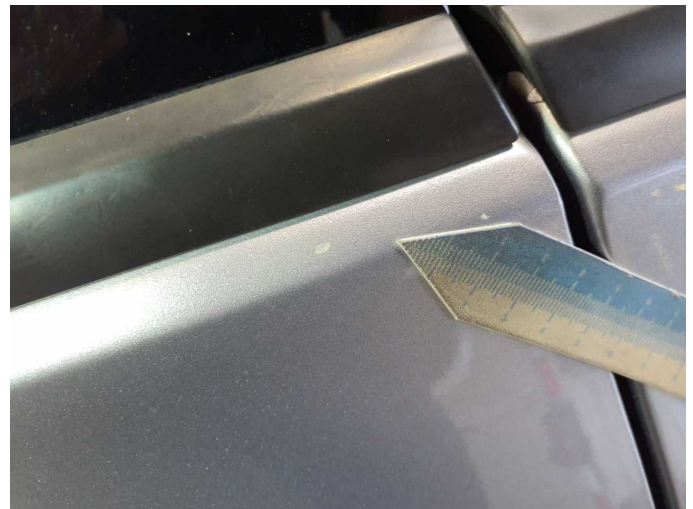
| No. | Component group | Description |
|---|---|---|
| 2 | Door - rear left side | Door - Stone chips - No deduction |

**Wear and tear 2:** Door - rear left side: Door - Stone chips - No deduction
