## Expertise

Protocol number: 46153462  
Order No. / Reference: 26522381  
Inspection date: 23 Jun 2026

Model: XCeed 1.5 T-GDI OPF DCT7 VISION

VIN: U5YH5F15GPL155163

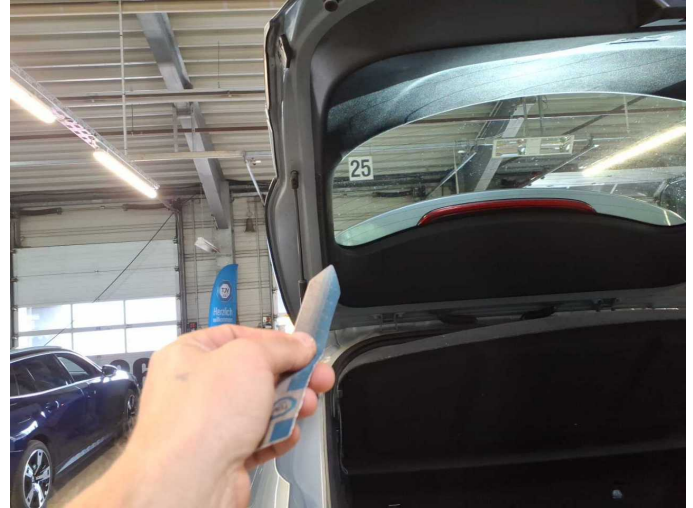
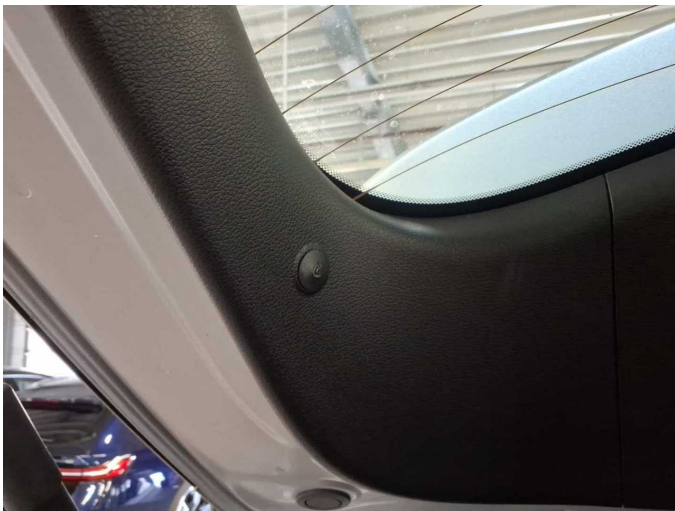
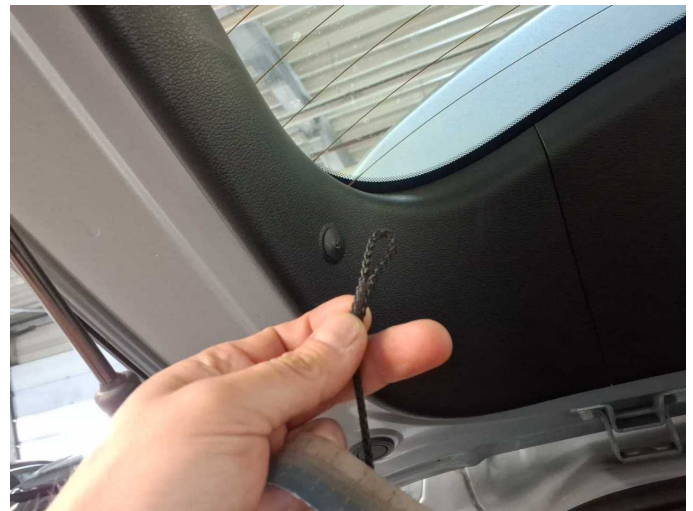
Damage 1: Interior: Rear shelf (Halterung) - Broken / torn - Replace

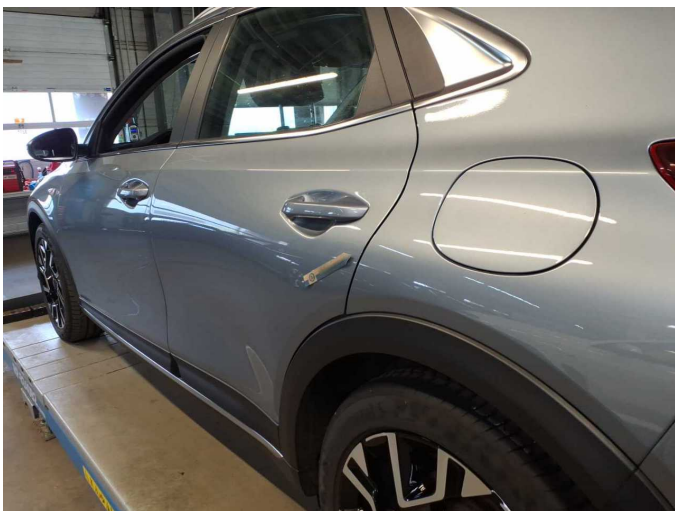
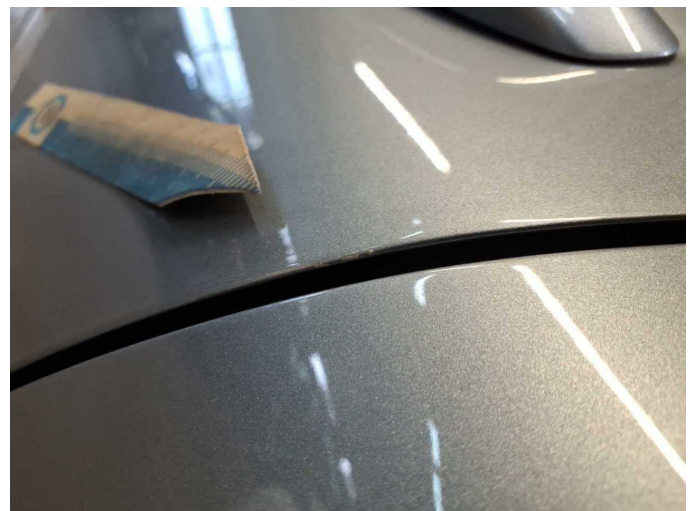
Damage 2: Door - rear left side: Door edge - Scratch(es) - Smart repair

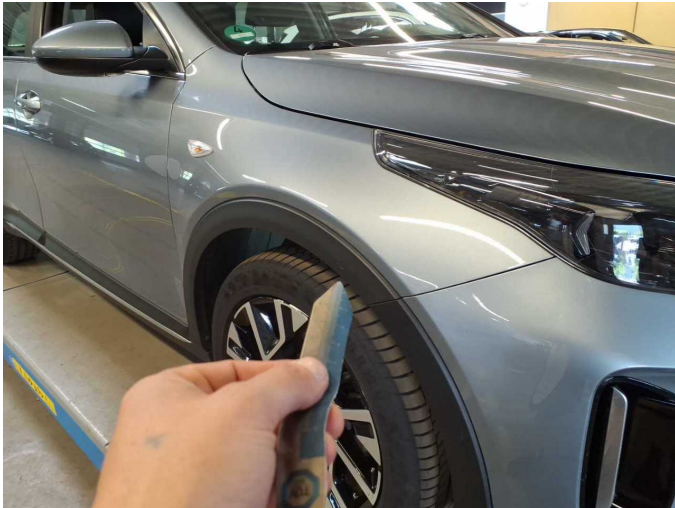
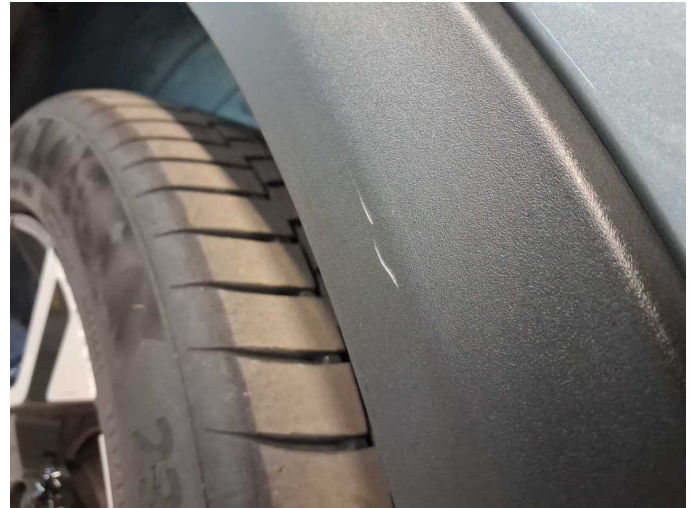
**Damage 3:** Mudguard - right side: Wheel well extension - Scratch(es) - Smart repair

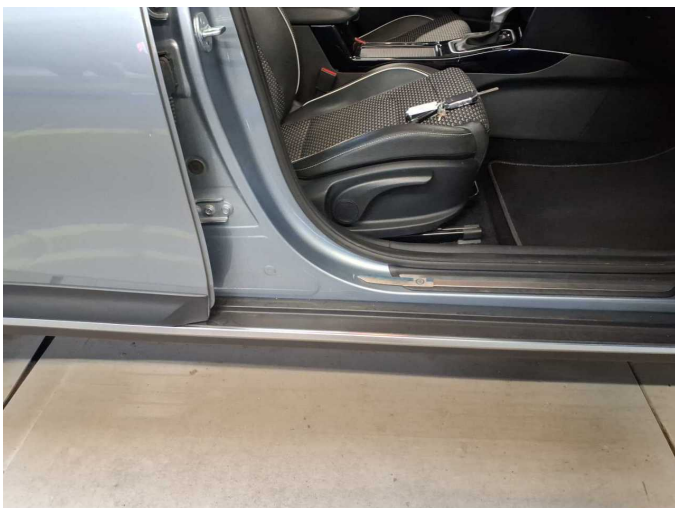
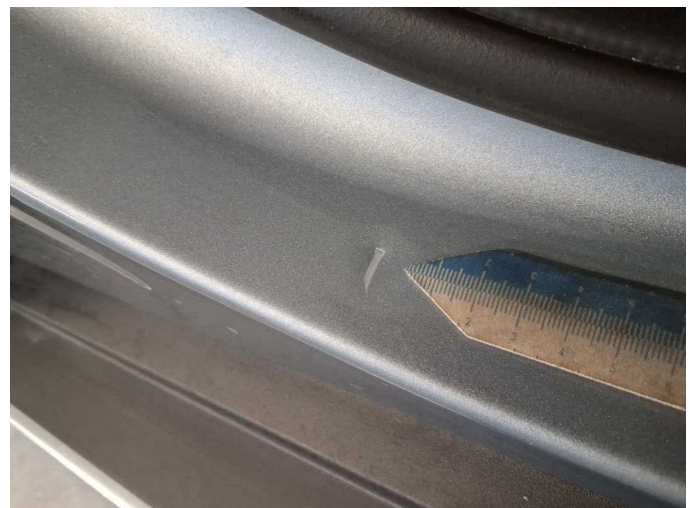
**Damage 4:** Sill - right side: Sill - Dent / paintcoat damage - Smart repair

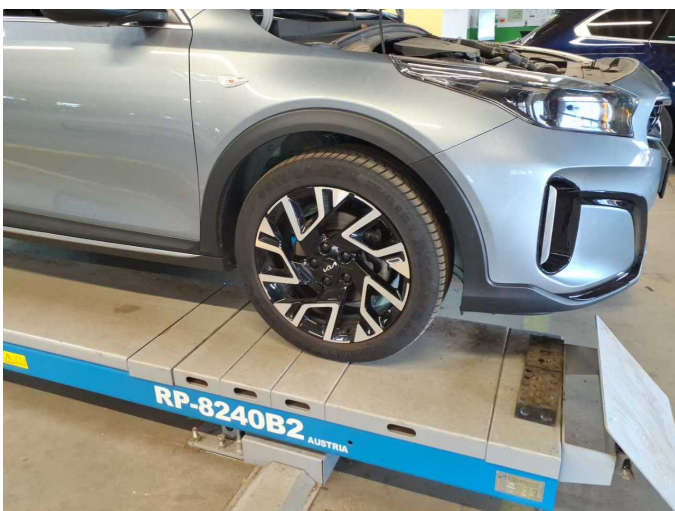
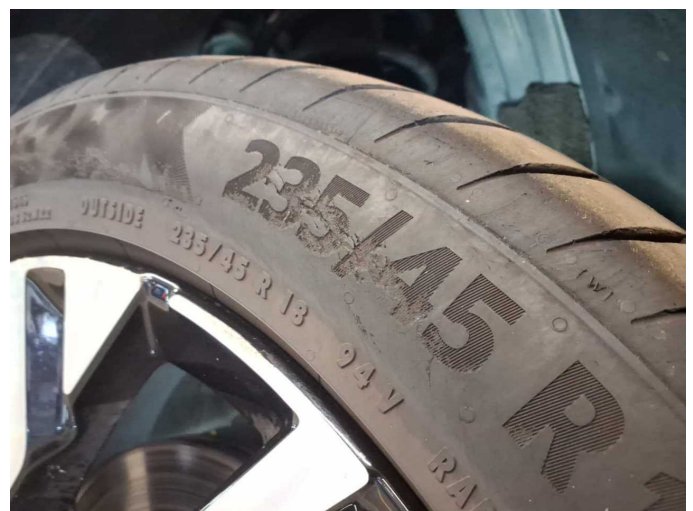
**Damage 5:** Wheel / tyres: Tyre - front right side (Flanke) - Damaged - Replace

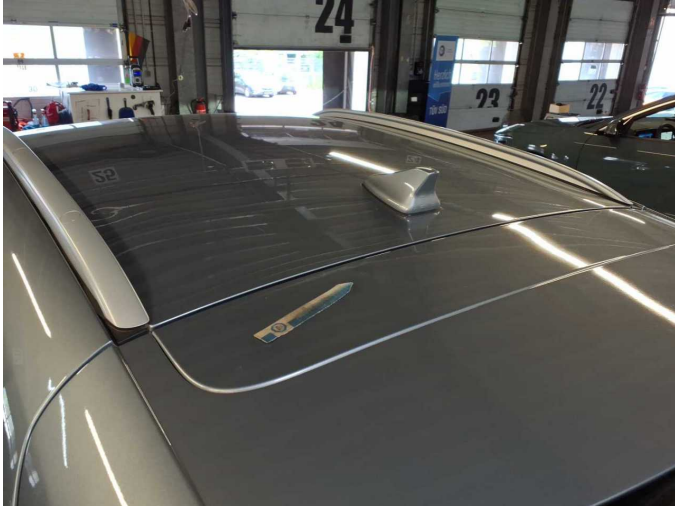
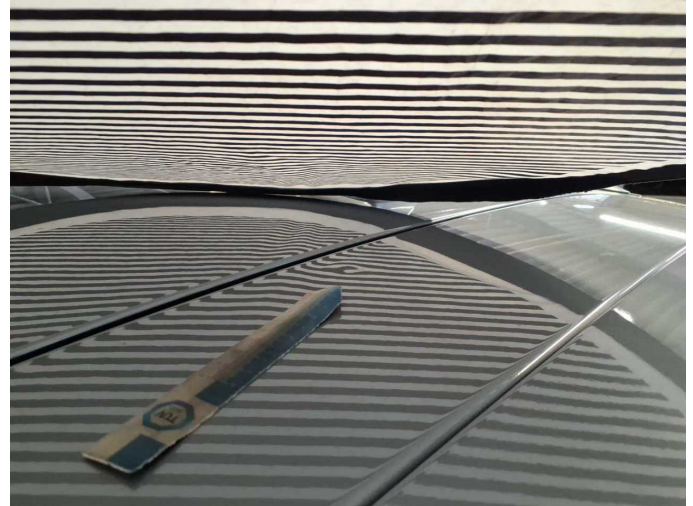
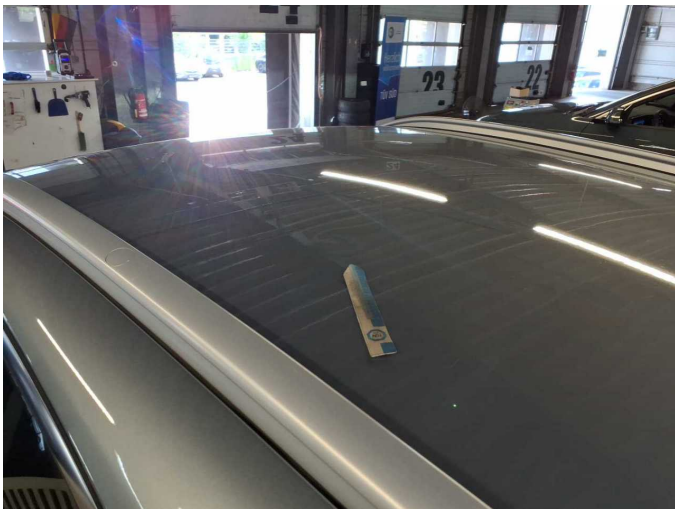
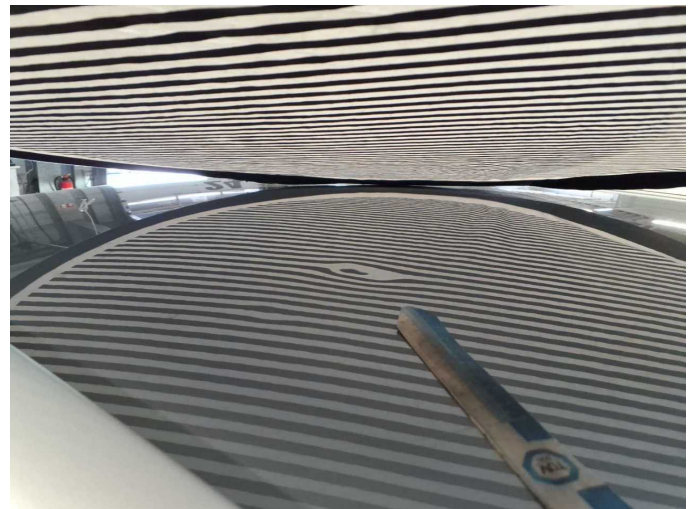
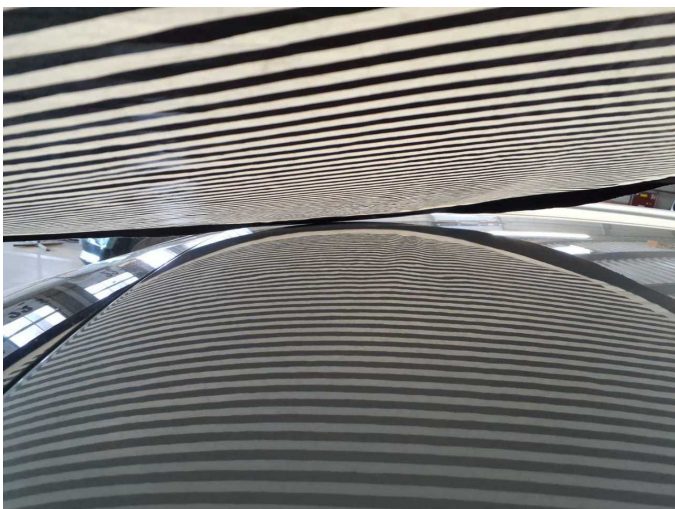
**Damage 6:** Roof: Roof - dent(s) - Smooth repair work

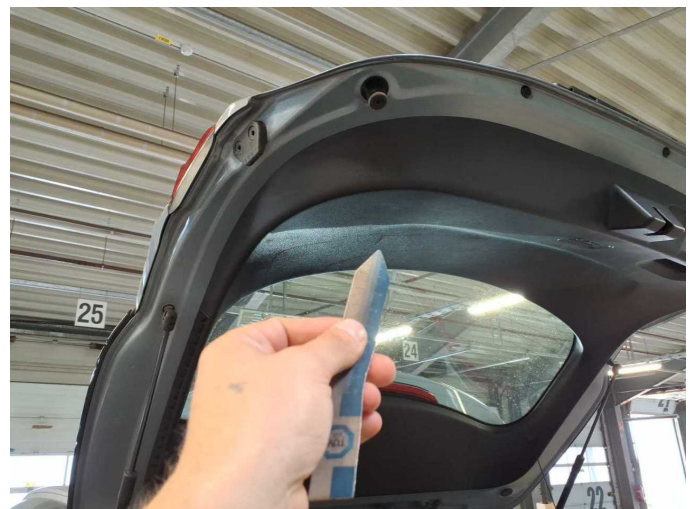
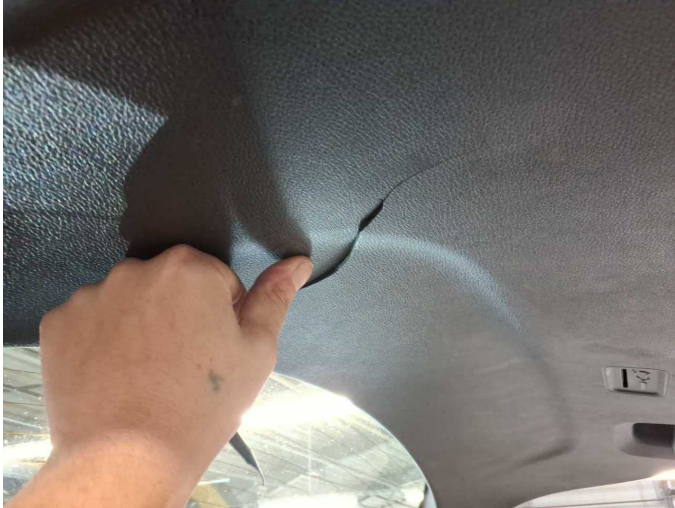
**Damage 7:** Trim / covers: Boot lid - interior trim - Broken / torn - Replace

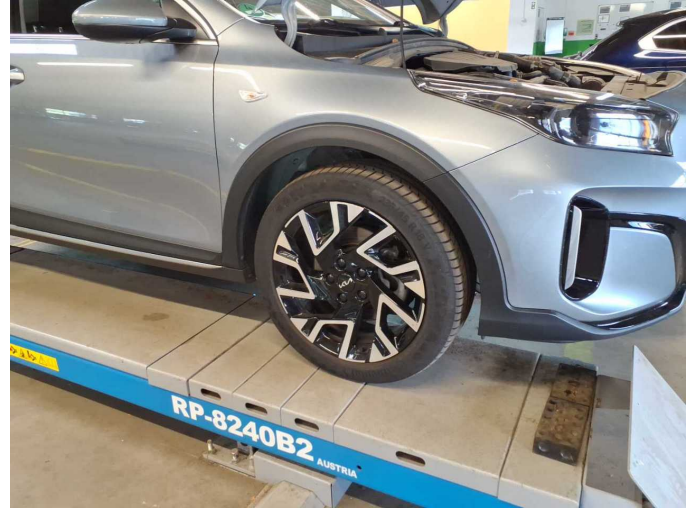
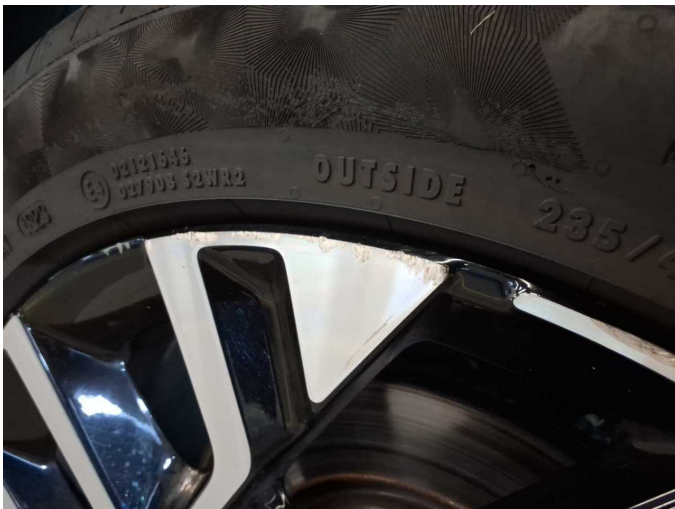
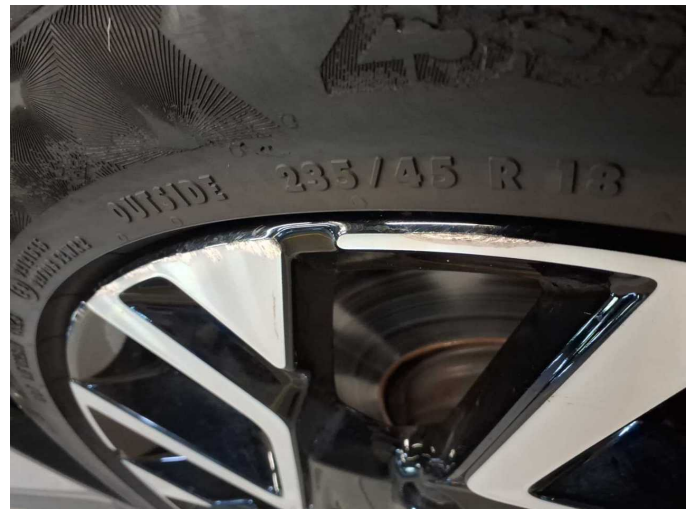
**Damage 8:** Wheel / tyres: Alloy rim - front right side - Scratch(es) - Loss in value

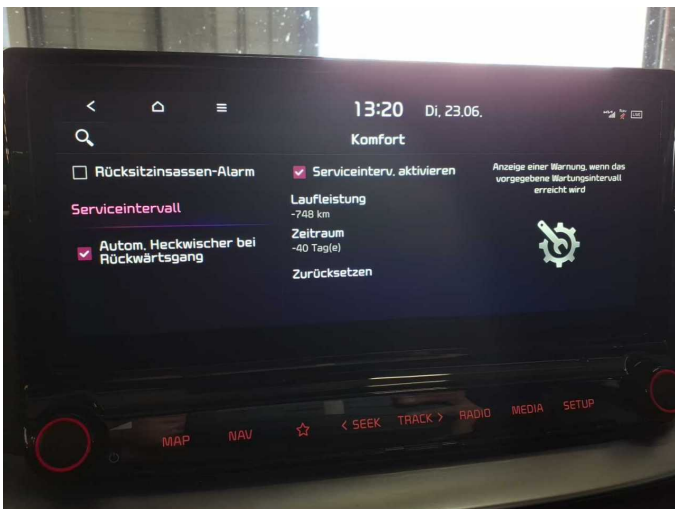
**Damage 9:** Misc.: Inspection / maintenance - Due - Perform

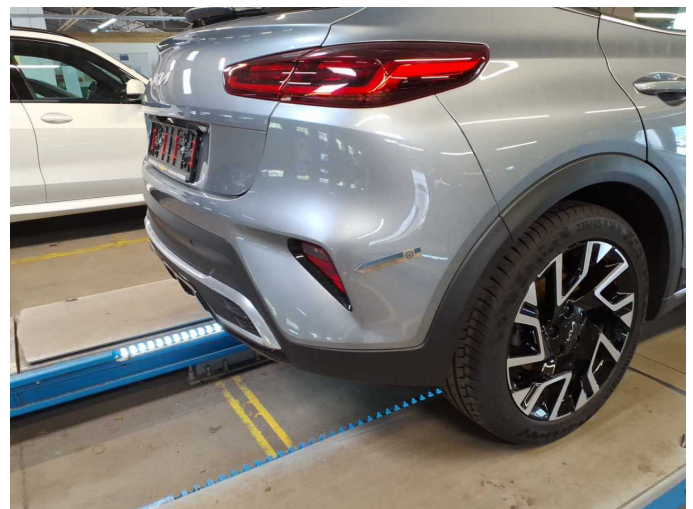
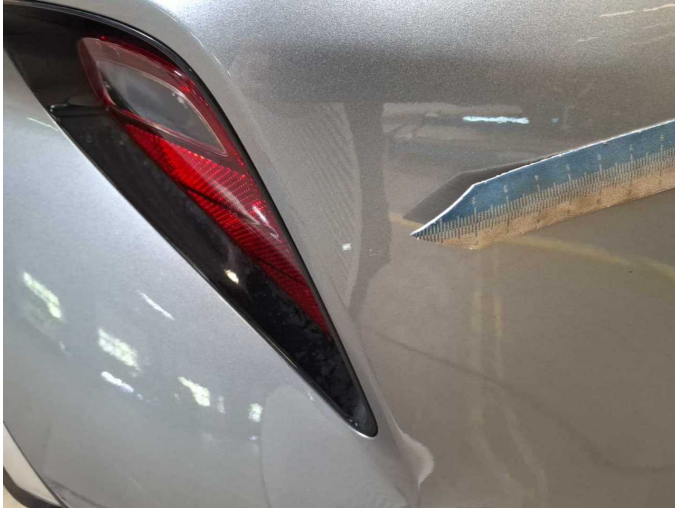
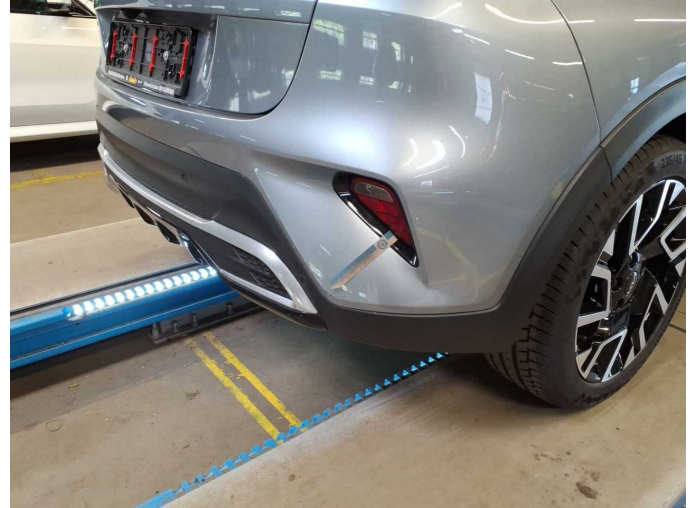
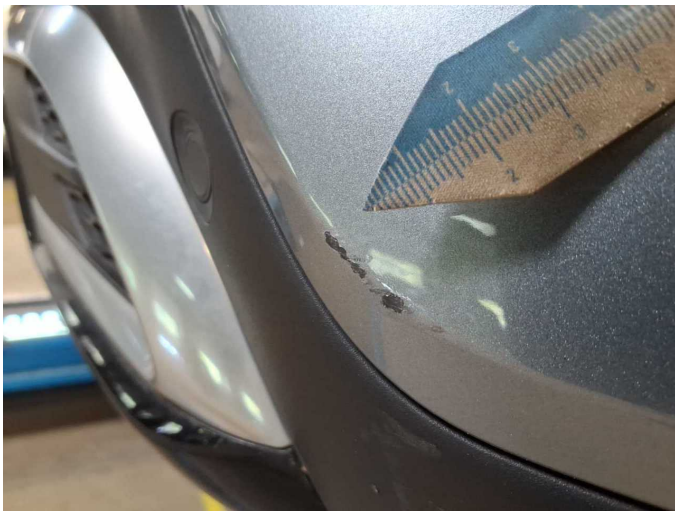
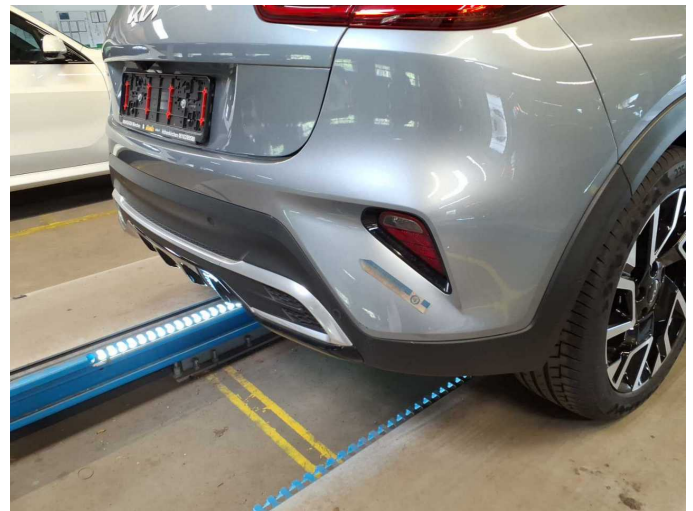
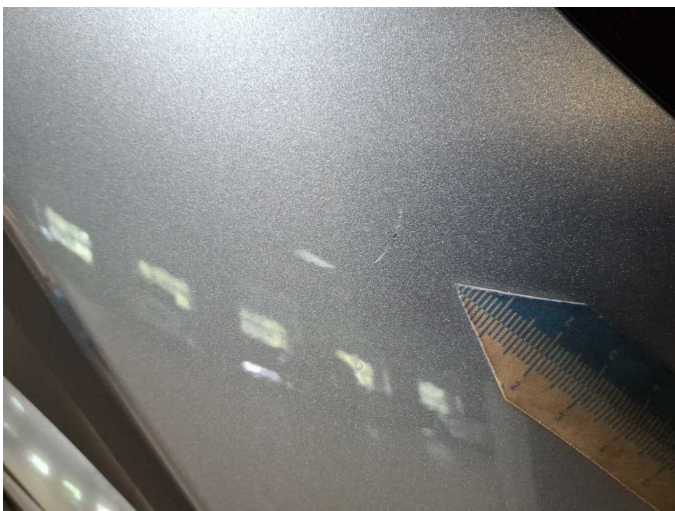
**Damage 10:** Rear bumper: Rear bumper - Scratch(es) - Paint

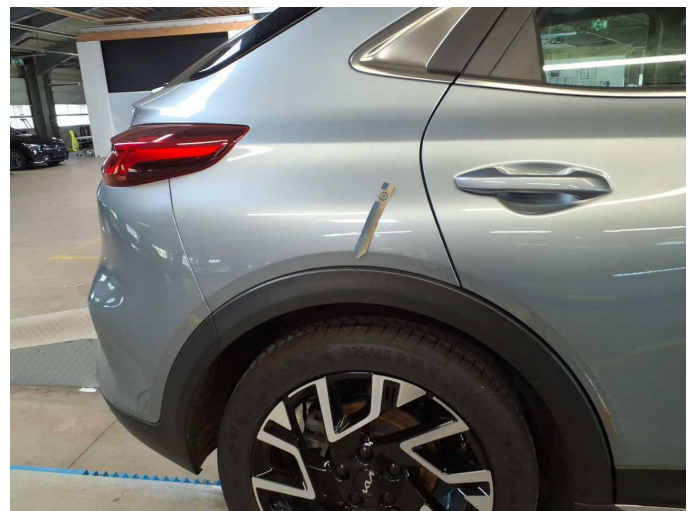
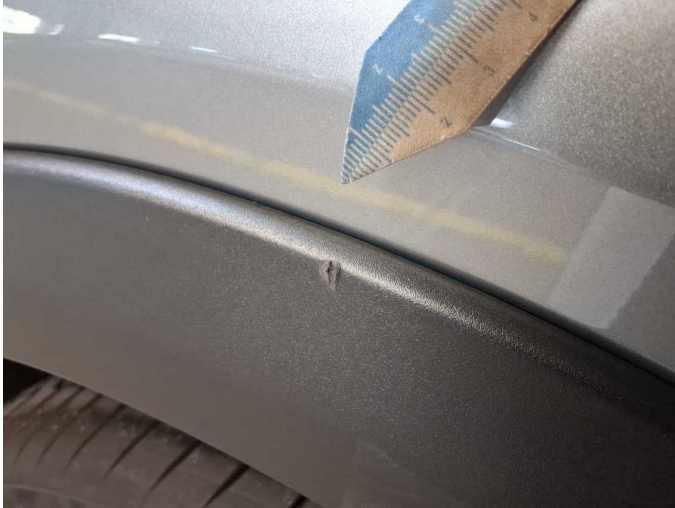
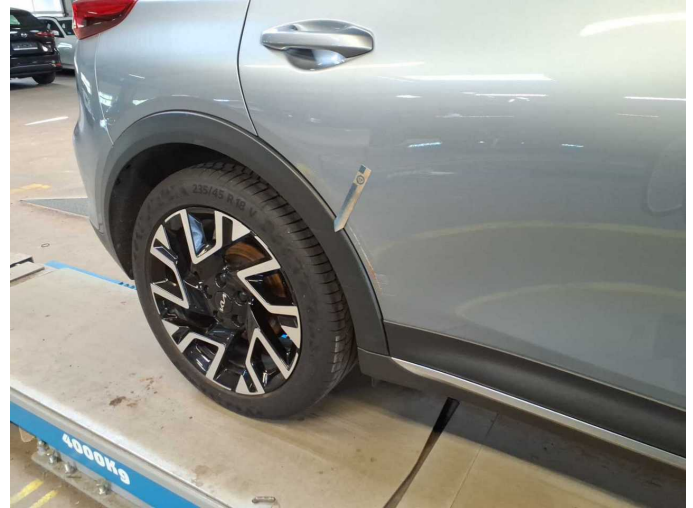
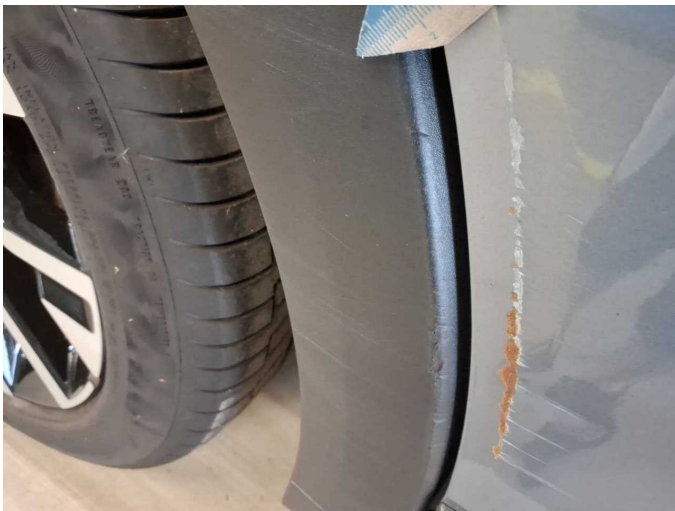
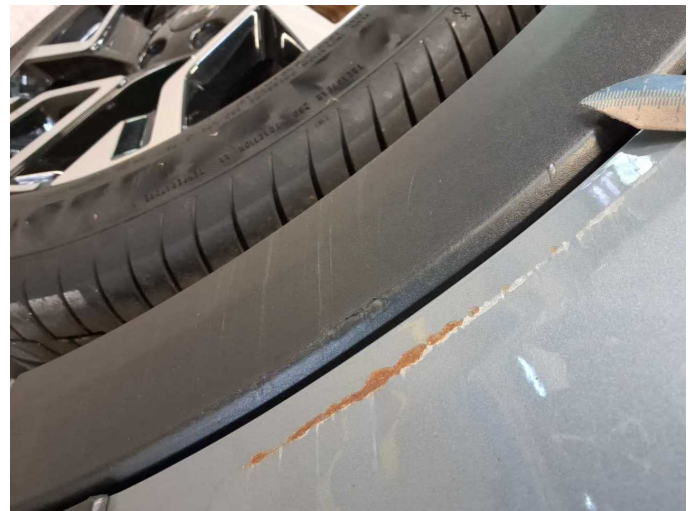
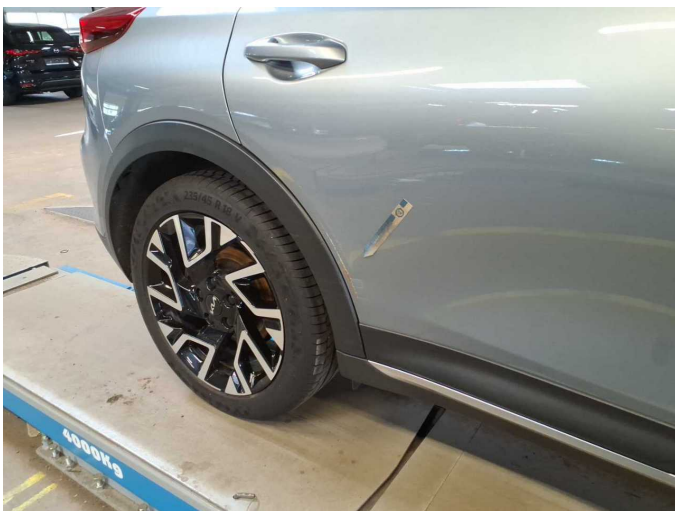
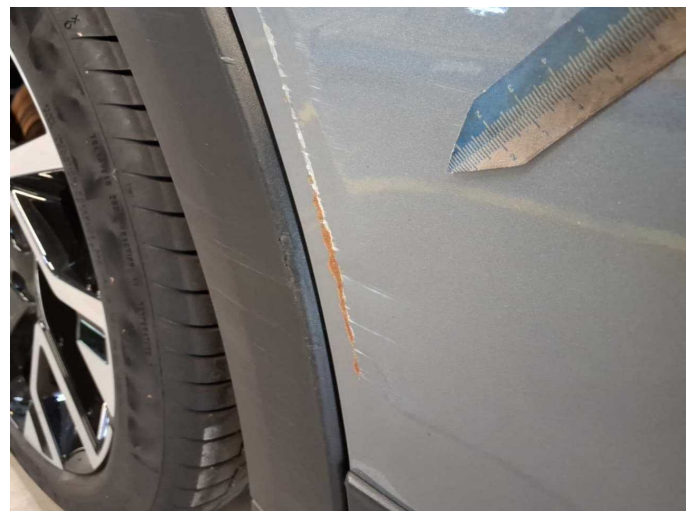
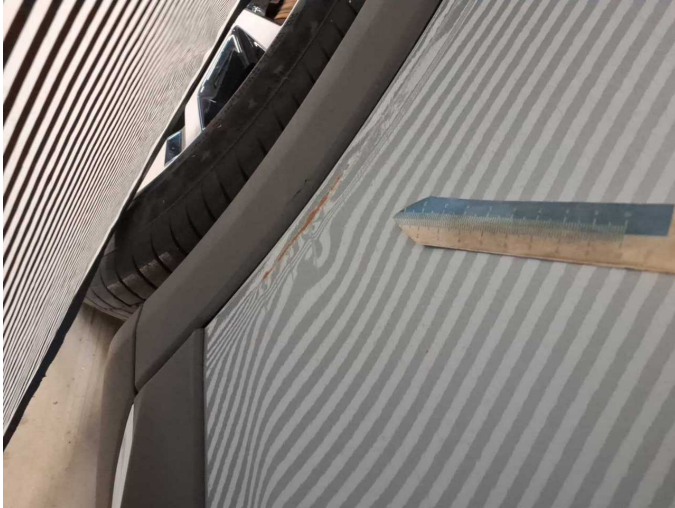
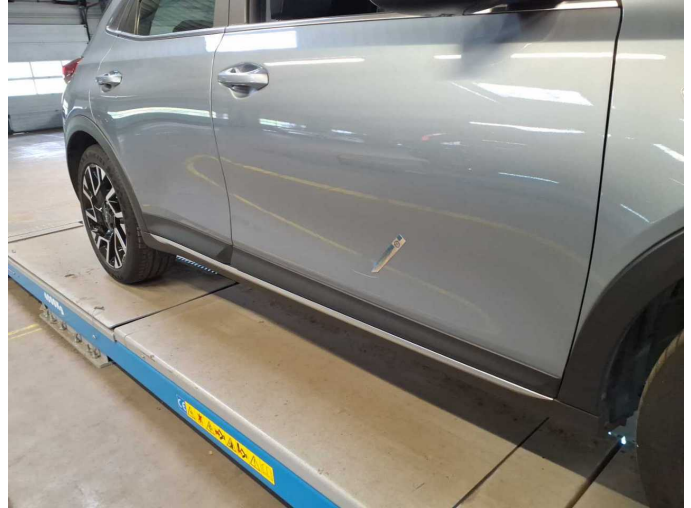
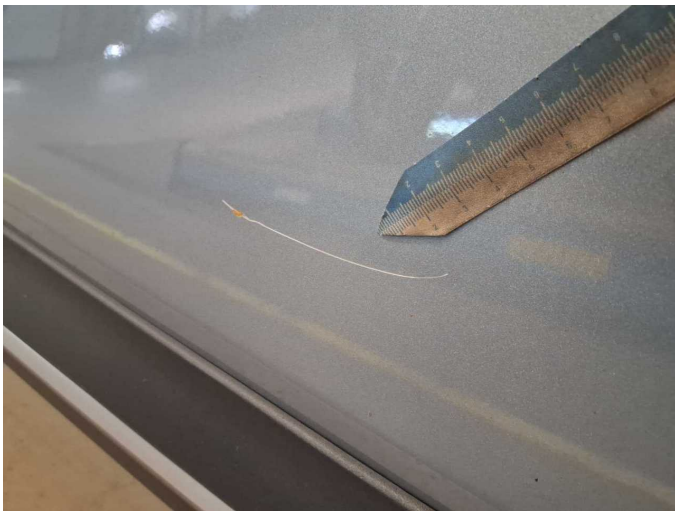
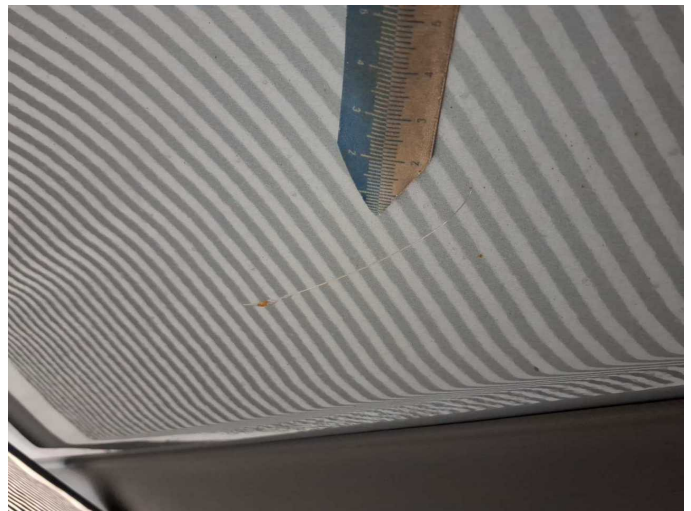
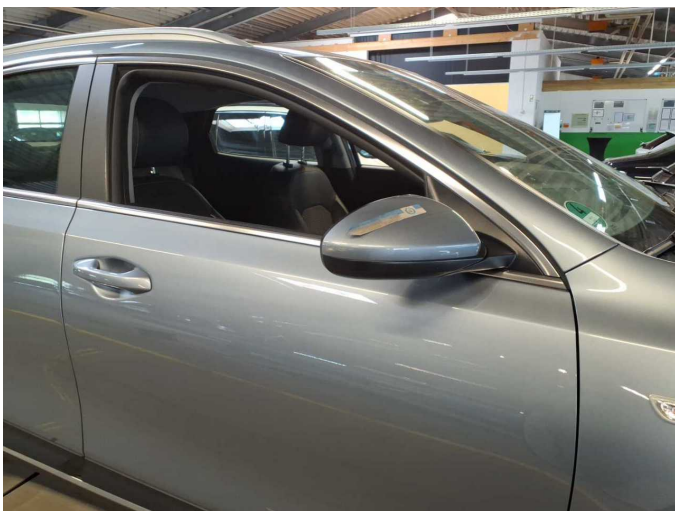
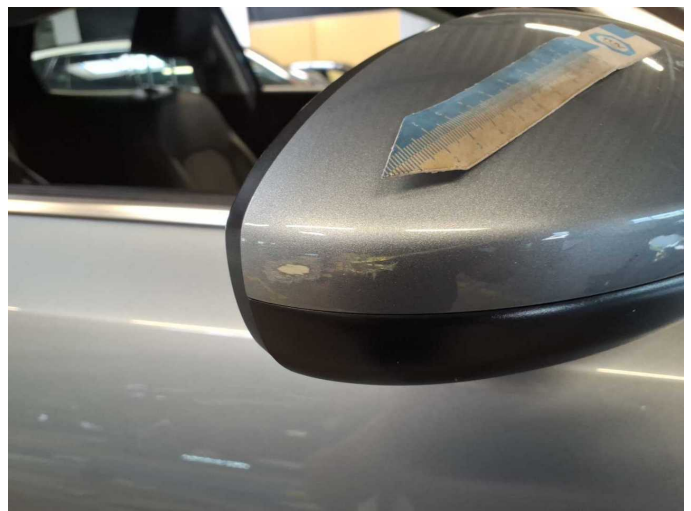
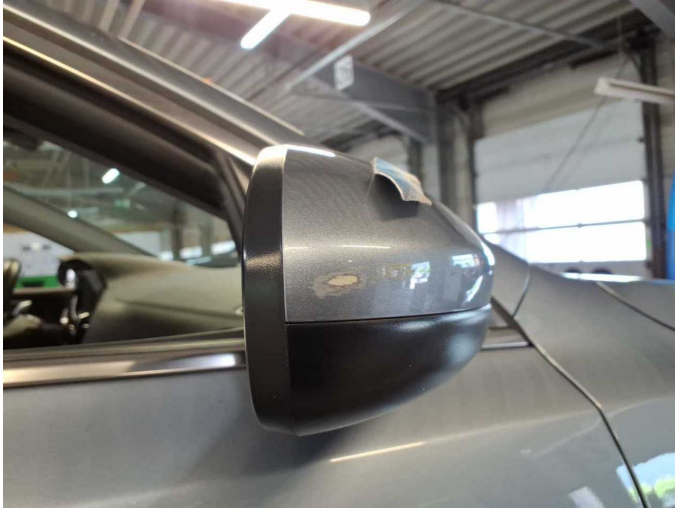
No.	Accident
1	Side right

**Accident 1:** Side right

Accident 1: Side right
