Expertise

Protocol number: 46177909
Order No. / Reference: 26472614
Inspection date: 26 Jun 2026

Manufacturer: Seat

Model: Cupra Born 150kW/58kWh

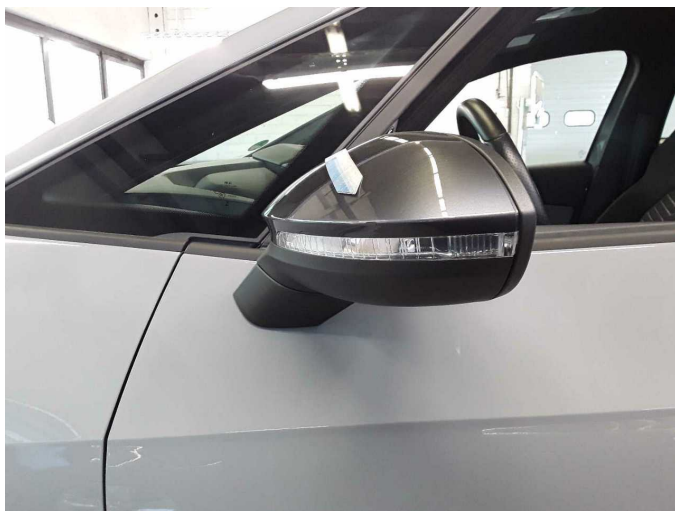
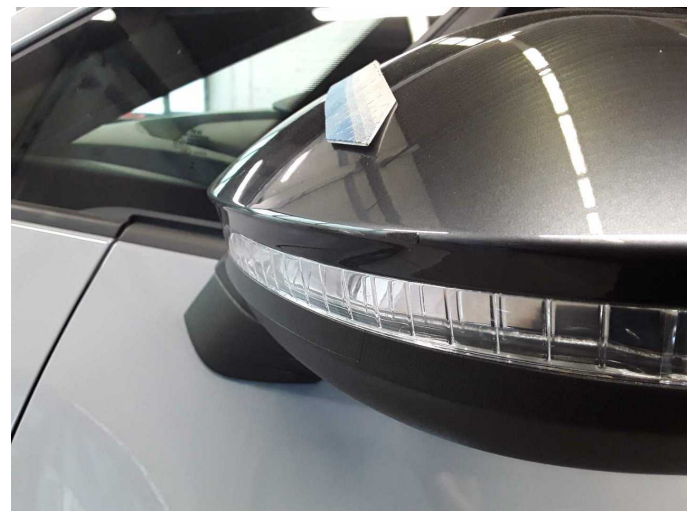
No.	Component group	Description
1	Wing mirror - left side	Cap - Scratch(es) - Smart repair
2	Front bumper	Front bumper - Scratched - Paint
3	Rear bumper	Rear bumper - Scratched - Paint

Damage 1: Wing mirror - left side: Cap - Scratch(es) - Smart repair

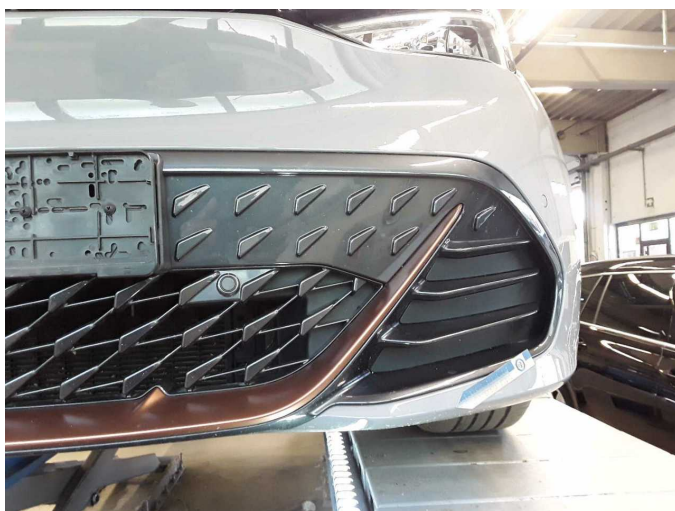
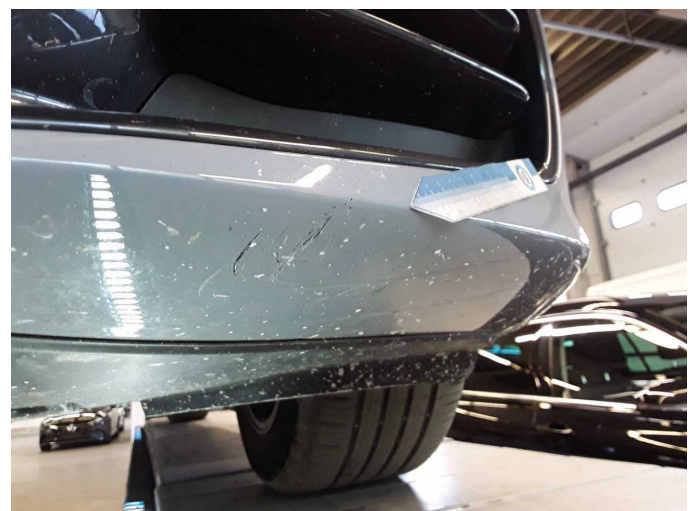
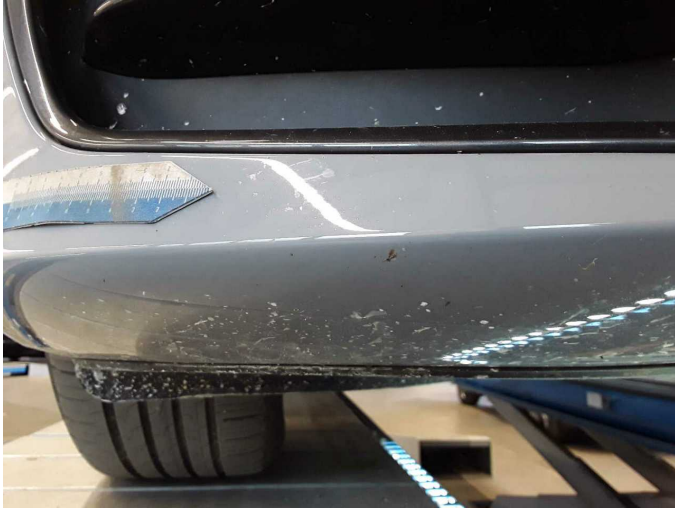
Damage 2: Front bumper: Front bumper - Scratched - Paint

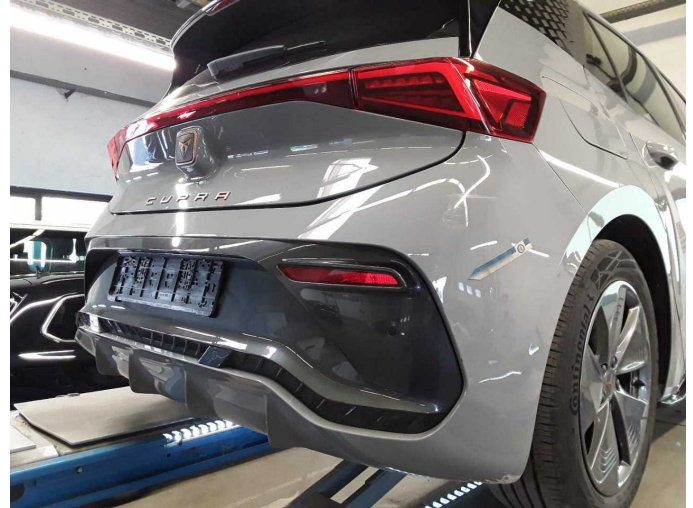
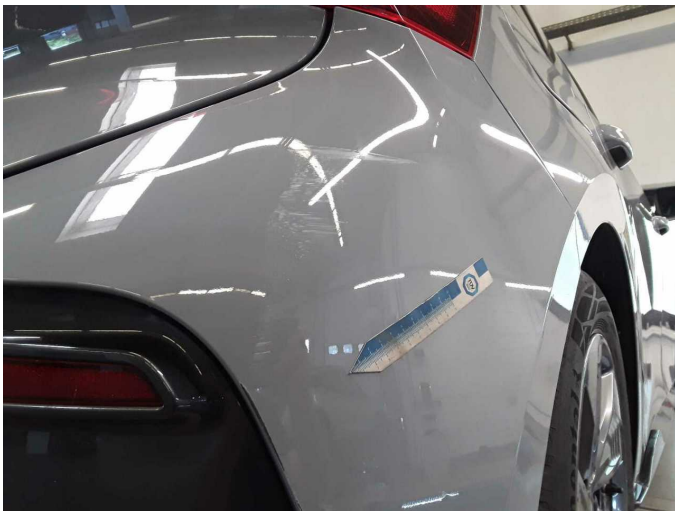
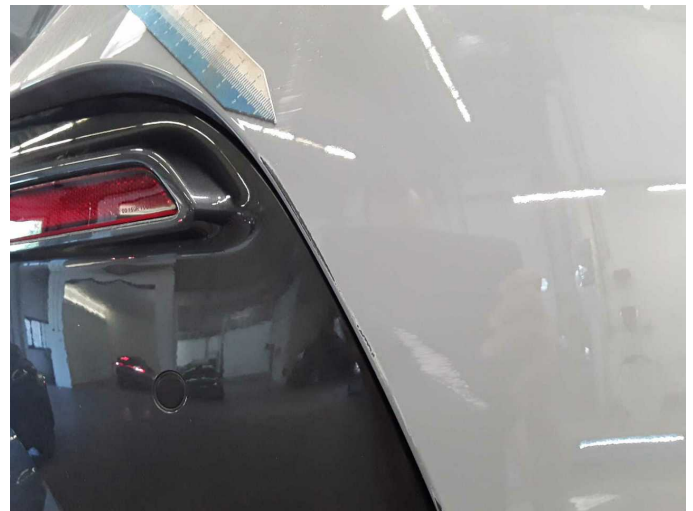
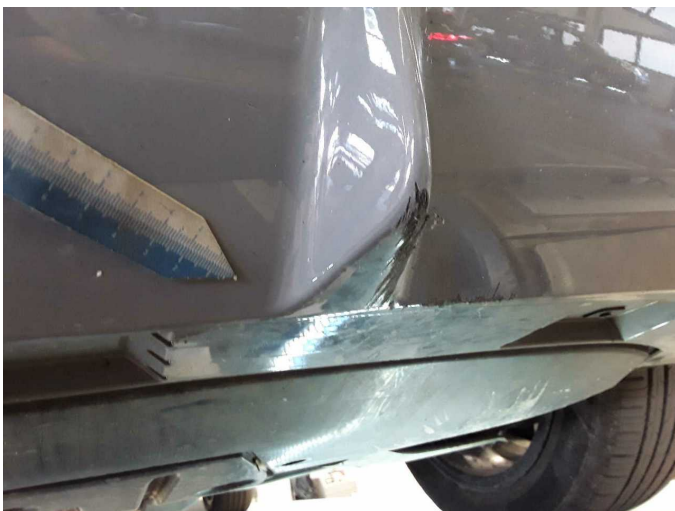
Damage 3: Rear bumper: Rear bumper - Scratched - Paint
