Expertise

Protocol number: 46365872  
Order No. / Reference: 26641733  
Inspection date: 2 Jul 2026

Manufacturer: Ford

Model: Focus Turnier 1.5 EcoBlue Start-Stopp-System  
COOL&CONNECT

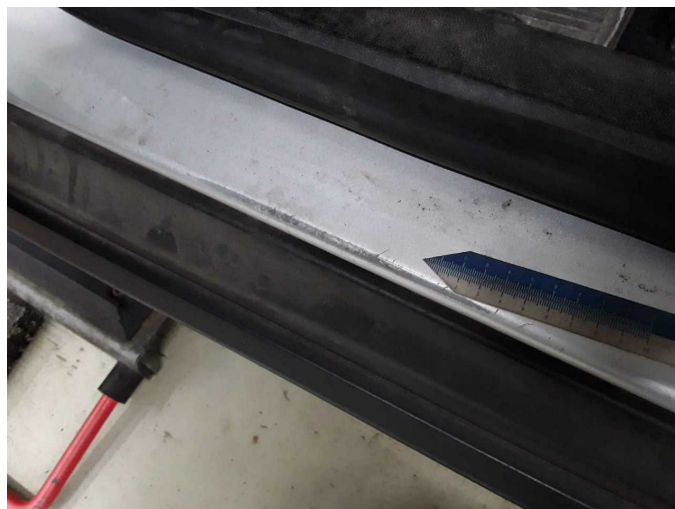
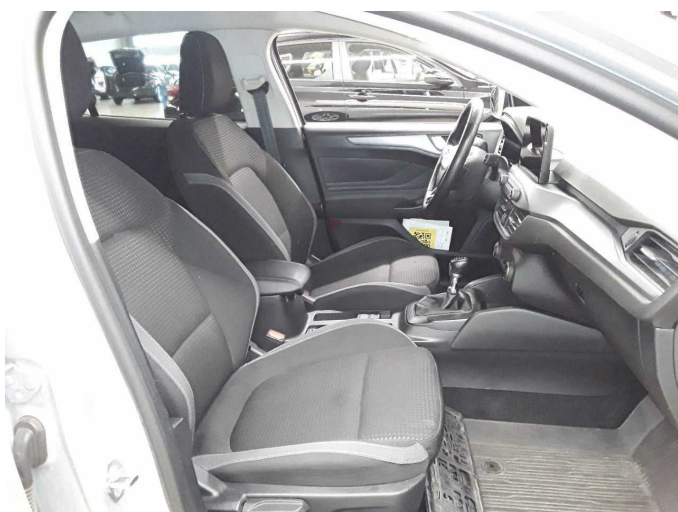
| No. | Component group | Description |
|---|---|---|
| 2 | Sill - left side | Sill - Scratched - Smart repair |

**Damage 2:** Sill - left side: Sill - Scratched - Smart repair

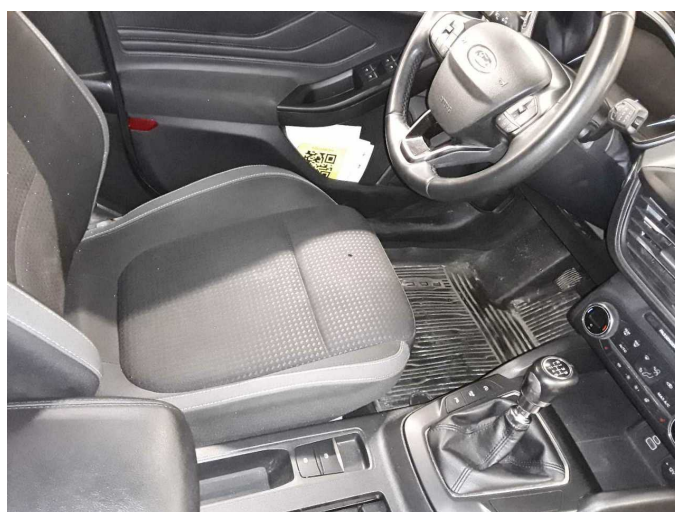
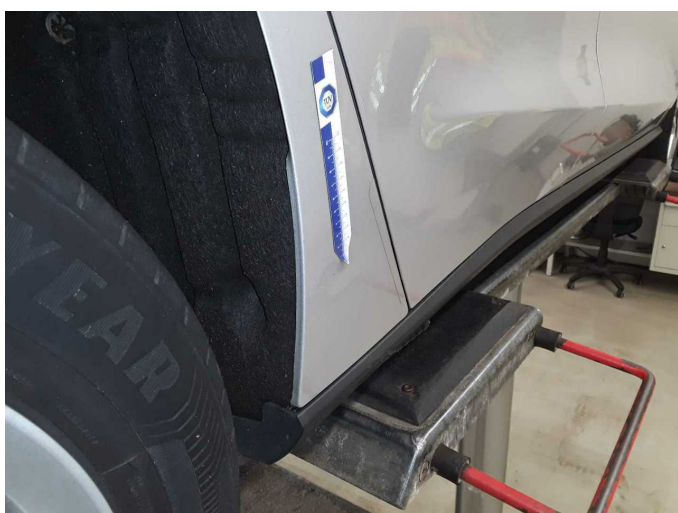
| No. | Component group | Description |
|---|---|---|
| 3 | Interior | Interior (Rauchgeruch) - Odour - Ozone treatment |

**Damage 3:** Interior: Interior (Rauchgeruch) - Odour - Ozone treatment

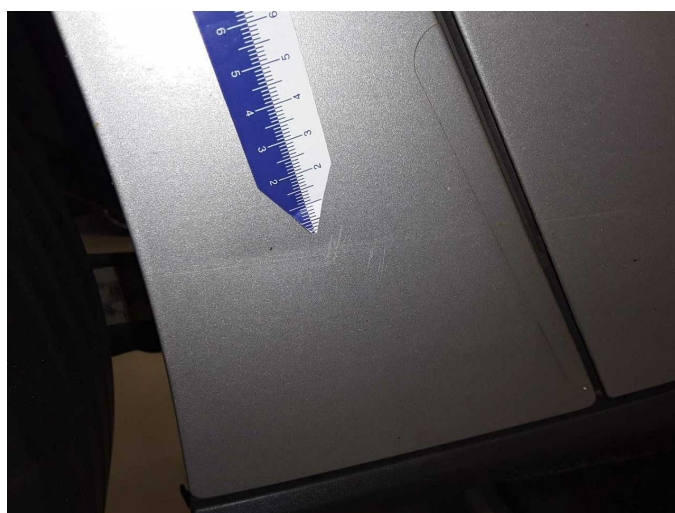
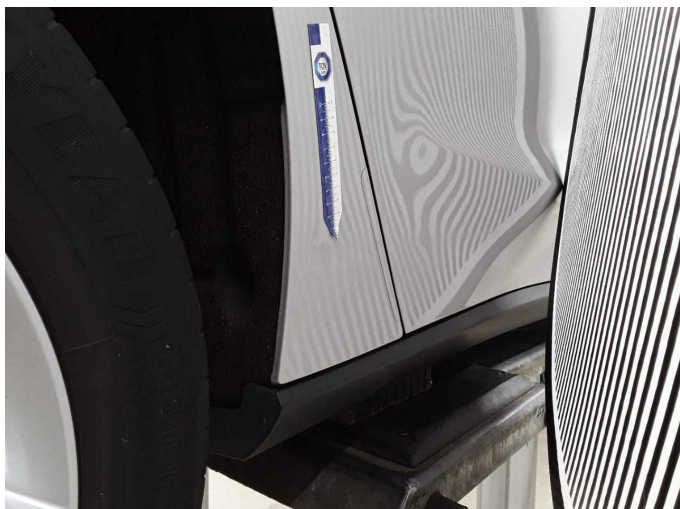
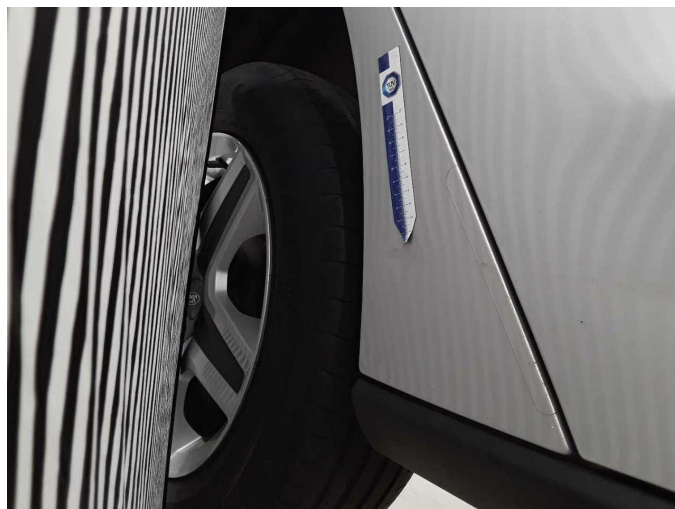
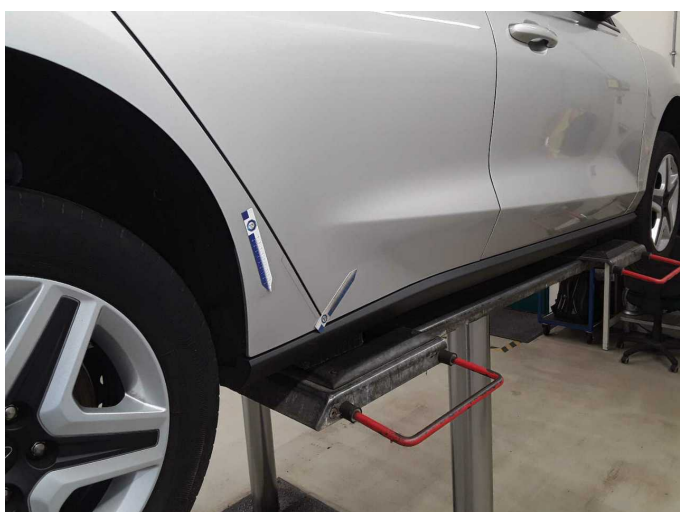
| No. | Component group | Description |
|---|---|---|
| 4 | Side panel - rear right side | Side panel - Dent / paintcoat damage - Smart repair |

**Damage 4:** Side panel - rear right side: Side panel - Dent / paintcoat damage - Smart repair

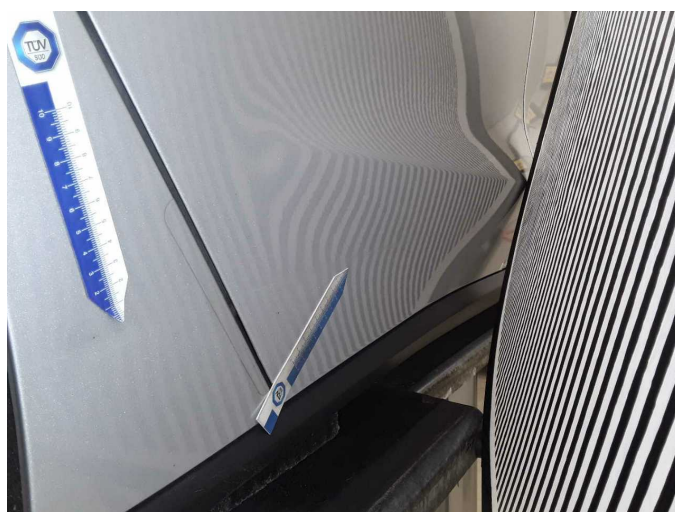
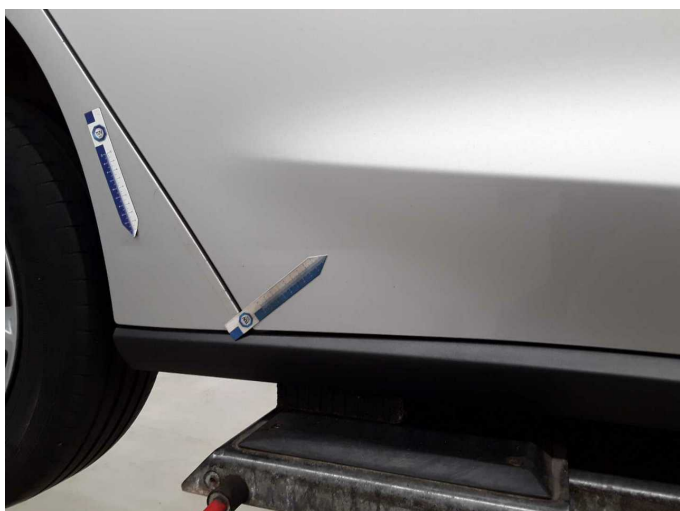
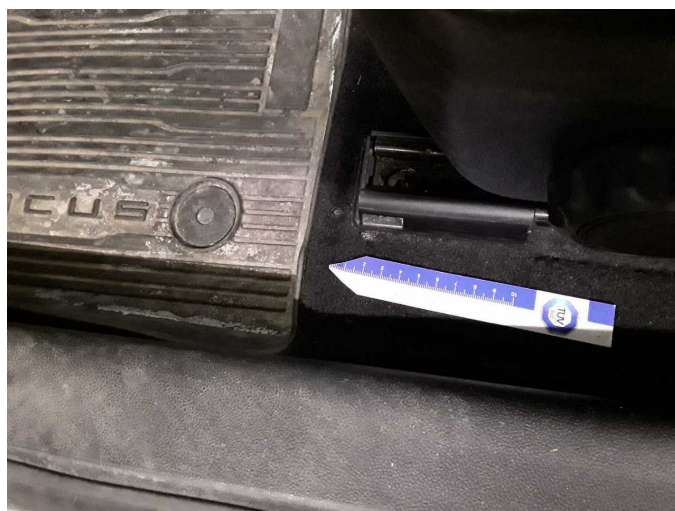
| No. | Component group | Description |
|---|---|---|
| 5 | Door - rear right side | Door - Dent / paintcoat damage - Smart repair |

**Damage 5:** Door - rear right side: Door - Dent / paintcoat damage - Smart repair

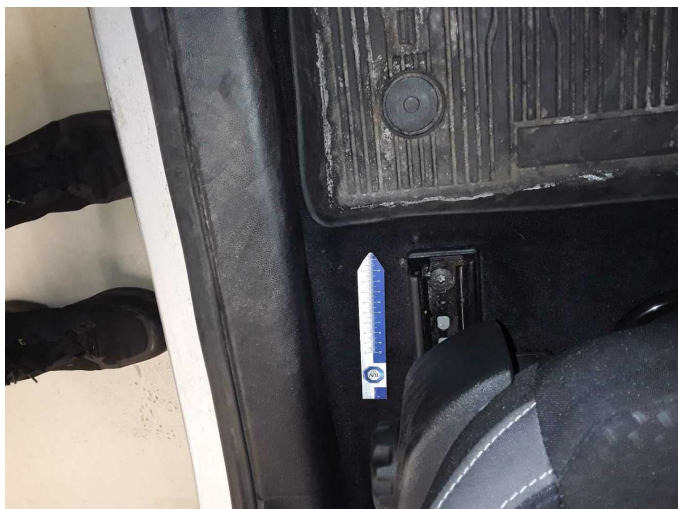
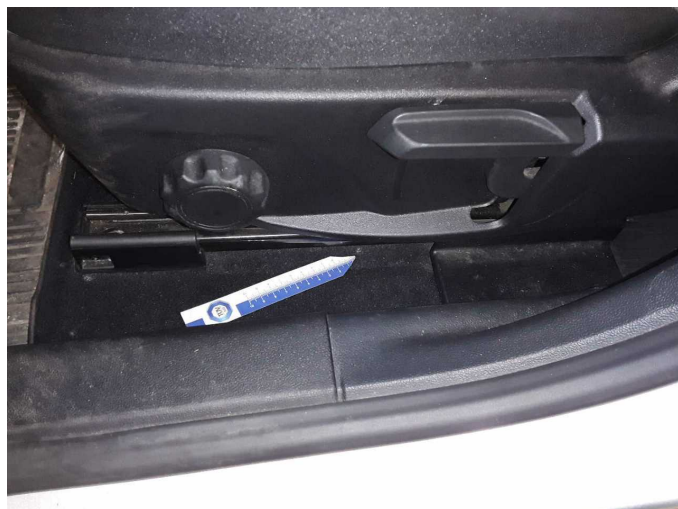
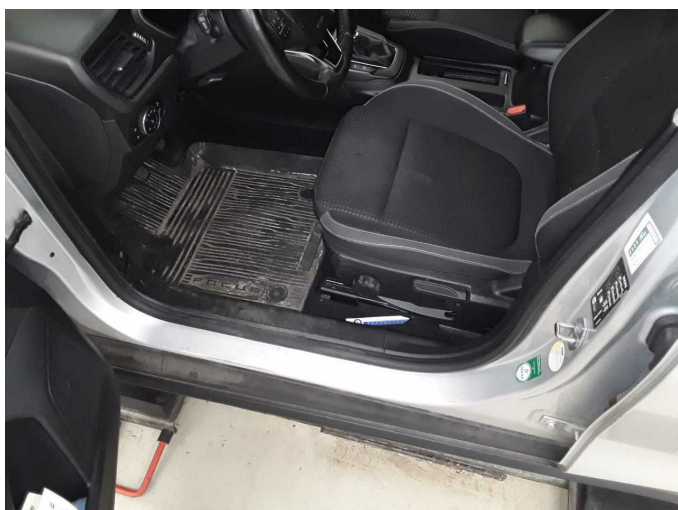
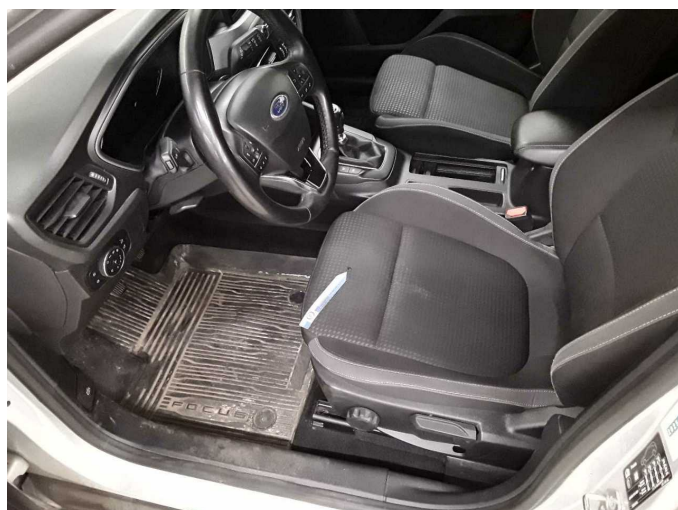
| No. | Component group | Description |
|---|---|---|
| 6 | Trim / covers | Carpet - front left side (mehrere Brandlöcher) - Burn hole (cigarettes) - Smart repair |

**Damage 6:** Trim / covers: Carpet - front left side (mehrere Brandlöcher) - Burn hole (cigarettes) - Smart repair

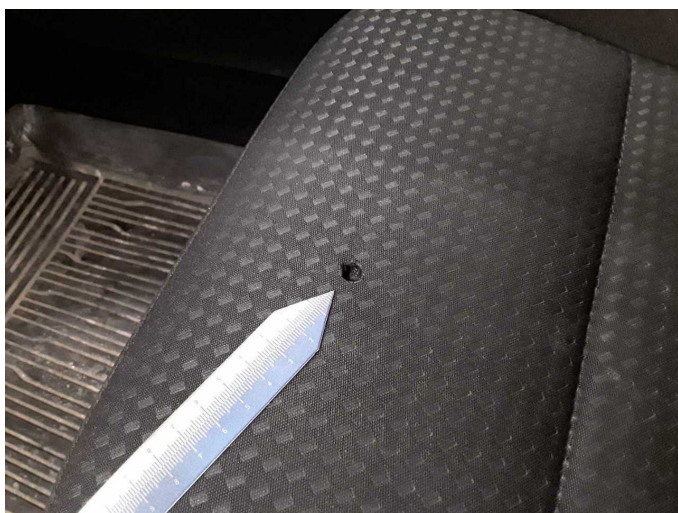
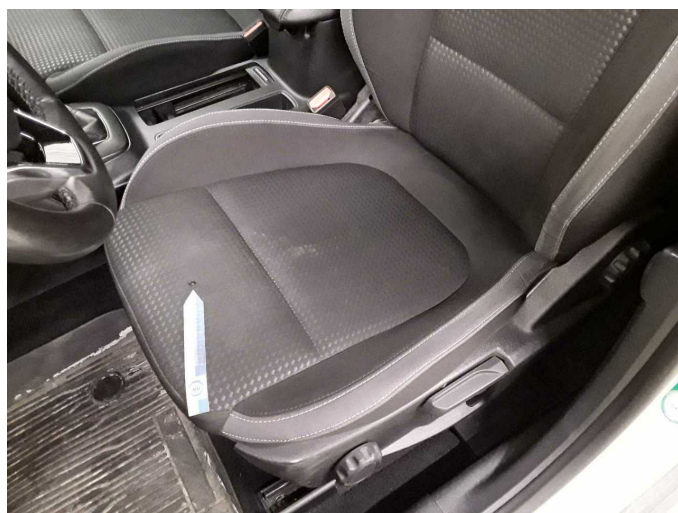
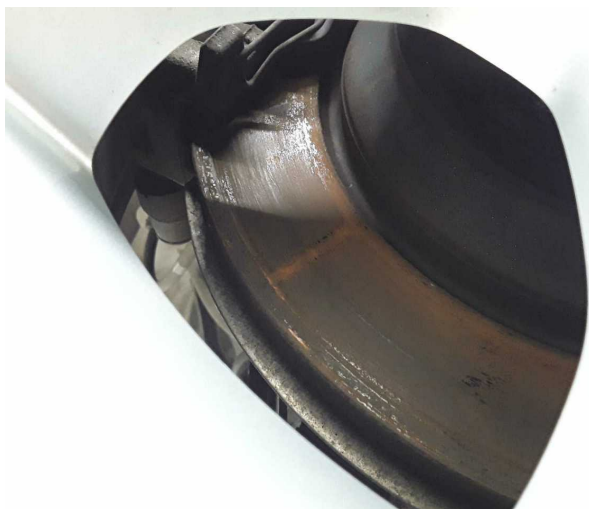
| No. | Component group | Description |
|---|---|---|
| 7 | Seat - front | Seat cover - left side - Burn hole (cigarettes) - Replace |

**Damage 7:** Seat - front: Seat cover - left side - Burn hole (cigarettes) - Replace

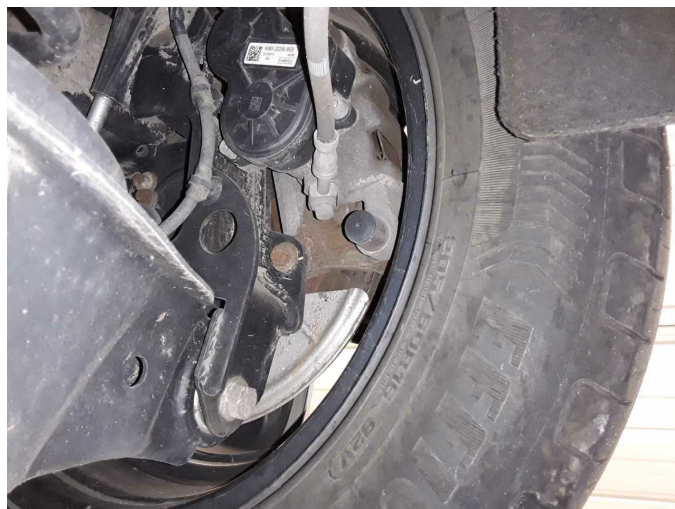
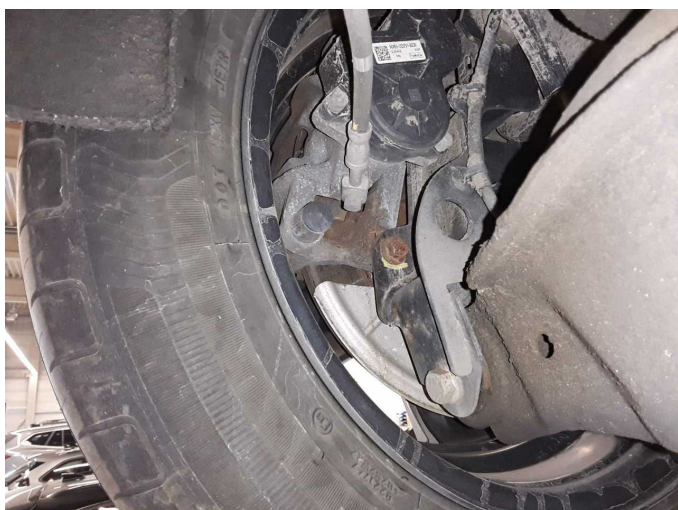
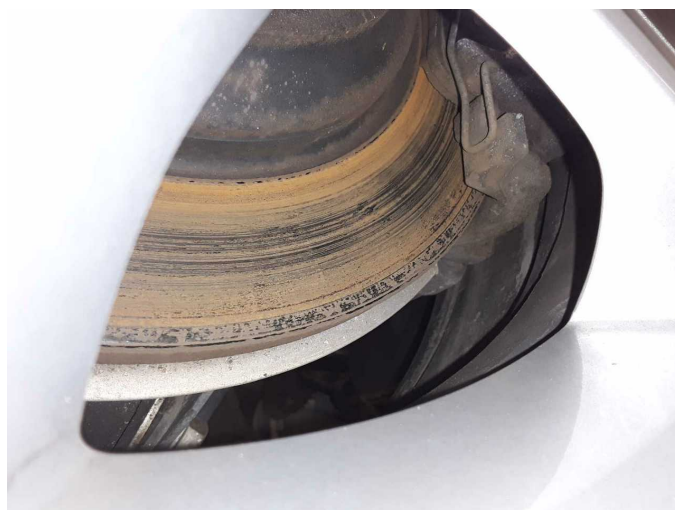
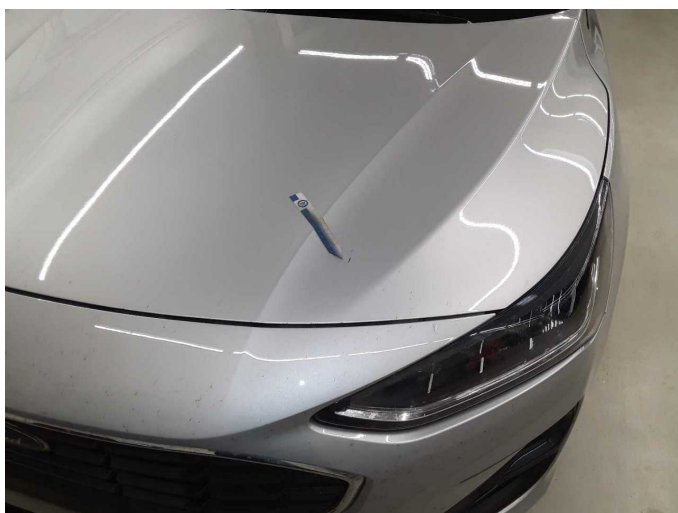
| No. | Component group | Description |
|---|---|---|
| 8 | Braking system | Brake discs and pads - rear - Corrosion - Replace |

**Damage 8:** Braking system: Brake discs and pads - rear - Corrosion - Replace

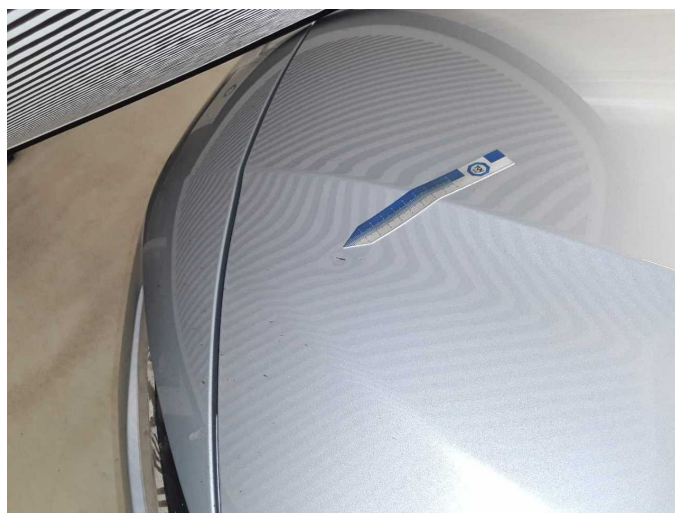
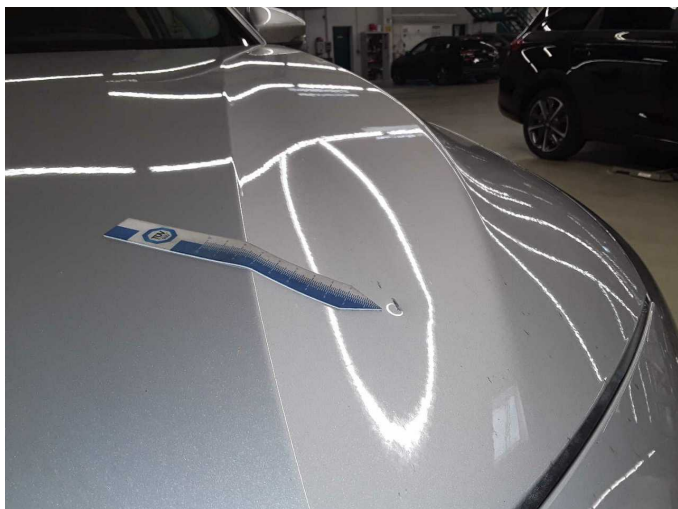
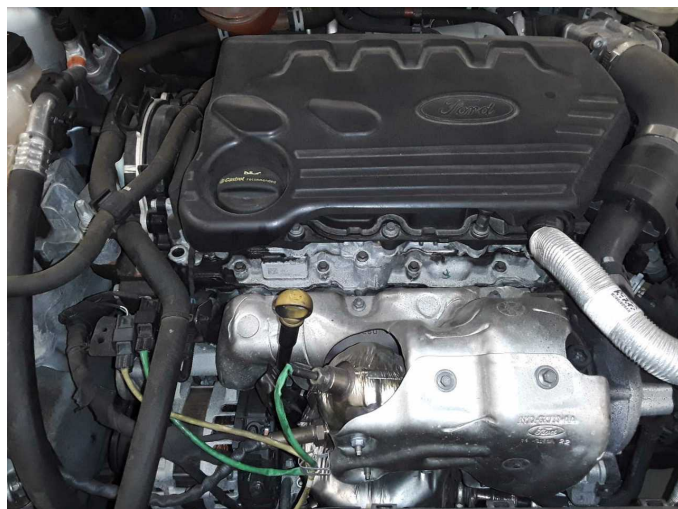
| No. | Component group | Description |
|---|---|---|
| 9 | Bonnet | Bonnet - Dent / paintcoat damage - Paint |

**Damage 9:** Bonnet: Bonnet - Dent / paintcoat damage - Paint

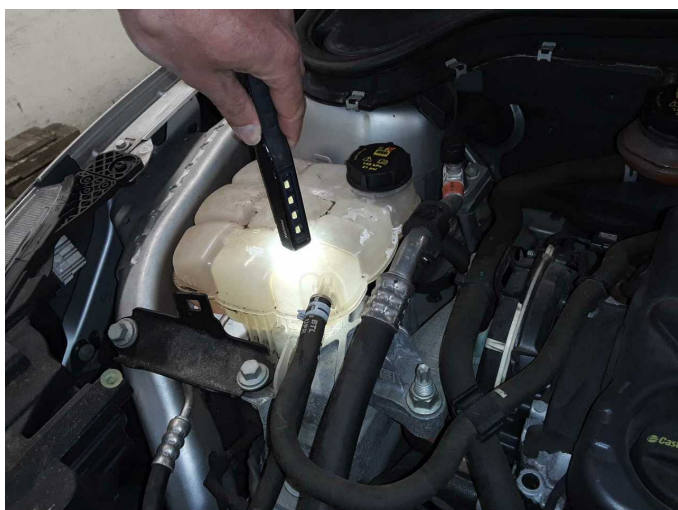
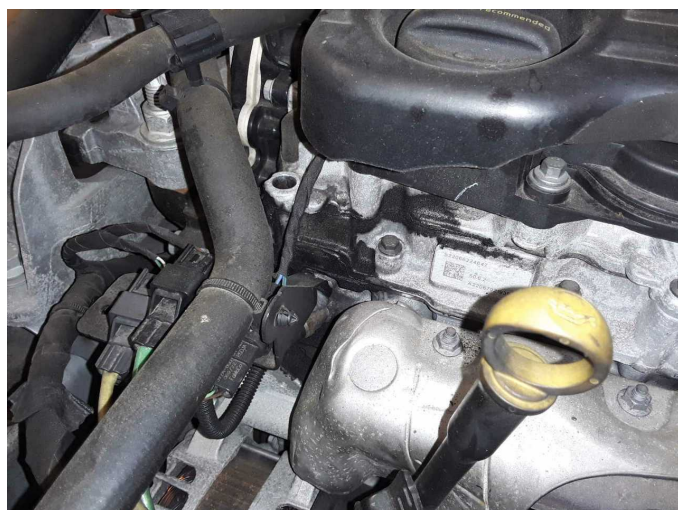
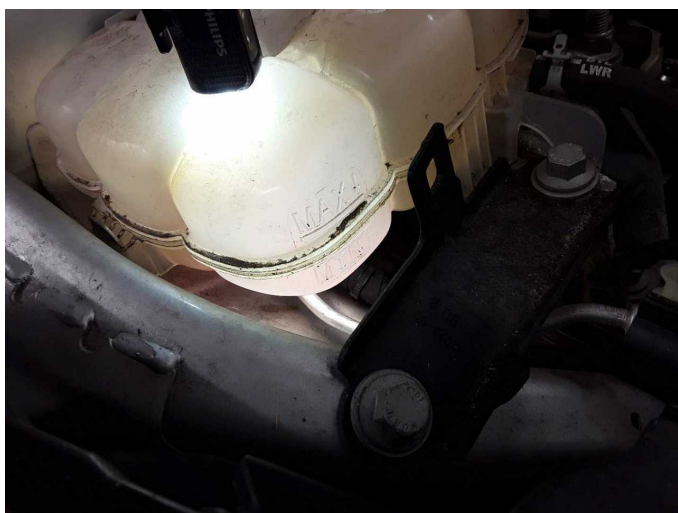
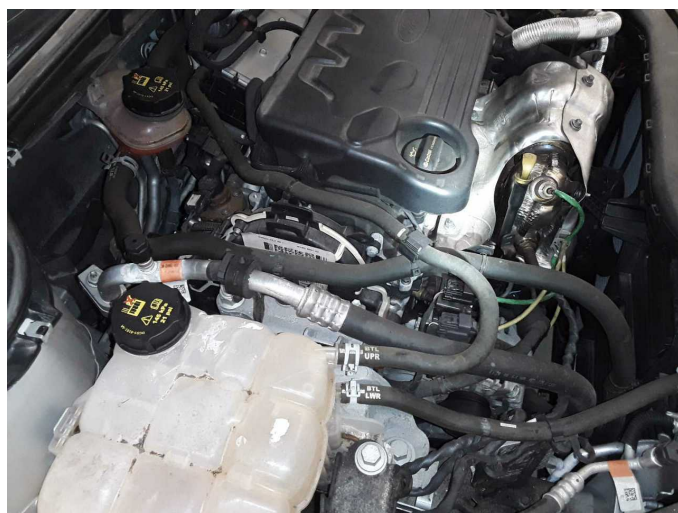
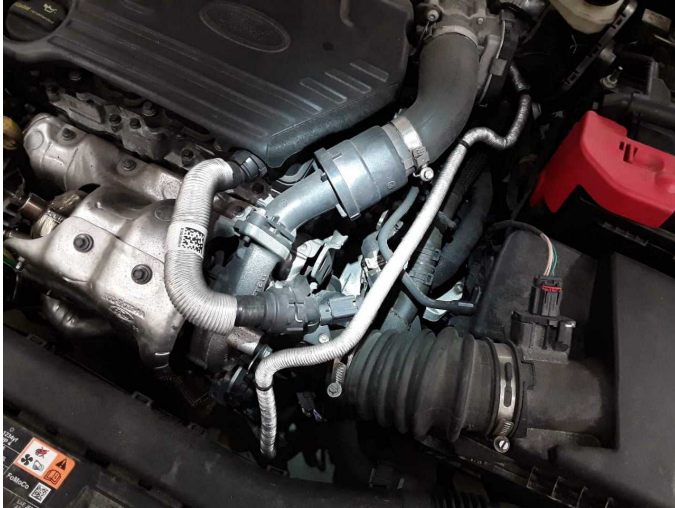
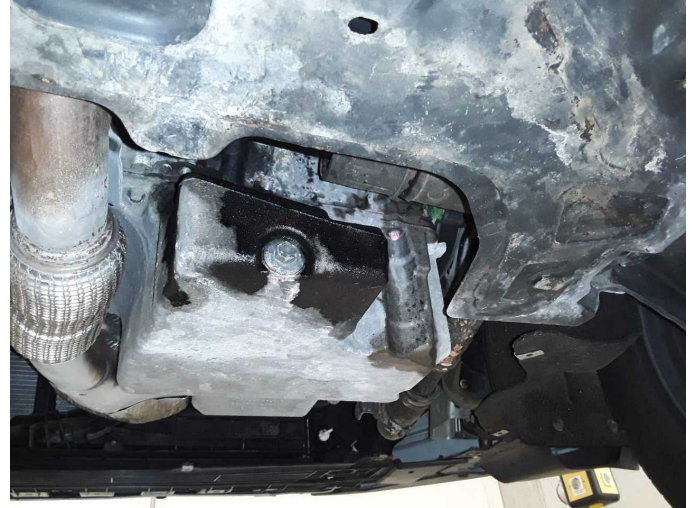
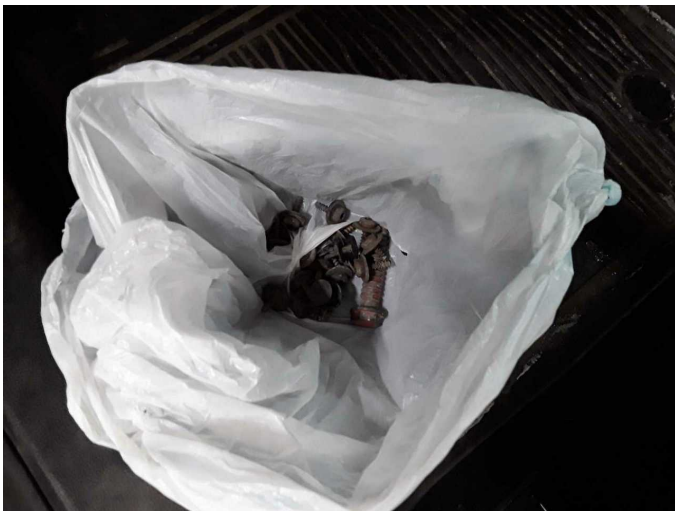
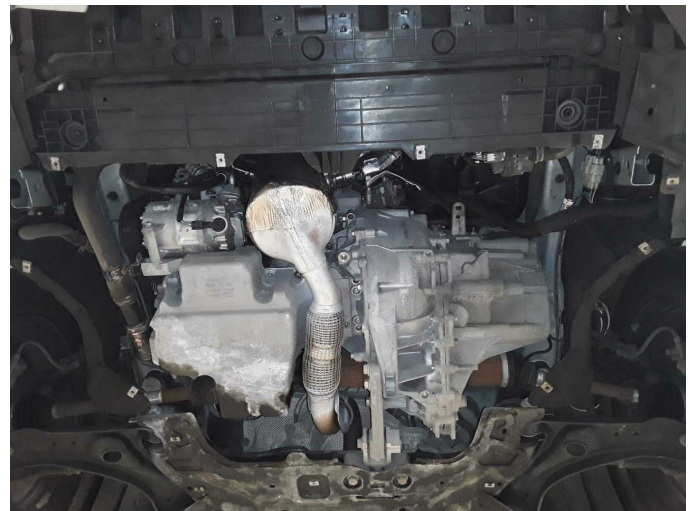
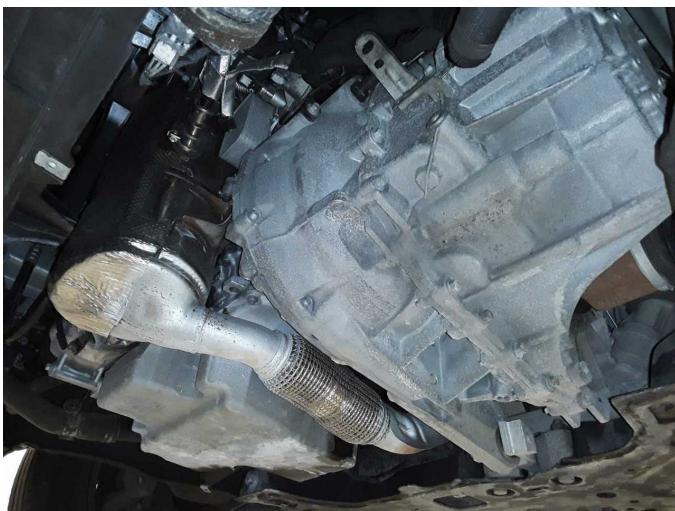
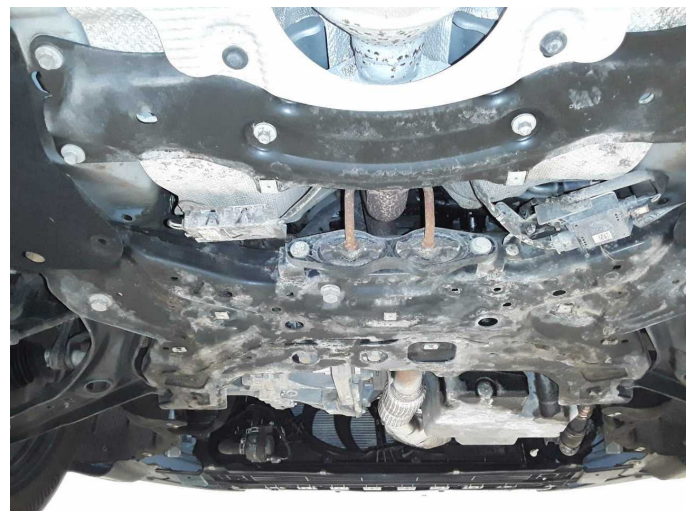
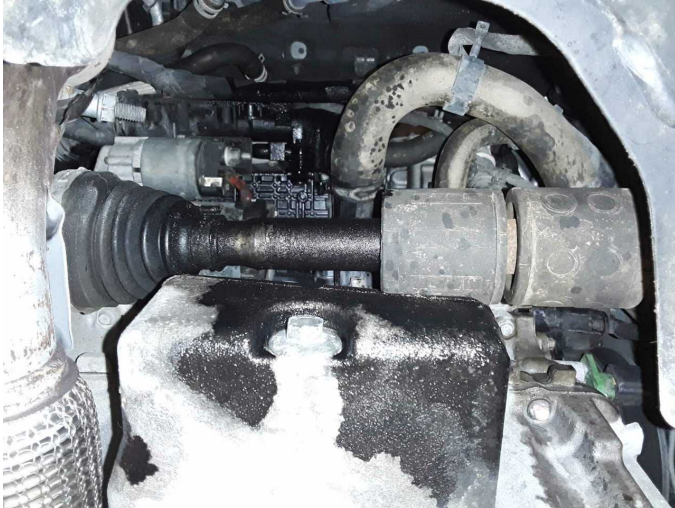
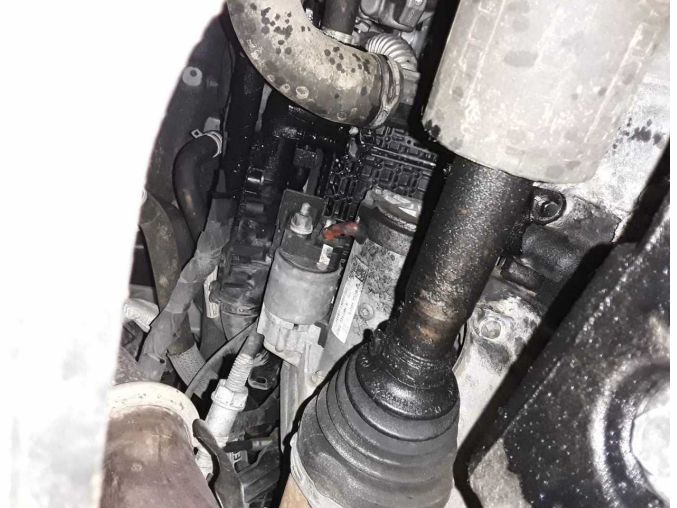
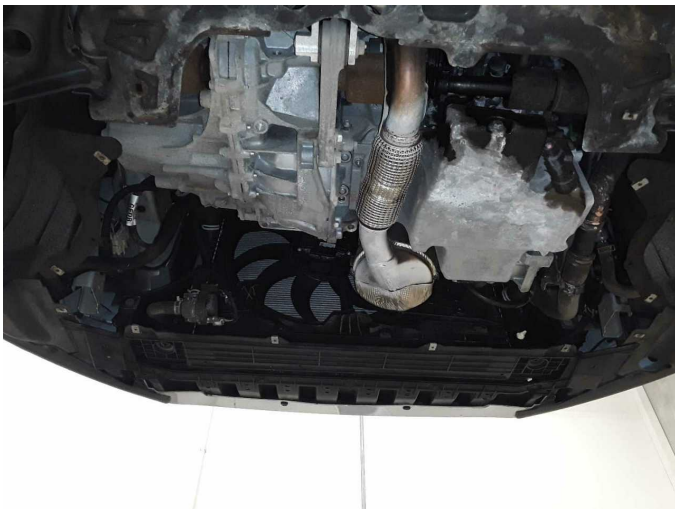
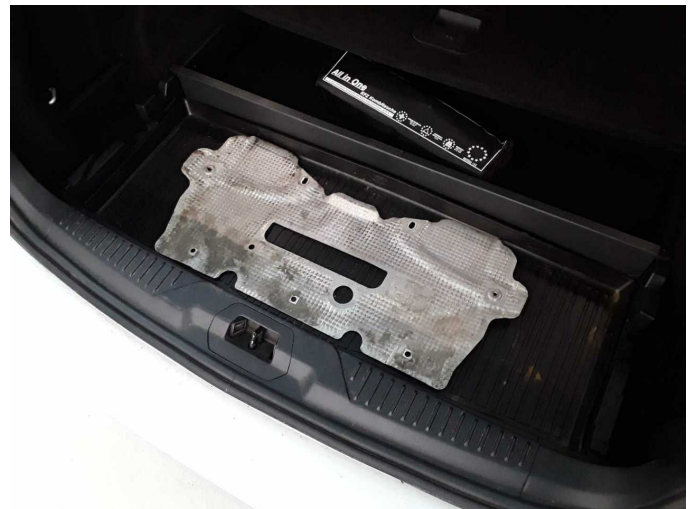
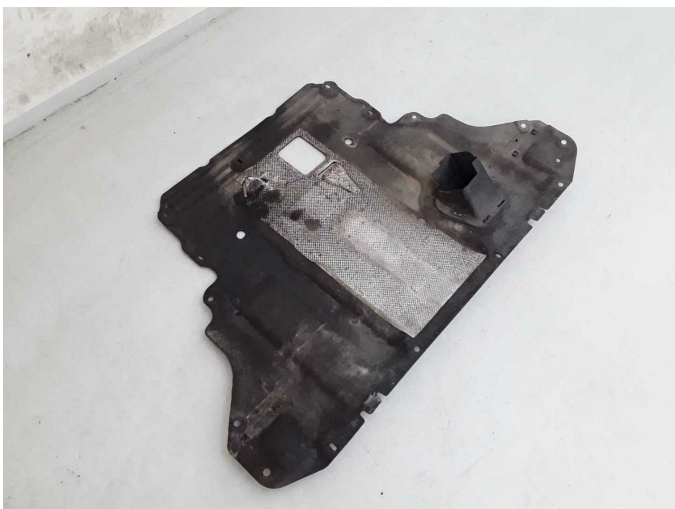
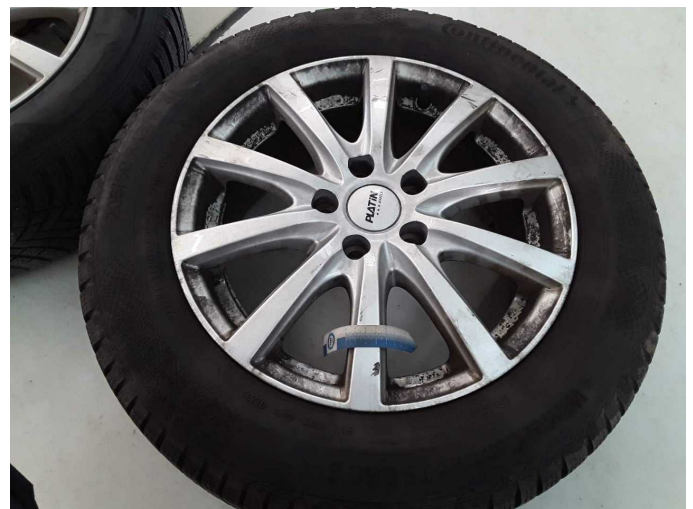
| Engine function test | An engine test run was performed, problem has been detected<br>This is due to the following reason.:<br>Motorschaden |

| No. | Component group | Description |
|---|---|---|
| 10 | Engine cooling | Coolant (Siehe Kostenvoranschlag) - Leaking - Replace |

**Damage 10:** Engine cooling: Coolant (Siehe Kostenvoranschlag) - Leaking - Replace

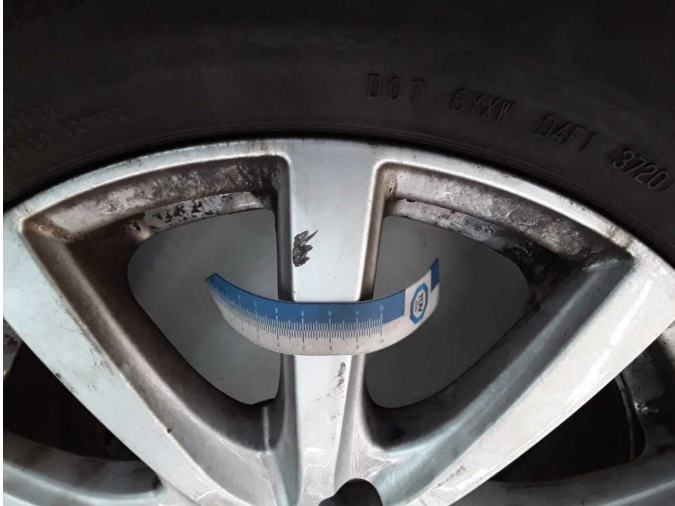
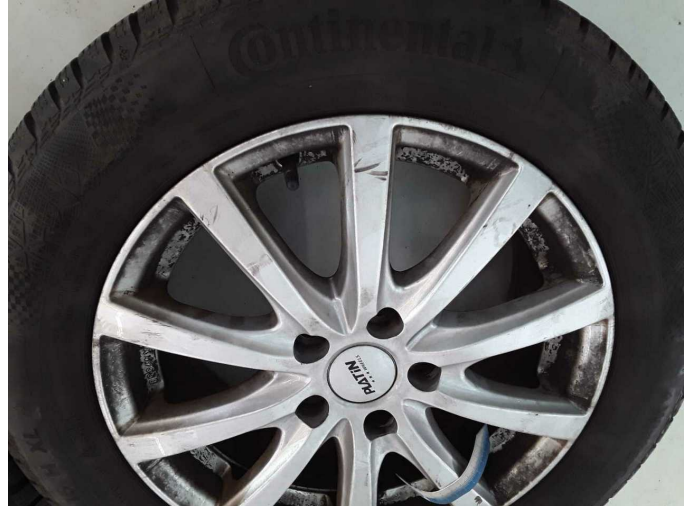
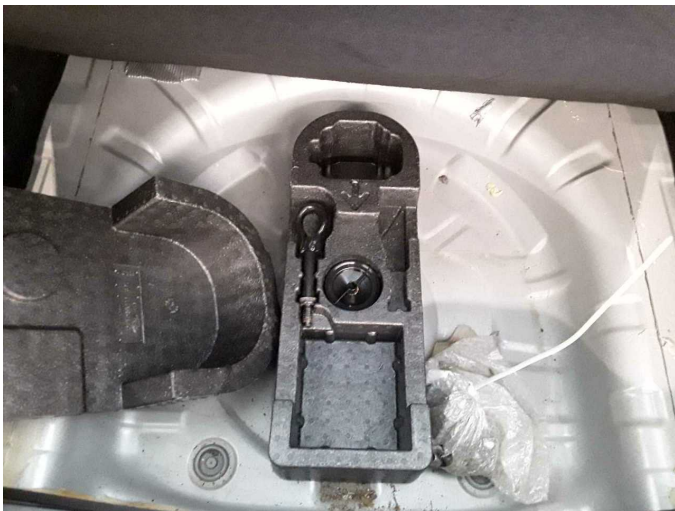
| No. | Component group | Description |
|---|---|---|
| 2 | 2nd wheel set | 1 alloy rim - Scratch(es) - No deduction |

**Wear and tear 2:** 2nd wheel set: 1 alloy rim - Scratch(es) - No deduction

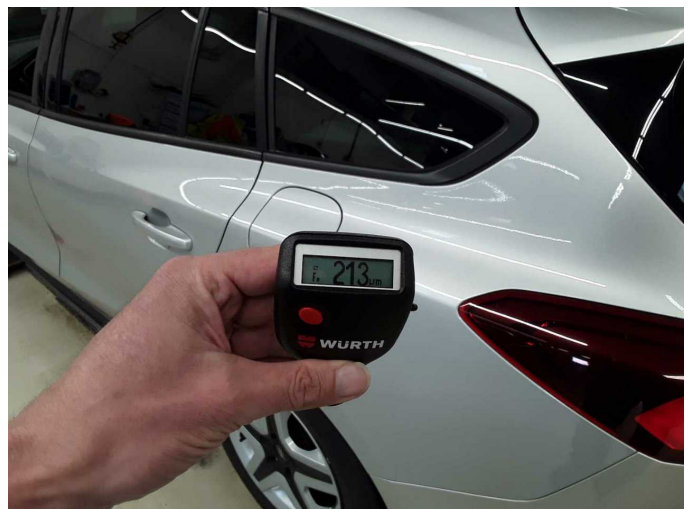
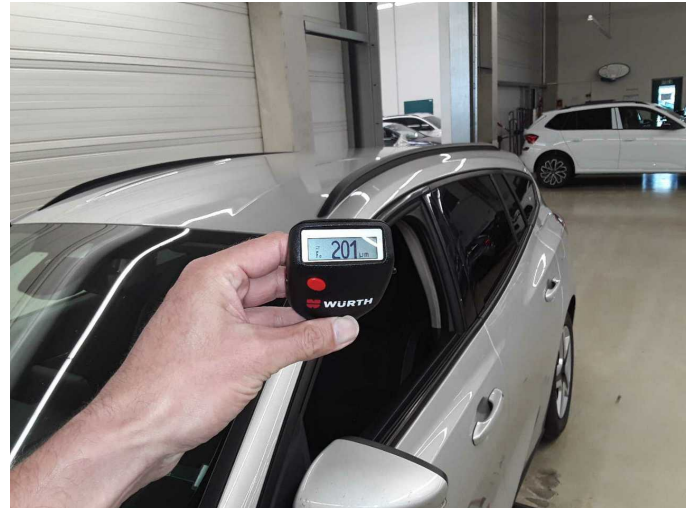
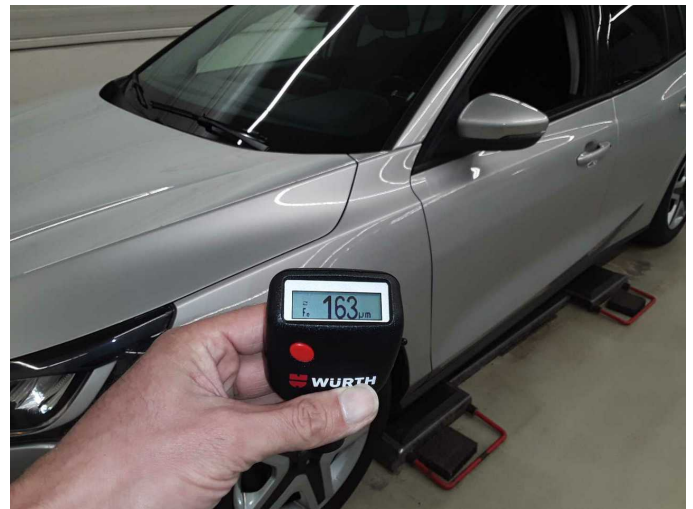
| No. | Repainting |
|---|---|
| 1 | Roof rail - left side, Mudguard - left side, Mudguard - right side, Side panel - rear left side, Side panel - rear right side, Door - rear left side, Door - rear right side, Door - front left side, Door - front right side, Professionally carried out, Invoice of repair done Non-existent |

**Repainting 1:** Roof rail - left side, Mudguard - left side, Mudguard - right side, Side panel - rear left side, Side panel - rear right side, Door - rear left side, Door - rear right side, Door - front left side, Door - front right side
