Expertise

Protocol number: 45710886
Order No. / Reference: 26482872
Inspection date: 1 Jun 2026

Model: Astra 1.5 D Automatik Ultimate

VIN: VXKFBYHZTP1029900

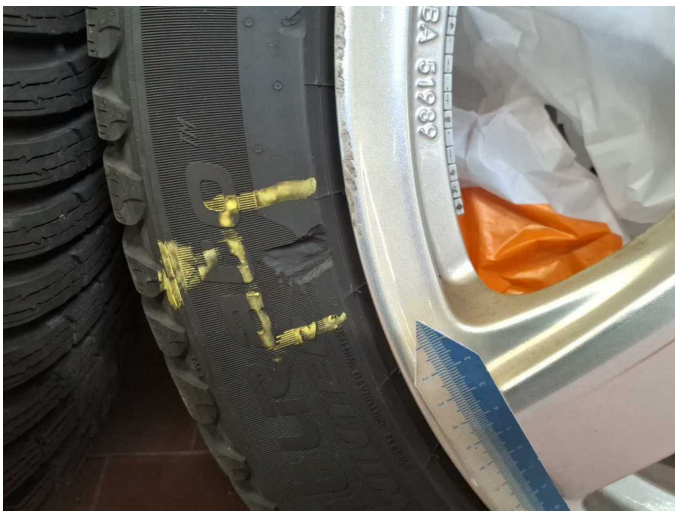
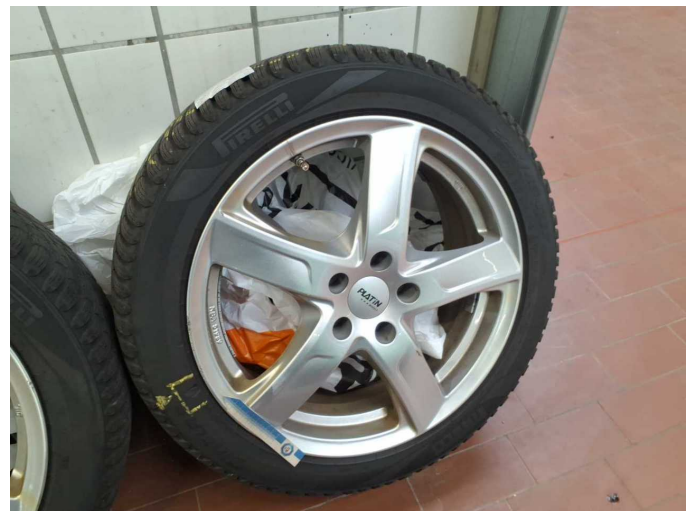
Damage 1: 2nd wheel set: 1 tyre (Nicht im Leasing) - Damaged

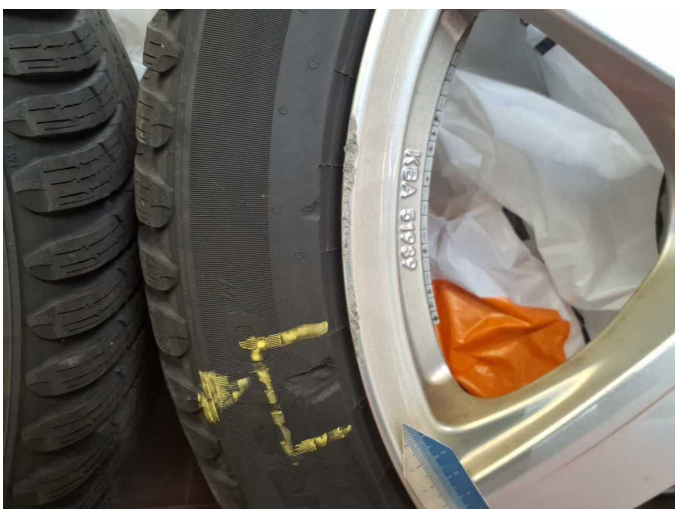
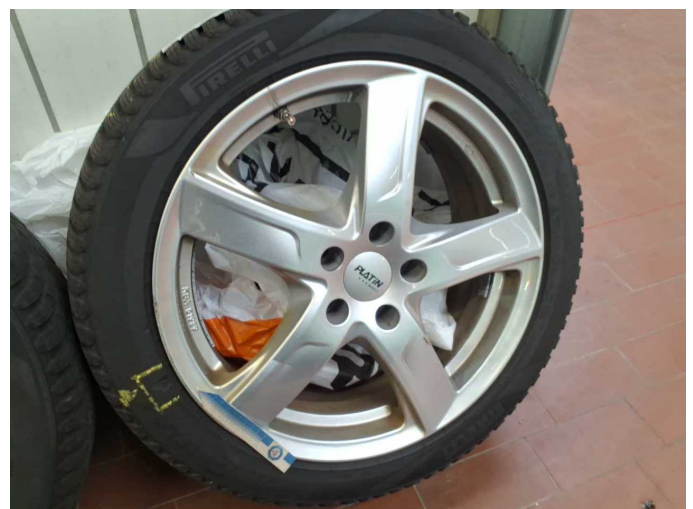
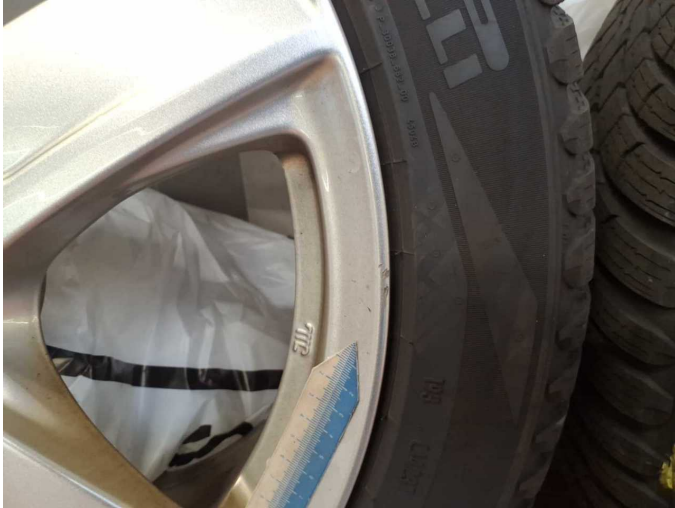
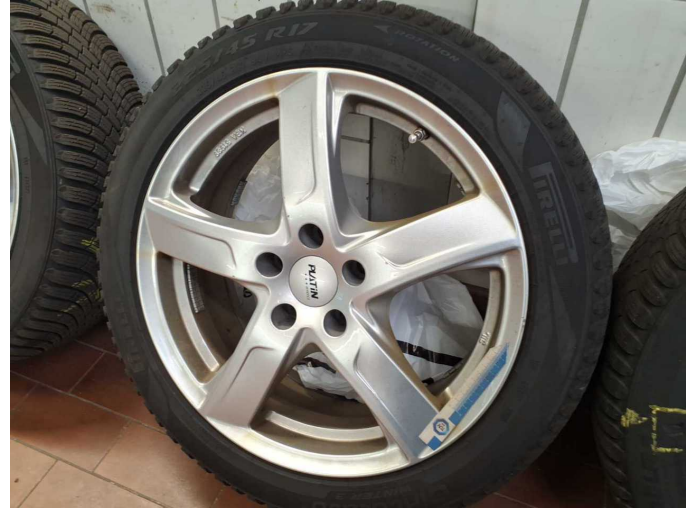
Damage 2: 2nd wheel set: 2 alloy rims (Nicht im Leasing) - Damaged

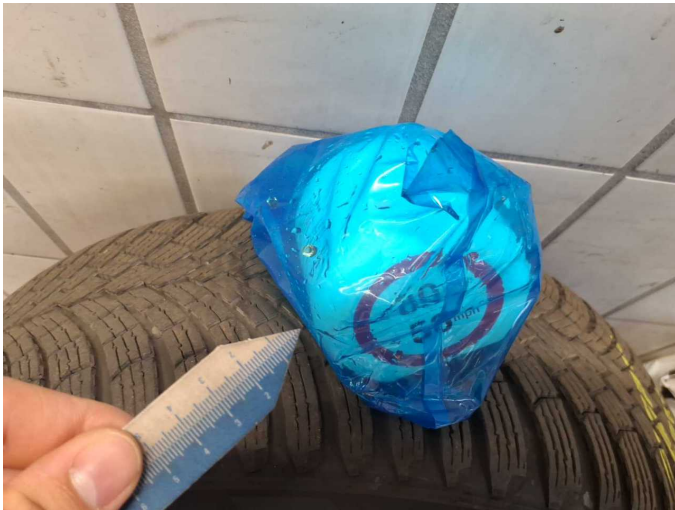
Damage 3: Equipment: Tirefit filler (Undicht) - Damaged - Replace

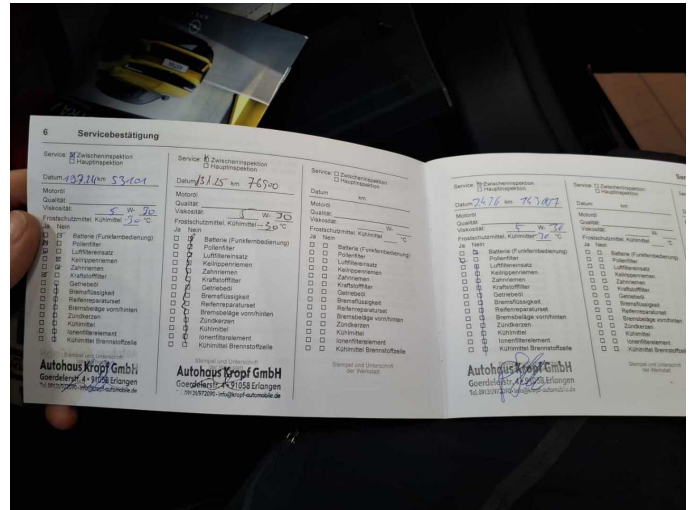
Damage 4: Documents: Service book (Zwischenwartung fehlt, ggf.Folgekosten möglich) - Incomplete - Loss in value

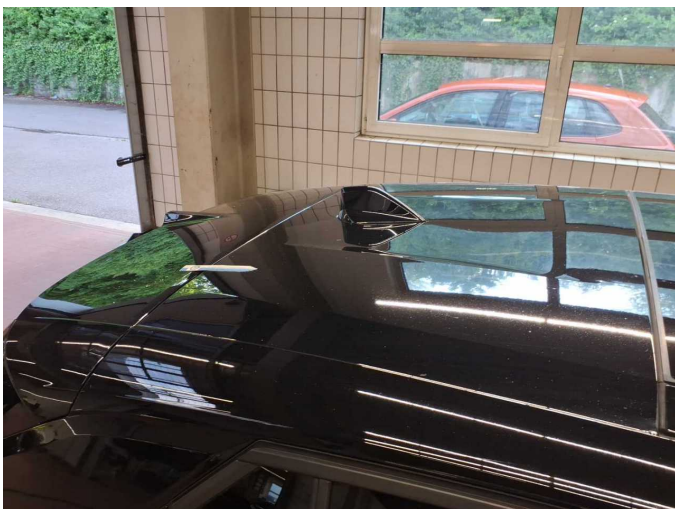
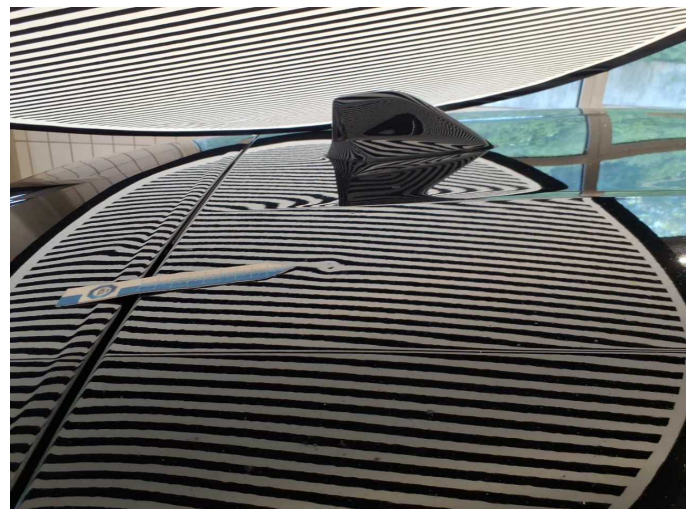
Damage 5: Roof: Roof - dent(s) - Smooth repair work

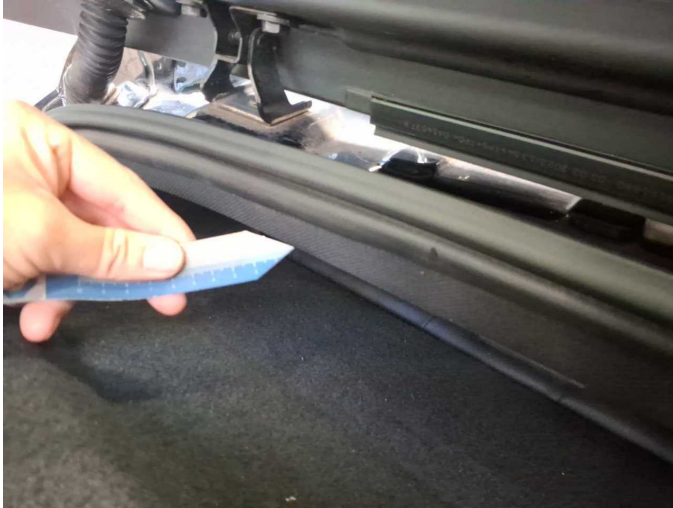
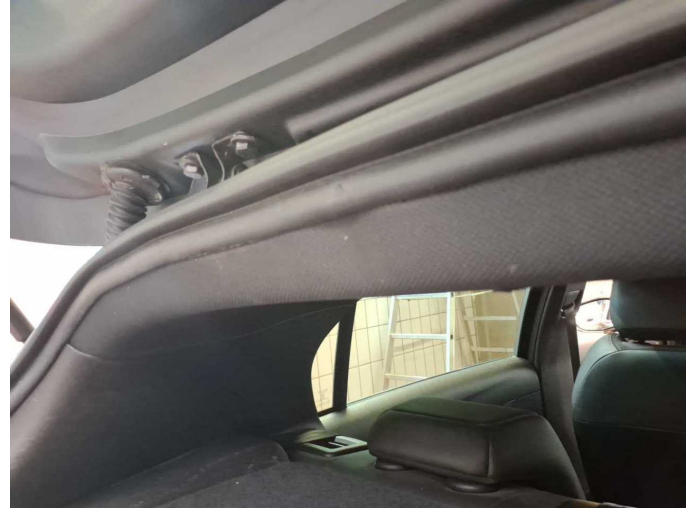
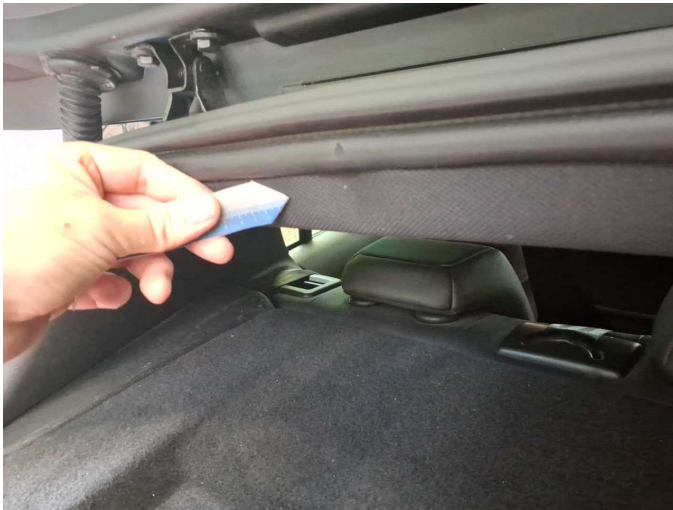
Damage 6: Trim / covers: Roof lining - dent(s) - Loss in value

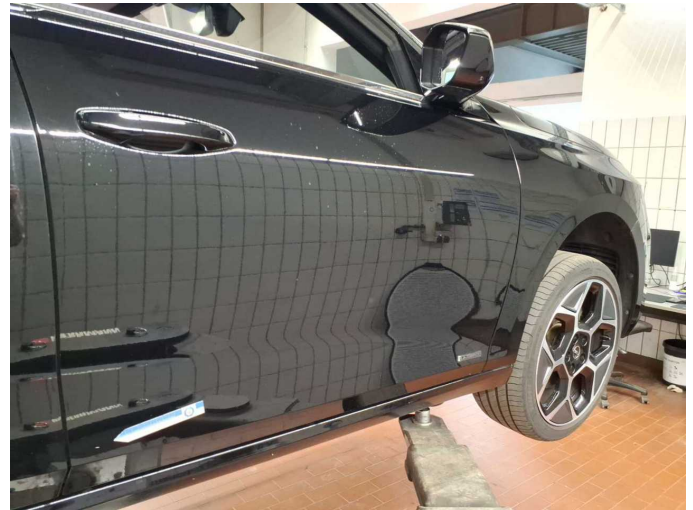
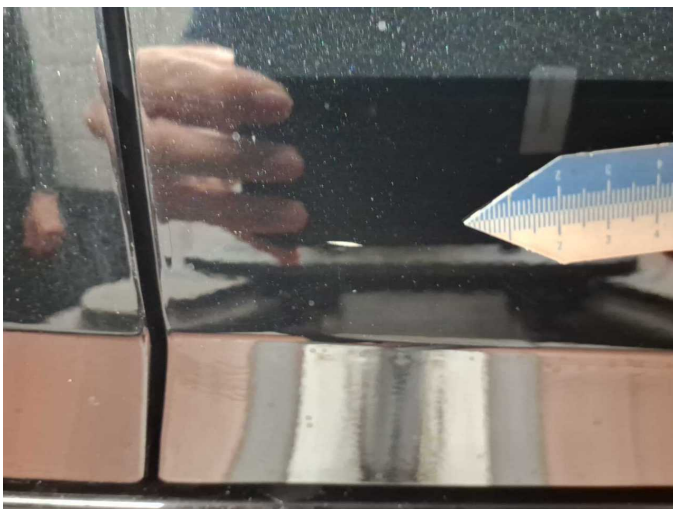
Damage 7: Door - front right side: Door - Scratch(es) - Smart repair

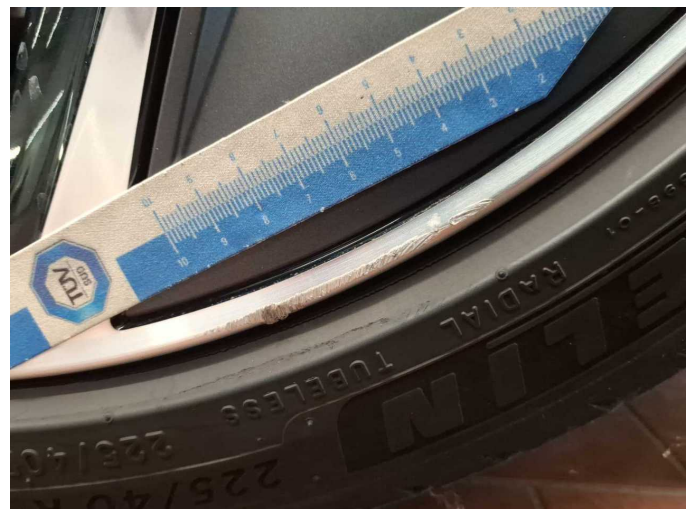
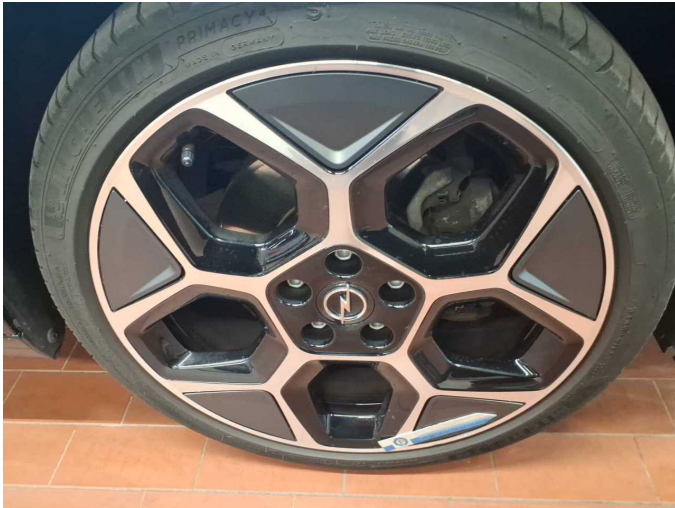
Damage 8: Wheel / tyres: Alloy rim - front right side (Optischer Mangel) - Scratched - Loss in value

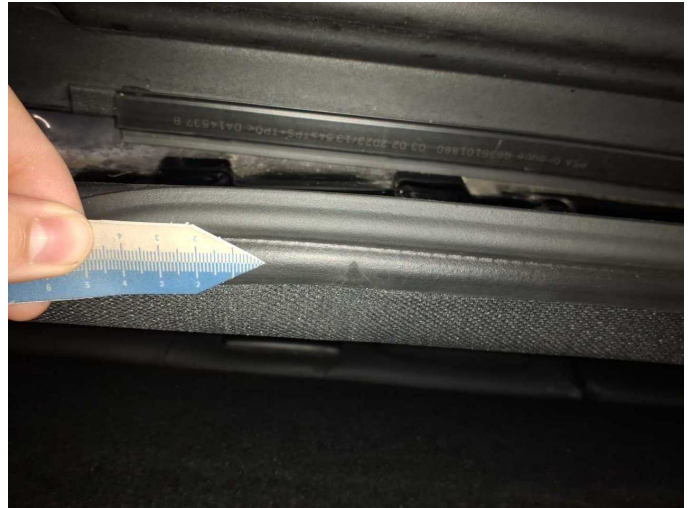
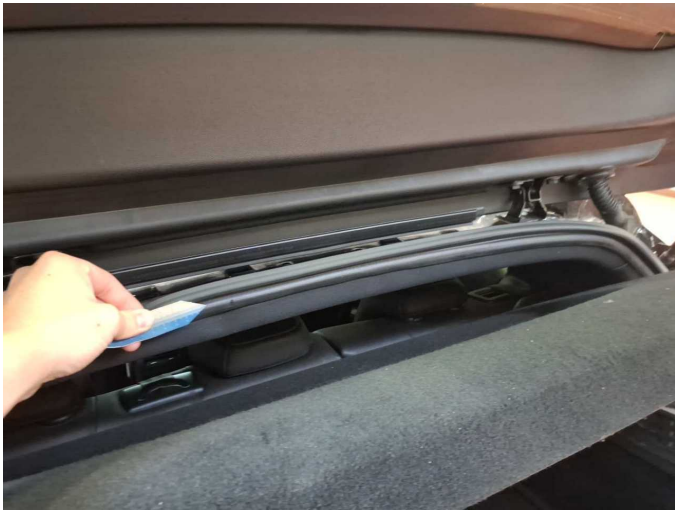
Damage 9: Boot lid / rear door: Seal - centre - Damaged - Replace

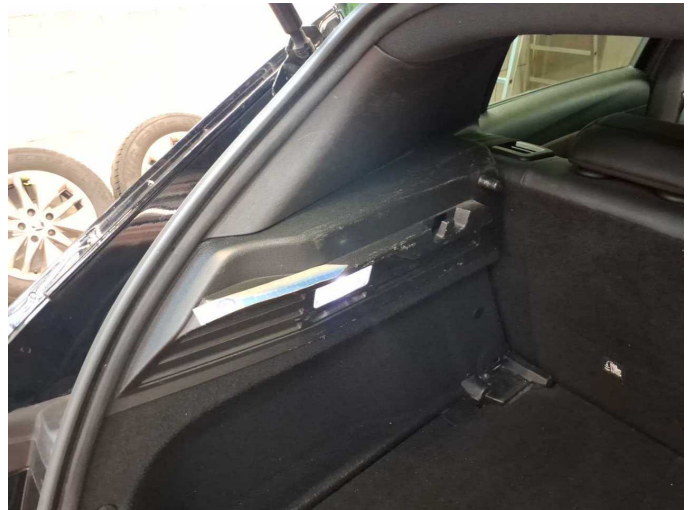
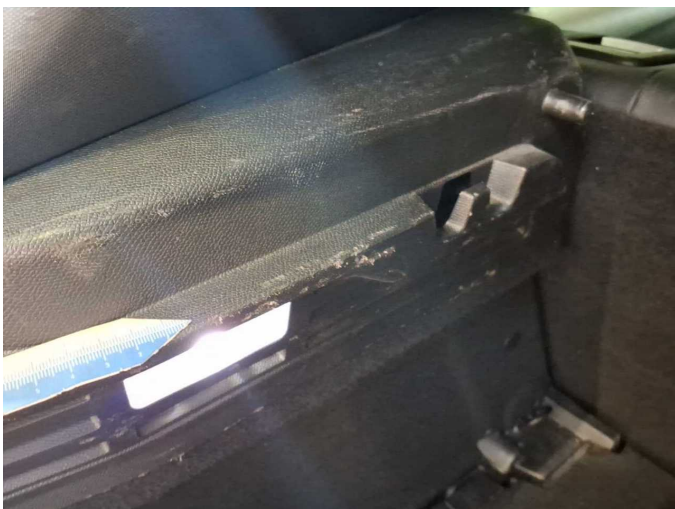
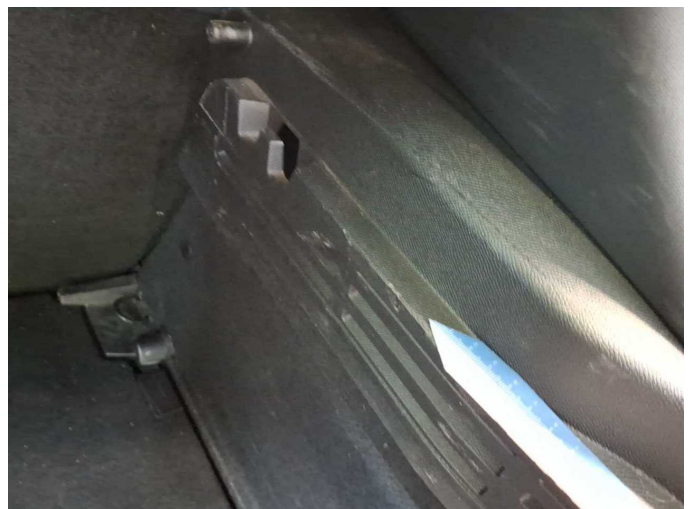
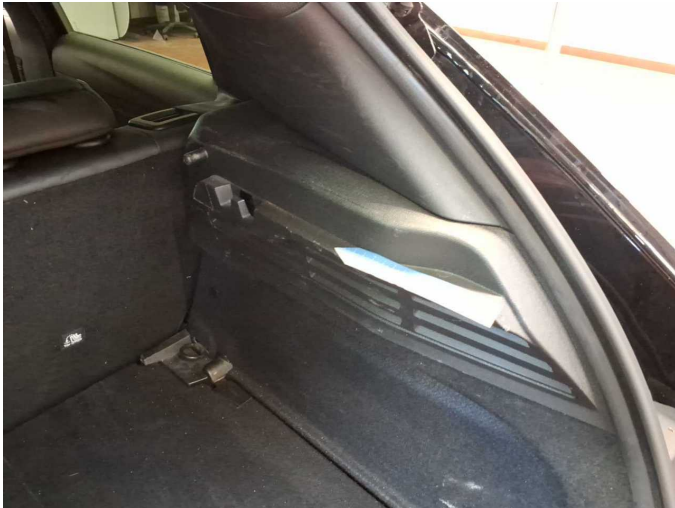
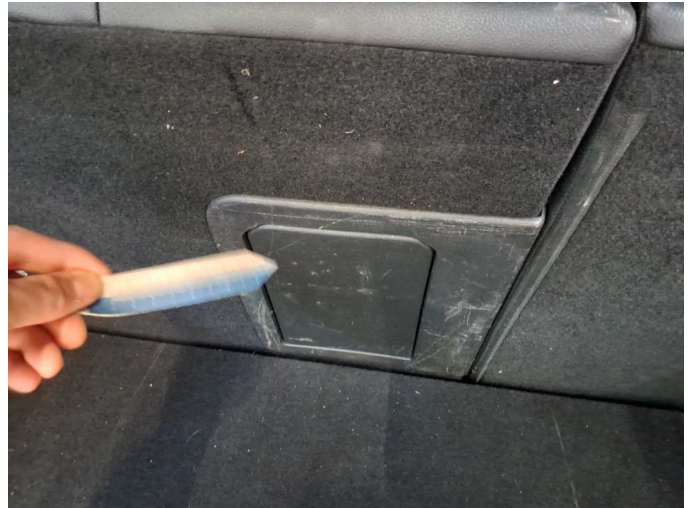
Damage 10: Trim / covers: Boot lid - interior trim - Scratch(es) - Loss in value

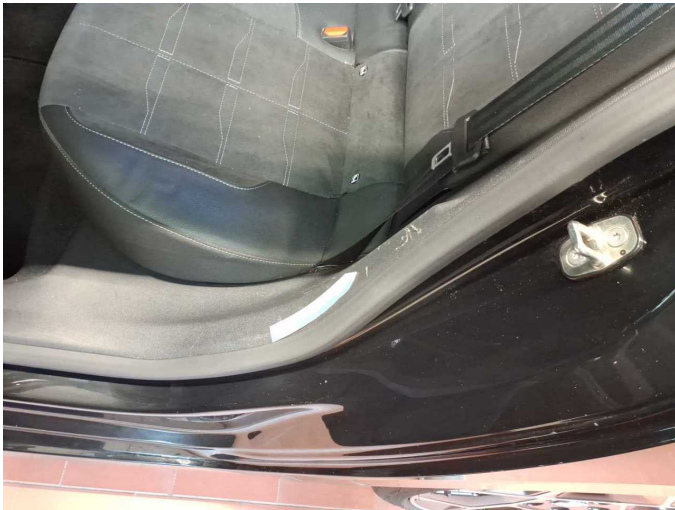
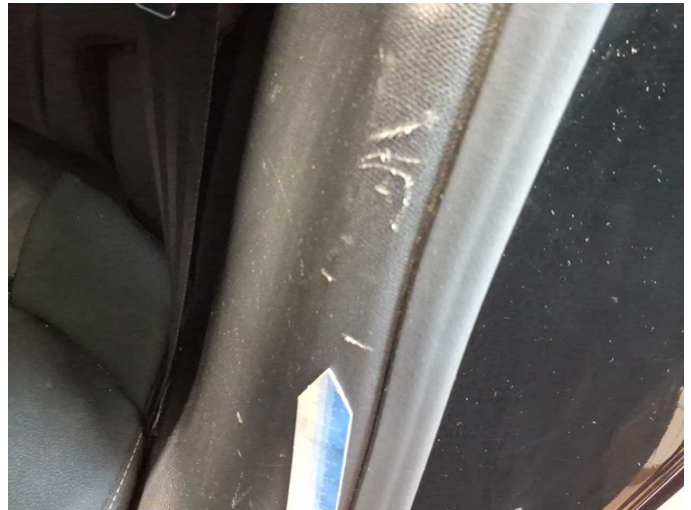
Damage 11: Trim / covers: C-pillar - trim - interior, left sde (Beschädigung zu tief) - Scratched - Replace

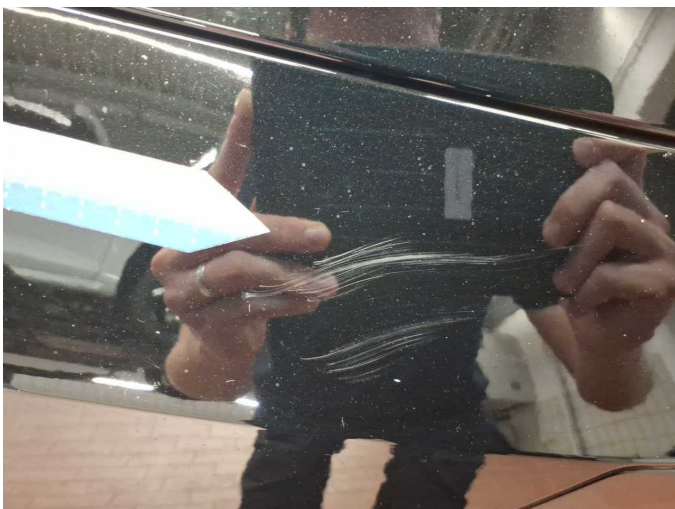
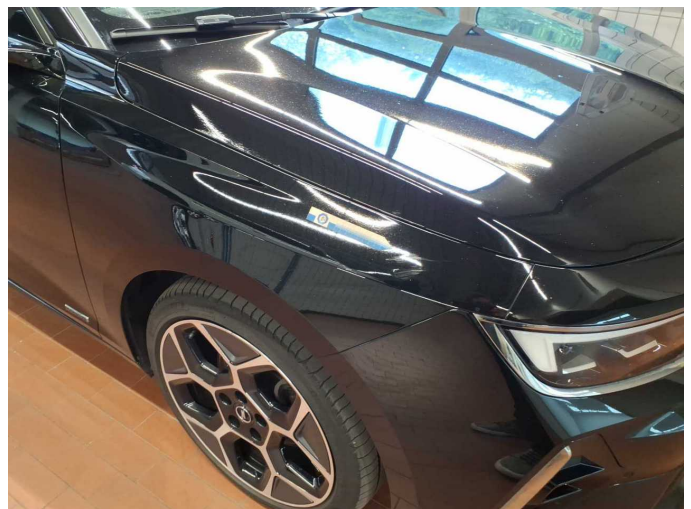
Damage 12: Mudguard - right side: Mudguard - right side - Scratched - Paint

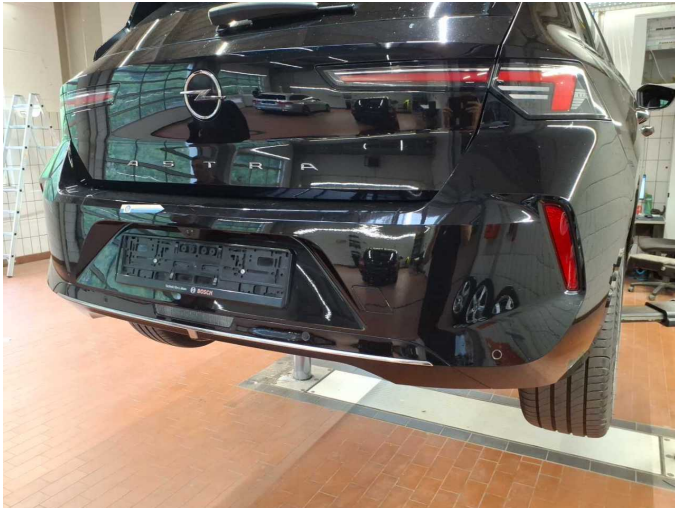
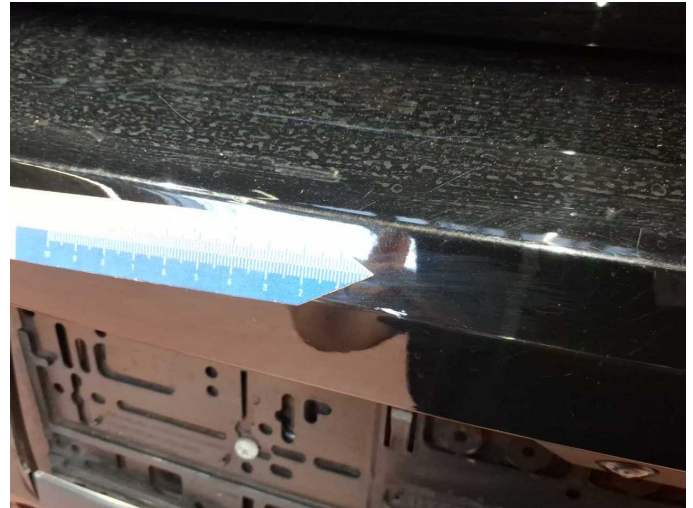
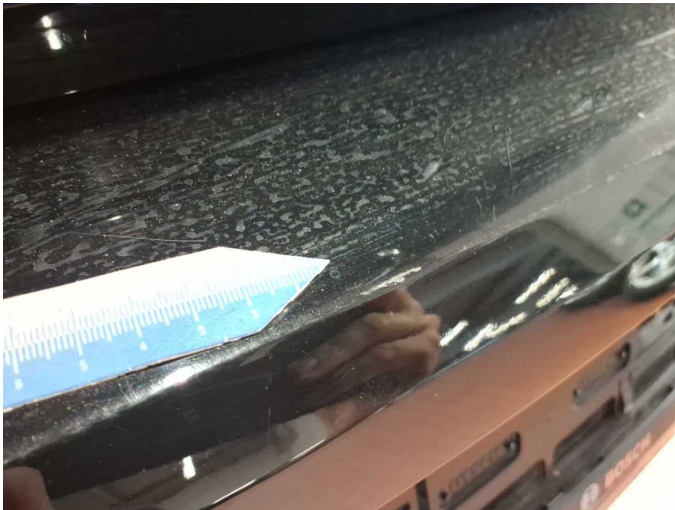
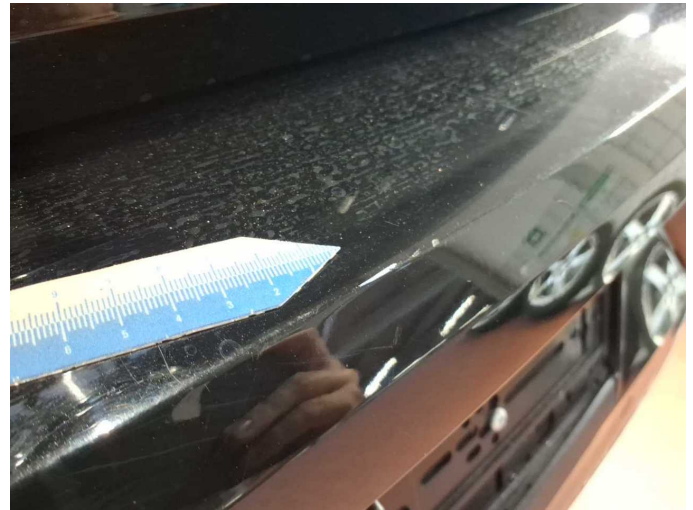
Damage 13: Rear bumper: Rear bumper - Scratch(es) - Paint

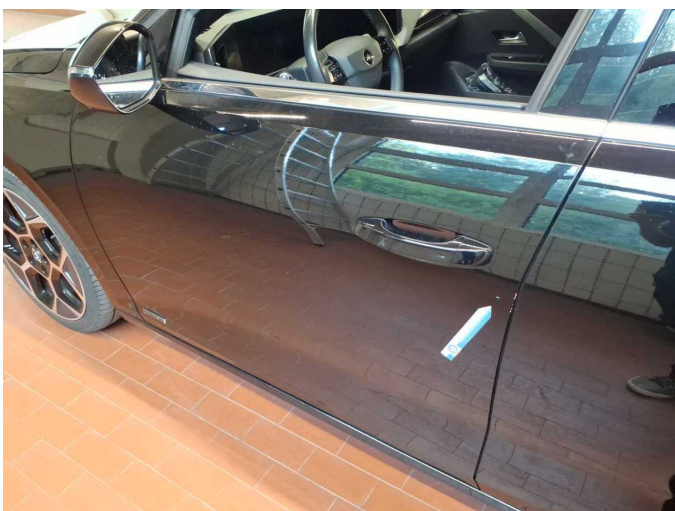
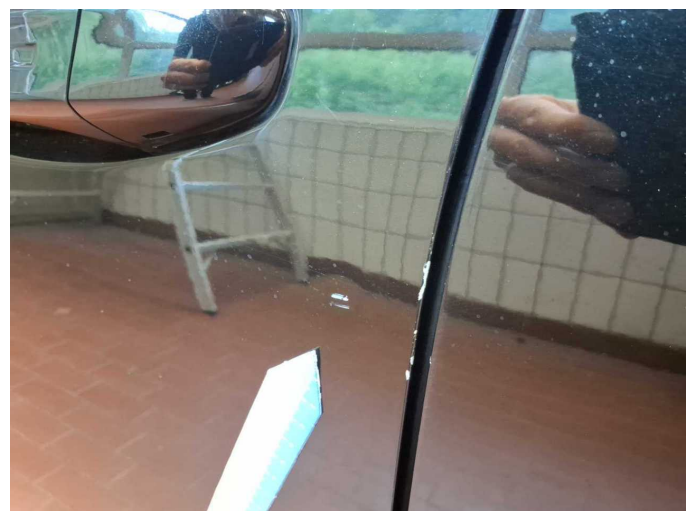
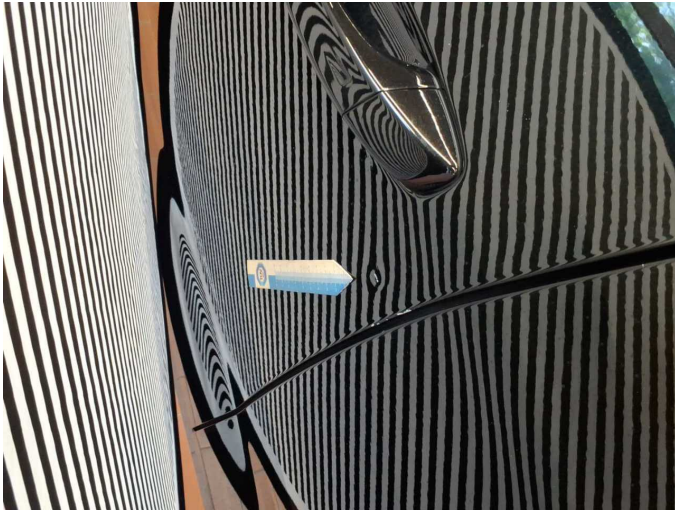
Damage 14: Door - front left side: Door - Dent / paintcoat damage - Repair and paint

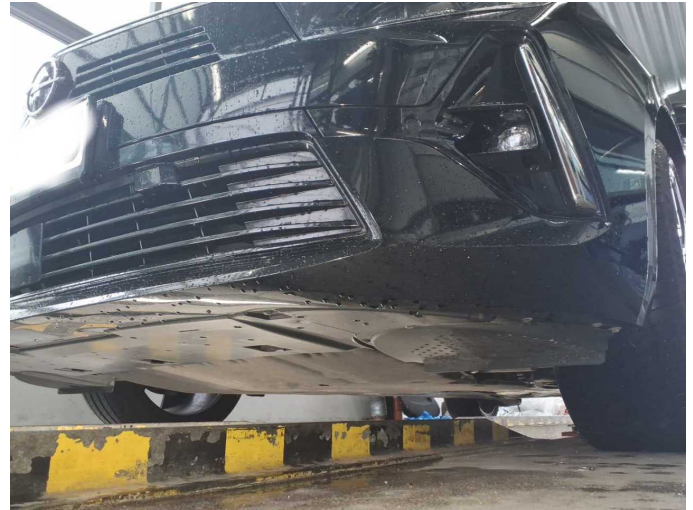
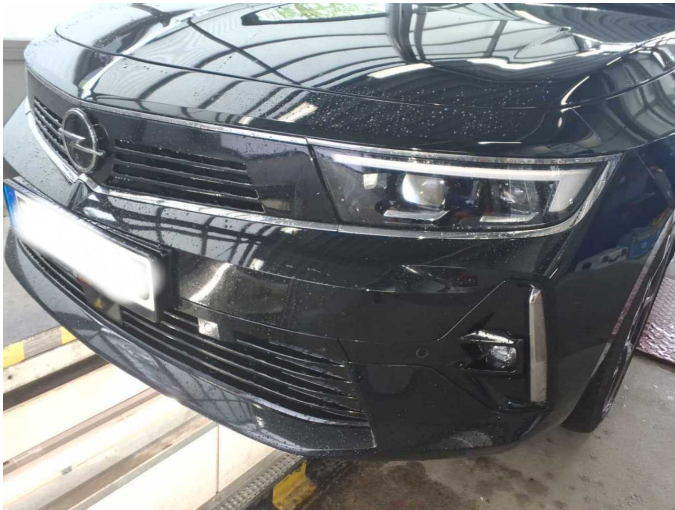
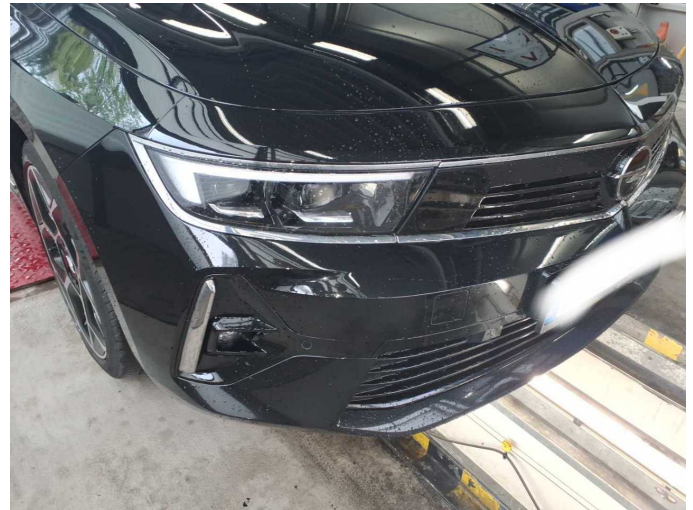
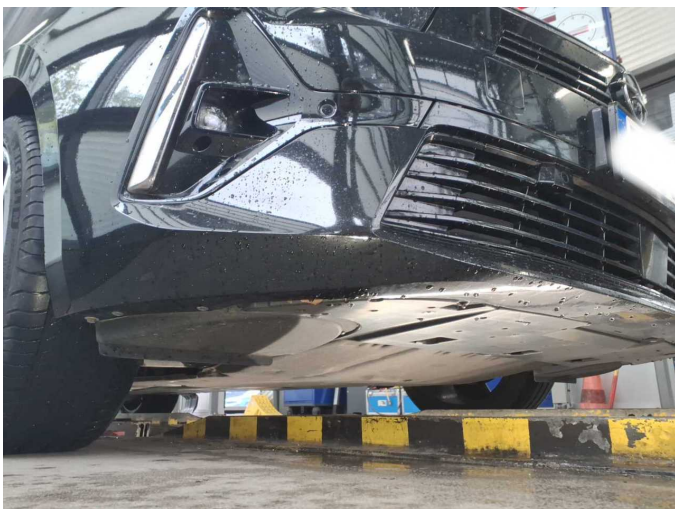
Wear and tear 1: Front bumper: Front bumper - Stone chips - No deduction

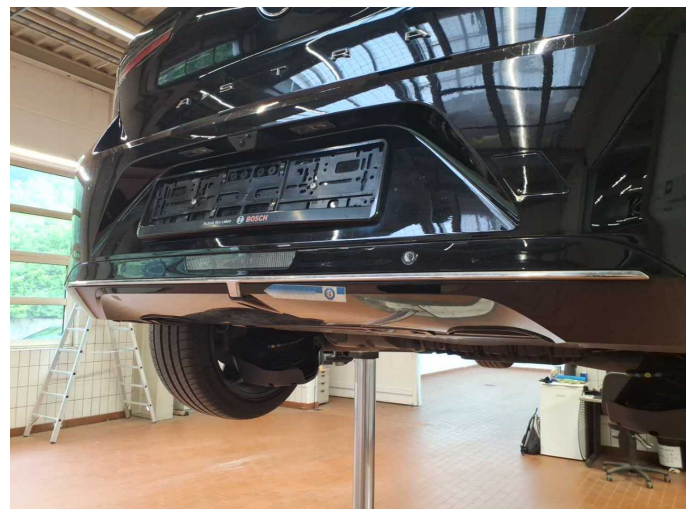
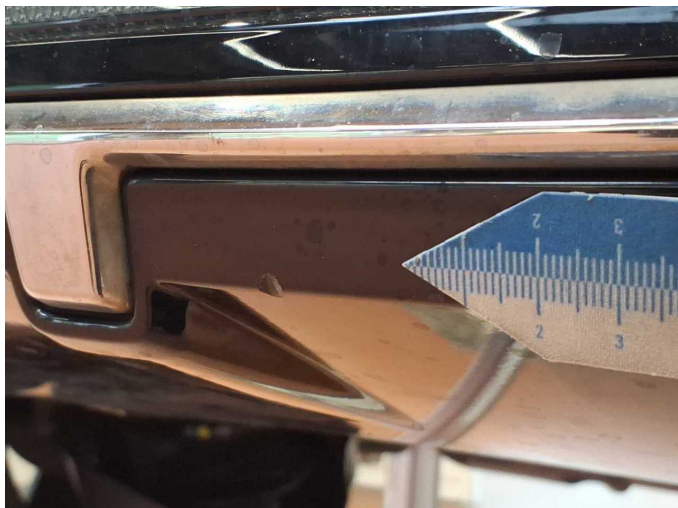
Wear and tear 2: Rear bumper: Spoiler - Scratch(es) - No deduction
