Expertise

Protocol number: 46231358
Order No. / Reference: 26153739
Inspection date: 15 Jun 2026

Model: 317 CDI Sprinter Standard HA PRO

VIN: W1V3KBFZ3TP858009

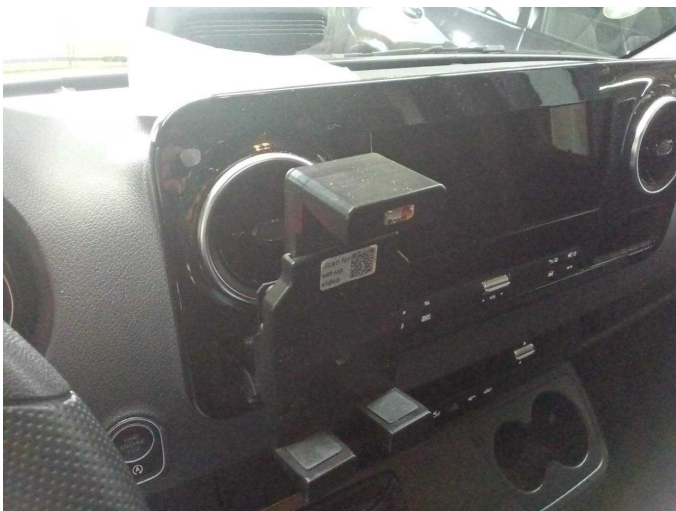
Damage 1: Multimedia system: Mobile phone holder - Differs from the original configuration - Remove

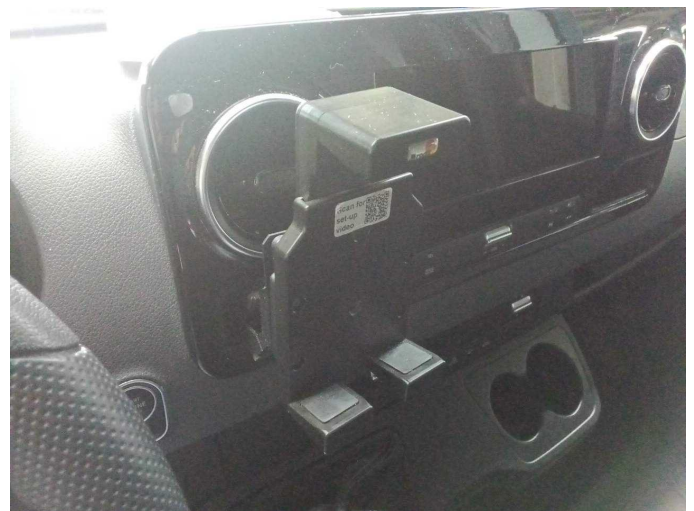
Damage 1: Multimedia system: Mobile phone holder - Differs from the original configuration - Remove

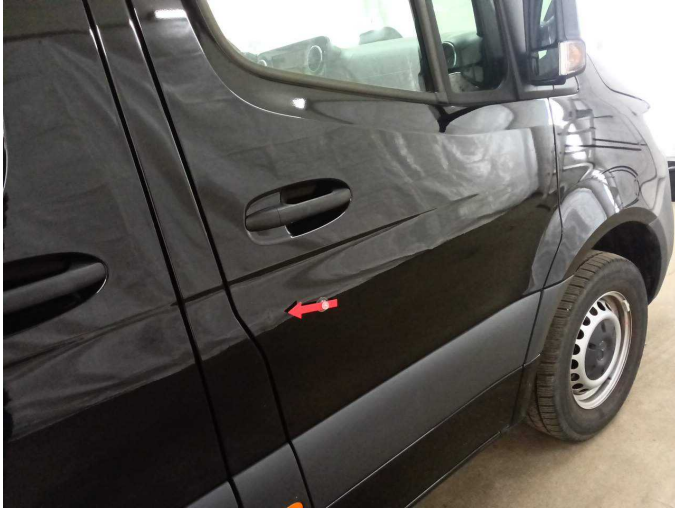
Damage 2: Door - front right side: Door - dent(s) - Smooth repair work

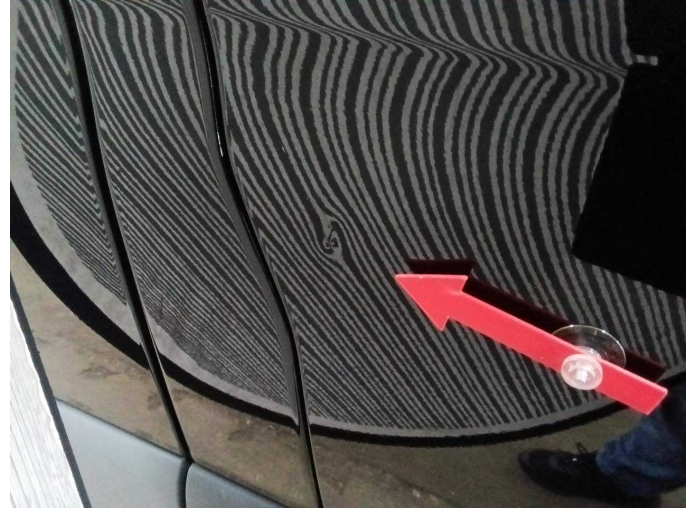
Damage 2: Door - front right side: Door - dent(s) - Smooth repair work

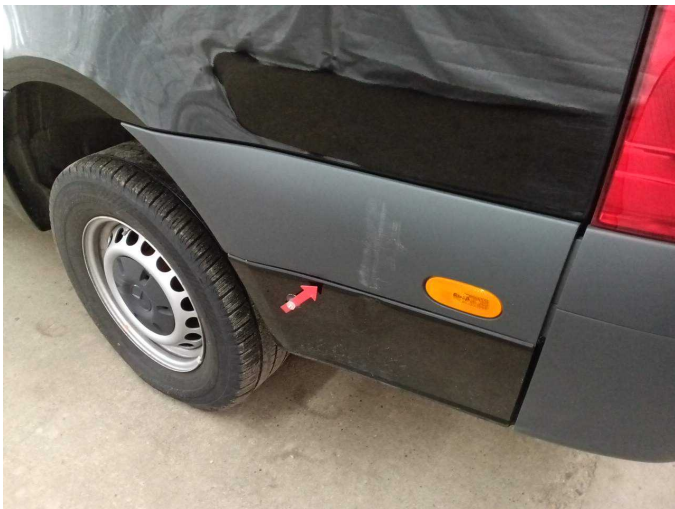
Damage 3: Side panel - rear left side: Brightware - Scratched - Replace

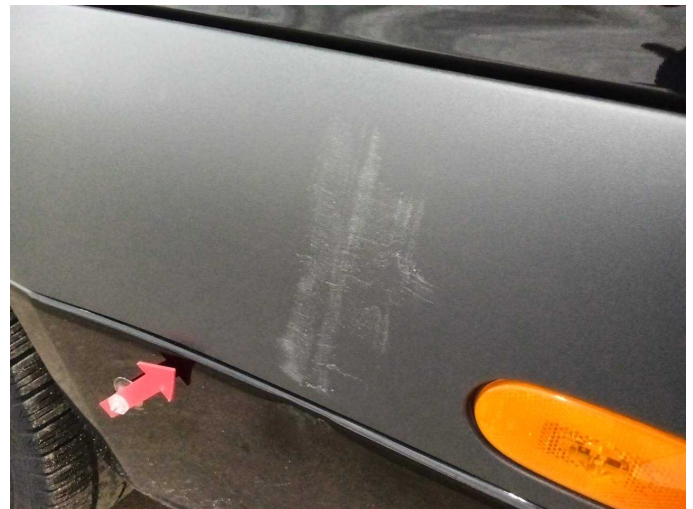
Damage 3: Side panel - rear left side: Brightware - Scratched - Replace

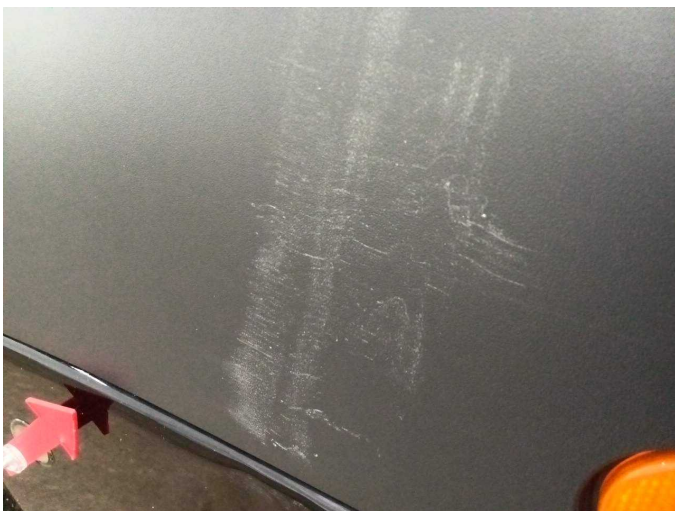
Damage 3: Side panel - rear left side: Brightware - Scratched - Replace

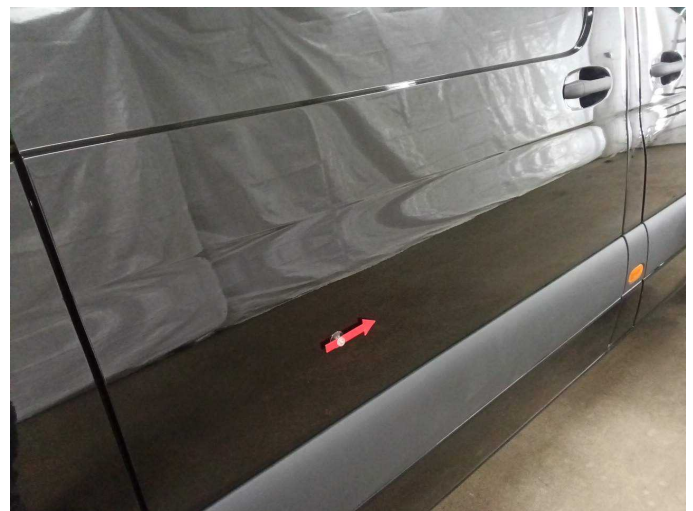
Damage 5: Sliding door, right: Sliding door - dent(s) - Smooth repair work

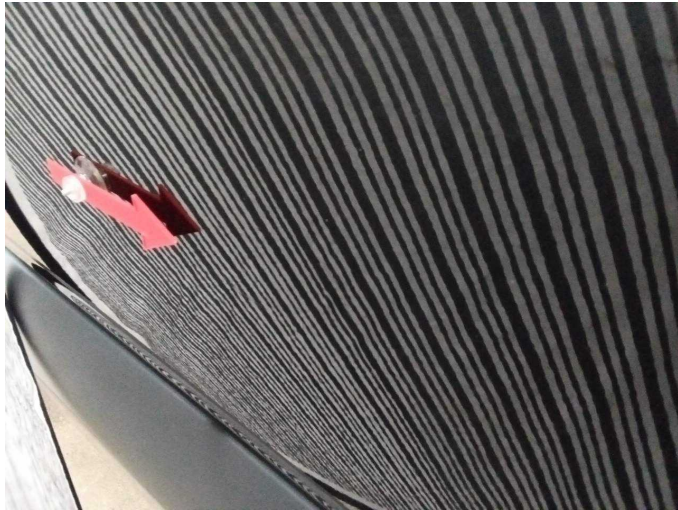
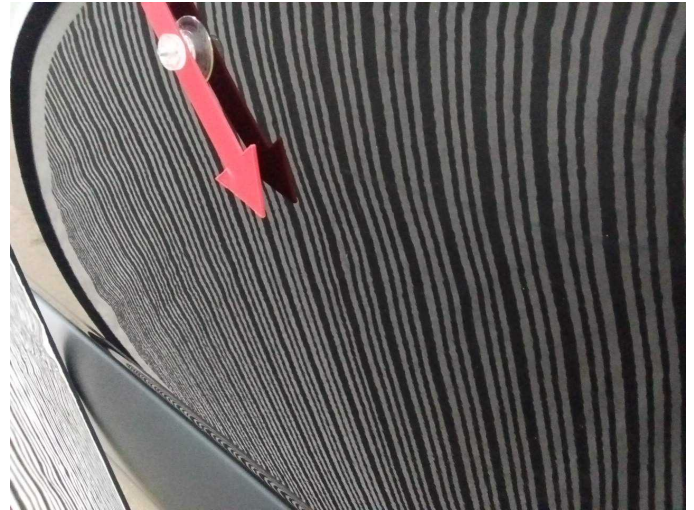
Damage 5: Sliding door, right: Sliding door - dent(s) - Smooth repair work

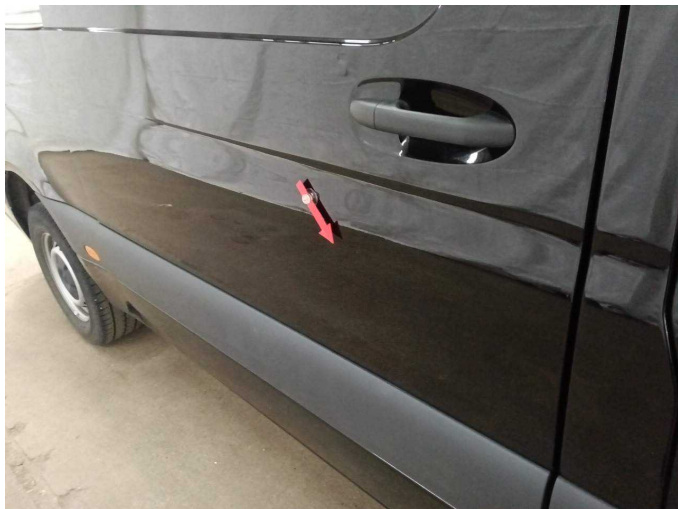
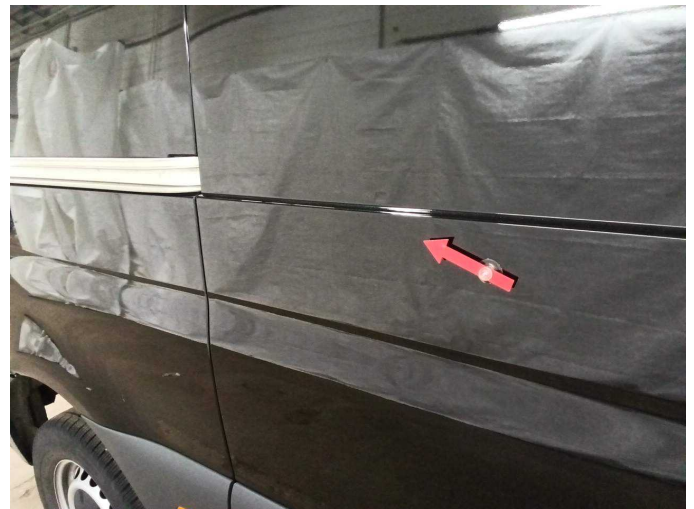
Damage 5: Sliding door, right: Sliding door - dent(s) - Smooth repair work

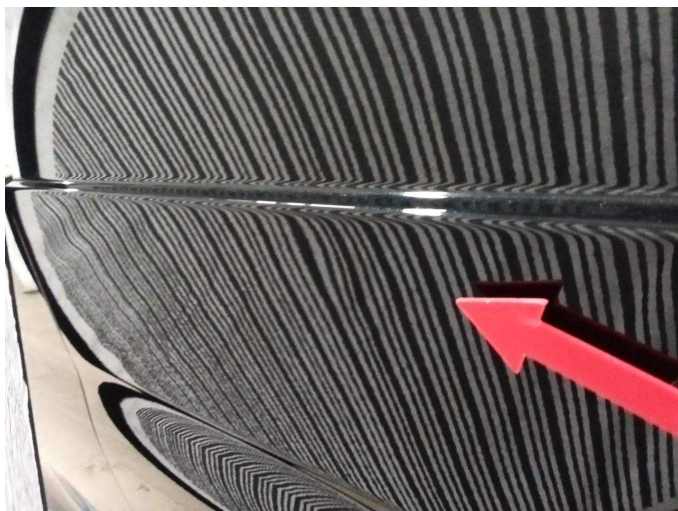
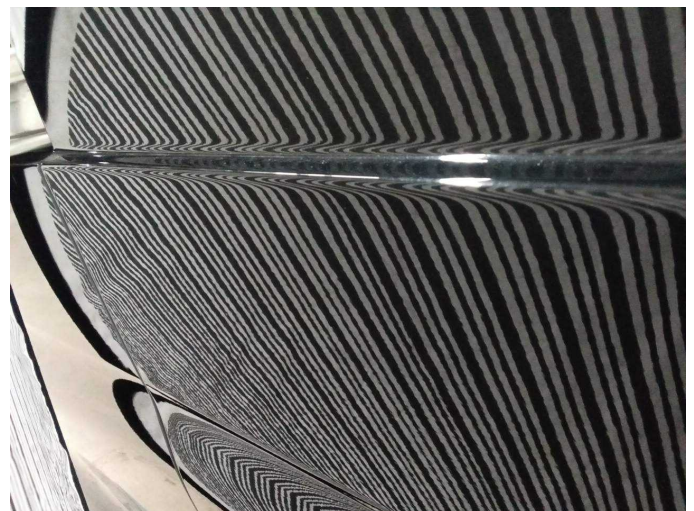
Damage 5: Sliding door, right: Sliding door - dent(s) - Smooth repair work

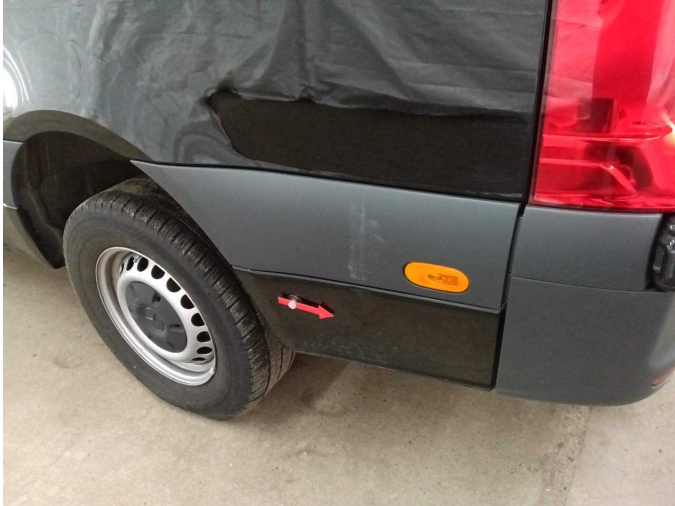
Damage 6: Side panel - rear left side: Side panel - Dent / paintcoat damage - Repair and paint

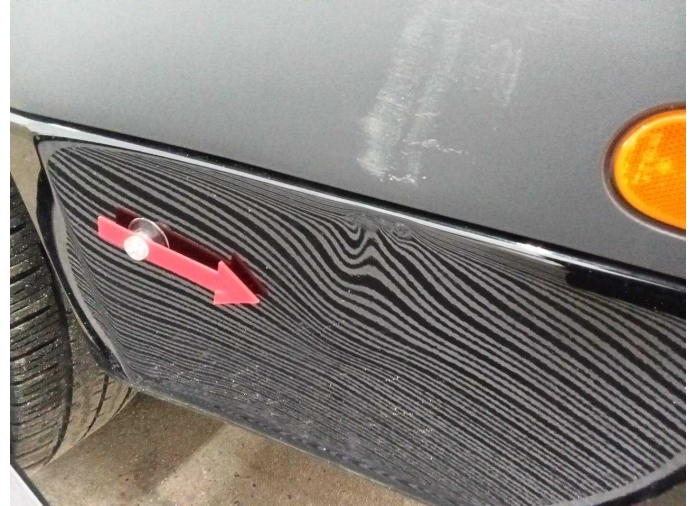
Damage 6: Side panel - rear left side: Side panel - Dent / paintcoat damage - Repair and paint

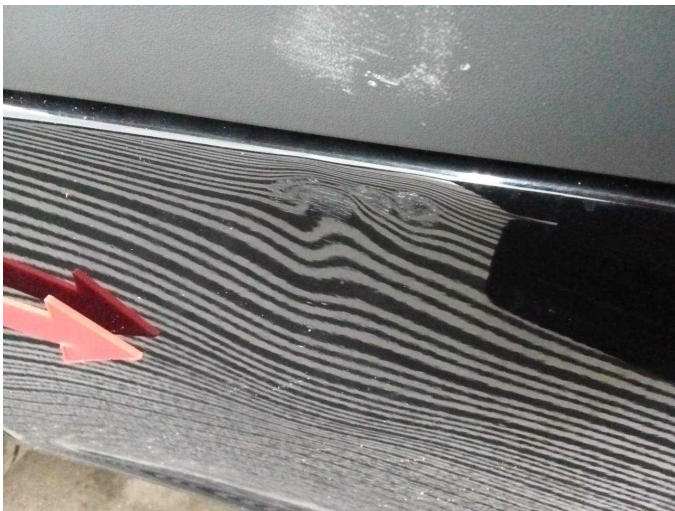
Damage 6: Side panel - rear left side: Side panel - Dent / paintcoat damage - Repair and paint

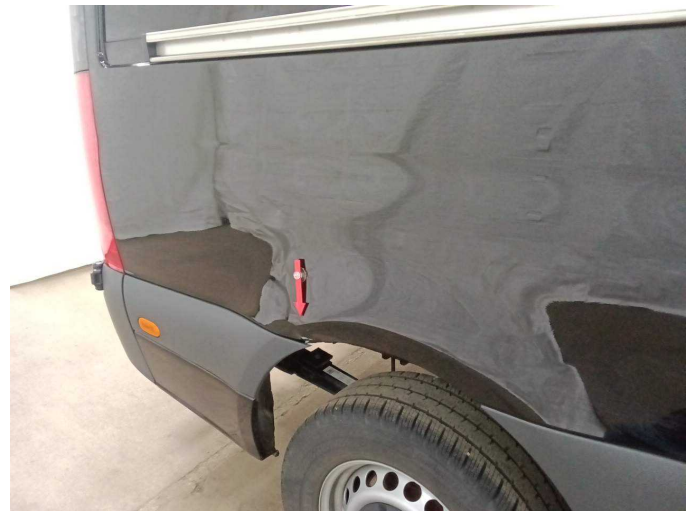
Damage 7: Side panel - rear right side: Side panel - Dent / paintcoat damage - Repair and paint

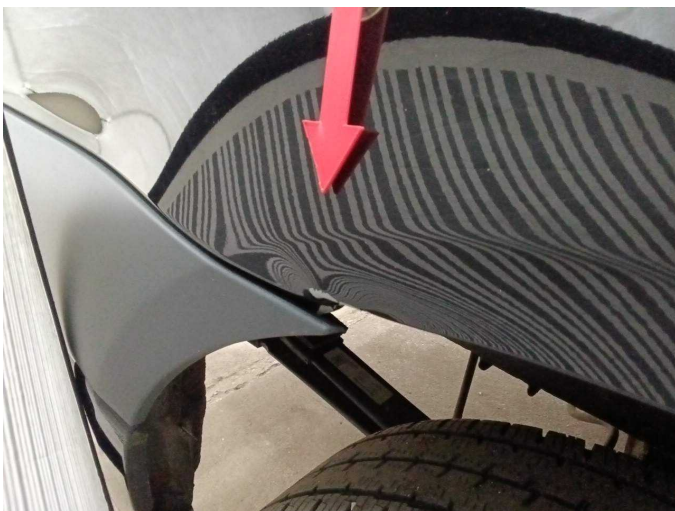
Damage 7: Side panel - rear right side: Side panel - Dent / paintcoat damage - Repair and paint

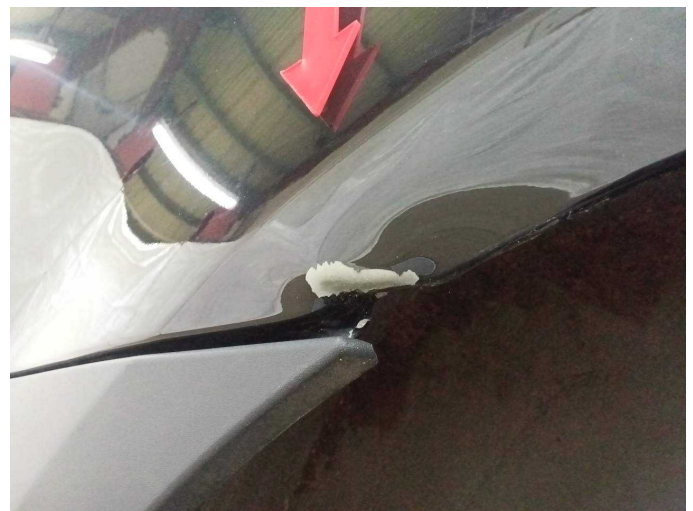
Damage 7: Side panel - rear right side: Side panel - Dent / paintcoat damage - Repair and paint

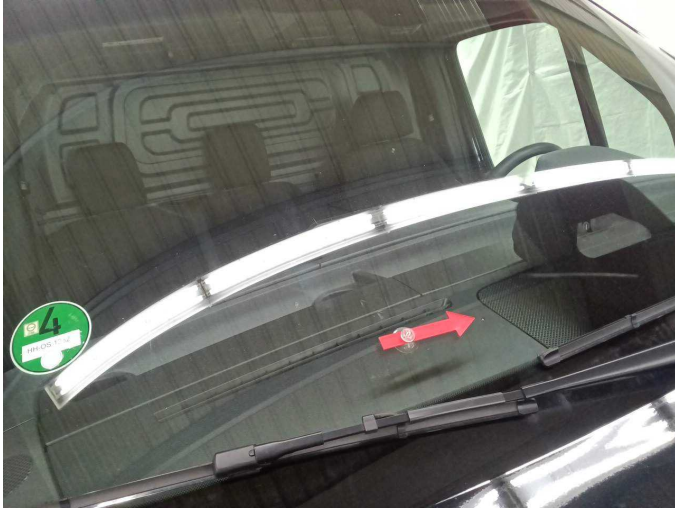
Damage 8: Vehicle glazing: Windscreen - Stone chips - Replace

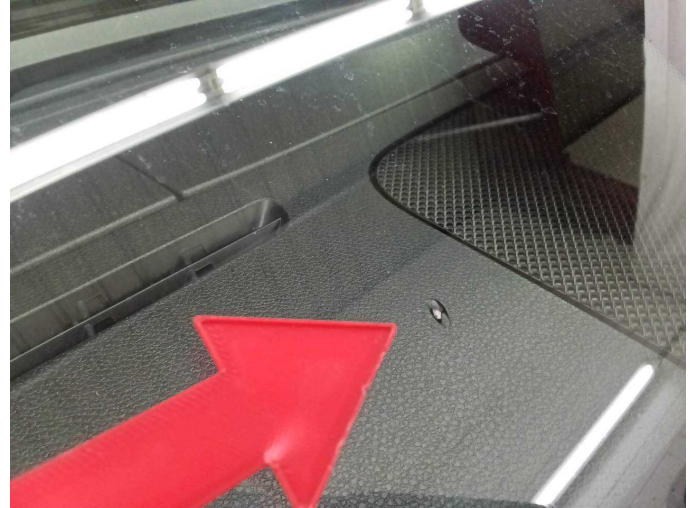
Damage 8: Vehicle glazing: Windscreen - Stone chips - Replace

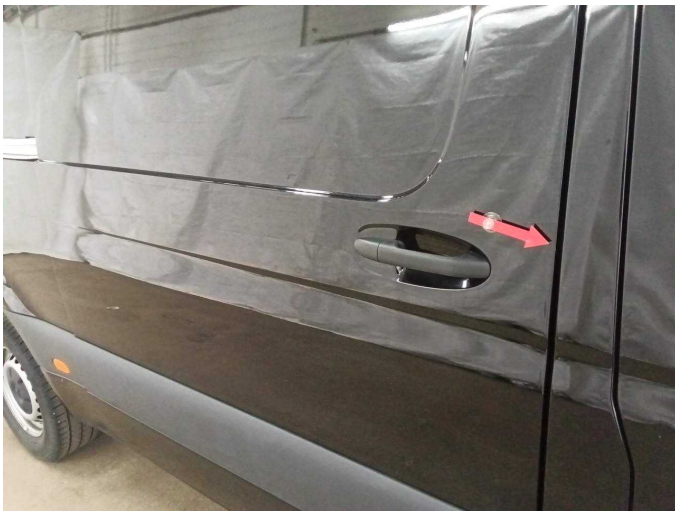
Wear and tear 2: Door - rear right side: Door edge - Scratch(es) - No deduction
