Expertise

Protocol number: 46303645  
Order No. / Reference: 26508860  
Inspection date: 29 Jun 2026

Manufacturer: Volkswagen

Model: Caddy Cargo 2.0 TDI BMT DSG

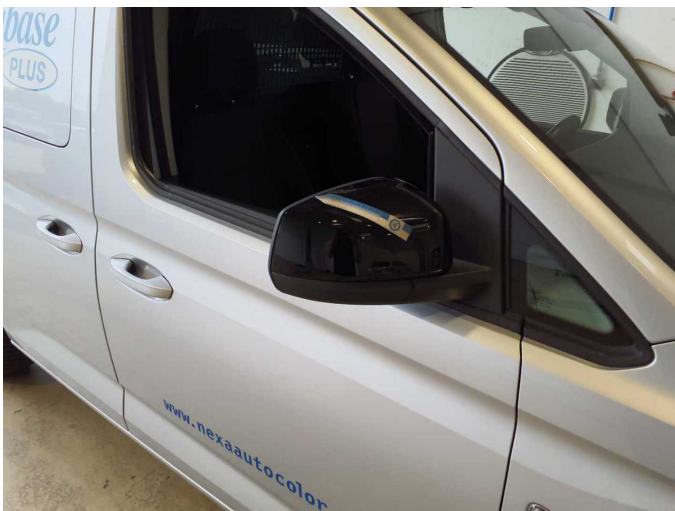
| No. | Component group | Description |
|---|---|---|
| 1 | Wing mirror - right side | Cap - Scratch(es) - Smart repair |

Damage 1: Wing mirror - right side: Cap - Scratch(es) - Smart repair

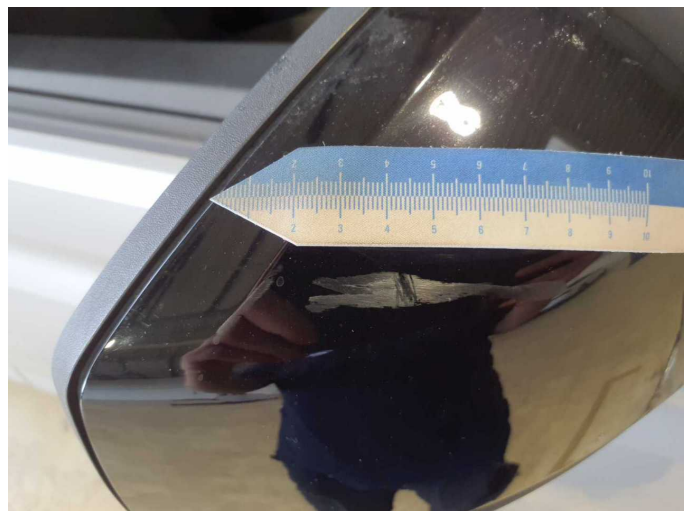
Damage 1: Wing mirror - right side: Cap - Scratch(es) - Smart repair

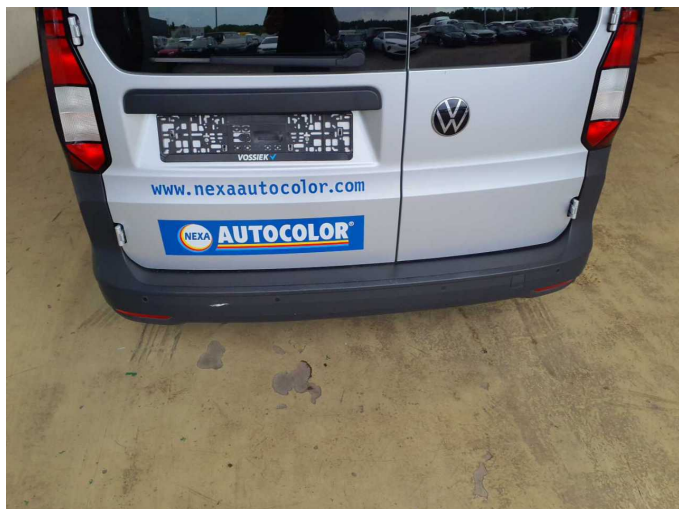
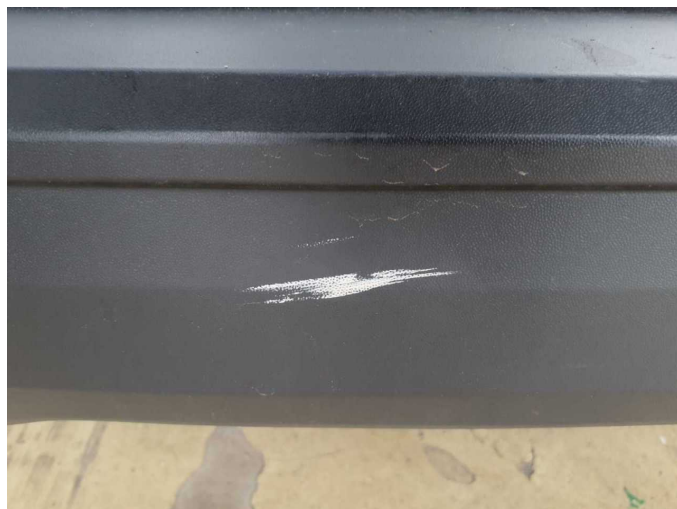
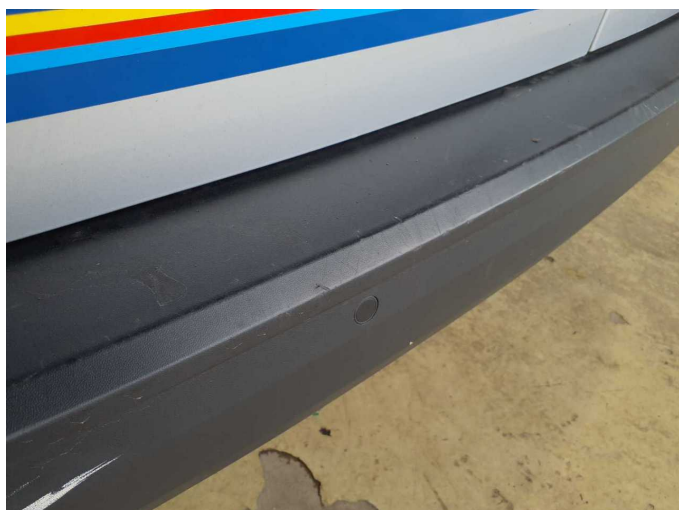
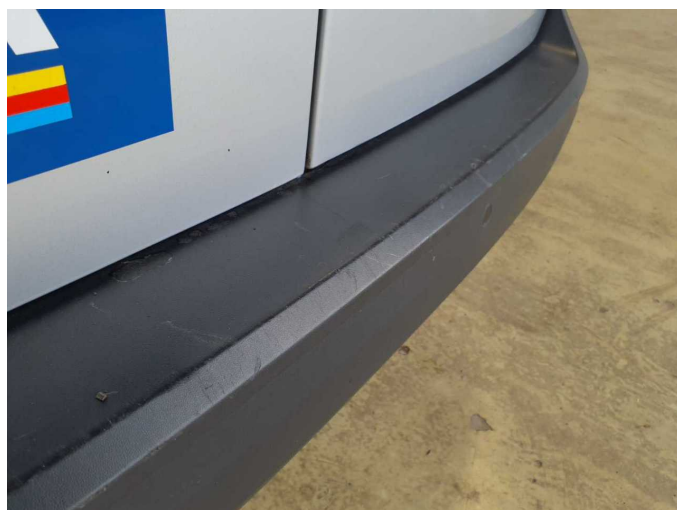
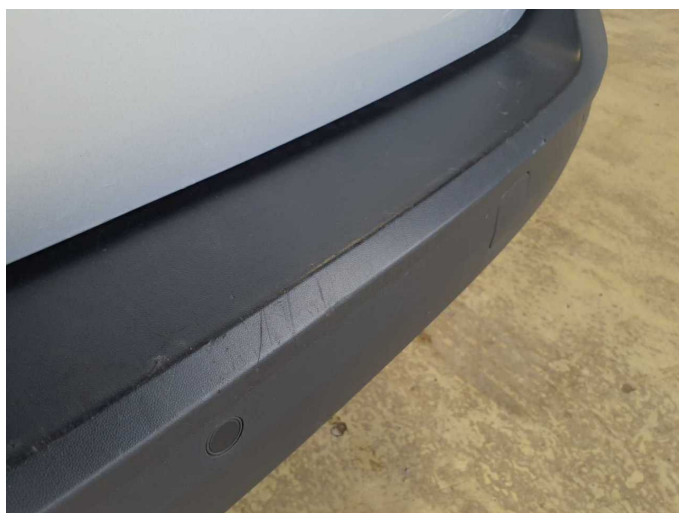
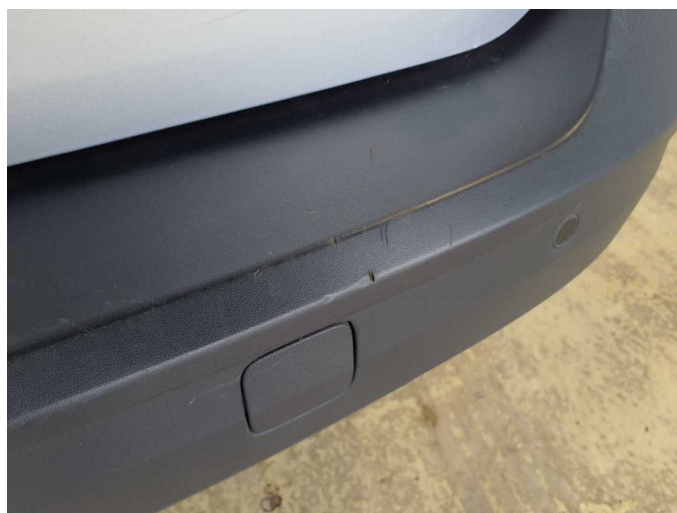
| No. | Component group | Description |
|---|---|---|
| 2 | Rear bumper | Rear bumper (unpainted) - Scratch(es) - Loss in value |

**Damage 2:** Rear bumper: Rear bumper (unpainted) - Scratch(es) - Loss in value

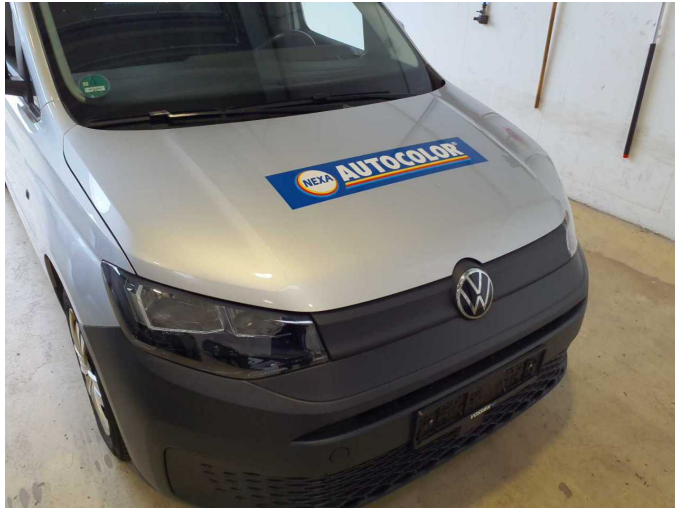
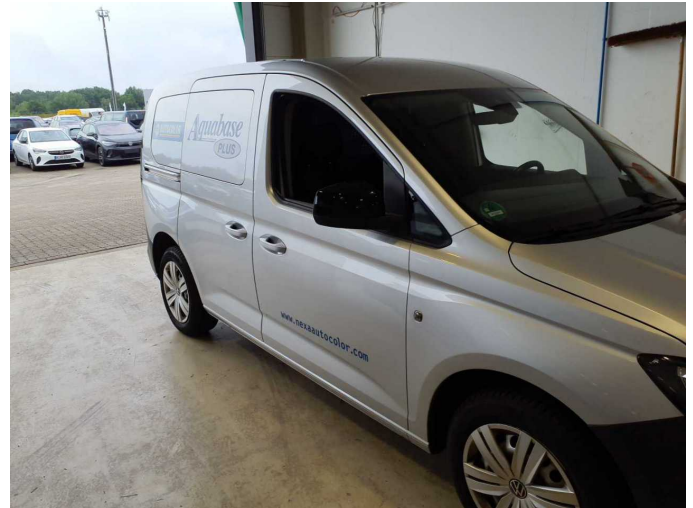
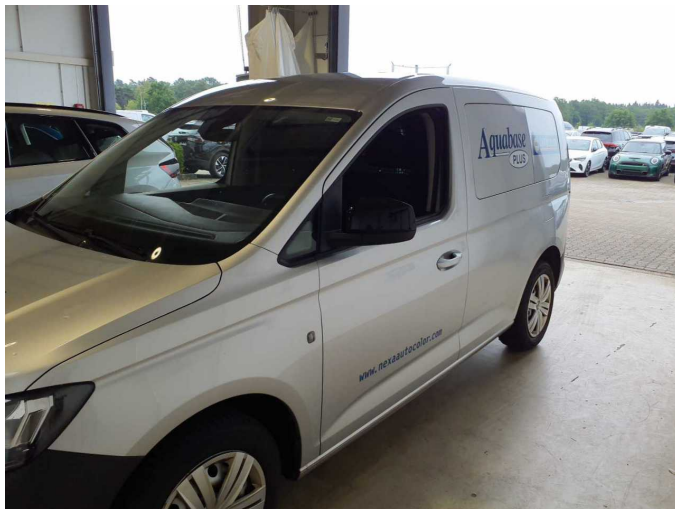
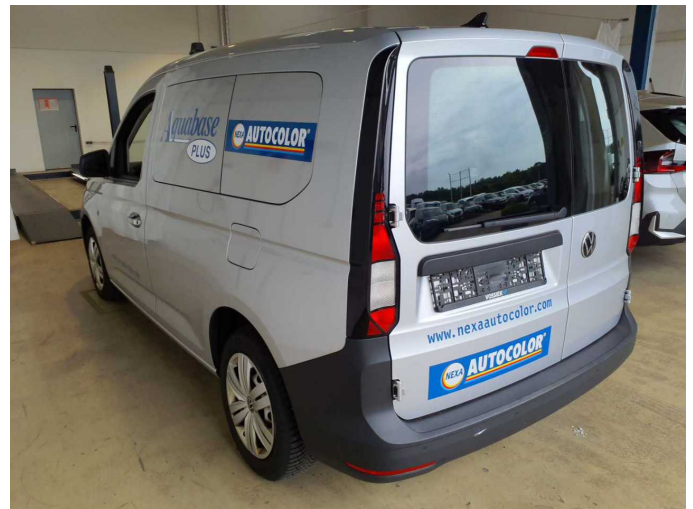
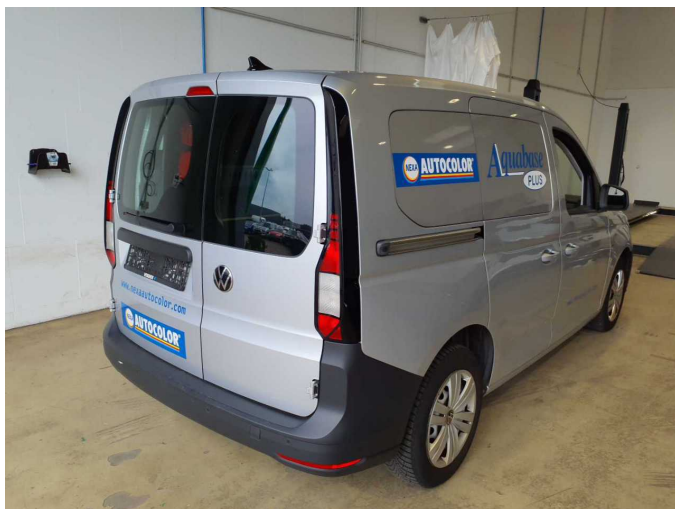
| No. | Component group | Description |
|---|---|---|
| 3 | Body | Body - Glued / labelled - De-glue / neutralise |

**Damage 3:** Body: Body - Glued / labelled - De-glue / neutralise

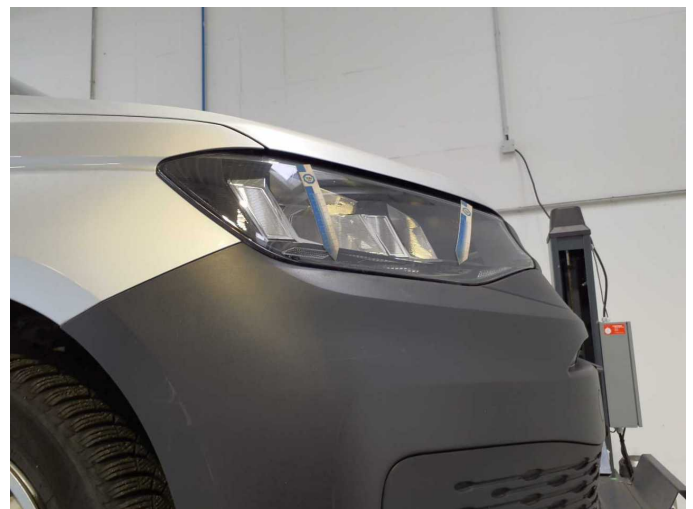
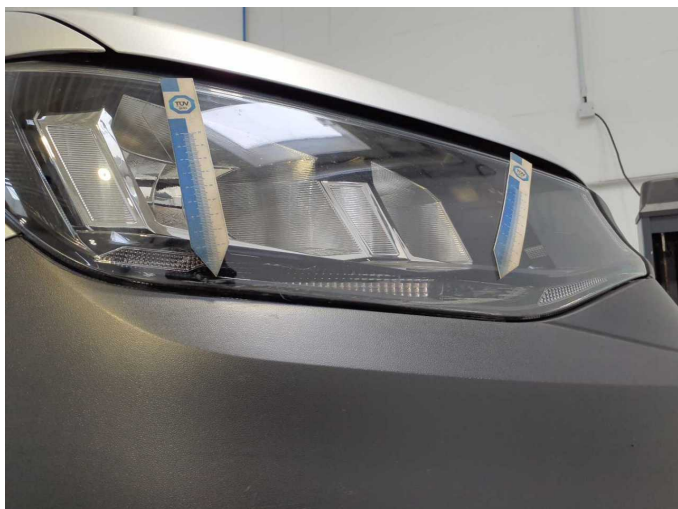
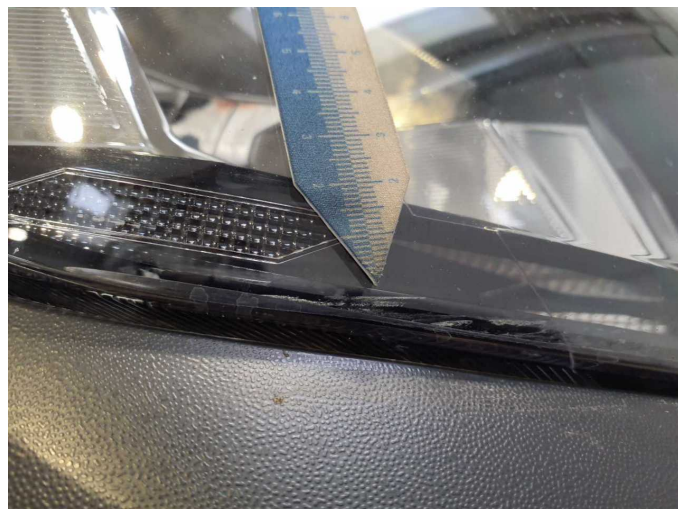
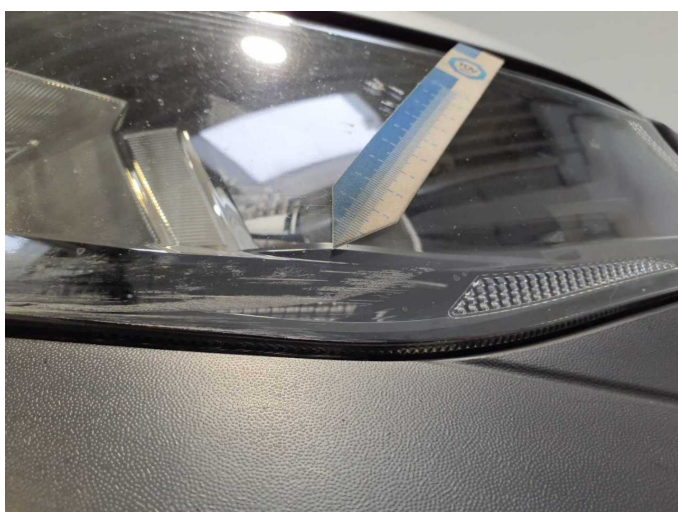
| No. | Component group | Description |
|---|---|---|
| 4 | Headlight | Headlight - right side - Scratch(es) - Replace |

**Damage 4:** Headlight: Headlight - right side - Scratch(es) - Replace

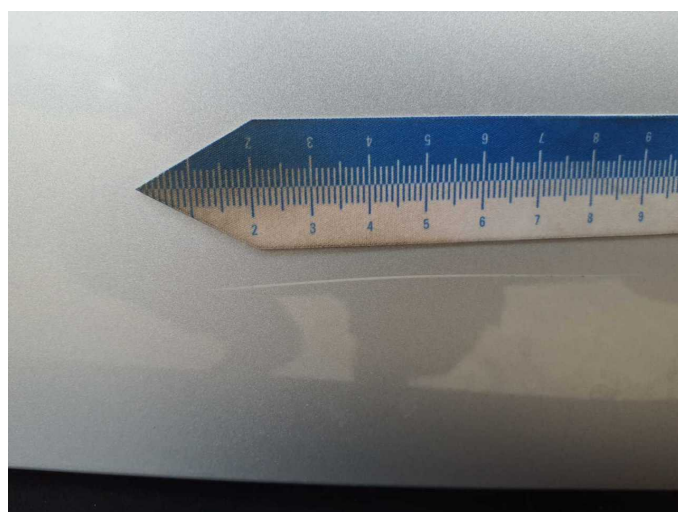
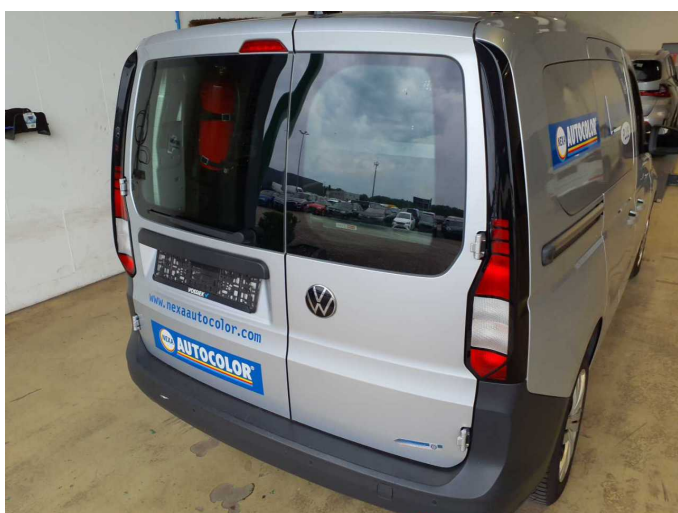
| No. | Component group | Description |
|---|---|---|
| 5 | Boot lid / rear door | Rear door - right side - Scratch(es) - Paint |

**Damage 5:** Boot lid / rear door: Rear door - right side - Scratch(es) - Paint

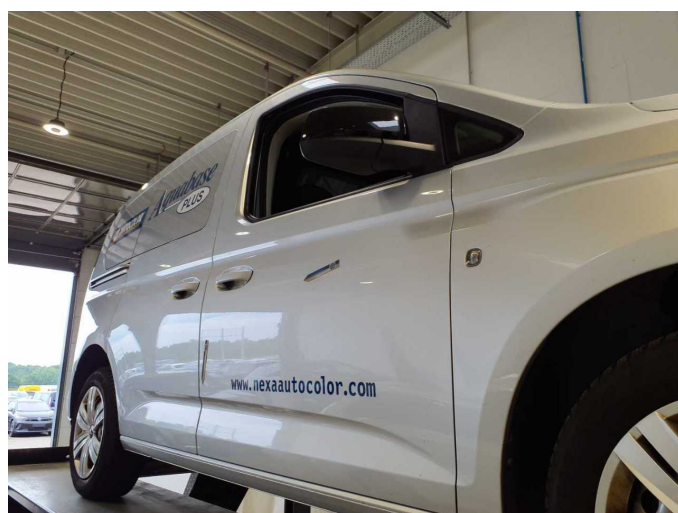
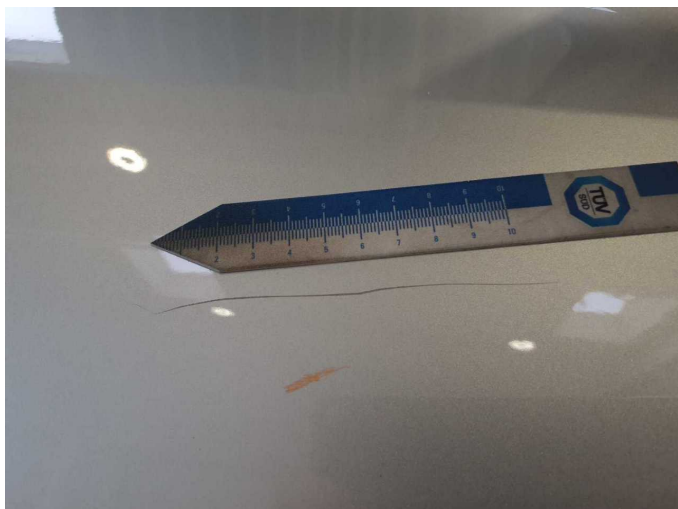
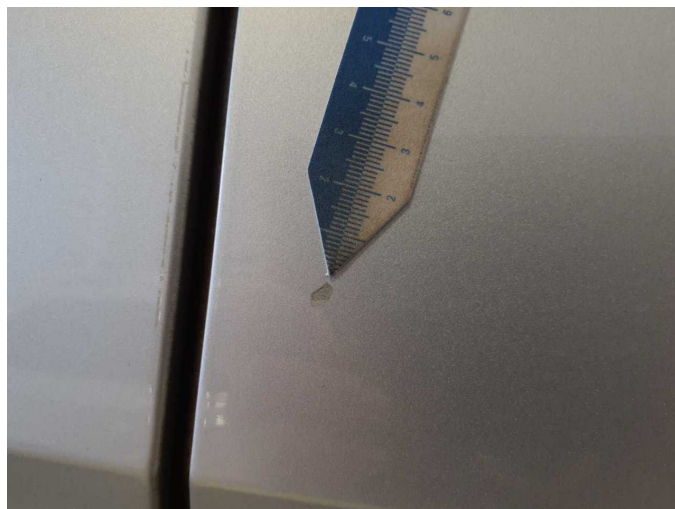
| No. | Component group | Description |
|---|---|---|
| 6 | Door - front right side | Door - Scratch(es) - Paint |

**Damage 6:** Door - front right side: Door - Scratch(es) - Paint

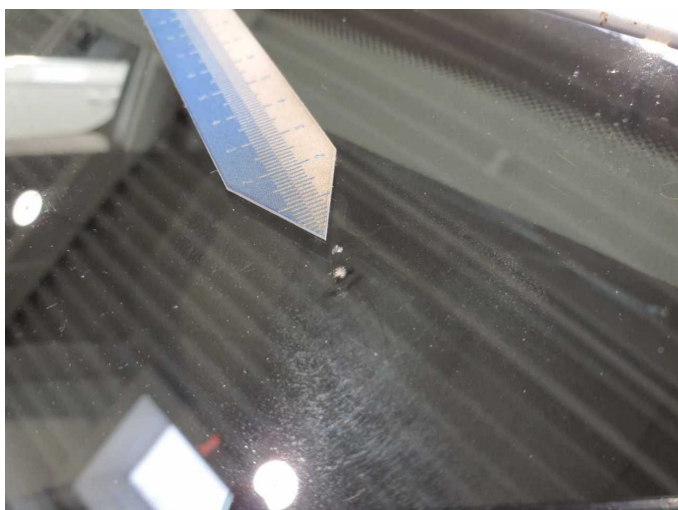
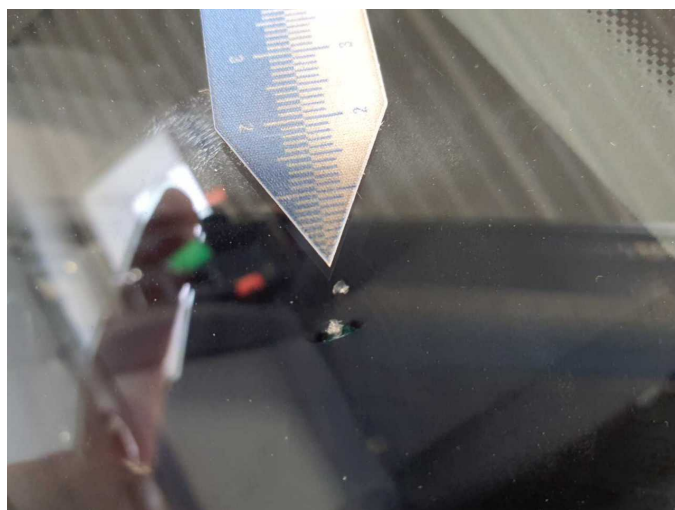
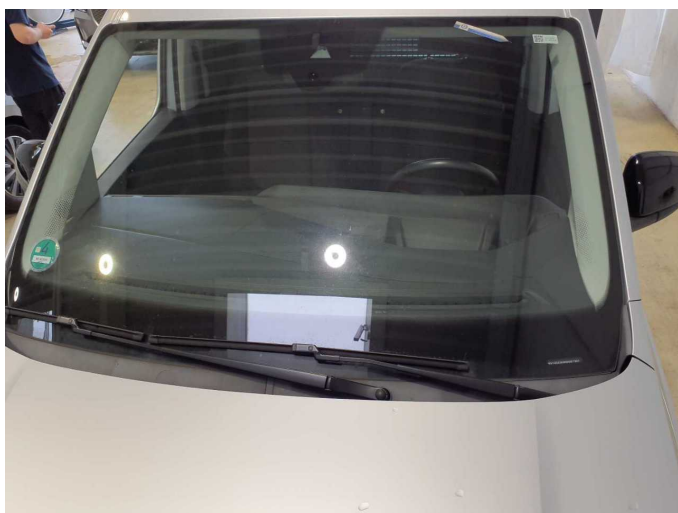
| No. | Component group | Description |
|---|---|---|
| 7 | Vehicle glazing | Windscreen - Stone chips - Replace |

**Damage 7:** Vehicle glazing: Windscreen - Stone chips - Replace

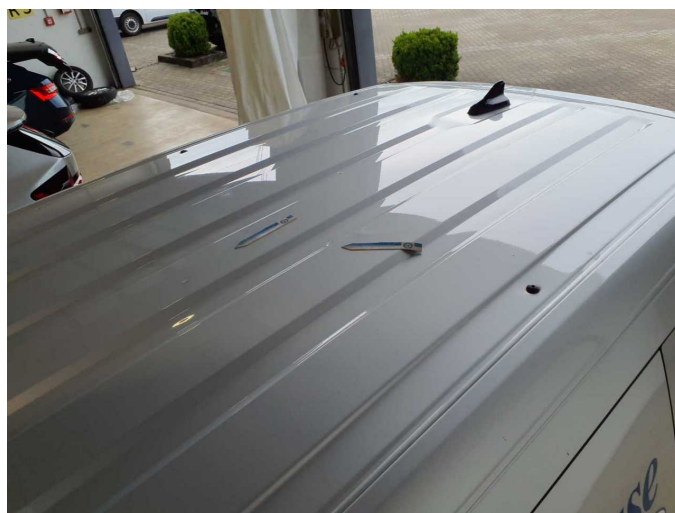
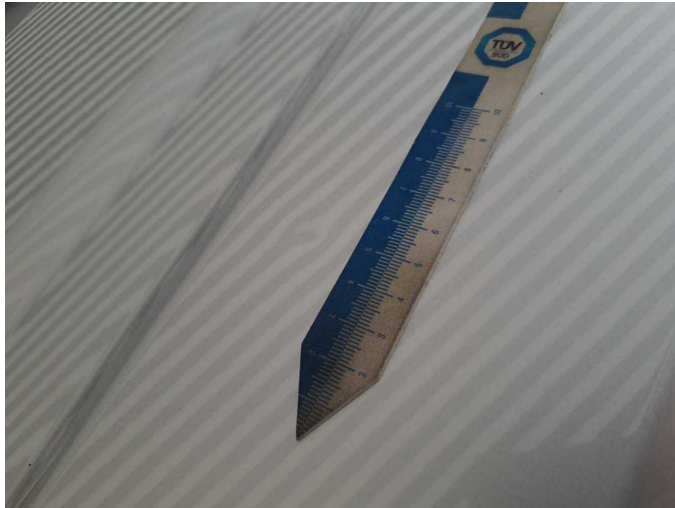
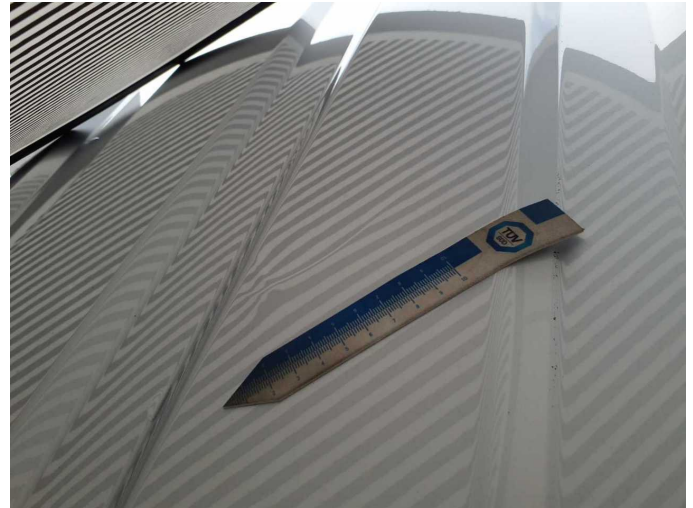
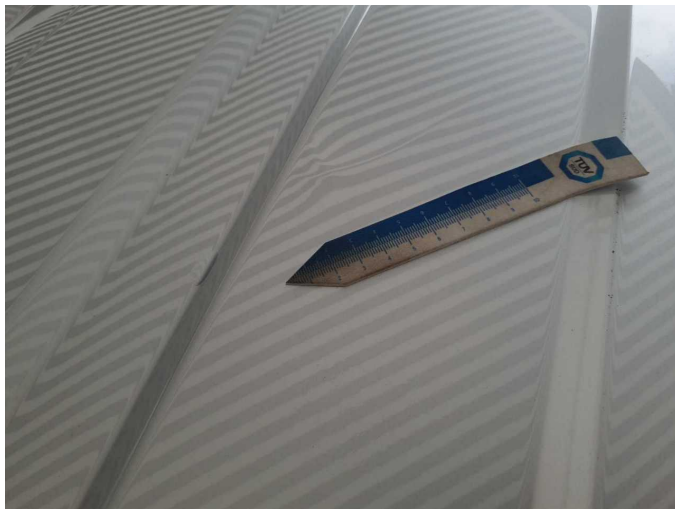
| No. | Component group | Description |
|---|---|---|
| 8 | Roof | Roof - Deformed - Repair and paint |

**Damage 8:** Roof: Roof - Deformed - Repair and paint

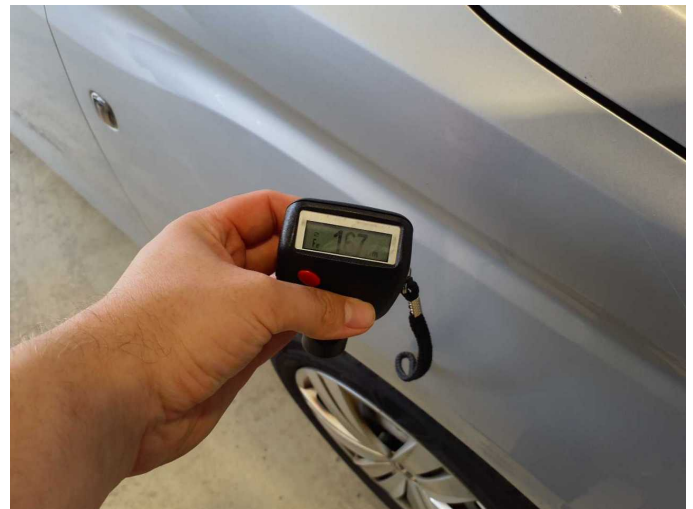
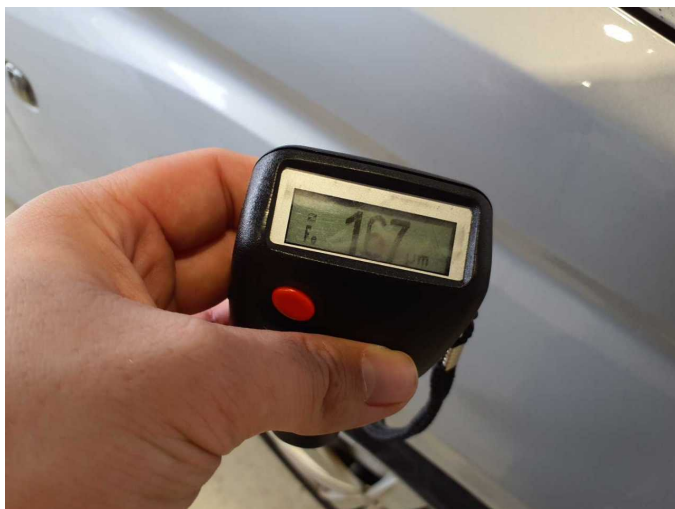
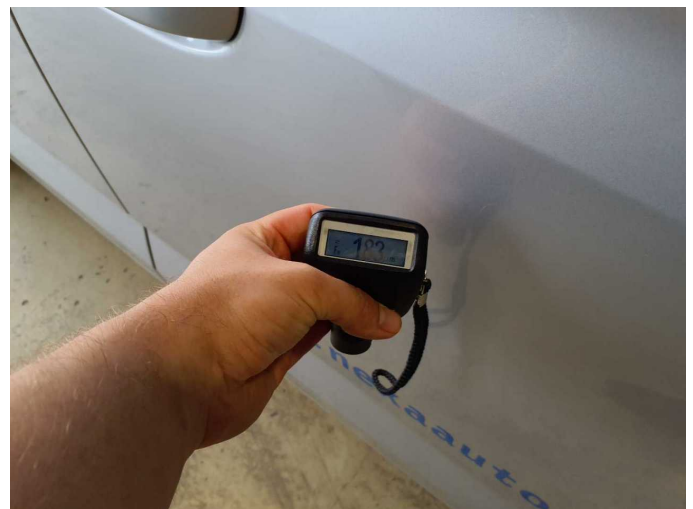
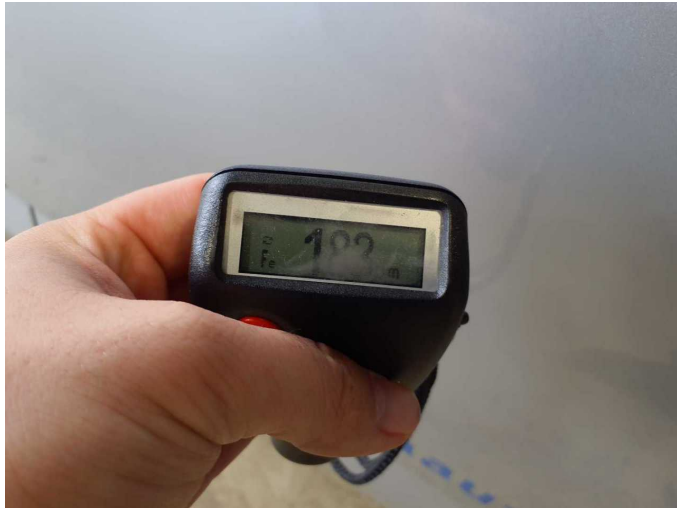
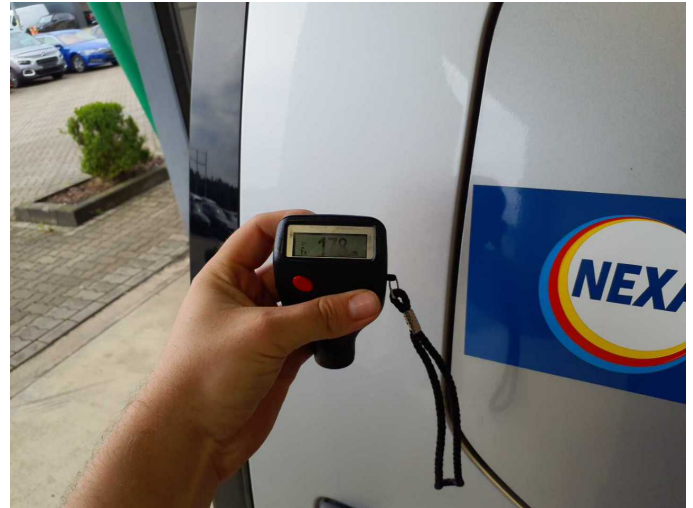
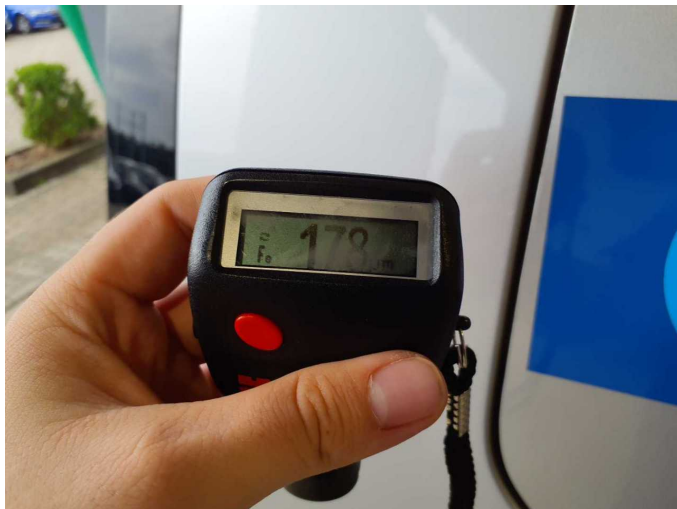
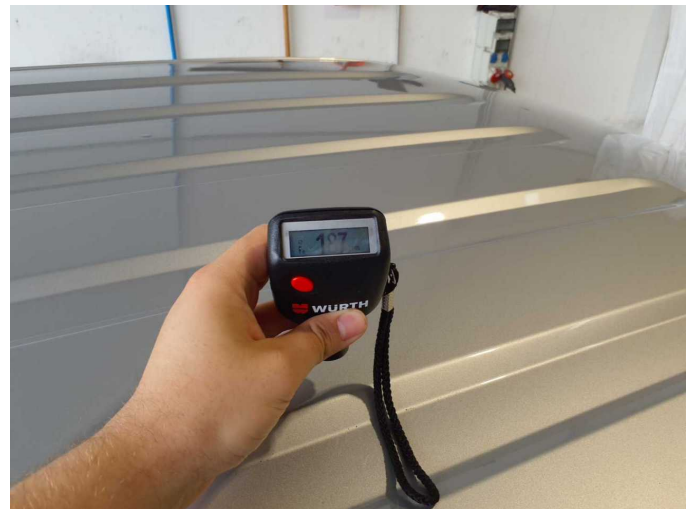
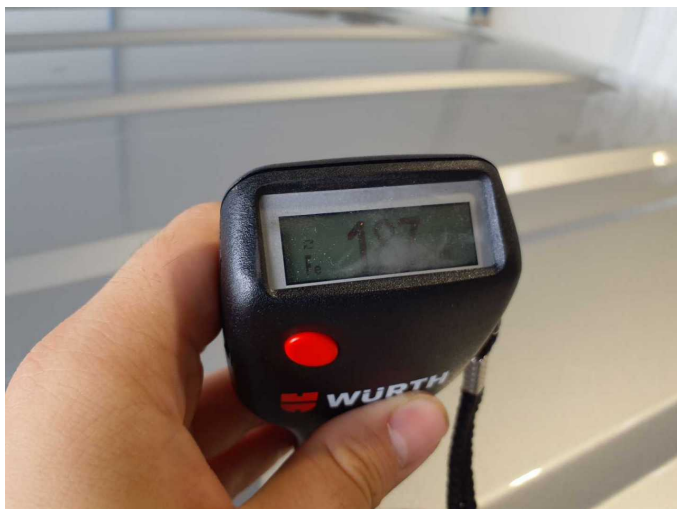
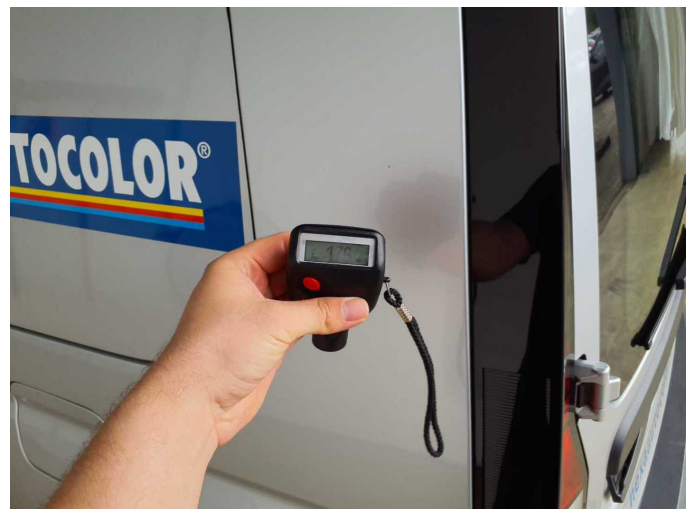
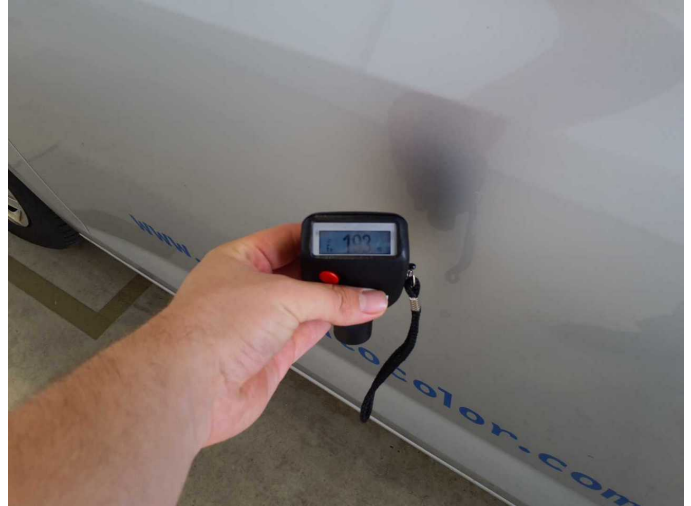
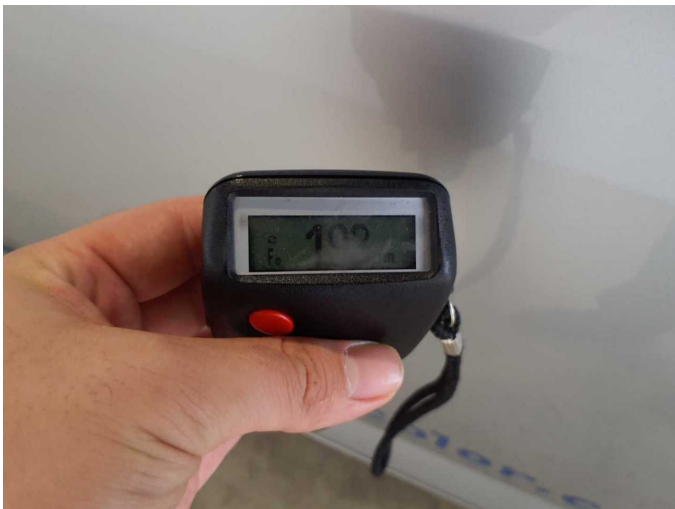
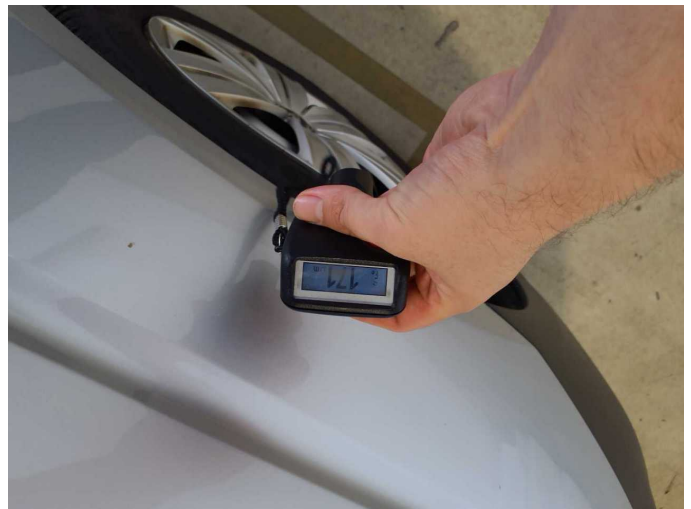
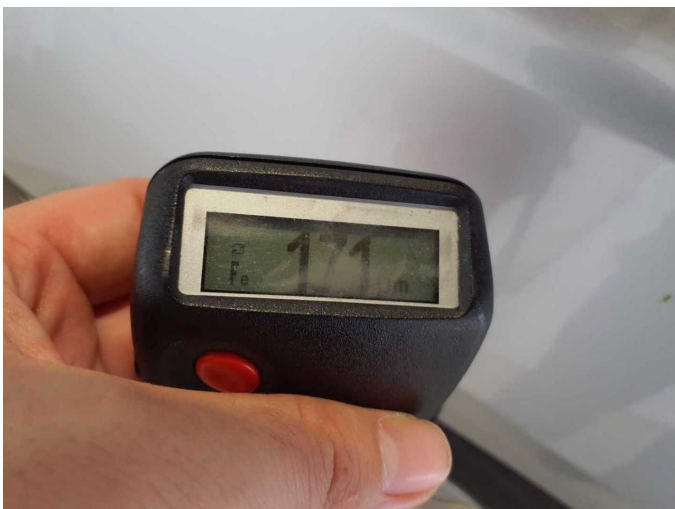
| 1 | Roof, Mudguard - left side, Mudguard - right side, Side panel - rear left side, Side panel - rear right side, Door - front left side, Door - front right side, Professionally carried out, Invoice of repair done Non-existent |

| Roof | 187 µm | Mudguard - left side | 171 µm |
| Mudguard - right side | 167 µm | Side panel - rear left side | 176 µm |
| Side panel - rear right side | 178 µm | Door - front left side | 193 µm |
| Door - front right side | 183 µm | | |

**Repainting 1:** Roof, Mudguard - left side, Mudguard - right side, Side panel - rear left side, Side panel - rear right side, Door - front left side, Door - front right side
