## Expertise

Protocol number: 46195938  
Order No. / Reference: 26152005  
Inspection date: 22 Jun 2026

Model: Vito 116 CDI Extralang HA Aut. PRO

VIN: W1VVLCEZXT4563603

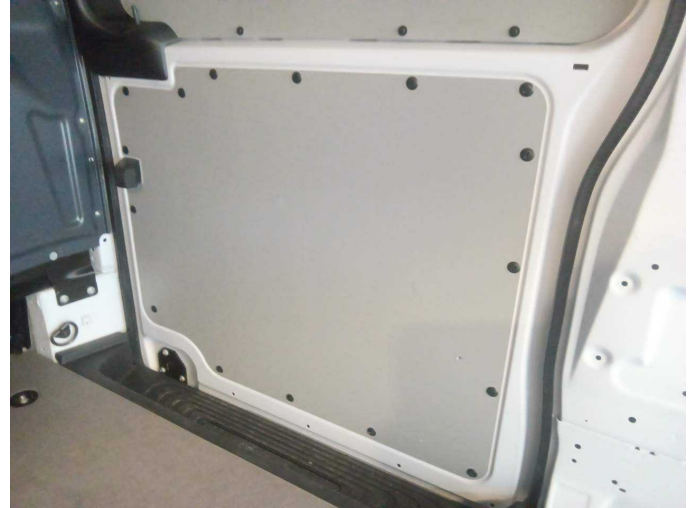
Damage 1: Sliding door, right: Trim - Holes - Replace

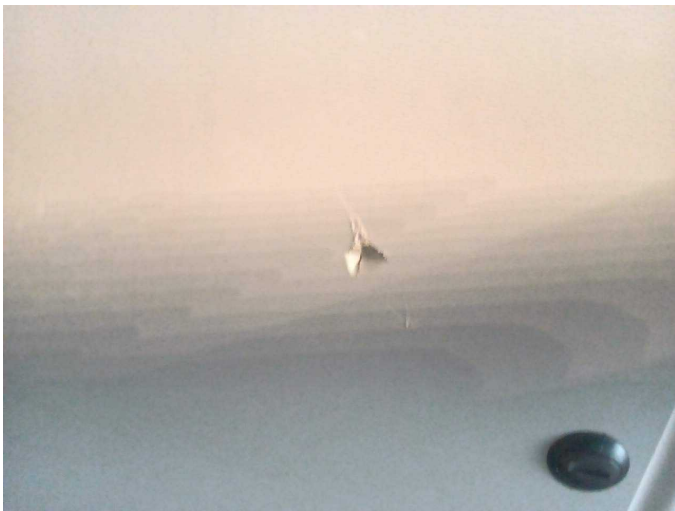
Damage 1: Sliding door, right: Trim - Holes - Replace

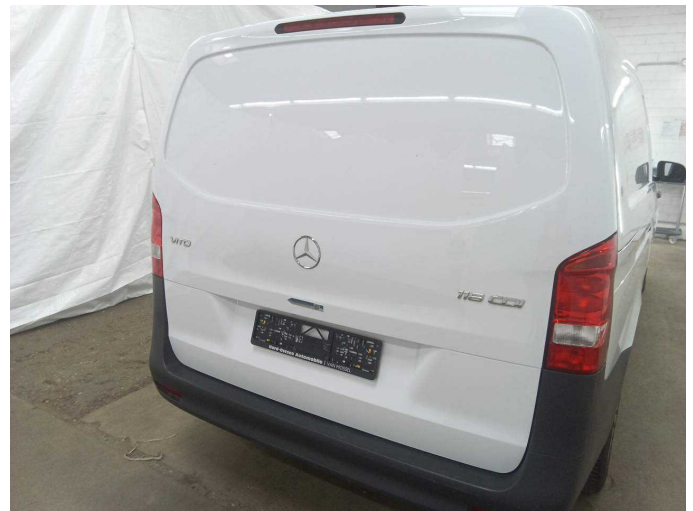
Damage 2: Boot lid / rear door: Boot lid - dent(s) - Smooth repair work

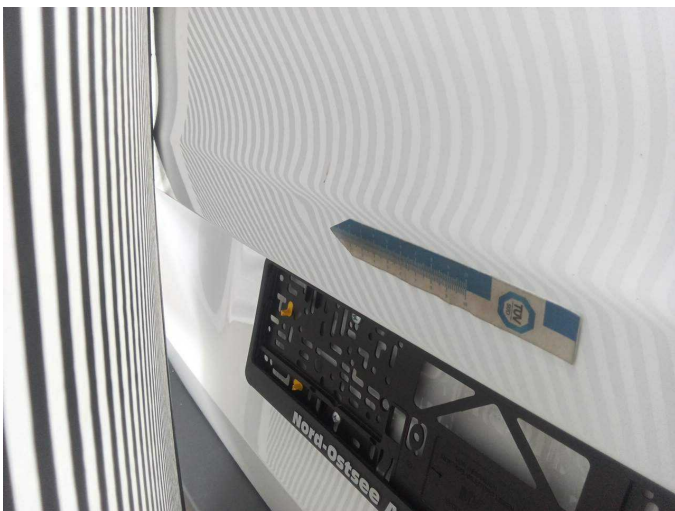
Damage 2: Boot lid / rear door: Boot lid - dent(s) - Smooth repair work

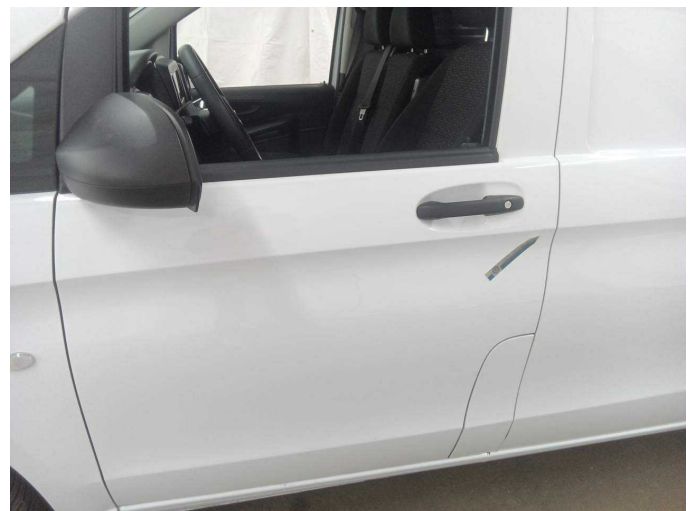
Damage 3: Door - front left side: Door - Scratch(es) - Smart repair

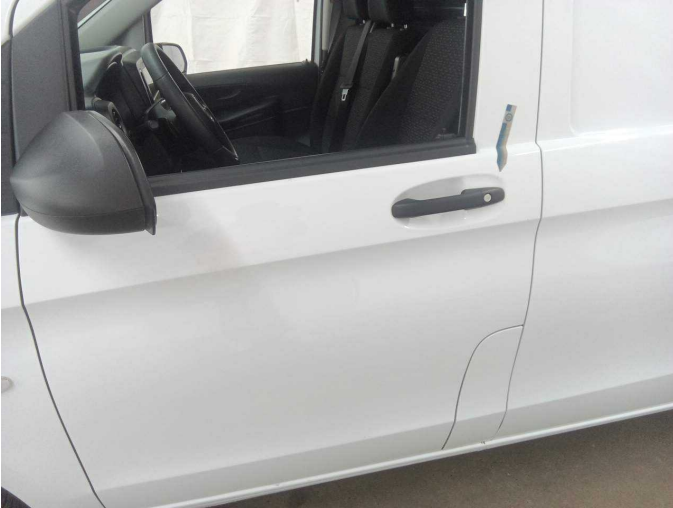
**Damage 3:** Door - front left side: Door - Scratch(es) - Smart repair

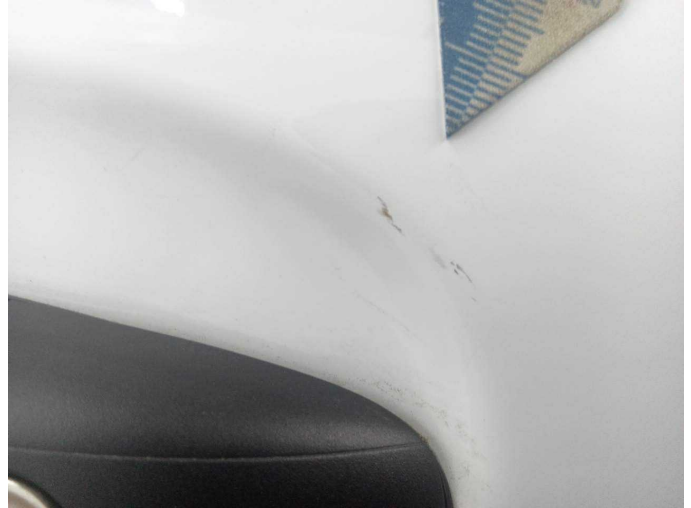
**Damage 3:** Door - front left side: Door - Scratch(es) - Smart repair

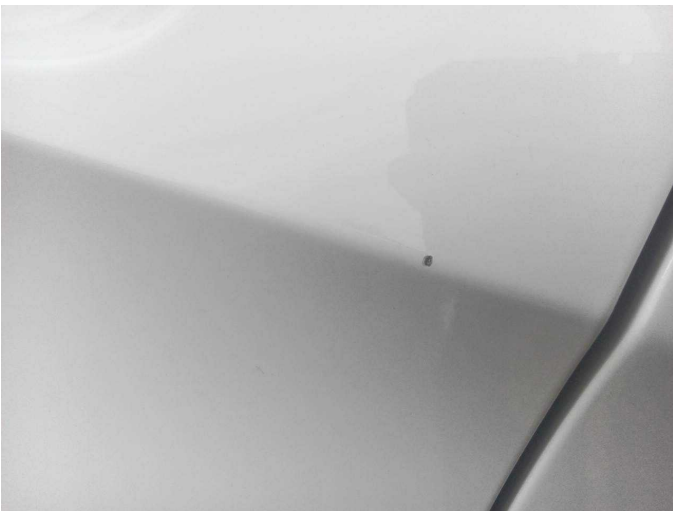
**Damage 3:** Door - front left side: Door - Scratch(es) - Smart repair

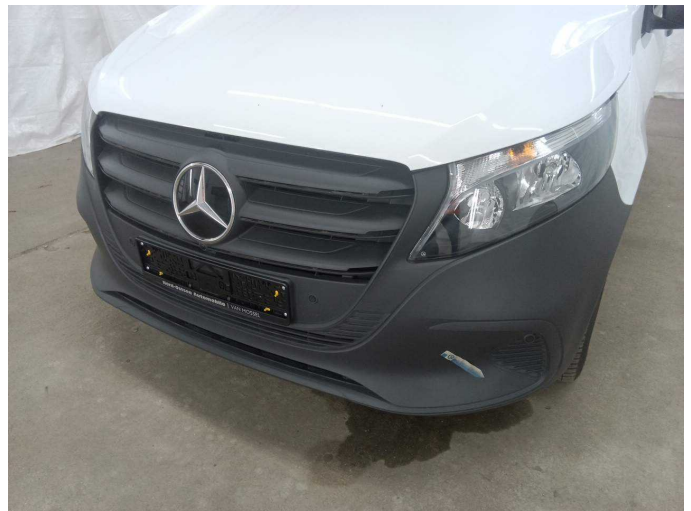
**Damage 4:** Front bumper: Front bumper - Scratch(es) - Replace

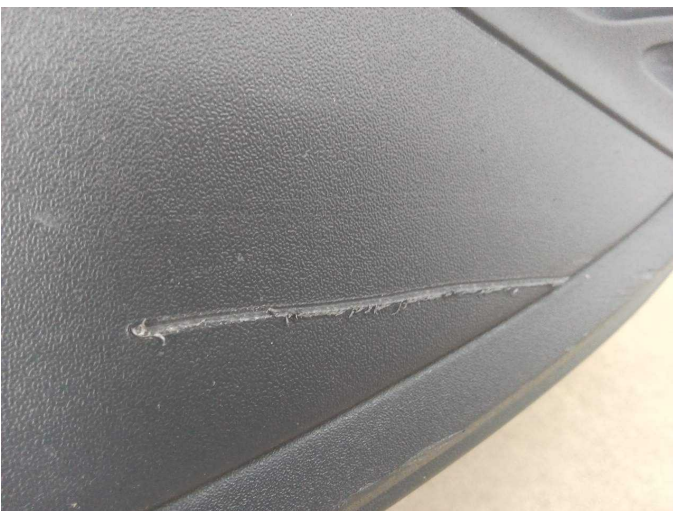
**Damage 4:** Front bumper: Front bumper - Scratch(es) - Replace

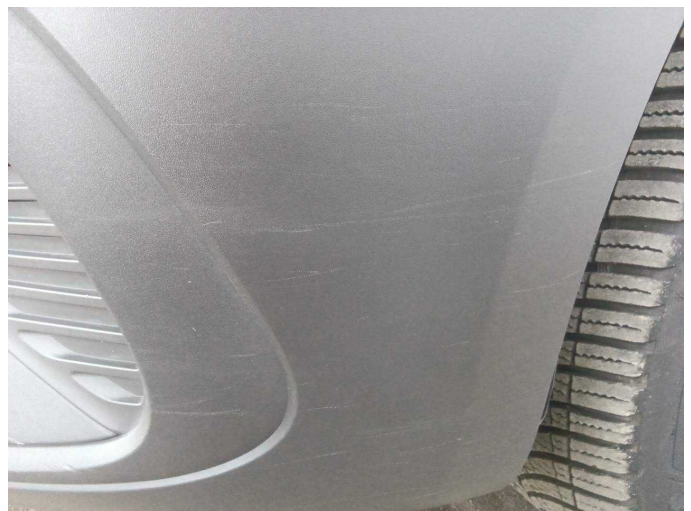
**Damage 4:** Front bumper: Front bumper - Scratch(es) - Replace

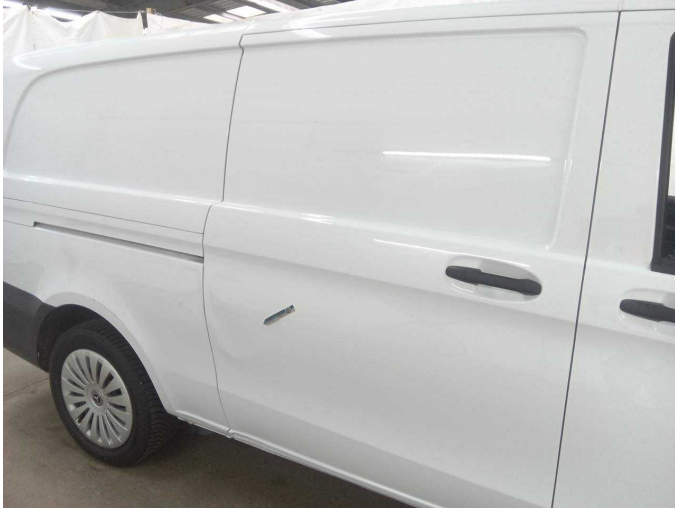
**Damage 5:** Sliding door, right: Sliding door - Damaged - Replace

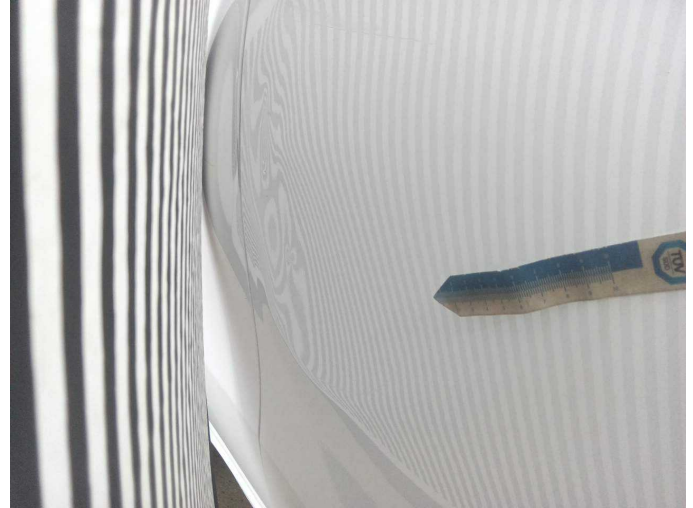
**Damage 5:** Sliding door, right: Sliding door - Damaged - Replace

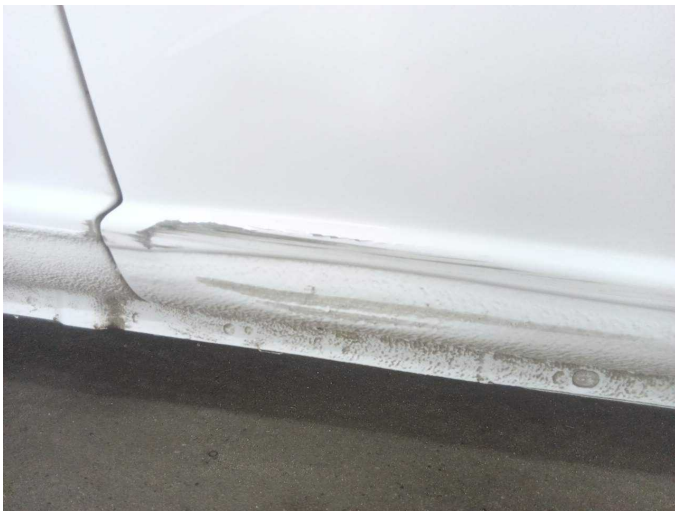
**Damage 5:** Sliding door, right: Sliding door - Damaged - Replace

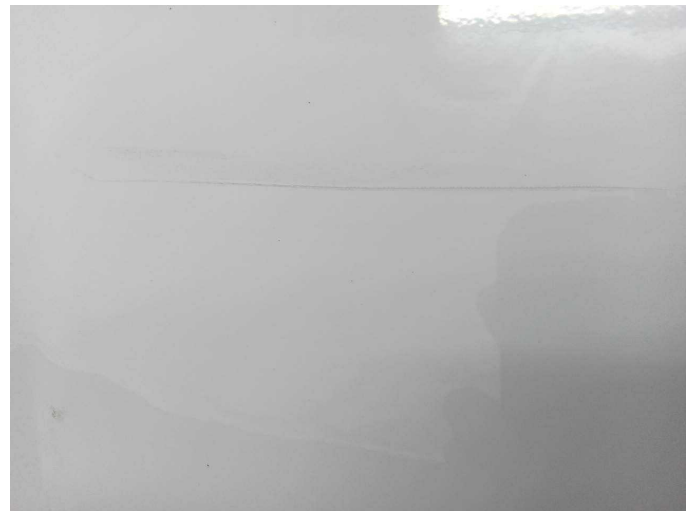
**Damage 5:** Sliding door, right: Sliding door - Damaged - Replace

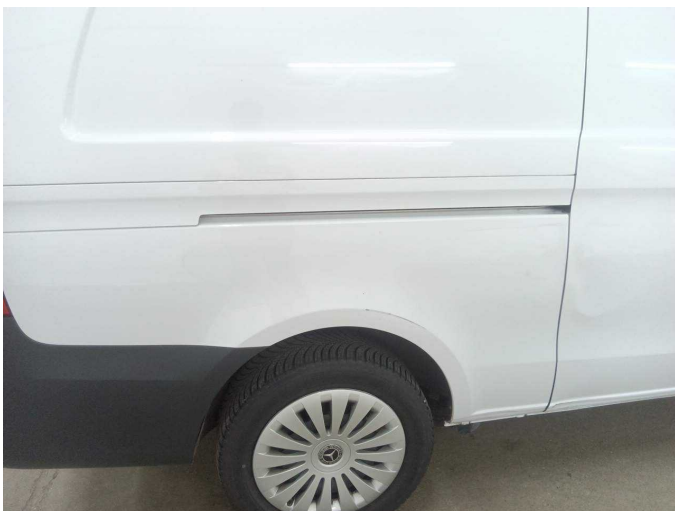
**Damage 6:** Side panel - rear right side: Side panel - Dent / paintcoat damage - Repair and paint

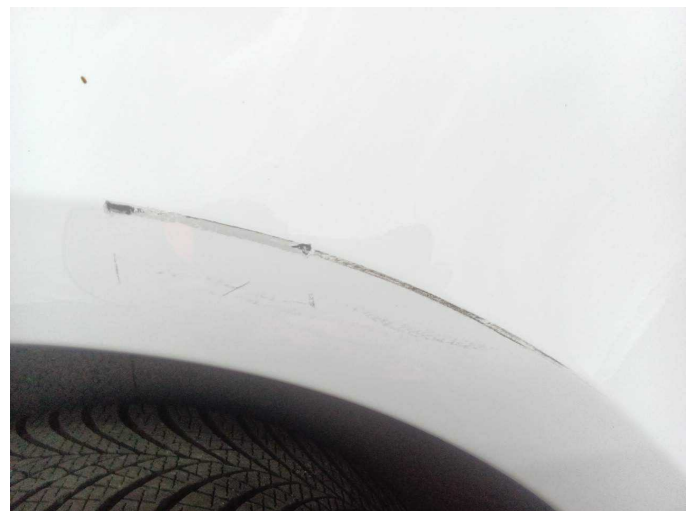
**Damage 6:** Side panel - rear right side: Side panel - Dent / paintcoat damage - Repair and paint

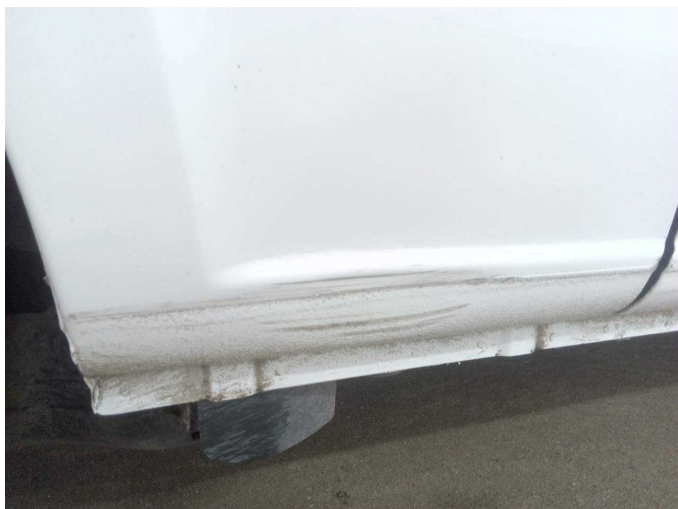
**Damage 6:** Side panel - rear right side: Side panel - Dent / paintcoat damage - Repair and paint

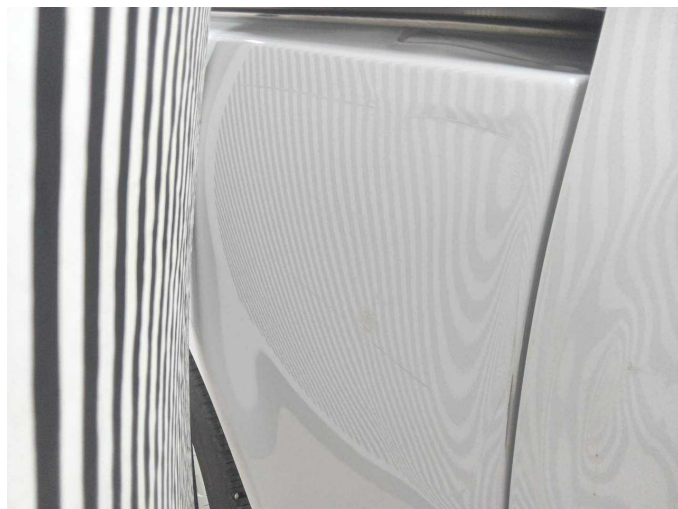
**Damage 6:** Side panel - rear right side: Side panel - Dent / paintcoat damage - Repair and paint
