Expertise

Protocol number: 45875171
 Order No. / Reference: 26562365
 Inspection date: 10 Jun 2026

Model: Focus Turnier 1.5 EcoBlue Start-Stopp-System Aut. ACTIVE

VIN: WF0PXXGCHPNA25756

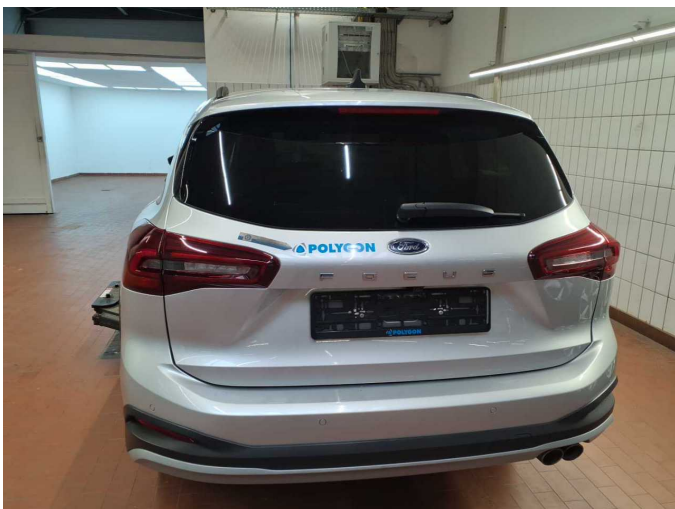
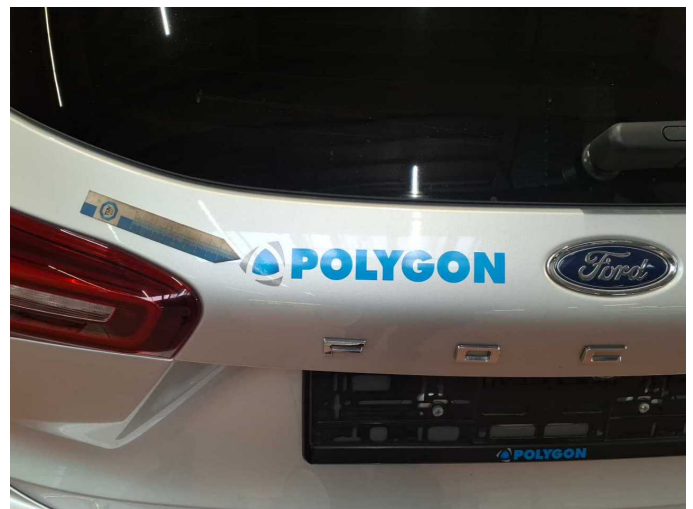
Damage 1: Boot lid / rear door: Boot lid - Glued / labelled - De-glue / neutralise

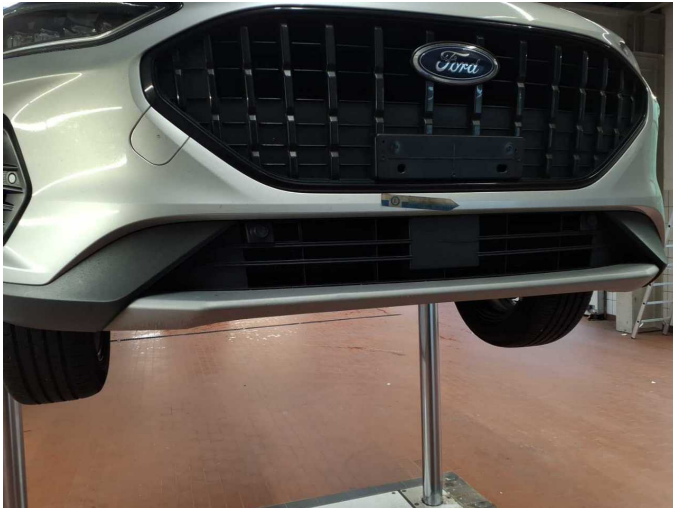
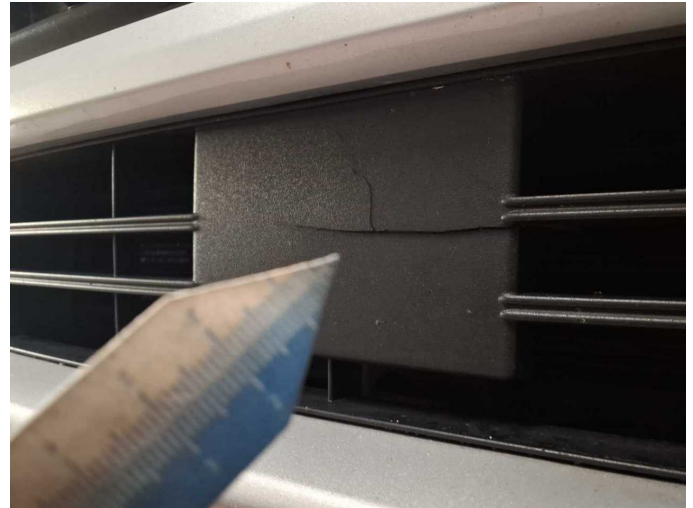
Damage 2: Front bumper: Grille - Broken / torn - Replace

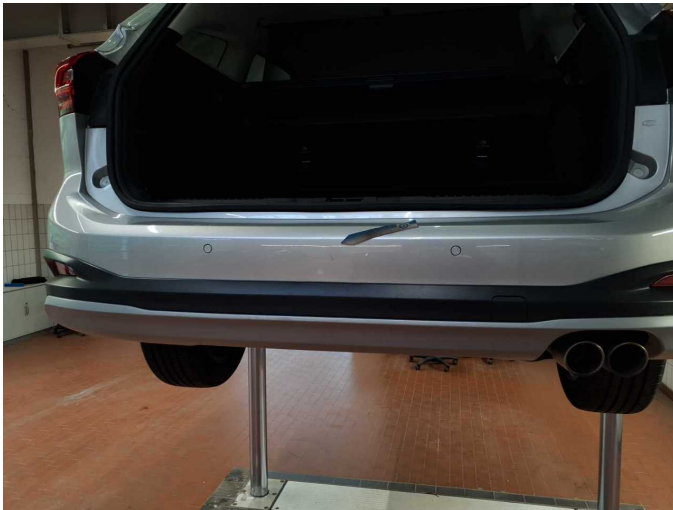
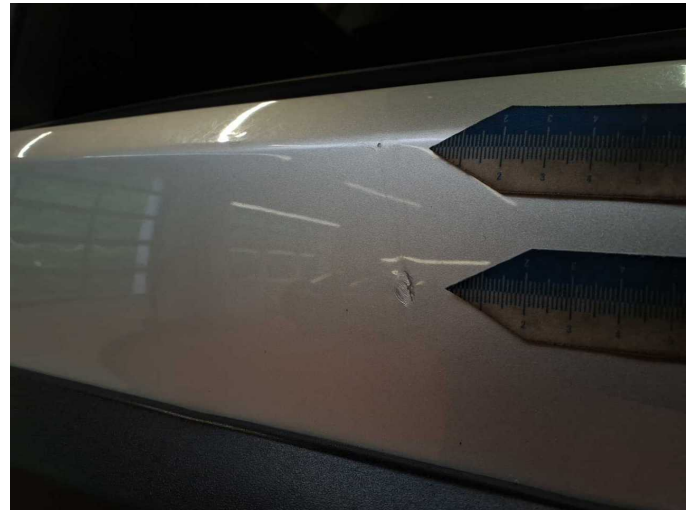
Damage 3: Rear bumper: Rear bumper - Scratched - Smart repair

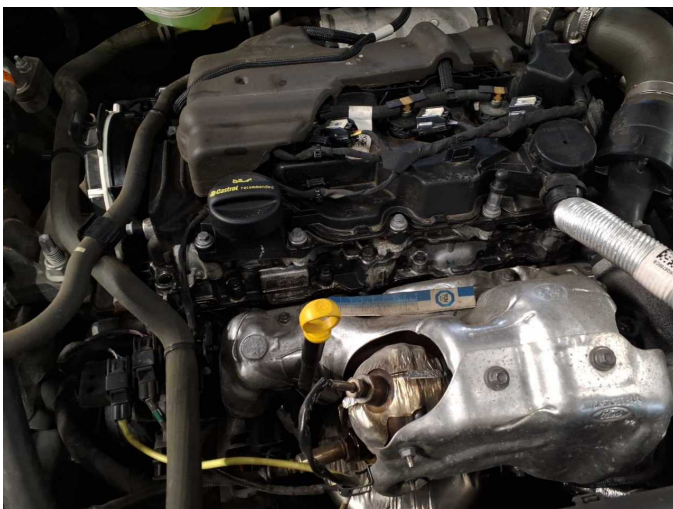
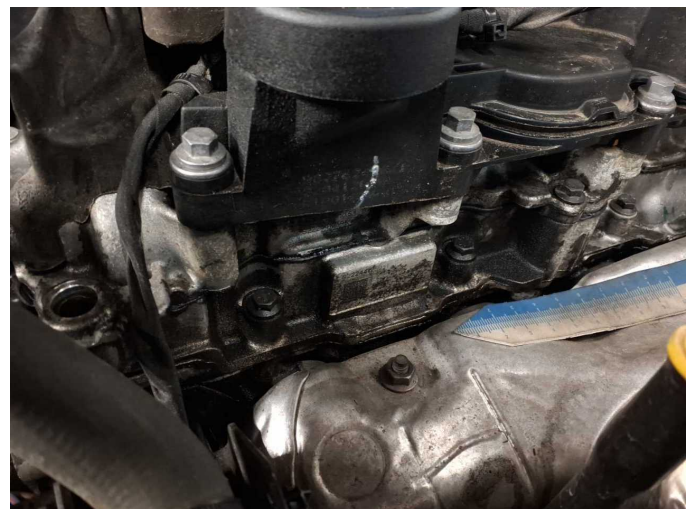
Damage 4: Engine: Engine (Ölverlust-Mehrkosten möglich) - Leaking - Perform diagnosis

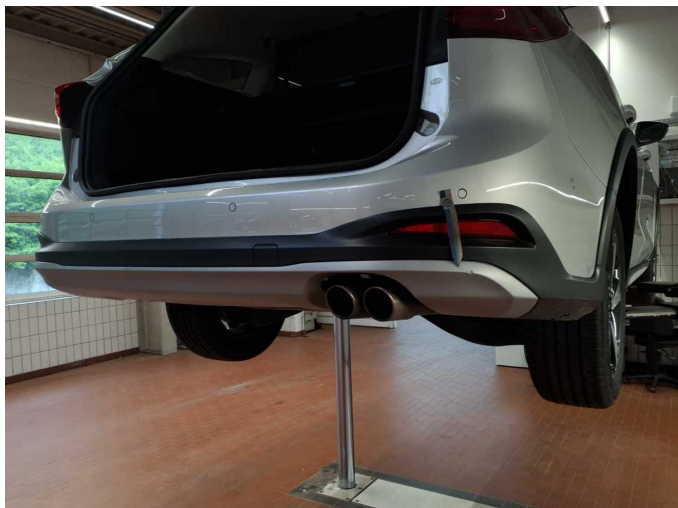
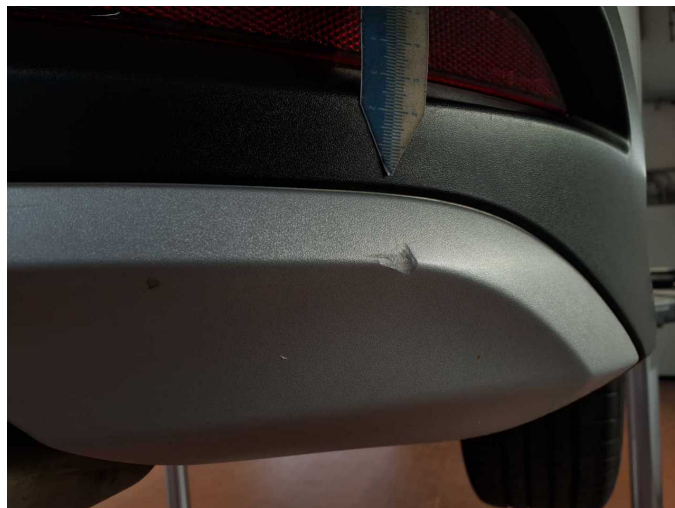
Damage 5: Rear bumper: Spoiler - Scratched - Replace
