Expertise

Protocol number: 46323368
Order No. / Reference: 26539100
Inspection date: 25 Jun 2026

Model: Transit 310 L2 VA Trend

VIN: WF0CXXTTRCLY65137

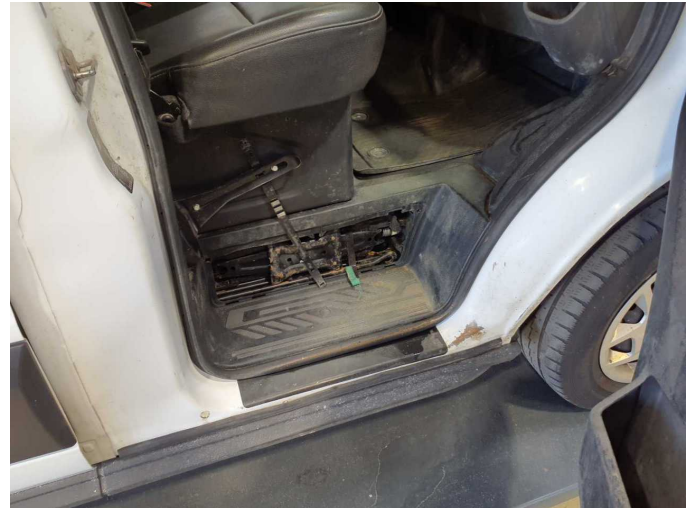
| No. | Component group | Description |
|---|---|---|
| 1 | Trim / covers | Sill - front right side - Missing - Replace |

Damage 1: Trim / covers: Sill - front right side - Missing - Replace

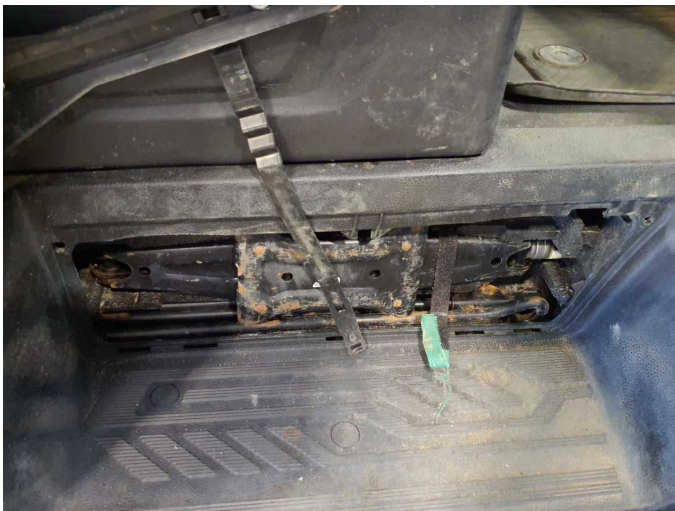
Damage 1: Trim / covers: Sill - front right side - Missing - Replace

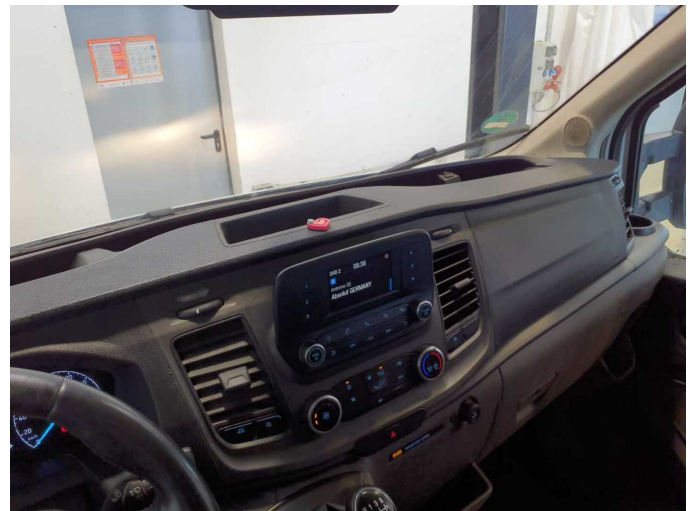
| No. | Component group | Description |
|---|---|---|
| 2 | Instrument panel | Instrument panel (Mitte) - Glued / labelled - De-glue / neutralise |

Damage 2: Instrument panel: Instrument panel (Mitte) - Glued / labelled - De-glue / neutralise

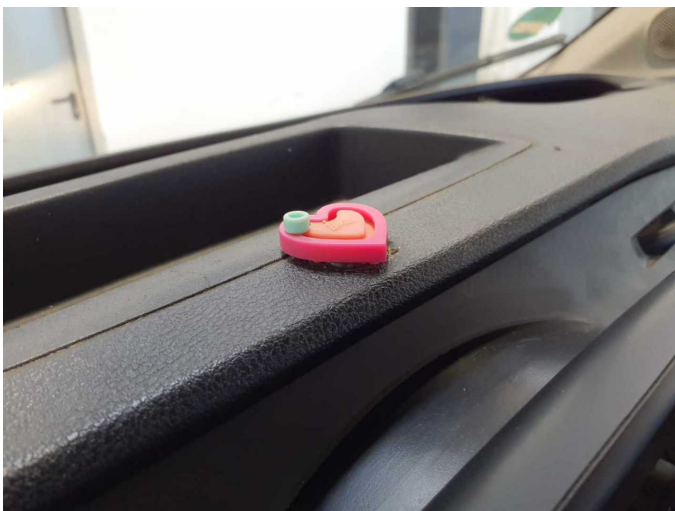
Damage 2: Instrument panel: Instrument panel (Mitte) - Glued / labelled - De-glue / neutralise

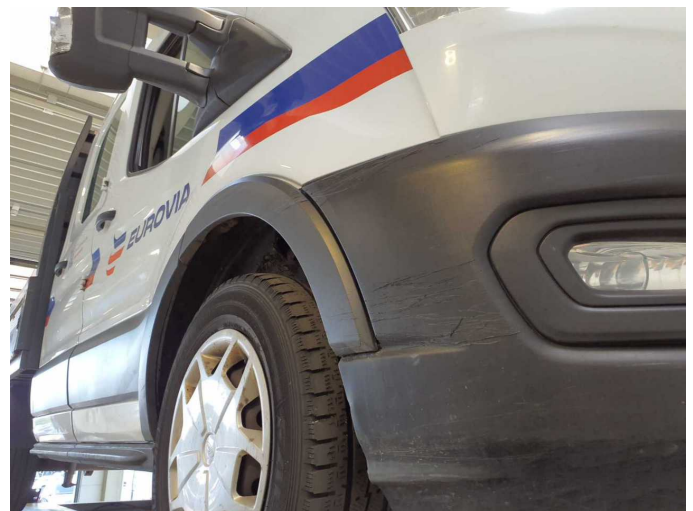
| No. | Component group | Description |
|---|---|---|
| 3 | Mudguard - right side | Wheel well extension - Scratch(es) - Loss in value |

Damage 3: Mudguard - right side: Wheel well extension - Scratch(es) - Loss in value

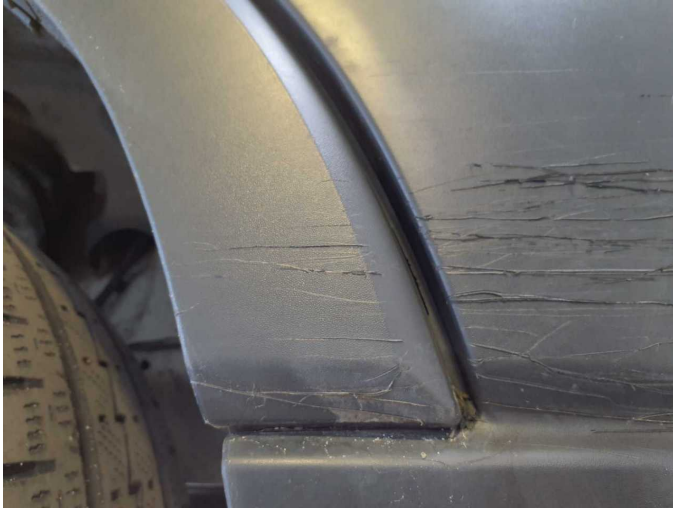
Damage 3: Mudguard - right side: Wheel well extension - Scratch(es) - Loss in value

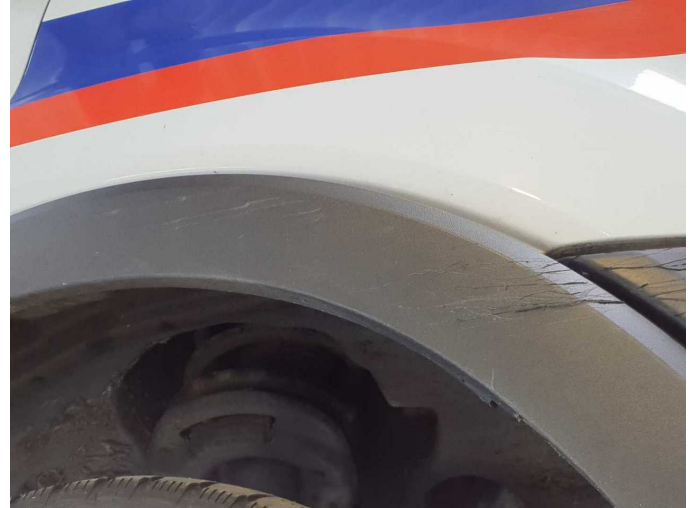
Damage 3: Mudguard - right side: Wheel well extension - Scratch(es) - Loss in value

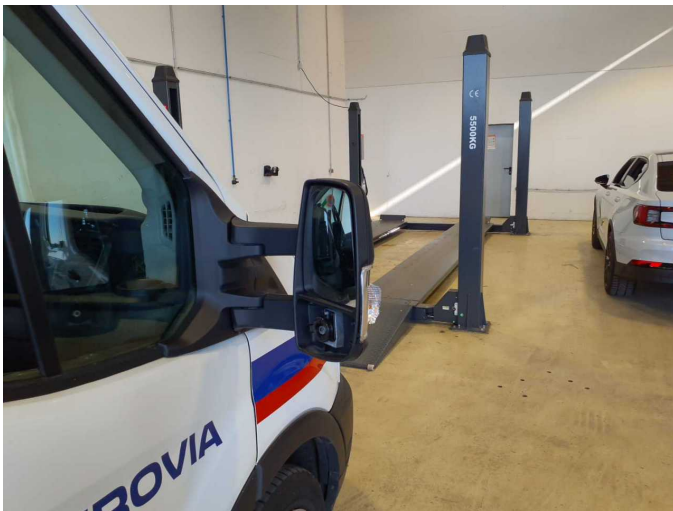
| No. | Component group | Description |
|---|---|---|
| 4 | Wing mirror - right side | Mirror glass - Missing - Replace |

Damage 4: Wing mirror - right side: Mirror glass - Missing - Replace

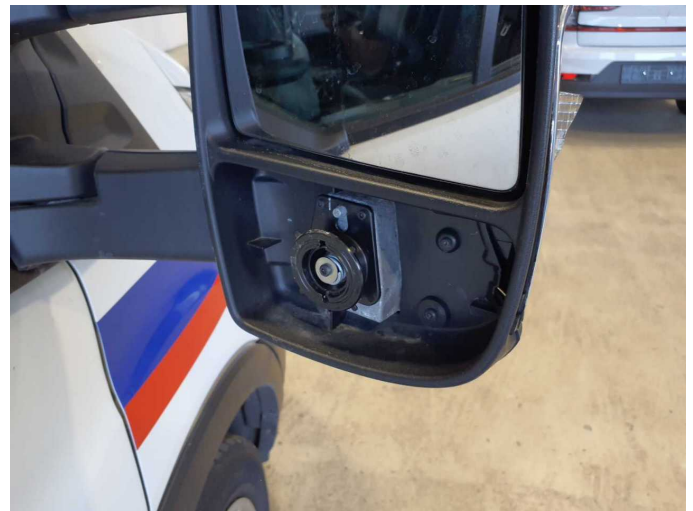
Damage 4: Wing mirror - right side: Mirror glass - Missing - Replace

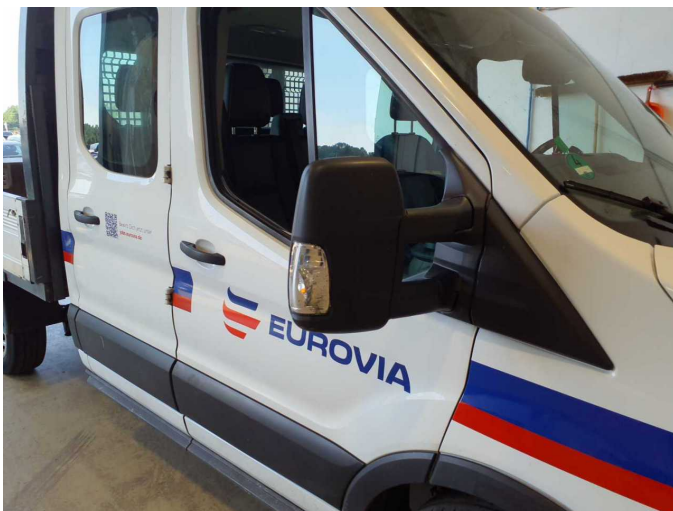
| No. | Component group | Description |
|---|---|---|
| 5 | Indicator - front | Mirror - right side - Broken / torn - Replace |

Damage 5: Indicator - front: Mirror - right side - Broken / torn - Replace

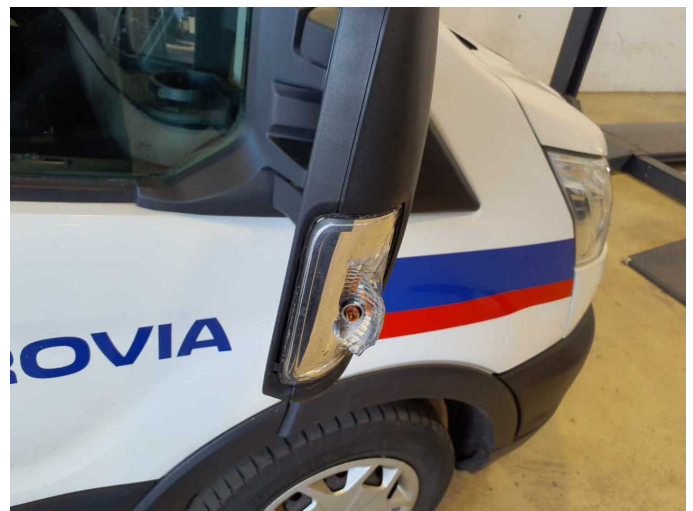
Damage 5: Indicator - front: Mirror - right side - Broken / torn - Replace

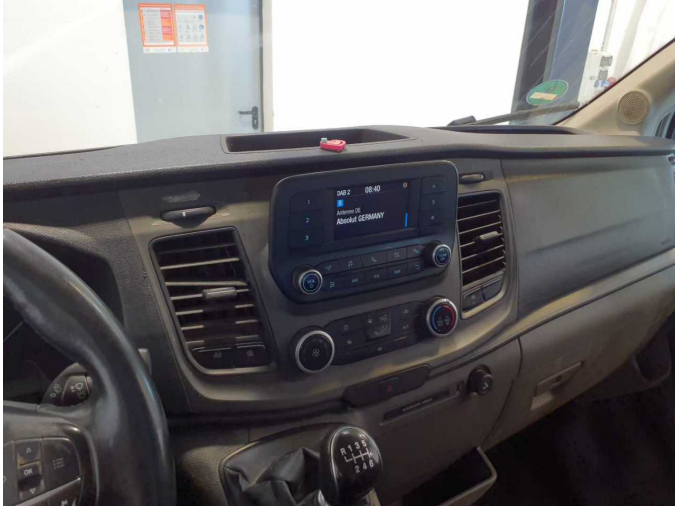
| No. | Component group | Description |
|---|---|---|
| 6 | Instrument panel | Air nozzle - centre - Broken / torn - Replace |

Damage 6: Instrument panel: Air nozzle - centre - Broken / torn - Replace

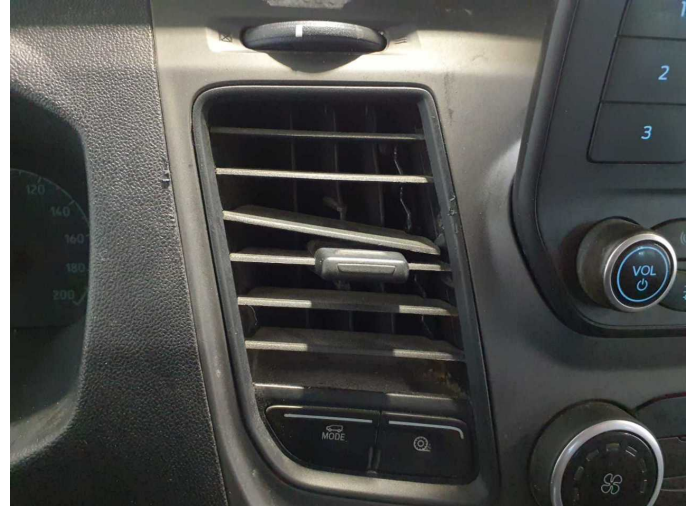
Damage 6: Instrument panel: Air nozzle - centre - Broken / torn - Replace

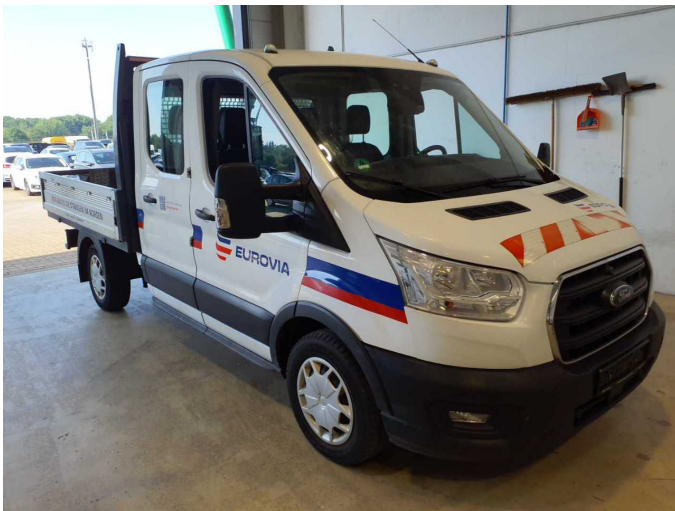
| No. | Component group | Description |
|---|---|---|
| 7 | Body | Body - Glued / labelled - De-glue / neutralise |

Damage 7: Body: Body - Glued / labelled - De-glue / neutralise

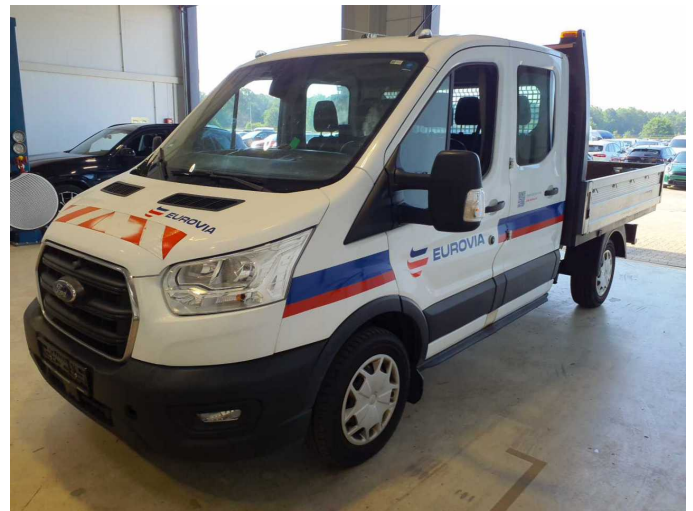
Damage 7: Body: Body - Glued / labelled - De-glue / neutralise

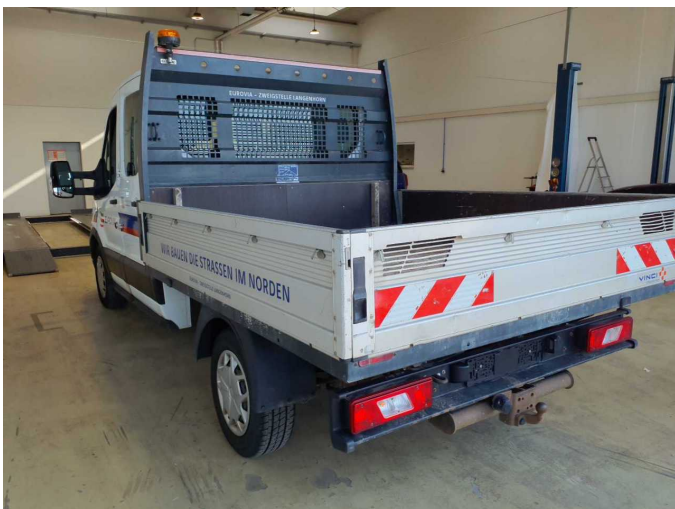
Damage 7: Body: Body - Glued / labelled - De-glue / neutralise

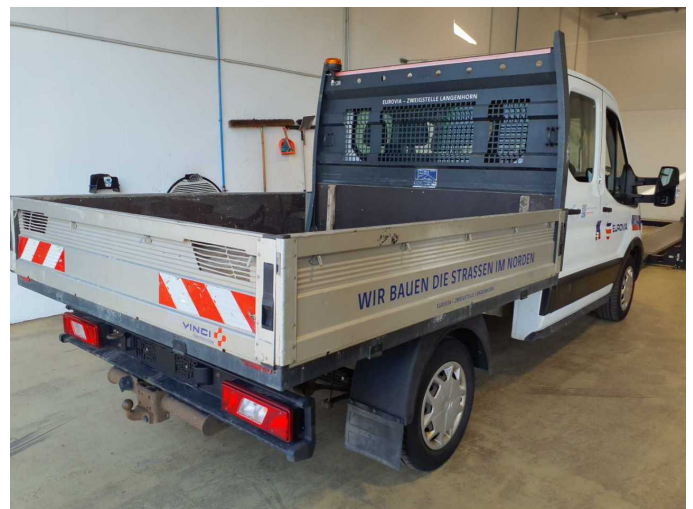
Damage 7: Body: Body - Glued / labelled - De-glue / neutralise

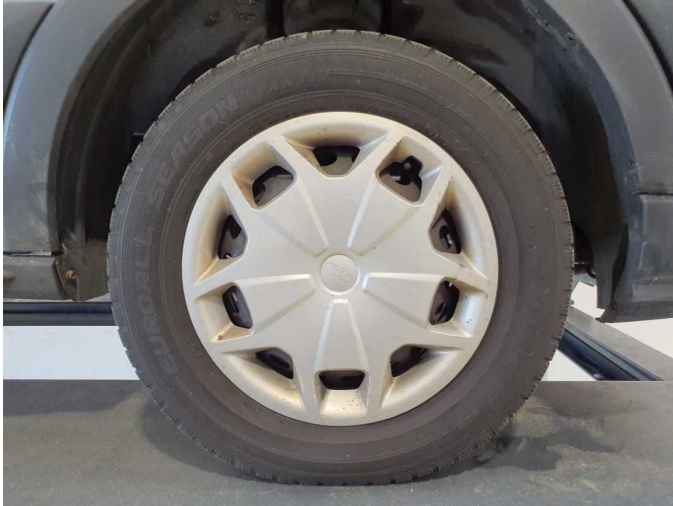
| No. | Component group | Description |
|---|---|---|
| 8 | Wheel / tyres | Tyre - front - Worn - Replace |

Damage 8: Wheel / tyres: Tyre - front - Worn - Replace

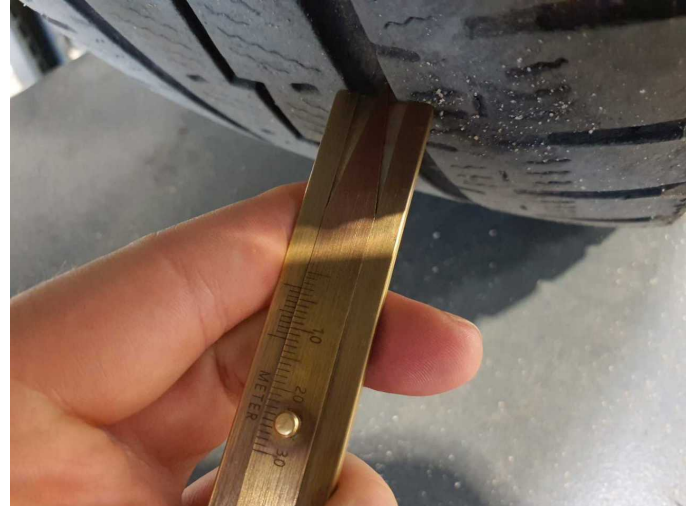
Damage 8: Wheel / tyres: Tyre - front - Worn - Replace

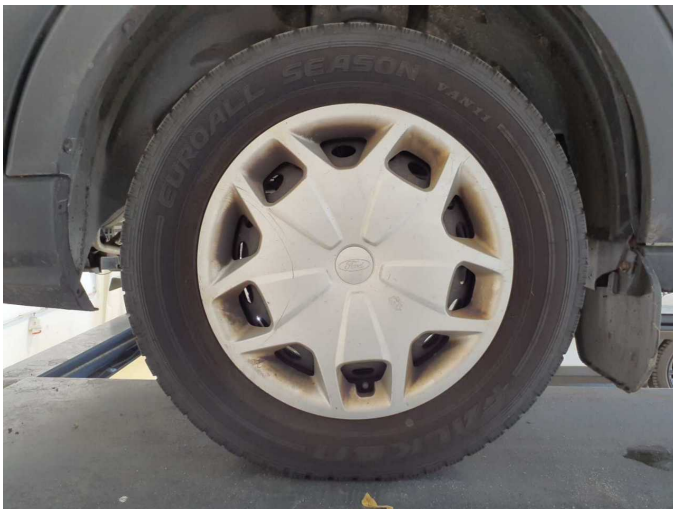
Damage 8: Wheel / tyres: Tyre - front - Worn - Replace

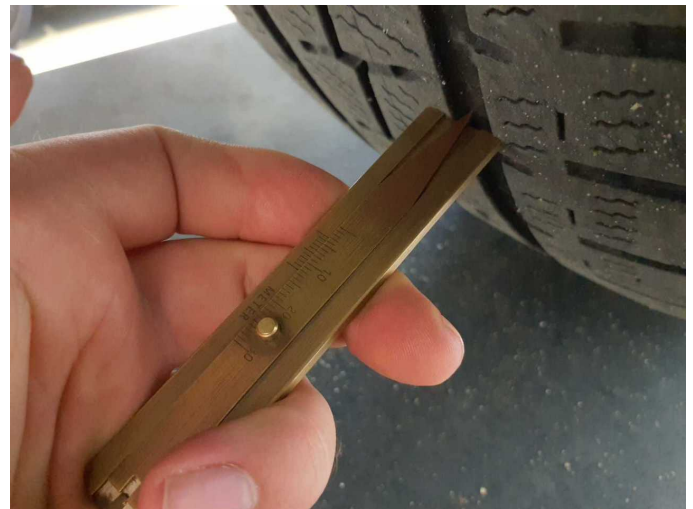
Damage 8: Wheel / tyres: Tyre - front - Worn - Replace

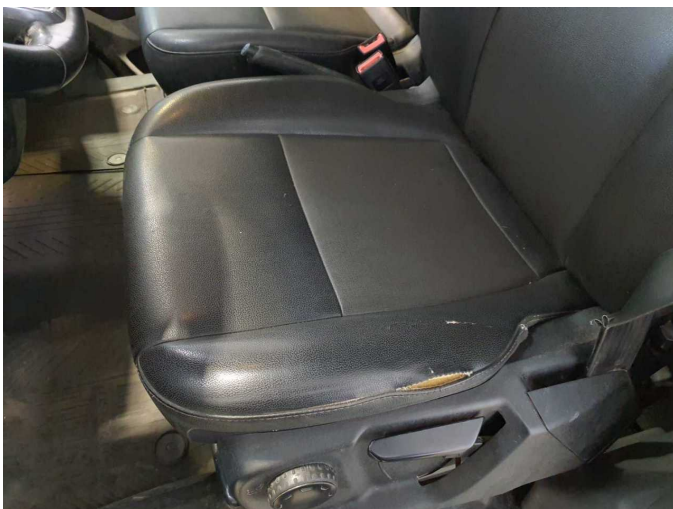
| No. | Component group | Description |
|---|---|---|
| 9 | Seat - front | Seat cover - left side - Porous / cracked - Replace |

Damage 9: Seat - front: Seat cover - left side - Porous / cracked - Replace

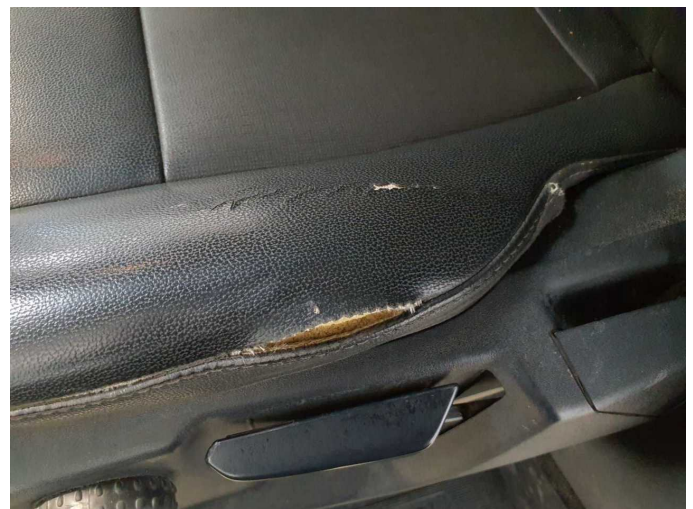
Damage 9: Seat - front: Seat cover - left side - Porous / cracked - Replace

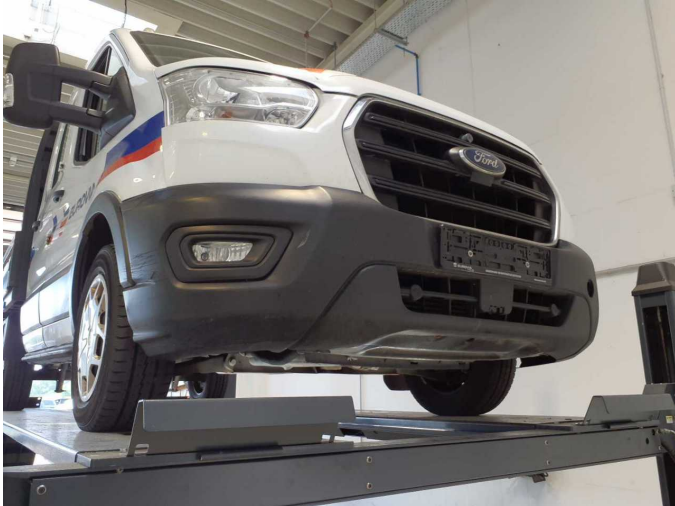
| No. | Component group | Description |
|---|---|---|
| 10 | Front bumper | Front bumper (Zusätzlich lose & Abdeckkappe Abschleppöse fehlt) - Scratch(es) - Replace |

Damage 10: Front bumper: Front bumper (Zusätzlich lose & Abdeckkappe Abschleppöse fehlt) - Scratch(es) - Replace

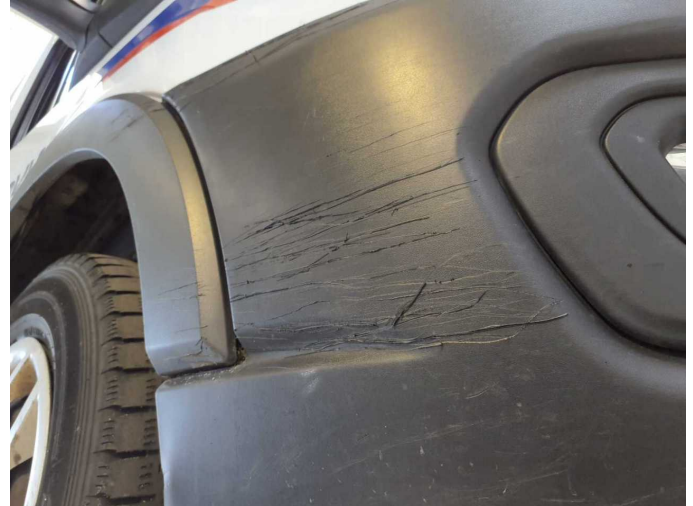
Damage 10: Front bumper: Front bumper (Zusätzlich lose & Abdeckkappe Abschleppöse fehlt) - Scratch(es) - Replace

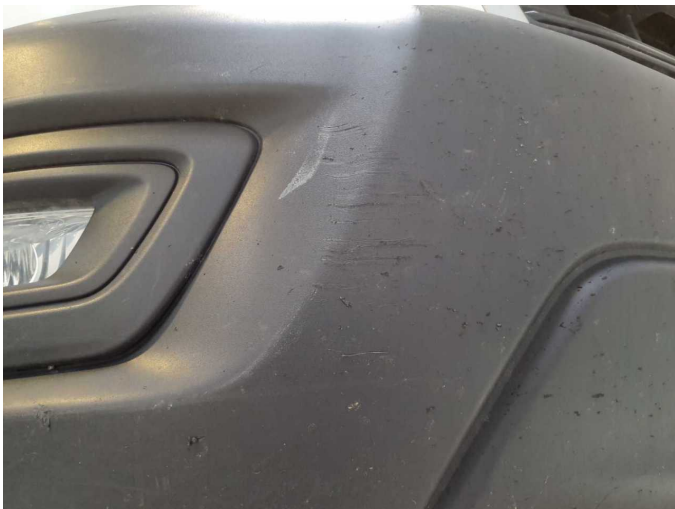
Damage 10: Front bumper: Front bumper (Zusätzlich lose & Abdeckkappe Abschleppöse fehlt) - Scratch(es) - Replace

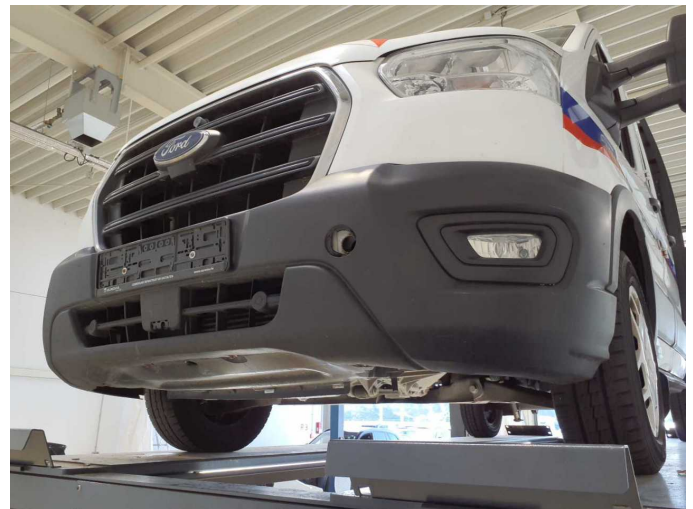
Damage 10: Front bumper: Front bumper (Zusätzlich lose & Abdeckkappe Abschleppöse fehlt) - Scratch(es) - Replace

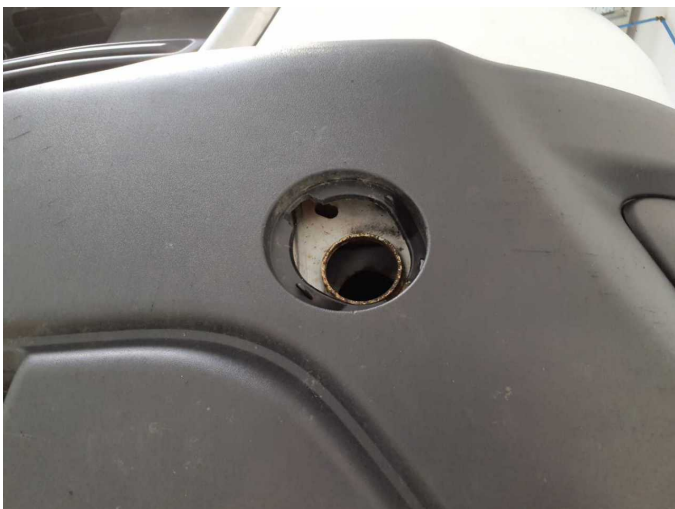
Damage 10: Front bumper: Front bumper (Zusätzlich lose & Abdeckkappe Abschleppöse fehlt) - Scratch(es) - Replace

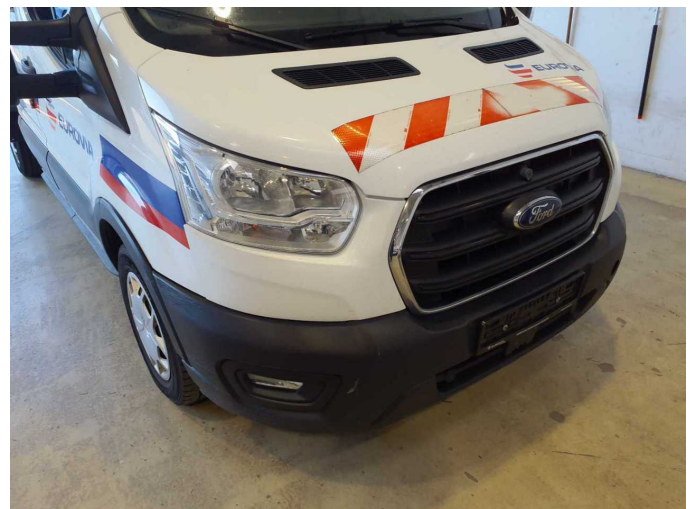
Damage 10: Front bumper: Front bumper (Zusätzlich lose & Abdeckkappe Abschleppöse fehlt) - Scratch(es) - Replace

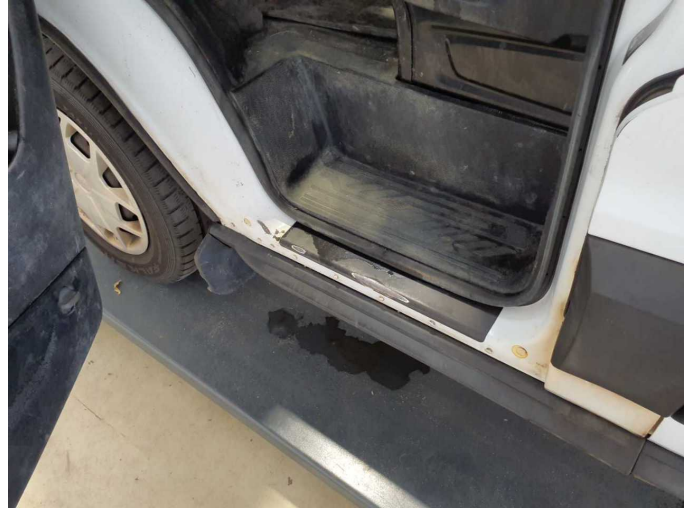
| No. | Component group | Description |
|---|---|---|
| 11 | Sill - left side | Sill - Corrosion - Repair and paint |

Damage 11: Sill - left side: Sill - Corrosion - Repair and paint

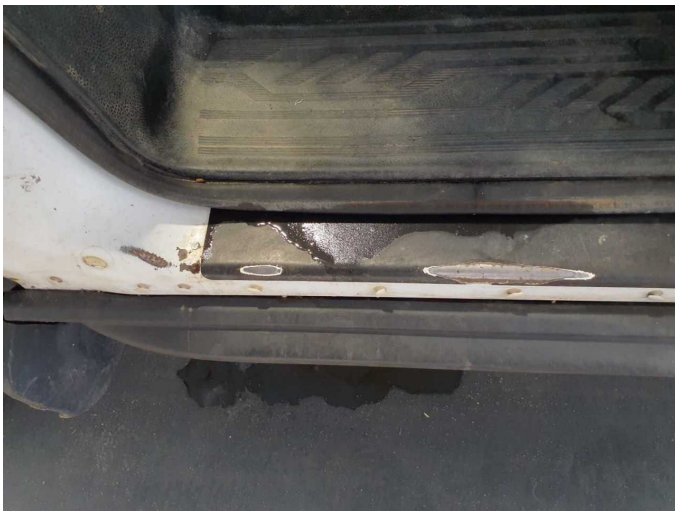
Damage 11: Sill - left side: Sill - Corrosion - Repair and paint

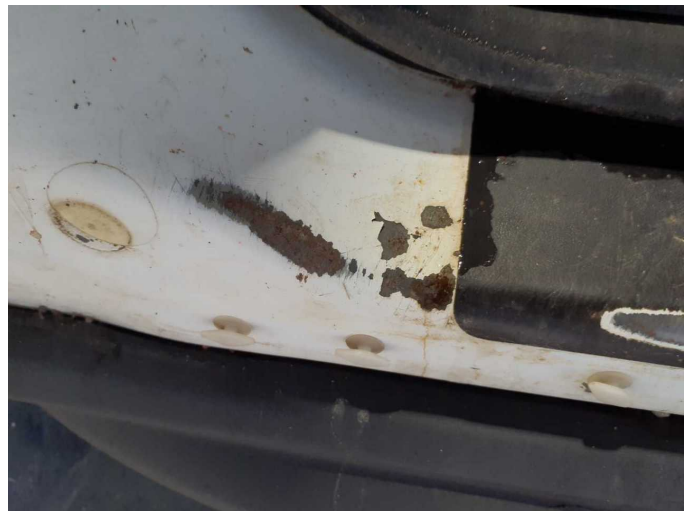
Damage 11: Sill - left side: Sill - Corrosion - Repair and paint

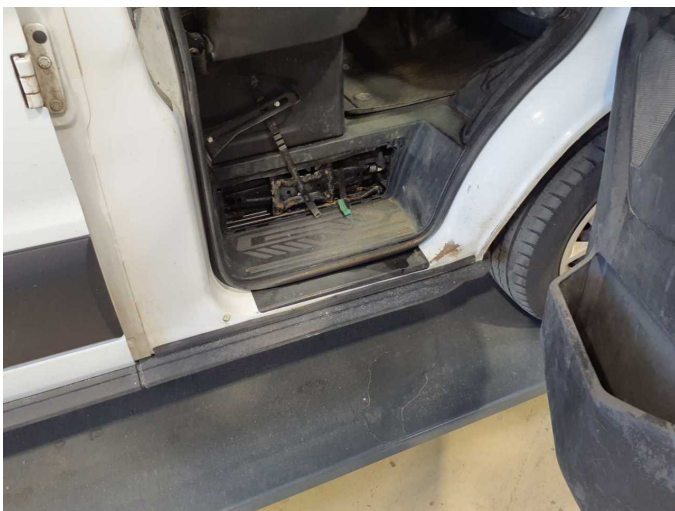
| No. | Component group | Description |
|---|---|---|
| 12 | Sill - right side | Sill (Vorn) - Corrosion - Repair and paint |

Damage 12: Sill - right side: Sill (Vorn) - Corrosion - Repair and paint

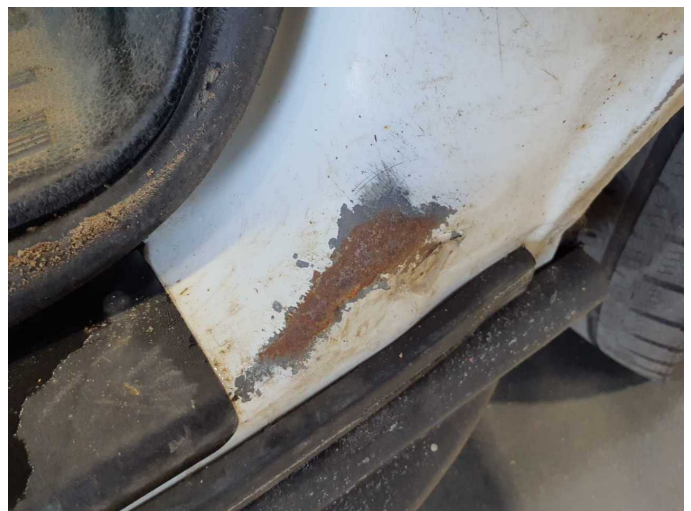
Damage 12: Sill - right side: Sill (Vorn) - Corrosion - Repair and paint

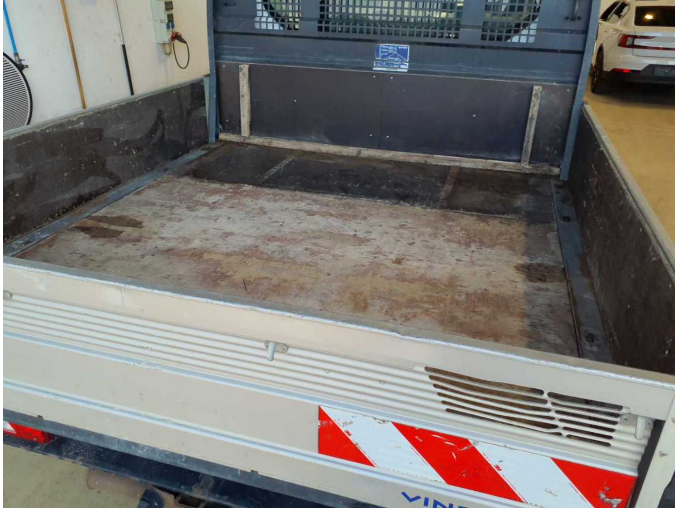
| No. | Component group | Description |
|---|---|---|
| 13 | Interior | Cargo area floor - Broken / torn - Loss in value |

Damage 13: Interior: Cargo area floor - Broken / torn - Loss in value

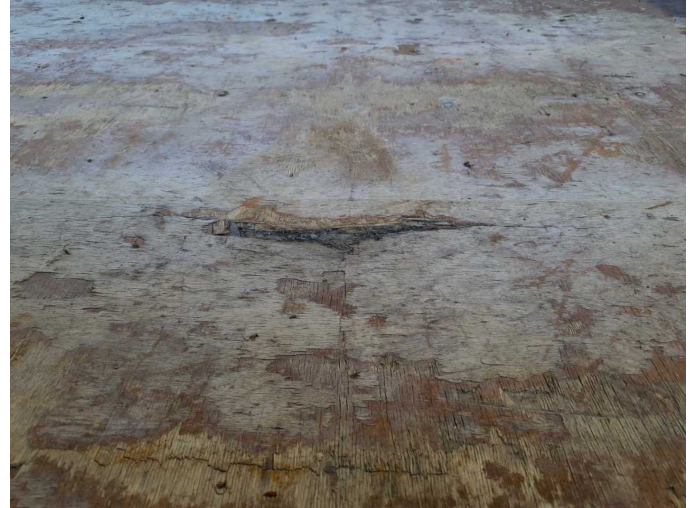
Damage 13: Interior: Cargo area floor - Broken / torn - Loss in value

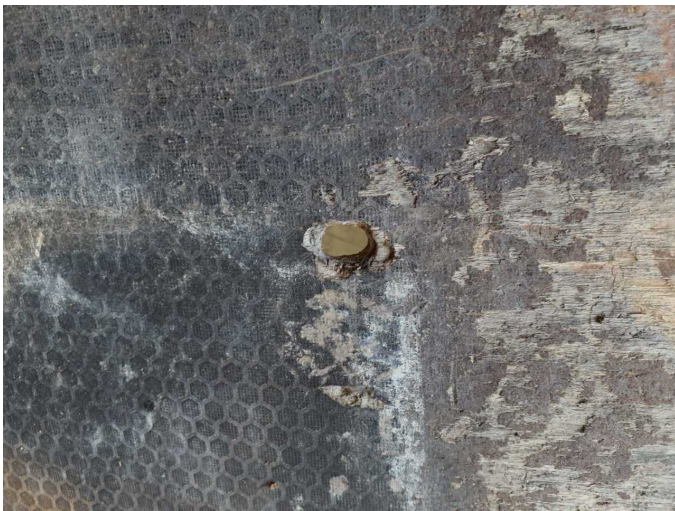
Damage 13: Interior: Cargo area floor - Broken / torn - Loss in value
