Expertise

Protocol number: 45868278
Order No. / Reference: 26372800
Inspection date: 10 Jun 2026

Manufacturer: Skoda

Model: Kodiaq 2.0 TDI 4x4 DSG Ambition

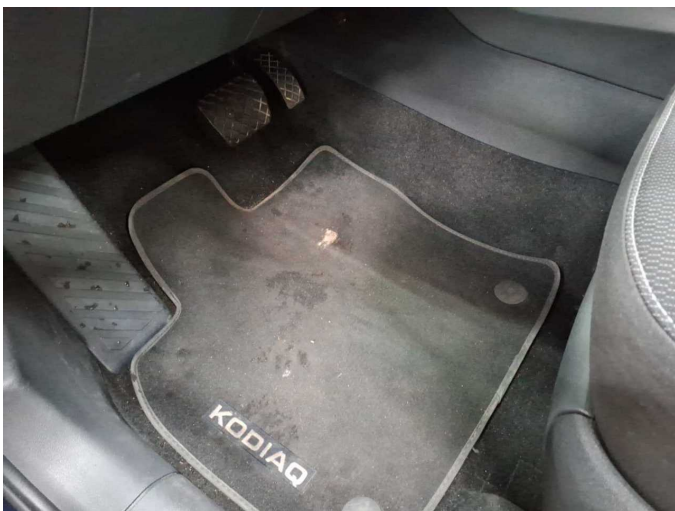
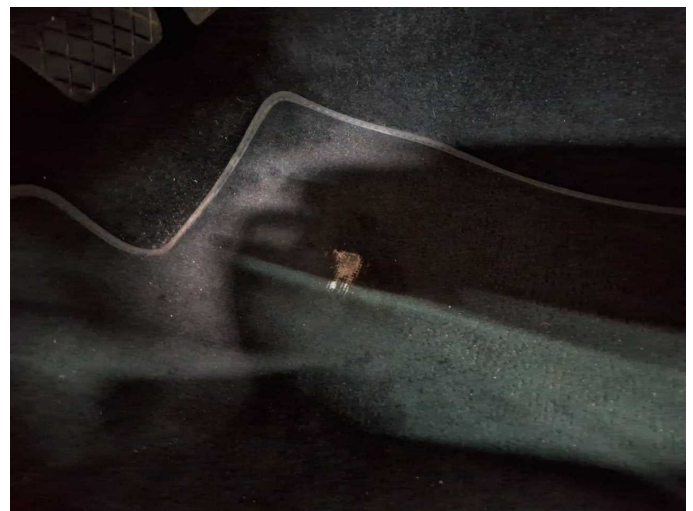
| No. | Component group | Description |
|---|---|--|
| 1 | Trim / covers | Floor mats - Holes - Replace |

Damage 1: Trim / covers: Floor mats - Holes - Replace

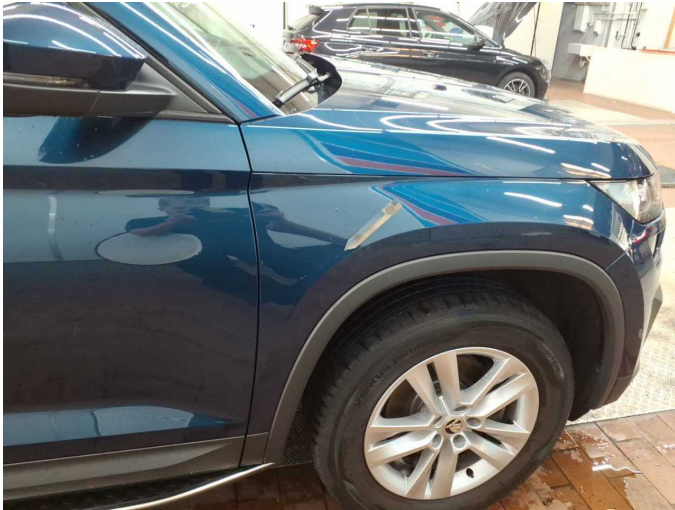
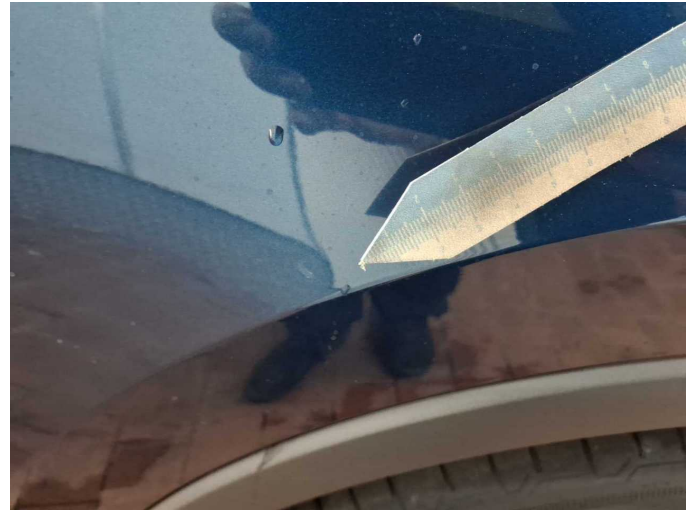
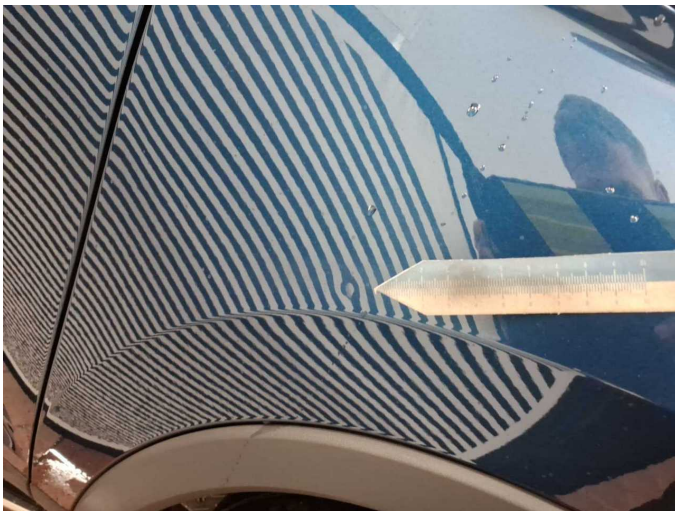
| No. | Component group | Description |
|---|---|--|
| 3 | Mudguard - right side | Mudguard - right side - Dent / paintcoat damage - Smart repair |

Damage 3: Mudguard - right side: Mudguard - right side - Dent / paintcoat damage - Smart repair

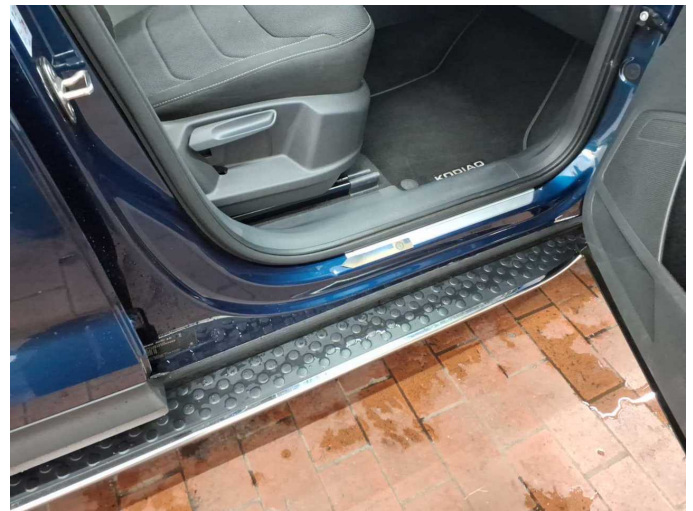
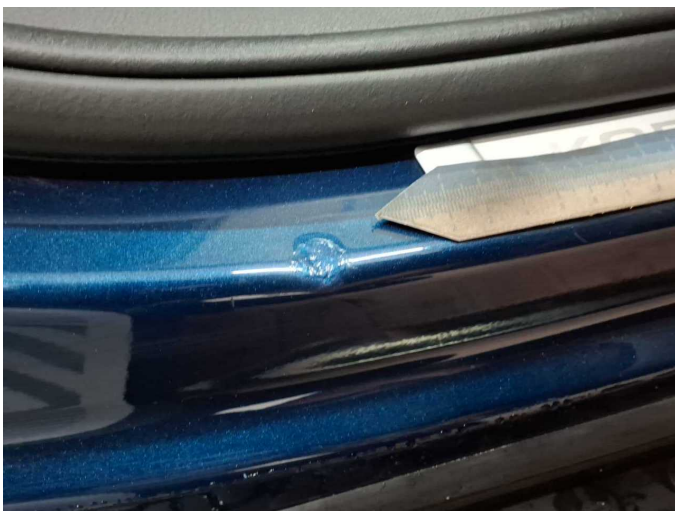
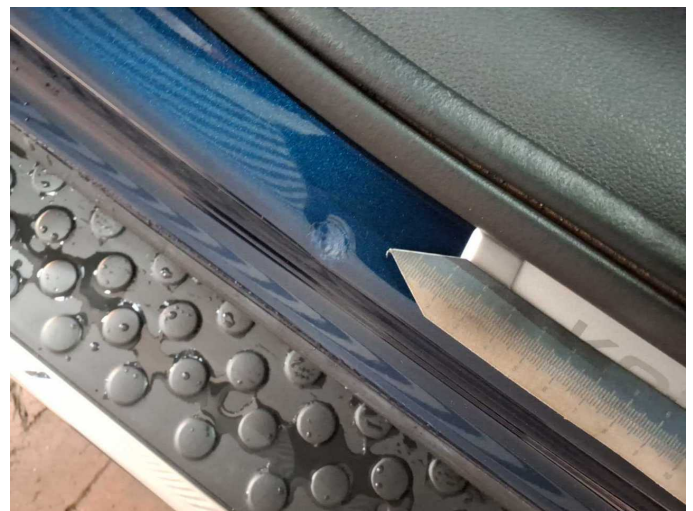
| No. | Component group | Description |
|---|---|--|
| 4 | Sill - right side | Sill (5 AW) - Dent / paintcoat damage - Repair and paint |

Damage 4: Sill - right side: Sill (5 AW) - Dent / paintcoat damage - Repair and paint

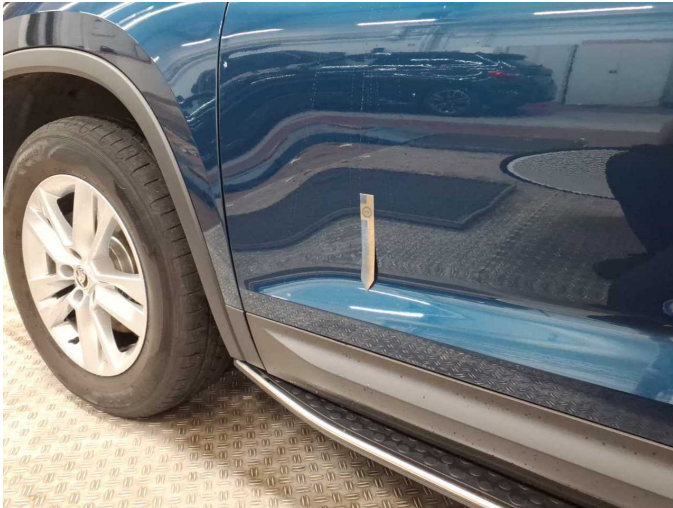
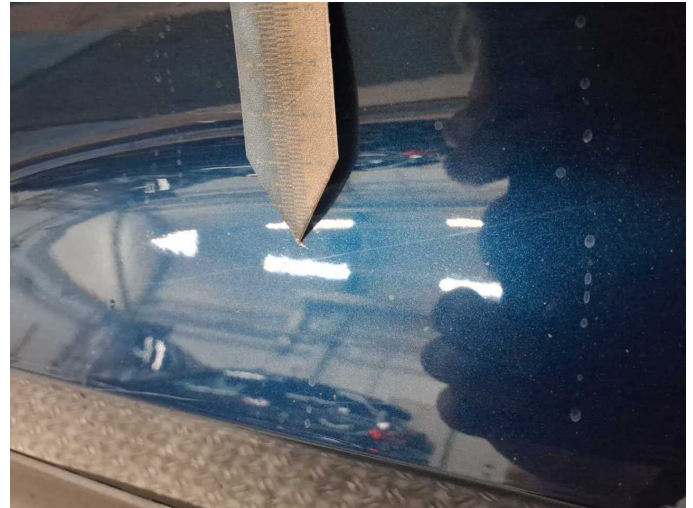
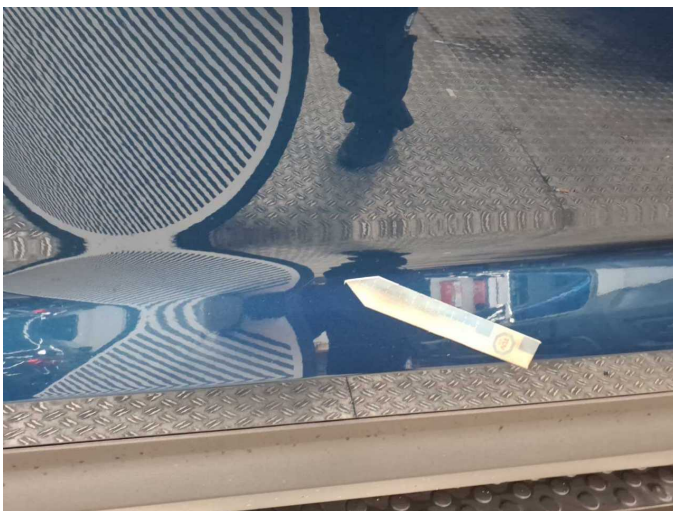
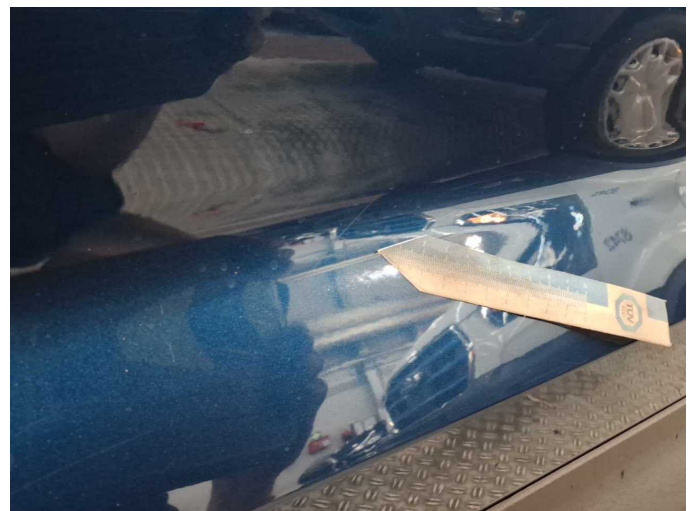
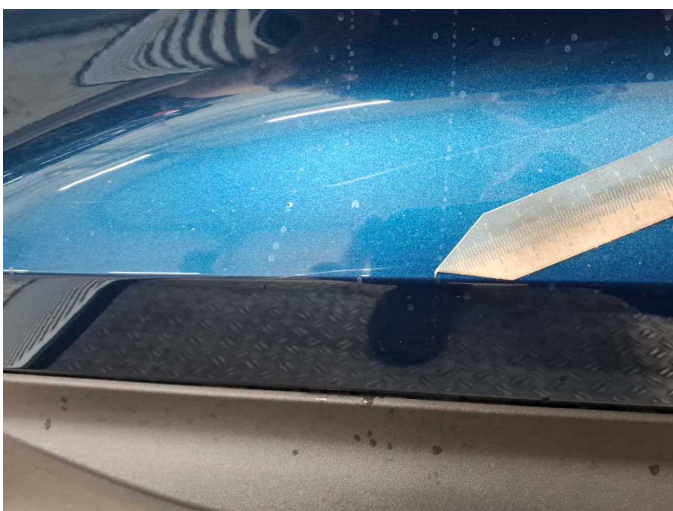
| No. | Component group | Description |
|---|---|--|
| 5 | Door - front left side | Door - Scratch(es) - Paint |

Damage 5: Door - front left side: Door - Scratch(es) - Paint

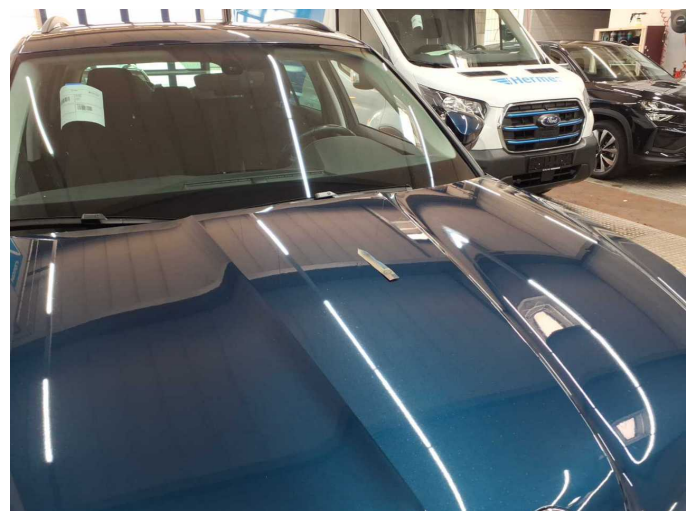
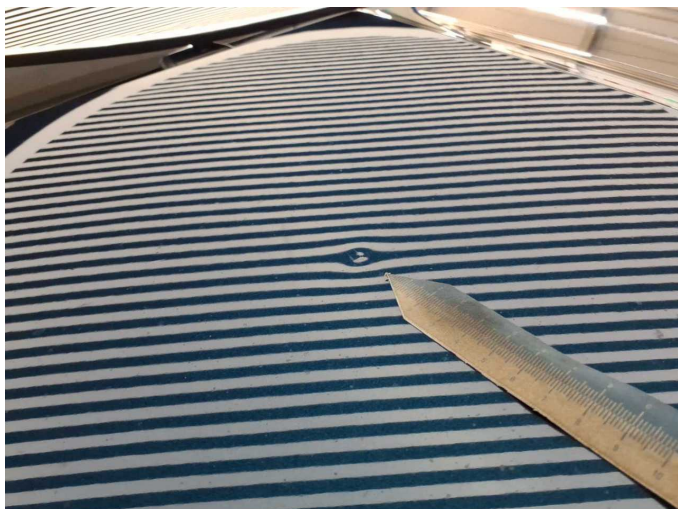
| No. | Component group | Description |
|---|---|--|
| 5 | Bonnet | Bonnet - dent(s) - No deduction |

Wear and tear 5: Bonnet: Bonnet - dent(s) - No deduction

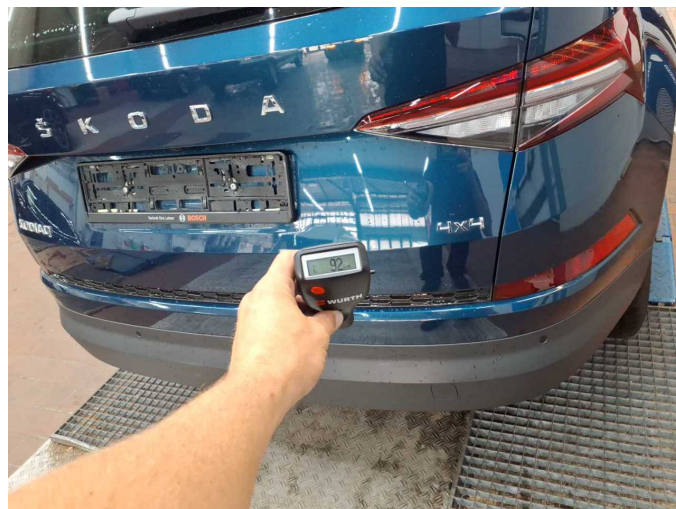
Previous damage 1: Rear

| No. | Previous damage | Extent of damage (Net) |
|---|---|---|
| 1 | Rear, Provided by user / customer, from 14 Aug 2025 | 1.156,93 € |

According to available information previous damages were repaired at the vehicle. Traces of repairs, which allow conclusions about the area of repair, were not recognizable during the inspection.
