Expertise

Protocol number: 46258377
Order No. / Reference: 26591600
Inspection date: 1 Jul 2026

Model: Transit 310 L2H3 Lkw VA Trend

VIN: WF0EXXTTREL66720

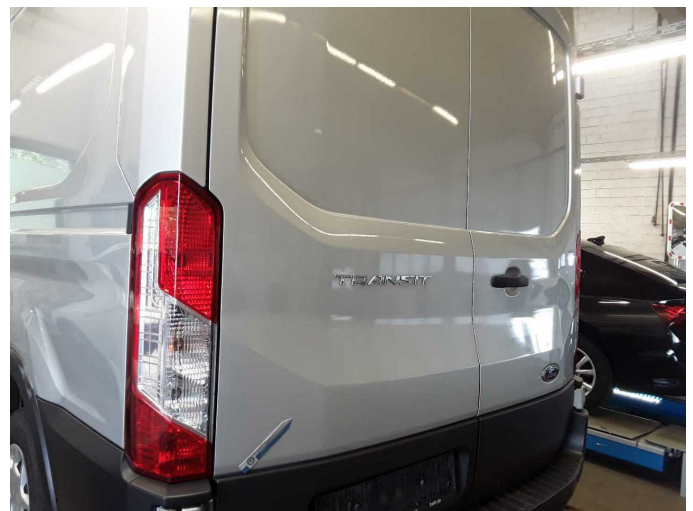
Damage 3: Boot lid / rear door: Rear door - left side - Paint defect - Smart repair

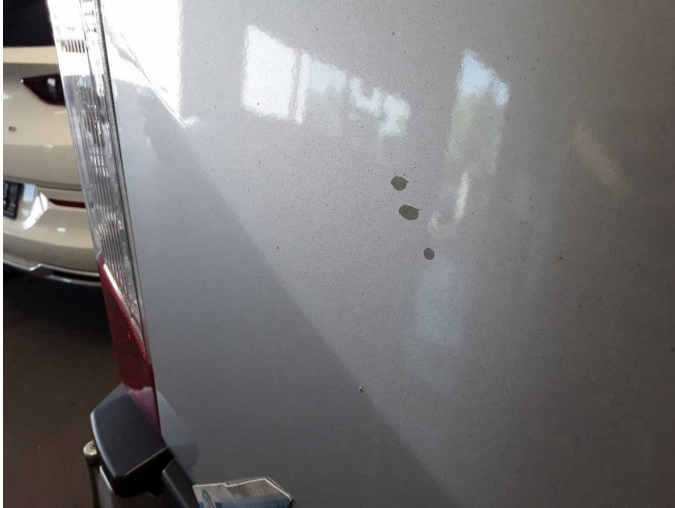
Damage 3: Boot lid / rear door: Rear door - left side - Paint defect - Smart repair

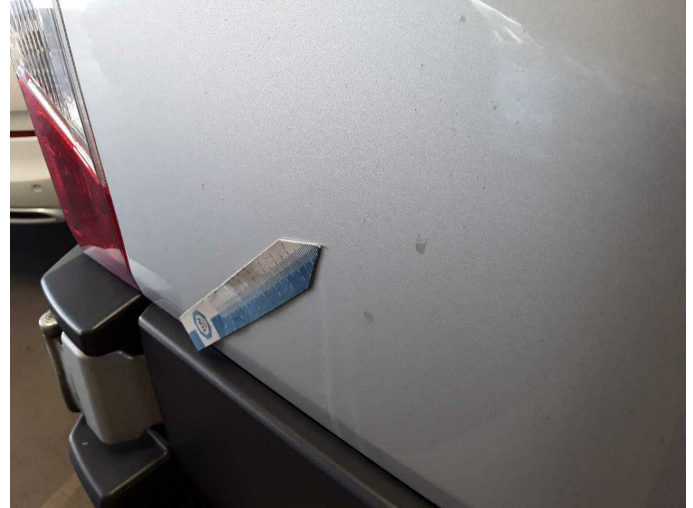
Damage 3: Boot lid / rear door: Rear door - left side - Paint defect - Smart repair

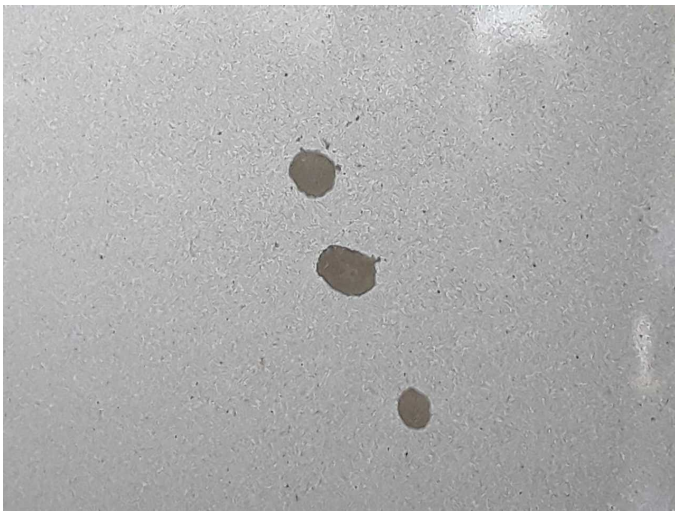
Damage 3: Boot lid / rear door: Rear door - left side - Paint defect - Smart repair

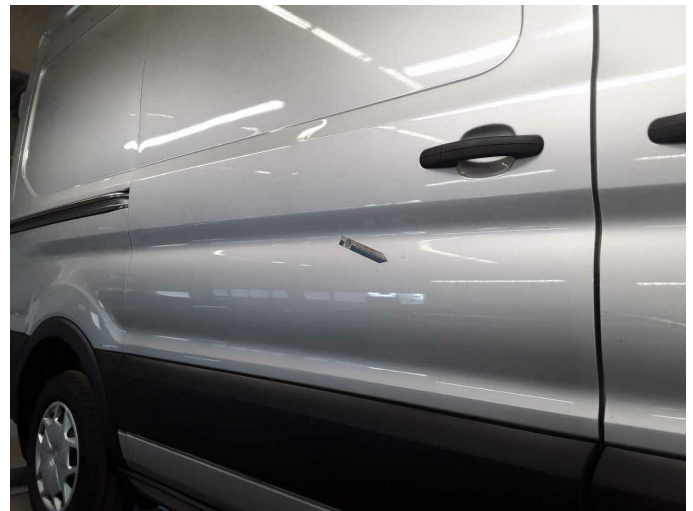
Damage 4: Door - rear right side: Door - Dent / paintcoat damage - Smart repair

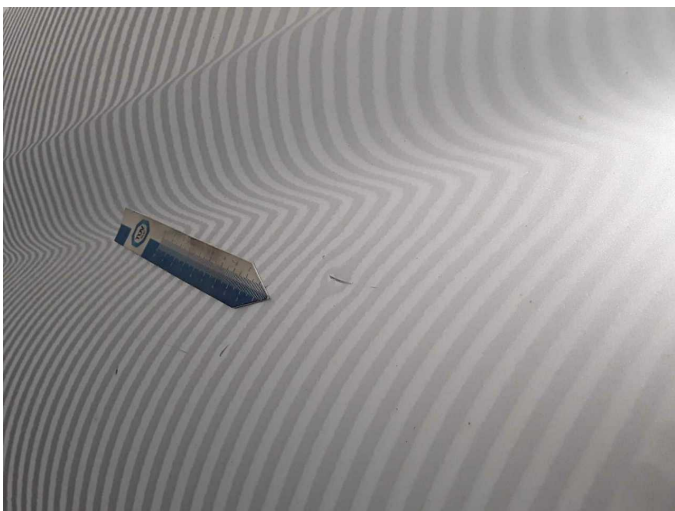
Damage 4: Door - rear right side: Door - Dent / paintcoat damage - Smart repair

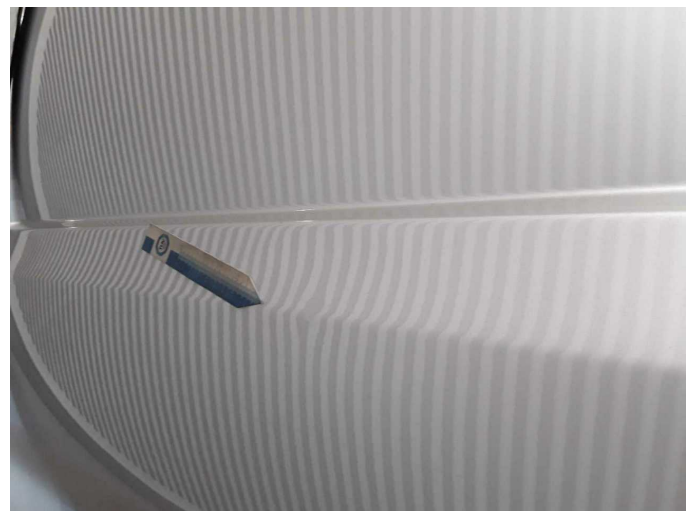
Damage 4: Door - rear right side: Door - Dent / paintcoat damage - Smart repair

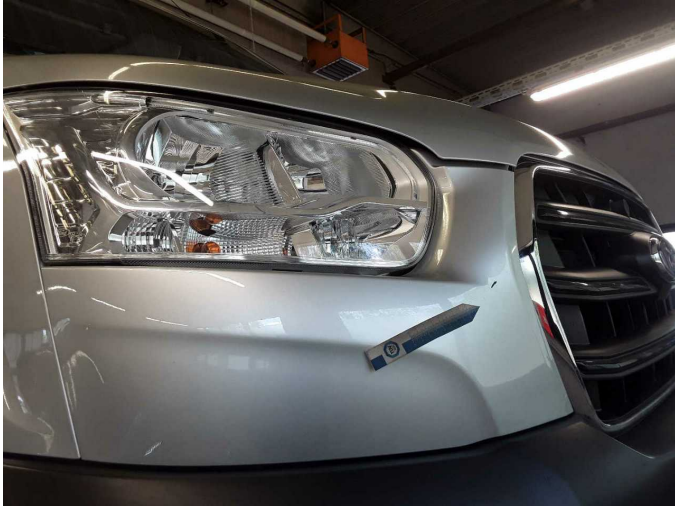
Damage 5: Front bumper: Front bumper - Scratch(es) - Paint

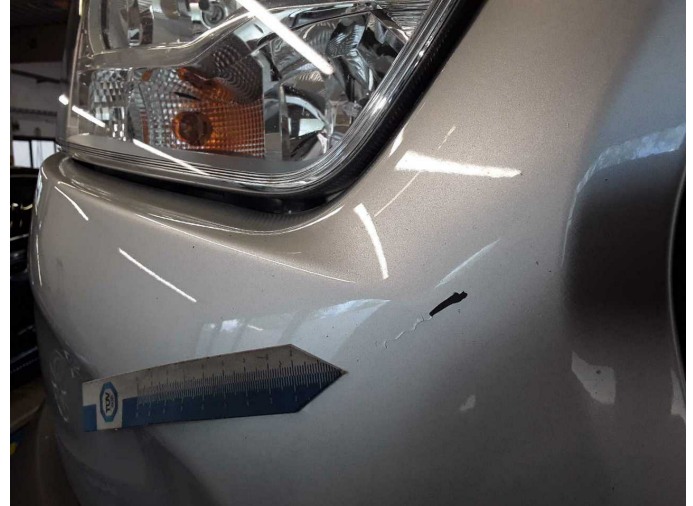
Damage 5: Front bumper: Front bumper - Scratch(es) - Paint

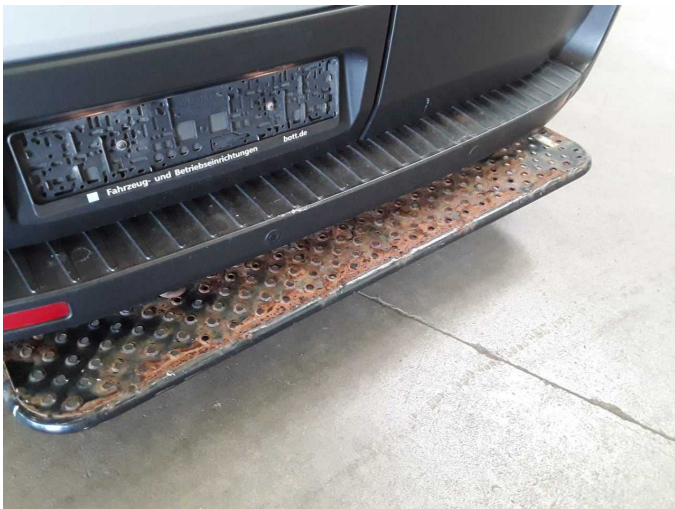
Wear and tear 1: Rear of vehicle: Foot plate - Corrosion - No deduction

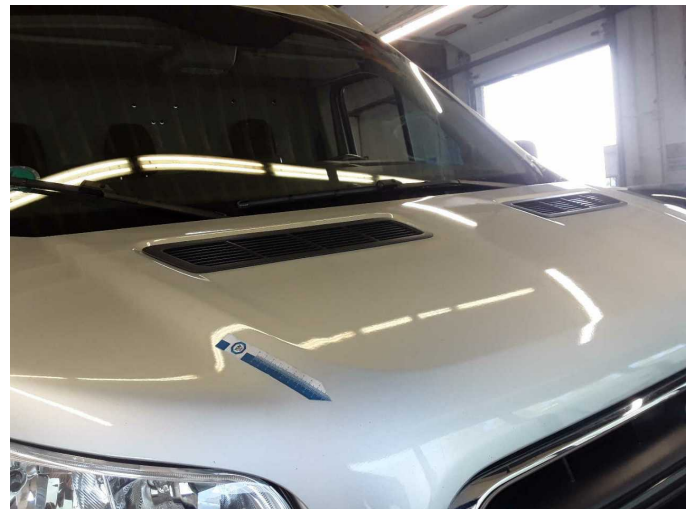
Wear and tear 2: Bonnet: Bonnet - Stone chips - No deduction

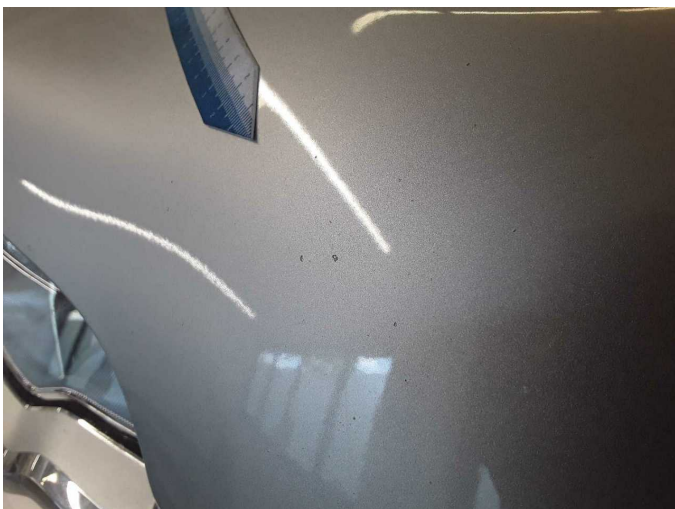
Wear and tear 2: Bonnet: Bonnet - Stone chips - No deduction

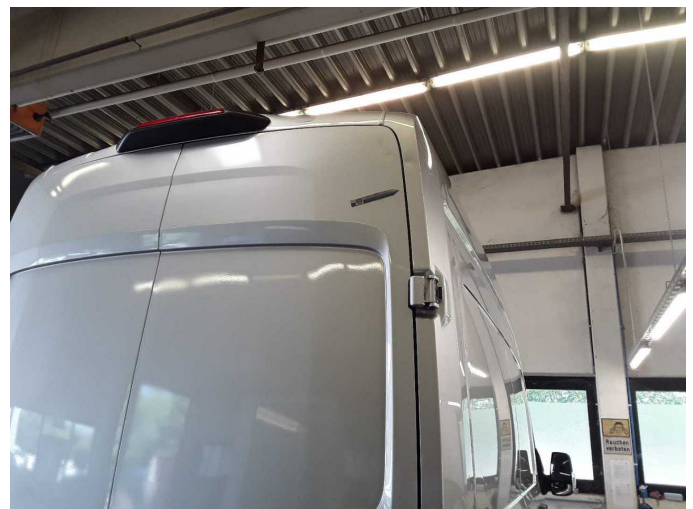
Accident 1: Rear, Side right

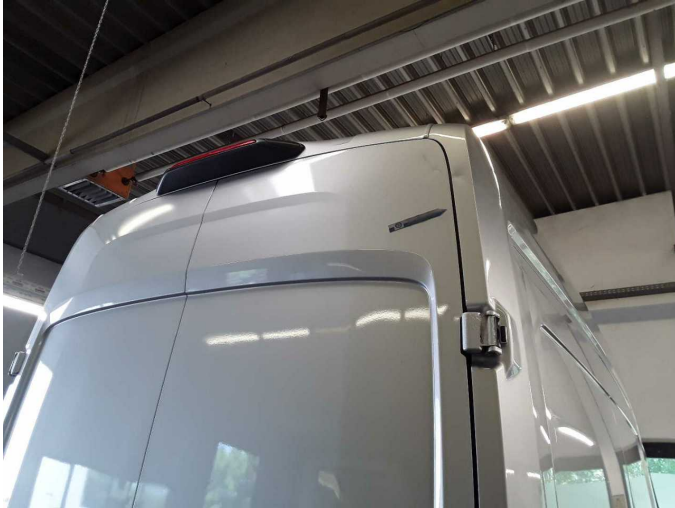
Accident 1: Rear, Side right

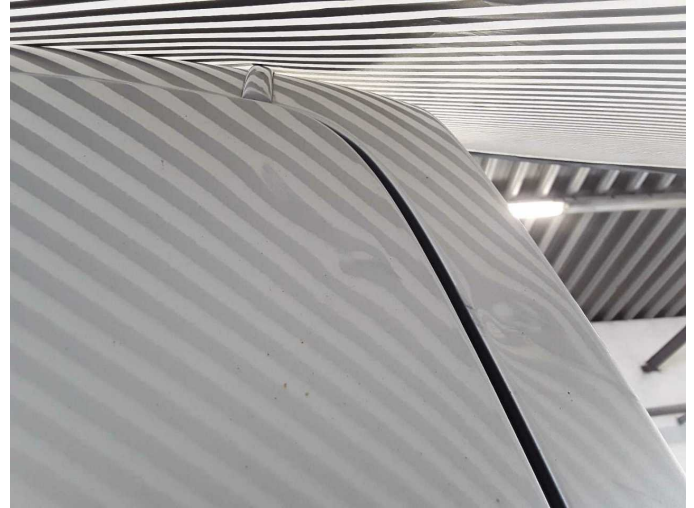
Accident 1: Rear, Side right

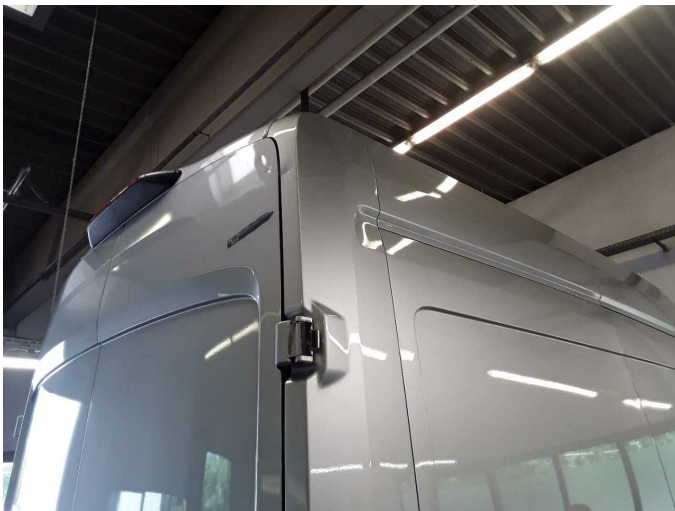
Accident 1: Rear, Side right

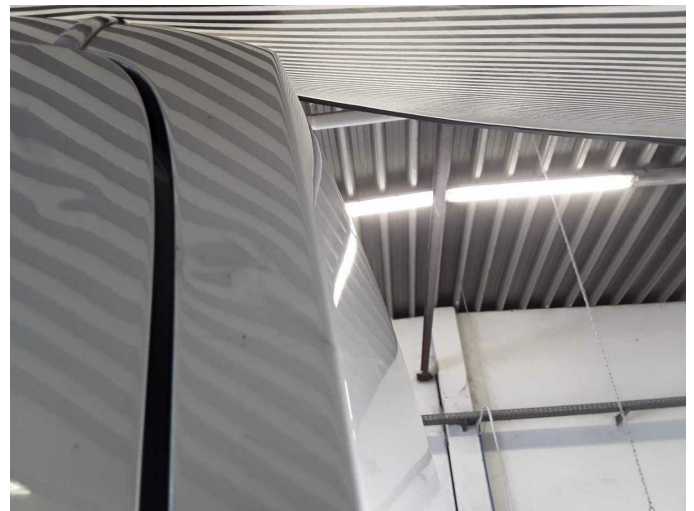
Accident 1: Rear, Side right

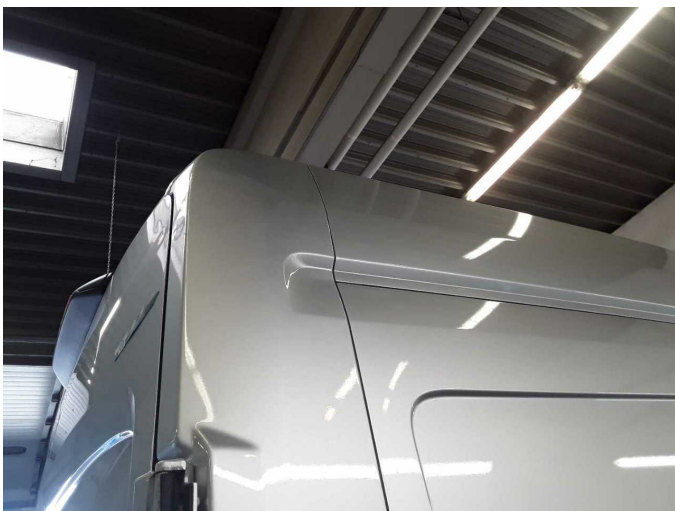
Accident 1: Rear, Side right
