Expertise

Protocol number: 46128473
Order No. / Reference: 26483077
Inspection date: 27 May 2026

Model: Oktavia Combi 2.0 TDI DSG Style

VIN: TMBJJ8NX9PY093683

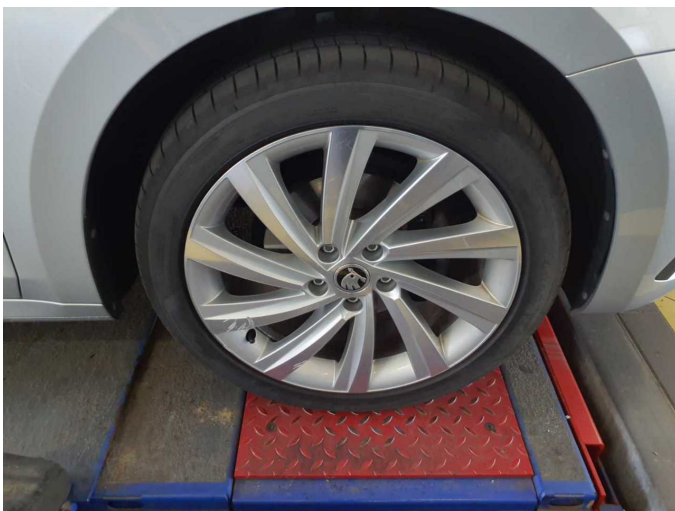
No.	Component group	Description
1	Misc.	Inspection / maintenance - No evidence - No deduction
2	Misc.	Main inspection - No evidence - No deduction
3	Wheel / tyres	Alloy rim - front right side - Scratched - Loss in value

Damage 3: Wheel / tyres: Alloy rim - front right side - Scratched - Loss in value

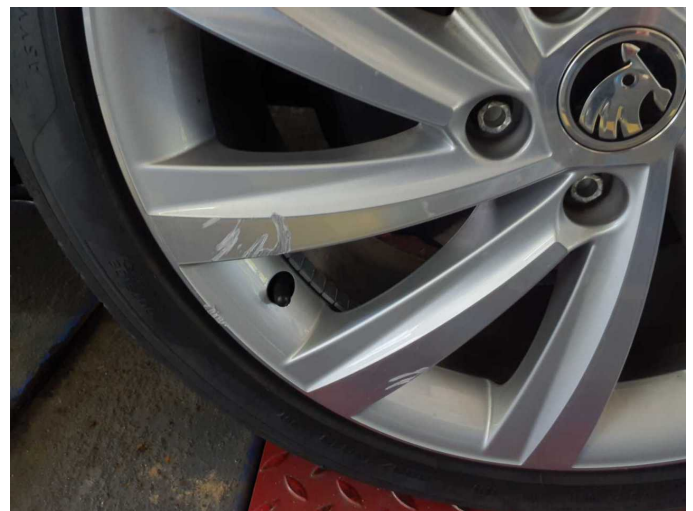
Damage 3: Wheel / tyres: Alloy rim - front right side - Scratched - Loss in value

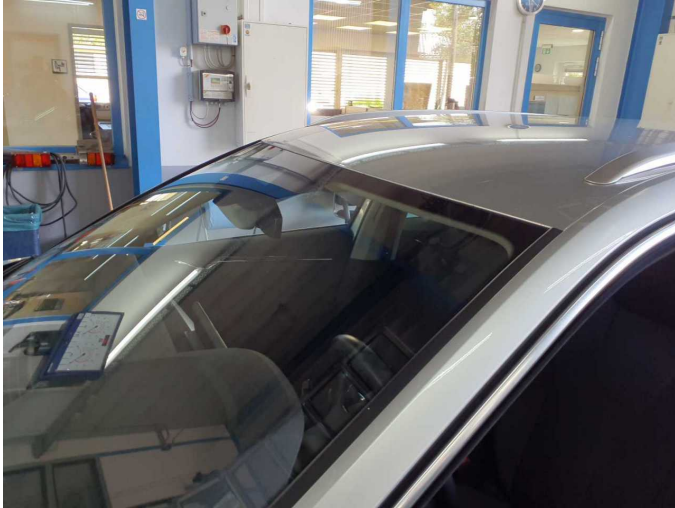
No.	Component group	Description
1	Vehicle glazing	Windscreen - Stone chips - No deduction
2	Bonnet	Bonnet - Stone chips - No deduction
3	Front bumper	Front bumper - Stone chips - No deduction

Wear and tear 1: Vehicle glazing: Windscreen - Stone chips - No deduction

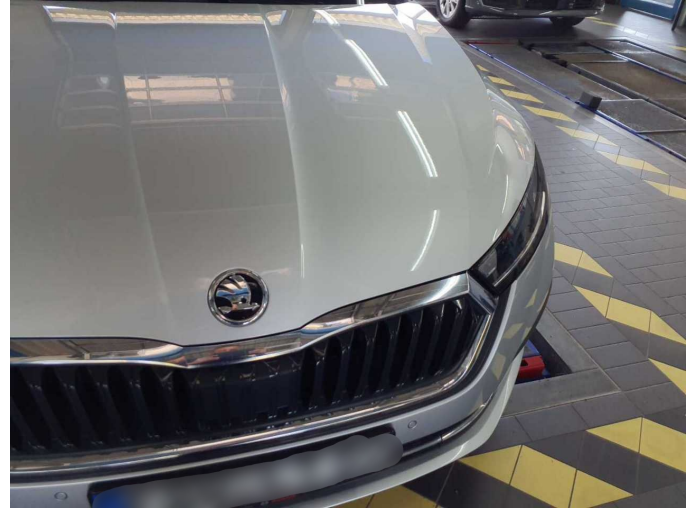
Wear and tear 2: Bonnet: Bonnet - Stone chips - No deduction

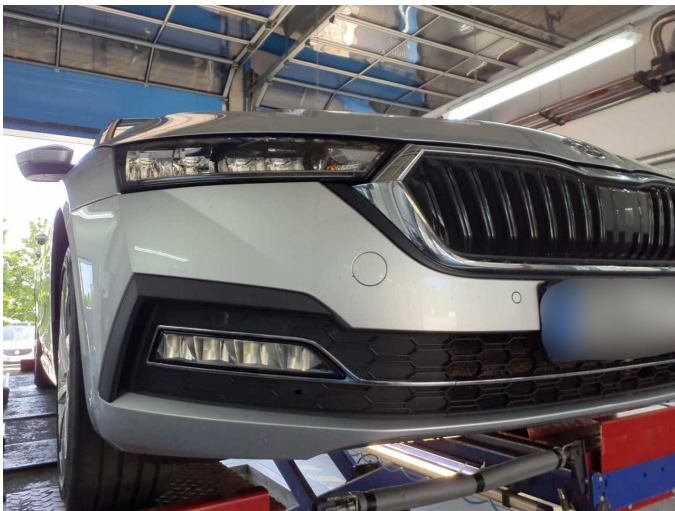
Wear and tear 3: Front bumper: Front bumper - Stone chips - No deduction

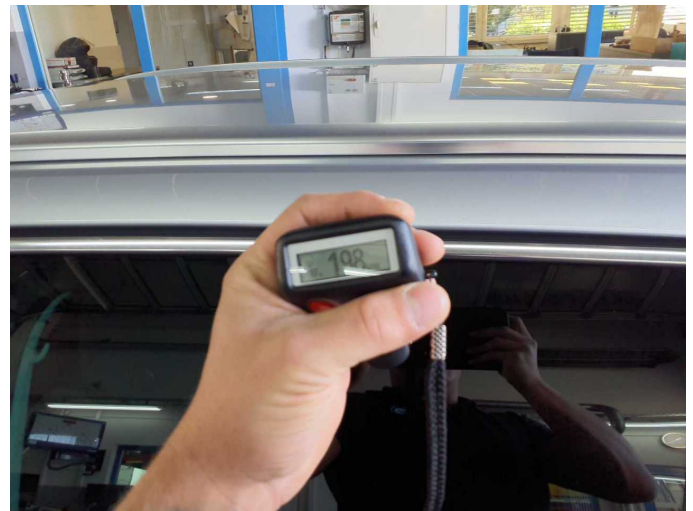
No.	Repainting
1	Roof rail - left side, Side panel - rear left side, Professionally carried out, Invoice of repair done Non-existent

Roof rail - left side: 198 μm

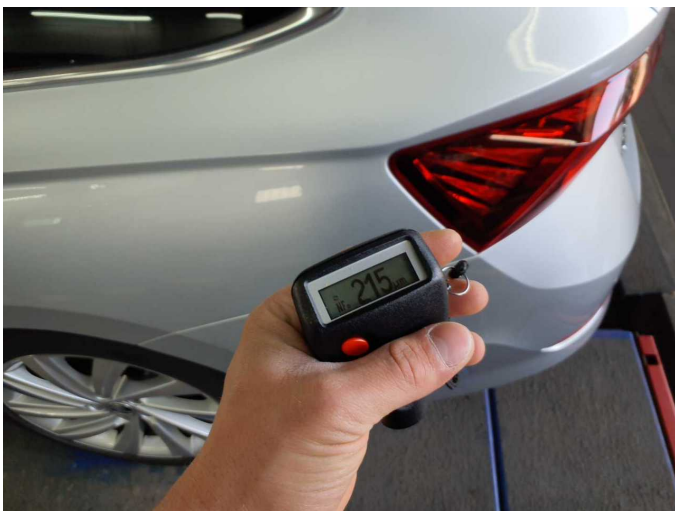
No.	Previous damage	Extent of damage (Net)
1	Side - left, Professionally repaired, Invoice of repair done Non-existent

Side panel - rear left side: 215 μm
