Expertise

Protocol number: 46296210  
Order No. / Reference: 26655890  
Inspection date: 2 Jul 2026

Manufacturer: Ford

Model: Transit Custom 280 L1H1 LKW VA Trend

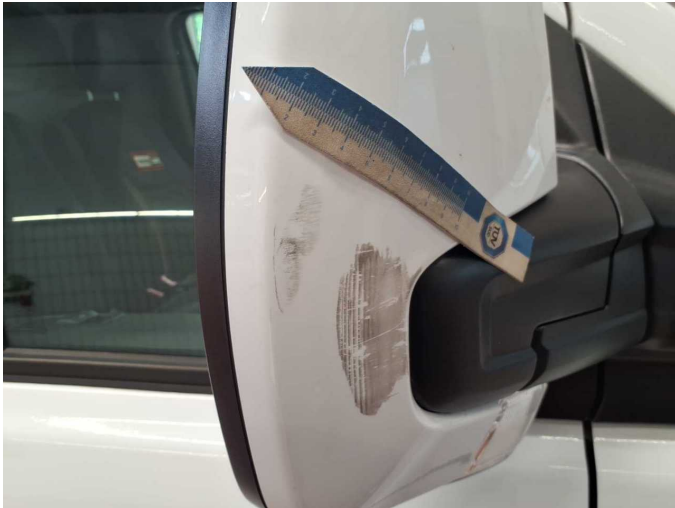
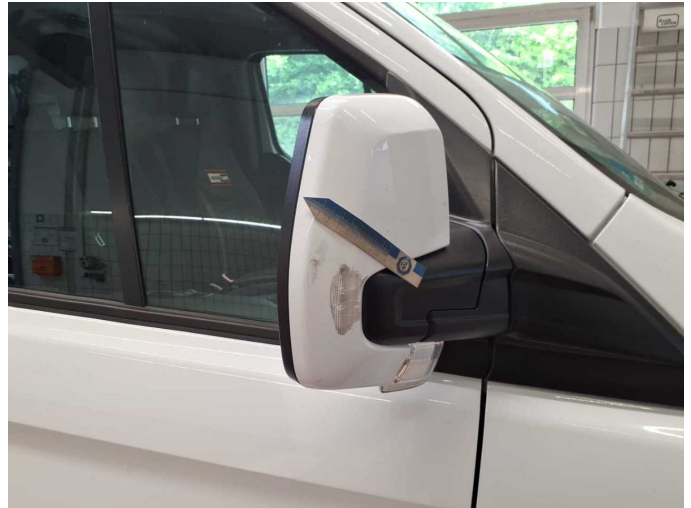
| No. | Component group | Description |
|---|---|---|
| 1 | Wing mirror - right side | Cap - Scratch(es) - Smart repair |

**Damage 1:** Wing mirror - right side: Cap - Scratch(es) - Smart repair

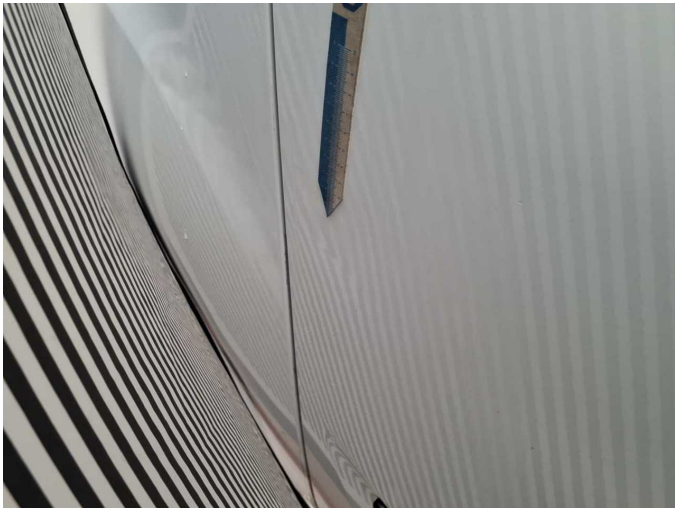
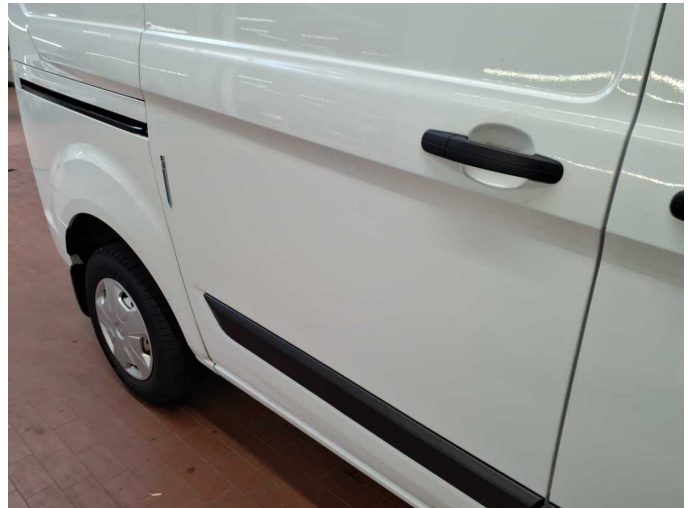
| No. | Component group | Description |
|---|---|---|
| 2 | Sliding door, right | Sliding door - dent(s) - Smooth repair work |

**Damage 2:** Sliding door, right: Sliding door - dent(s) - Smooth repair work

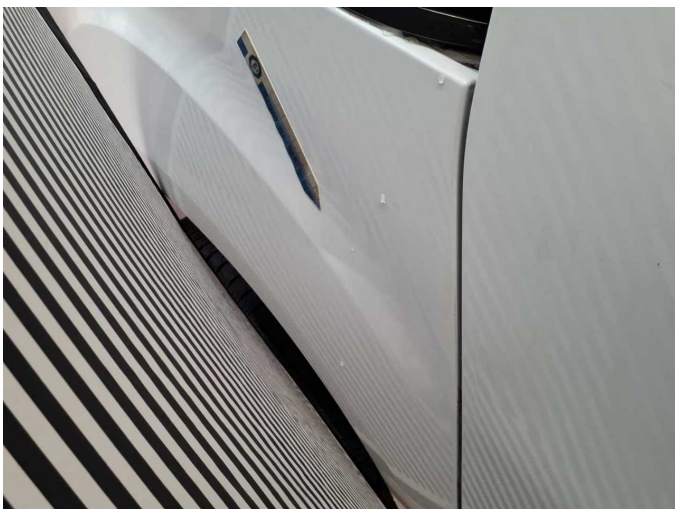
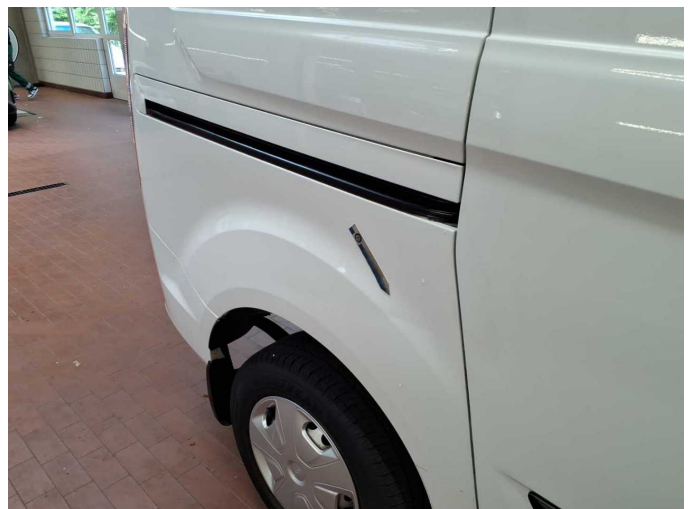
| No. | Component group | Description |
|---|---|---|
| 3 | Side panel - rear right side | Side panel - dent(s) - Smooth repair work |

**Damage 3:** Side panel - rear right side: Side panel - dent(s) - Smooth repair work

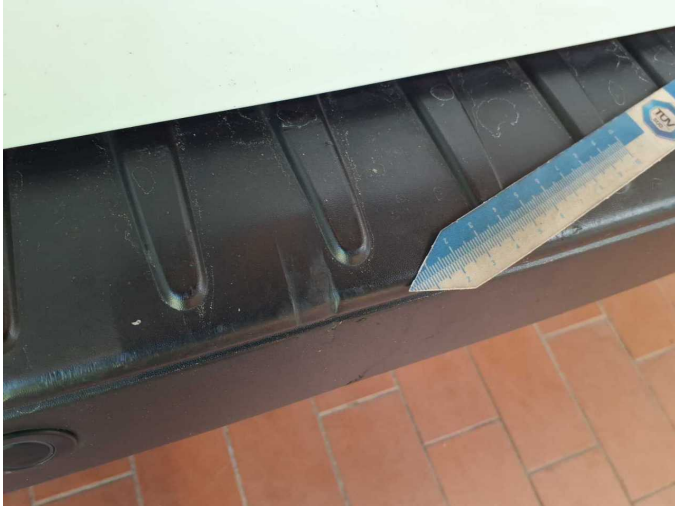
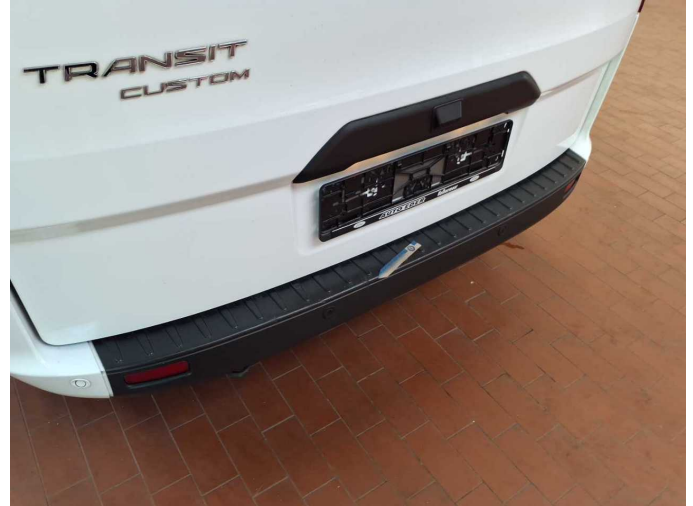
| No. | Component group | Description |
|---|---|---|
| 4 | Rear bumper | Rear bumper - Deformed - Loss in value |

**Damage 4:** Rear bumper: Rear bumper - Deformed - Loss in value

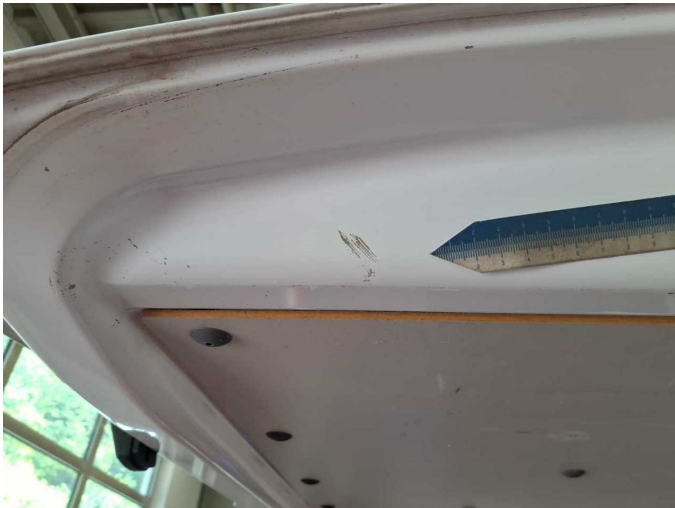
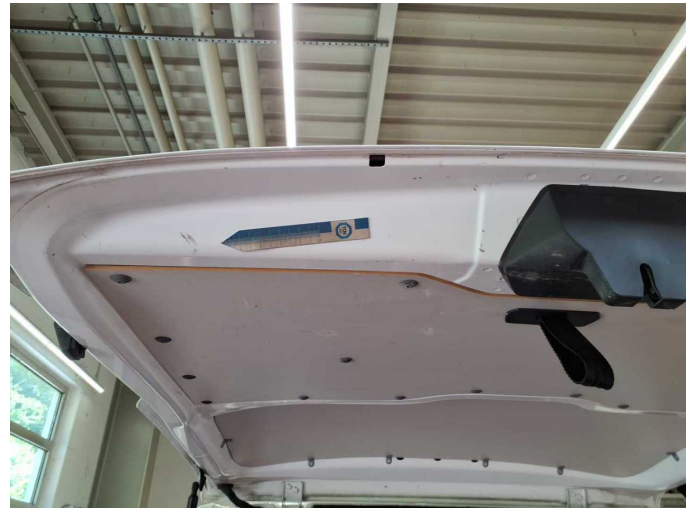
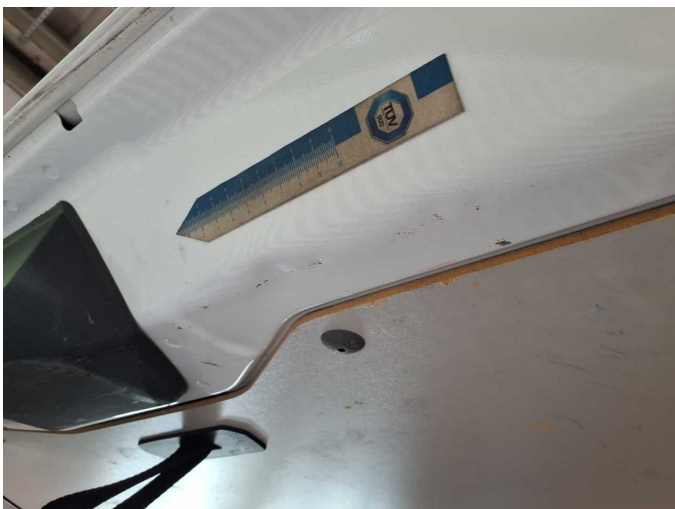
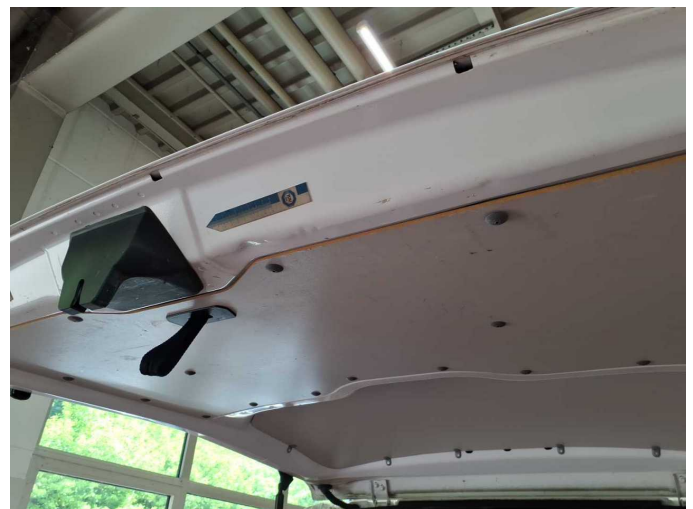
| No. | Component group | Description |
|---|---|---|
| 1 | Boot lid / rear door | Boot lid - Dent / paintcoat damage - No deduction |

**Wear and tear 1:** Boot lid / rear door: Boot lid - Dent / paintcoat damage - No deduction

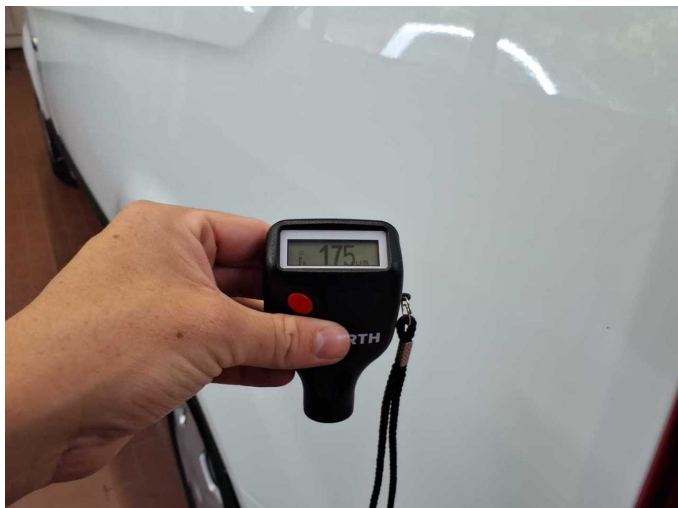
**Repainting 1:** Side panel - rear left side

| 1 | Side panel - rear left side, Professionally carried out, Invoice of repair done Non-existent |

Side panel - rear left side

175 µm

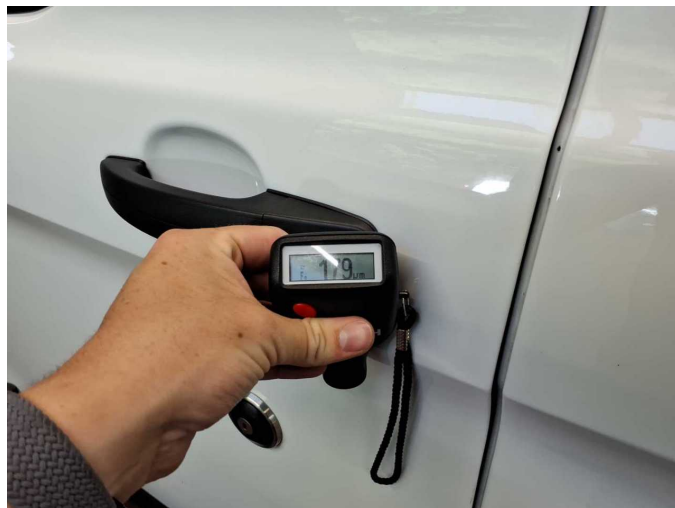
**Repainting 2:** Door - front left side

| 2 | Door - front left side, Professionally carried out, Invoice of repair done Available |

Door - front left side

179 µm
