Expertise

Protocol number: 45773040
Order No. / Reference: 26433653
Inspection date: 3 Jun 2026

Manufacturer: Ford

Model: Focus Turnier 2.0 EcoBlue Start-Stopp-System Aut.
COOL&CONNECT

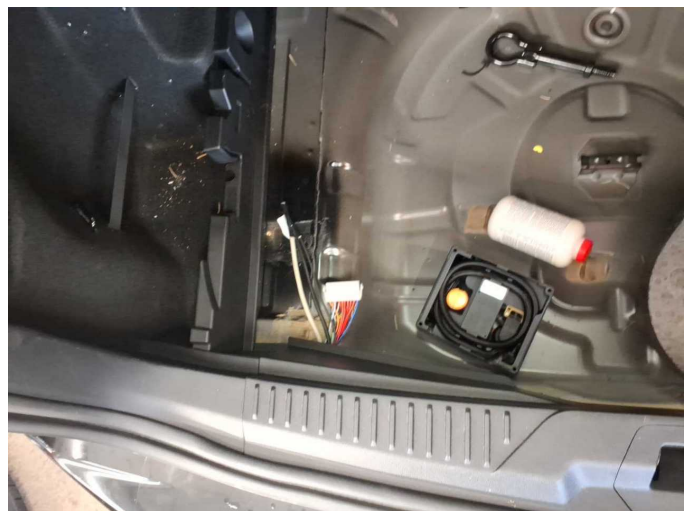
Damage 2: Electrical system: Cable strand (Rückkrüsten) - Specify findings - Remove

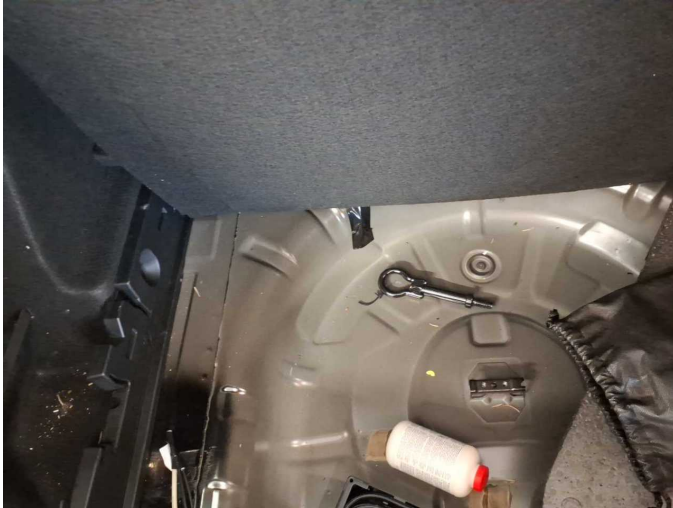
Damage 2: Electrical system: Cable strand (Rückkrüsten) - Specify findings - Remove

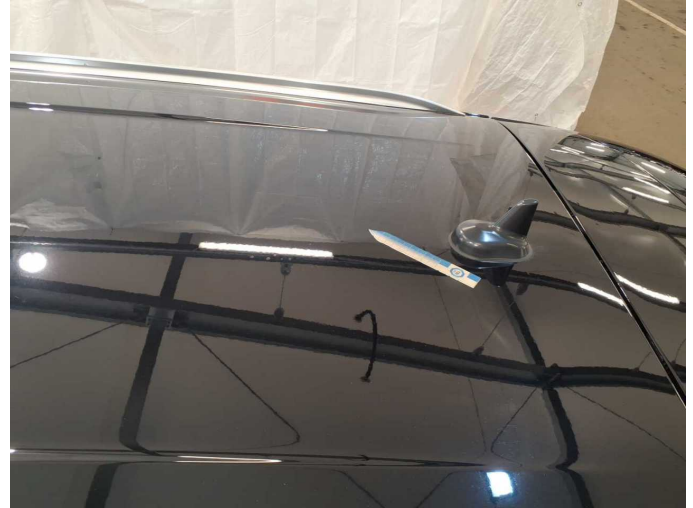
Damage 3: Roof: Roof - dent(s) - Smooth repair work

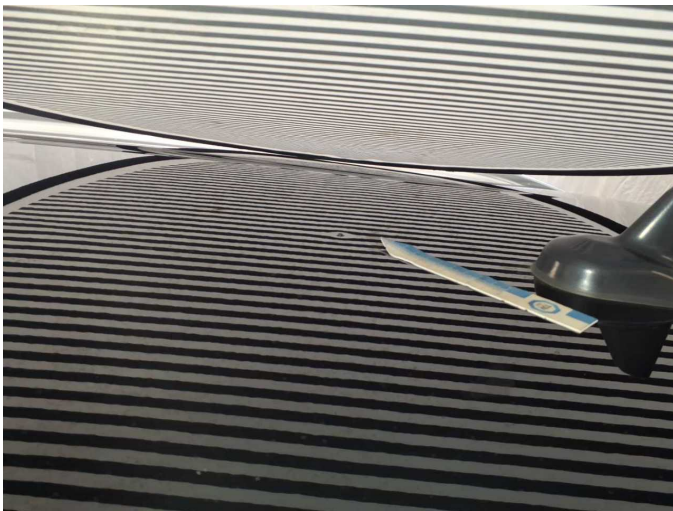
Damage 3: Roof: Roof - dent(s) - Smooth repair work

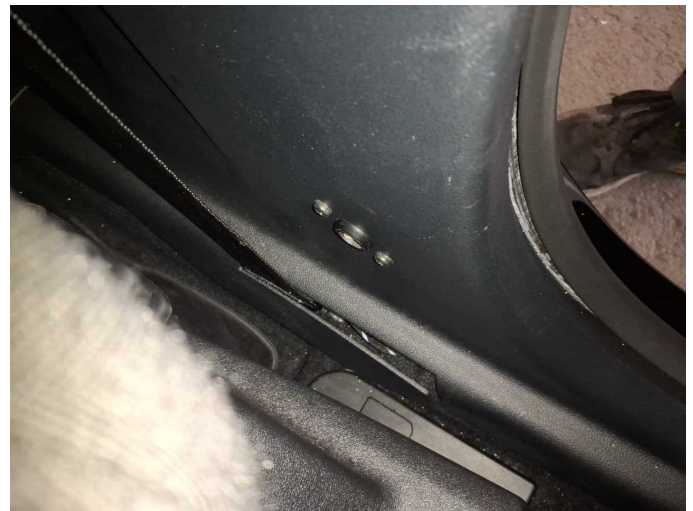
Damage 4: Trim / covers: B-pillar - trim - interior, left side - Damaged - Replace

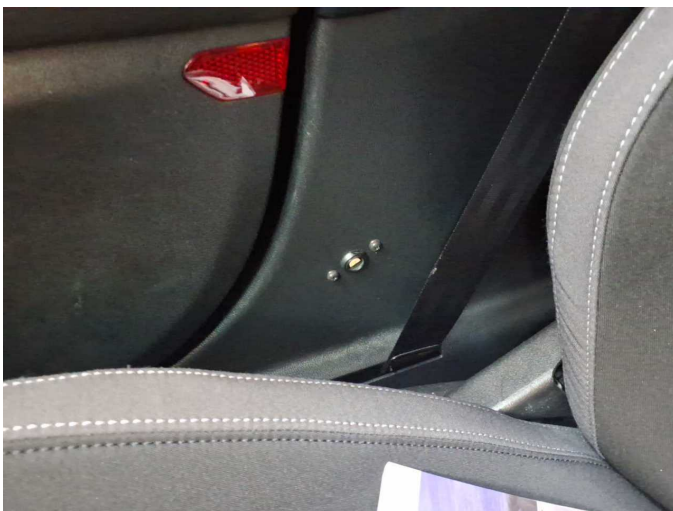
Damage 5: Trim / covers: B-pillar - trim - interior, right side - Damaged - Replace

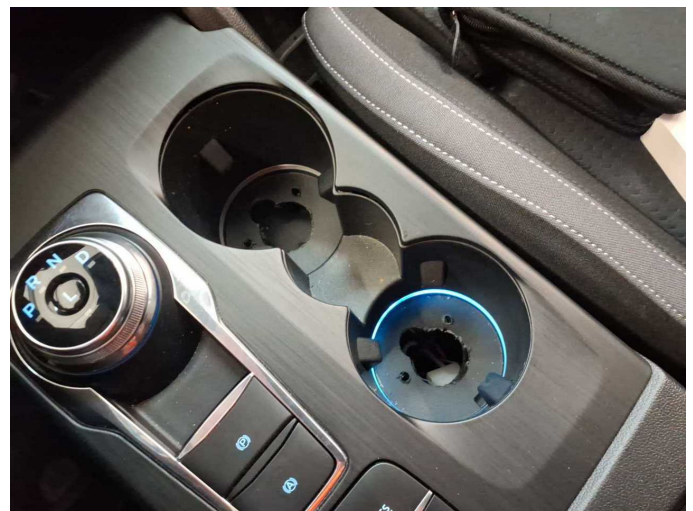
Damage 6: Instrument panel: Centre console - front - Damaged - Replace

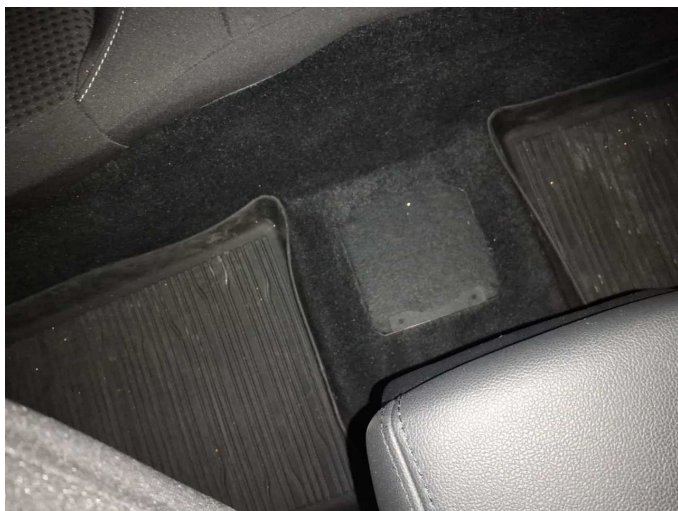
Damage 7: Trim / covers: Carpet - Damaged - Replace

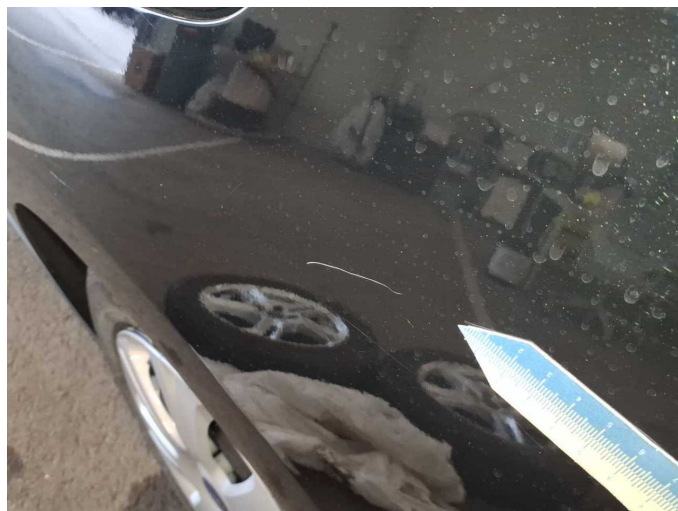
Damage 8: Side panel - rear left side: Side panel - Scratch(es) - Paint

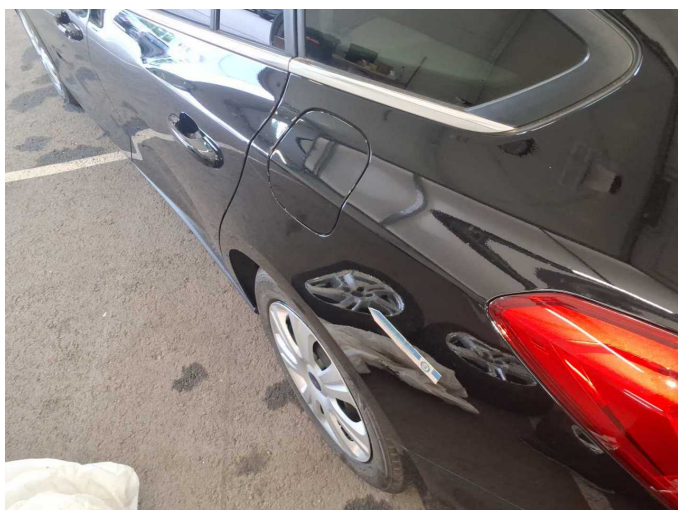
Damage 8: Side panel - rear left side: Side panel - Scratch(es) - Paint

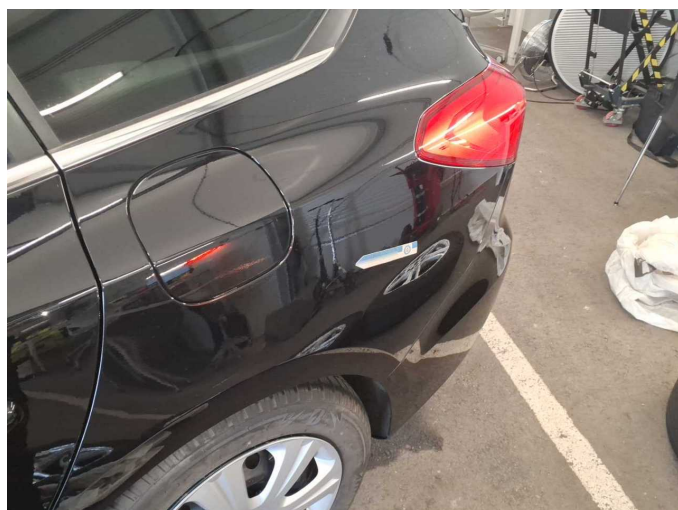
Damage 8: Side panel - rear left side: Side panel - Scratch(es) - Paint
