## Expertise

Protocol number: 46076527  
Order No. / Reference: 26474739  
Inspection date: 19 Jun 2026

Manufacturer: Mazda

Model: 2 SKYACTIV G 90 M HYBRID Homura

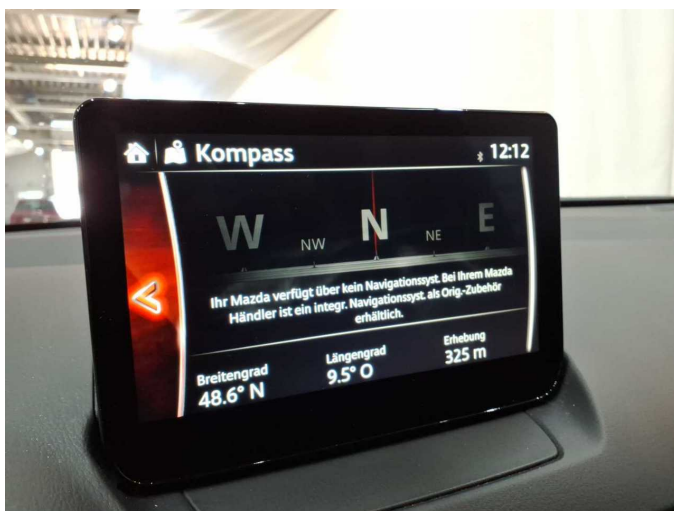
Figure 17: Navigation

No.	Component group	Description
1	Multimedia system	Navigation system (SD Karte) - Missing - No deduction
2	Bonnet	Bonnet - Stone chips - No deduction
3	Body	Body - Scratch(es) - No deduction

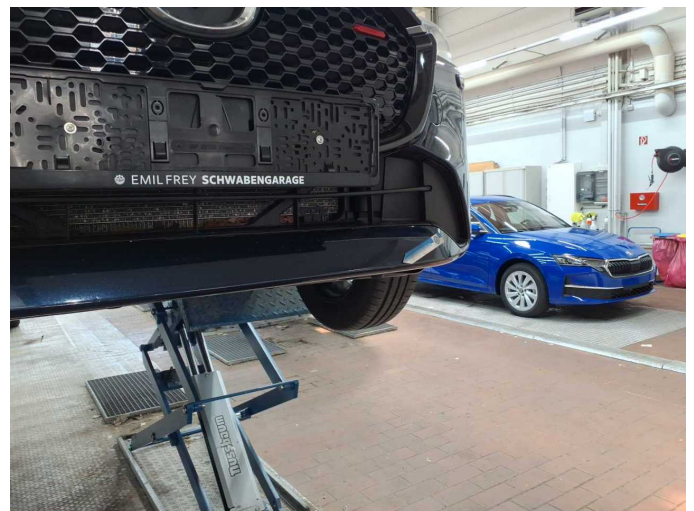
No.	Component group	Description
1	Front bumper	Front bumper - dent(s) - Loss in value
2	Bonnet	Insulation lining - Damage caused by marten / rodent - Replace

Damage 1: Front bumper: Front bumper - dent(s) - Loss in value

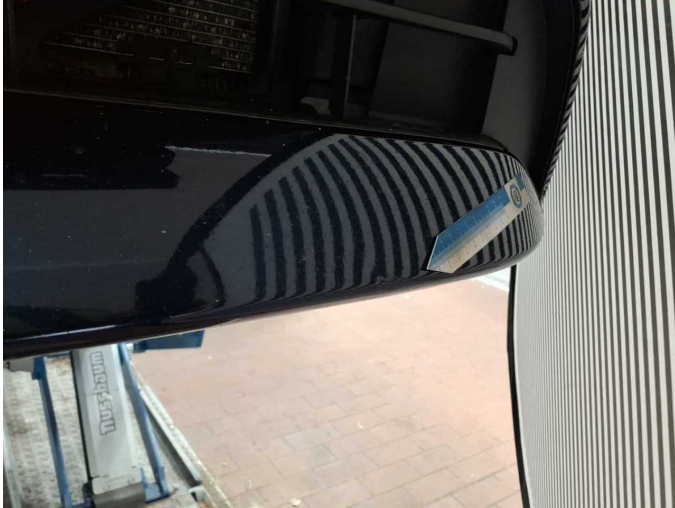
**Damage 1:** Front bumper: Front bumper - dent(s) - Loss in value

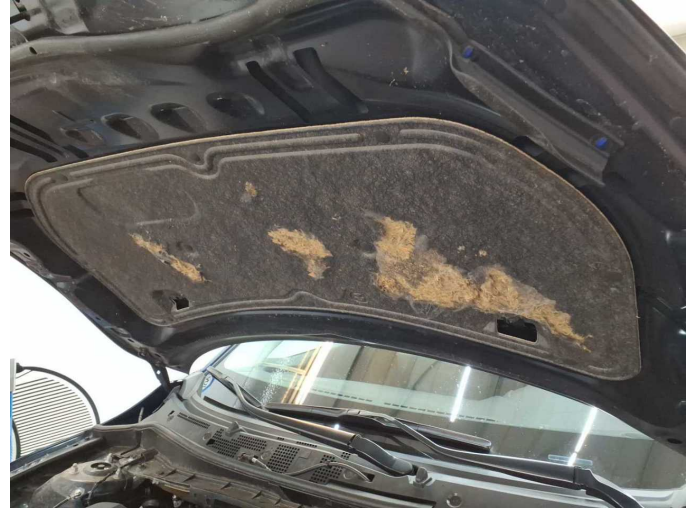
**Damage 2:** Bonnet: Insulation lining - Damage caused by marten / rodent  
- Replace
