Expertise

Protocol number: 46448405  
Order No. / Reference: 26479692  
Inspection date: 7 Jul 2026

Manufacturer: Mercedes-Benz  
VIN: W1V3KBFZ7TP862046

Model: 317 CDI Sprinter Standard HA 9G-TRONIC PRO Kasten

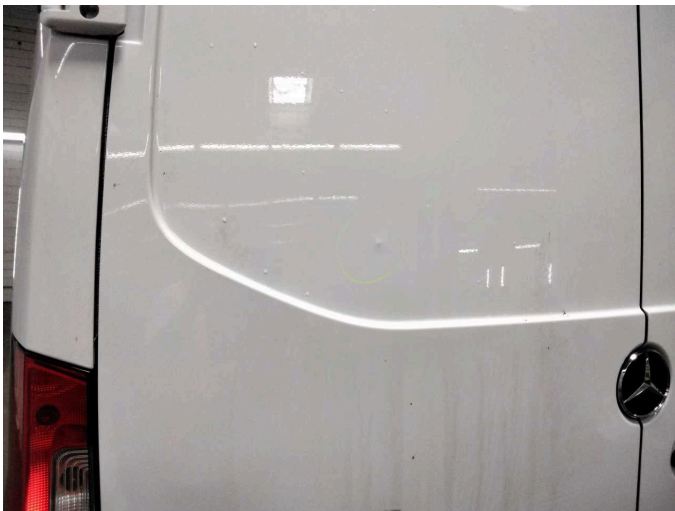
| No. | Component group | Description |
|---|---|---|
| 1 | Boot lid / rear door | Rear door - left side - dent(s) - Smooth repair work |

**Damage 1:** Boot lid / rear door: Rear door - left side - dent(s) - Smooth repair work

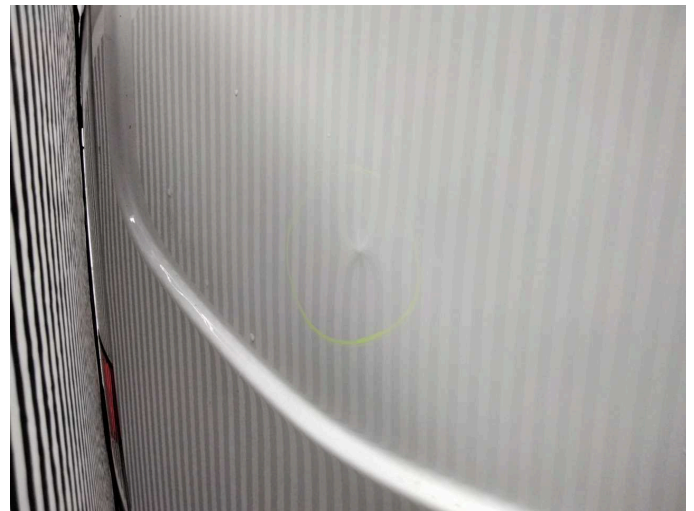
**Damage 1:** Boot lid / rear door: Rear door - left side - dent(s) - Smooth repair work

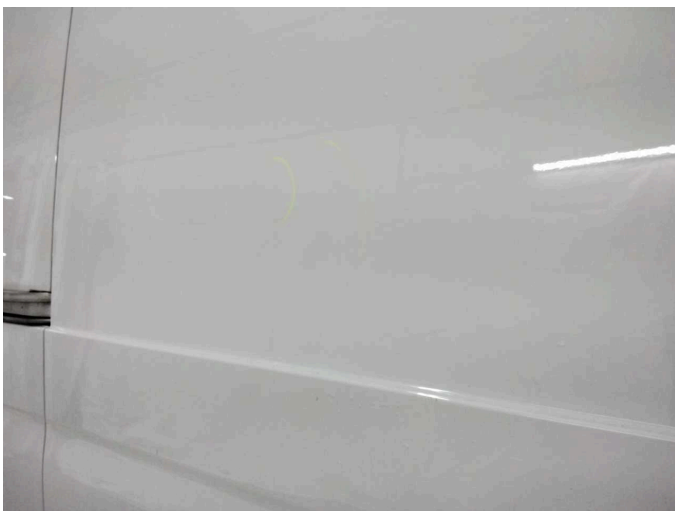
| No. | Component group | Description |
|---|---|---|
| 2 | Sliding door, right | Sliding door - dent(s) - Smooth repair work |

**Damage 2:** Sliding door, right: Sliding door - dent(s) - Smooth repair work

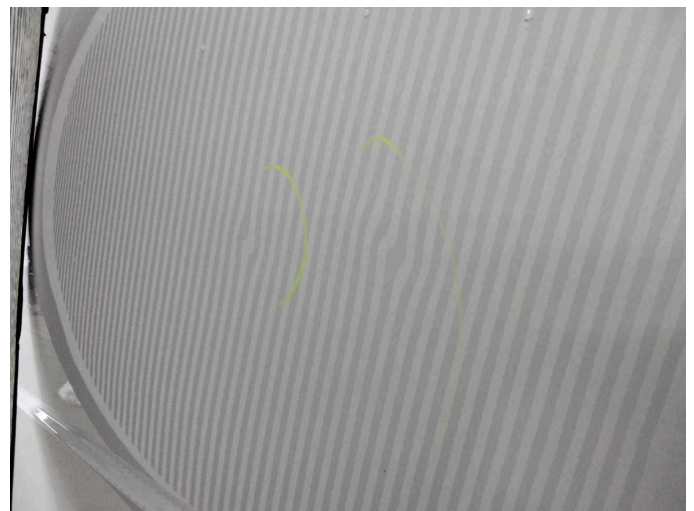
**Damage 2:** Sliding door, right: Sliding door - dent(s) - Smooth repair work

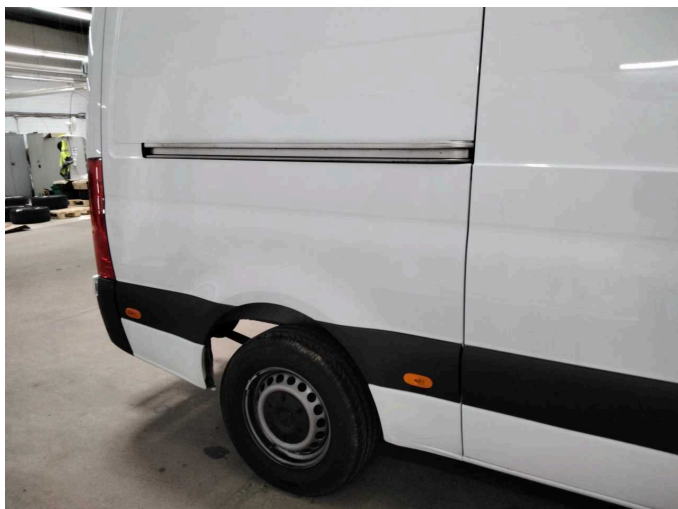
| No. | Component group | Description |
|---|---|---|
| 3 | Side panel - rear right side | Side panel - Dent / paintcoat damage - Repair and paint |

**Damage 3:** Side panel - rear right side: Side panel - Dent / paintcoat damage - Repair and paint

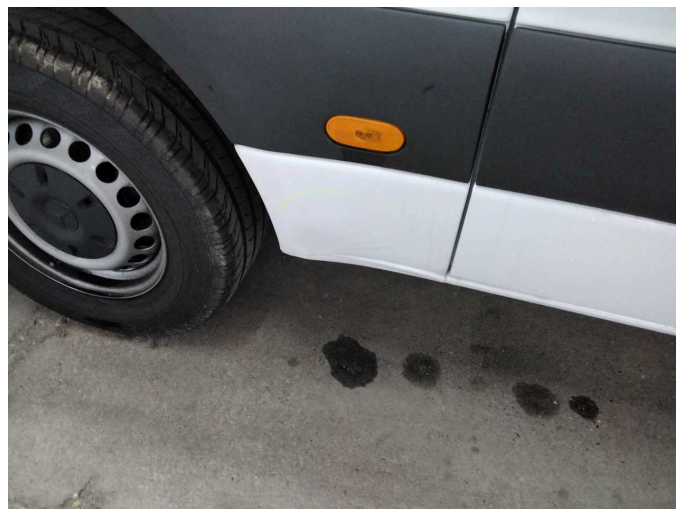
**Damage 3:** Side panel - rear right side: Side panel - Dent / paintcoat damage - Repair and paint

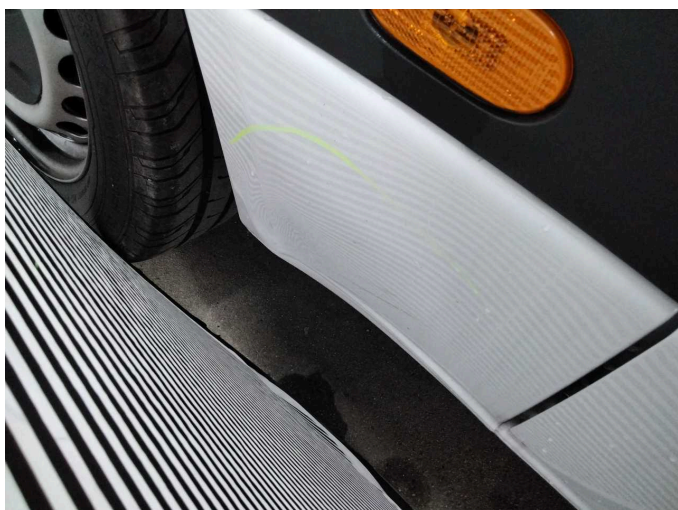
**Damage 3:** Side panel - rear right side: Side panel - Dent / paintcoat damage - Repair and paint

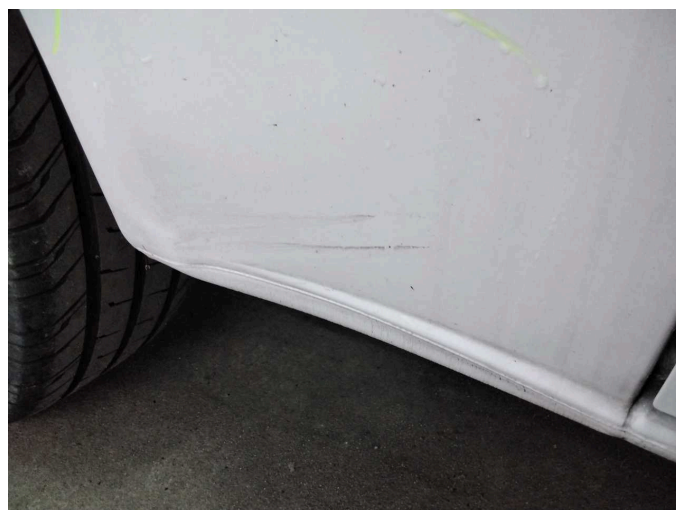
**Damage 3:** Side panel - rear right side: Side panel - Dent / paintcoat damage - Repair and paint

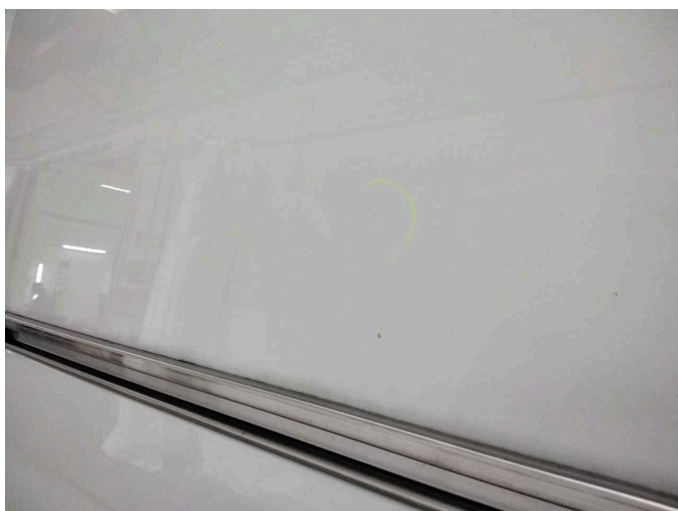
**Damage 3:** Side panel - rear right side: Side panel - Dent / paintcoat damage - Repair and paint

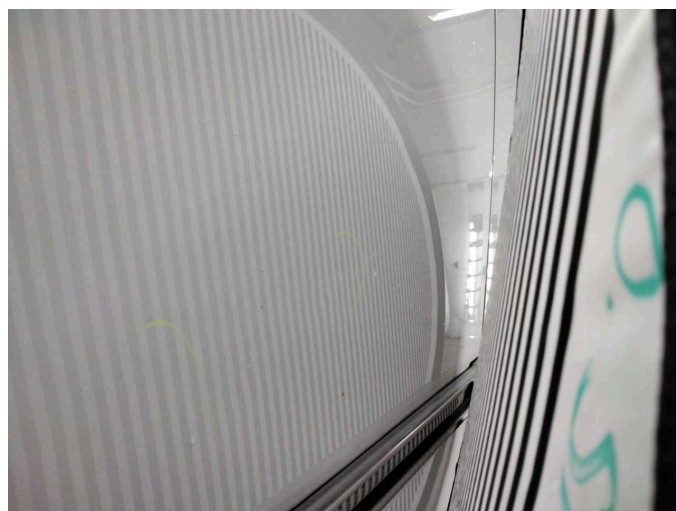
**Damage 3:** Side panel - rear right side: Side panel - Dent / paintcoat damage - Repair and paint

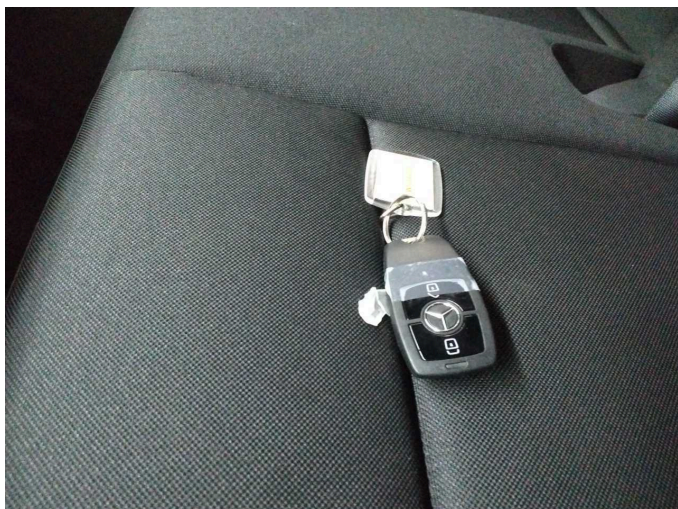
Equipment - Vehicle key

**Missing part 1:** Equipment: Vehicle key - Missing - Replace
