## Expertise

Protocol number: 45948116  
Order No. / Reference: 26360219  
Inspection date: 10 Jun 2026

Model: Focus Turnier 1.5 EcoBlue Start-Stopp-System Aut. TITANIUM

VIN: WF0PXXGCHPNY34710

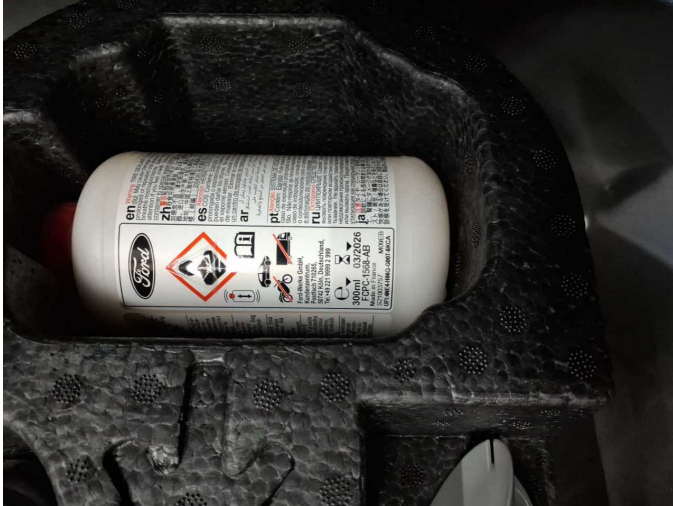
**Damage 2:** Equipment: Tirefit filler - Expired - Replace

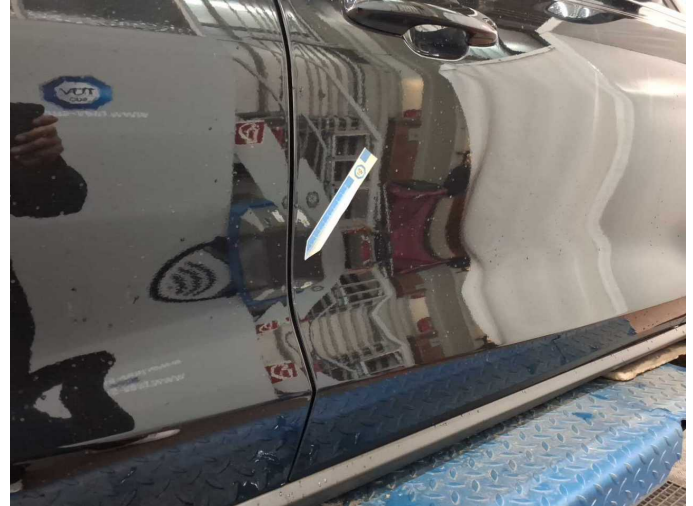
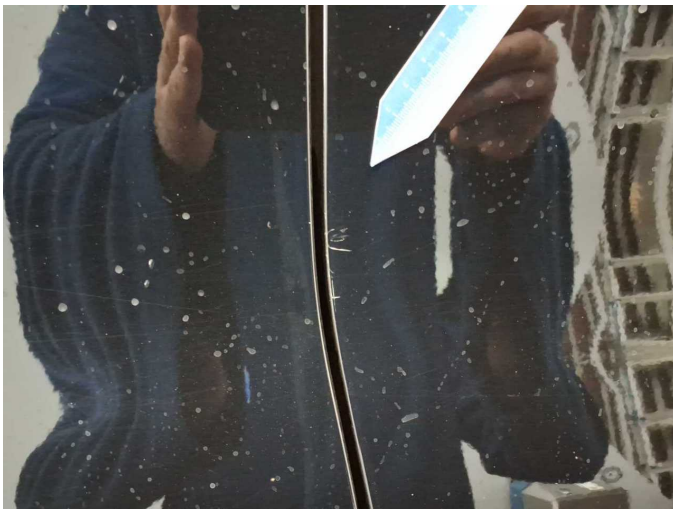
**Damage 3:** Door - front right side: Door - Scratch(es) - Smart repair

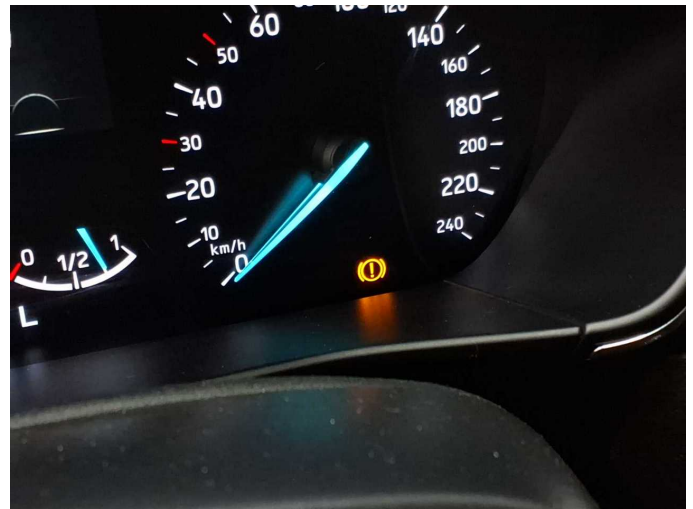
**Damage 4:** Instrument panel: Indicator light (Bremsanlage) - on - Perform diagnosis

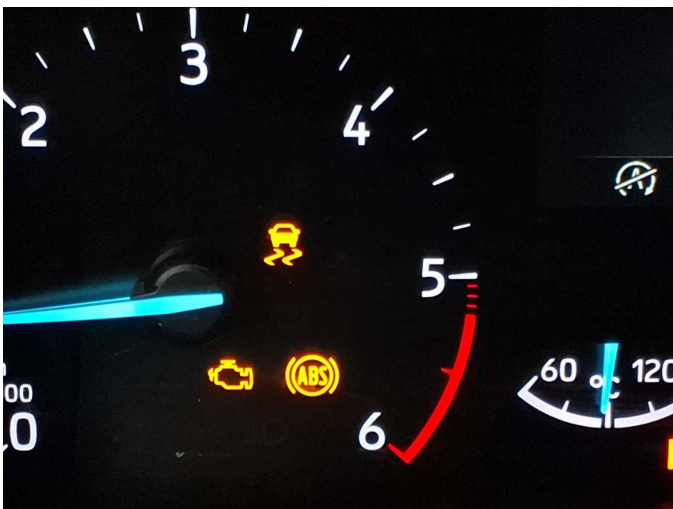
**Damage 5:** Instrument panel: Indicator light (Abs) - on - Perform diagnosis

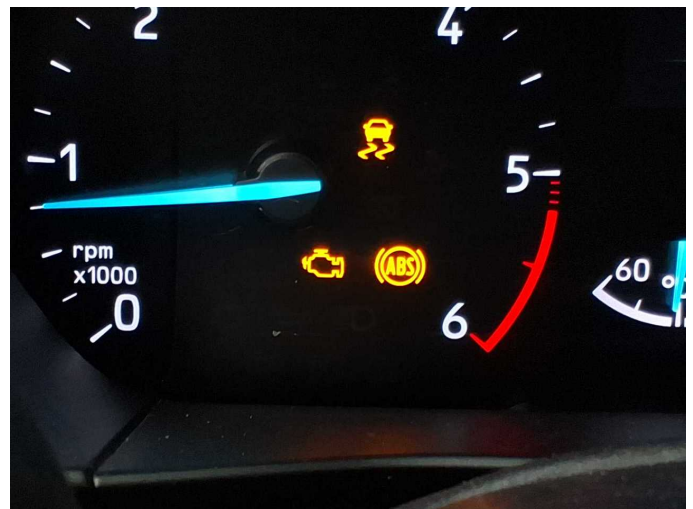
**Damage 6:** Instrument panel: Indicator light (Motorkontrollleuchte) - on - Perform diagnosis
