Expertise

Protocol number: 46707843  
Order No. / Reference: 26795076  
Inspection date: 24 Jul 2026

Model: Transit 350 L4H3 Lkw HA Trend

VIN: WF0EXXTTREMUM21977

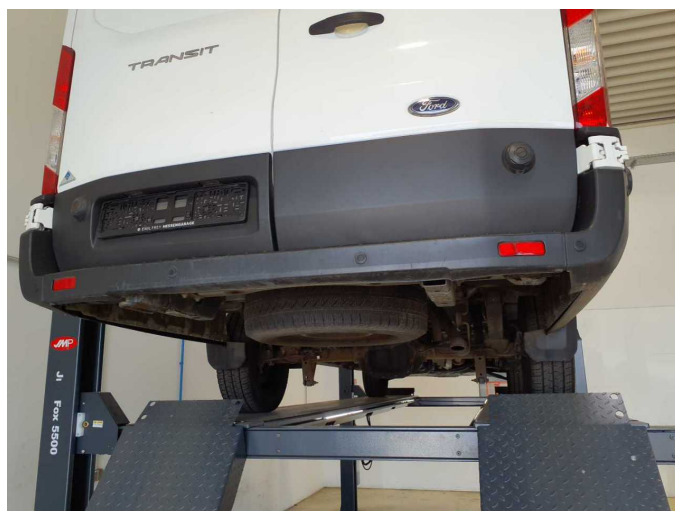
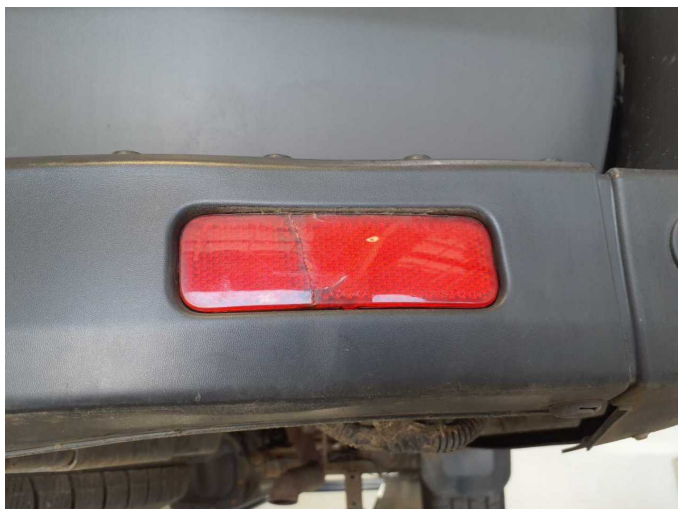
| No. | Component group | Description |
|---|---|---|
| 1 | Rear bumper | Reflector - right side - Broken / torn - Replace |

Damage 1: Rear bumper: Reflector - right side - Broken / torn - Replace

**Damage 1:** Rear bumper: Reflector - right side - Broken / torn - Replace

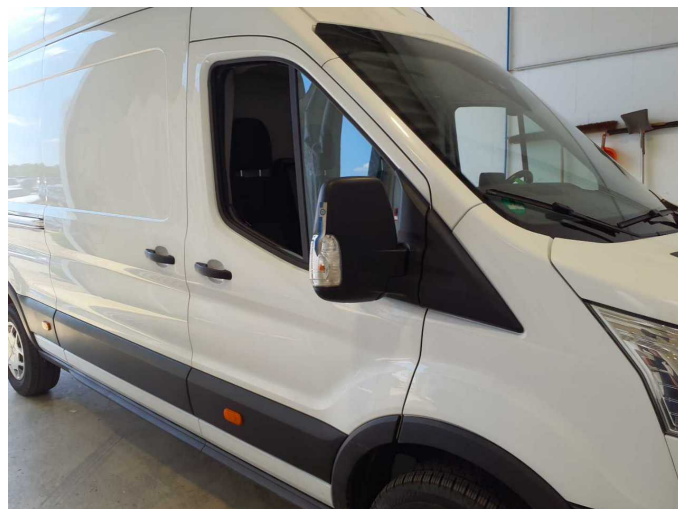
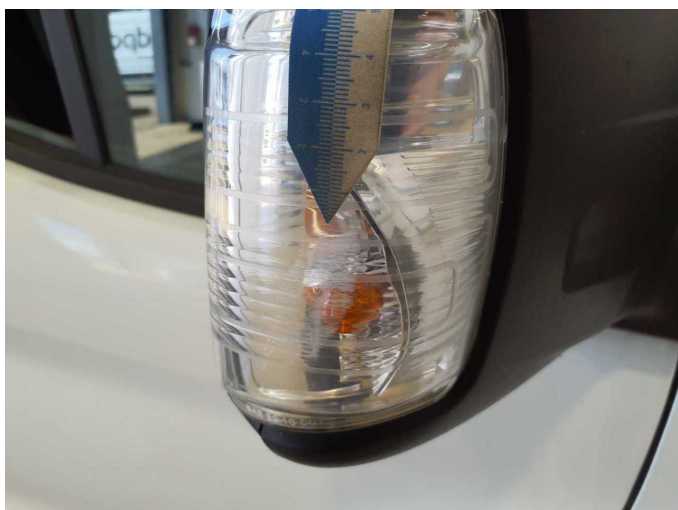
| No. | Component group | Description |
|---|---|---|
| 2 | Indicator - front | Mirror - right side - Scratch(es) - Replace |

**Damage 2:** Indicator - front: Mirror - right side - Scratch(es) - Replace

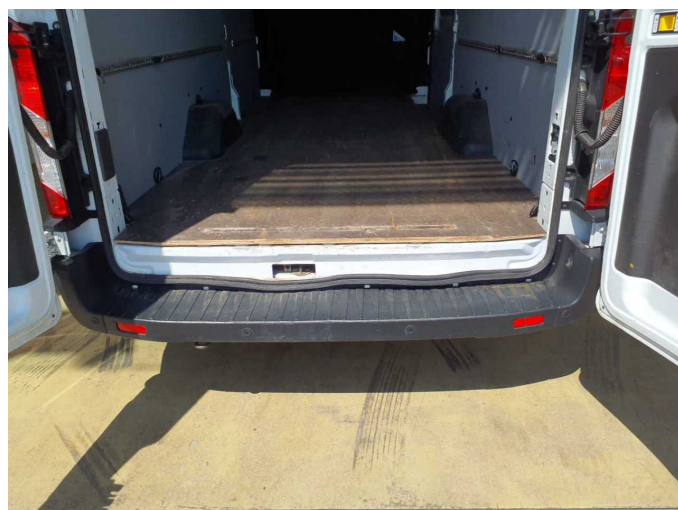
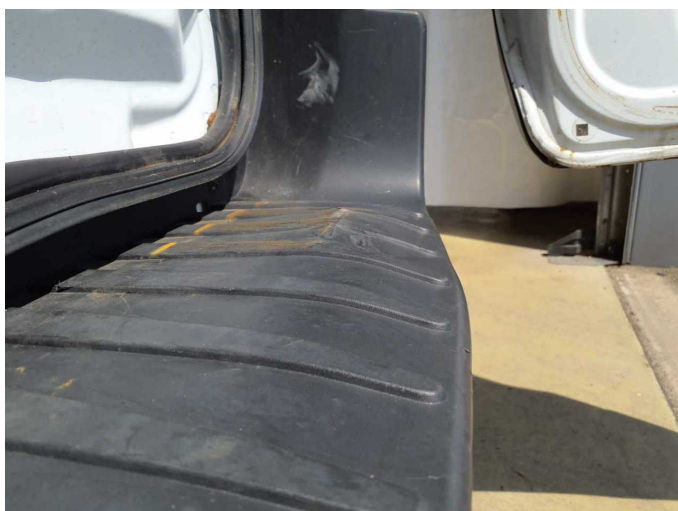
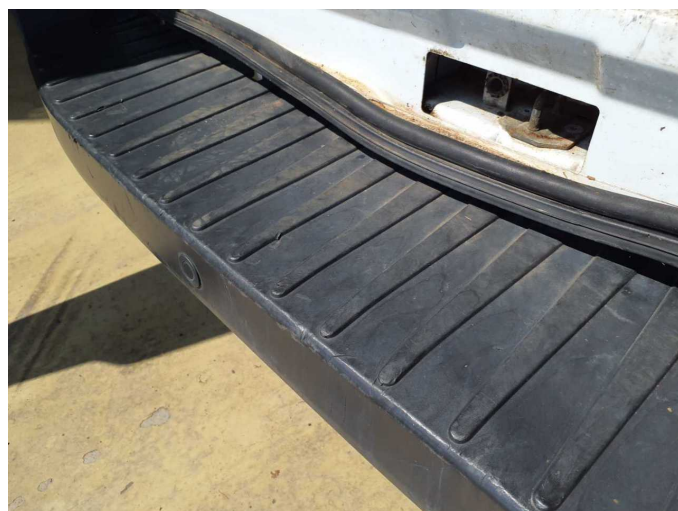
| No. | Component group | Description |
|---|---|---|
| 3 | Rear bumper | Rear bumper (unpainted) - dent(s) - Loss in value |

**Damage 3:** Rear bumper: Rear bumper (unpainted) - dent(s) - Loss in value

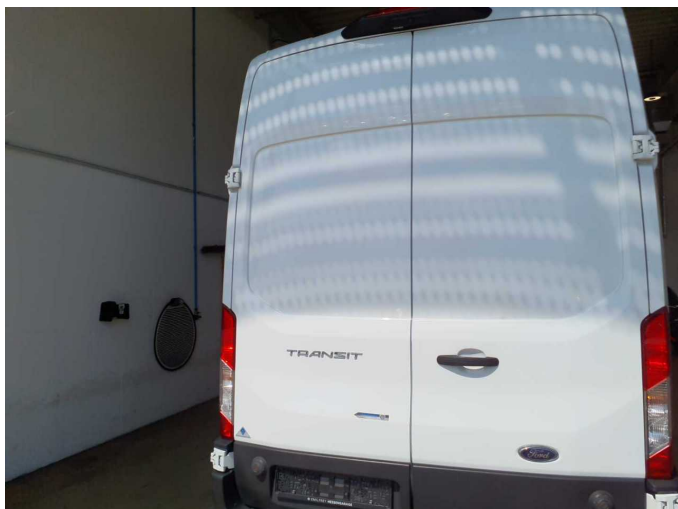
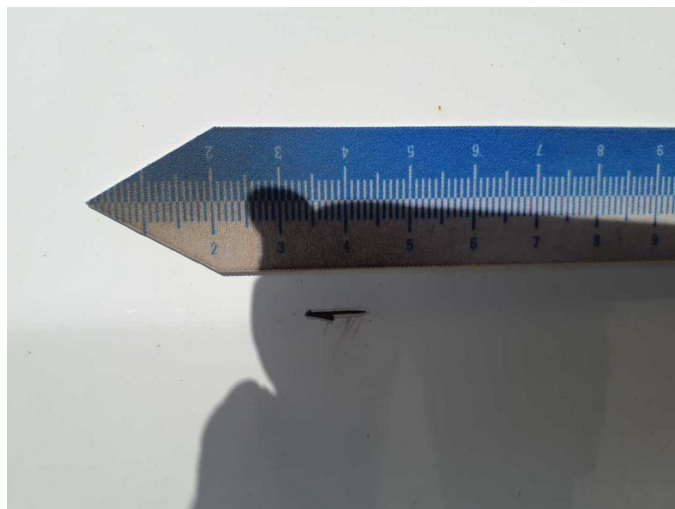
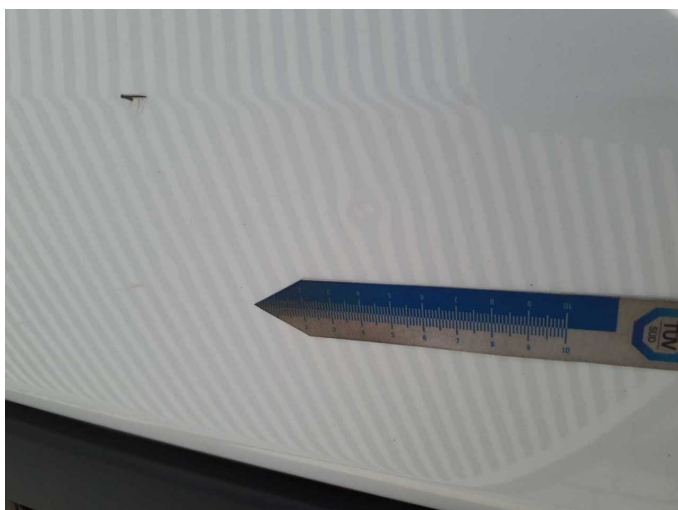
| No. | Component group | Description |
|---|---|---|
| 4 | Boot lid / rear door | Rear door - left side - Dent / paintcoat damage - Smart repair |

**Damage 4:** Boot lid / rear door: Rear door - left side - Dent / paintcoat damage - Smart repair

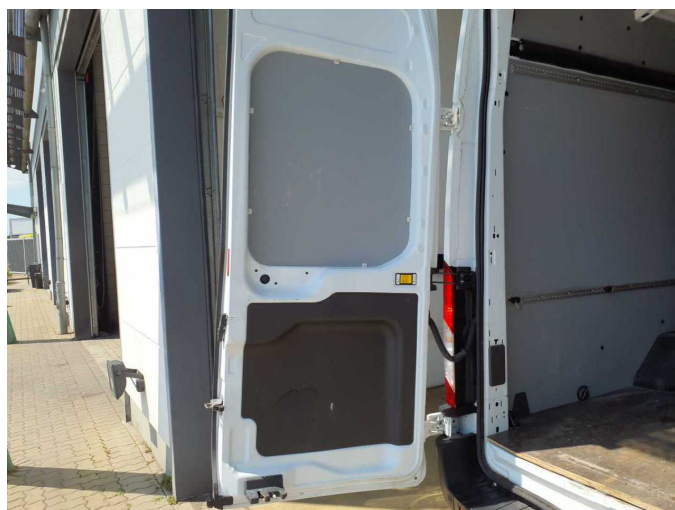
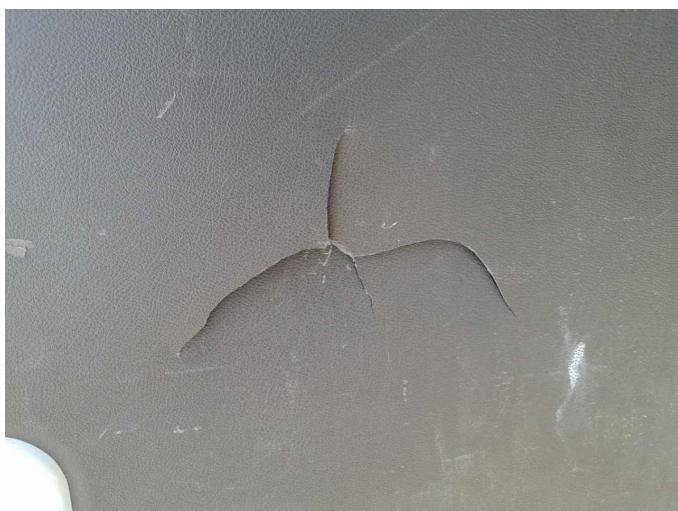
| No. | Component group | Description |
|---|---|---|
| 5 | Boot lid / rear door | Rear door - left side (Innenverkleidung) - Broken / torn - Replace |

**Damage 5:** Boot lid / rear door: Rear door - left side (Innenverkleidung) - Broken / torn - Replace

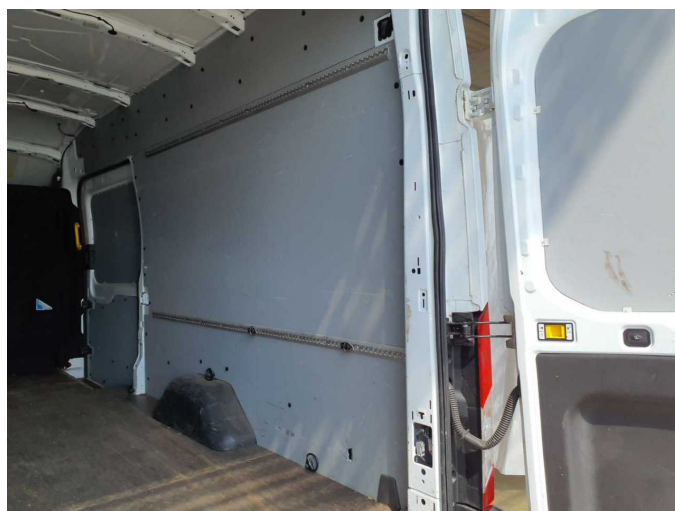
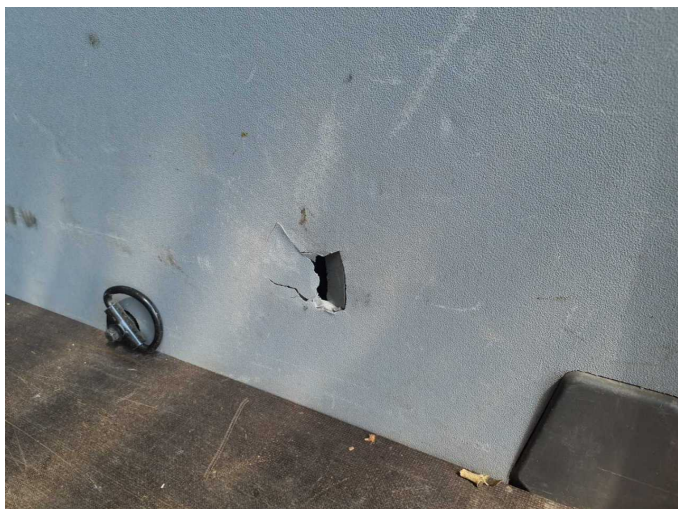
| No. | Component group | Description |
|---|---|---|
| 6 | Trim / covers | Cargo area - lining - right side - Holes - Replace |

**Damage 6:** Trim / covers: Cargo area - lining - right side - Holes - Replace

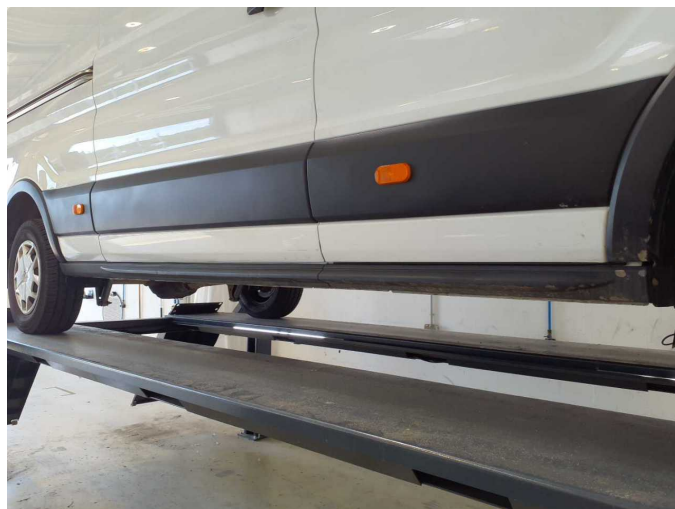
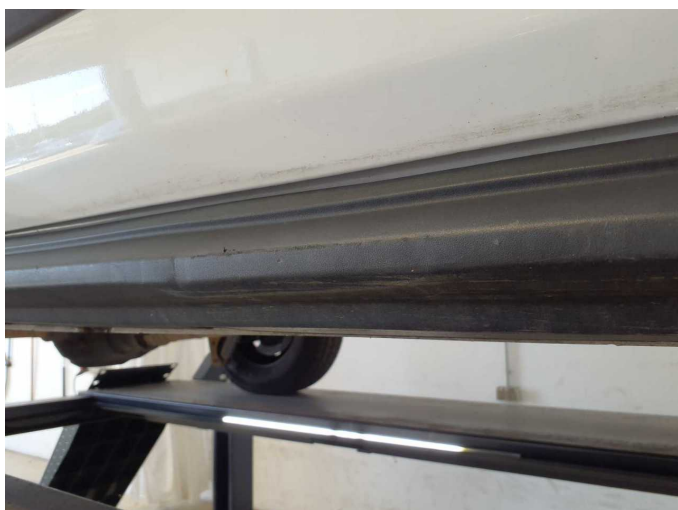
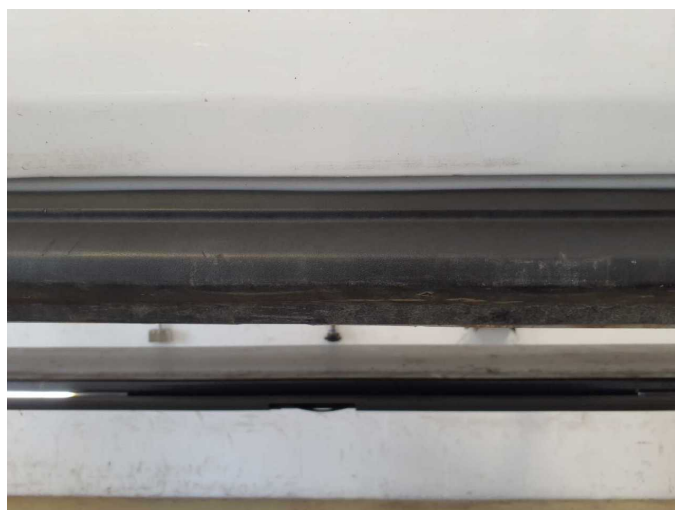
| No. | Component group | Description |
|---|---|---|
| 7 | Sill - right side | Trim - Scratch(es) - Replace |

**Damage 7:** Sill - right side: Trim - Scratch(es) - Replace

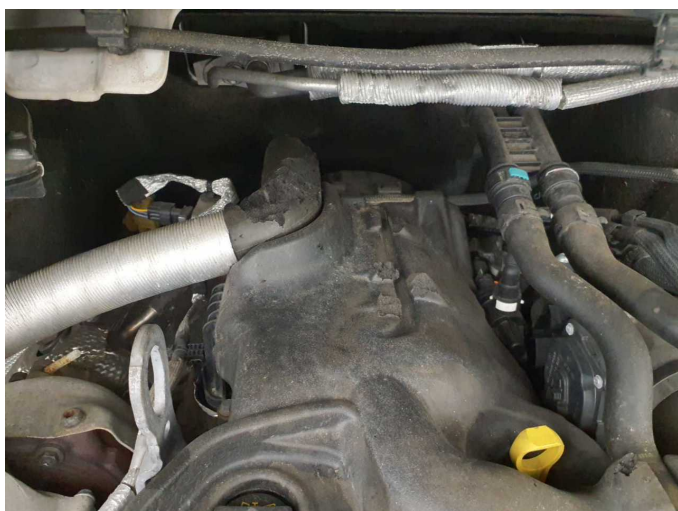
| No. | Component group | Description |
|---|---|---|
| 8 | Engine | Engine cover - Damage caused by marten / rodent - Replace |

**Damage 8:** Engine: Engine cover - Damage caused by marten / rodent - Replace

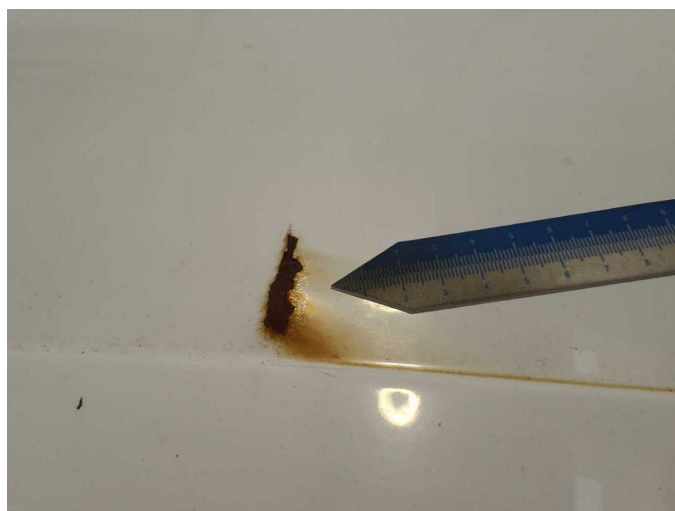
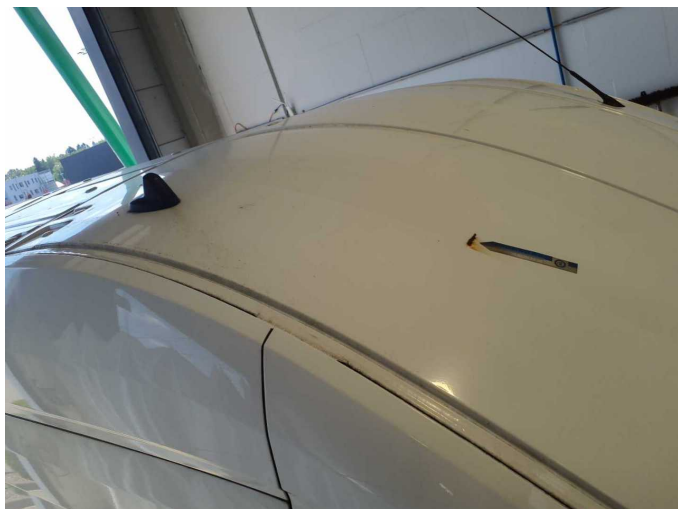
| No. | Component group | Description |
|---|---|---|
| 9 | Roof | Roof (vorne) - Corrosion - Paint |

**Damage 9:** Roof: Roof (vorne) - Corrosion - Paint

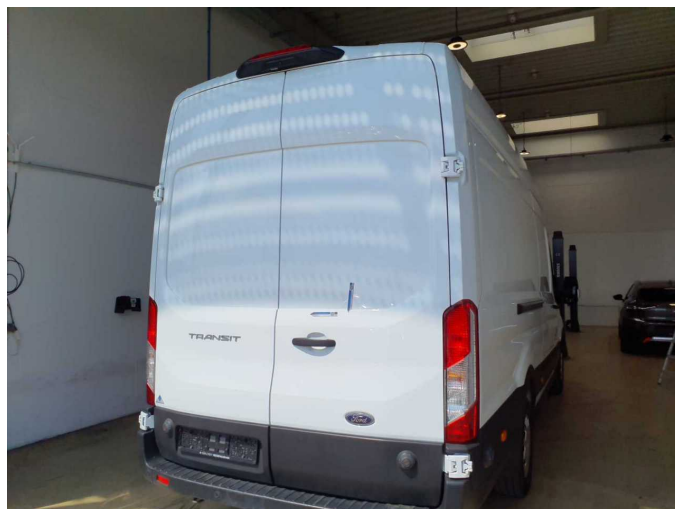
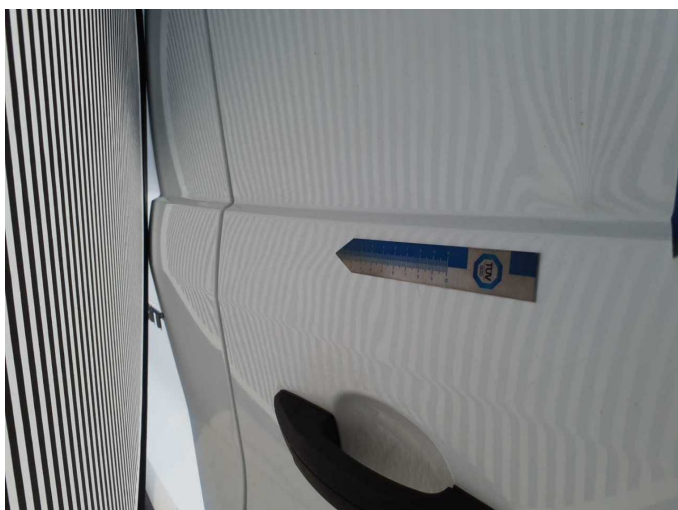
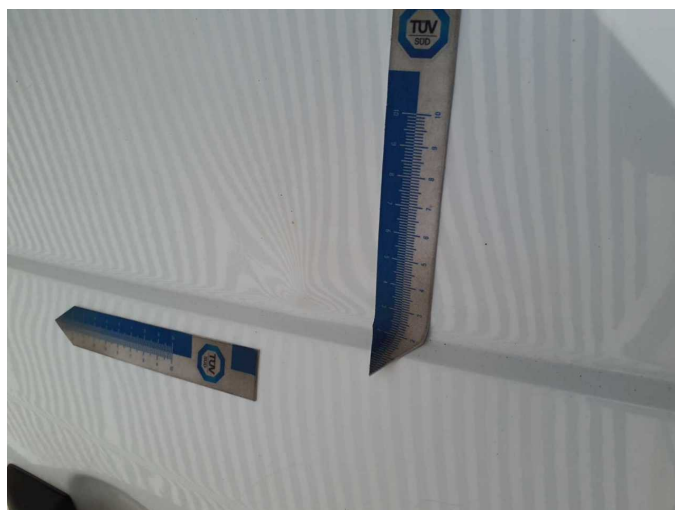
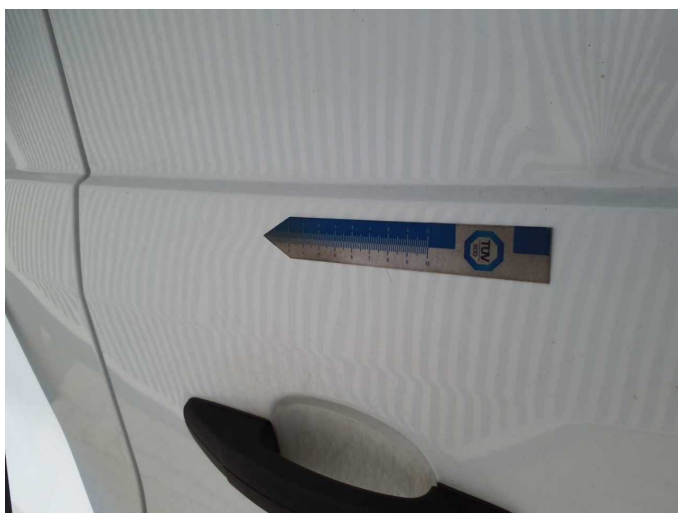
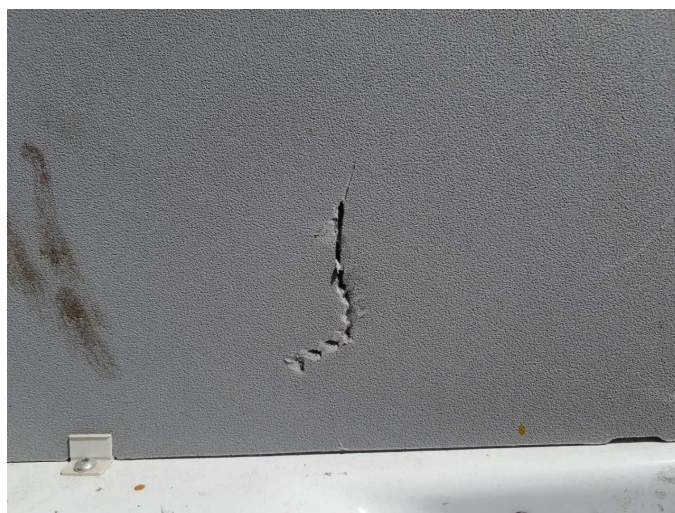
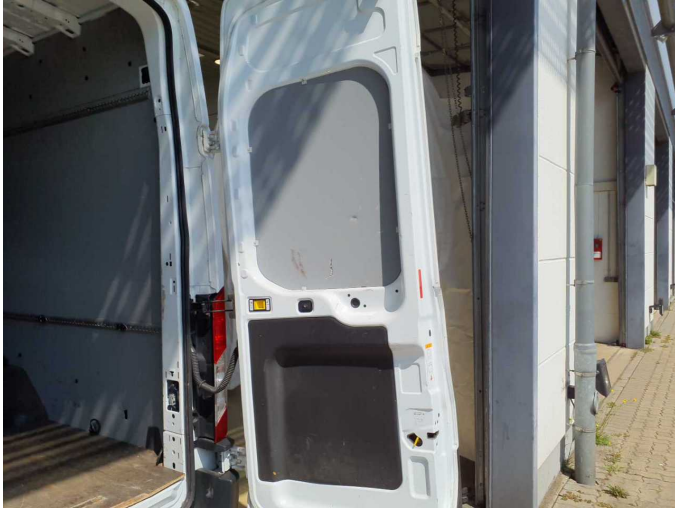
| No. | Component group | Description |
|---|---|---|
| 10 | Boot lid / rear door | Rear door - right side (+ Innenverkleidung erneuern) - Deformed - Paint |

**Damage 10:** Boot lid / rear door: Rear door - right side (+ Innenverkleidung erneuern) - Deformed - Paint

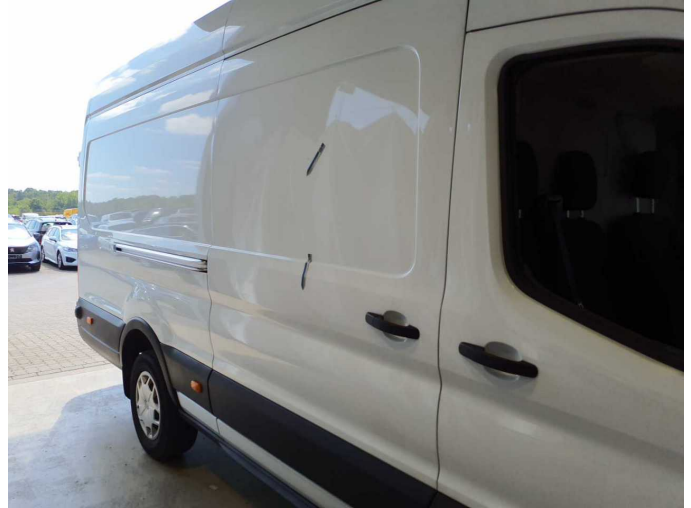
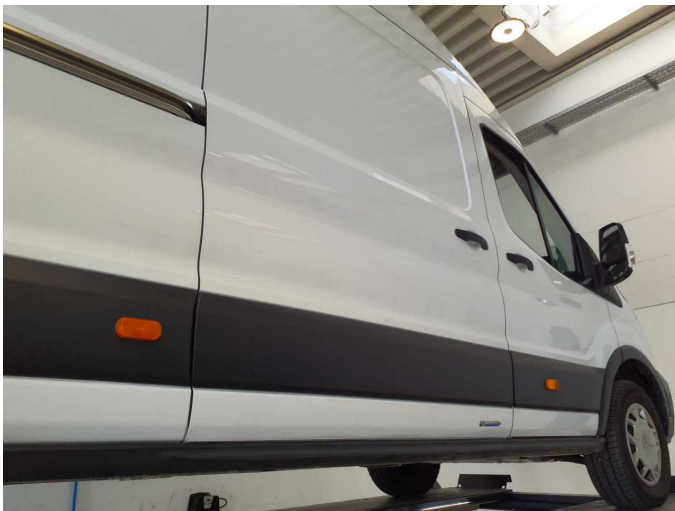
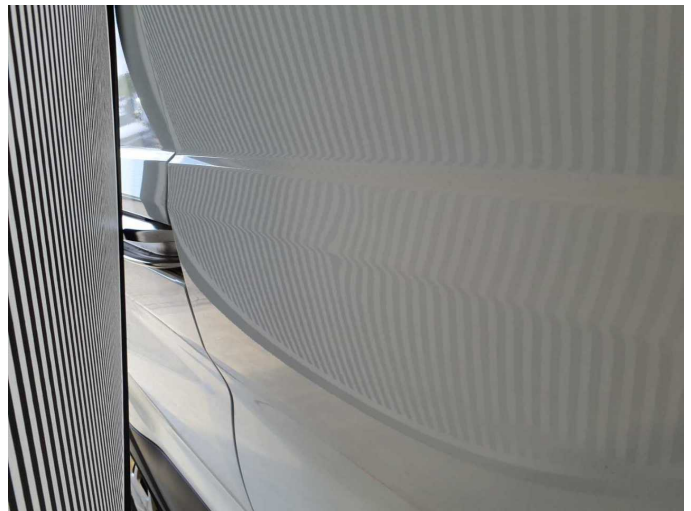
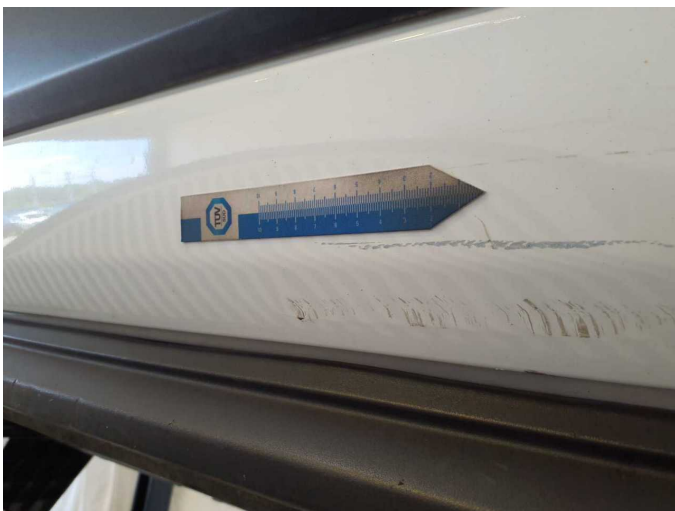
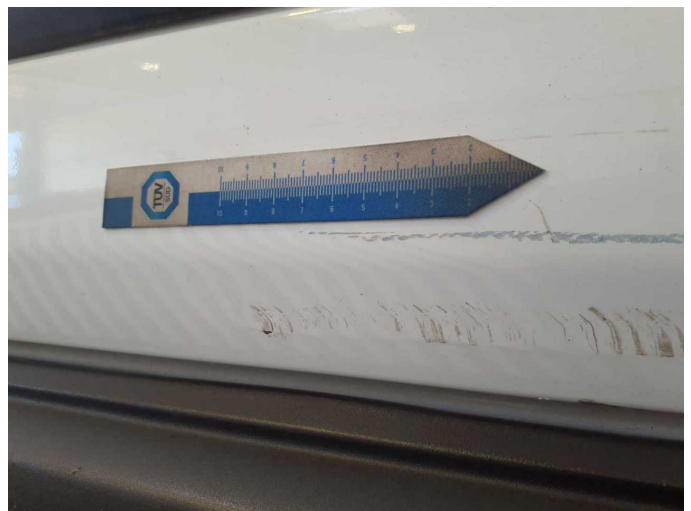
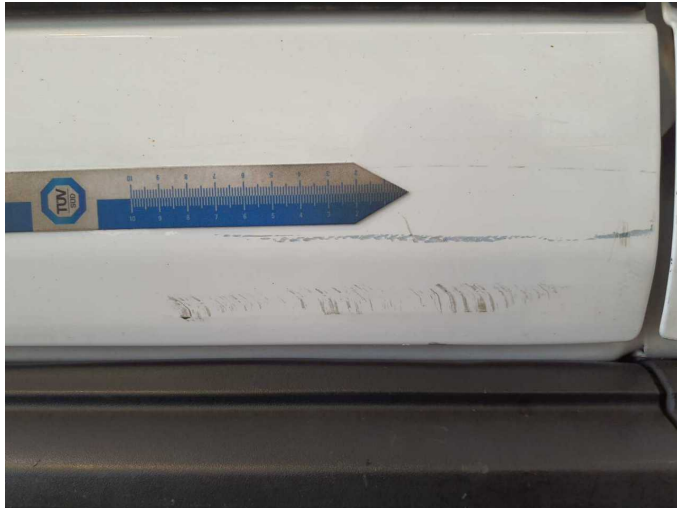
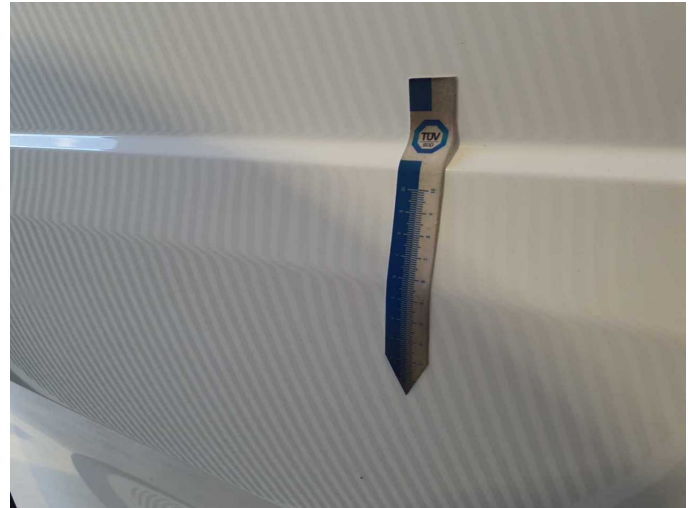
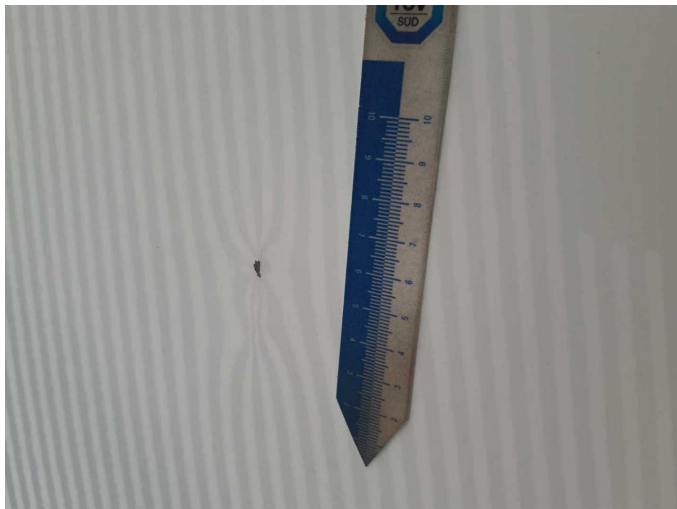
| No. | Component group | Description |
|---|---|---|
| 11 | Sliding door, right | Sliding door - Dent / paintcoat damage - Paint |

**Damage 11:** Sliding door, right: Sliding door - Dent / paintcoat damage - Paint
